Subj: DRINKING WATER LEAD SAMPLING RESULTS AT IKEGO CHILD

DEVELOPMENT CENTER

# Overview of Testing Results for Lead in Drinking Water and Corrective Actions for Fleet Activities Yokosuka Ikego Child Development Center (Building 673)

### Floor Plan - Ikego Child Development Center (Building 673)

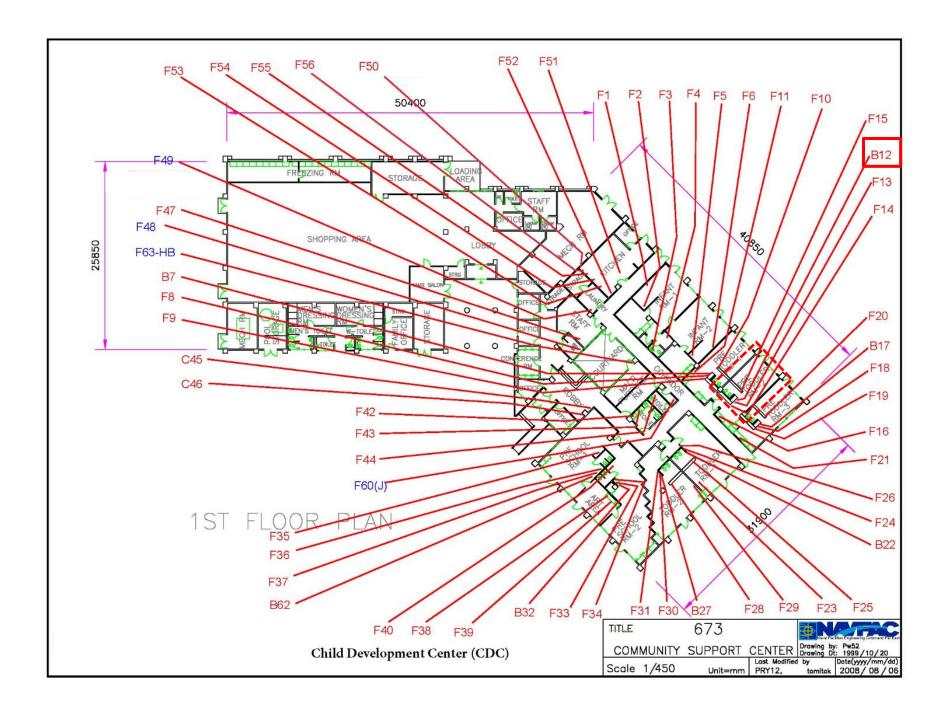
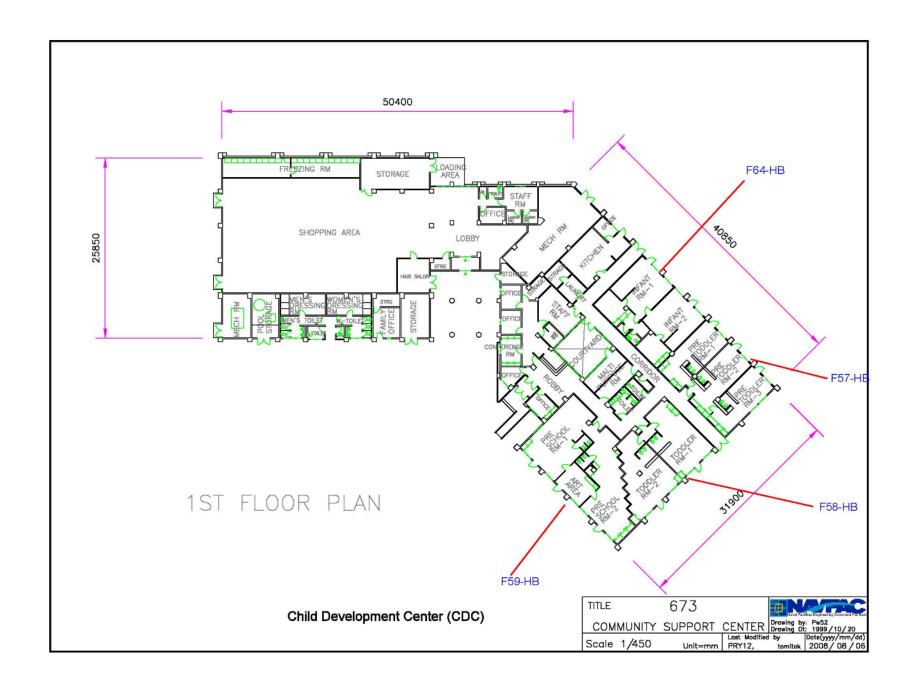
- 4. Details on the corrective actions we plan to take to reduce the amount of lead in water at this fixture, are discussed in enclosure (1). Also, enclosure (2) and enclosure (3) indicates the location of the fixtures that had lead levels higher than the screening level.

A floor plan of the FLEACT Yokosuka, Ikego CDC has also been included to show the locations for the fixtures that exceeded 15 ppb.

The outlet that exceeded the screening level of 15 ppb was a bubbler water fountain located in the Pre-toddler #2 room, which tested at 14 ppb and 30 ppb, respectively. Since follow-up testing indicates that the elevated levels of lead appeared to be caused by the components of the bubbler water fountain and upstream plumbing, the supply valve to the fountain was closed rendering it unusable. A new fountain and upstream piping will be installed. Per EPA guidance, this outlet will remain out of service until corrective actions are completed. Testing will be conducted after implementation of corrective measures.
