**Naval Facilities Engineering Command Southwest
BRAC PMO West
San Diego, CA**

**AIR MONITORING SUMMARY REPORT
FOR PARCEL E REMEDIAL ACTION
PHASE 2**

HUNTERS POINT NAVAL SHIPYARD, SAN
FRANCISCO, CALIFORNIA

January 1st, 2021 through January 31st, 2021

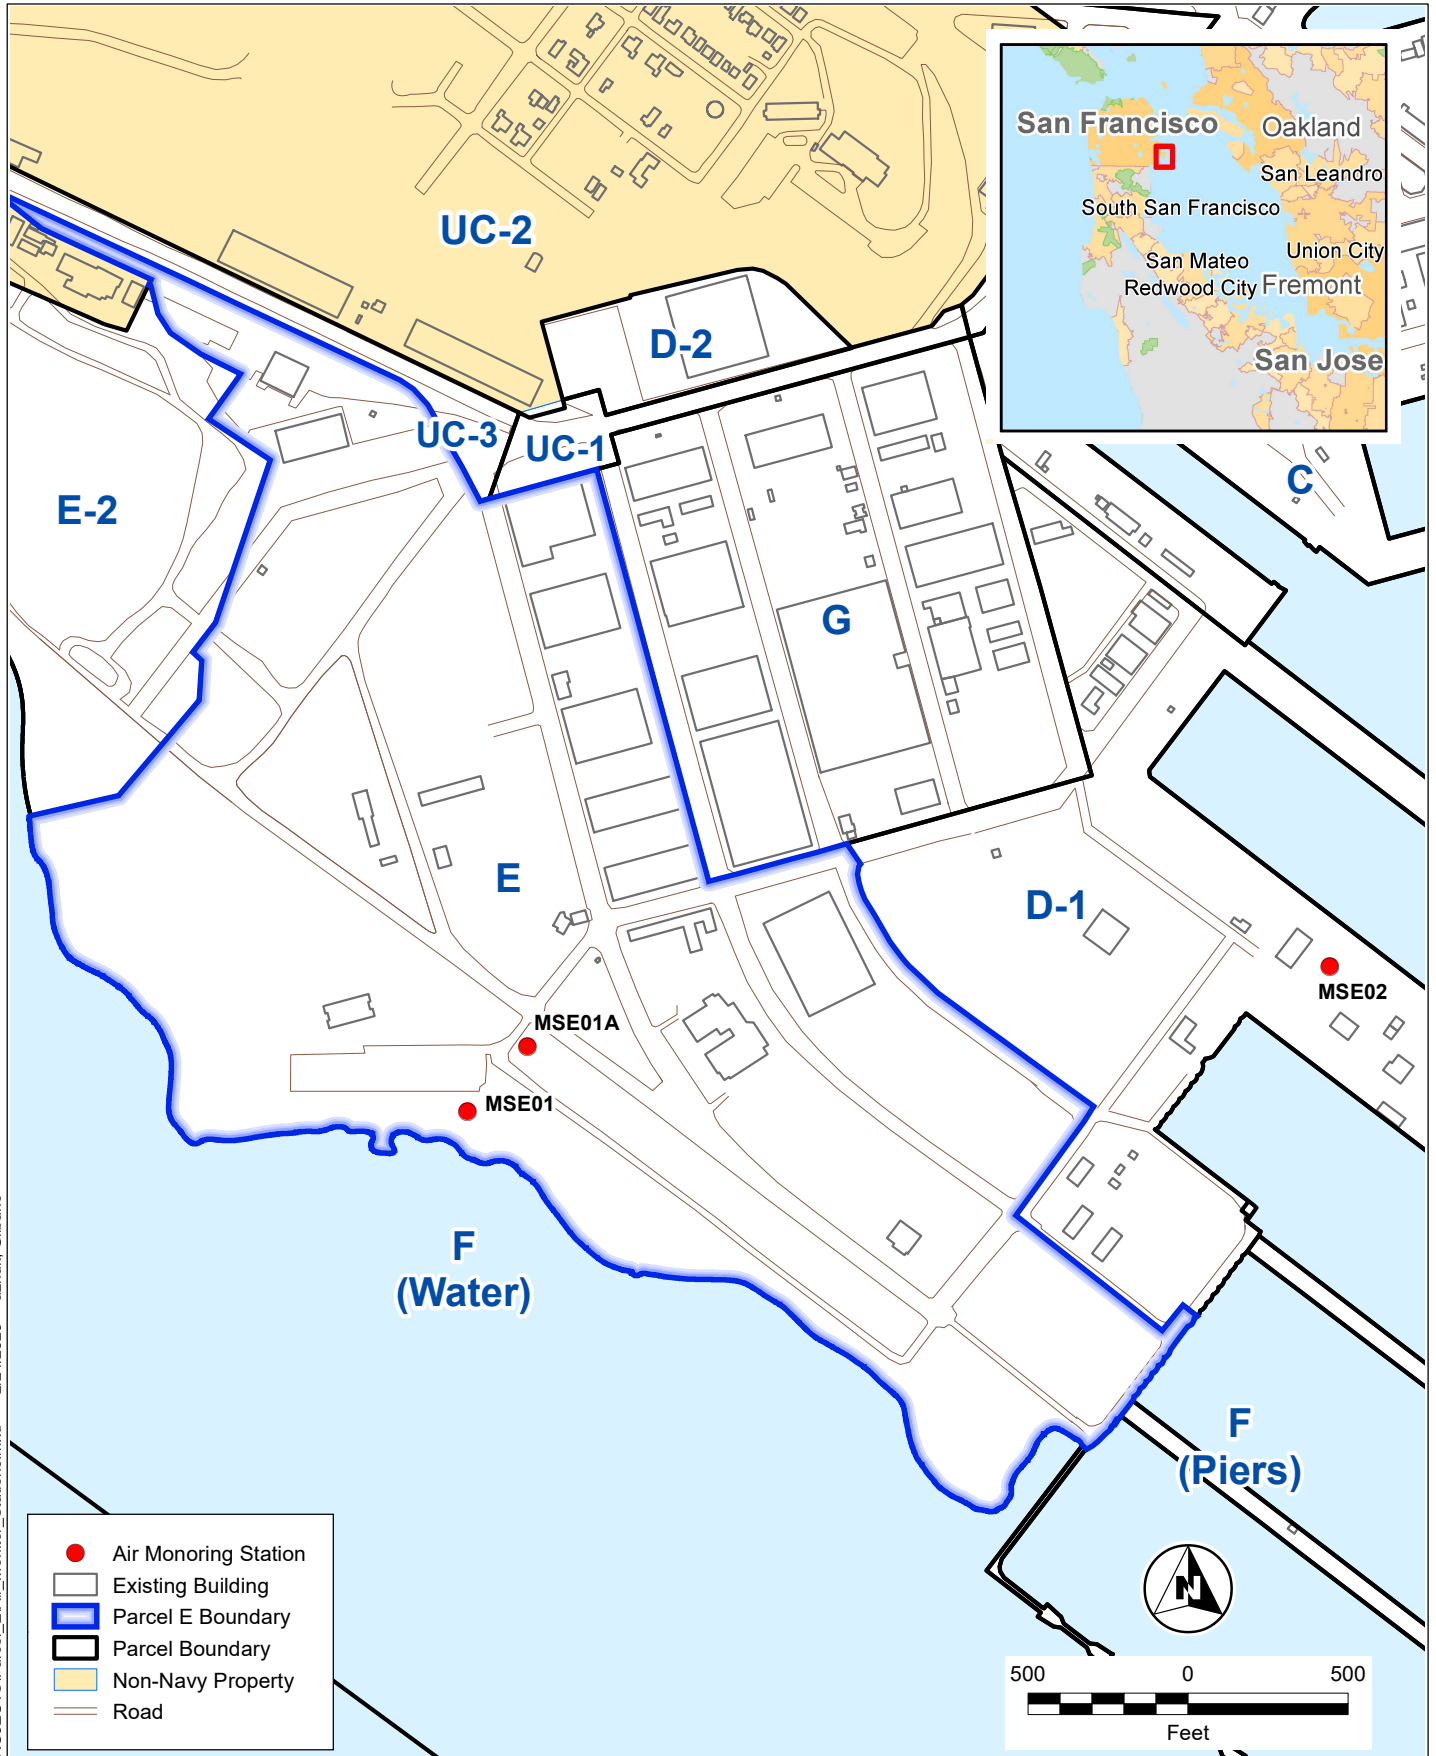
Figure 2-1
Air Monitoring Stations

Air monitoring stations were deployed at one upwind and one downwind location from the work area whenever active soil handling operations were in progress. Based on past meteorological data, the prevalent wind direction at HPNS was from the west or west-southwest. The locations of Parcel E air monitoring stations are presented on Figure 2-1.

Sample locations are shown on Figure 2-1
