# SEE INSIDE FOR INFORMATION ABOUT NAVY ENVIRONMENTAL WORK IN THE TREASURE ISLAND HOUSING AREA

## Recently Completed, Ongoing, and Upcoming Fieldwork in the Treasure Island Housing Area

This fact sheet presents the different projects that are recently completed, ongoing or beginning soon.

February 2021

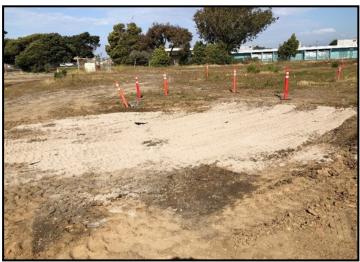
Photograph 2: Backfilled Excavation at Halyburton Court

Forty-one discrete locations were identified for excavations within the northern portion of Site 12 purple dots on map. Eighteen additional locations were identified within Halyburton Court. The discrete chemical excavations were completed between 2018 and 2020. Chemicals of concern identified in soil were: lead, polycyclic aromatic hydrocarbons (PAHs), polychlorinated biphenyls (PCBs), and dioxins. Additionally, chromium and pesticides were included in soil removal actions. Excavated soil was radiologically surveyed and characterized for waste disposal. For each discrete excavation, clean imported soil was used as backfill. Following completion of excavations and disposal, the site was restored with an approved grass seed mix compatible with adjacent areas.

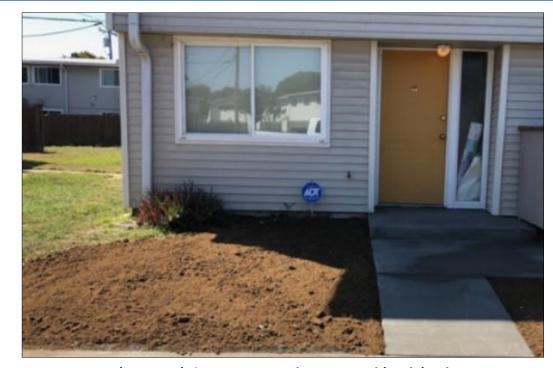
Photograph 3: Post excavation near residential unit

In September 2019, during the discrete chemical excavations in the housing area, surface scans performed under a removed concrete walkway at a residential unit identified fragments of a degraded low-level radiological object in the soil (indicated on the map with an orange dot). The soil was removed, the site was backfilled with clean soil, and a new concrete walkway was installed. Radiological scans performed at the site by the Navy and California Department of Public Health (CDPH) confirmed there was no health risk to local residents or the public while impacted material was in place, during its removal, and after site restoration. Further details regarding this discovery can be found at "Timely Topics" section of the Navy's website.

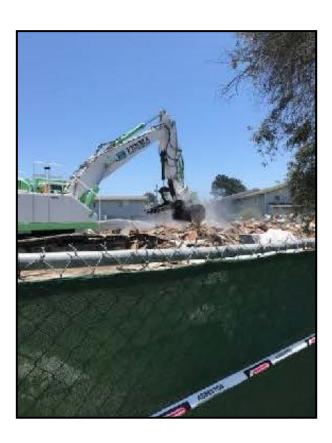
Photograph 4: Demolition of Building 1217

Buildings 1126 and 1217 were demolished in order to remove chemical contamination under and around the foundations. Building 1127 was also demolished because of fire damage sustained in 2018. Prior to demolition, radiological scanning and asbestos abatement were completed. The concrete foundations of 1126 and 1217 were broken up and moved to Westside SWDA for further evaluation. All materials generated during the demolition were radiologically scanned prior to being transported offsite for disposal.

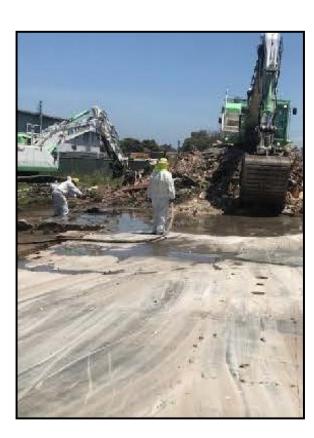
Photograph 5: Cleared foundation at
Building 1126

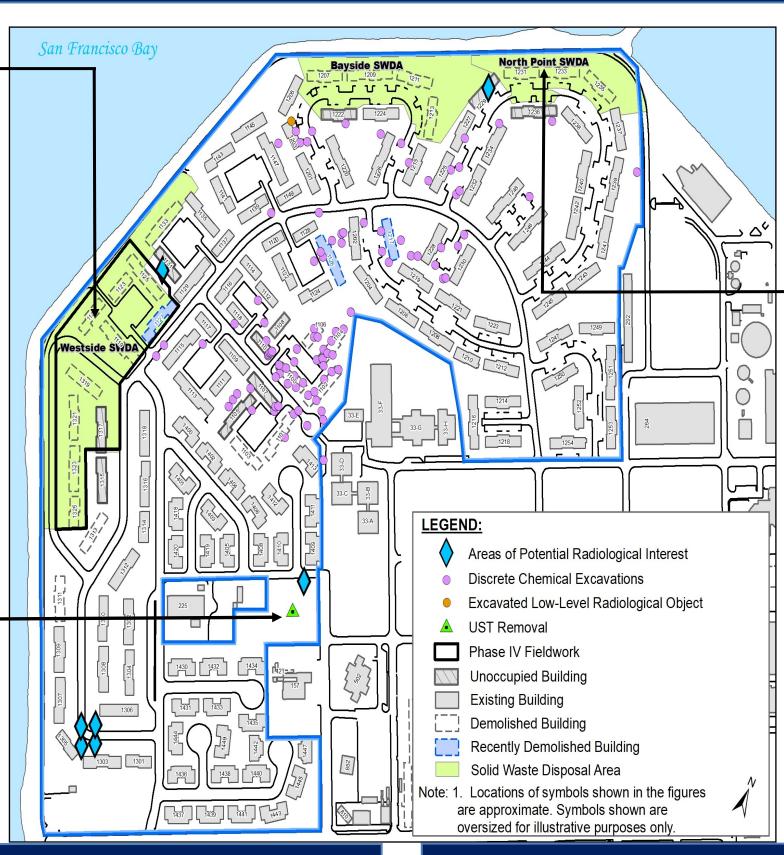
The Westside SWDA Phase IV fieldwork will begin in early 2021. This Phase IV fieldwork area is noted on the map in black. Fieldwork will include removal of excavated soil and debris currently stockpiled from previous phases of work. The site will be graded with approximately 16,000 cubic yards of approved import fill. Noise associated with heavy equipment backup alarms is anticipated during normal working hours. Dust control and air monitoring will be implemented to prevent airborne particulates and maintain public safety. The site surface will be restored with an approved grass seed mix compatible with adjacent areas.

Fieldwork at seven subsurface radiological areas of interest is scheduled to begin in spring 2021 and will last for approximately 2 weeks. The seven areas (see blue diamonds on map) were identified for additional evaluation. Prior to the evaluation, a temporary radiological control area will be established around each location. The evaluations will be performed by excavating and performing radiological surveys and scans of the excavated soil. All fieldwork will be conducted under third party oversight. The radiological isotope of concern for these seven areas of interest is Radium-226.

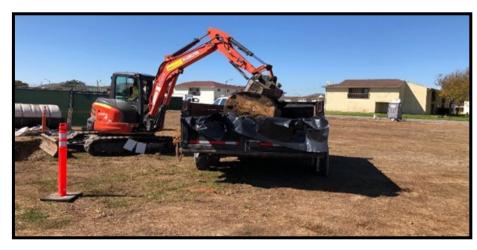
Photograph 6: Removal of underground storage tank

In 2019, two underground storage tanks (USTs) were identified during remediation activities in an open field within the 1400 series housing area. The USTs were used for total petroleum hydrocarbon (TPH) storage. The tanks were removed along with the TPH-contaminated soil from the area. The tanks and soil were radiologically scanned prior to being transported offsite for disposal. Confirmation soil samples were collected within the excavations and clean backfill was used. The site surface was restored with an approved grass seed mix compatible with adjacent areas.

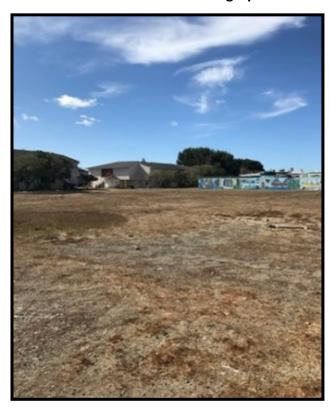
Photograph 7: Underground storage tank location near 1400 series housing

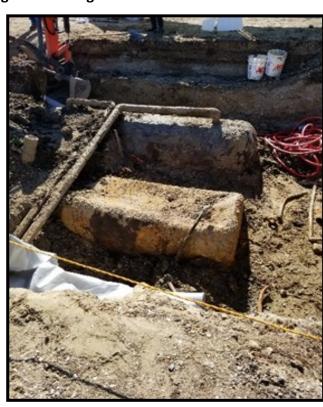
Photograph 8: Underground storage tanks
