2021 Look Back / 2022 Look Ahead Environmental Cleanup Program

Naval Station Treasure Island Restoration Advisory Board Meeting

12/8/2021

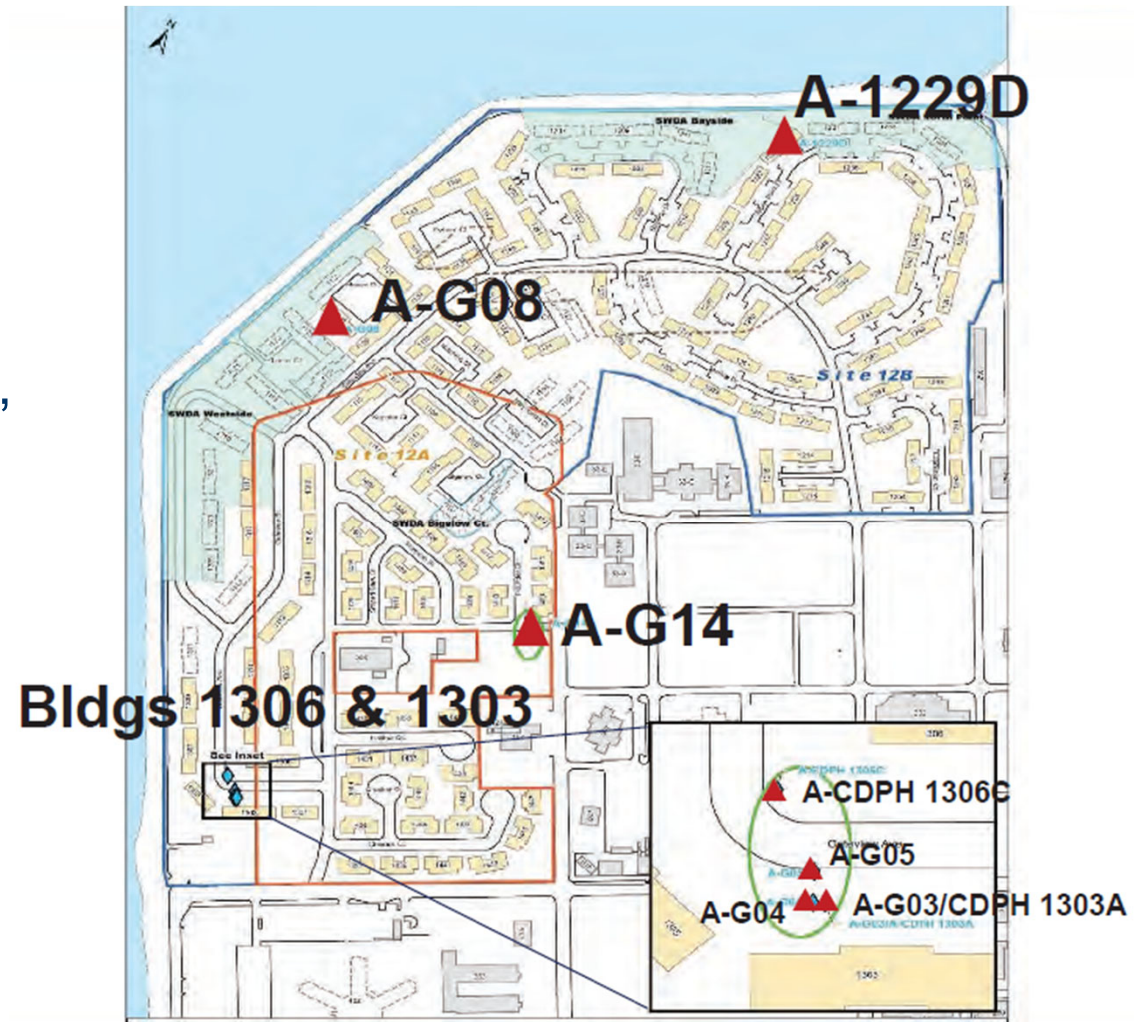
- Investigated seven (7) previously identified radiological anomalies by excavating June 7-18, 2021
- Only one of seven locations, presented a low-level radiological object (LLRO)
- This LLRO was under the foundation of Bldg 1229. A vacant building which was never leased to TIDA for occupancy

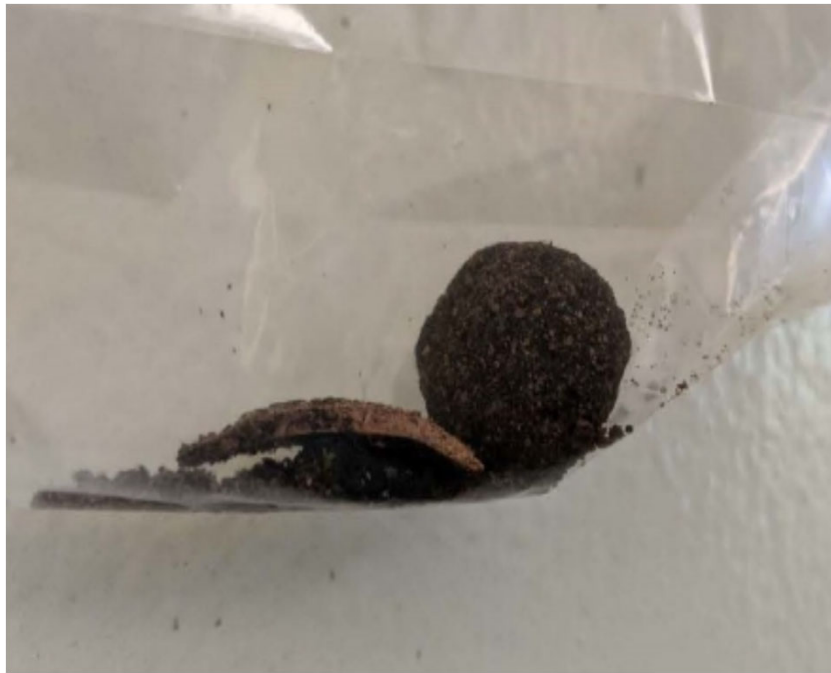
• A-1229D Excavation

A-1229D Excavation LLRO – Clump of Sandy Material

- No previous excavation was performed at this location
- Sawed through approximately 4 inches of concrete
- A LLRO was found approximately 2 inches below concrete
- The LLRO was a 1 inch diameter clump of sandy material
- Removed one cubic foot of material around and below LLRO location
- No additional elevated counts were recorded following the removal

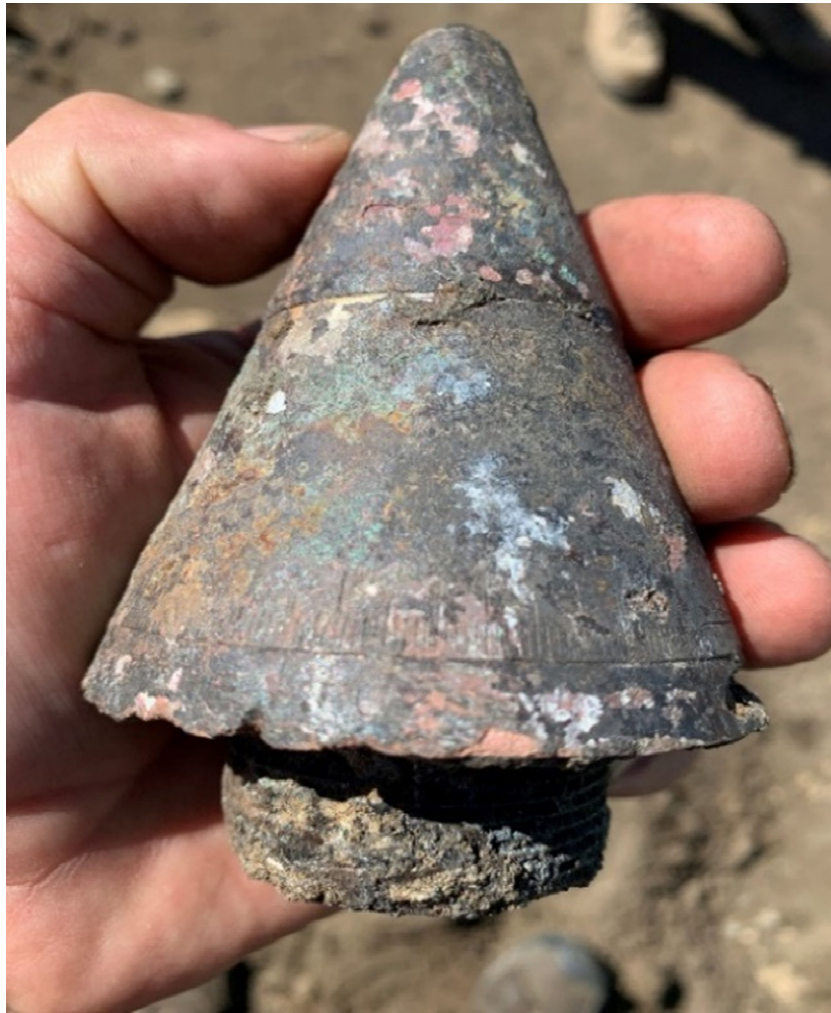
Projectile Fuze (MEC)

- 26 MEC and 77 MDAS items recovered to date during the Phase IV NTCRA fieldwork
 - Cartridge cases
 - Projectiles
 - MK II Hand Grenades

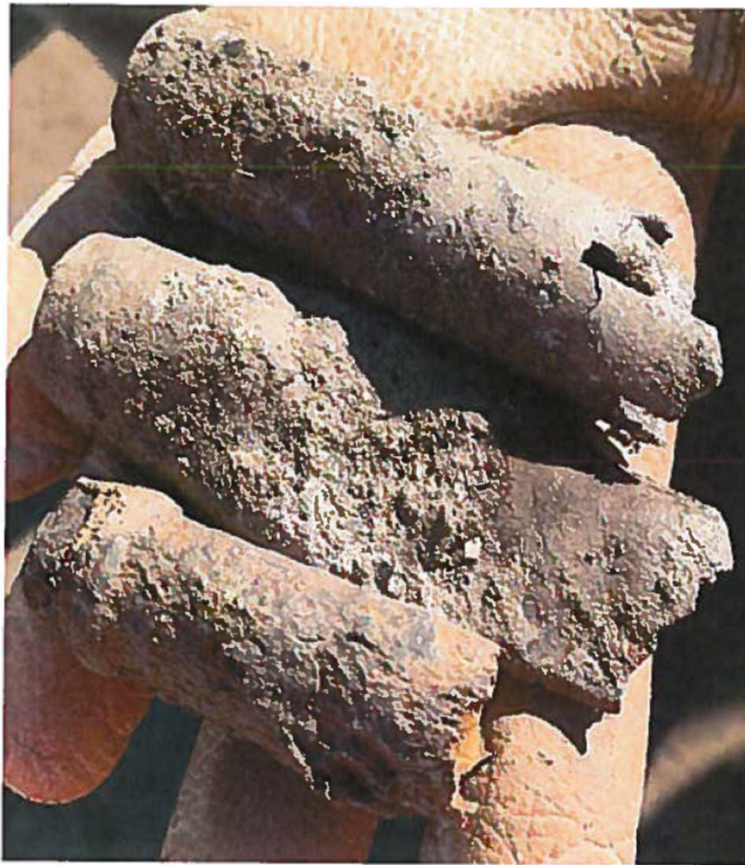
Top two items 20mm cartridge cases
Bottom item 20 mm projectile (MDAS)

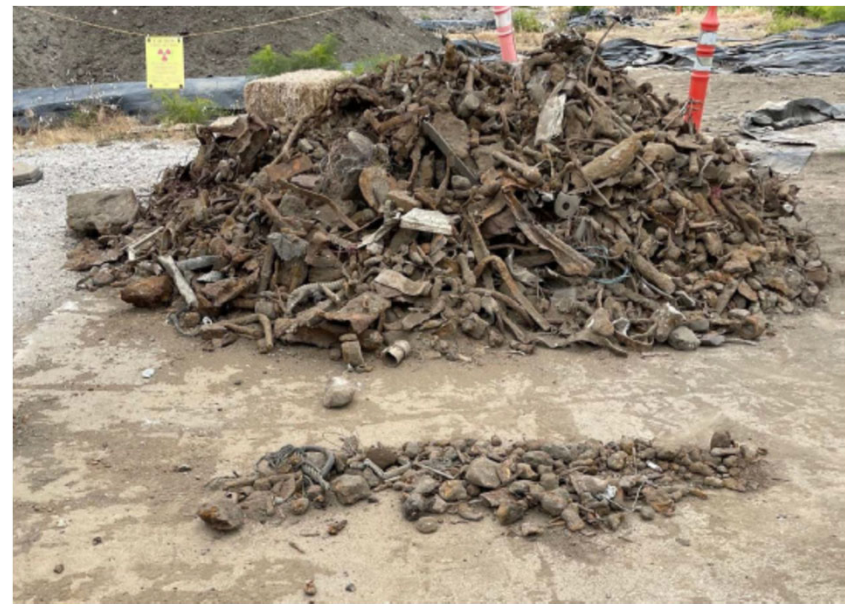
Metallic debris encountered in stockpiles

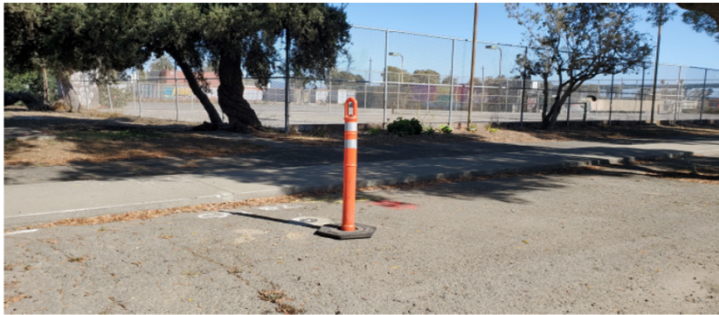
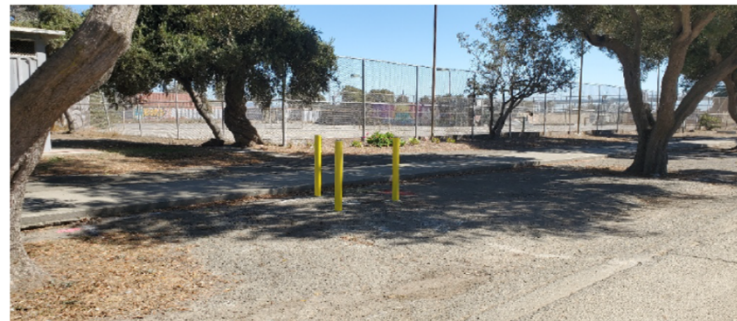
Before and after the bollard installation on Ave M

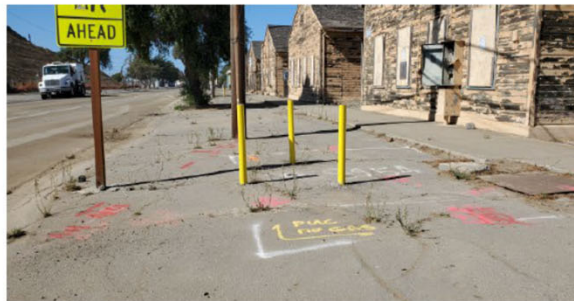
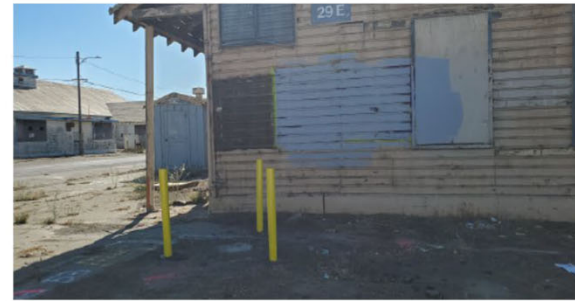
Typical bollard installation, embedded about 2' and filled with cement

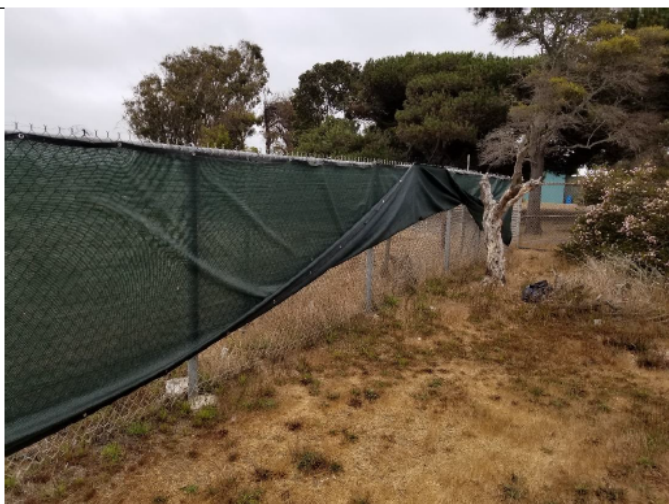
Halyburton / Bigelow Ct.
(Site 12):
View of loose privacy screen along the southeast boundary of the site. View to N.

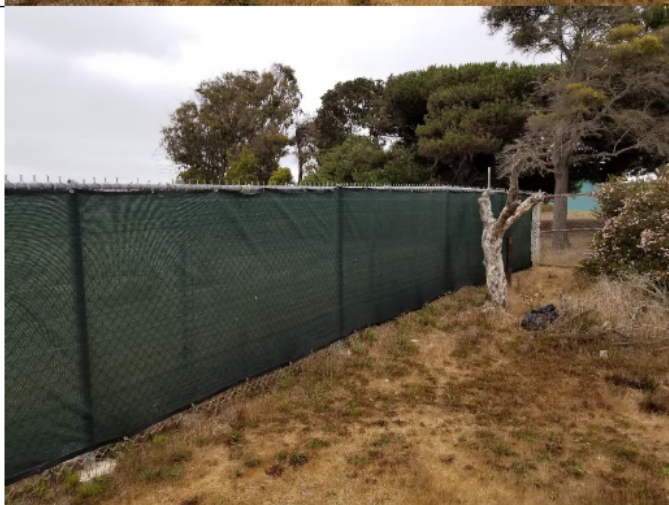
Halyburton / Bigelow Ct.
(Site 12):
Privacy screen re-attached to fence mesh. View to N.

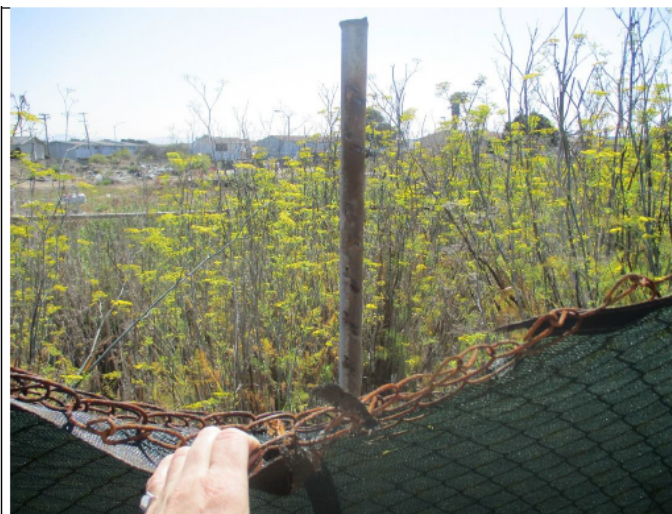
SWDA Westside Site 12:
View of fence post detached from fence mesh. View to E.

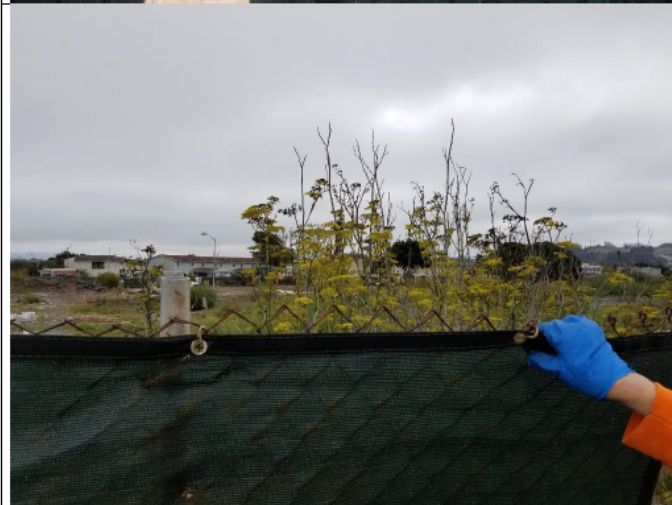
SWDA Westside Site 12:
Fence post re-attached to fence mesh. View to E.
