ENVIRONMENTAL CONDITION OF PROPERTY REPORT

NAVAL AIR STATION JOINT RESERVE BASE
WILLOW GROVE, PENNSYLVANIA

11 May 2006

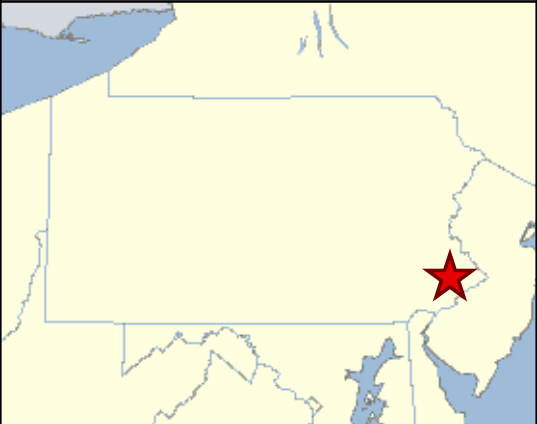
SITE LOCATION MAP

- CERCLA Sites
- County Line
- Roads
- Buildings
- NAS JRB Willow Grove
- U.S. Navy owned
- Willow Grove Air Reserve Station owned

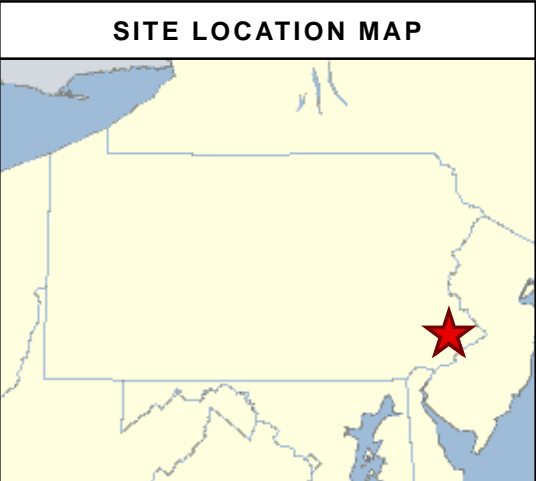
- Aboveground Storage Tank Locations*
- County Line
- Roads
- Buildings
- NAS JRB Willow Grove
- U.S. Navy owned
- Willow Grove Air Reserve Station owned

*RN (N), RN (S), Fly Club, and Building #621 not depicted on figure.

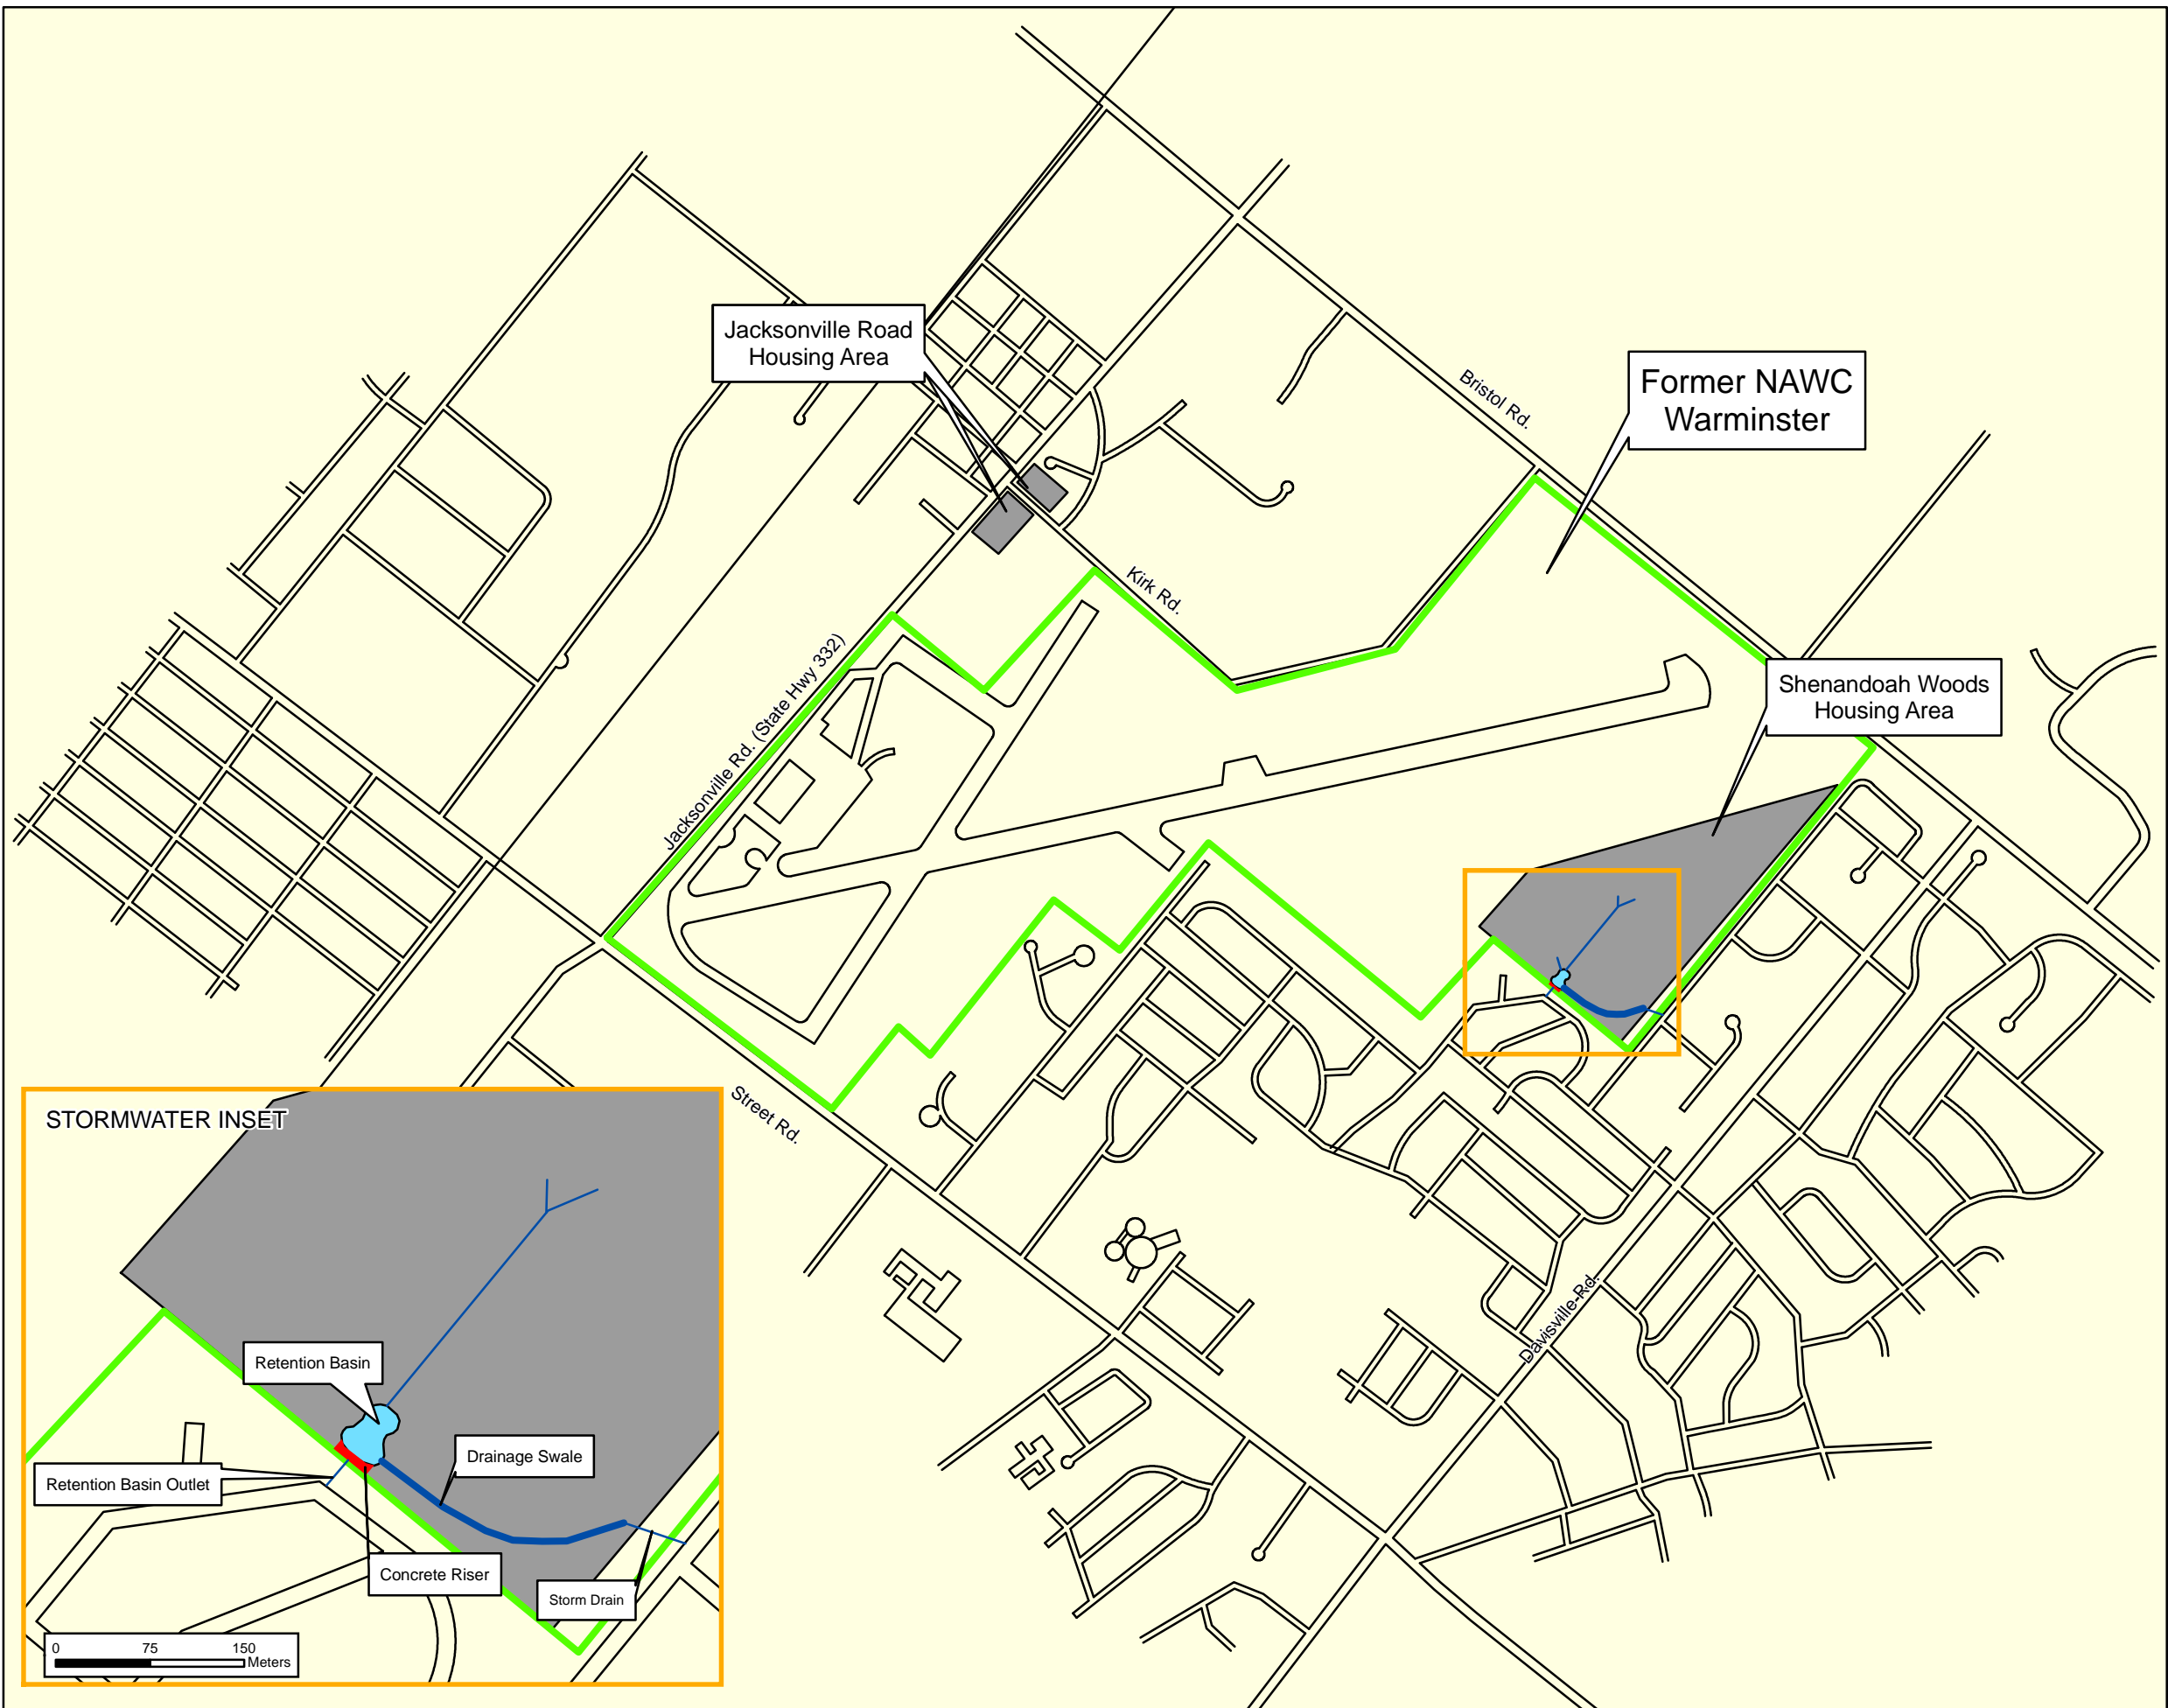
FIGURE
4-1

LOCATION OF STORMWATER RETENTION BASIN
