NAVAL ACTIVITY PUERTO RICO

Restoration Advisory Board Meeting

29 August 2018

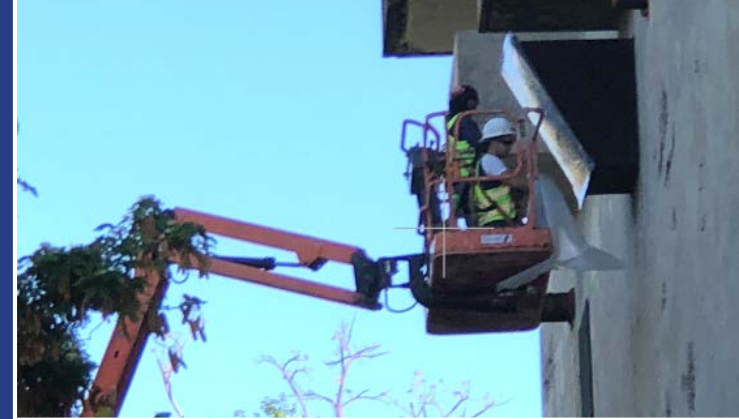
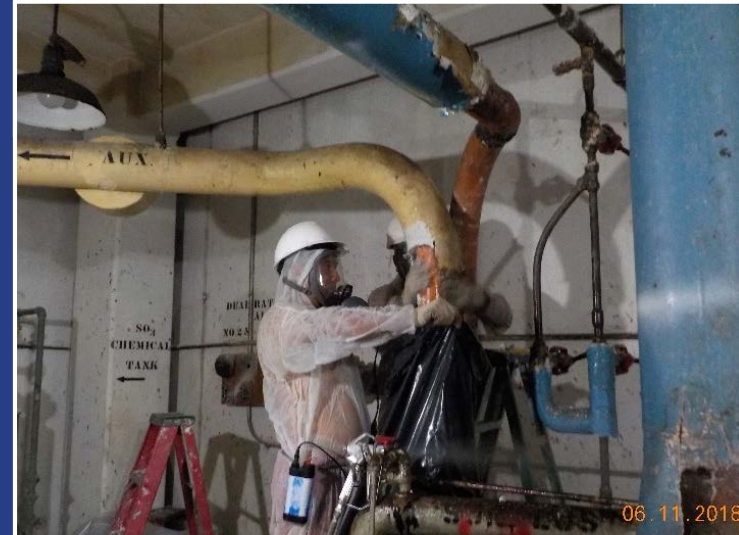
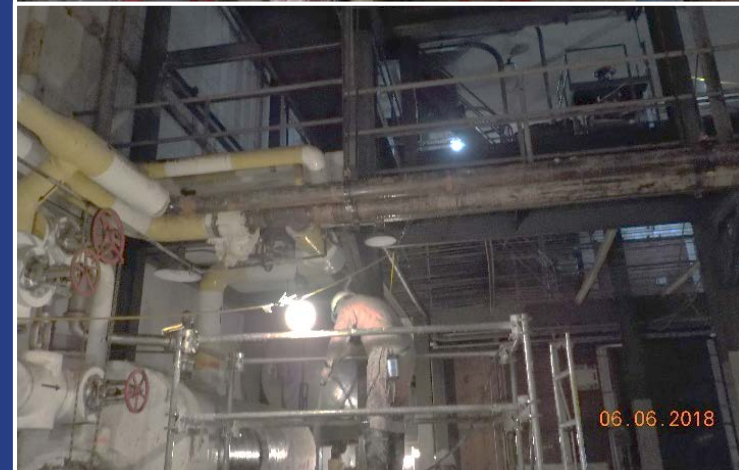
- Phase 1
 - Mobilization, pre-cleaning of work areas and sealing building
 - Sampling/analysis & disposal of pooled water in north room
- Phase 2
 - Asbestos removal in south room
 - Debris removal in north room
 - Asbestos removal in north room
- Phase 3
 - PCB removal using decontamination gel throughout building
 - Confirmation sampling to determine effectiveness of PCB removal

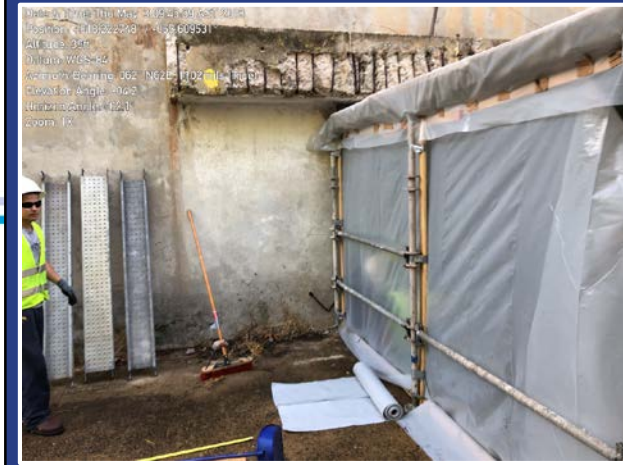
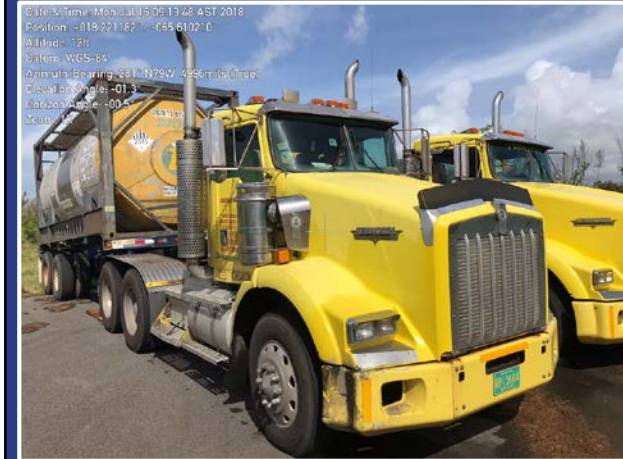
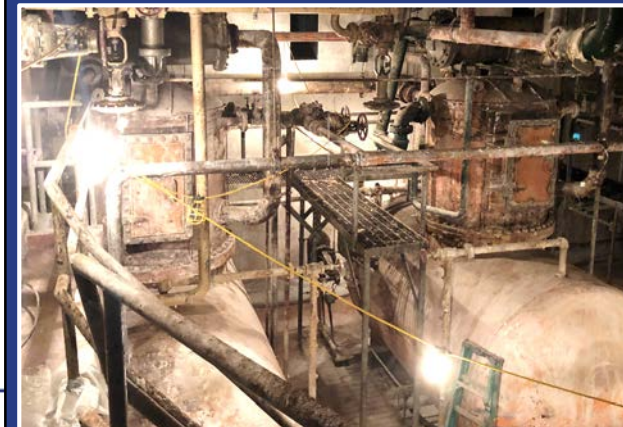
- Phase 1 complete
 - Building sealed and under negative pressure using 15 negative air machines
 - North room pooled water sampled, analyzed and transported off island for disposal
- Phase 2 in progress
 - All bulk asbestos removed from south room
 - Bulk debris sampled, analyzed and currently being removed from north room
 - Tar sealant from trenches has been sampled and sent to laboratory for analysis
- Phase 3 September 2018
 - Work will continue through the remainder of calendar year 2018

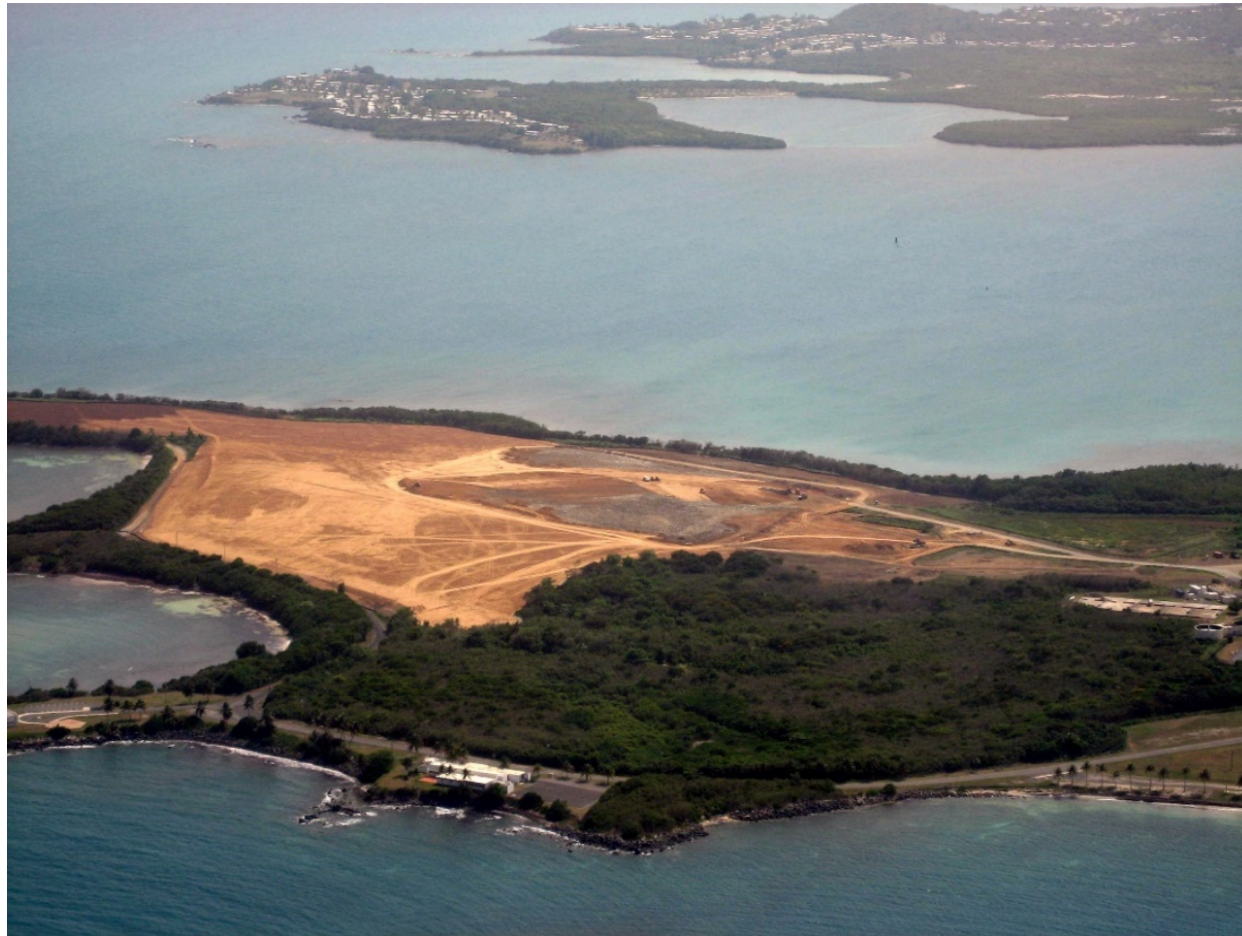
- Phase 1 closure construction began January 2007
- Navy accepted Phase 1 closure December 2007

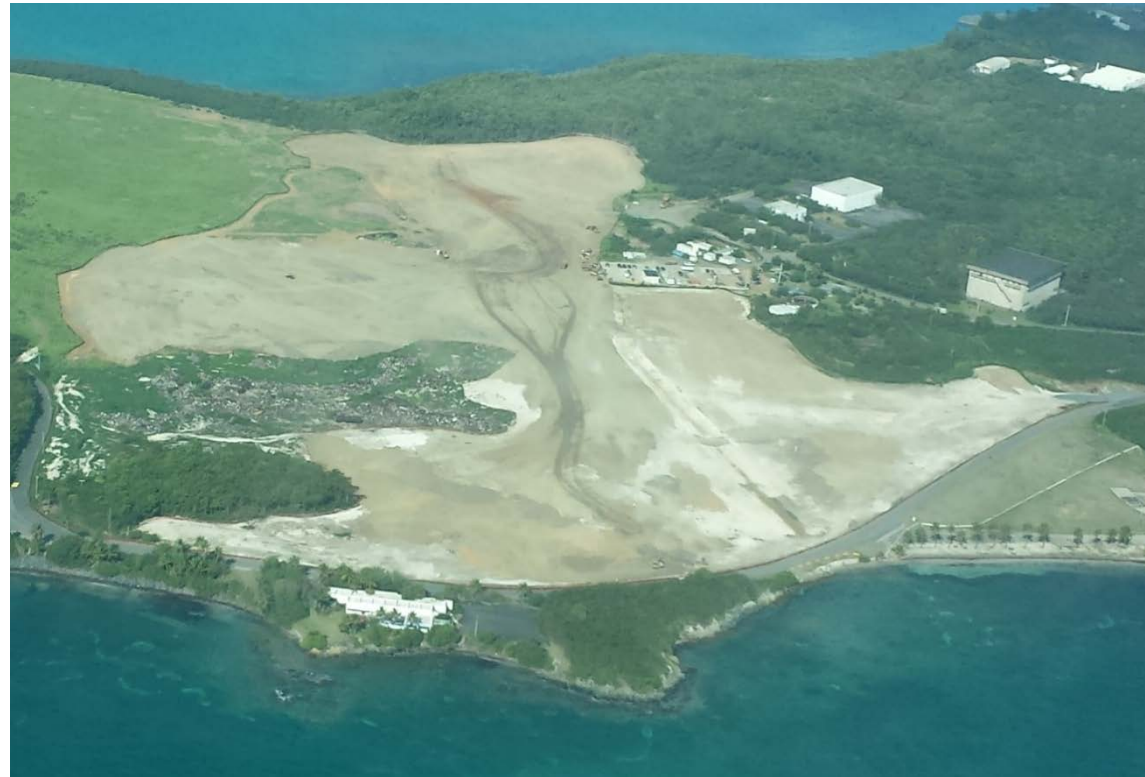
- Phase 2 closure construction began December 2014
- Navy accepted Phase 2 closure December 2016

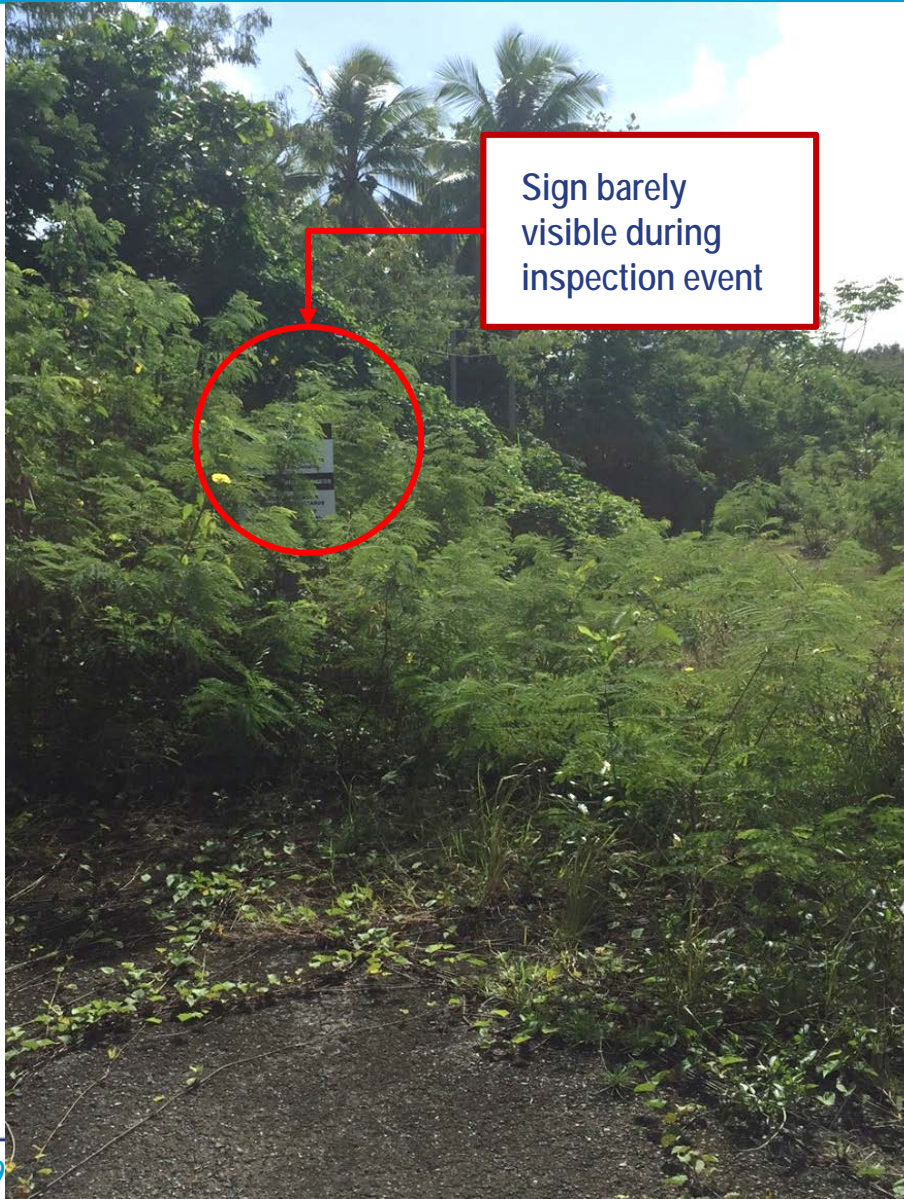
Sign barely visible during inspection event

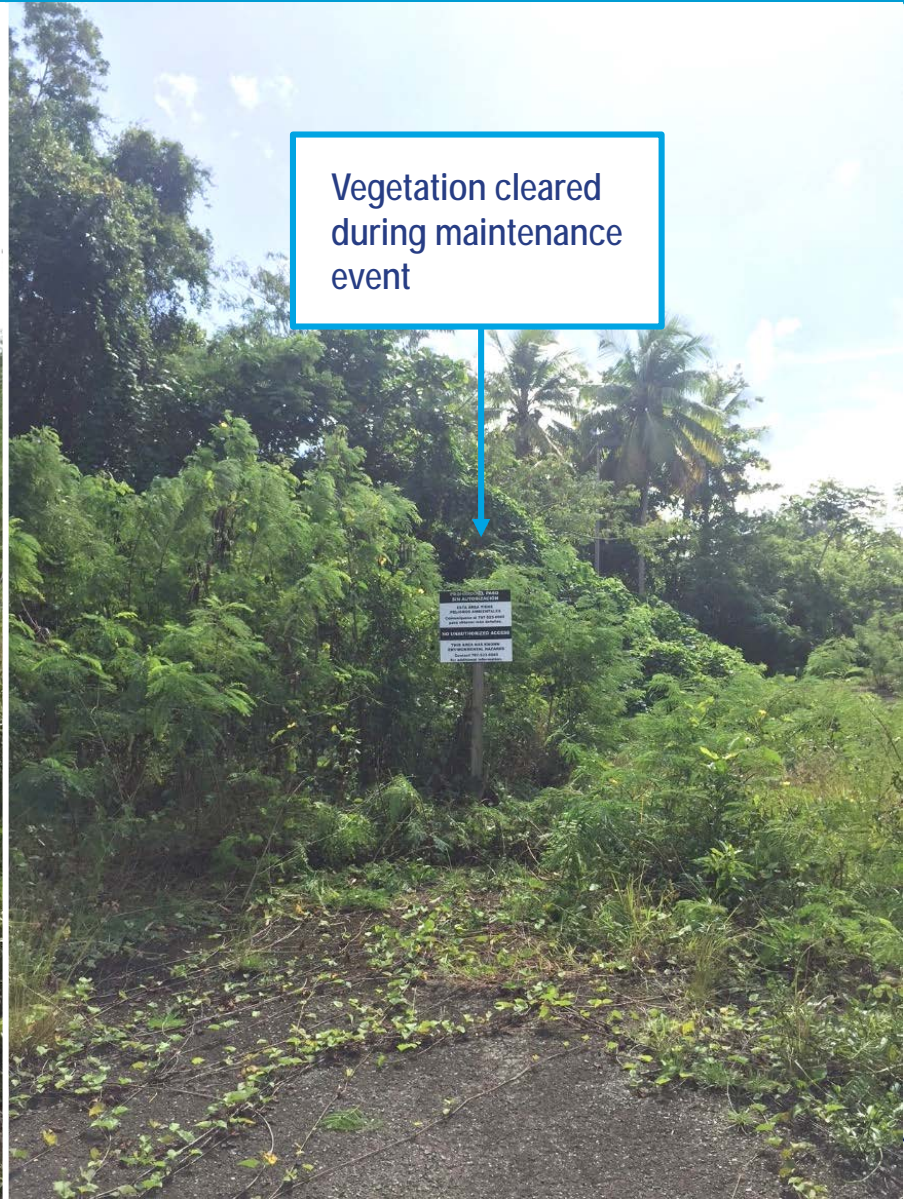
Vegetation cleared during maintenance event

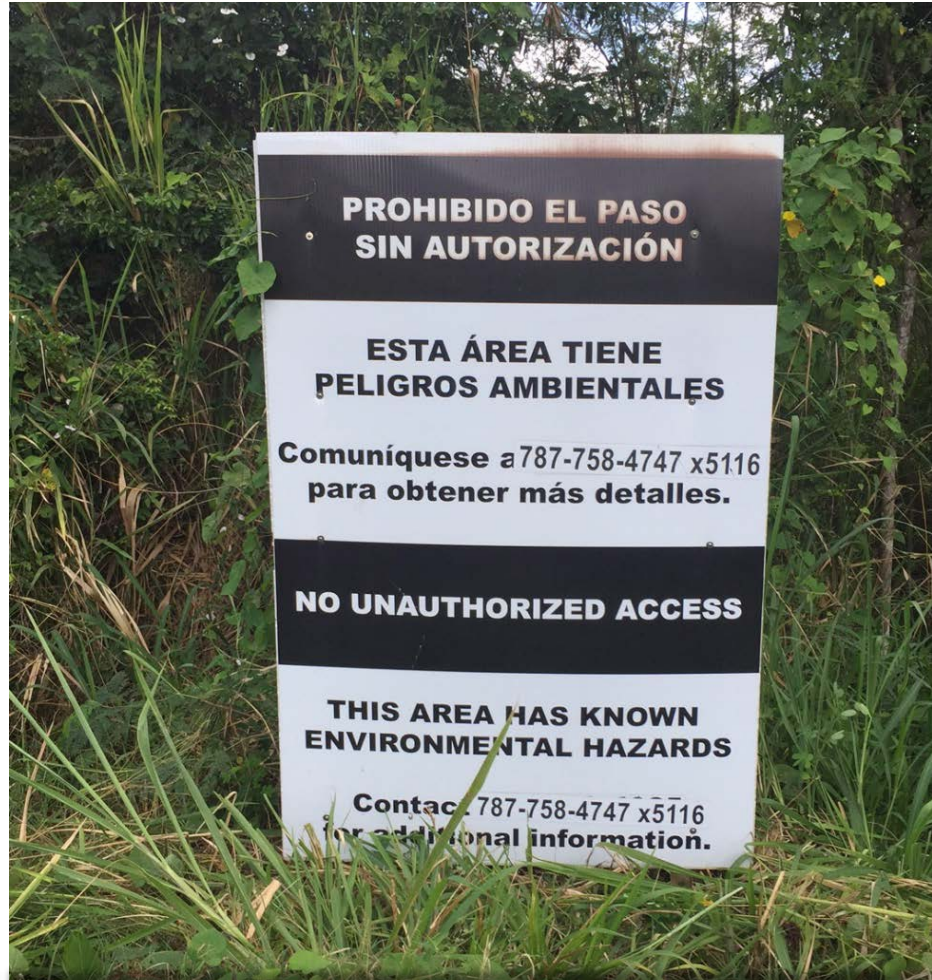
Vegetation cleared during maintenance event

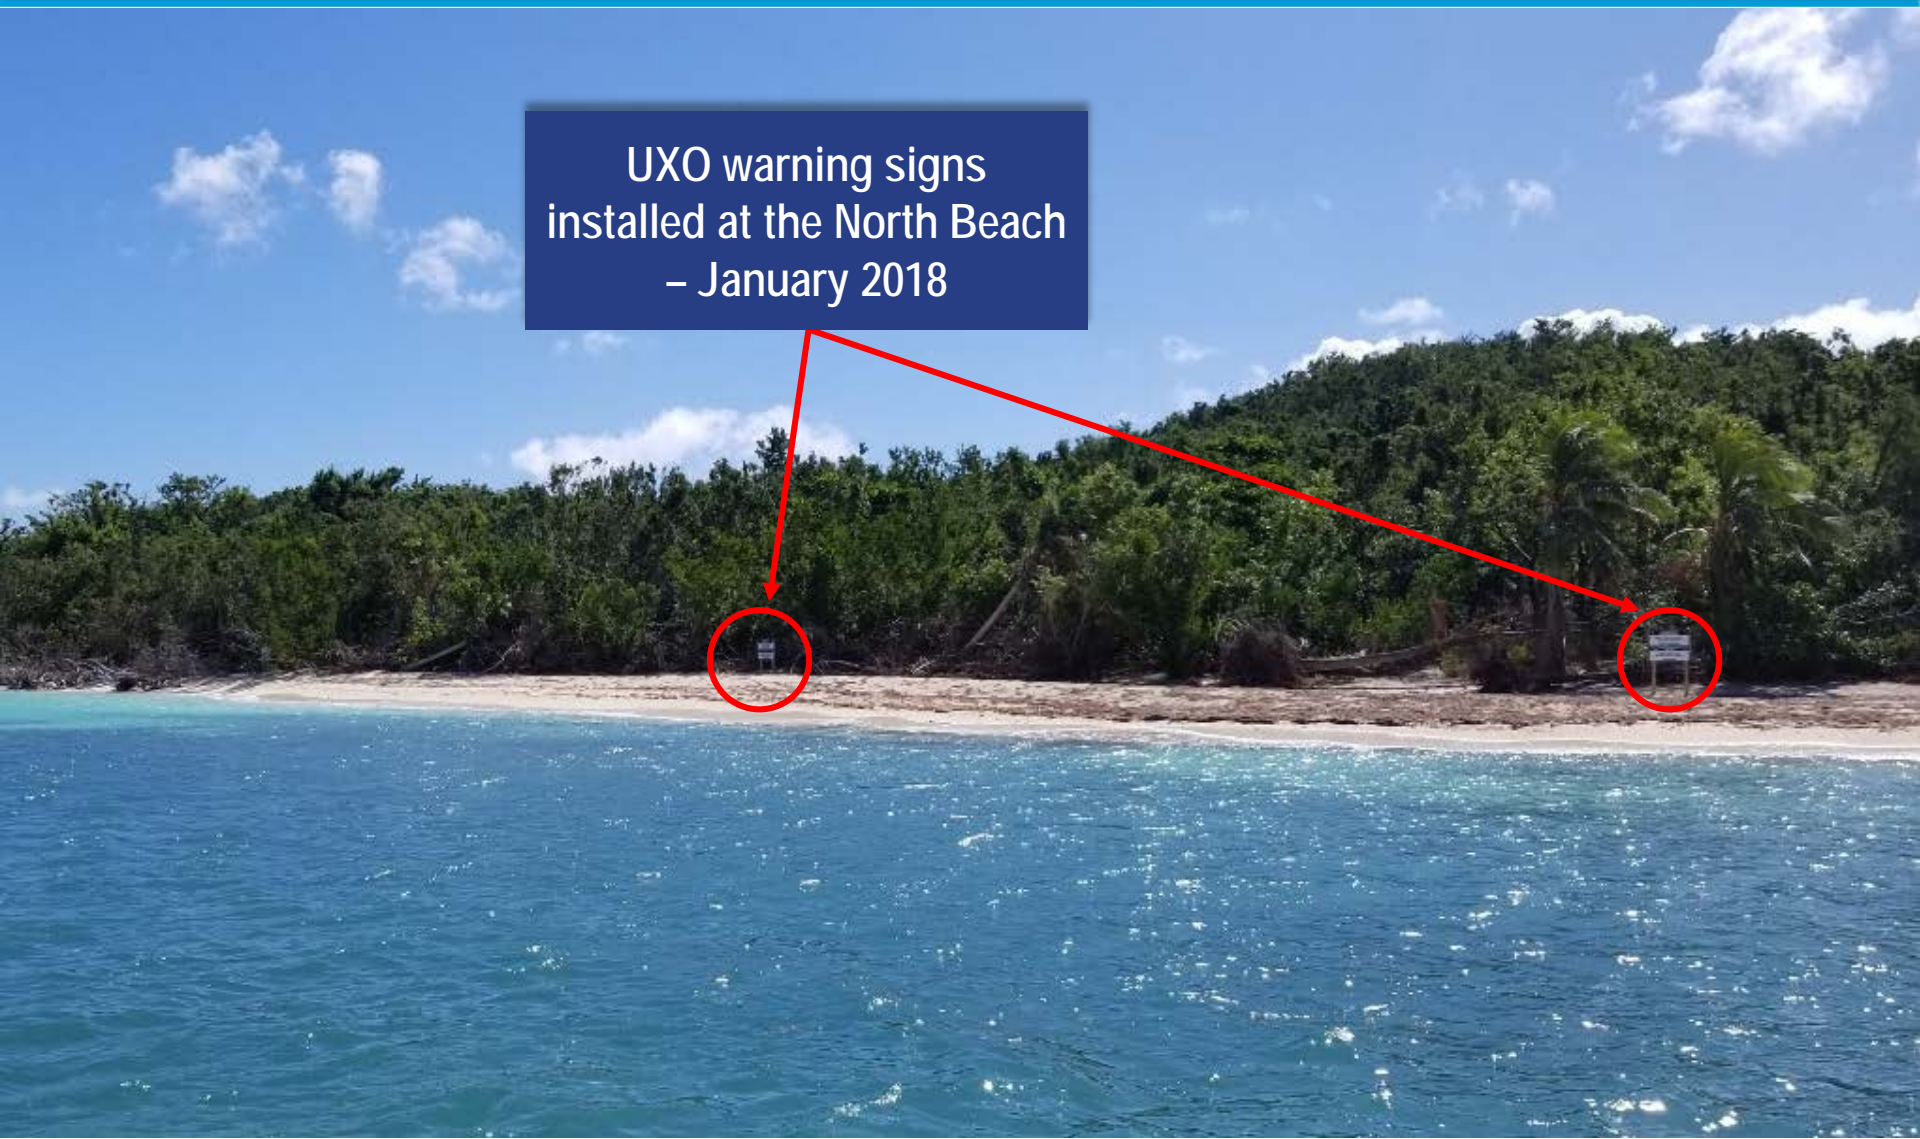
Piñeros Island Sign Photo

UXO warning signs
installed at the North Beach
– January 2018

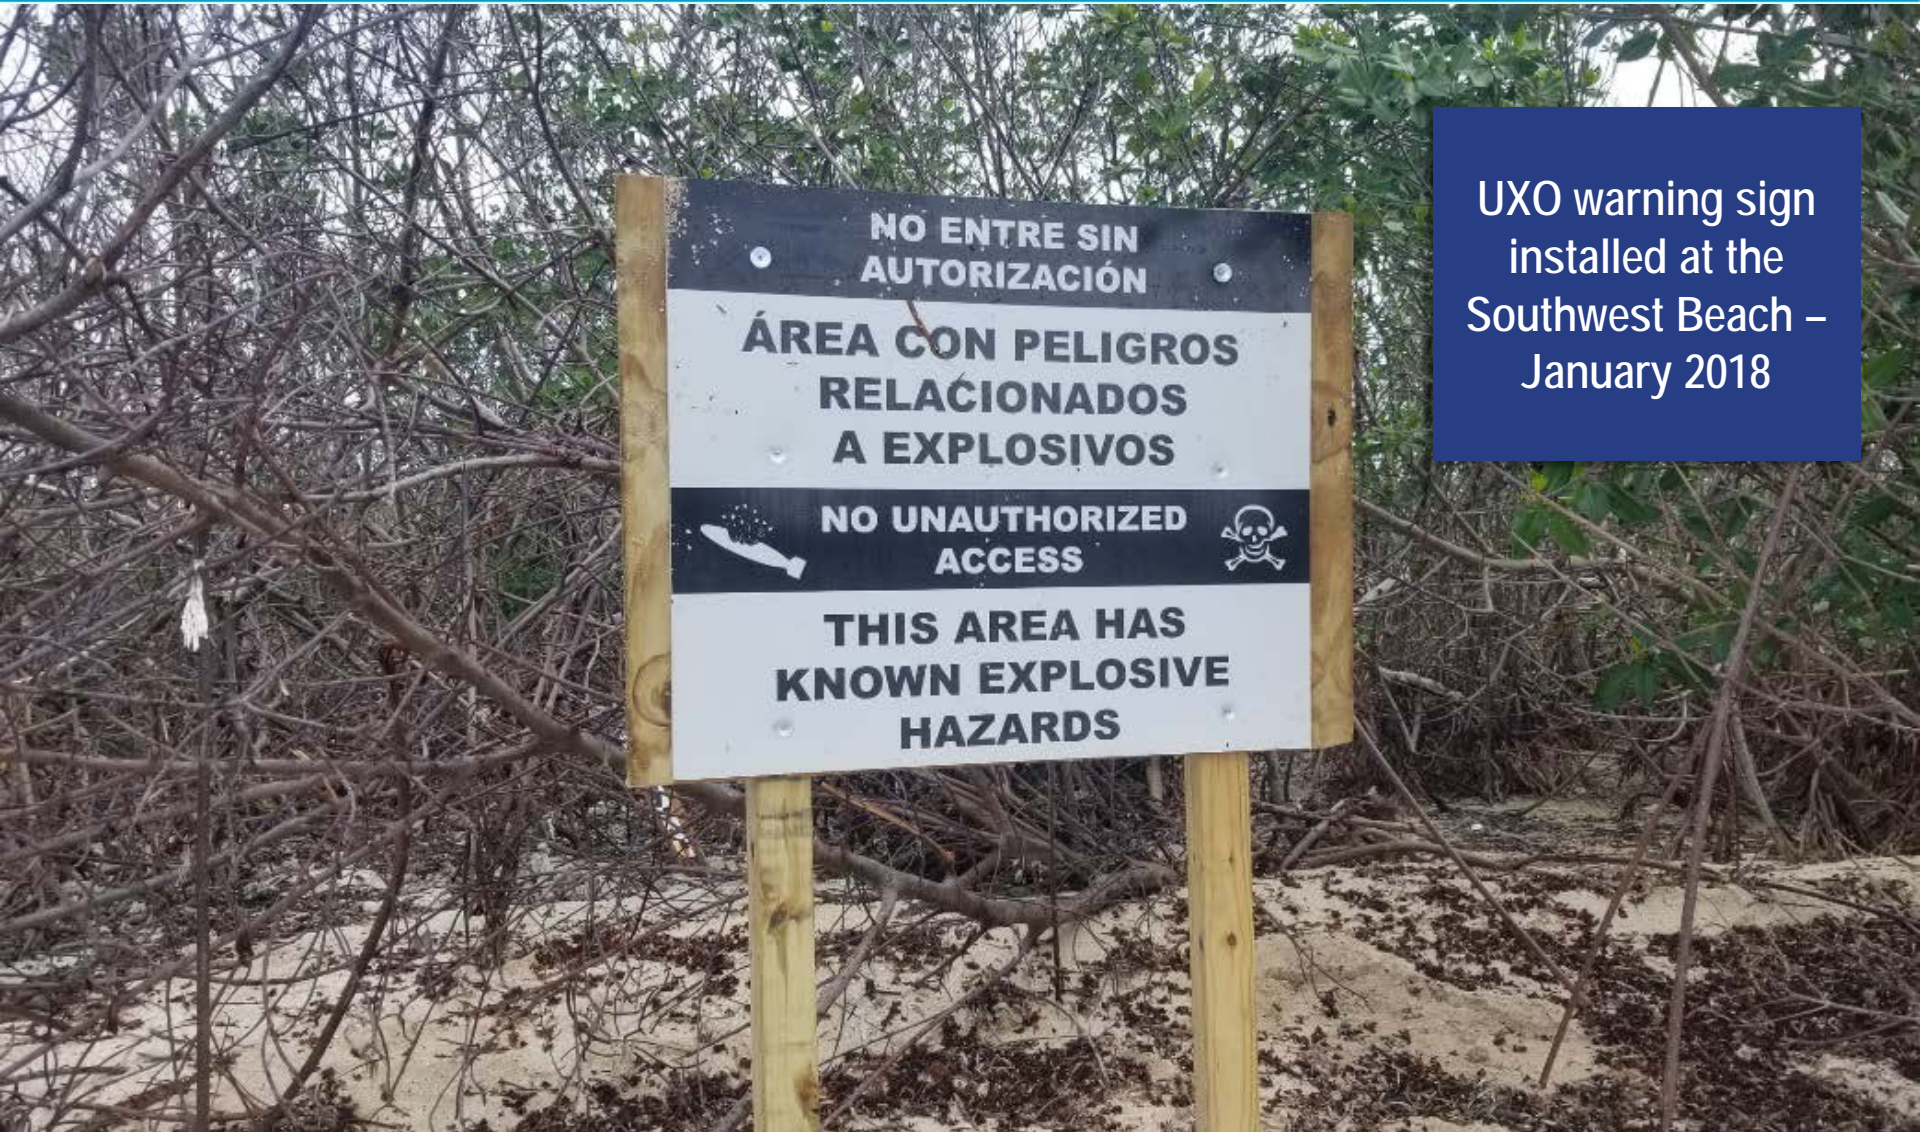
Piñeros Island Sign Photo

UXO warning sign
installed at the
Southwest Beach –
January 2018

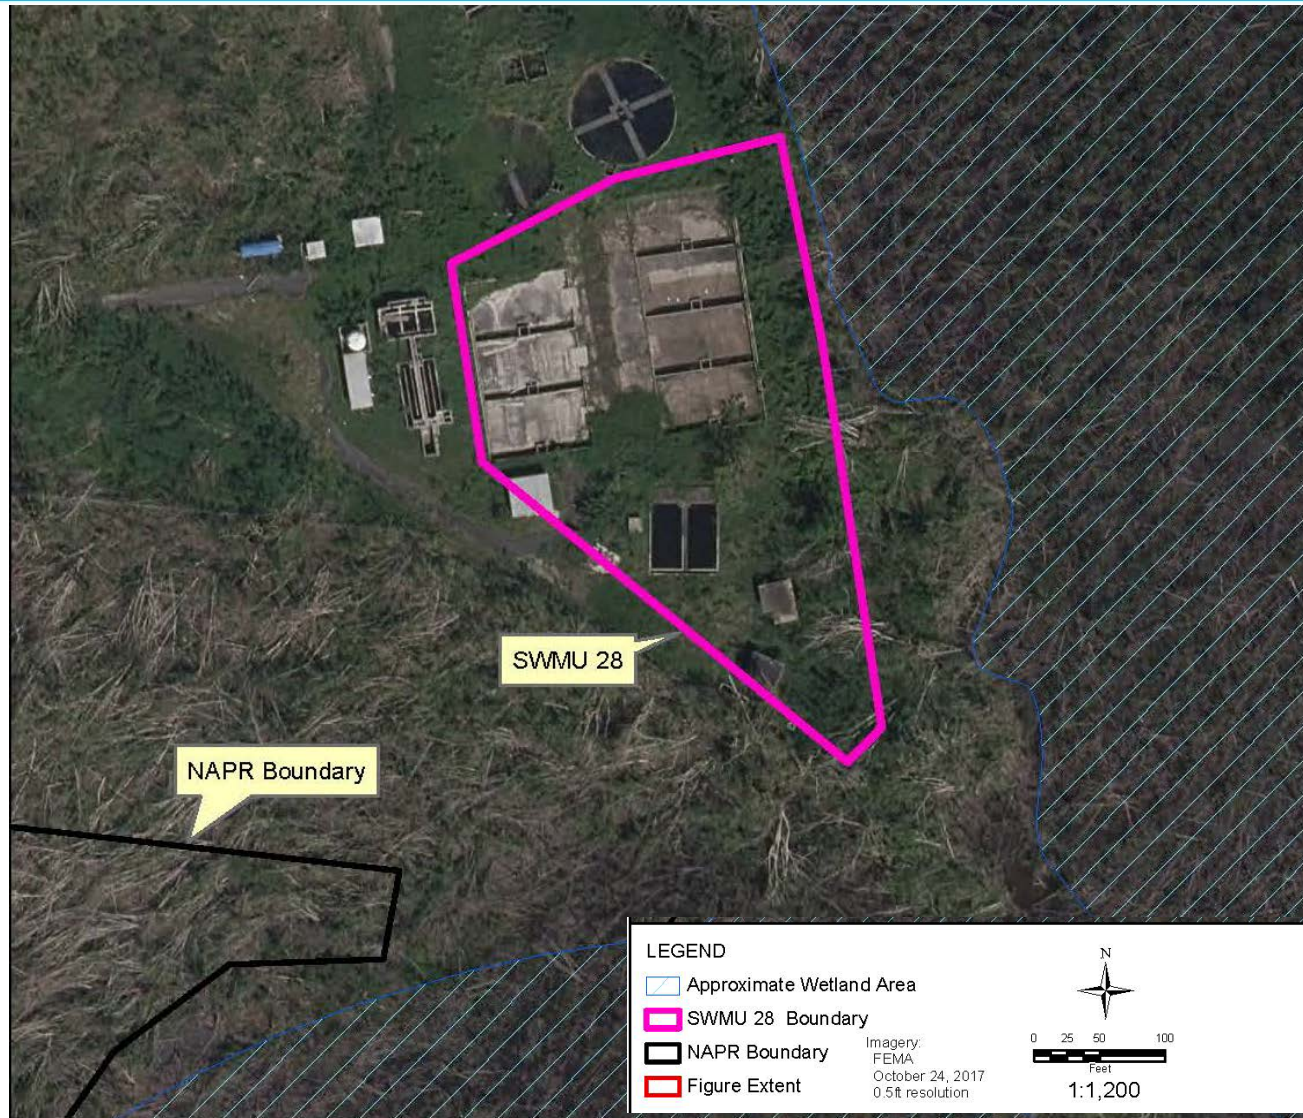
SWMU 28 – Site Layout

- Former sludge drying beds for the Bundy Area Waste Water Treatment Plant (WWTP)
 - Constructed in the early 1970s
 - Received domestic sewage from the Bundy housing area, officer's quarters, enlisted personnel barracks, and military messes
 - The WWTP is no longer in operation
 - Sludge was removed from the drying beds at the time of closure
