Former Naval Station Treasure Island San Francisco, California IR Site 12 Conceptual Site Model Update Fact Sheet

November 2022

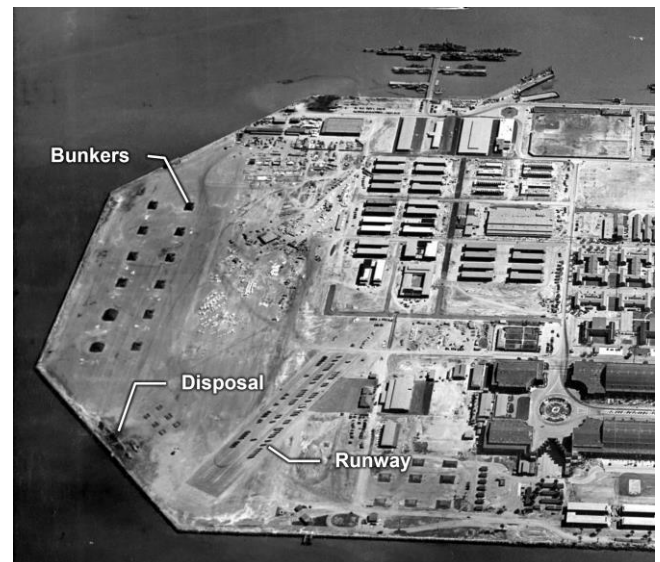
**Photo 1: Northern Portion of Naval Station
Treasure Island (1944)**

Between 1942 and 1945, the Navy constructed multiple ammunition storage bunkers in the northern portion of IR Site 12. Rubbish disposal activities continued at the end of the runway.

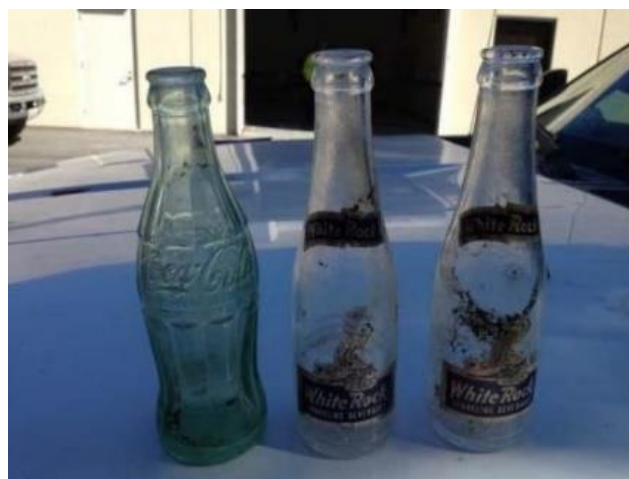
Photo 2: Sanitary waste found within the CRA

According to the housing development plans, certain construction areas within the CRA were excavated to prevent potential soil settlement and ensure stability of building foundations. Any rubbish found was mixed with excavated soil and placed back into the excavation at a depth of approximately 2 to 4 feet below ground surface (bgs). The excavation was then backfilled to finished grade with excavated soil identified as rubbish free.

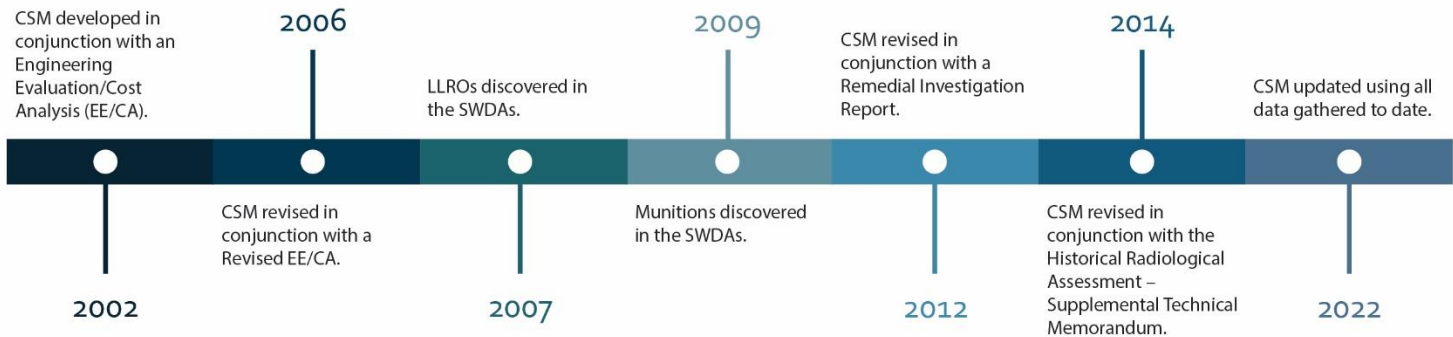
CSM TIMELINE

The CSM has been refined and updated as more data has been collected and additional historical documents have been reviewed. The CSM was developed in 2002 and received minor revisions in 2006, 2012, and 2014. The CSM identifies that the source of chemical contamination and low-level radiological objects (LLROs) were associated with rubbish disposal.
