Hunters Point Naval Shipyard Environmental Program Fieldwork Update

Hunters Point Shipyard Citizens Advisory Committee
Environmental & Reuse Subcommittee Meeting
August 22, 2022

**Hunters Point Naval Shipyard
Navy Base Realignment and Closure (BRAC)**

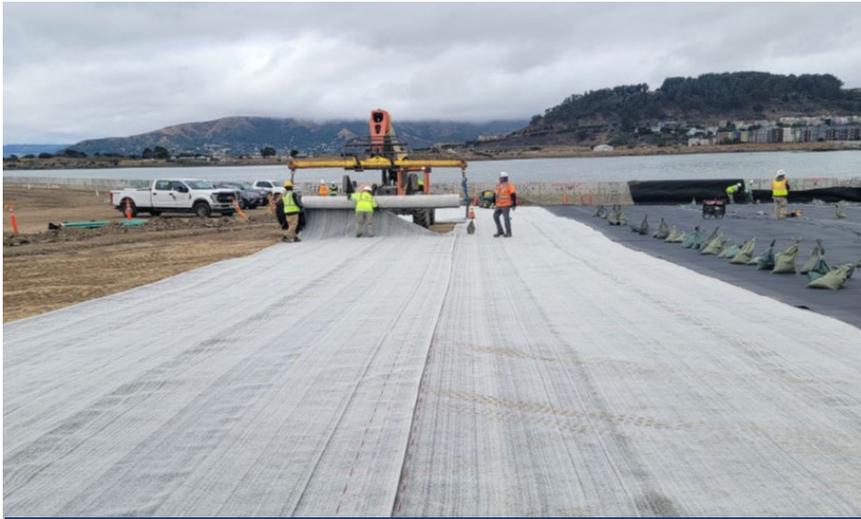
A geosynthetic clay liner (GCL) was installed for extra protection over landfill wastes

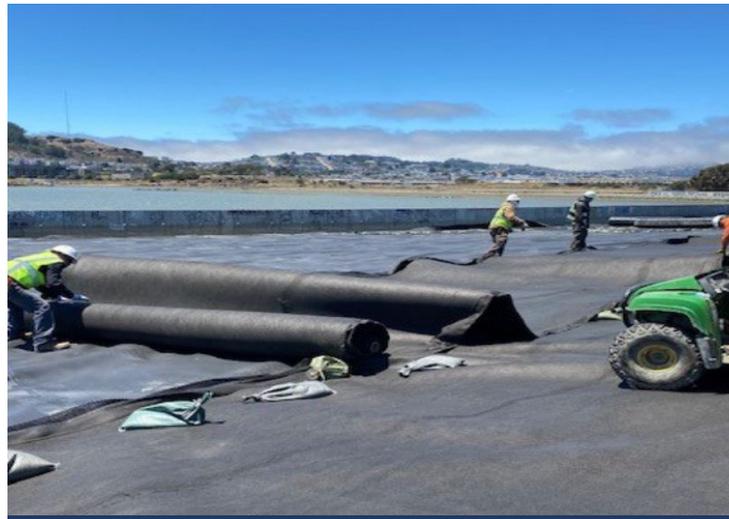
Drainage geocomposite (left) and high-density polyethylene (HDPE) (right) were installed over the site to drain excess water in cover soils (wetlands excepted)

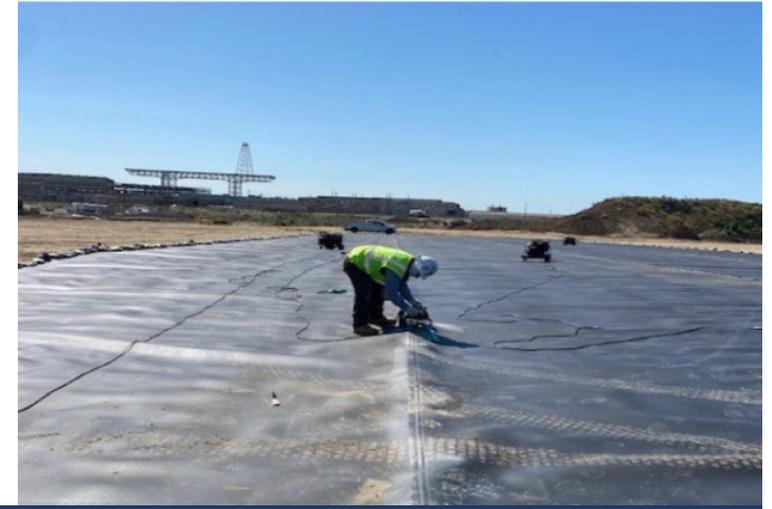
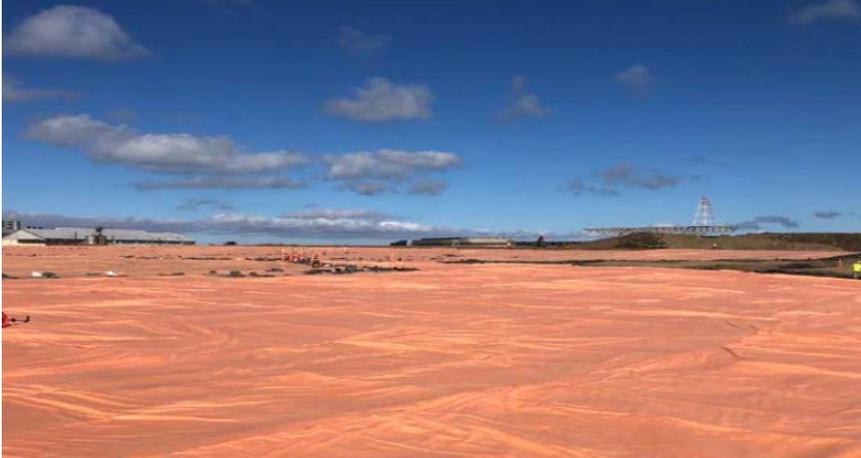
A demarcation layer has been placed over the entire site to serve as warning that that impacted soils are close

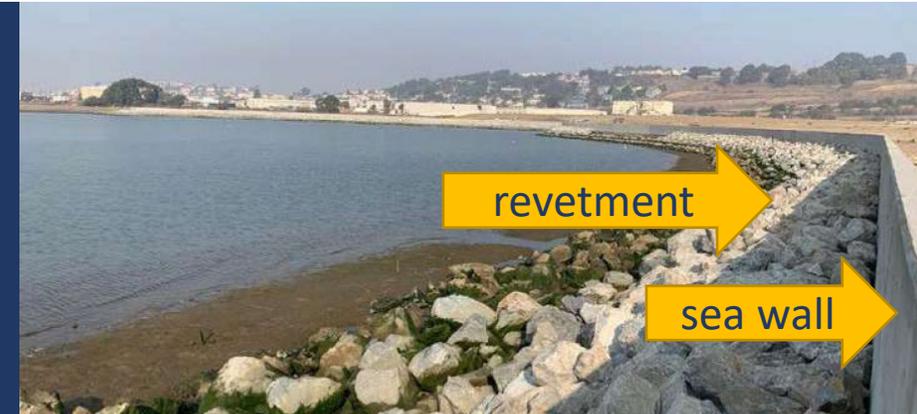
- A barrier of large rocks has been installed along 1,800 feet of shoreline where Parcel E-2 meets the shoreline
- It is about 35 feet wide and rises about 9 feet above mean sea level

View of revetment and sea wall

- A revetment and sea wall are included in the design to protect the shoreline.
- Together, they act as a barrier to prevent erosion of the soil cover.
- The sea wall will also protect a walking path that will link to the Bay Trail.

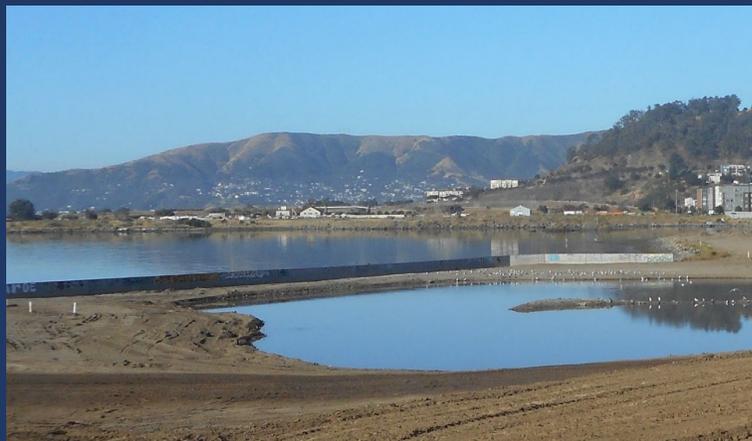
View of sea wall from parcel E-2

- A 3-foot-high concrete sea wall was added at the top of the revetment to address potential wave run-up during winter storms
- Together, the sea wall and revetment extend 12 feet above mean sea level (approximately 9 feet above average high tide in the San Francisco Bay)

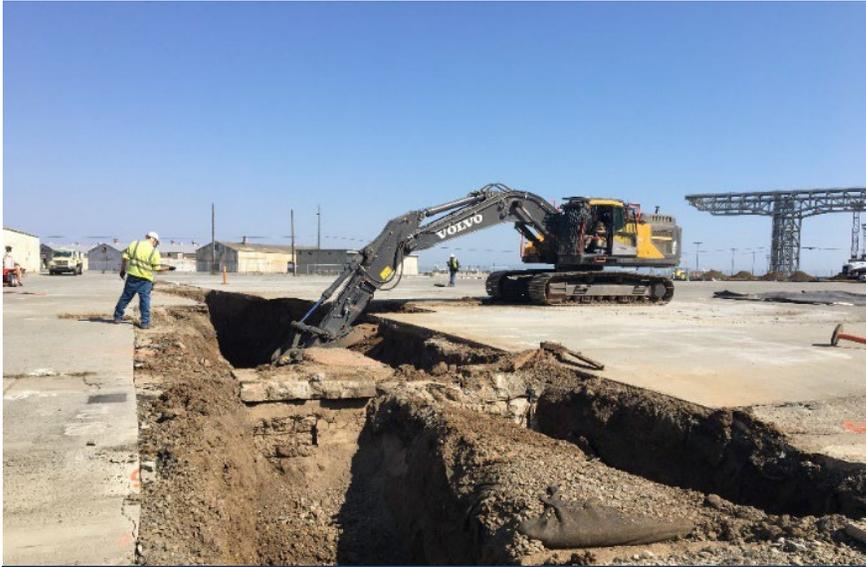
Radiological excavation at Phase 1 trench unit

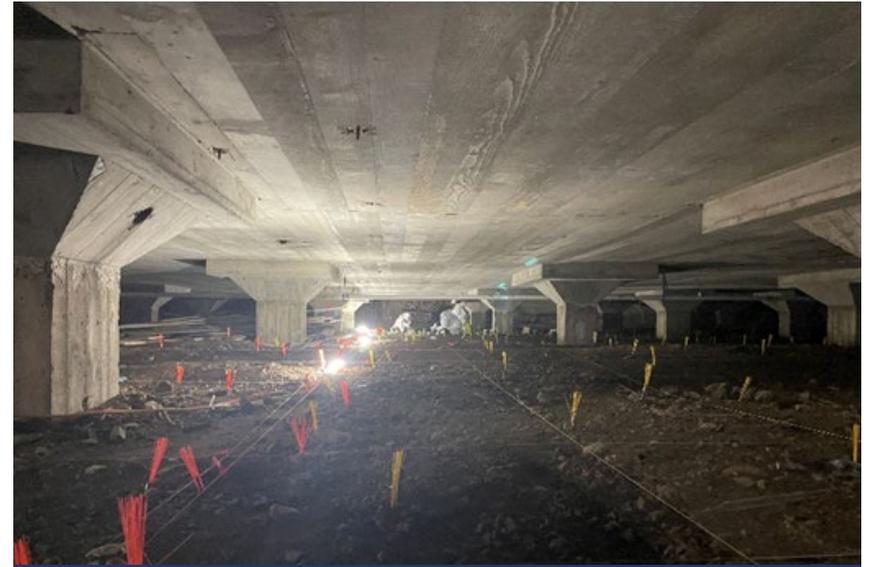
Building crawlspace survey unit investigations

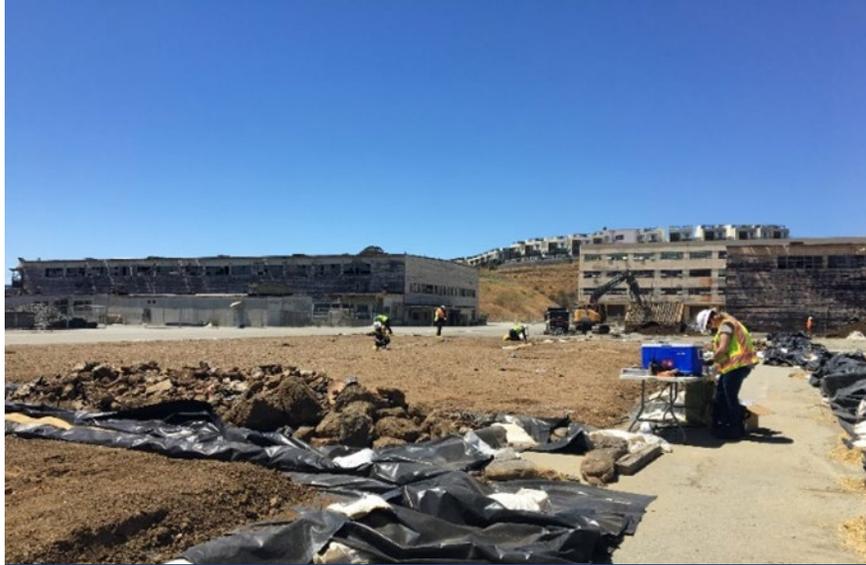
Soil sampling at Radiological screening yard pad

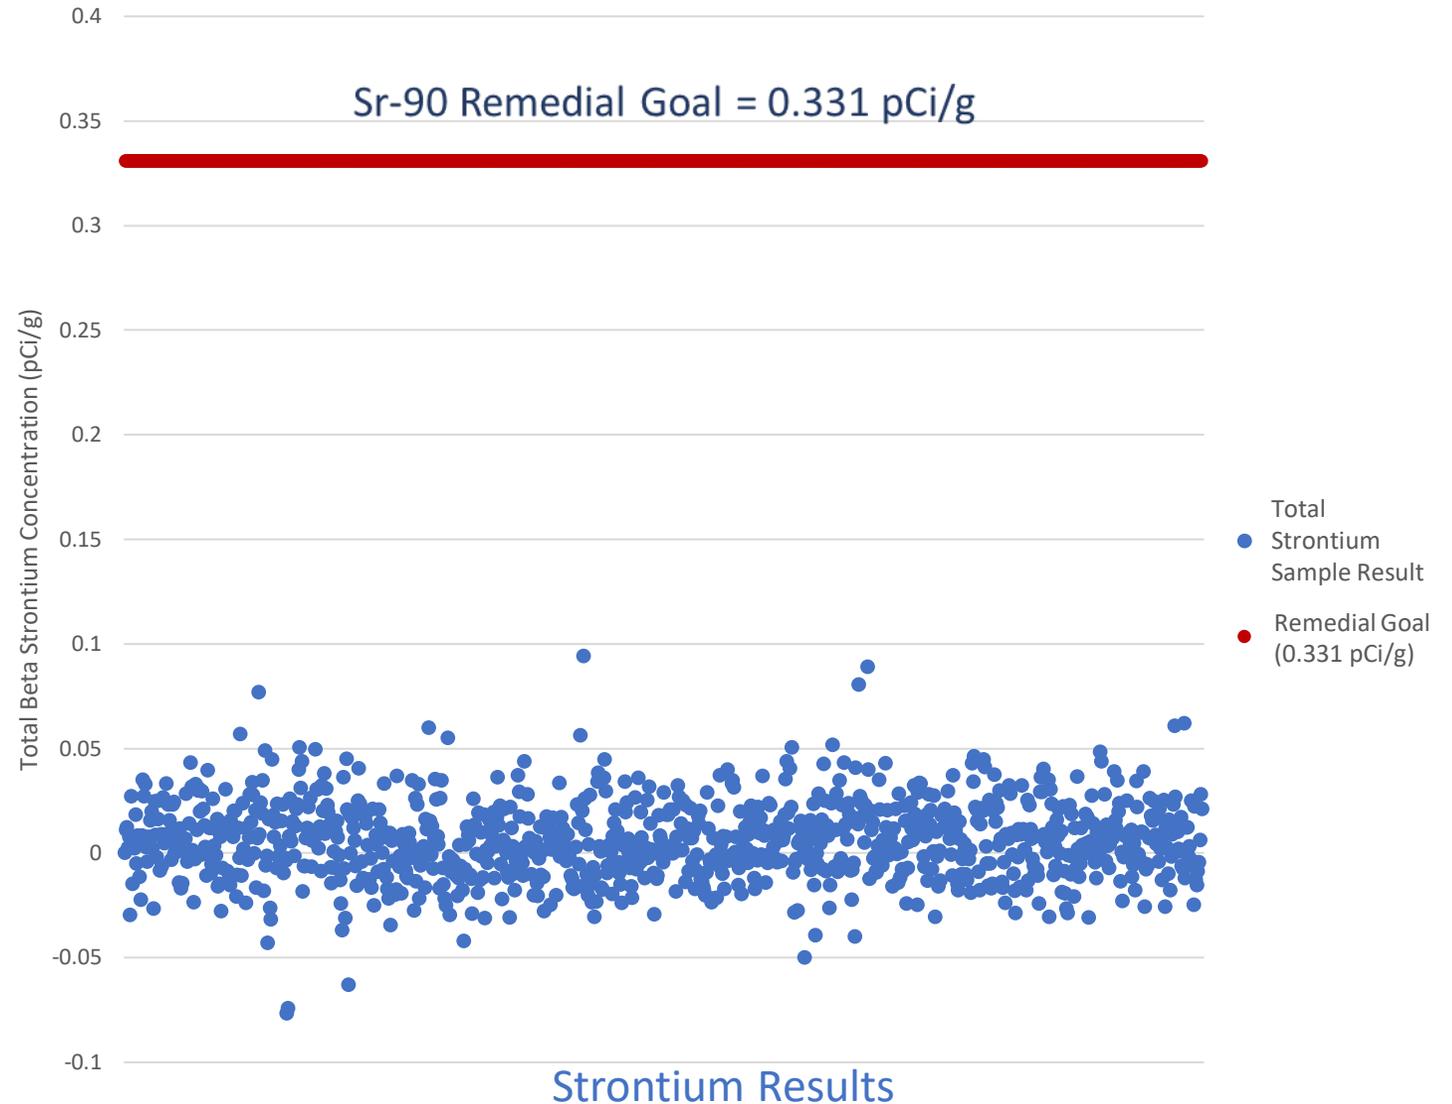
- Strontium results have been compared to the Remedial Goal for Strontium 90 (Sr-90)
- More than 1,000 projects samples were analyzed
- No samples have exceeded the Navy's Remedial Goal for Sr-90
- A validation study is underway to provide quality control and confidence in results
 - Began in June 2022
 - Results expected by the end of September 2022

Strontium includes strontium isotopes Sr-89 and Sr-90

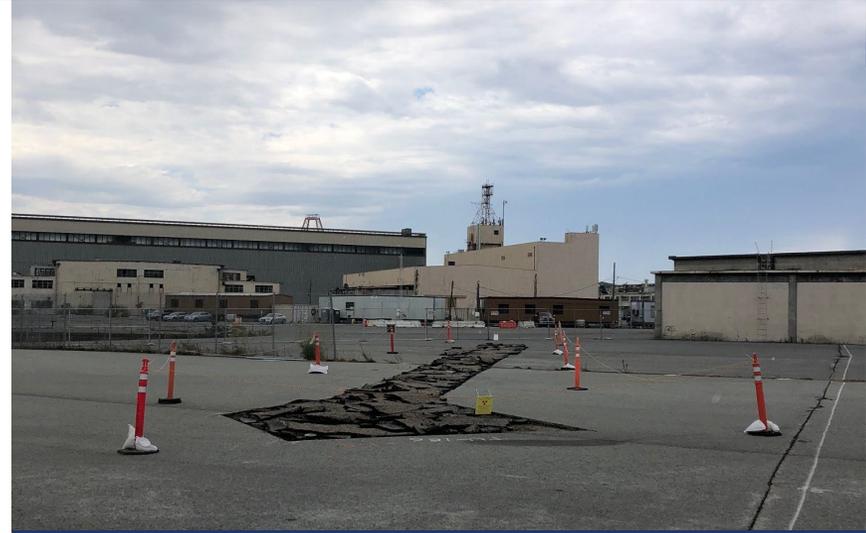
Asphalt at TU-186 is flipped to prepare for radiological survey
