FACT SHEET

Hunters Point Naval Shipyard

Parcel B Radiological Object Recovery

December 2023

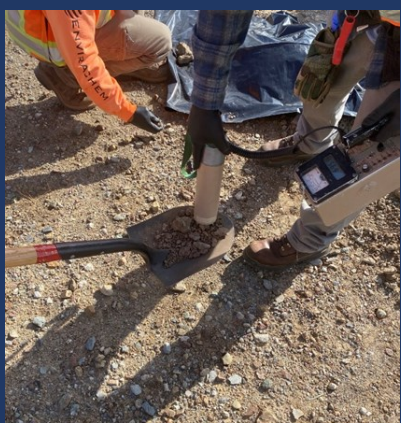
This image shows the location of the glass object in loose soil using static gamma count equipment. It is located on an RSY pad within a restricted area on Parcel B.

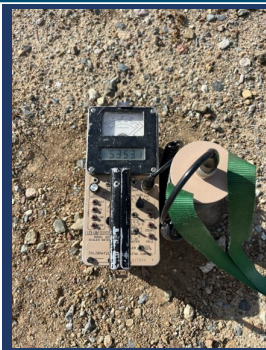
Static Gamma Count at Surface

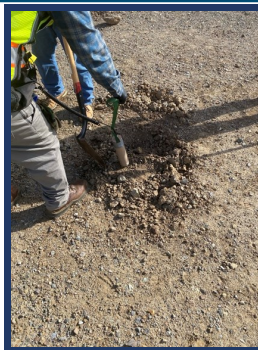
Excavation and Investigation

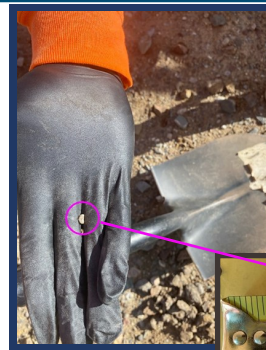
Upon investigation, a small piece of glass, approximately 3/16 inch in diameter (about the size of a green pea), was found approximately 6-inches below the surface in loose soil on the RSY pad. Static gamma counts and dose-rate readings were collected before the item was bagged, labeled, and taken for further analysis. Laboratory analysis of the pea-sized object identified low level radium-226 activity.

Glass Object Recovered
