SAN JOSE WATER COMPANY

Los Gatos Creek Watershed Maintenance Program Manual

September 2022

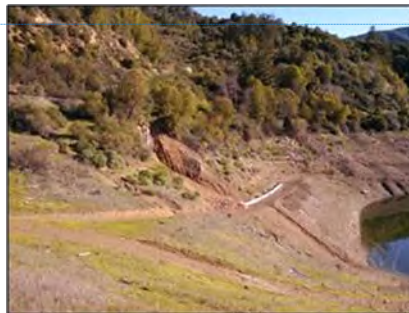
Photo 4. Gullying on Austrian Dam (Feb. 2016)

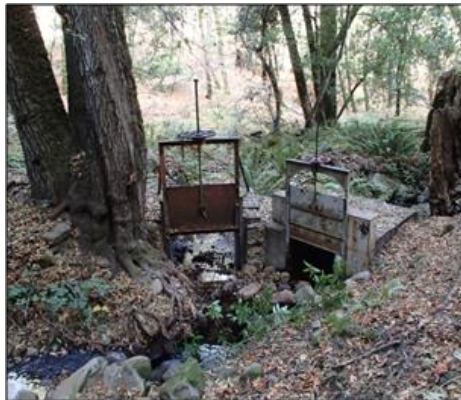
Photo 14. Creek “splitter” gates northwest of Lake Ranch Reservoir (Dec. 2013).

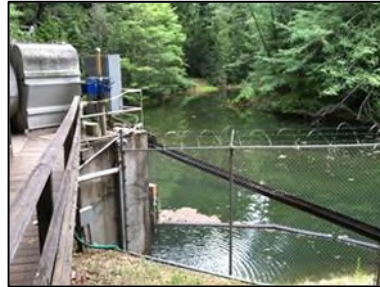
Photo 19. Inflated rubber dam on Los Gatos Creek provides an adequate pool elevation for the Ostwald Intake (Oct. 2013).

Water is diverted from Los Gatos Creek through the Ostwald Intake Facility year-round when there is natural streamflow or released water from Lake Elsmar. Under normal conditions, the rubber dam is inflated to provide a pool elevation that can supply the intake by gravity (Photo 19). The dam is lowered occasionally during storm events when water cannot be effectively treated due to high turbidity. The dam is also lowered to allow creek

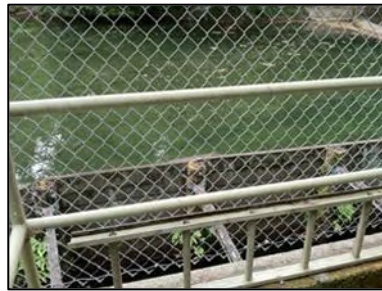
Photo 20. Wooden boards that protect the intake manifold at Ostwald Intake are rotting and in need of repair and replacement (Oct. 2013).

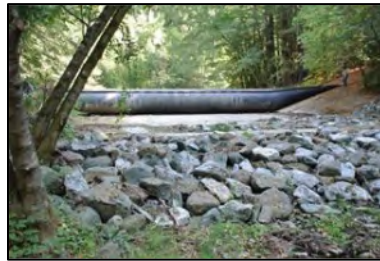
Photo 21. Inflatable dam at Ostwald Intake (Dec. 2013).

In terms of stream channel geomorphology at the Ostwald Intake Facility, the inflatable dam creates a pool environment when inflated. The channel width at the inflatable dam is about 70 feet wide on the bed, with 20-foot-long trapezoidal streambanks on either side (**Photo 21**). Fine sediment settles on the channel bed behind the dam. During the active winter flow season, when the dam is deflated, larger storms carry the finer sediment downstream.

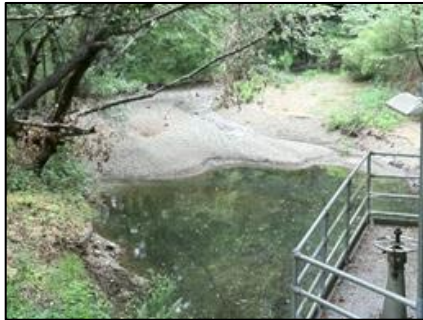
Photo 25. Sediment deposited upstream of Hooker Intake Facility (May 2013).

removed from the facility since the 1990s. As shown in Photo 25, sediment has accumulated behind the dam, and approximately 661 cubic yards of sediment currently needs to be removed. The frequency of future sediment removal will depend on the magnitude and frequency of winter storm events. It is anticipated that sediment removal at the Hooker Intake Facility will occur no more than four times during a 10-year period. Following the initial sediment removal of 661 cubic yards, future sediment removal projects will be restricted to a 500-cubic-yard limit. A threshold of 250 cubic yards of reduced storage capacity will be required to initiate any subsequent sediment removal work. Sediment accumulation of less than 250 cubic yards will

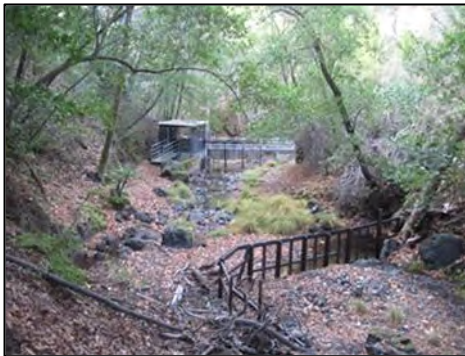
Photo 38. Debris rack in near ground to right, Lower Cavaneer Intake Facility in background (Dec. 2013).

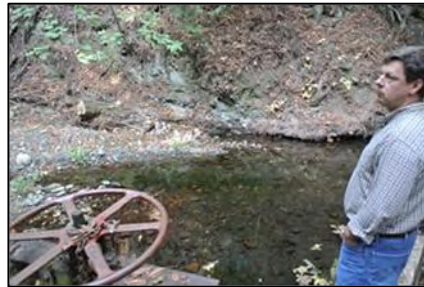
Photo 41. Creek behind Beardsley weir with intake gate mechanism to left (Oct. 2013).

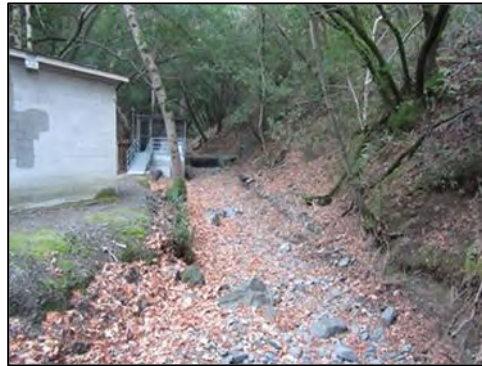
Photo 43. Trout Creek Intake Facility weir and intake in distance, pump house to left (Oct. 2013).

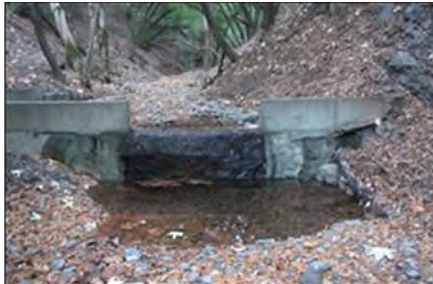
Photo 44. Trout Creek Intake Facility weir and downstream pool (Oct. 2013).

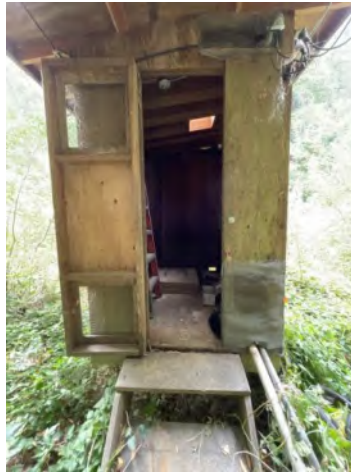
Photo 52. Aldercroft Heights Extraction Well pump house (Aug. 2021)

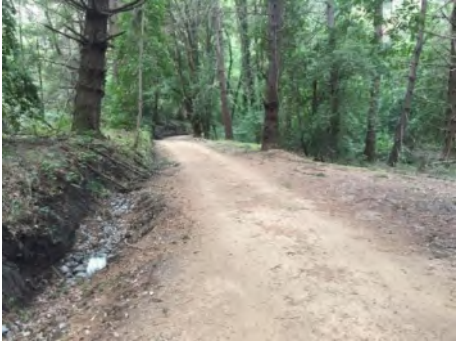
Photo 1. Culvert inlet (Jan 2019).

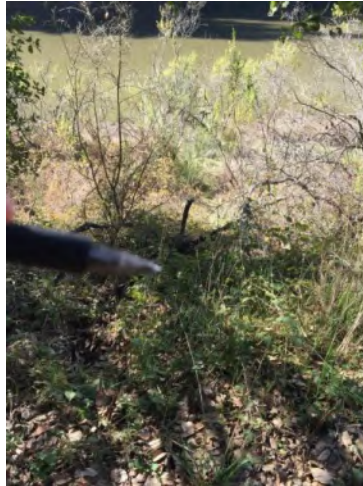
Photo 2. Culvert outlet (Jan 2019).

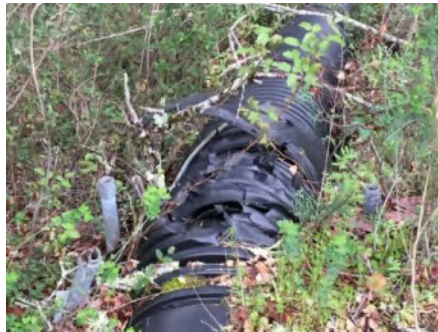
Photo 2. Culvert outlet in need of repair ([March 2021](#)).

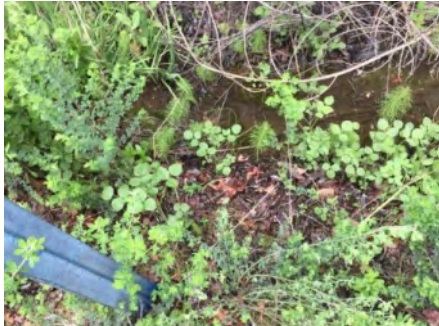
Photo 1. Buried/damaged culvert inlet suspected below blue marker ([March 2021](#)).

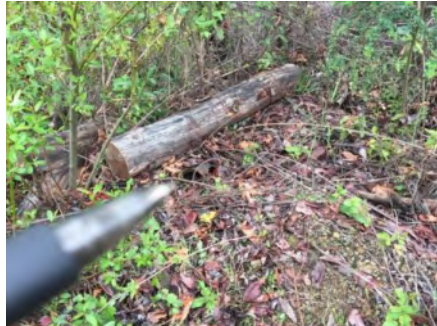
Photo 2. Suspected culvert outlet area. Pencil points to damaged piece of pipe ([March 2021](#)).
