NAVAL ACTIVITY PUERTO RICO

**Restoration Advisory Board
Meeting #54**

May 11, 2023

Solid Waste Management Units (SWMUs) 55 and 70

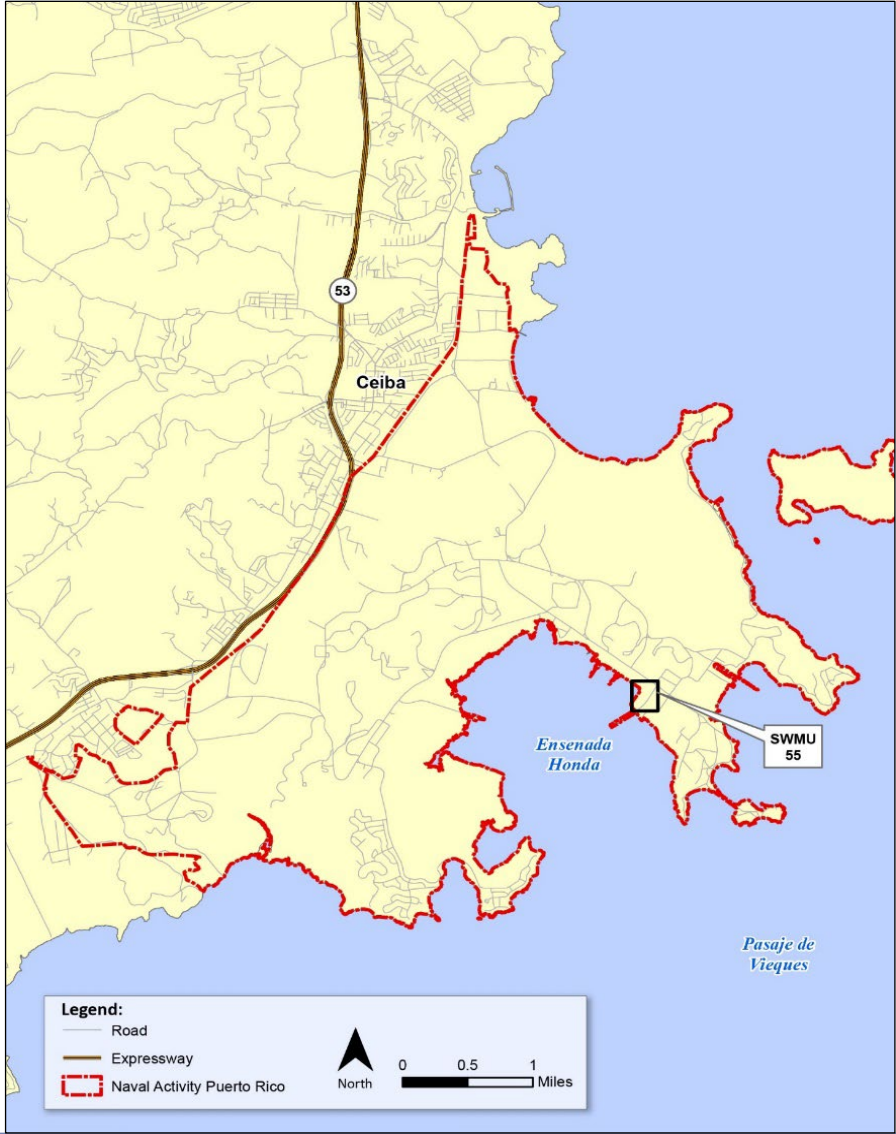
SWMU 55 – TCE Plume Near the Tow Way Fuel Farm

- TCE plume south of Forrestal Drive, near former Building 2314
 - Former Building 2314 was reportedly used for the storage and maintenance of small watercraft.
 - Exact activities and materials stored are unknown
 - Source of TCE not determined based on available records, but a leaking floor drain line is suspected
- Property owned by the Commonwealth of Puerto Rico and Operated as the Ceiba Ferry Terminal
- Land Use Controls are in place to prohibit unrestricted use and prevent exposure to contaminants in groundwater
- Corrective Action Implemented in accordance with the Statement of Basis
- Corrective Action Objectives (CAOs) for Chemicals of Concern in Groundwater

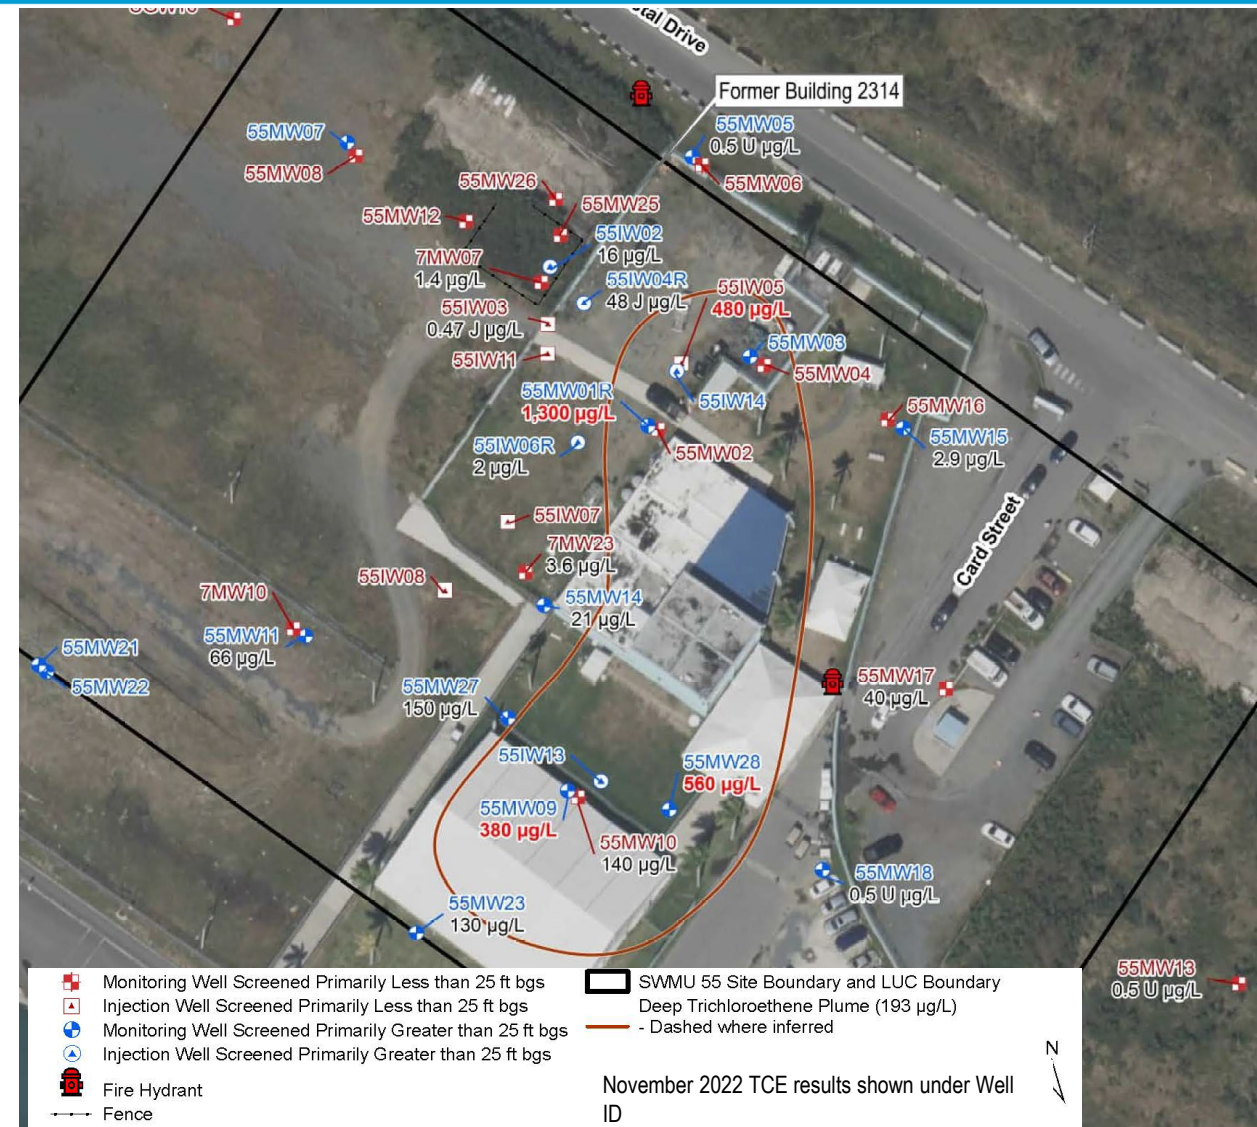
Chemical of Concern	CAO
TCE	193 µg/L
cis-1,2-dichloroethene	20,901 µg/L
Vinyl chloride	39.7 µg/L

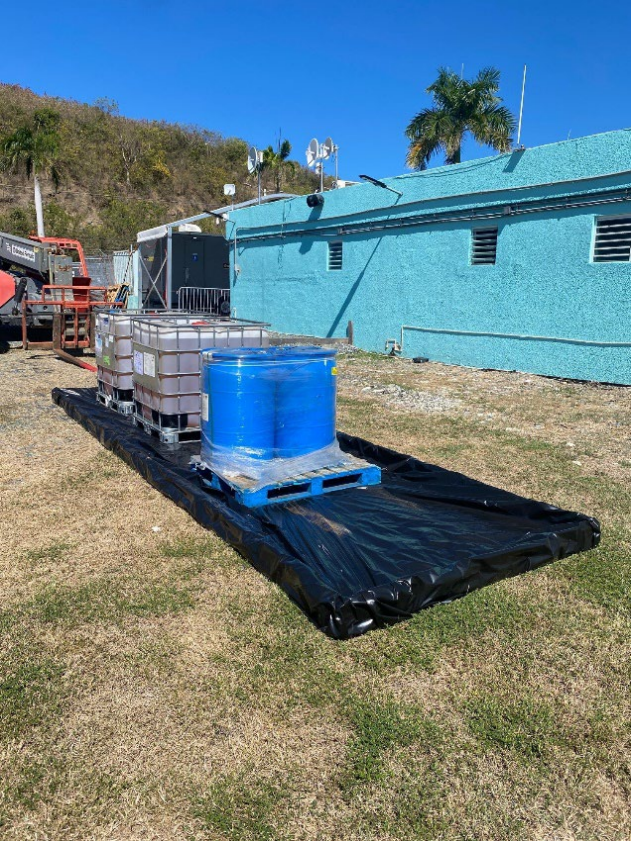
EVO Totes and Drums w/in Secondary Containment

Sunshade over EVO containers

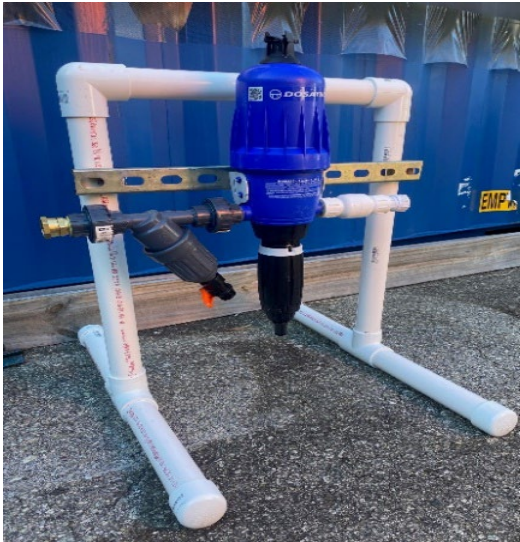
Dosatron Set-up

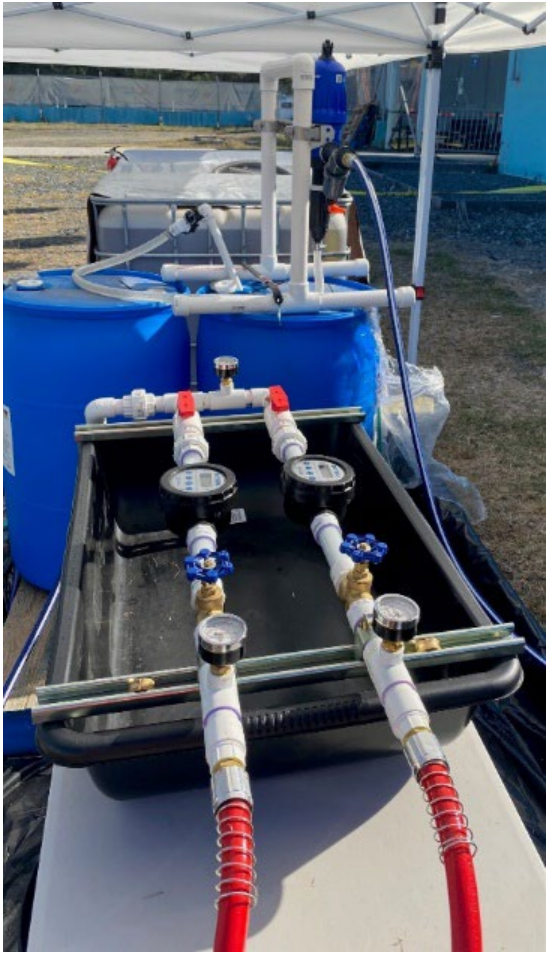
Injection Manifold and Dosatron

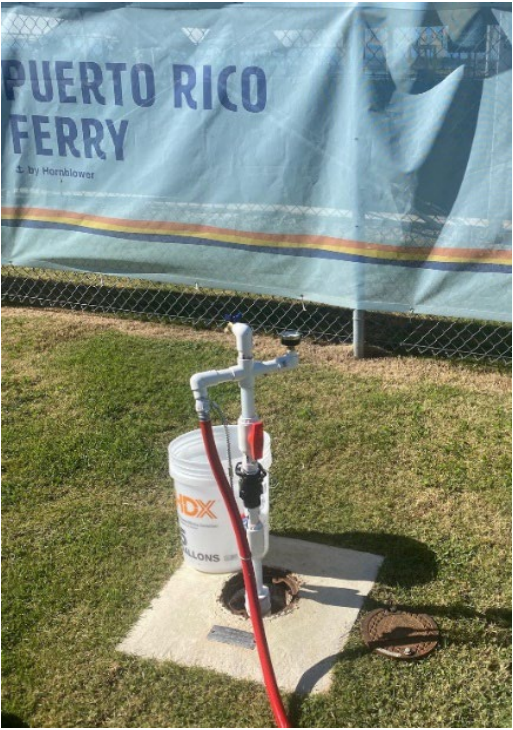
Injection Wellhead

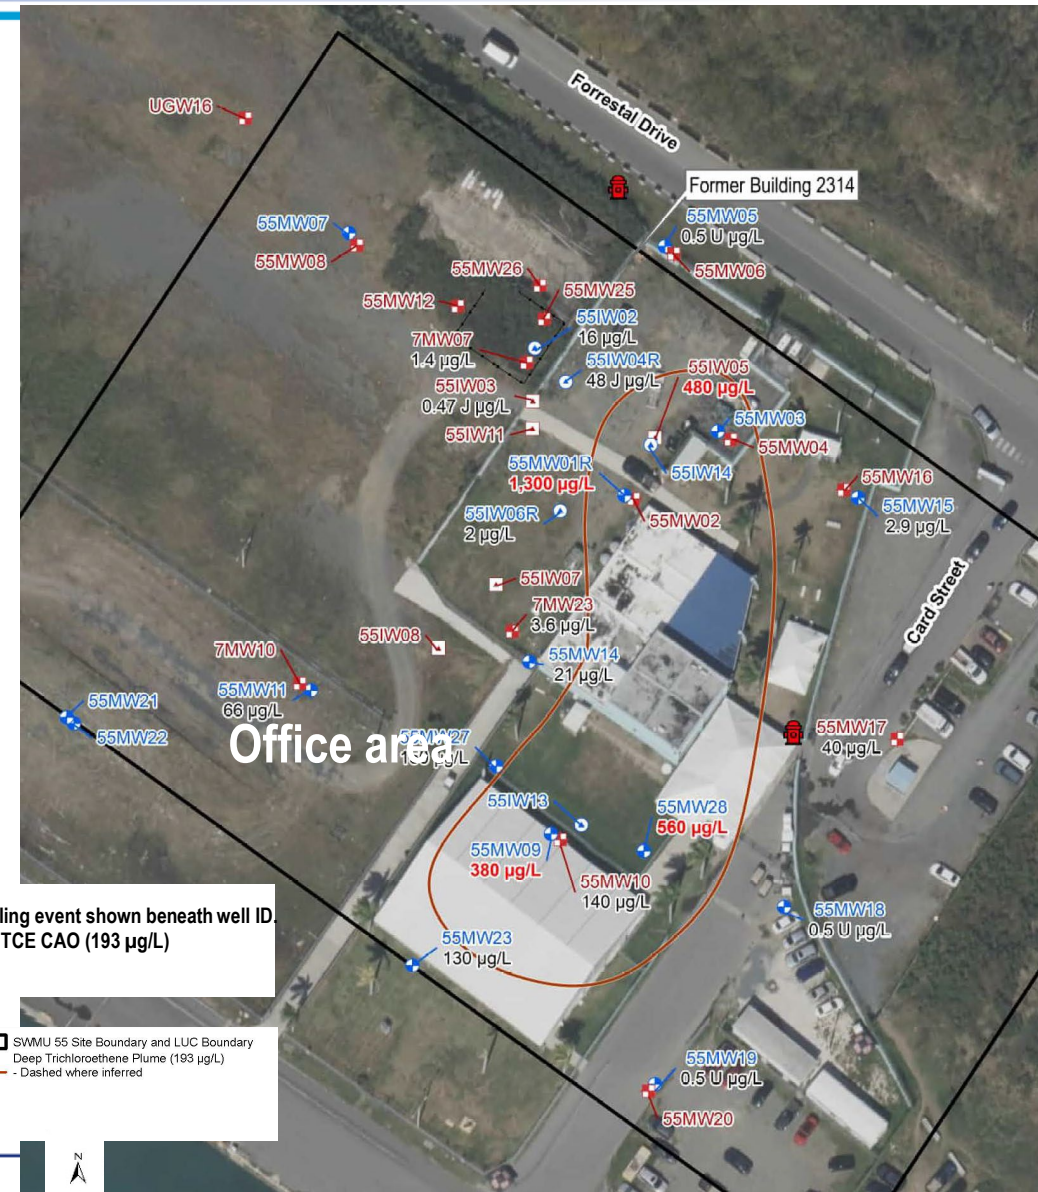
TCE concentrations from November 2022 sampling event shown beneath well ID.
 Black text = no detection or detected below the TCE CAO (193 µg/L)
 Red text = exceeds TCE CAO

- Monitoring Well Screened Primarily Less than 25 ft bgs
- Injection Well Screened Primarily Less than 25 ft bgs
- Monitoring Well Screened Primarily Greater than 25 ft bgs
- Injection Well Screened Primarily Greater than 25 ft bgs
- Fire Hydrant
- Fence
- SWMU 55 Site Boundary and LUC Boundary
- Deep Trichloroethene Plume (193 µg/L)
- Dashed where inferred

Well	Target Injection Volume (gallons)	Volume Injected (gallons)	Percent Complete
55IW04R	2,000	4,086	204%
55IW06R	4,100	2,019	49%
55IW07	7,000	7,000	100%
55IW13	13,000	13,007	100%
55IW14	10,000	66	1%
55MW03	9,934	9,961	100%

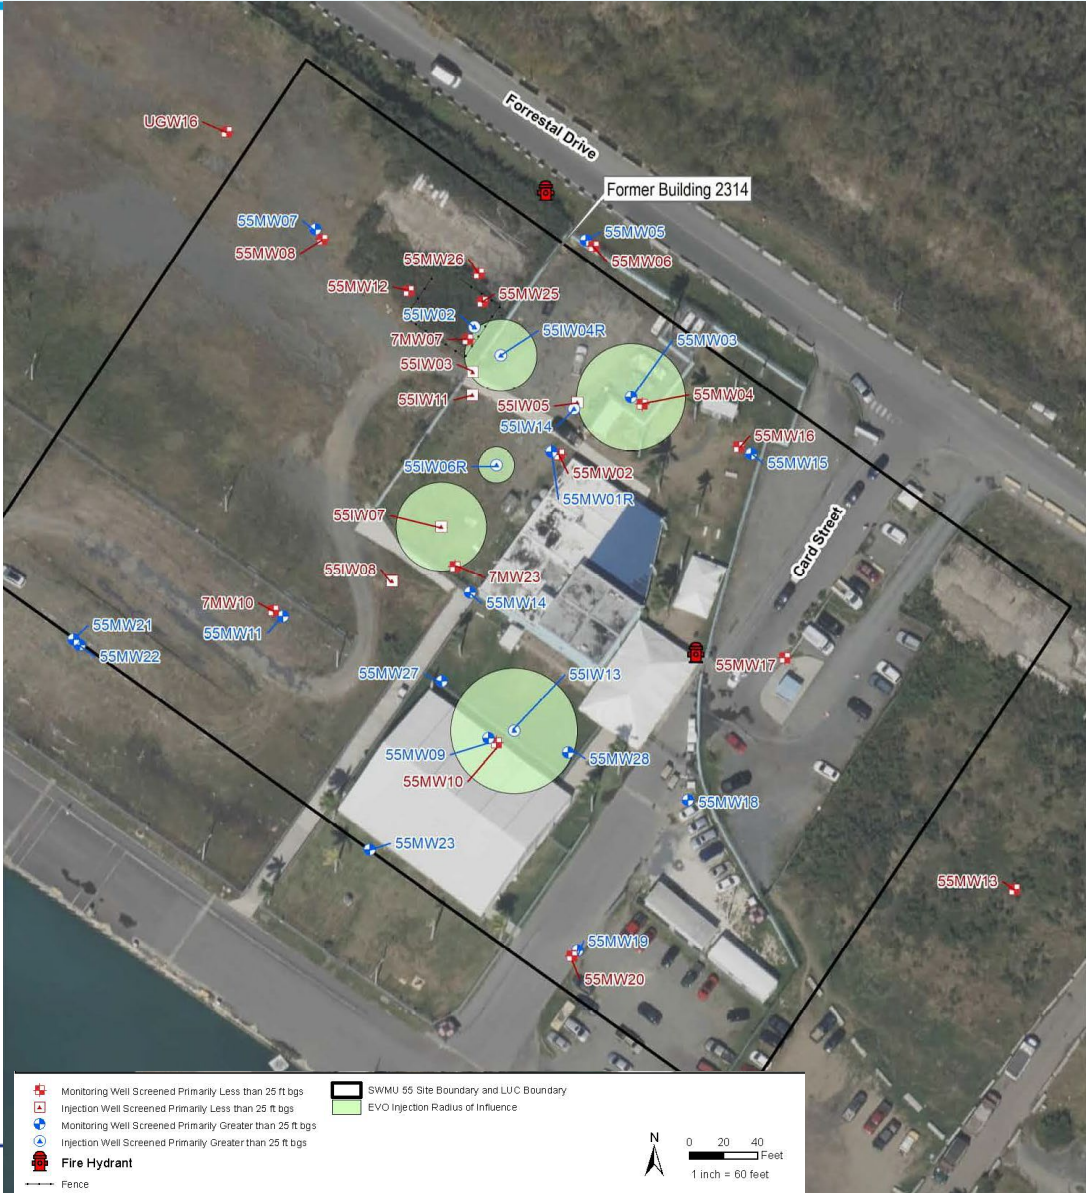
Injection Radius of Influence (ROI) (based on injection volume)		
Well	Injection Volume (gallons)	ROI
55IW04R	4,086	20 feet
55IW06R	2,019	10 feet
55IW07	7,000	25 feet
55IW13	13,007	35 feet
55MW03	9,961	30 feet

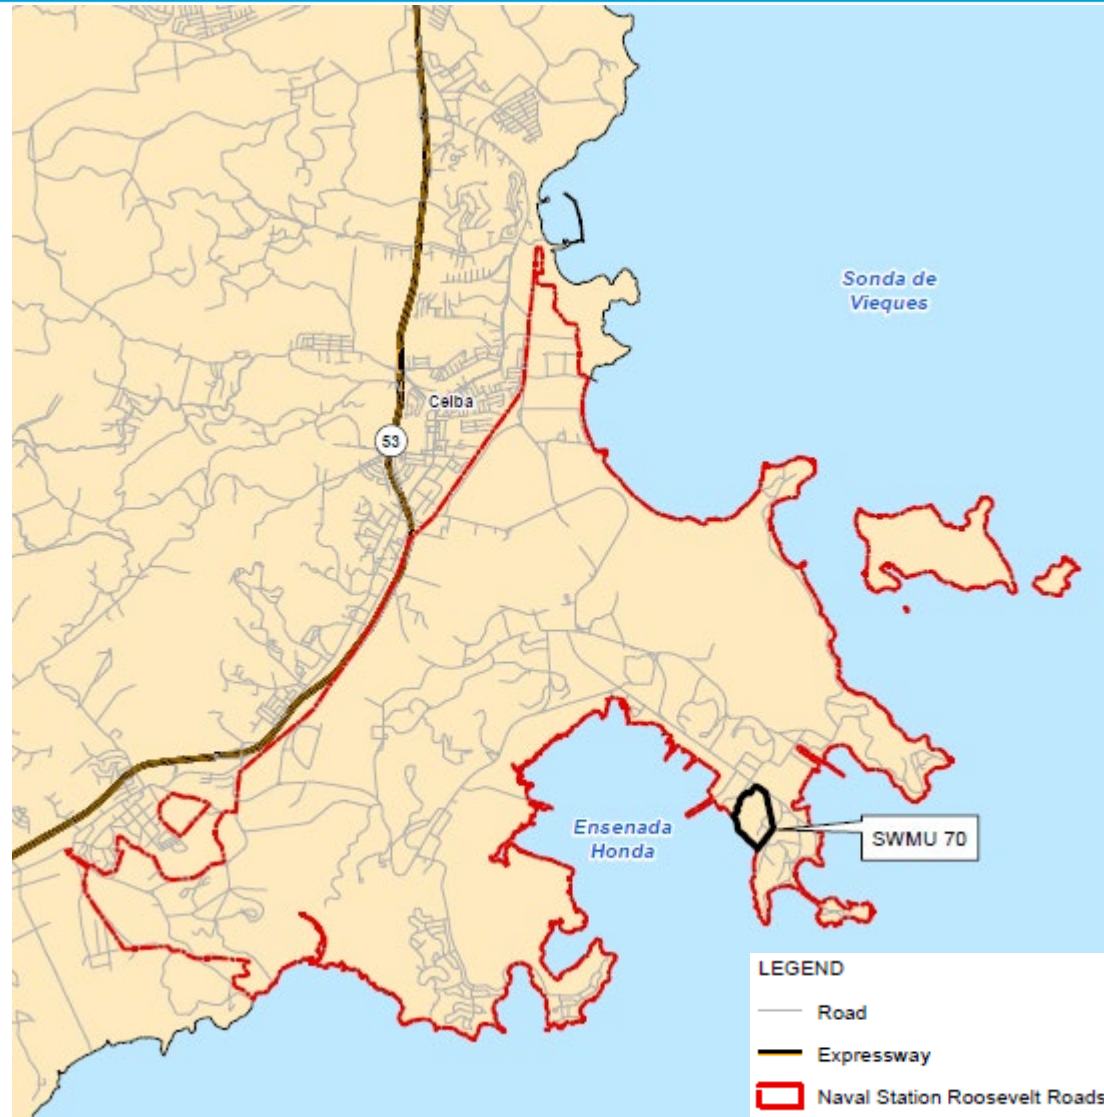
SWMU 70 - Disposal Area Northwest of SWMU 3 Landfill

- 52-acre area adjacent to and north of Ensenada Honda
 - Upland area is ~27 acres in the northern portion of the site with thick, secondary growth vegetation
 - Wetland area is ~25 acres in the southern portion of the site consisting of wetland with mangroves
- Historical site conditions included disturbed ground, cleared areas, and stressed vegetation visible in historical aerials from 1976 to 1983
- Debris consists primarily of metal, concrete, and miscellaneous waste (PVC, buoys, etc.)
- SWMU 70 Full RCRA Facility Assessment (RFA) was completed in 2015, during which surface debris removal was recommended for the site
- 83 debris piles were identified for removal prior to the Interim Corrective Measures implementation

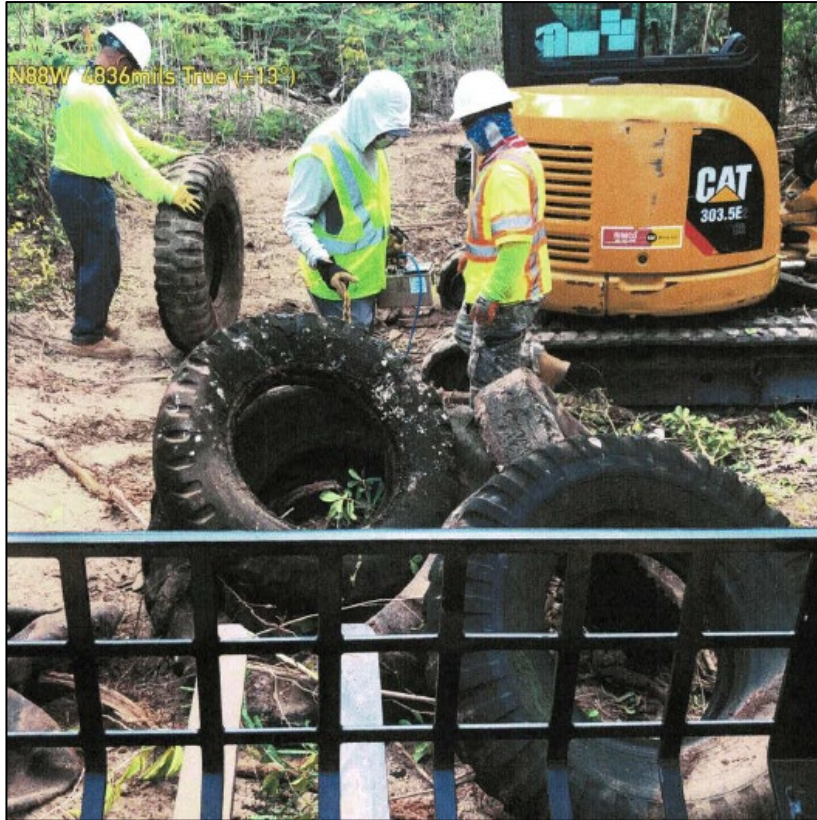
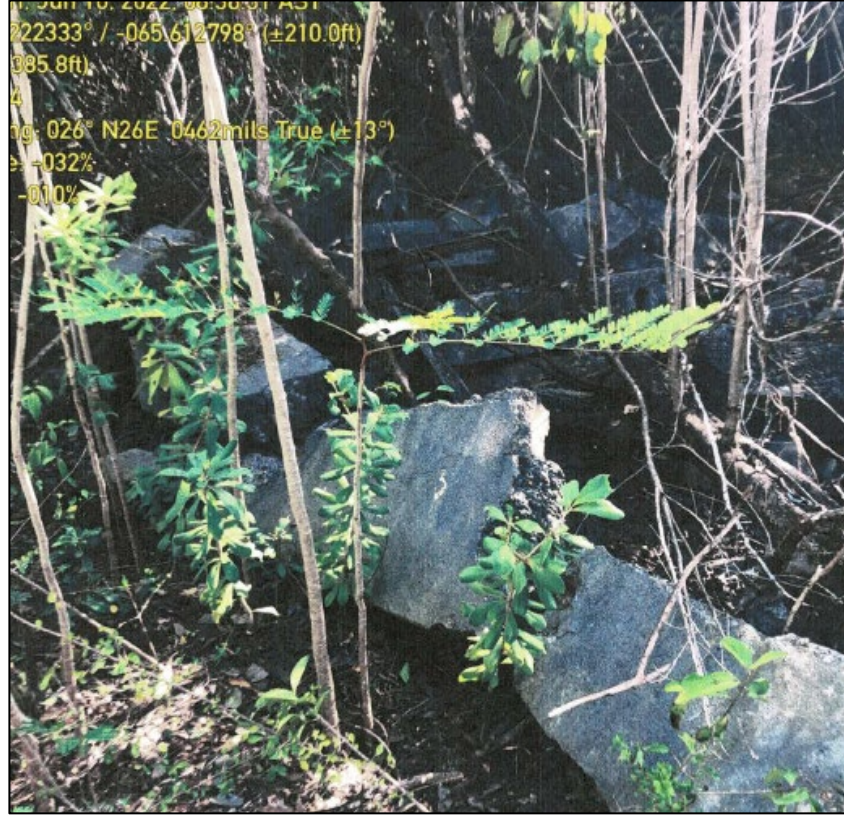
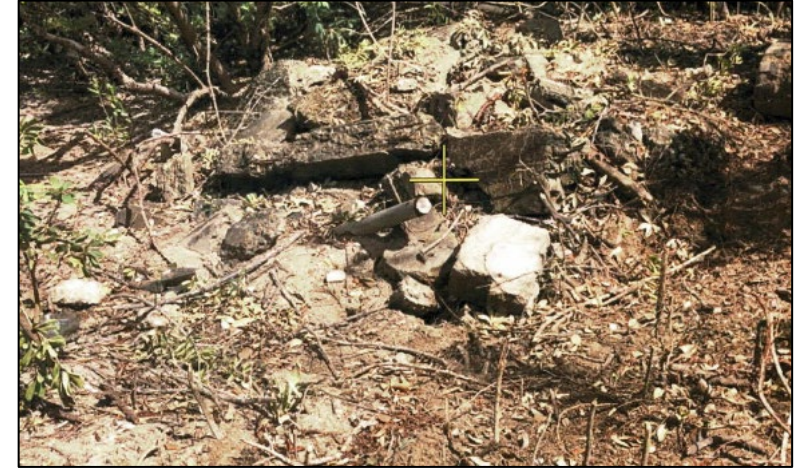
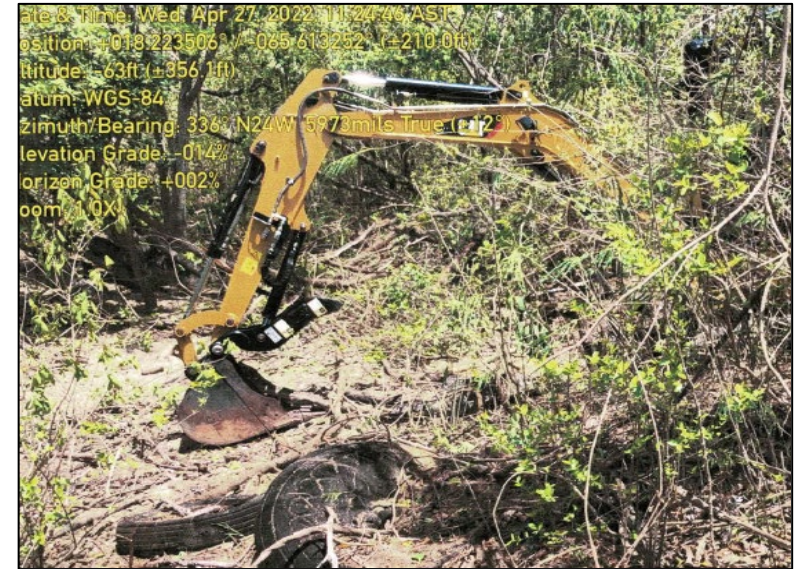
SWMU 70 – Debris Removal

- 26 debris piles were removed from the wetland area
- Removal of 9,800 cubic yards of various metals and inert waste (wood, tires, rubber, and plastic) within and adjacent to the wetlands
- The removal effort occurred in two phases due to COVID-19, December 2019 – March 2020 and April 2022 – July 2022.
- Monitoring for mangrove regrowth following the debris removal will be performed at 6-, 12-, 18-, and 24-months following the debris removal.

- 58 debris piles were removed from the upland portion of the site
- Removal of 366 tons of various material (concrete, buoys, metals, and other mixed waste) metals and inert waste
- The removal effort occurred from March – July 2022.
