## **Overview of Testing Results for Lead in Drinking Water and Corrective Actions for Naval Base Point Loma CDC, Patrick Wade CDC, Admiral Hartman Recreation Center, Gateway Village Recreation Center, Village at Serra Mesa Recreation Center, and Chesterton Community Center**

Priority Areas Lead Testing and Corrective Actions - June 2024

Child Development Center - Building 377

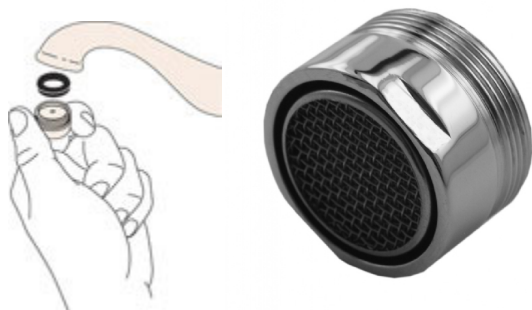
The **one** outlet that exceeded 10 ppb was a hand washing sink located in the Teacher Training Room (Room 116) inside the NBPL CDC (Building 377). Follow-up sampling at this outlet was conducted after removing and cleaning the faucet aerator. A faucet aerator (or tap aerator) is often found at the tip of modern indoor water faucets. Without an aerator, water usually flows out of a faucet as one big stream. An aerator spreads this stream into many little droplets, which helps save water, provides more uniform flow, and reduces splashing. However, the aerator and screen can trap debris which can accumulate lead.

After removing the faucet aerator, retesting showed that the sink in Room **116** at the NBPL CDC was below the screening level and the faucet was returned to service.

- If the lead concentration of the 30 second flush sample resulted in lower than 10 ppb lead, the aerators were the source of lead and the outlet can be used for drinking if the aerators are cleaned on a regular basis. The washing sinks in Room 116 at the NBPL CDC fit in this category.
