Central City
 Figure 2-3. Deficiencies of the Existing Levee System in Comparison to Design Criteria

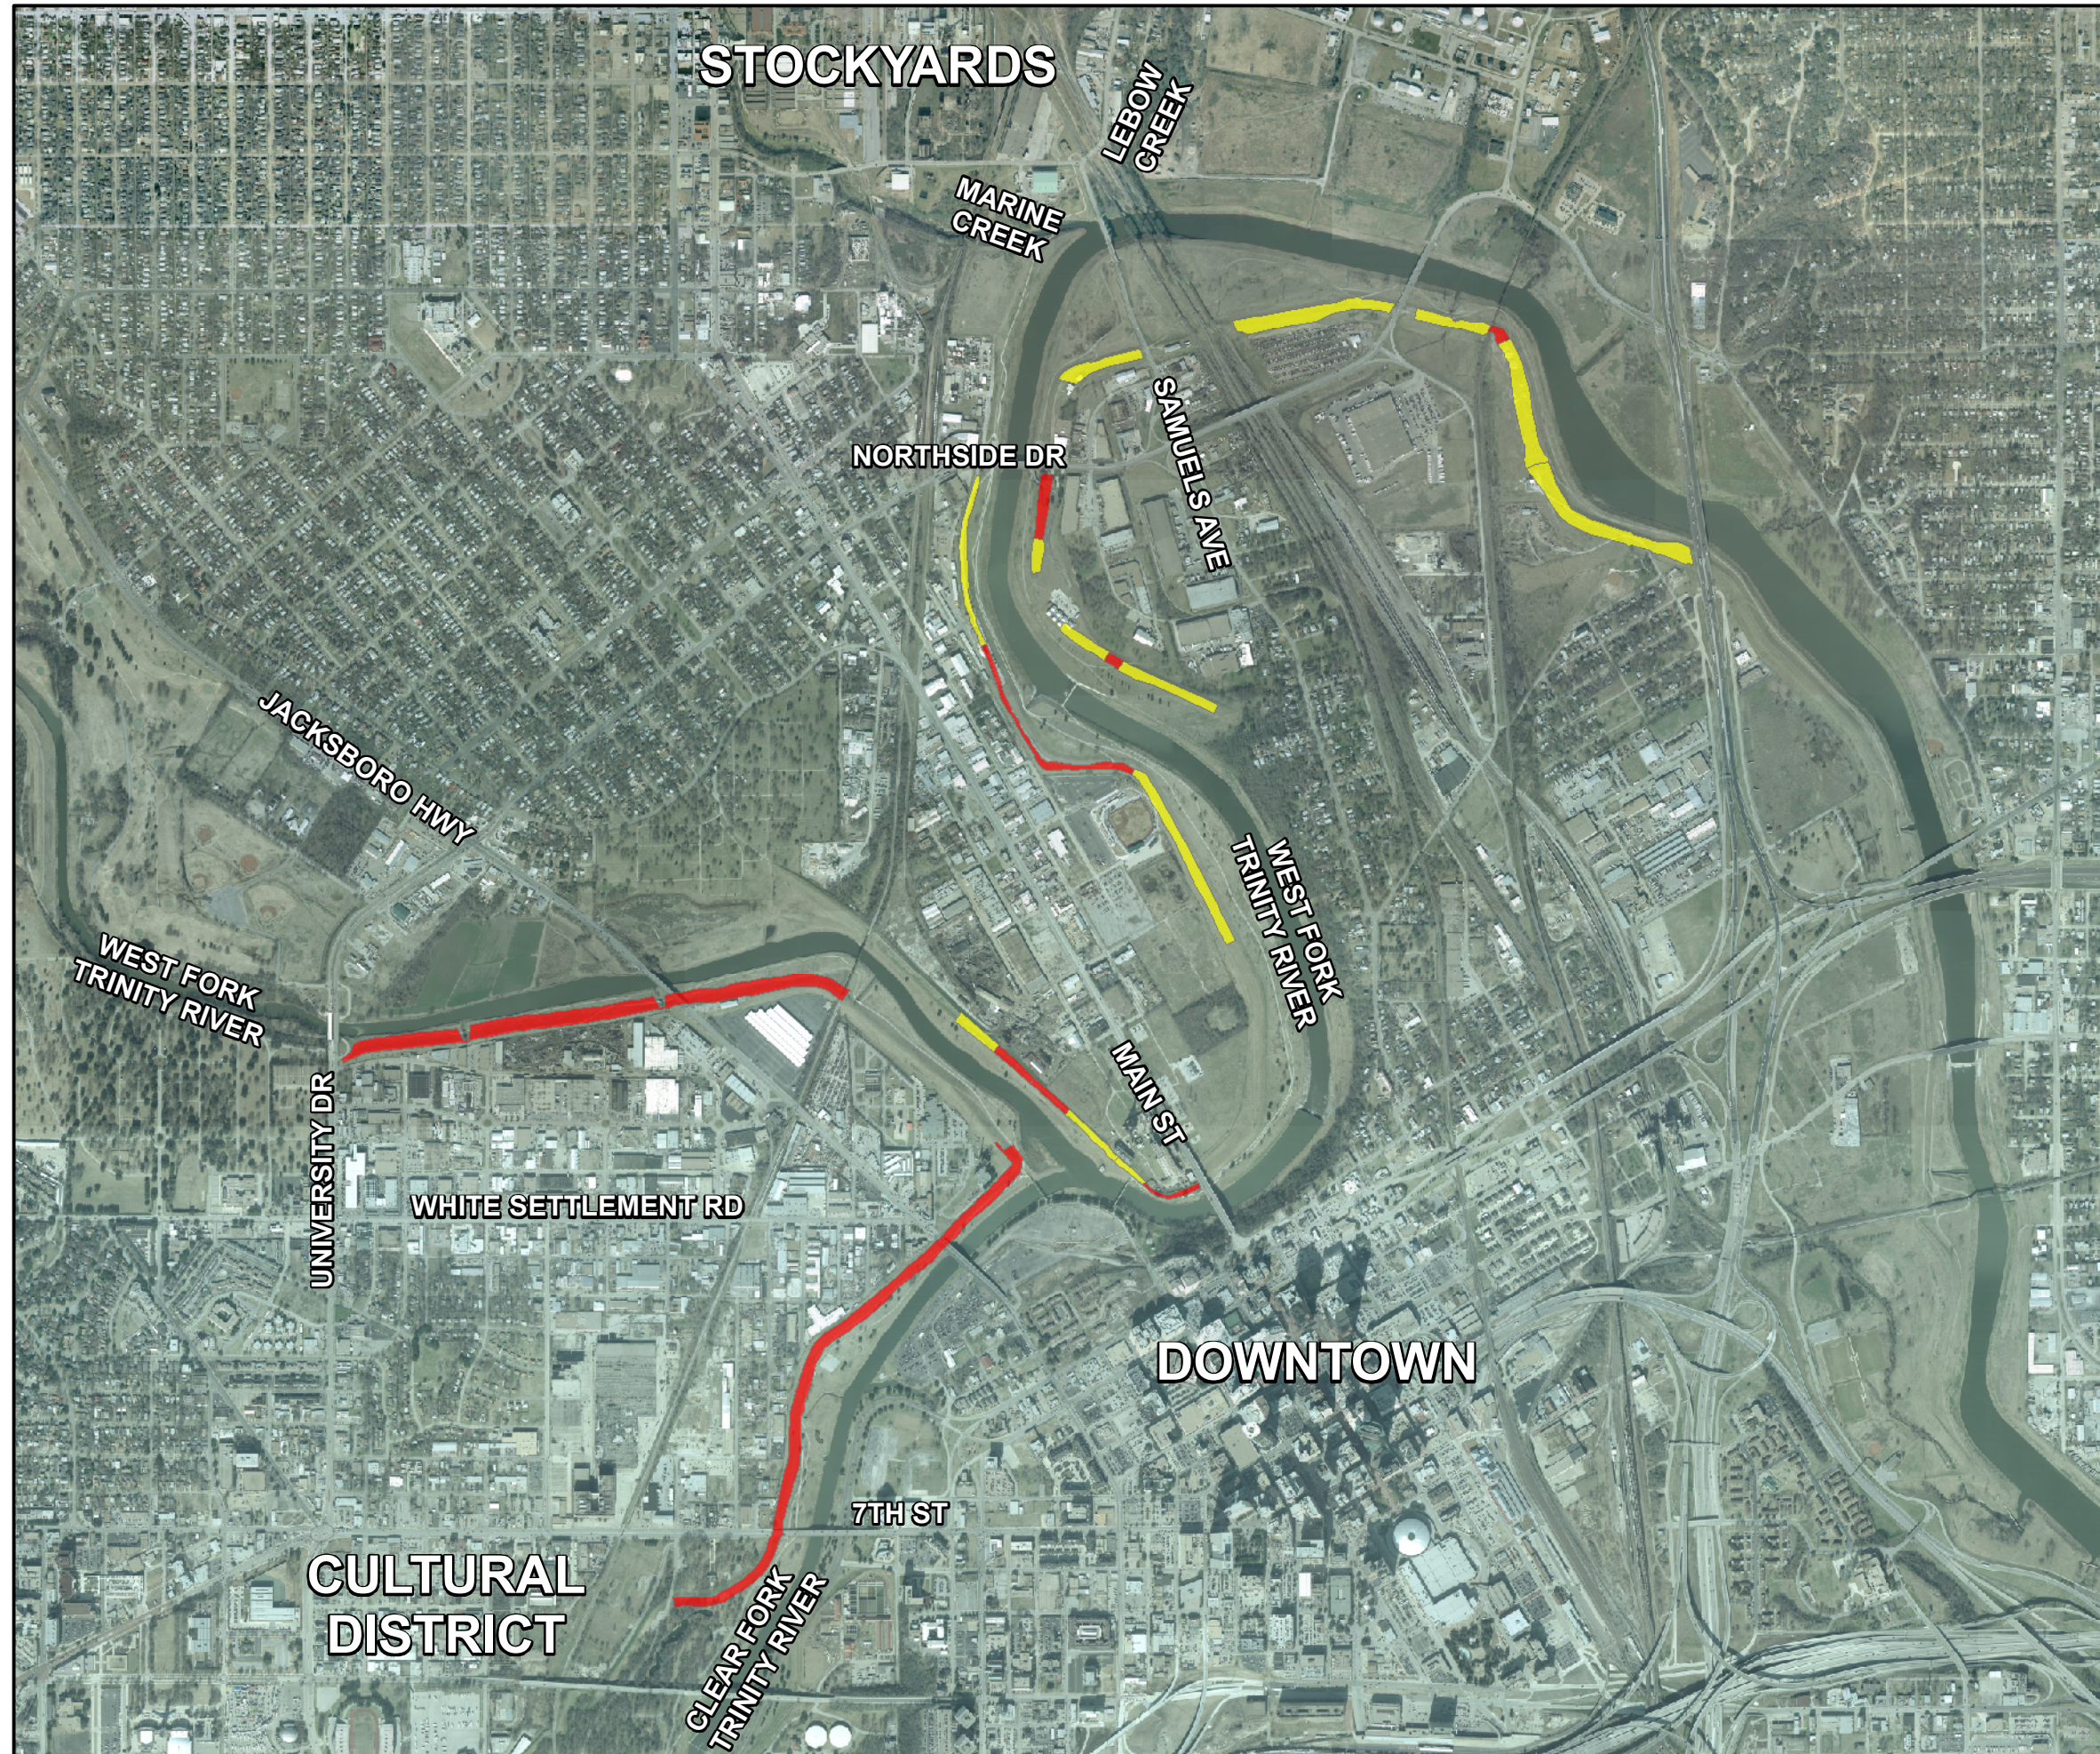
- 0-2 Ft Below Design Criteria
- 2-4 Ft Below Design Criteria
