# Engineering Evaluation and Cost Analysis Report

## Camp Swift, Texas

Property Number K06TX0304

**PARSONS**  
8000 Centre Park Drive, Suite 200  
Austin, Texas 78754

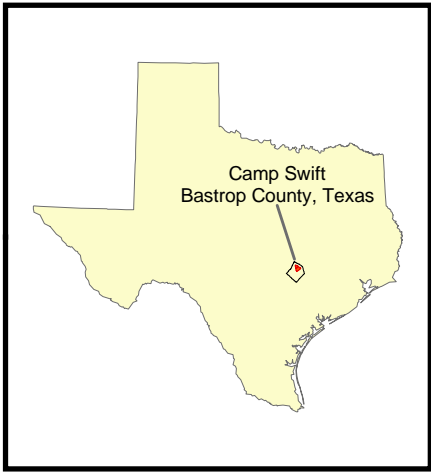
Figure 2.13  
Disturbed Ground  
Camp Swift, Texas

2.7.7.2 The results of the aerial photograph analysis are summarized in Table 2.7. For the purpose of the EE/CA investigation, the ASR areas were further subdivided into sectors based on current and past land use. The EE/CA sectors are also listed in Table 2.7. Areas of disturbed ground, including all types of disturbance, are shown in Figure 2.13.

Sample Identification	Sector Location	Historic Range/Training Area (as identified in 1943-44 Master Plan [Figure 2.5] and/or 1946 Master Plan [Figure 2.6])	Historic Ground Disturbance Type (as identified during Historical Aerial Photo Analysis [Figure 2.13])	Other Comments	Explosives Analysis		Metals Analysis	
					Normal Sample (Field Test Kits)	Duplicate Sample (Offsite Lab)	Normal Sample (Offsite Lab)	Duplicate Sample (Offsite Lab)
SCT01-UND-01	1: Firing Ranges	Field Combat Range No. 7			X		X	
SCT01-UXO-02		Transition Range No. 2	Ground Scar	Adjacent to UXO	X		X	
SCT01-UND-03		Submachine Gun Ranges Nos. 2-7					X	
SCT01-UND-04		Submachine Gun Ranges Nos. 2-7					X	
SCT03A-UND-01	3A: Remaining Lands (Boy Scouts)				X		X	
SCT03A-UND-02					X			
SCT03C-UND-01	3C: Remaining Lands (LCRA)				X		X	
SCT03C-UND-02					X	X	X	X
SCT03E-UND-01	3E: Remaining Lands (Other Areas)	Wake Island (Anti-Tank Training Area)	Impact Craters		X		X

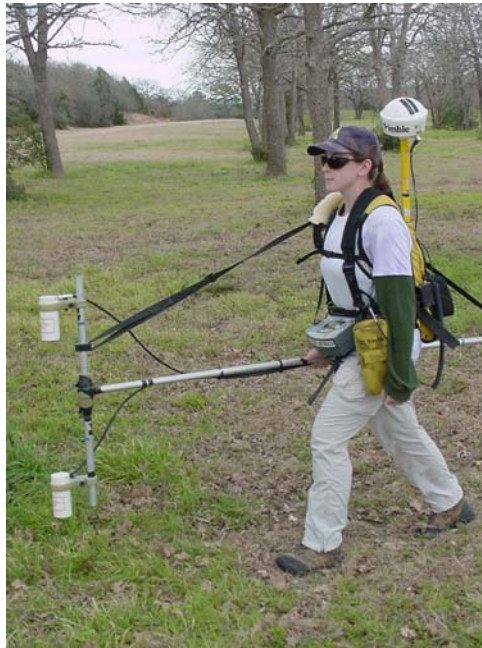
**Photograph 3.1 Geophysicist conducting survey with G-858G Magnetometer**

ambient magnetic field caused by ferrous metal (the sensors are fixed and aligned to eliminate a response to the earth's ambient field). The Magnetic Locators generate an audio output and a meter deflection when either of the two sensors is exposed to a disturbance of the earth's ambient field associated with a ferrous target and/or the presence of a permanent field associated with a ferrous target (in most cases, it will be a combination of both circumstances). Schonstedt Magnetic Locators were utilized by the USA Environmental excavation crews to verify that the anomaly had been excavated.

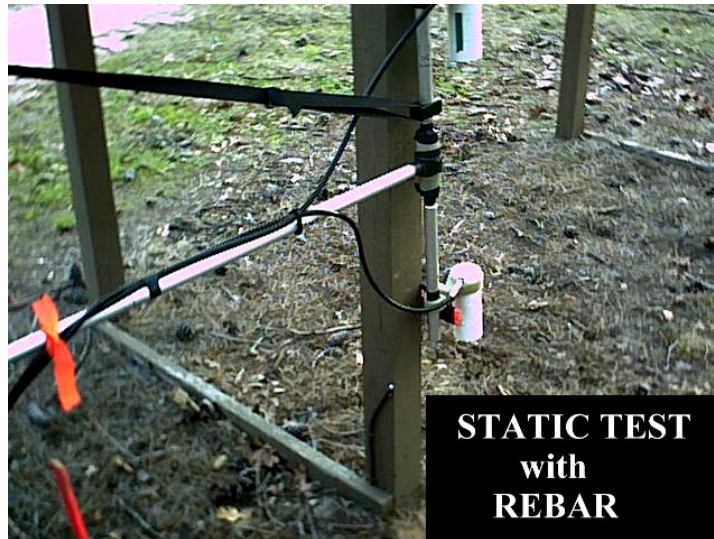
**Photograph 3.2 G-858G Static Test Layout**

- Static QC test with and without a piece of rebar to simulate an anomaly. This test was performed each morning and evening. Photograph 3.2 displays the static test setup.

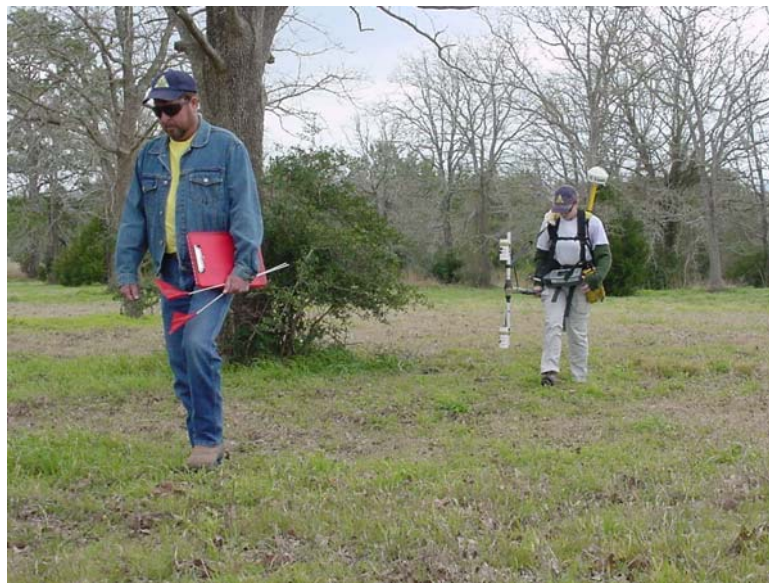
**Photograph 3.3 Meandering Path Survey**

3.1.4.5 Survey activities were conducted by carrying the G-858G magnetometer for the collection of geophysical data in conjunction with the ProXRS™ GPS unit, which recorded real-time positions for the G-858G readings. The magnetometer collected 10 readings per second and received positional information from the ProXRS™ every second so the geophysical data and GPS data could be synchronized. After collection, magnetometer data and GPS data were downloaded separately for data processing. A UXO-qualified technician provided advance visual surface OE removal of the surveyed areas for the magnetometer operators and served as an assistant to the geophysicist. Photograph 3.3 displays a geophysical team performing a meandering path survey. The person in the foreground is a UXO-qualified technician. The area covered by a transect was calculated as the distance traveled multiplied by the width of the G-858G influence (three feet). Five ordnance scrap items were identified on the ground surface by field teams during the geophysical survey. These findings are described in detail in Subchapter 3.2.

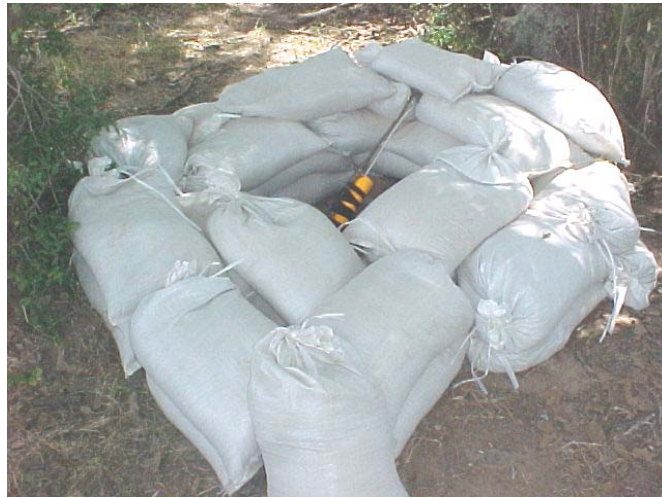
**Photograph 3.4 Sandbag Setup for UXO Detonation**

3.1.9.3 Once all safety precautions were implemented, each UXO item was explosively destroyed. All items were blown-in-place (BIP), except four training anti-tank mines which were moved to a remote designated detonation area at Griffith League Ranch with concurrence of the USAESCH OE Safety Specialist and BSA.

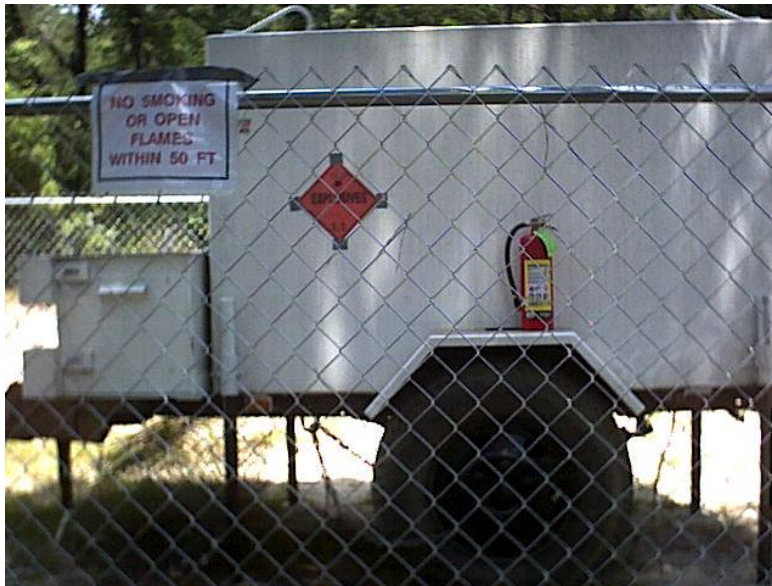
**Photograph 3.5 Explosives Storage Magazine**

3.1.9.2 Initially, explosives were delivered to the site on an as-needed basis. However, due to difficulties in receiving on-call explosives from the local supplier in a timely manner, an explosives storage magazine was mobilized to the site. An Explosives Siting Plan and an Explosives Management Plan were submitted to USAESCH on May 10, 2002, and, following approval of the plans by USAESCH, the magazine was ready for use on May 14, 2002. BSA allowed the magazine to be set up on the Griffith League Ranch property. Photograph 3.5 displays the magazine setup.

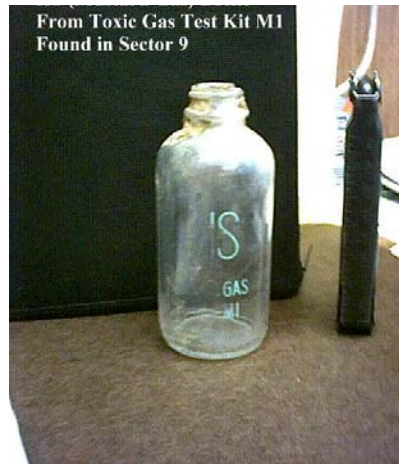
**Photograph 3.6 Bottle from HS Toxic Gas Set**

3.2.13.3 A total of 8 anomalies were identified in this area. During reacquisition, two of the anomalies were found to be caused by a wire and scrap metal on the ground surface. Of the six intrusively investigated anomalies, one ordnance scrap item, which weighed 0.25 pounds, was found. However, a clean empty bottle marked with the words "HS Toxic Gas Set, M1" was found on the ground surface during soil sampling conducted on June 13, 2002. The markings on the bottle indicate that it was part of a chemical agent identification set. These sets were used for training identification of various chemical agents that could be encountered on the battlefield. The bottle found in Sector 9, shown in Photograph 3.6, was placed in the custody of a USAESCH representative.

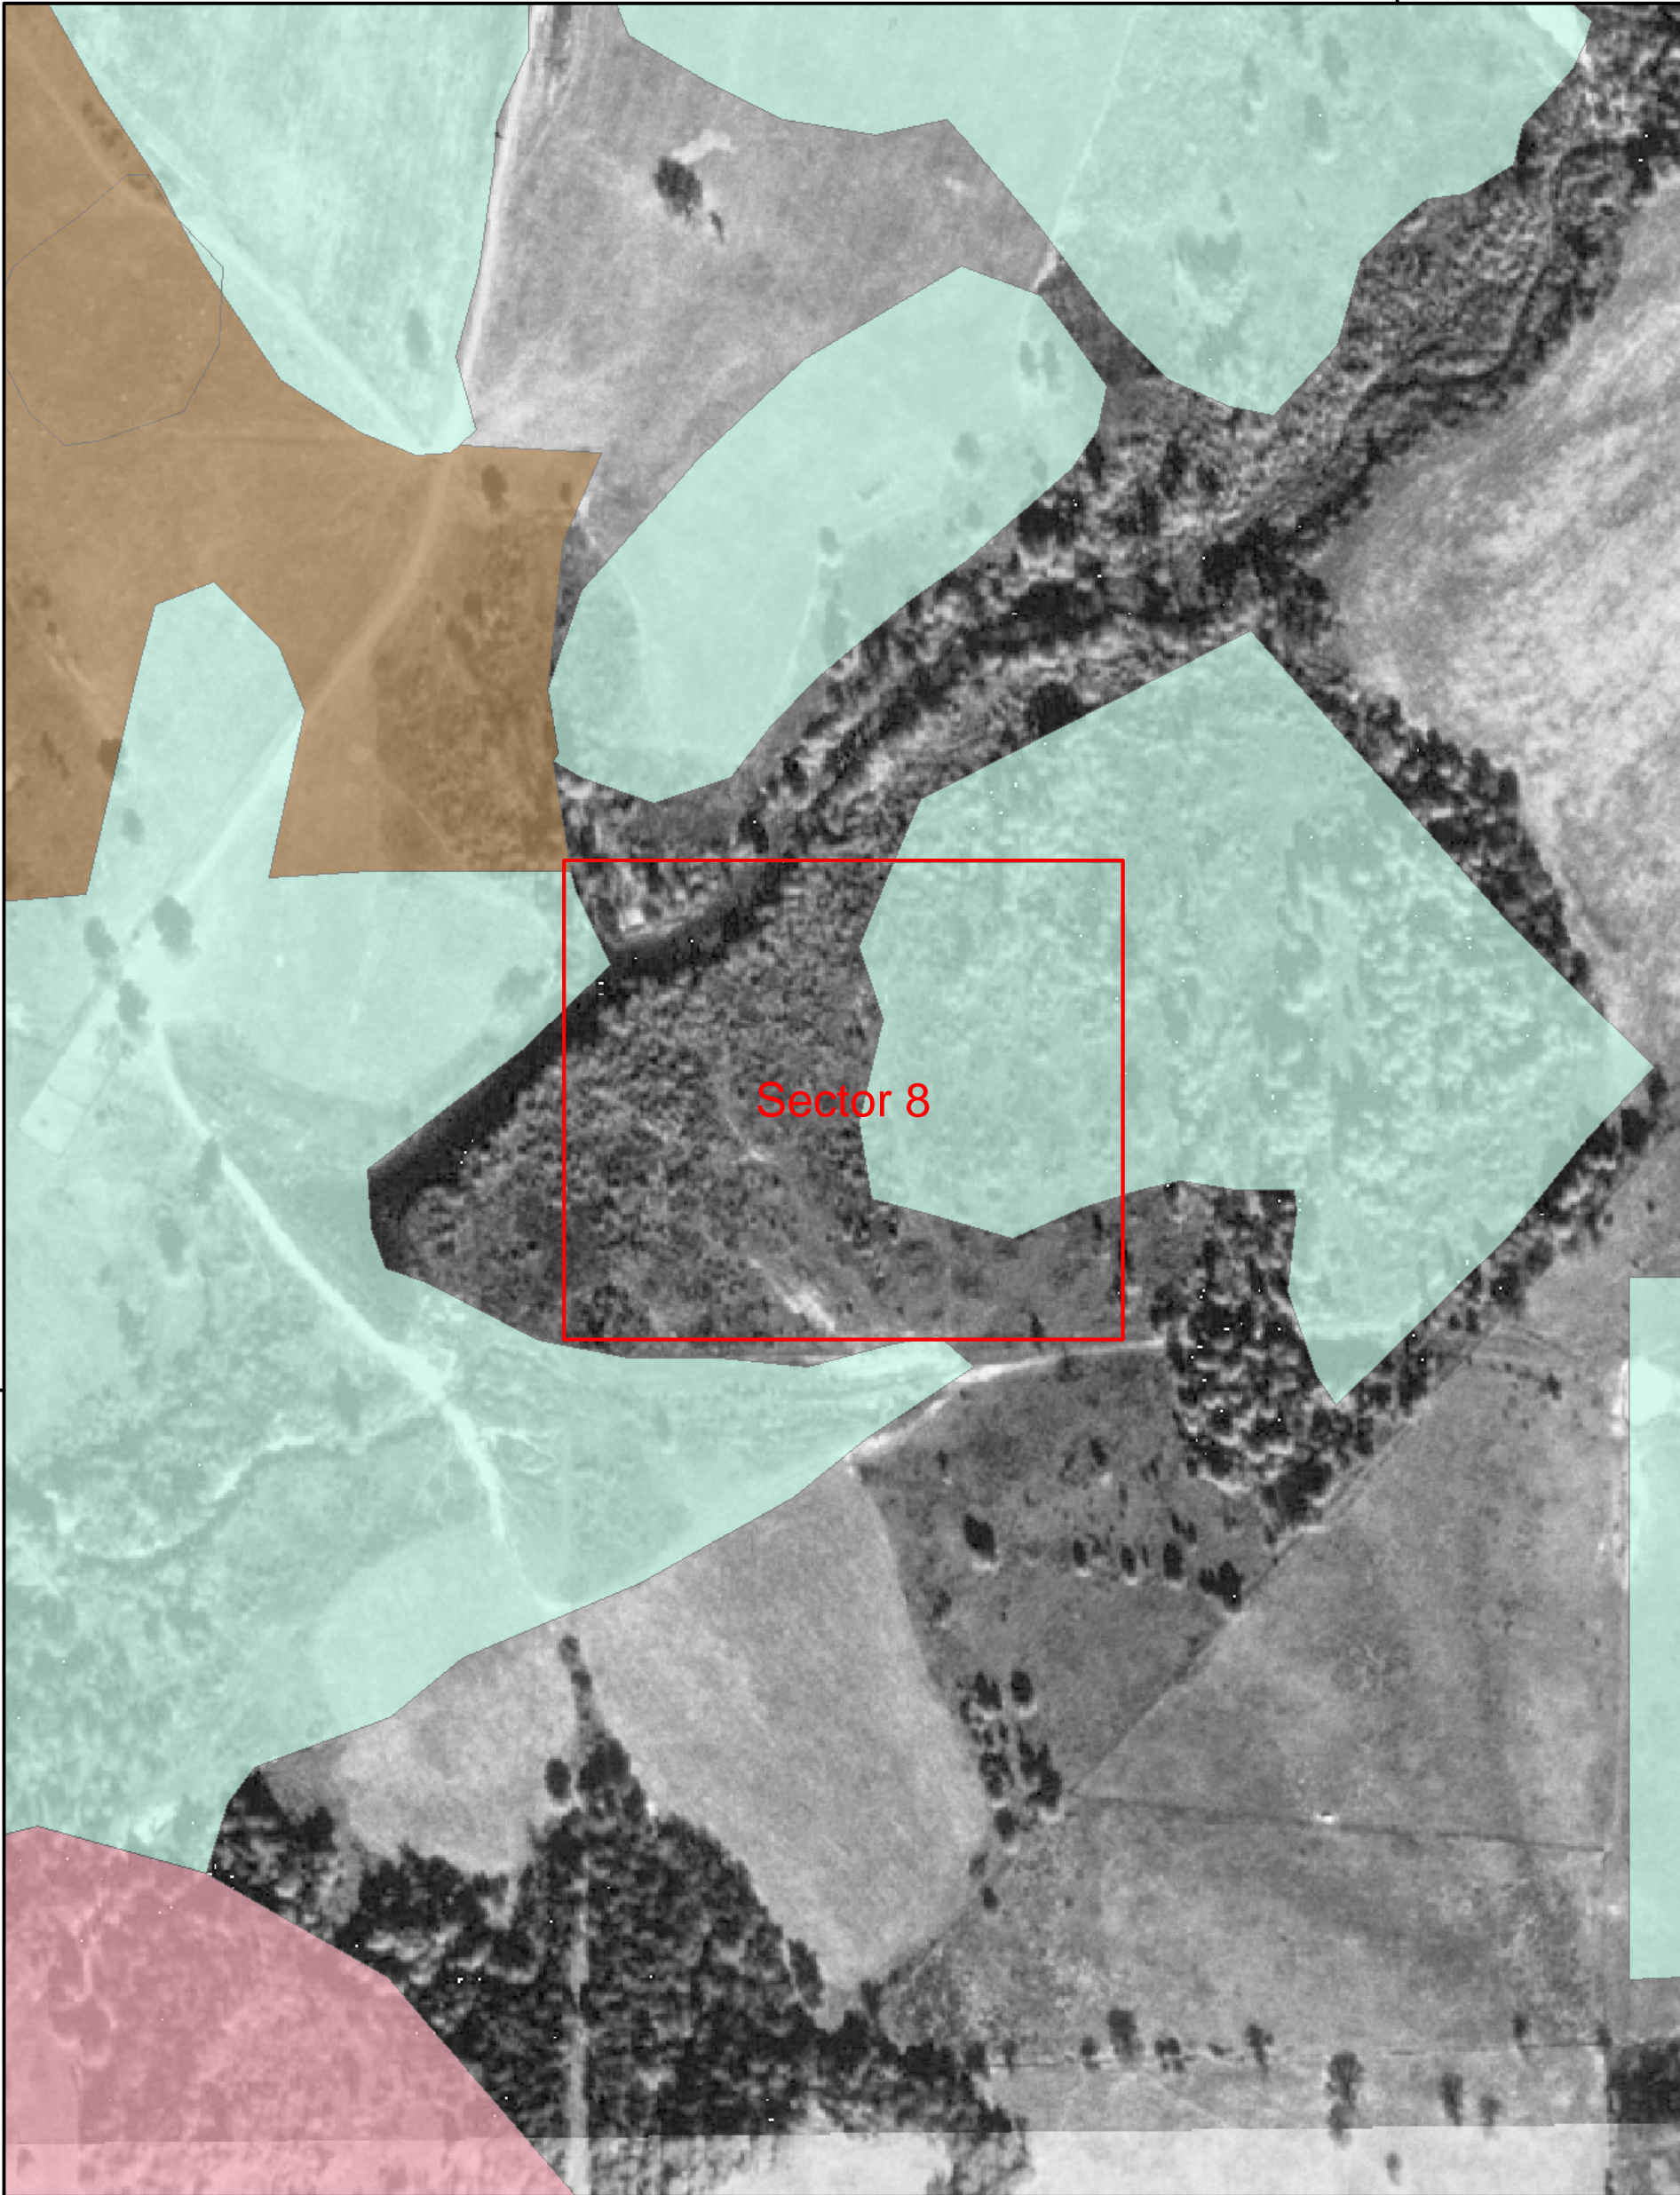
Figure 3.13  
EE/CA Field Investigation Results  
Sector 10

3.2.14.3 A total of 2.95 acres were surveyed in Sector 10 (Figure 3.13), and 94 anomalies were investigated. One UXO item was discovered in the sector: a practice anti-tank mine with energetic charge was found 4 inches bgs (Table 3.4). Six ordnance scrap items were recovered from this area during intrusive investigations, one was recovered during reacquisition, and another was recovered during the geophysical survey. The recorded weight for these items was 11 pounds. The presence of UXO in Sector 10 is consistent with the ASR information.

3.2.14.2 Sector 10 has confirmed past ordnance usage and confirmed past discoveries of OE; however, no OE items were discovered during the ASR survey nor during the February 2000 site visit. Past discoveries included practice mines and practice mine fuzes. Sector 10 was designated as an area with “confirmed contamination” in the ASR and received a RAC of 4. Numerous craters were observed during the February 2000 site visit of the demolition area. Analysis of the 1943 aerial photograph indicated evidence of impact craters and a pit in the area (ERDC, 2000), as shown in Figure 3.13.

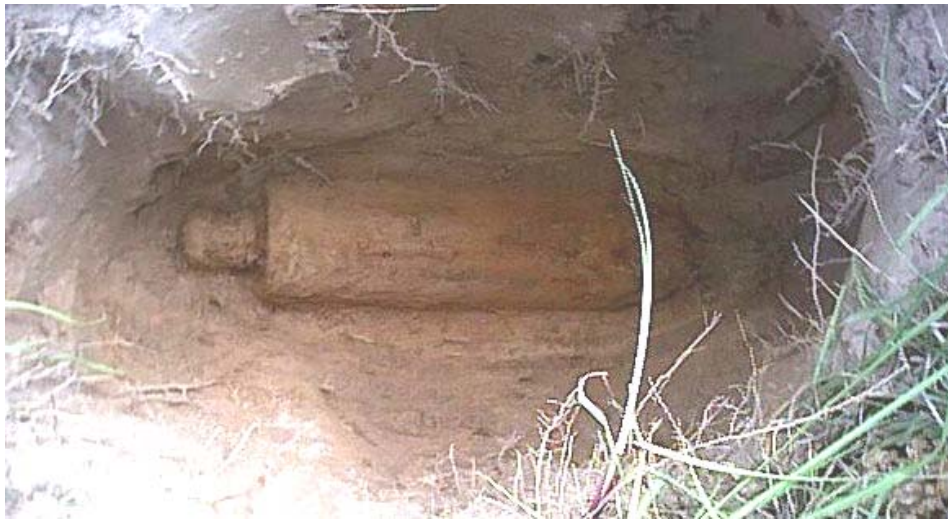
**Photograph 3.7 4.2-inch Mortar found at former Camp Swift**

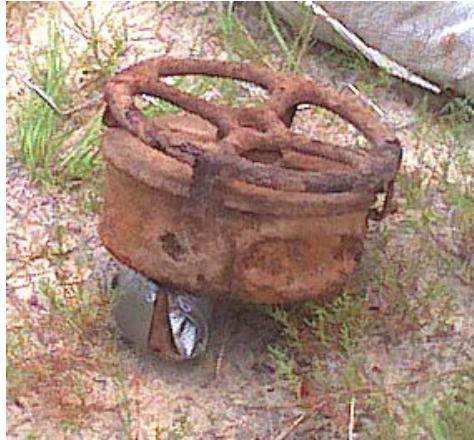
**Photograph 3.8 Practice Anti-Tank Mine (with booby trap) found at former Camp Swift**

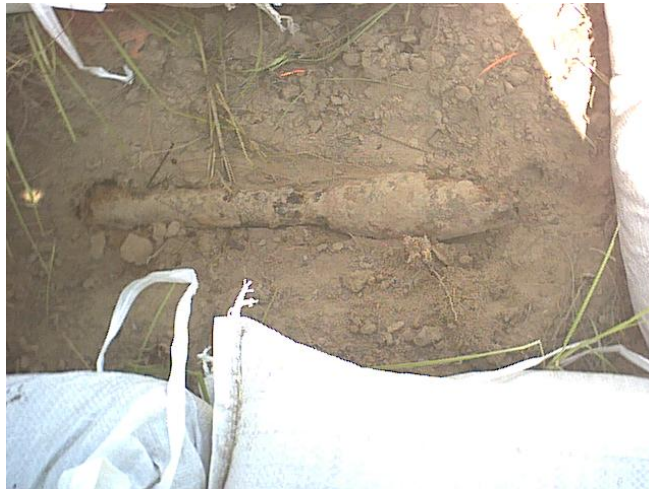
**Photograph 3.9 2.36-inch Practice Rocket found at former Camp Swift**

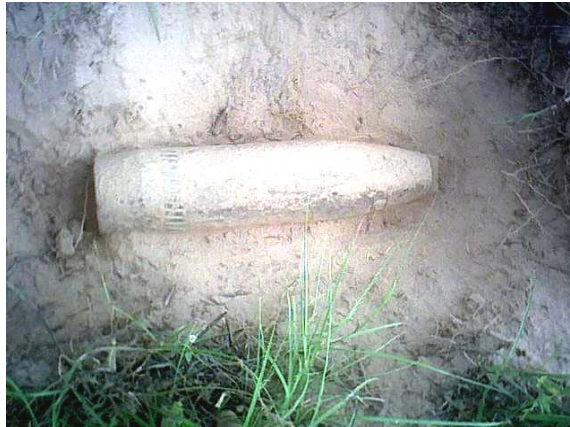
**Photograph 3.10 105mm Projectile found at former Camp Swift**

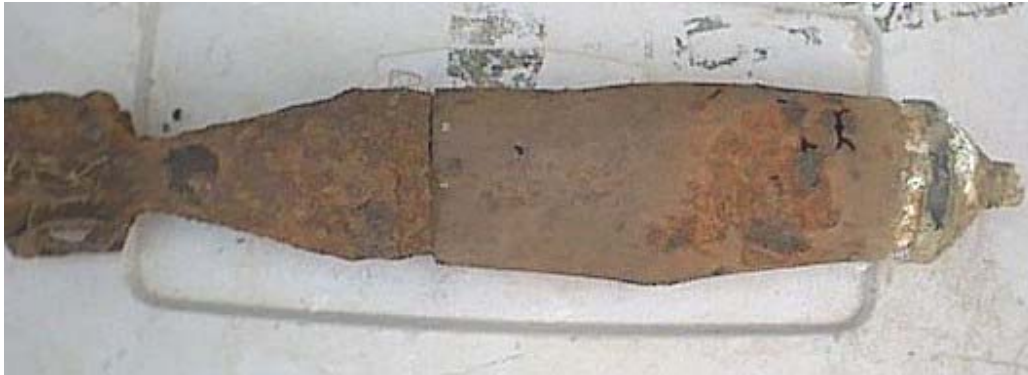
**Photograph 3.11 Expended 60mm Mortar found at former Camp Swift**

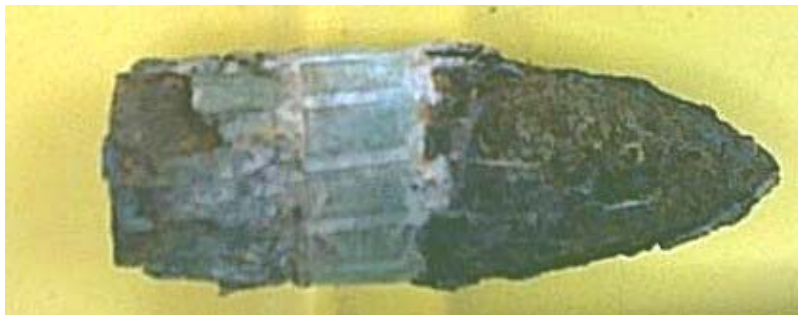
**Photograph 3.12 Expended 37mm Projectile found at former Camp Swift**

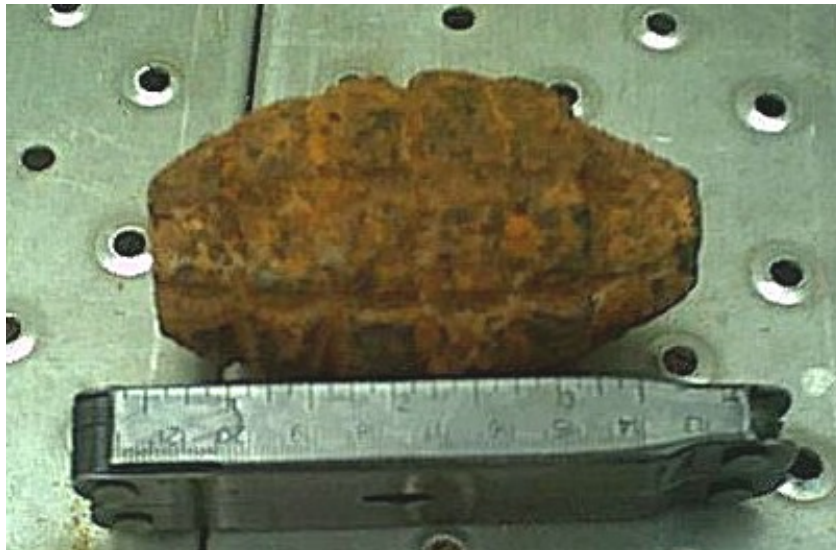
**Photograph 3.13 Practice Hand Grenade found at former Camp Swift**
