Fifth Five-Year Review Report

Hunters Point Naval Shipyard
San Francisco, California

November 2023

DCN: CH2M-0007-4930-0005

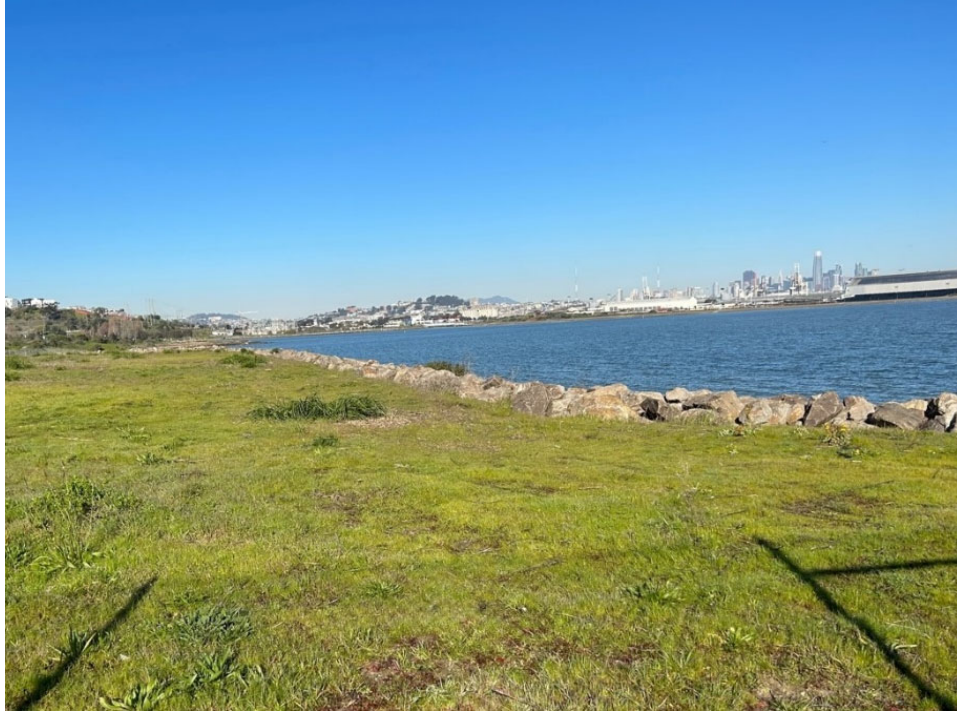
IR-07/18 Photograph 1: Soil cover near revetment crest. Facing northwest.
Photographed by: Marcella Navas/CH2M, 2/9/2023

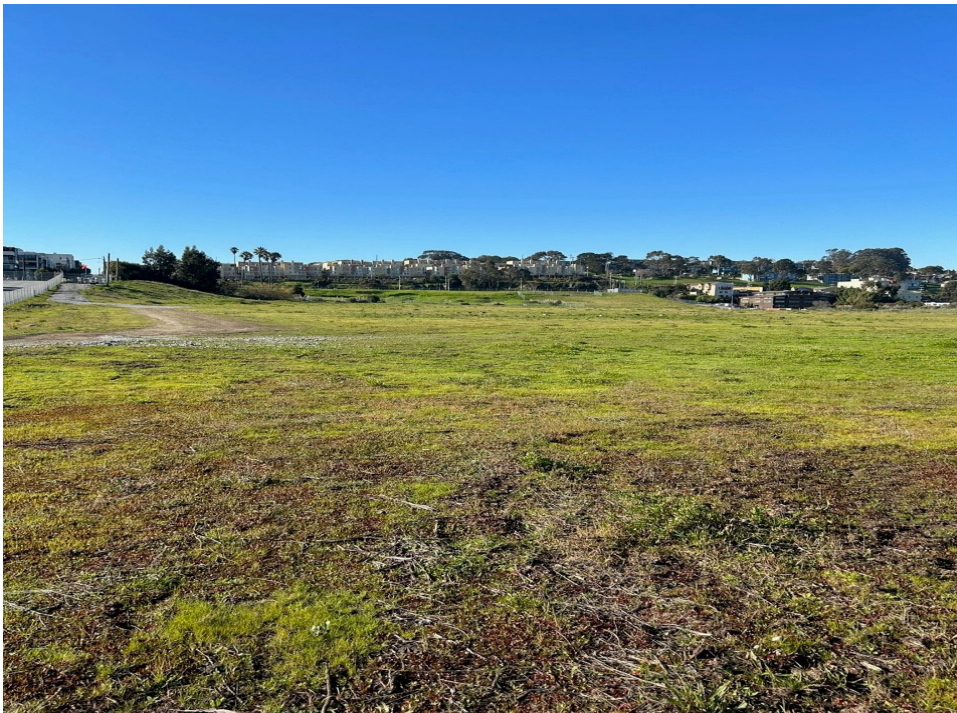
IR-07/18 Photograph 2: Soil cover. Facing southwest.
Photographed by: Marcella Navas/CH2M, 2/9/2023

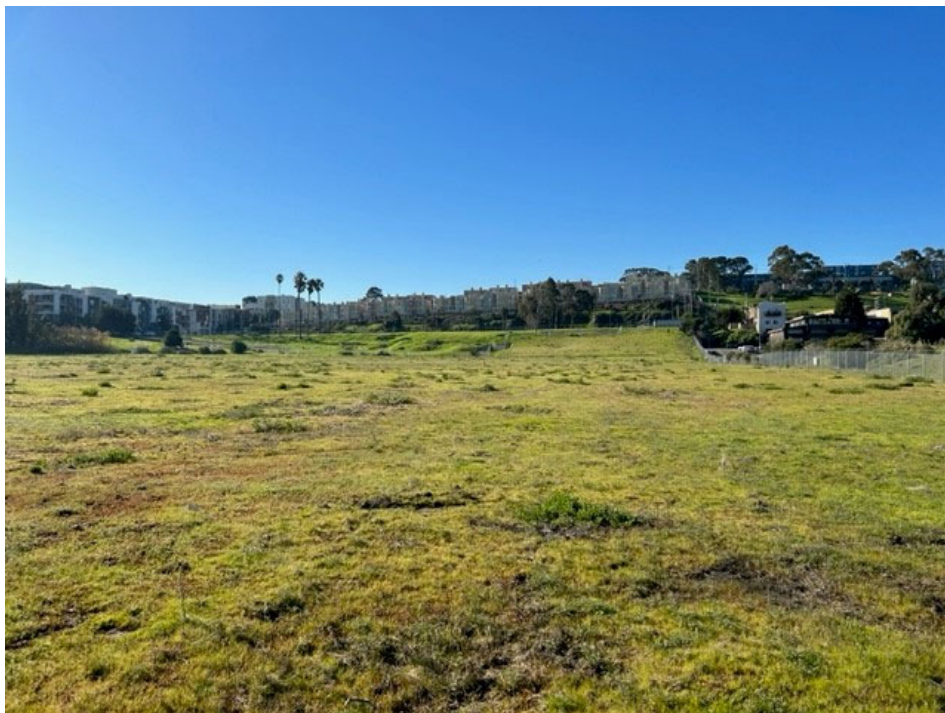
IR-07/18 Photograph 6: Soil cover southwest of revetment crest along non-Navy property. Facing southwest.

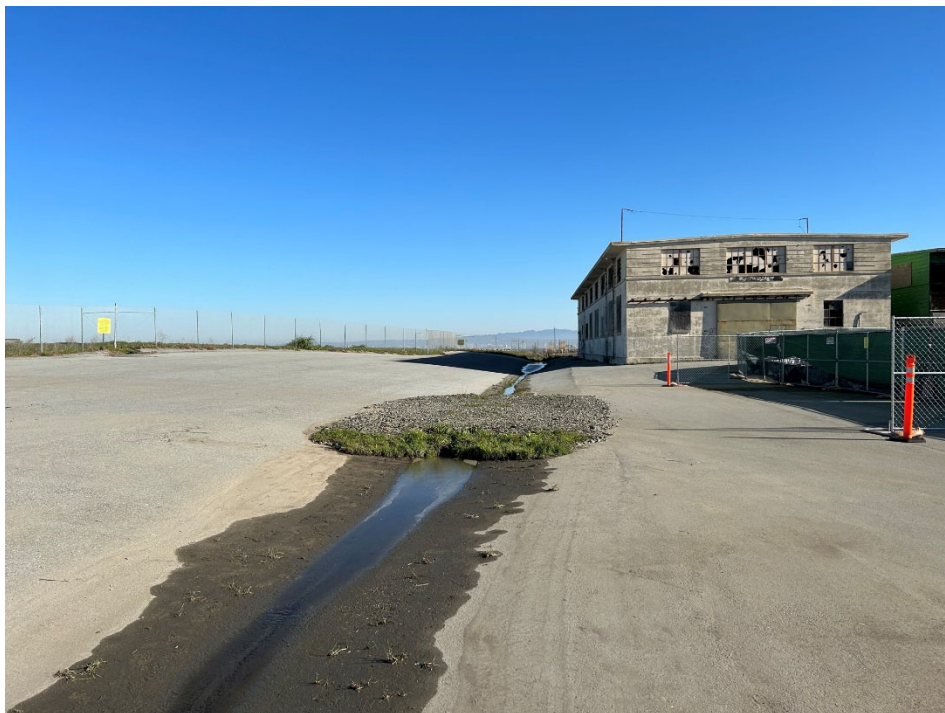
IR-07/18 Photograph 8: Drainage channel with gravel patch southwest of Building 146. Facing northeast.

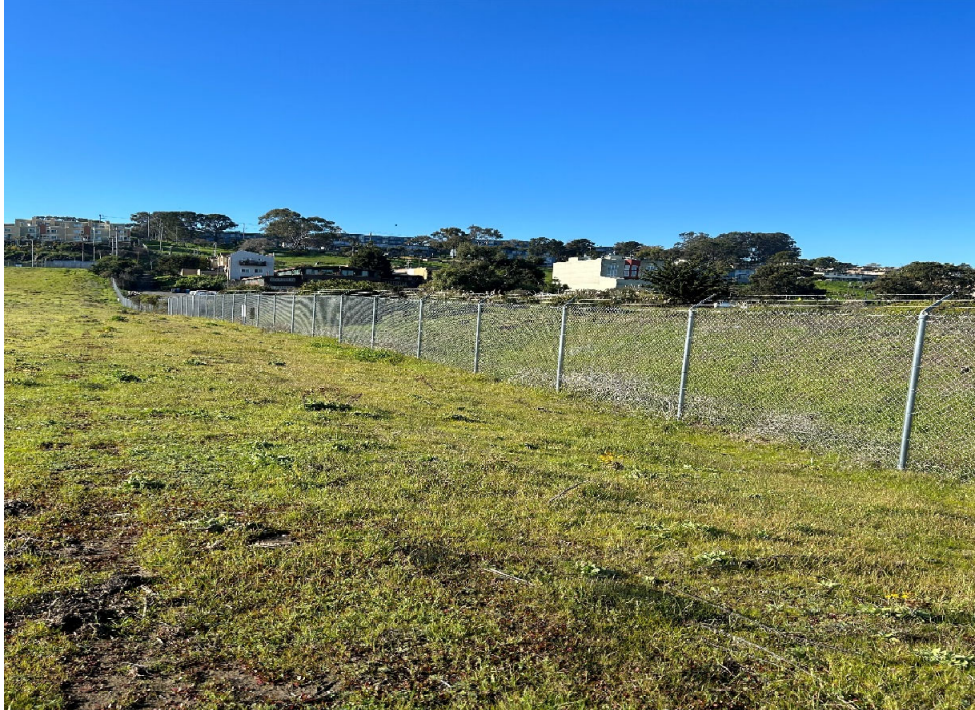
IR-07/18 Photograph 15: Chain-link fence along non-Navy property. Facing southwest.

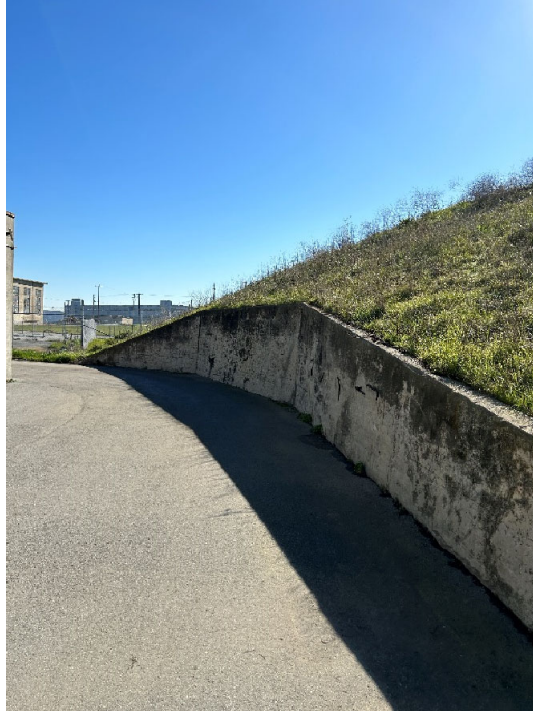
Parcel B-1 Photograph 1: Retaining wall southwest of Building 113. Facing southeast.
Photographed by: Marcella Navas/CH2M, 2/9/2023

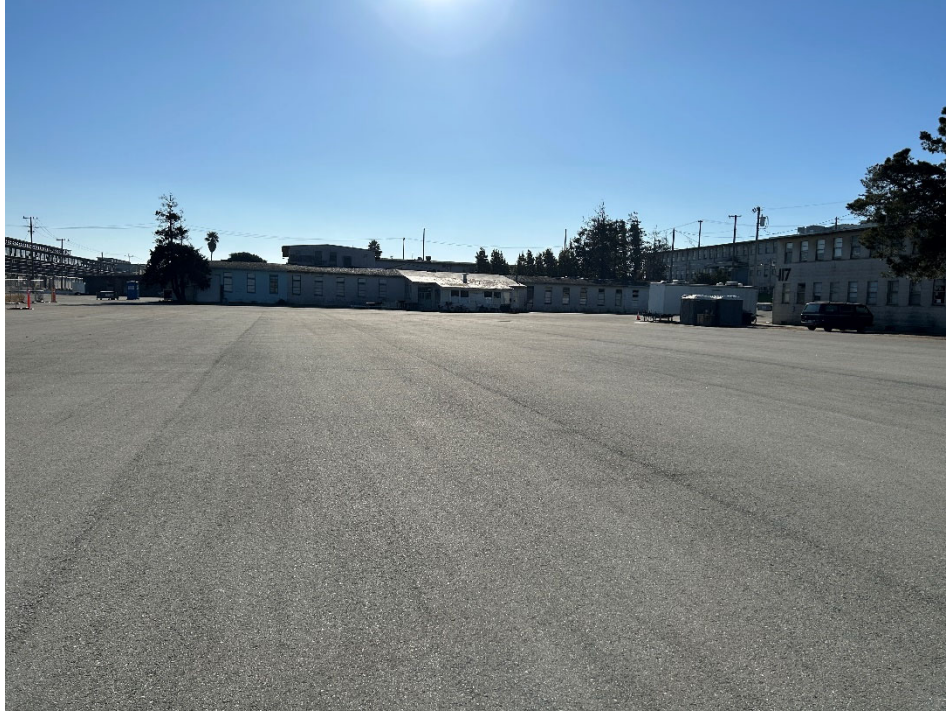
Parcel B-1 Photograph 5: Asphalt pavement cover southwest of Building 121. Cover is generally intact and in good condition. Facing east.

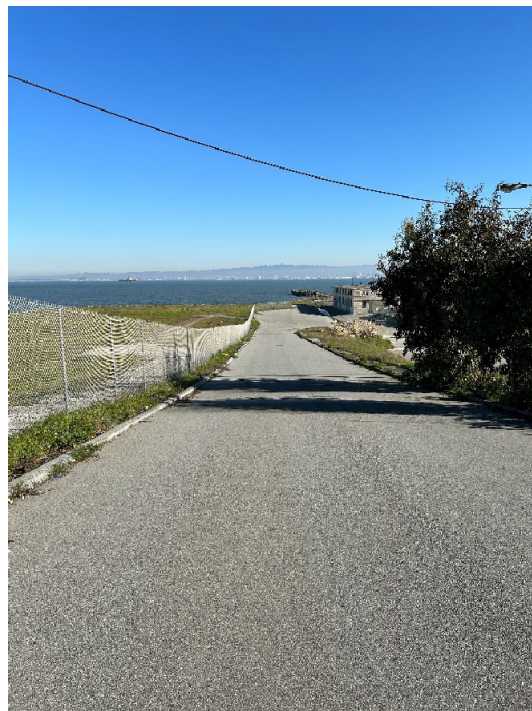
Parcel B-1 Photograph 6: Asphalt pavement cover along Donahue Street. Facing northeast.

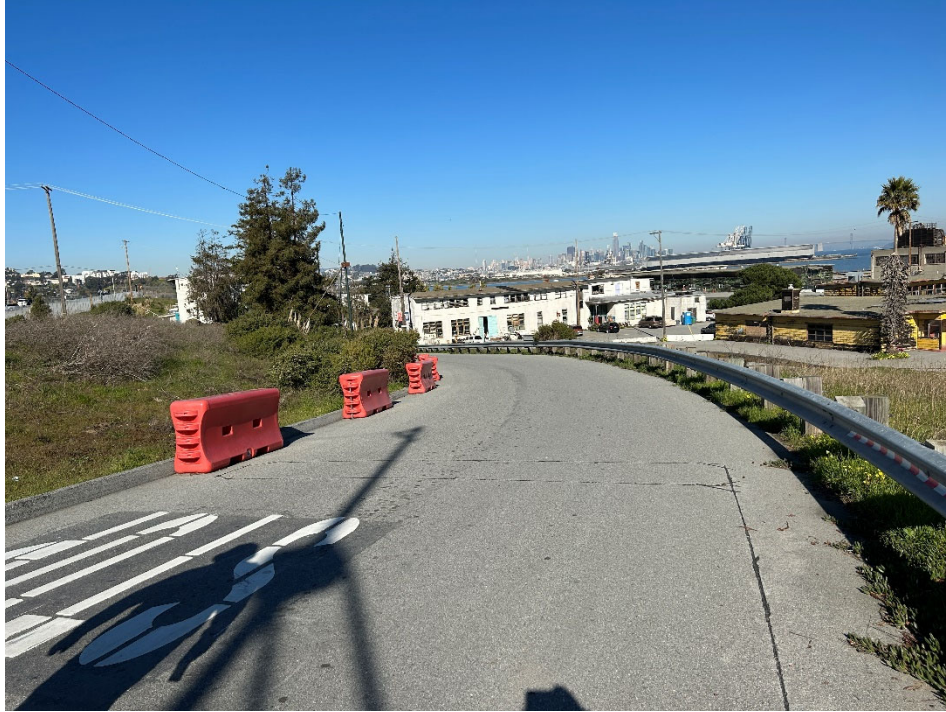
Parcel B-1 Photograph 11: Asphalt cover southwest of Building 113. Facing northwest.
Photographed by: Marcella Navas/CH2M, 2/9/2023

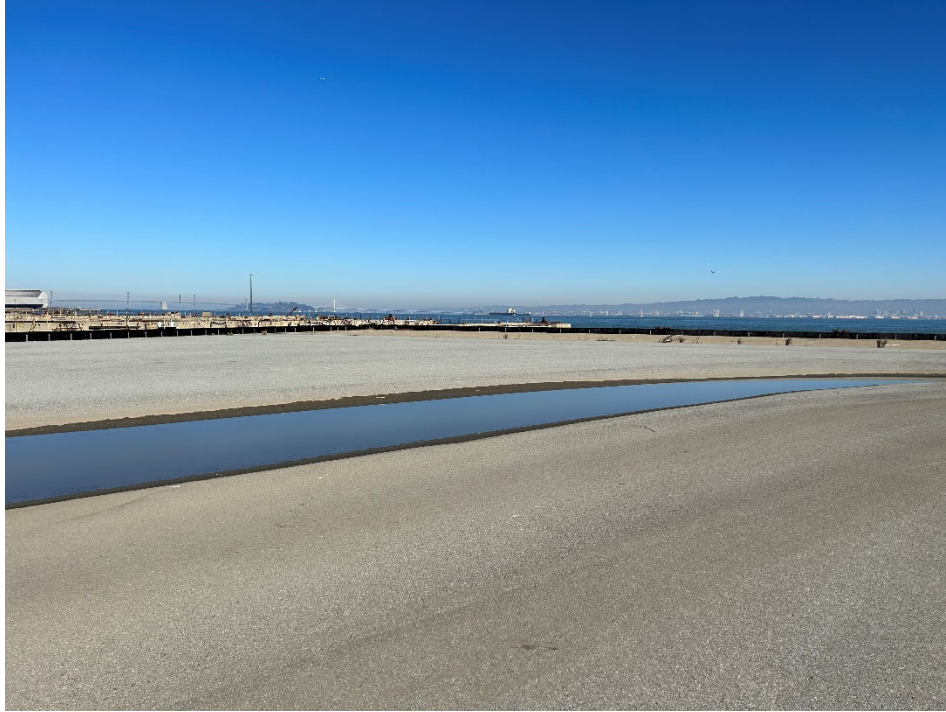
Parcel B-2 Photograph 1: Drainage swale in asphalt pavement cover northwest of Building 159. Facing north.

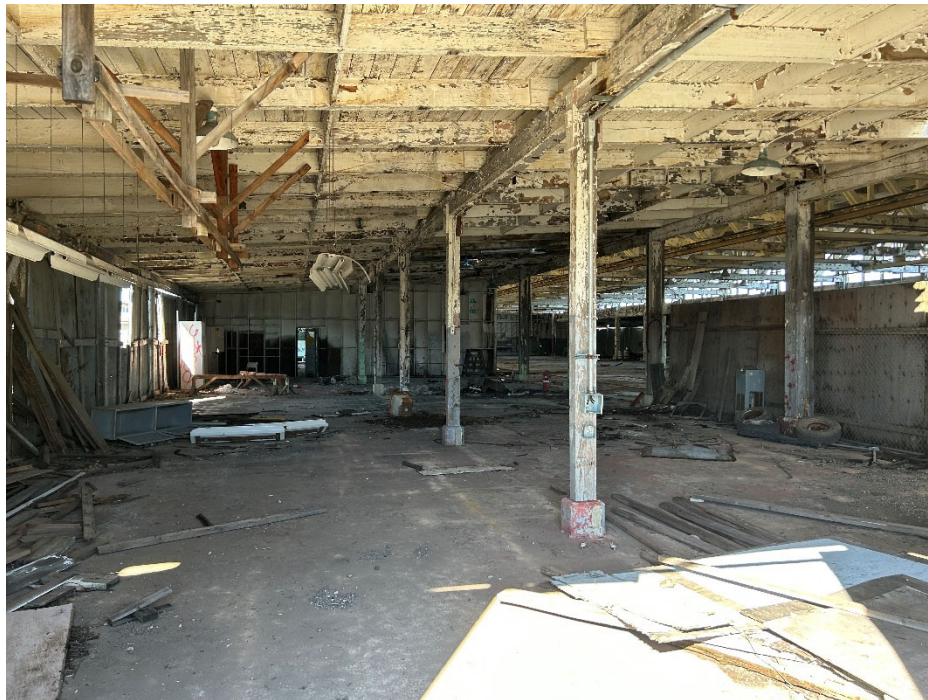
Parcel B-2 Photograph 10: View of the Building 128 foundation. Facing northwest.
Photographed by: Marcella Navas/CH2M, 2/9/2023

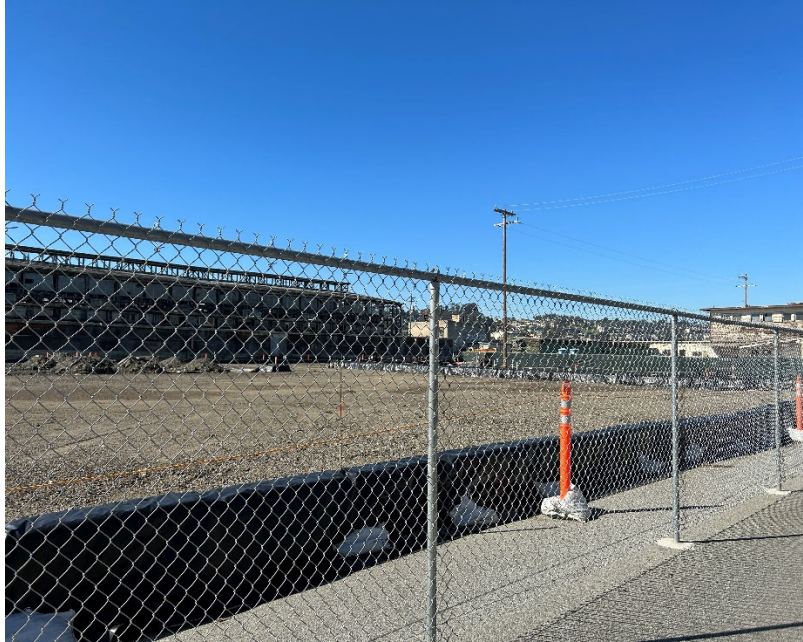
Parcel B-2 Photograph 11: Chain-link fence along Parcel B-1 boundary. Facing west.
Photographed by: Marcella Navas/CH2M, 2/9/2023

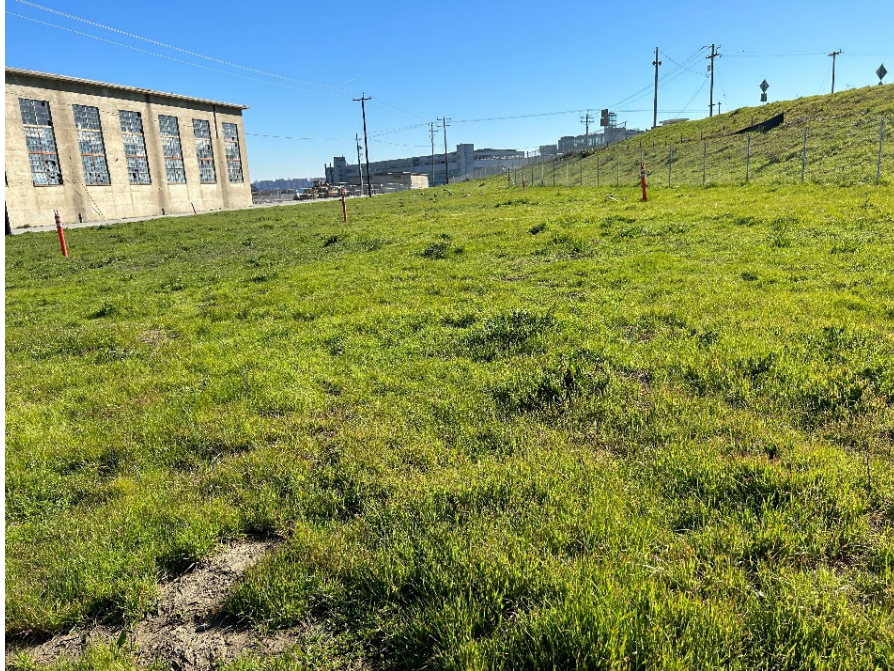
Parcel C Photograph 1: Soil cover west of Building 134. Facing southeast.
Photographed by: Marcella Navas/CH2M, 2/9/2023

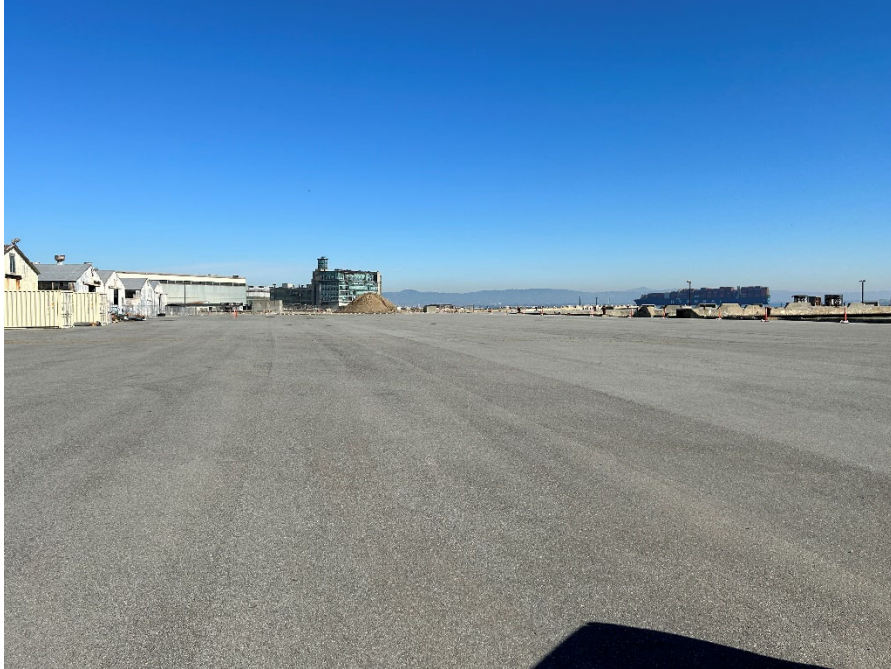
Parcel D-1 Photograph 1: Asphalt pavement cover adjacent to Parcel G. Facing northeast.

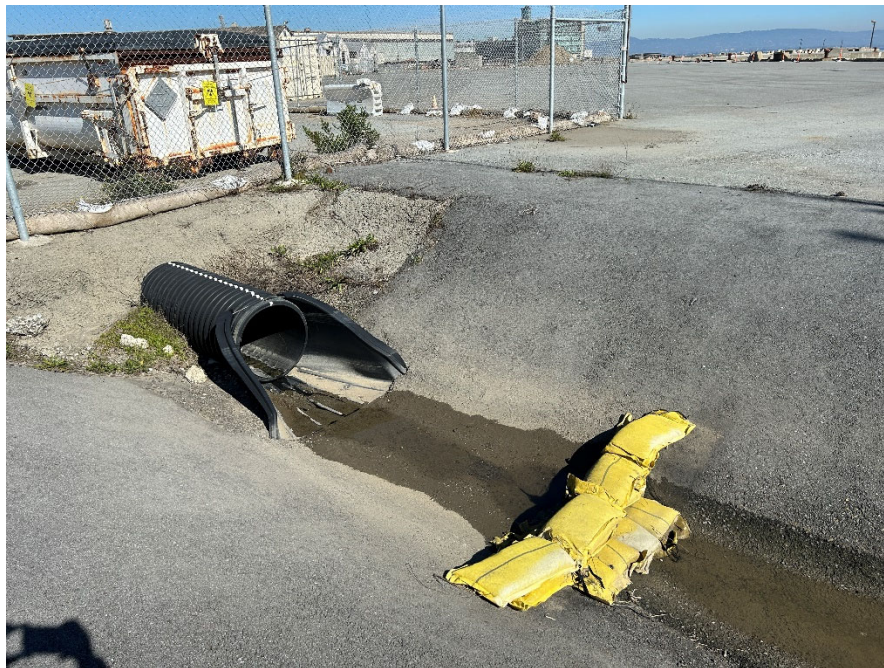
Parcel D-1 Photograph 8: Drainage swale adjacent to Parcel G. Minor vegetation growth in cracks along the seam between swale material and flat surface material. Facing northwest.

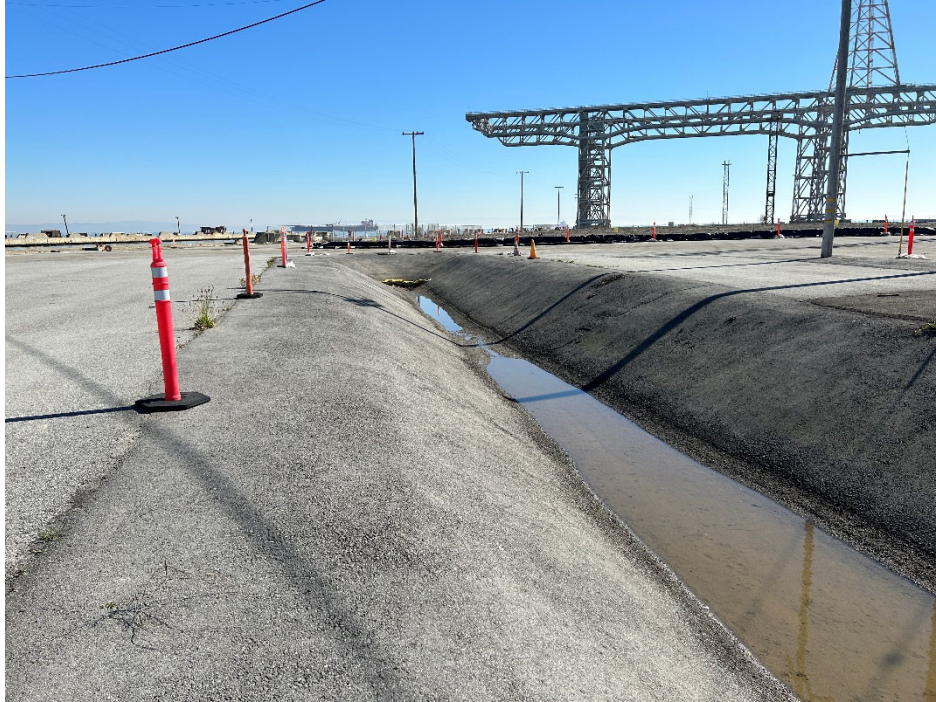
Parcel D-1 Photograph 9: Drainage swale with water southeast to Building 307. Facing northeast.

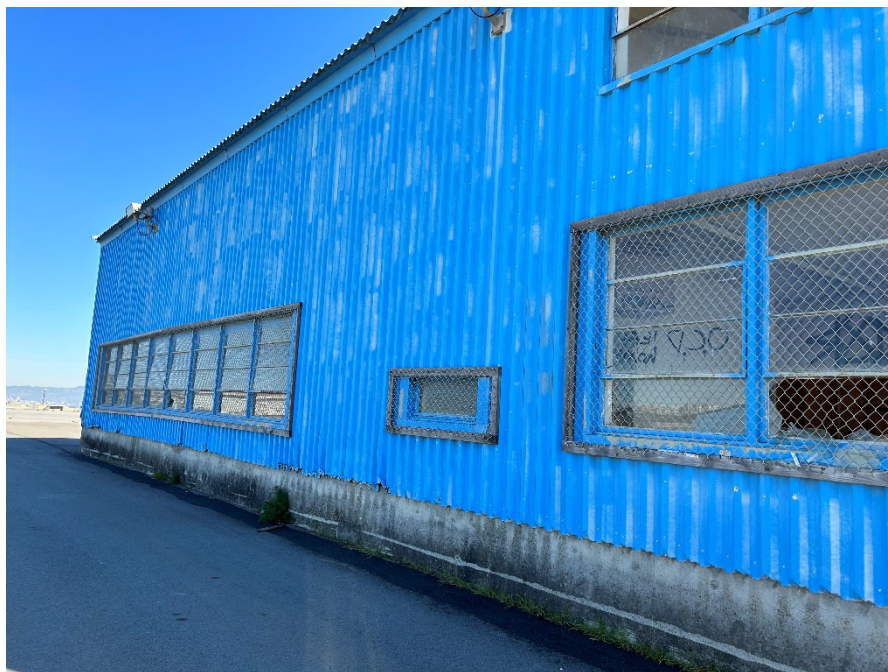
Parcel D-1 Photograph 10: Building 381, vegetation growth in the seam between exterior cover and building foundation. Facing northeast.

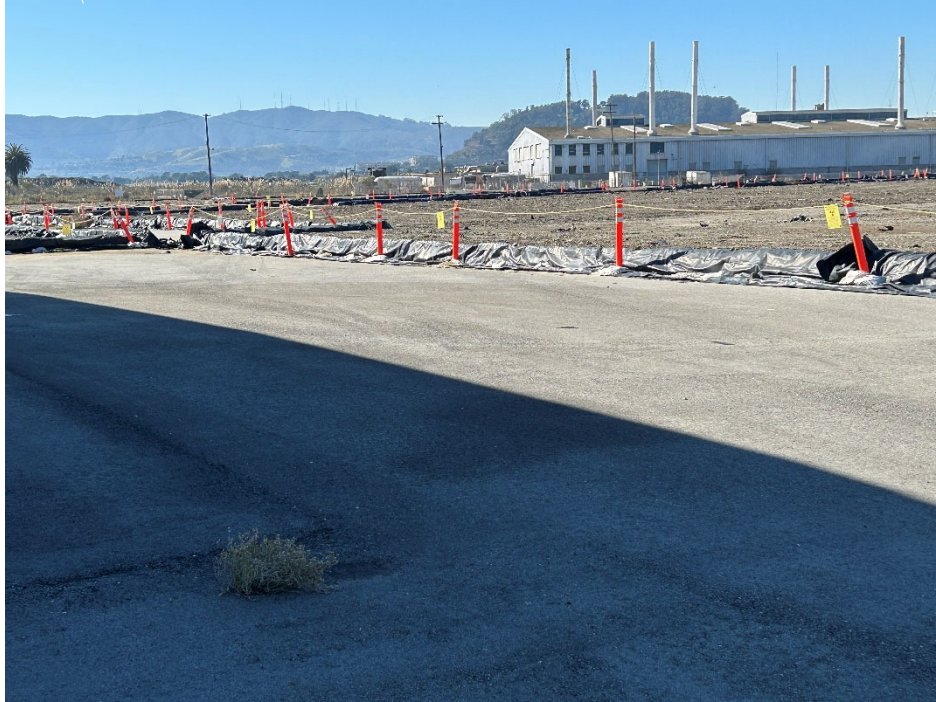
Parcel D-1 Photograph 11: Stormwater management best management practices southwest of Building 307. Facing southwest.

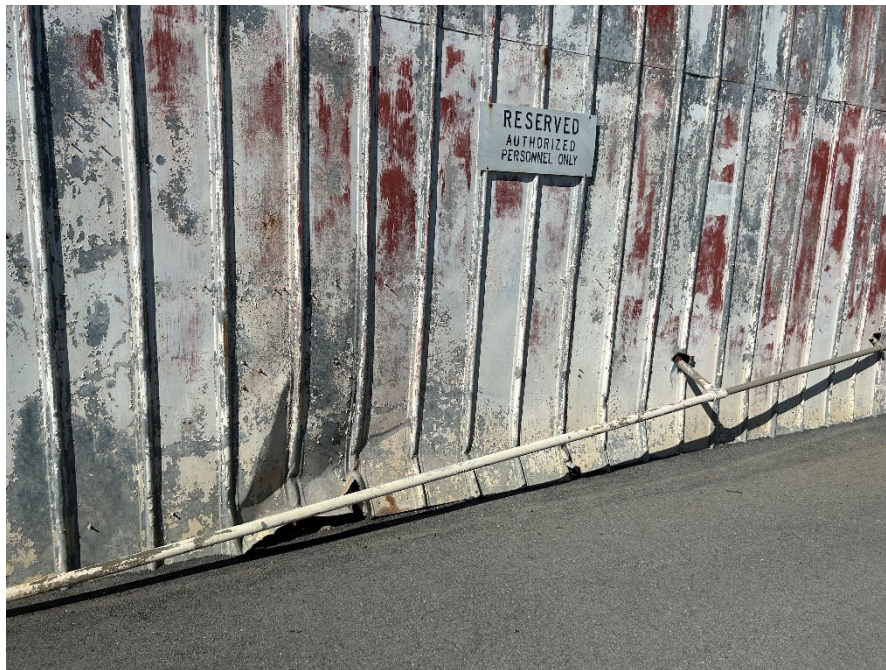
Parcel D-1 Photograph 16: Building 526 foundation. Facing southeast.
Photographed by: Marcella Navas/CH2M, 2/9/2023

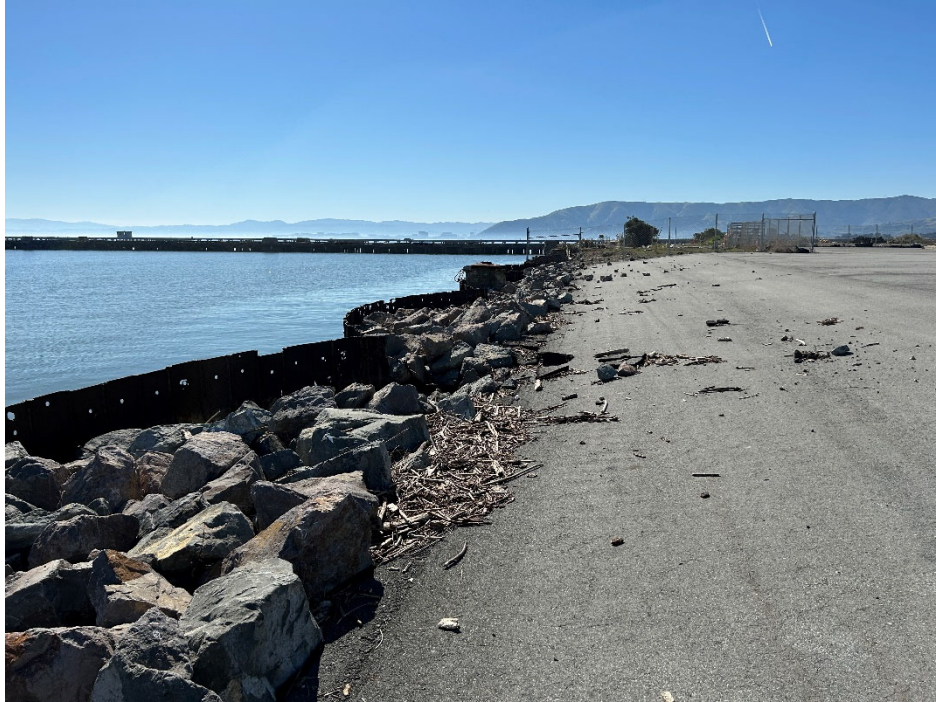
Parcel D-1 Photograph 17: Shoreline revetment east of Building 381. Facing southeast.
Photographed by: Marcella Navas/CH2M, 2/9/2023

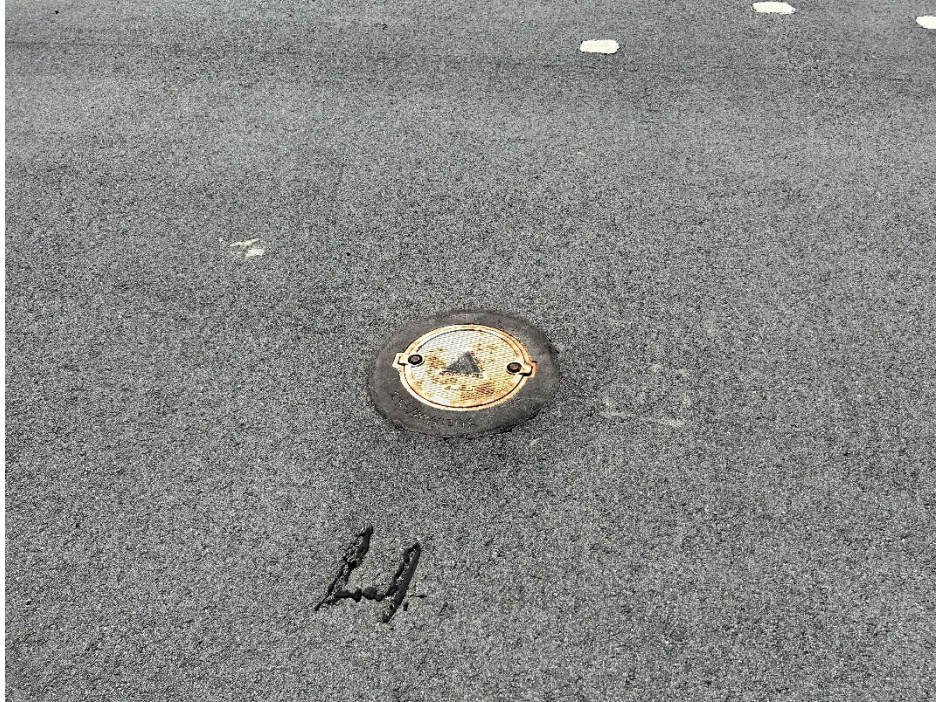
Parcel D-1 Photograph 19: Monitoring well completion and repaired boreholes east of Building 523. Facing southwest.

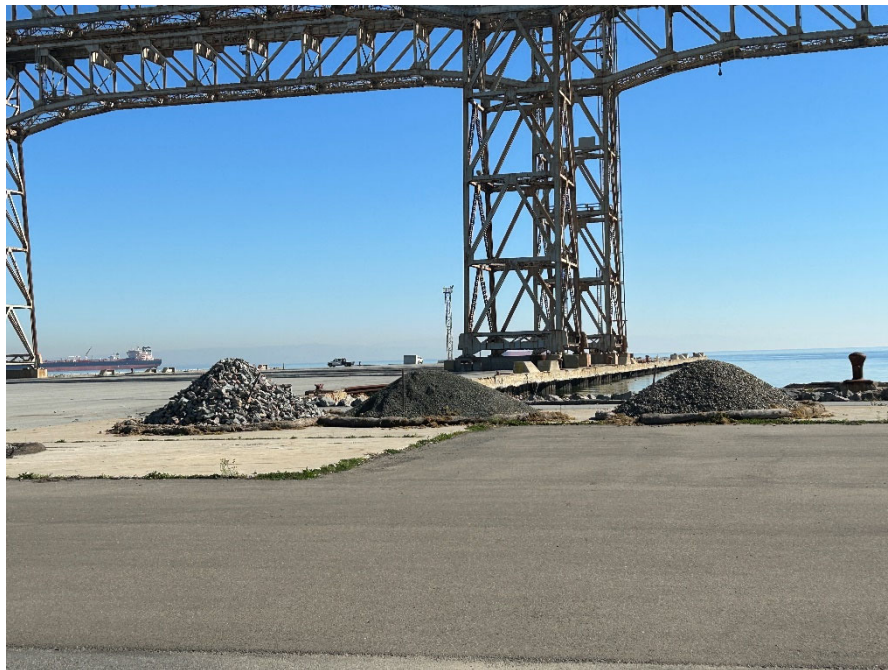
Parcel D-1 Photograph 20: Stockpiles from ongoing work with best management practices surrounding. Facing northeast.

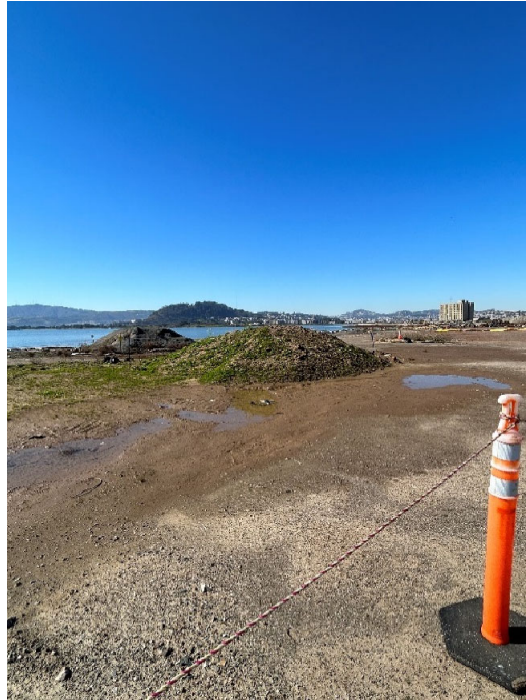
Parcel E Photograph 1: Soil stockpile at the intersection of J and Mahan Street with delineator barricading. Facing southwest.

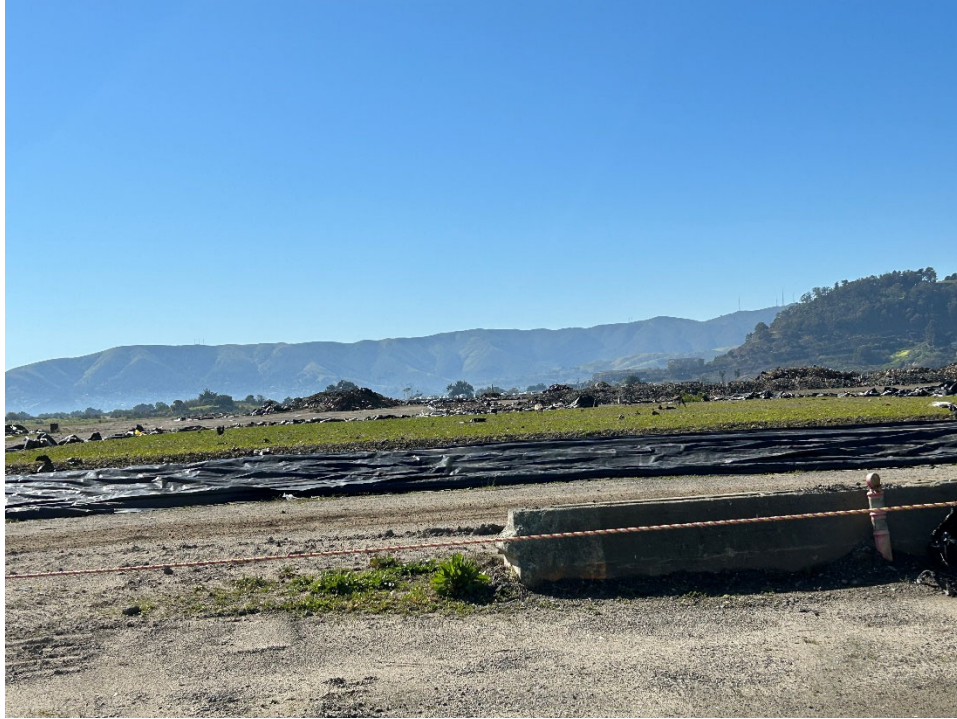
Parcel E Photograph 9: Stormwater management best management practices along corner of J Street and 6th Avenue. Facing southeast.

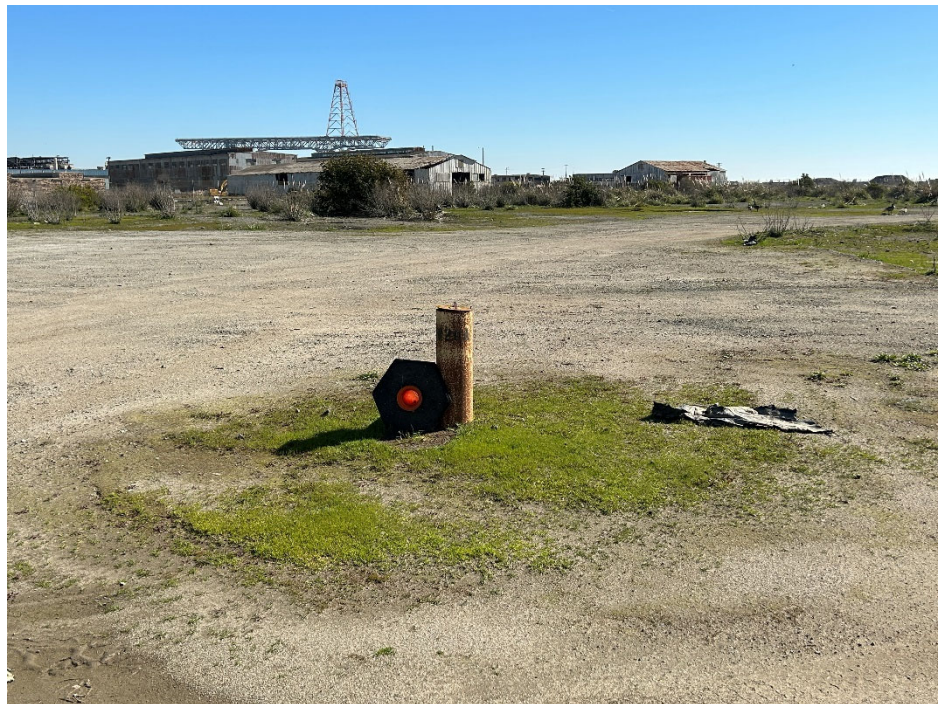
Parcel E Photograph 16: Monitoring well intact and in good condition. Facing northeast.
Photographed by: Marcella Navas/CH2M, 2/9/2023

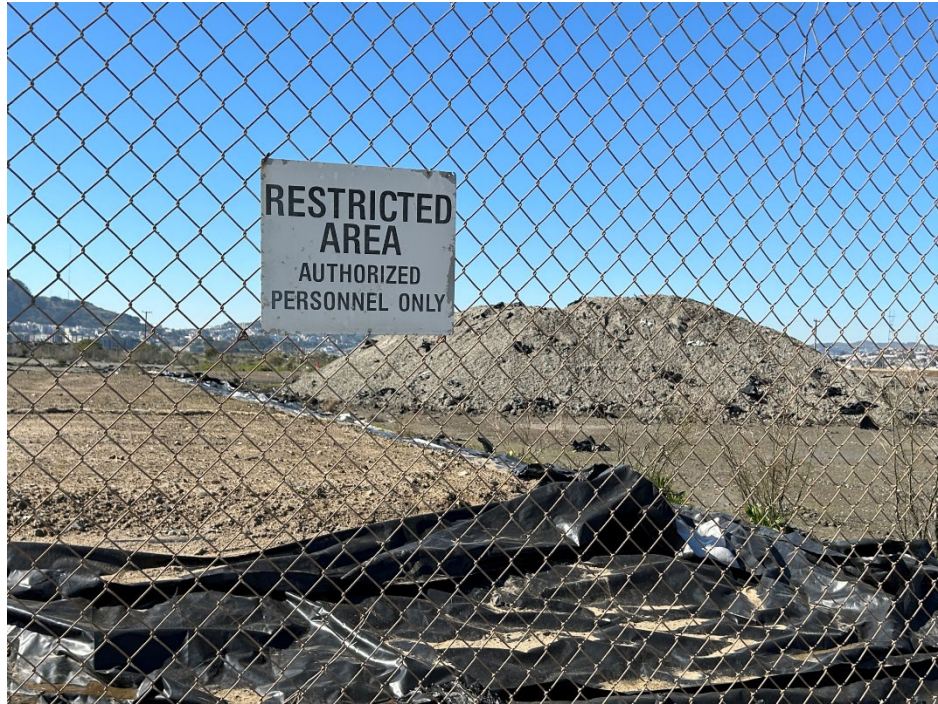
Parcel E Photograph 17: Restricted area signage. Facing southwest

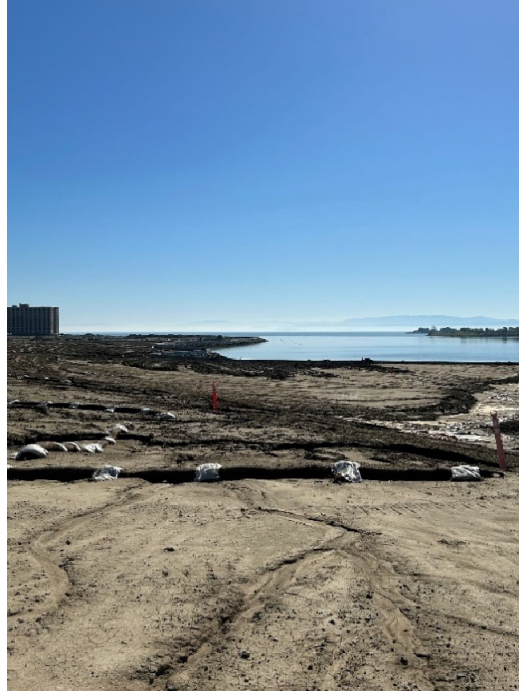
Parcel E-2 Photograph 1: Active construction with stormwater best management practices. Facing southeast.
Photographed by: Marcella Navas/CH2M, 2/9/2023
