THIRD FIVE-YEAR REVIEW FOR OLMSTED AIR FORCE BASE

Olmsted Air Force Base (Sunset Annex)

LONDONDERRY TOWNSHIP (Middletown),

APPENDIX E: Third Five Year Review Site Inspection Report (25 September 2023)

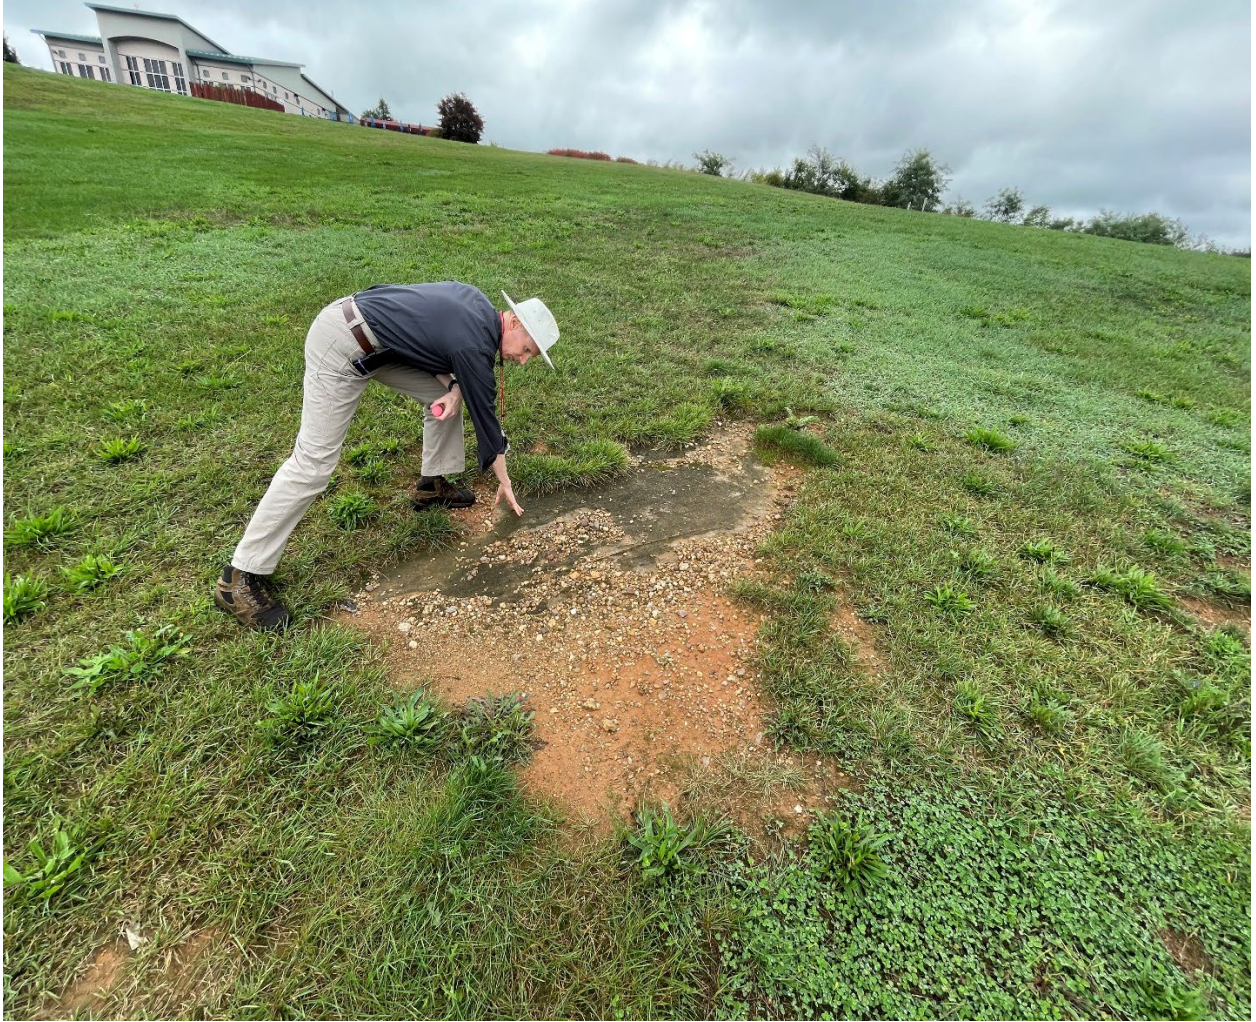
Photo S1: The soil of the landfill cap has eroded in various places, exposing the liner in this location. This patch measures approximately 4.5 by 7.5 feet.

geotextile was noted on the landfill cap/driving range area which is recommended for repair by the Township (see Photo S1 on page 38).

Results from the Annual Inspection indicate that the corrective actions taken to maintain the integrity of the landfill remain effective, but repairs are required on the Hillside Dump Area perimeter fence and Driving Range Landfill cap and soil cover. USACE will coordinate the repairs of the landfill area perimeter fence. It is the responsibility of the Londonderry Township DPW to repair the Driving Range soil cap, per the Post-Remediation Care Agreement (Appendix C).

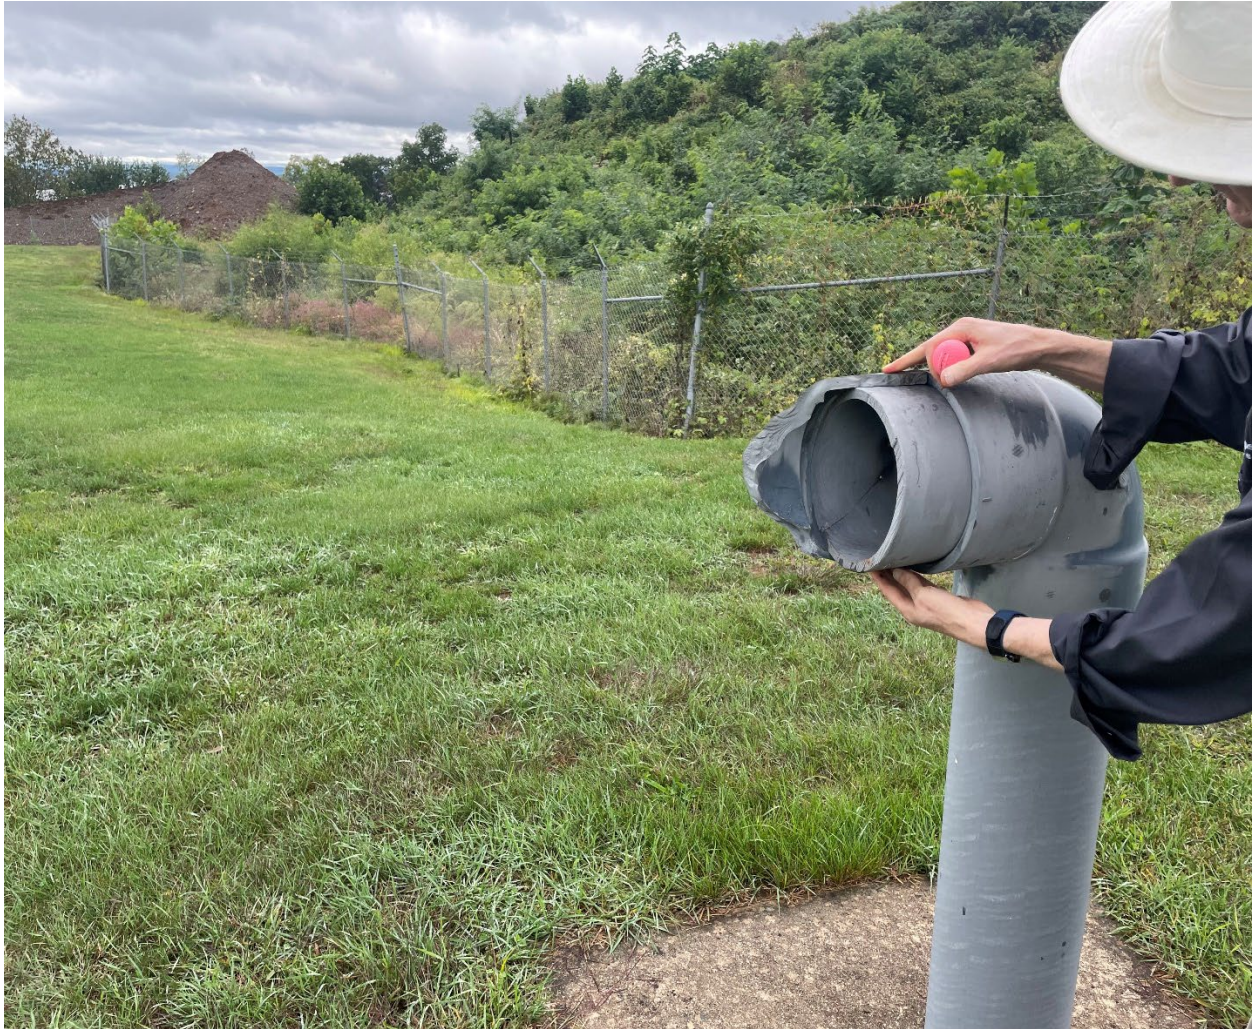
Photo S2: Landfill vent has been damaged from being struck by golf balls on the driving range. The perpendicular portion of the vent is still sufficiently shielded from precipitation and foreign debris.

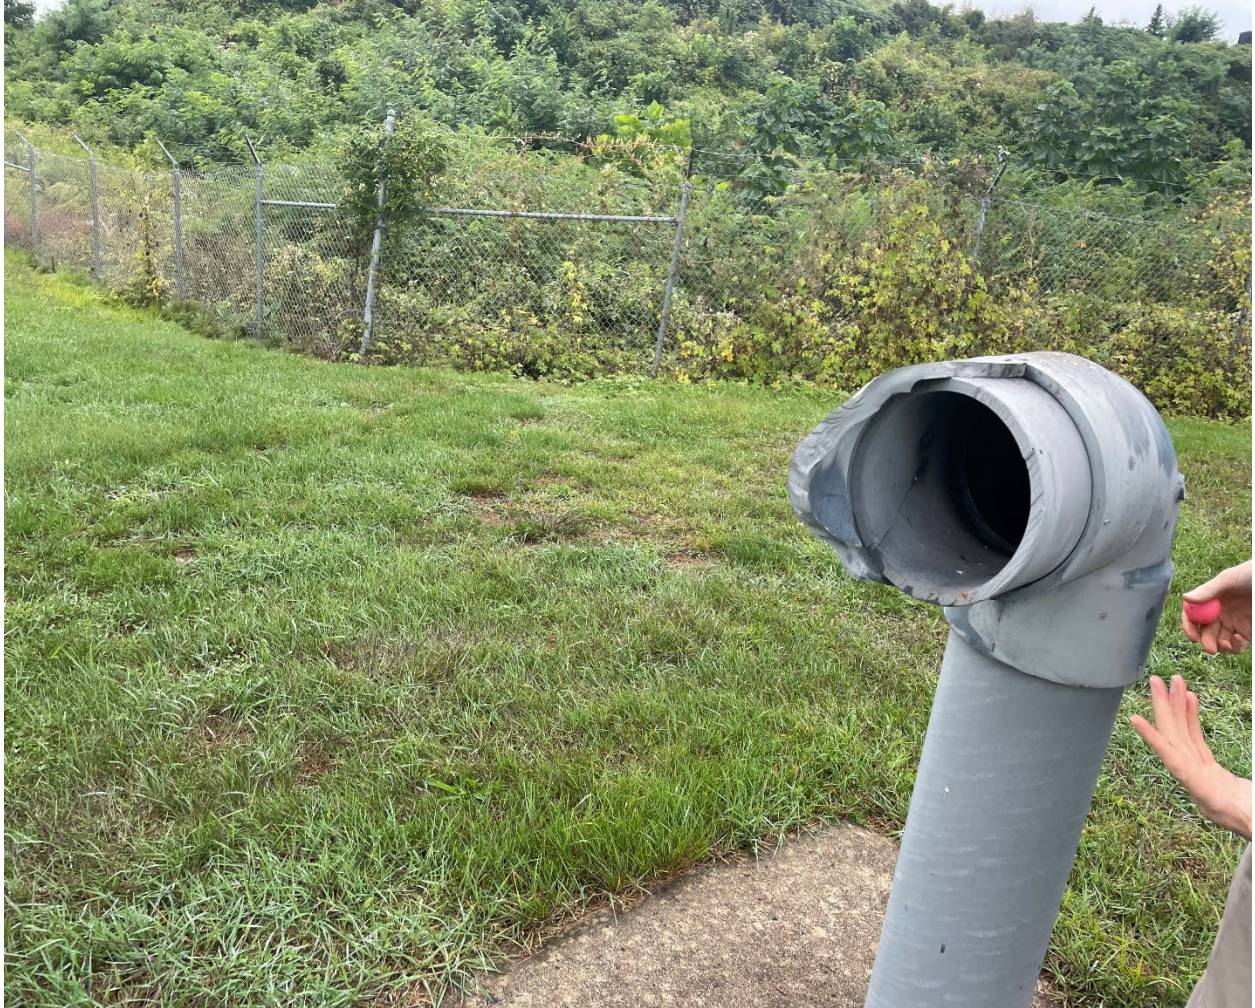
Photo S3: Another picture of the opening of the landfill vent.

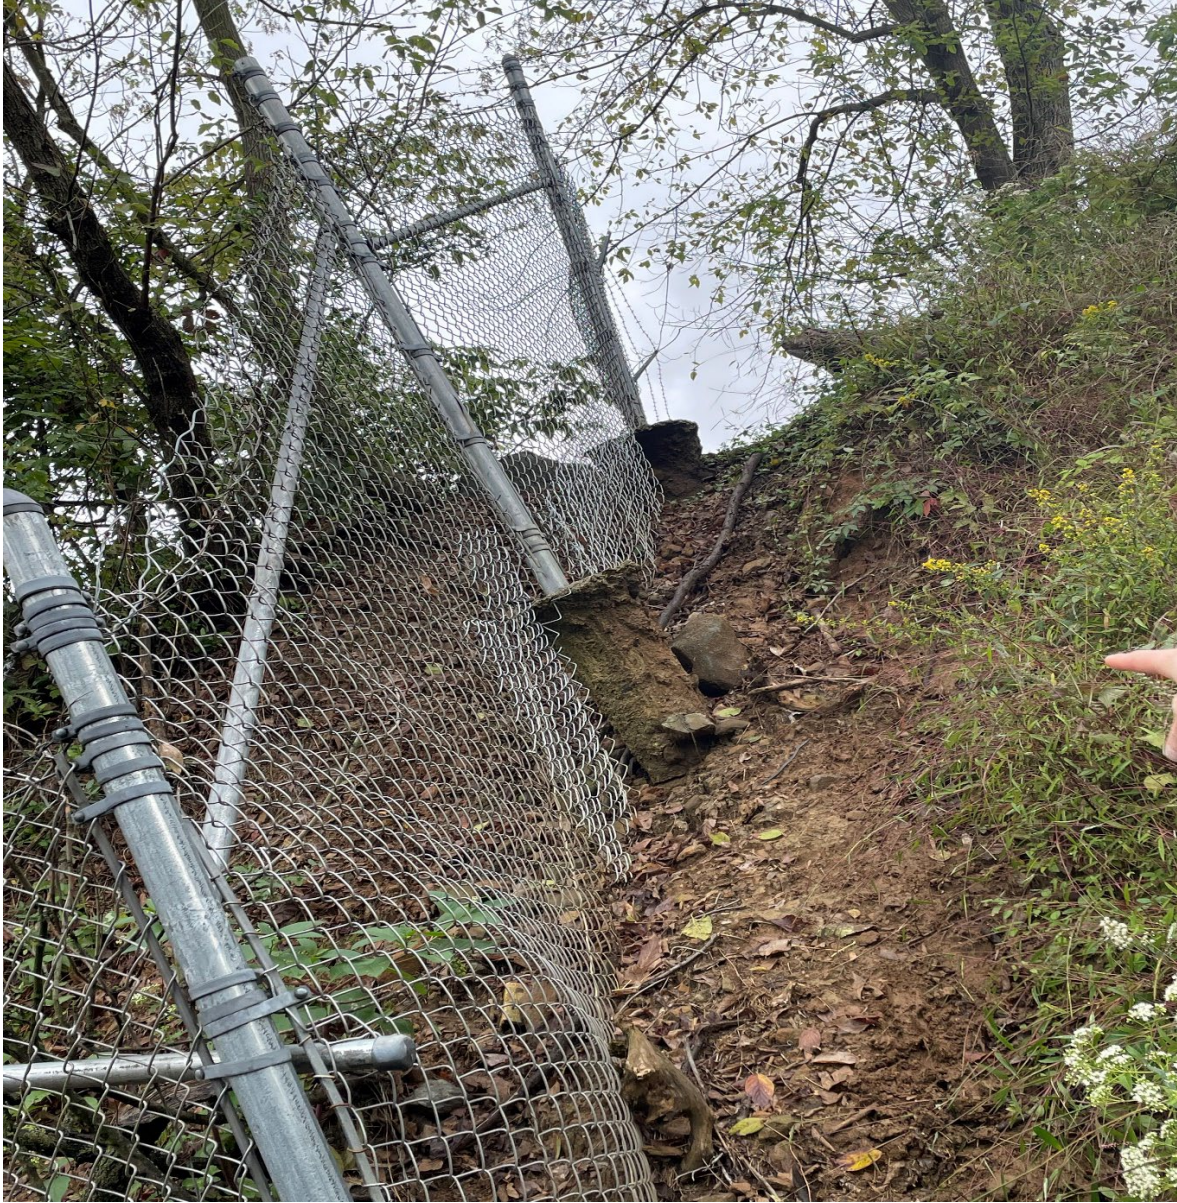
Photo S4: The perimeter fence is intact, but erosion has exposed the foundation of the fence post.

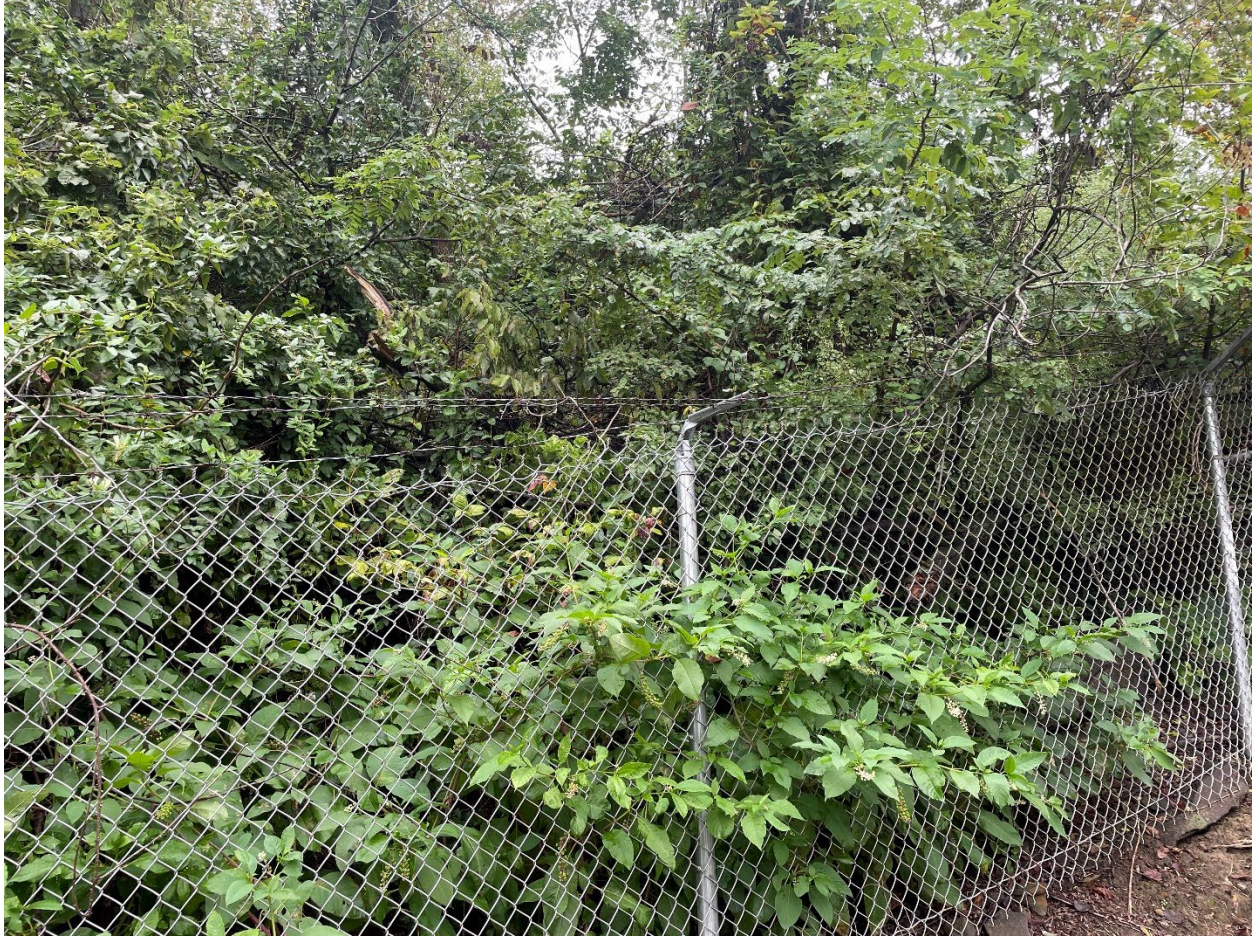
Photo S6: Perimeter fence barbedwire intact but needs to be repaired. Also, vegetation needs to be trimmed along the perimeter fence.

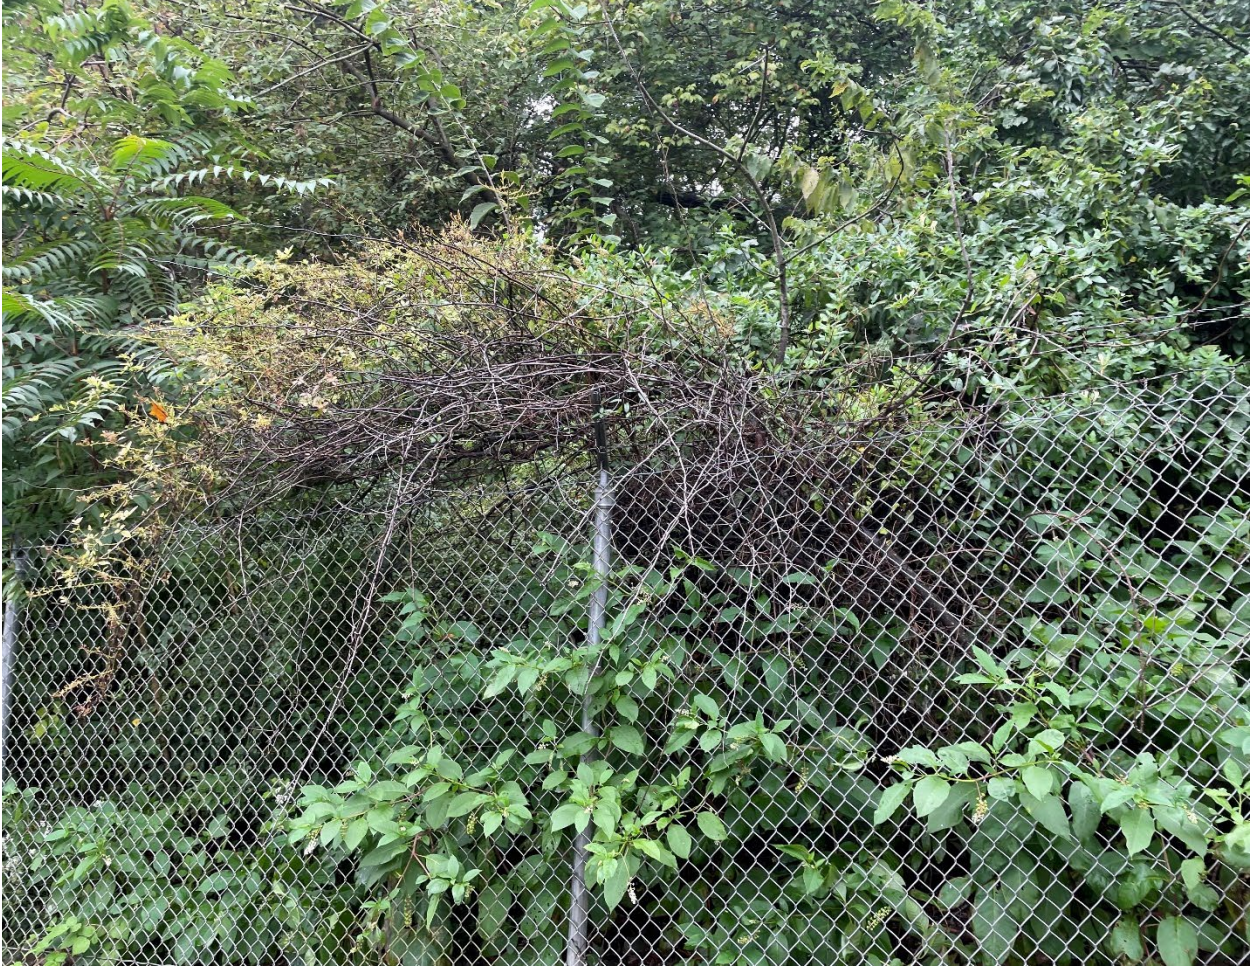
Photo S7: Vegetation along perimeter fence needs to be trimmed.

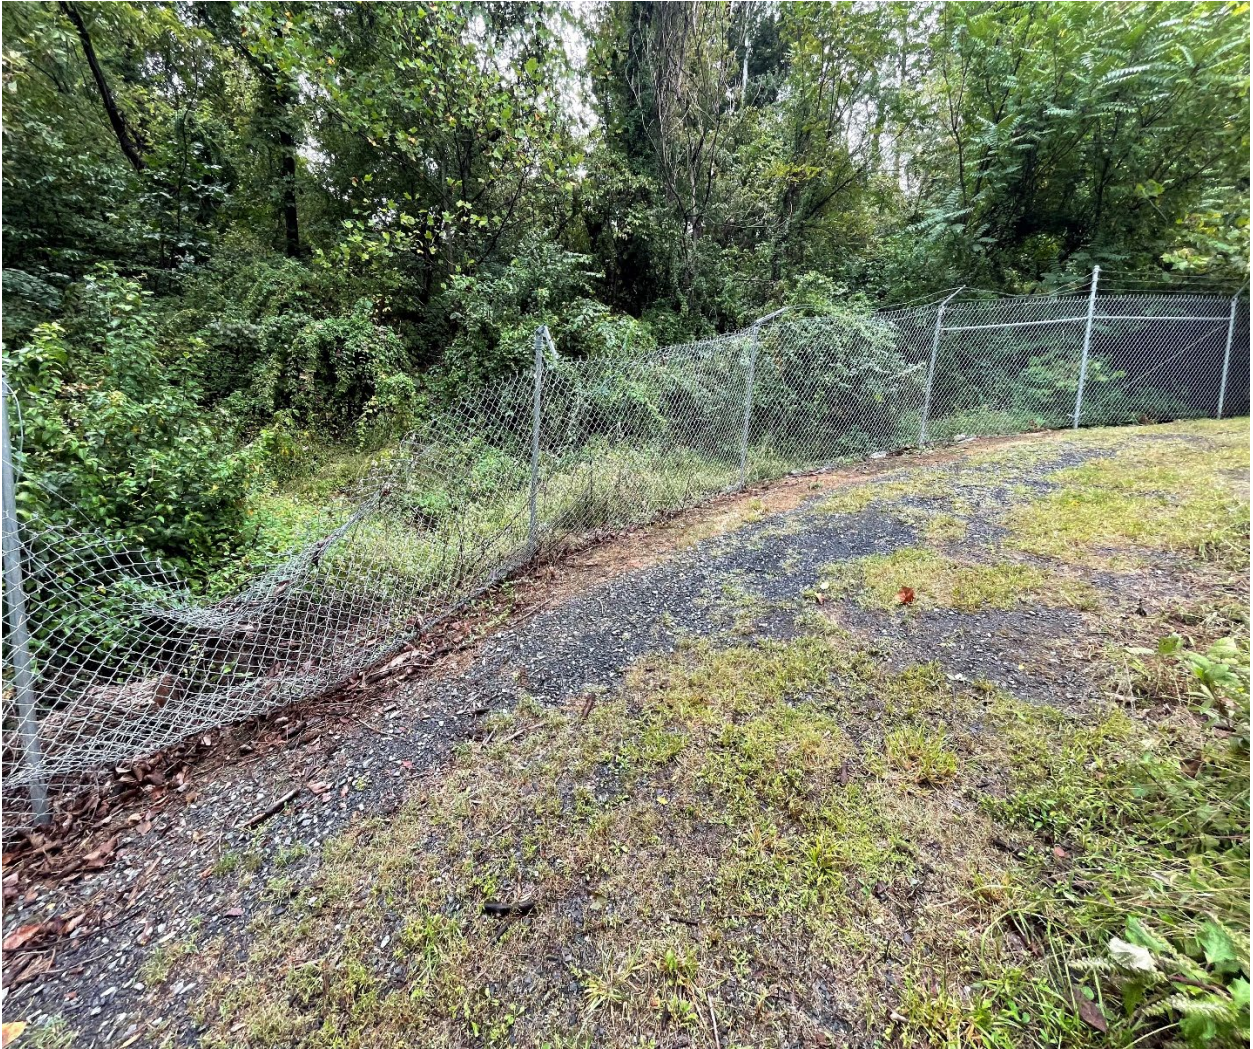
Photo S8: Perimeter fence needs to be repaired after felled trees have been removed.

| Inspection Checklist Post-Remediation Care Plan Sunset Landfill FUDS, Londonderry Township, PA | | | | | | |
|---|---|--|---|--|---|---|
| Fence Posts | Any fence posts leaning or bent? | X | | Several bent fence posts near felled trees. USACE is contracting the fence repair action. | Report Notification | |

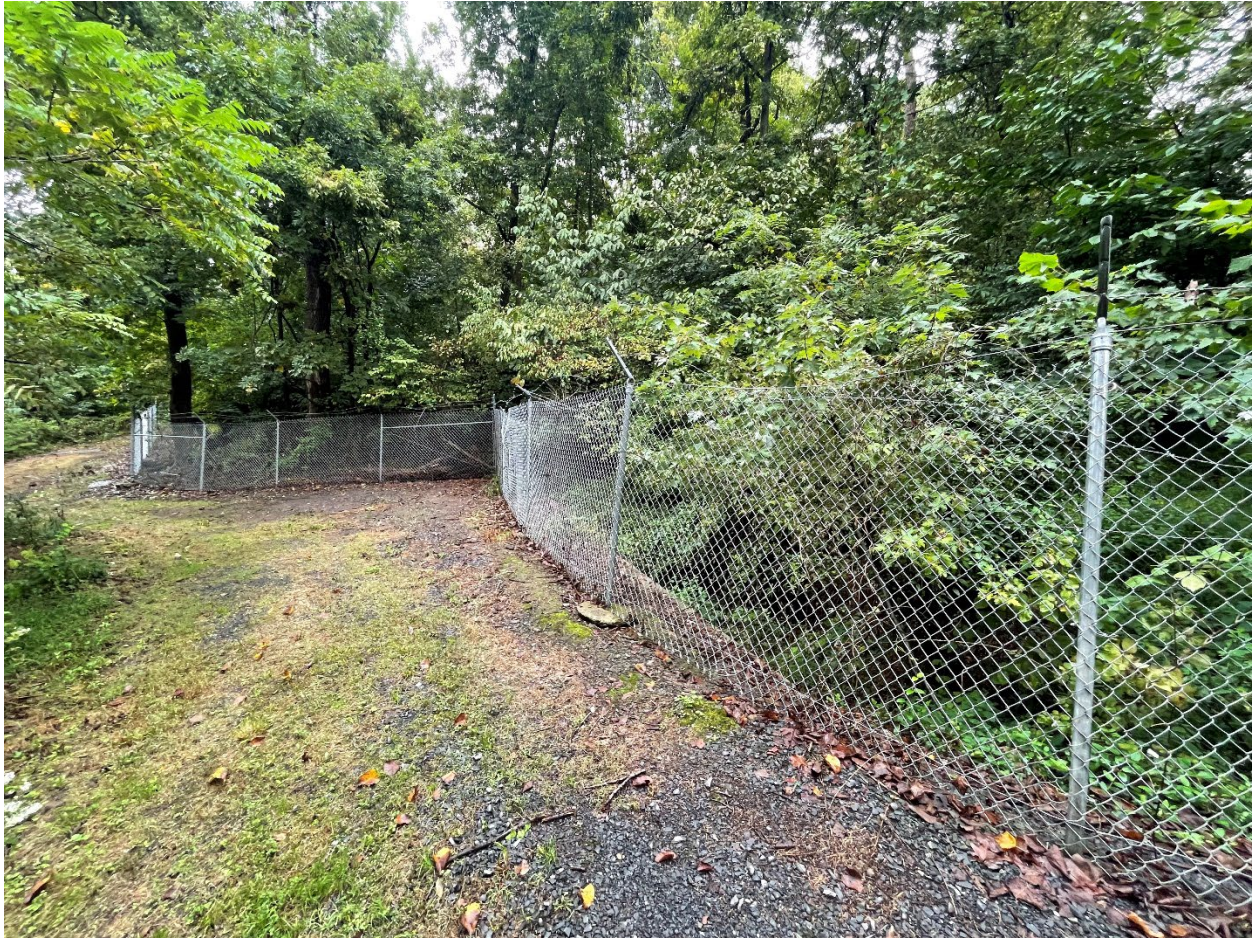
Photo S9: Perimeter fence barbedwire needs to be repaired.

| Inspection Checklist Post-Remediation Care Plan Sunset Landfill FUDS, Londonderry Township, PA | | | | | | |
|---|---|--|---|--|---|---|
| Barbed Wire | Are the 3 strands of barbed wire intact? | | X | Areas of the fencing barbed wire are damaged, indicated in report and photo log. USACE is planning fence repair action after Londonderry Township cleared felled trees. | Report Notification | |

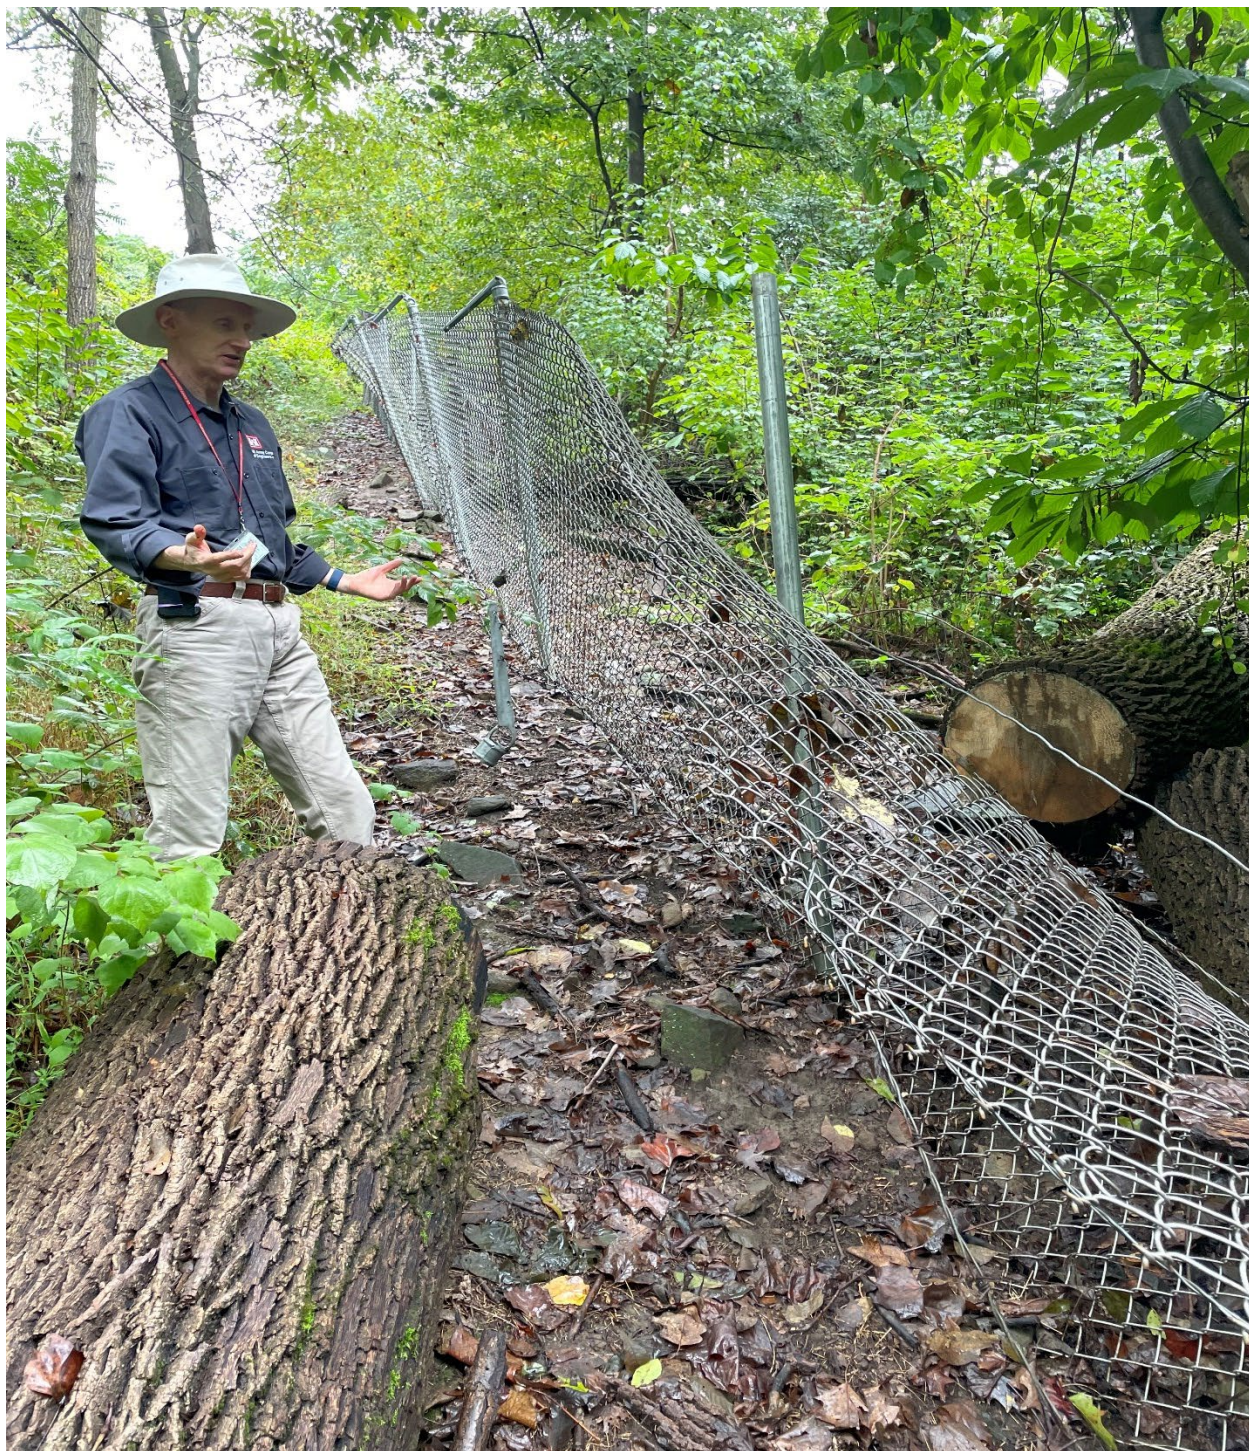
Photo S10: Perimeter fencing needs to be repaired from fallen trees.

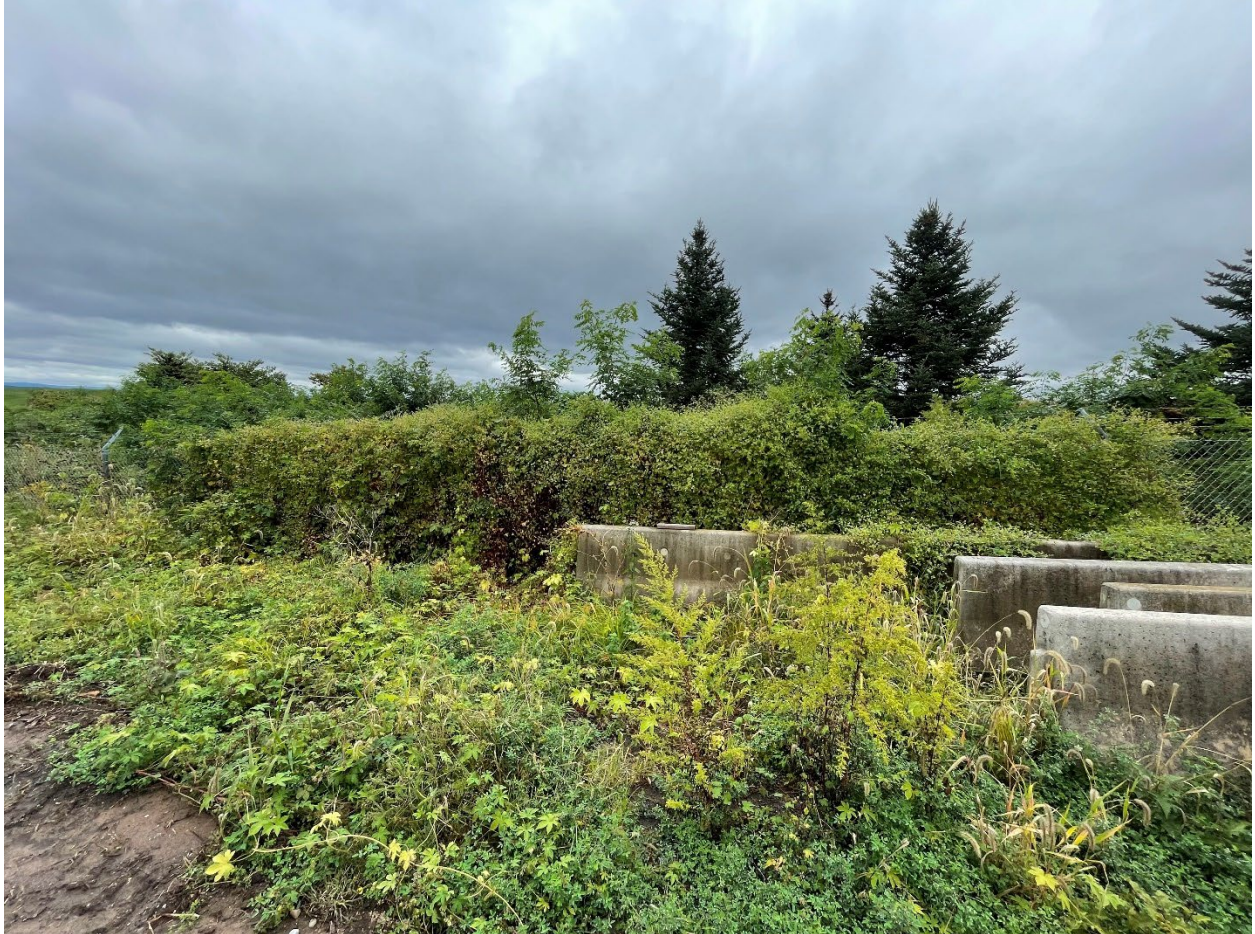
Photo S11: Perimeter fencing near the landfill cap needs vegetation trimmed.
