Chacon Creek, Laredo, Texas

Feasibility Report and Environmental Assessment

April 2024

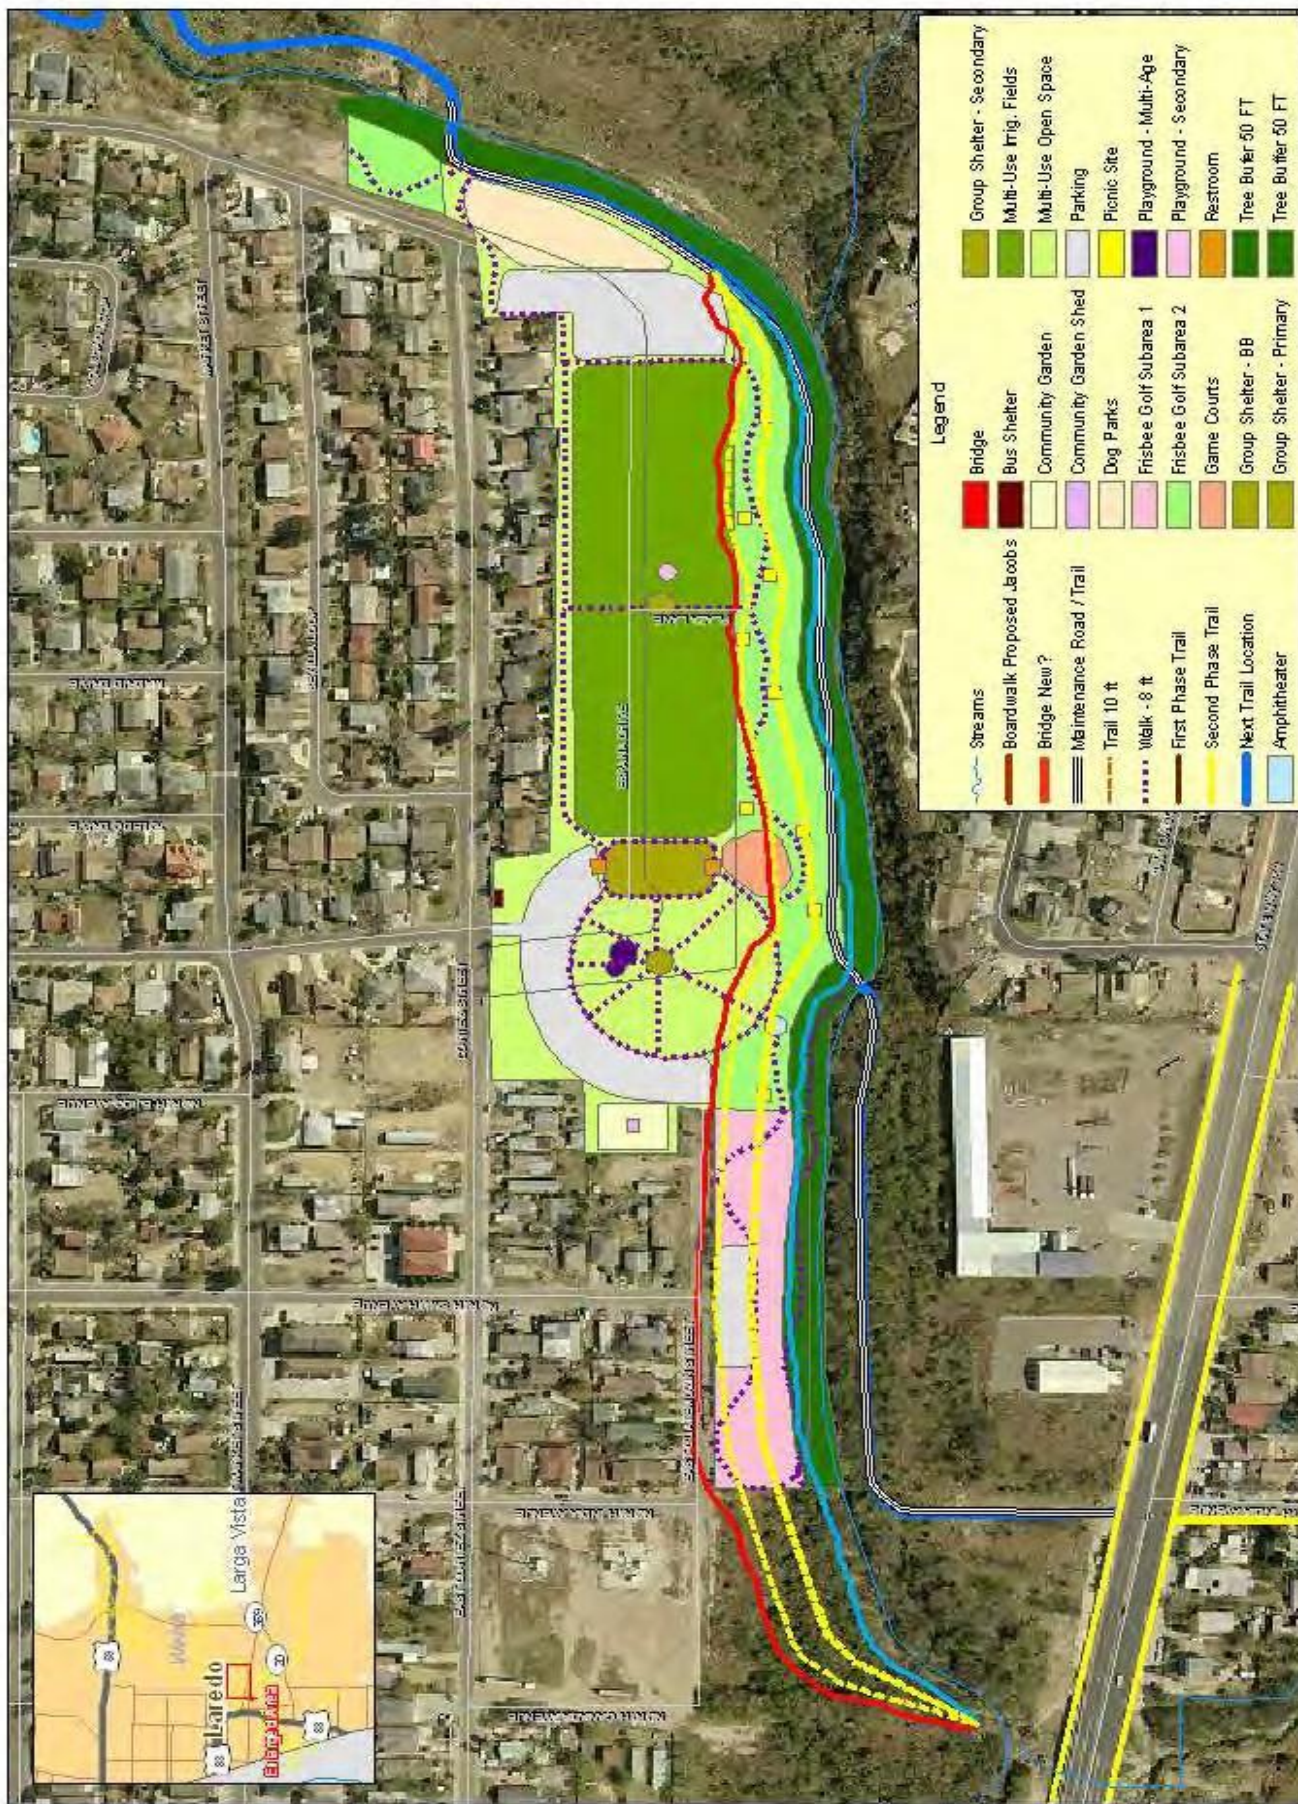
Figure 24.
(A8) VDS Plan with Small Channel
(Image source: USACE, 2010)

The proposed combination plan used the VDS Plan as the starting point, because it had the highest net benefits of the non-structural alternatives and combined it with the small channel alternative. Figure 24 shows this combination alternative (A8). The small channel configuration was evaluated because it would minimize any design adjustments necessary to retain the recreation features and benefits of the VDS Plan. Just as in the small channel design discussed for Reach 2, this structural component would entail a 50-foot-wide channel cut for creating valley storage and conveyance, with a second bench averaging a width of 50 feet and 1-on-4 side slopes. Total investment costs for this alternative are \$20,280,400 with total annual charges of \$1,144,100. Net annual benefits are \$216,300 with a benefit/cost ratio of 1.19-to- 1.00.

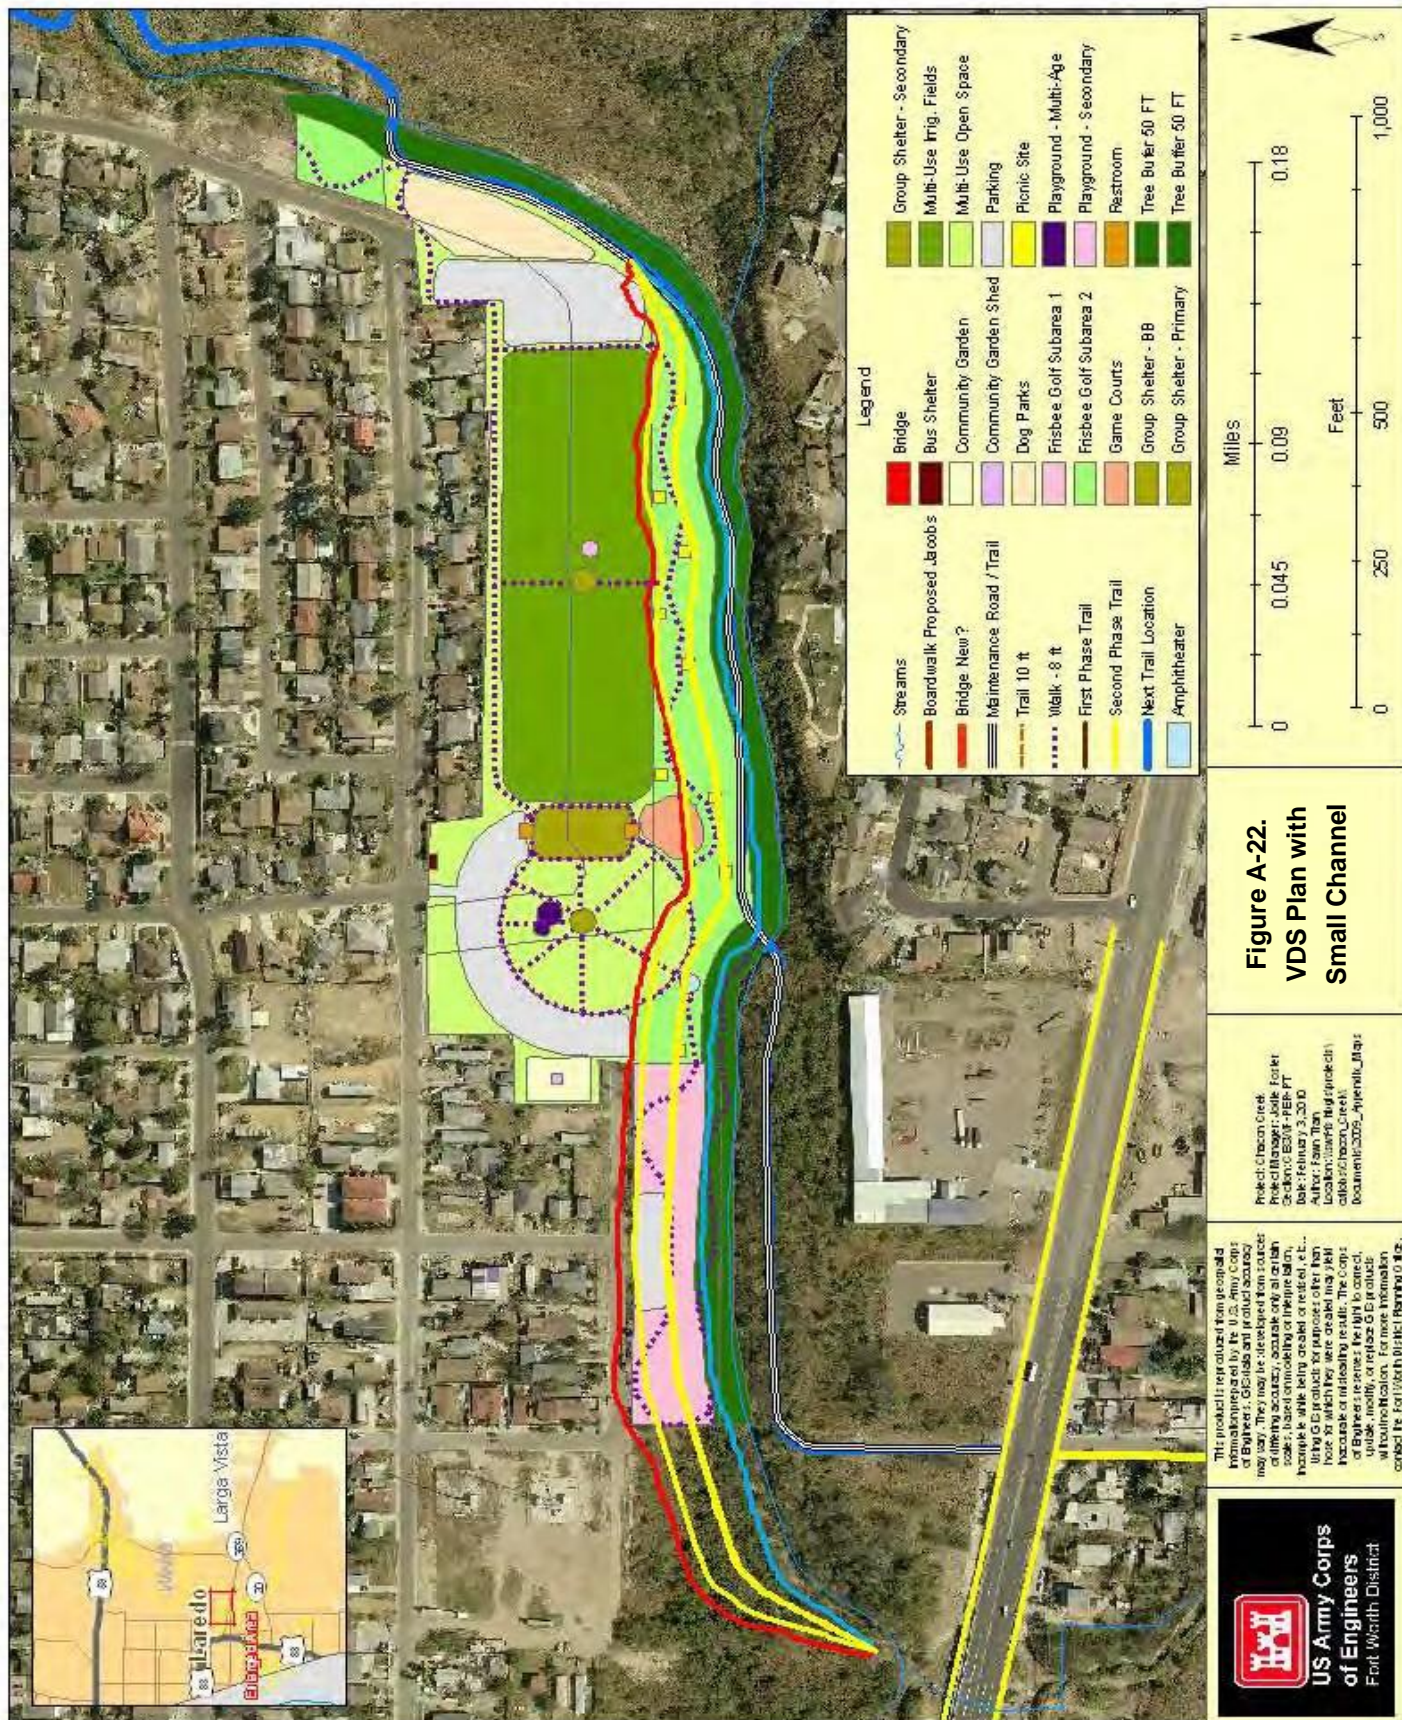
The proposed combination plan used the VDS Plan as the starting point, because it had the highest net benefits out of the non-structural alternatives, and combined it with the small channel alternative as discussed in the preliminary investigations of alternatives. Figure A-19 on the next page shows this combination alternative (A8). The small channel configuration was evaluated because it would minimize any design adjustments necessary to retain the recreation features and benefits of the VDS Plan. Just as in the small channel design discussed for Reach 2, this structural component would entail a 50-foot-wide channel cut for creating valley storage and conveyance, with a second bench averaging a width of 50 feet and 1-on-4 side slopes. Total investment costs for this alternative are \$20,280,400 with total annual charges of \$1,144,100. Net annual benefits are \$216,300 with a benefit/cost ratio of 1.19-to-1.00.

This alternative represents what is considered to be the optimally performing combination plan, because it would alleviate much of the flooding originating from Chacon Creek. However, there would still be flooding from the south and north ends of the reach, which floods residences along Cortez and Market Streets just north of the proposed buyout area. Therefore, as part of this plan, a levee feature that would address the easterly flows was considered. This would consist of a levee along the channel beginning north of Market Street and continuing down roughly through the Villa Del Sol Park. The levee would prevent out of bank flows from the creek that currently impact structures north of Cortez Street. However, this feature was deemed to be too expensive relative to the additional benefits it might generate.

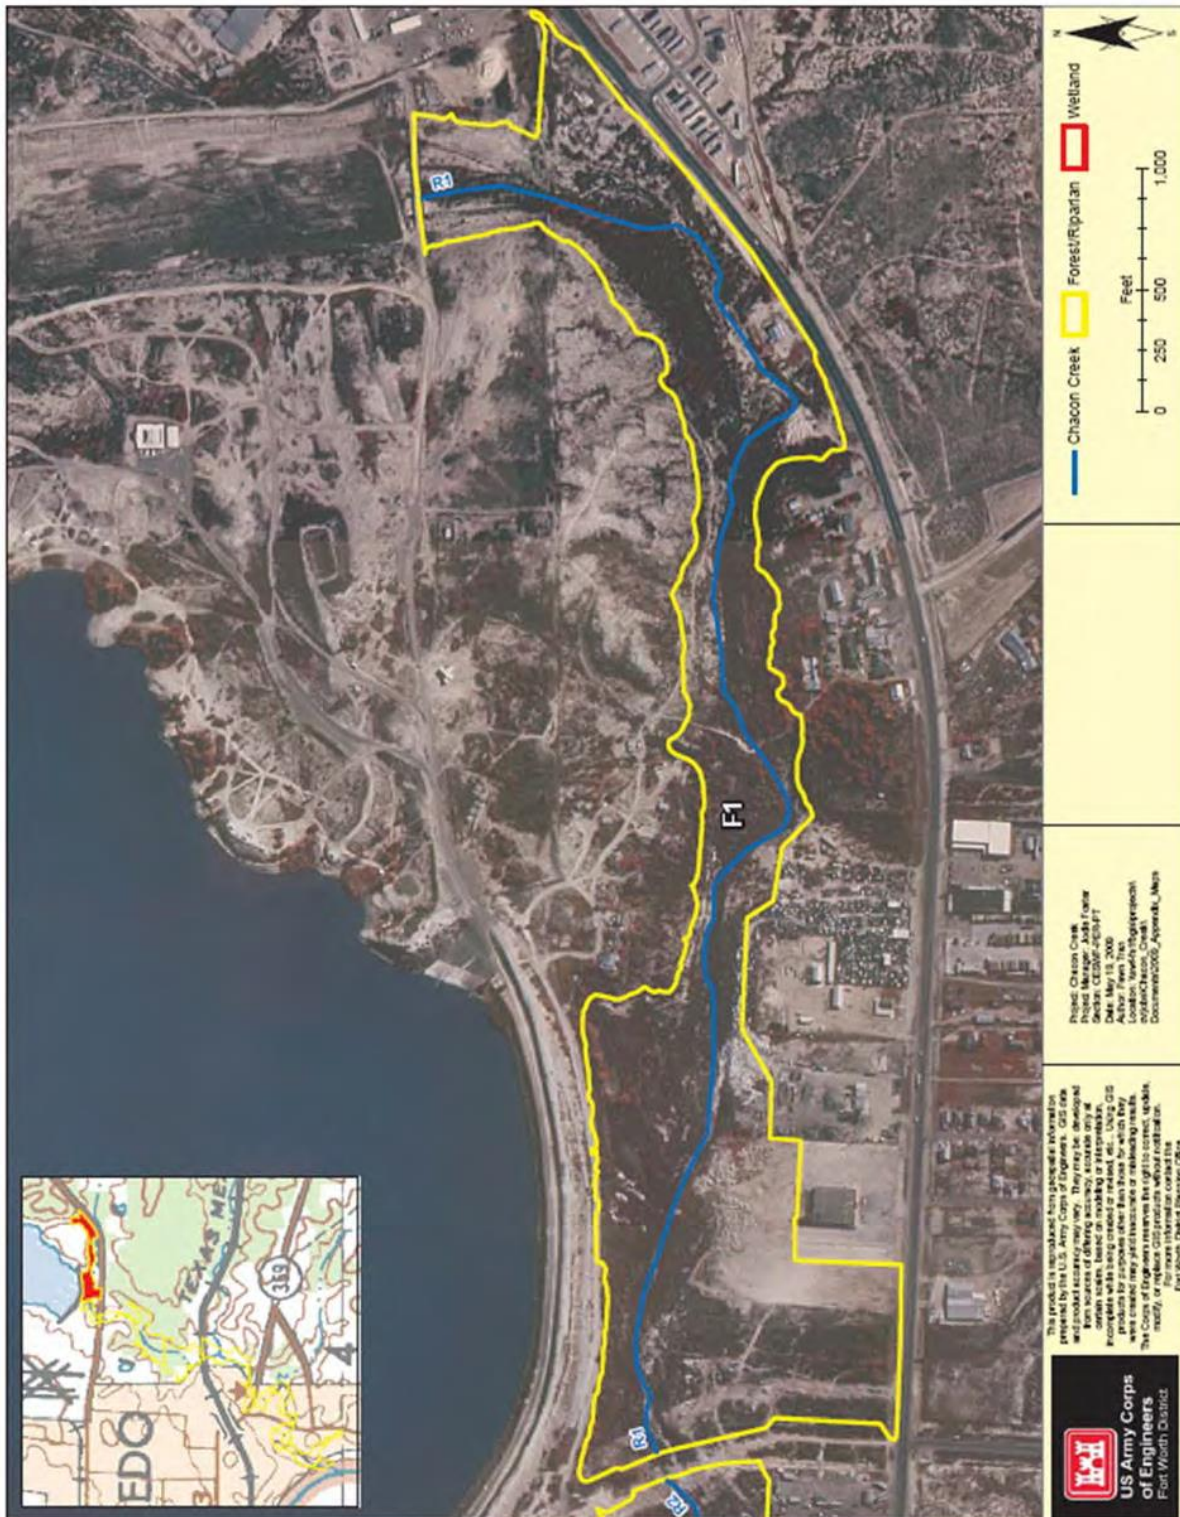
Figure 2. Study Area Cover Types

Riverine cover types were used to evaluate the aquatic system. The palustrine and herbaceous wetland cover types were used to assess the wetlands systems present in the study area. No palustrine wetlands were identified in the study area; therefore, no points were palustrine wetland points were evaluated. DS and DF cover type were used to evaluate mesic riparian settings and upland areas away from the channel corridor.

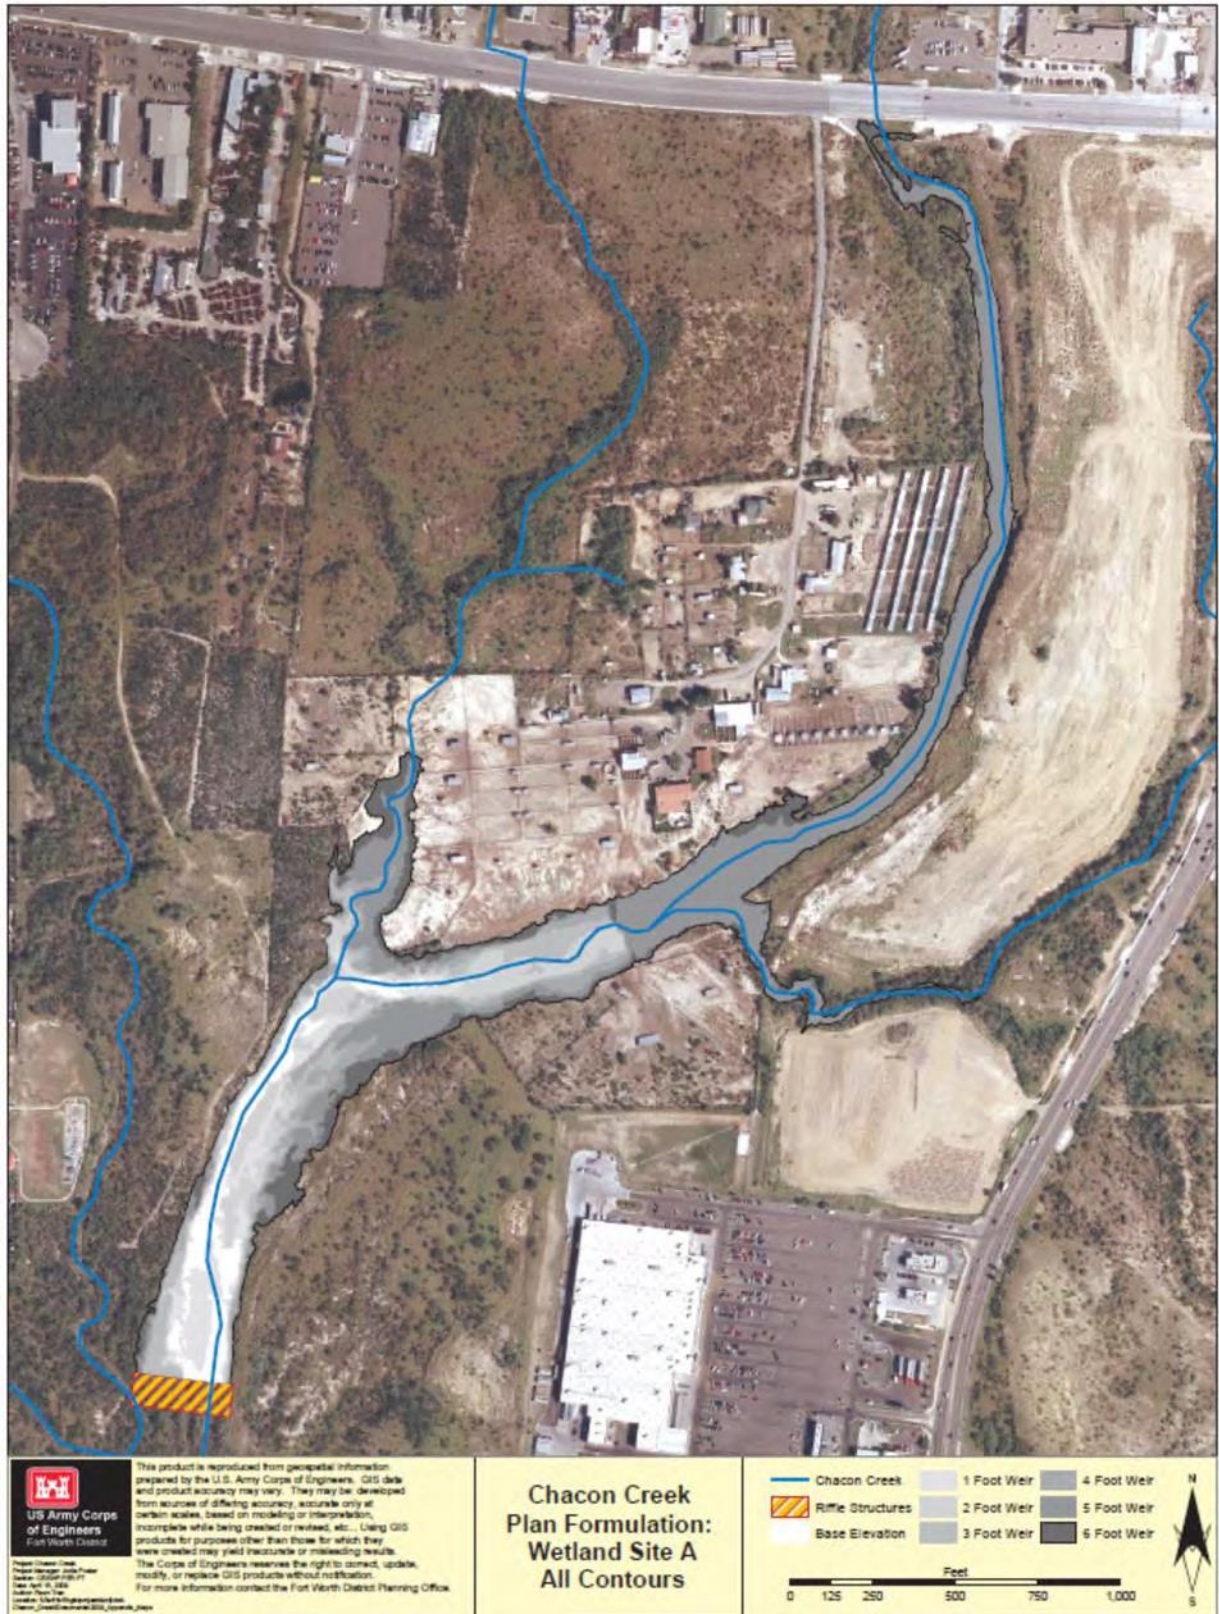
Figure 10. Chacon Creek Wetland Restoration Site A, All Contours

Target Year	0	1	5	10	25	50	AAHU
Scale A2 2-ft. Weir	HSI	0.50	0.50	0.80	1.00	0.80	0.60	4.623
	Acres	5.99	5.99	5.99	5.99	5.99	5.99	
	Target Year HU	3.00	3.00	4.79	5.99	4.79	3.59	
Scale A3 3-ft. Weir	HSI	0.50	0.50	0.80	1.00	0.80	0.60	6.121
	Acres	7.93	7.93	7.93	7.93	7.93	7.93	
	Target Year HU	3.97	3.97	6.34	7.93	6.34	4.76

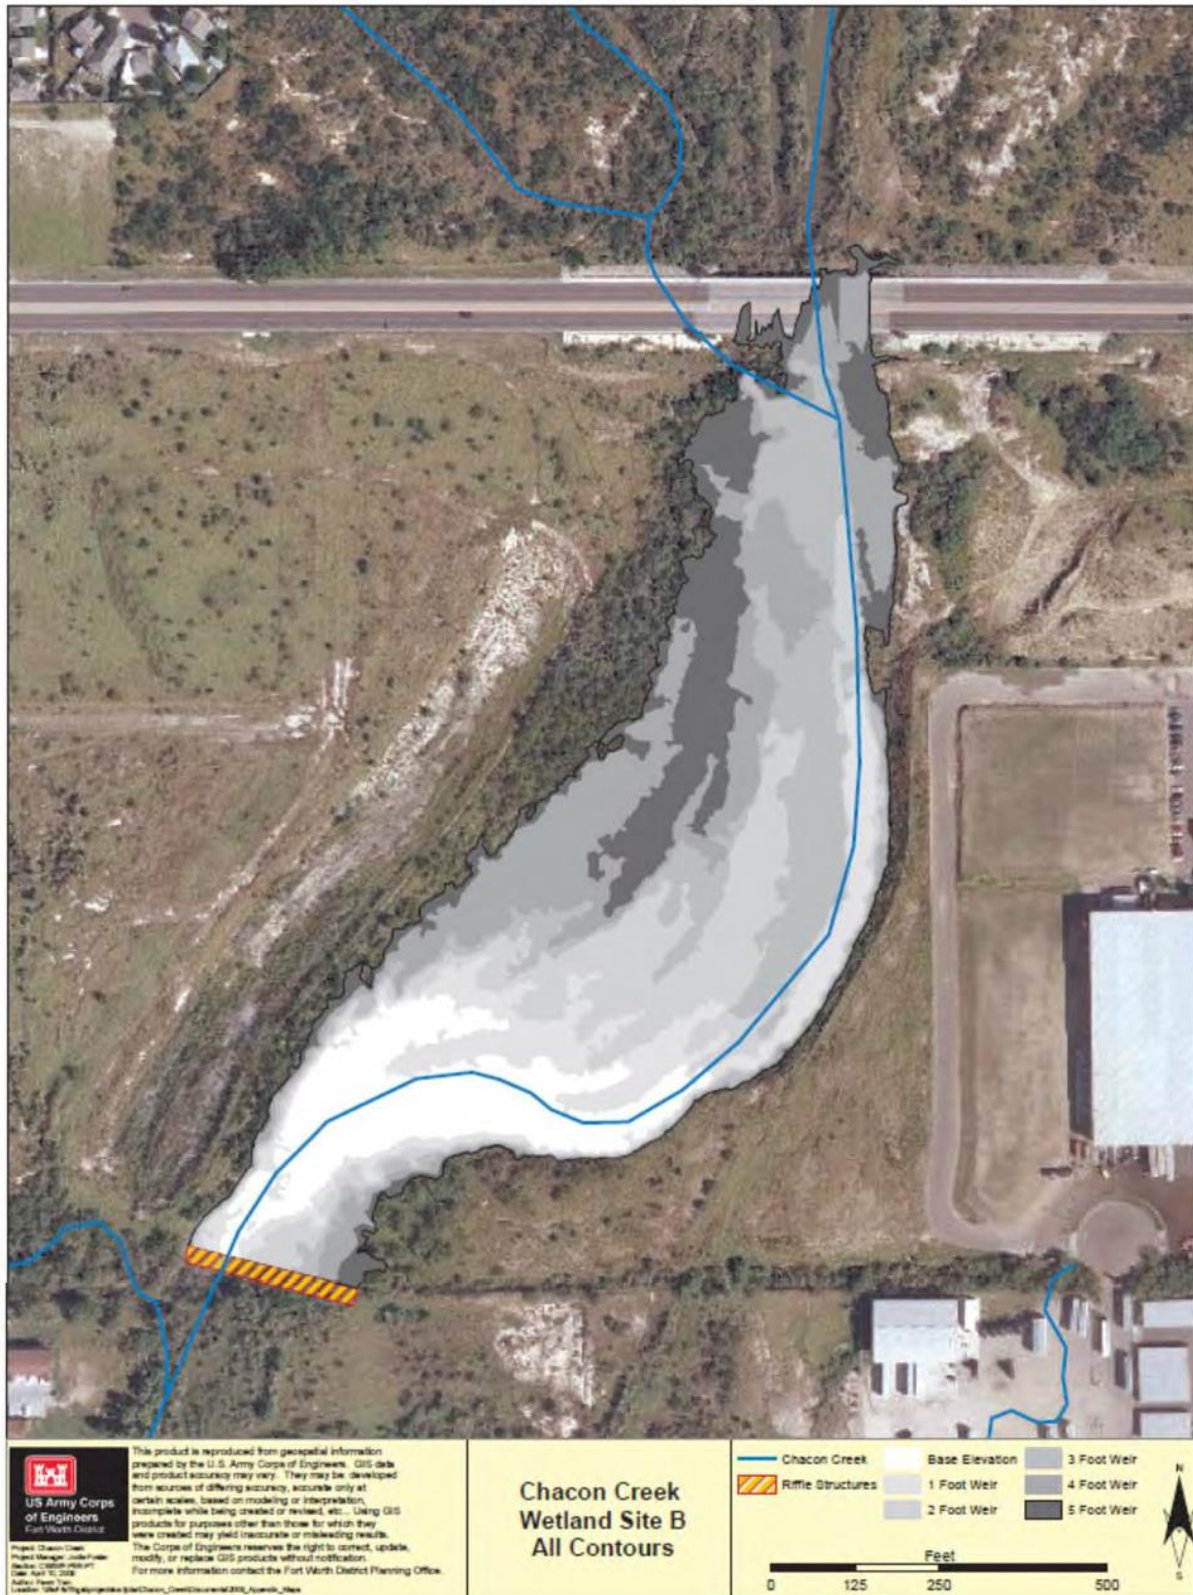
Figure 11. Chacon Creek Wetland Restoration Site B, All Contours

Target Year		0	1	5	10	25	50	AAHU
Scale B0 No Action	HSI	0.23	0.23	0.20	0.20	0.10	0.10	0.268
	Acres	1.95	1.95	1.95	1.95	1.95	1.95	
	Target Year HU	0.45	0.45	0.39	0.39	0.20	0.20	
Scale B1 1-ft. Weir	HSI	0.46	0.46	0.80	1.00	0.80	0.60	2.81
	Acres	3.65	3.65	3.65	3.65	3.65	3.65	
	Target Year HU	1.69	1.69	2.92	3.65	2.92	2.19	
Scale B2 2-ft. Weir	HSI	0.46	0.46	0.80	1.00	0.80	0.60	4.657
	Acres	6.05	6.05	6.05	6.05	6.05	6.05	
	Target Year HU	2.80	2.80	4.84	6.05	4.84	3.63	
Scale B3 3-ft. Weir	HSI	0.46	0.46	0.80	1.00	0.80	0.60	6.687
	Acres	8.69	8.69	8.69	8.69	8.69	8.69	
	Target Year HU	4.02	4.02	6.95	8.69	6.95	5.21

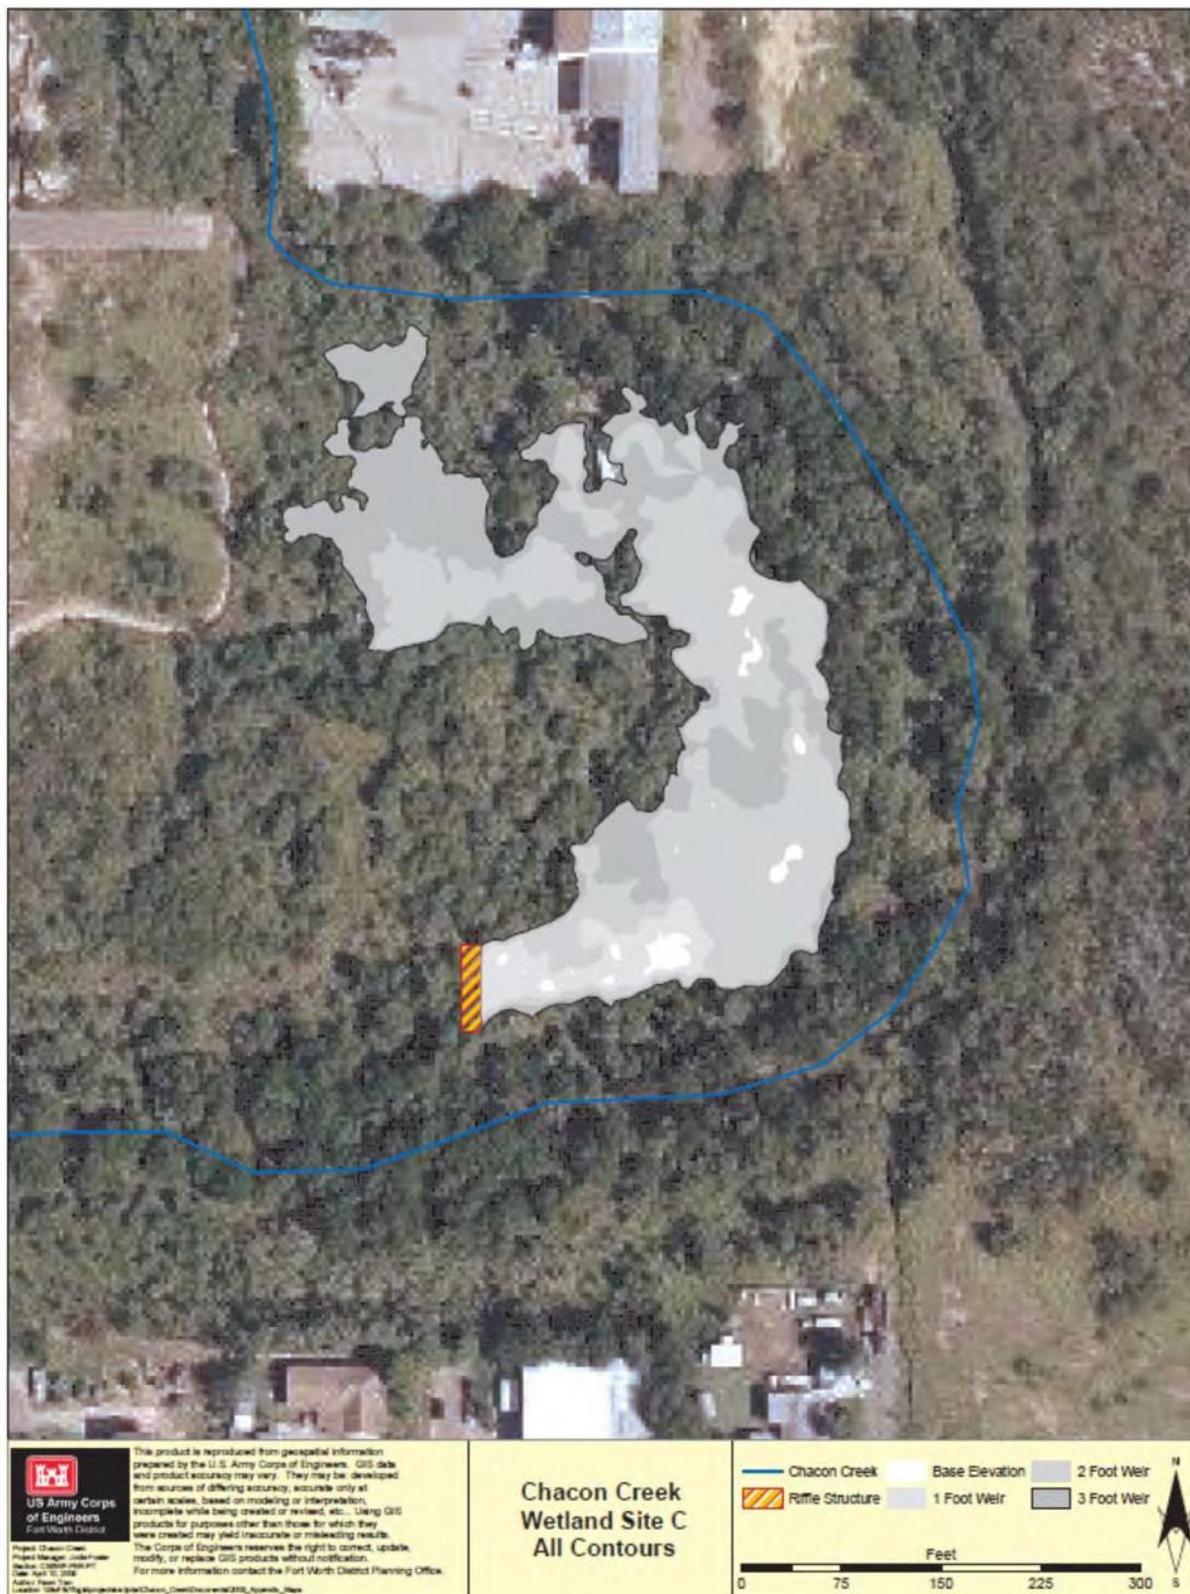
Figure 12. Chacon Creek Wetland Restoration Site C, All Contours

Target Year		0	1	5	10	25	50	AAHU
Scale C0 No Action	HSI	0.23	0.23	0.20	0.20	0.10	0.10	.01
	Acres	0.05	0.05	0.05	0.05	0.05	0.05	
	Target Year HU	0.01	0.01	0.01	0.01	0.01	0.01	
Scale C1 1-ft. Weir	HSI	0.38	0.38	0.75	0.90	0.75	0.60	0.108
	Acres	0.15	0.15	0.15	0.15	0.15	0.15	
	Target Year HU	0.06	0.06	0.11	0.14	0.11	0.09	
Scale C2 2-ft. Weir	HSI	0.38	0.38	0.75	0.90	0.75	0.60	0.843
	Acres	1.17	1.17	1.17	1.17	1.17	1.17	
	Target Year HU	0.44	0.44	0.88	1.05	0.88	0.70	
Scale C3 3-ft. Weir	HSI	0.38	0.38	0.75	0.90	0.75	0.60	1.489
	Acres	2.07	2.07	2.07	2.07	2.07	2.07	
	Target Year HU	0.79	0.79	1.55	1.86	1.55	1.24

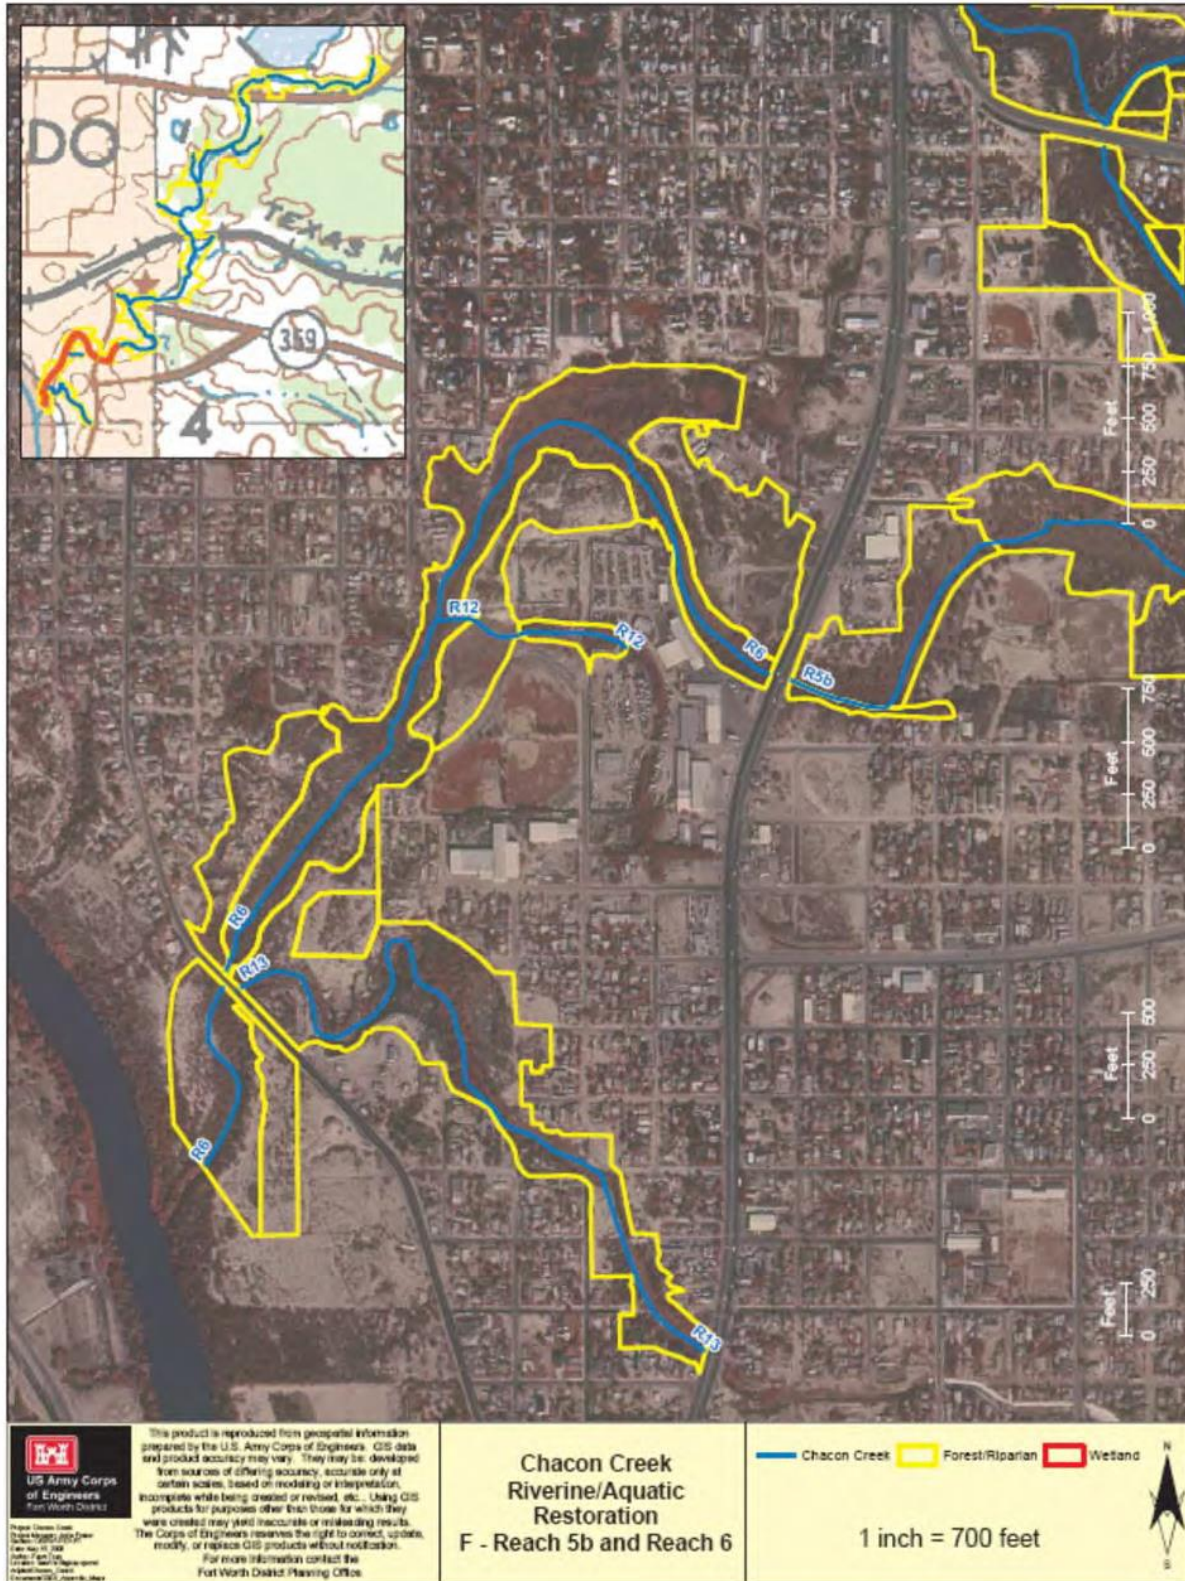
Figure 15. Chacon Creek Riverine Restoration Reach F5b/6

Riverine Reach F consists of segments R5b and R6, and would consist of the construction of riffle structure within the channel with scales ranging from 250 to 1,000 feet in length. The scales and associated acres and AAHUs are listed in Table 11 and depicted in Figure 15.

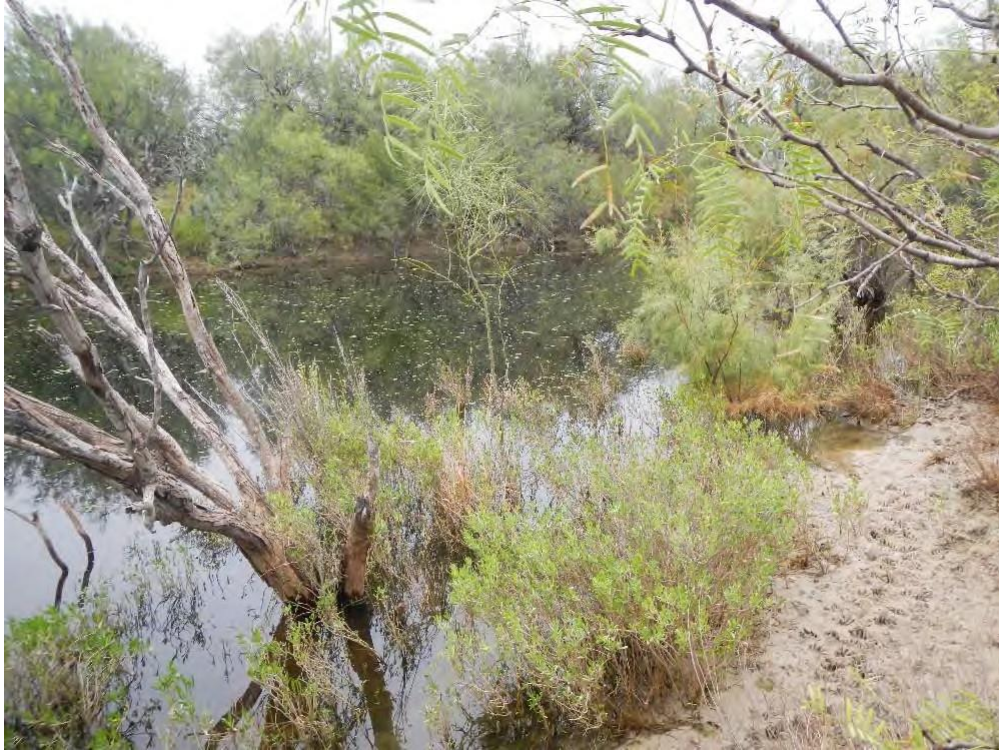
Photo 1. Ponded area of Chacon Creek, Riverine Section R1

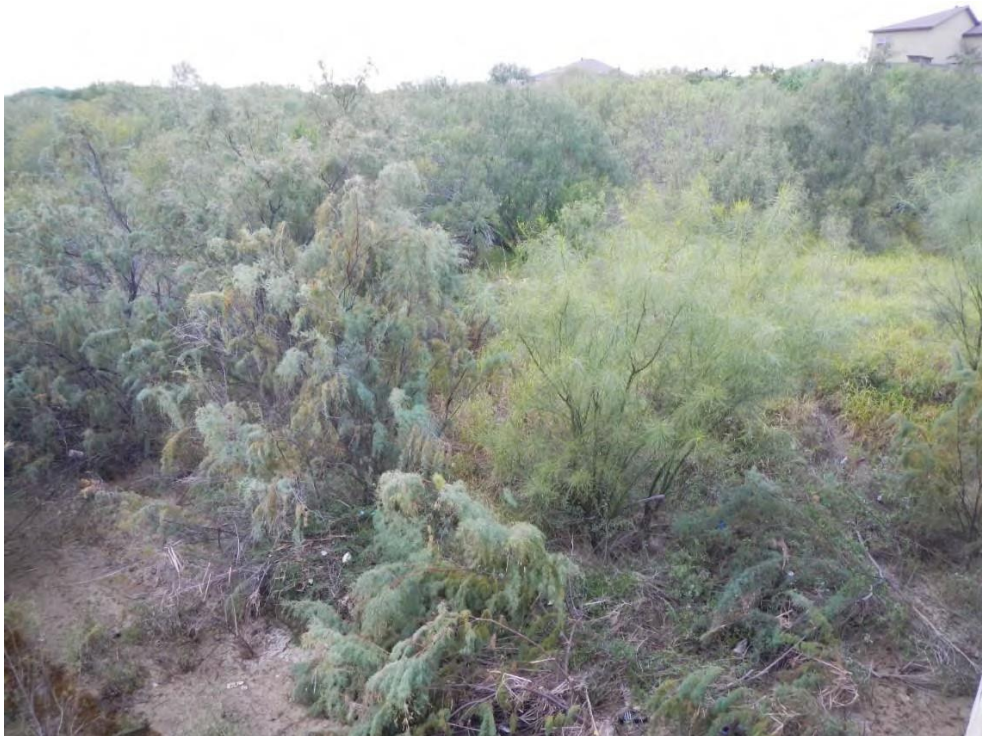
Photo 2. View of nearly dry Chacon Creek, from bridge on Escondido Road, looking north. Note saltcedar along banks.

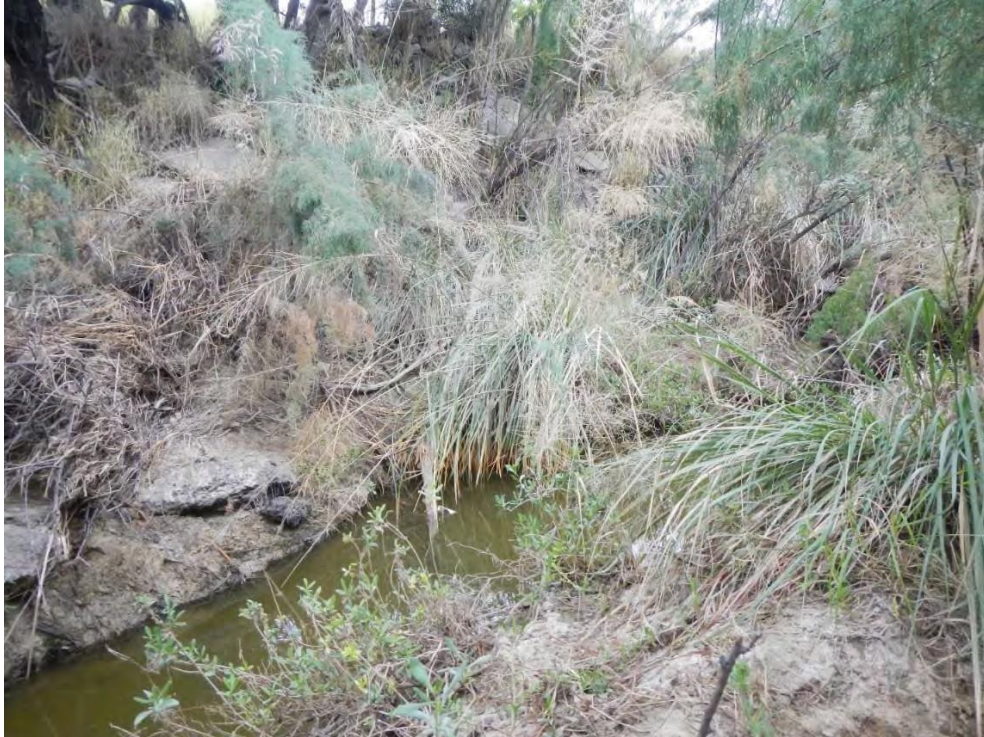
*Photo 3. Observations of Herbaceous Wetland 2.
Note saltcedar on banks of Chacon Creek.*

South of U.S. Highway 59, along R2, the project area is relatively narrow (**Figure 3.2**), and there was no right-of-entry within most sections of this reach. The wetland HW2 was accessed from a parking lot. The wetland was dominated by saltcedar along the creek banks, but no herbaceous wetland vegetation was present (**Photo 3**). This area is degraded, and covered with saltcedar, flood debris, and trash. The areas adjacent to HW2 were generally cleared, or mostly cleared and primarily covered with rock and gravel that was brought to the area by truck. HW3 was observed from the bridge on Business U.S. Highway 59Z. There was water in the creek bed, but the water

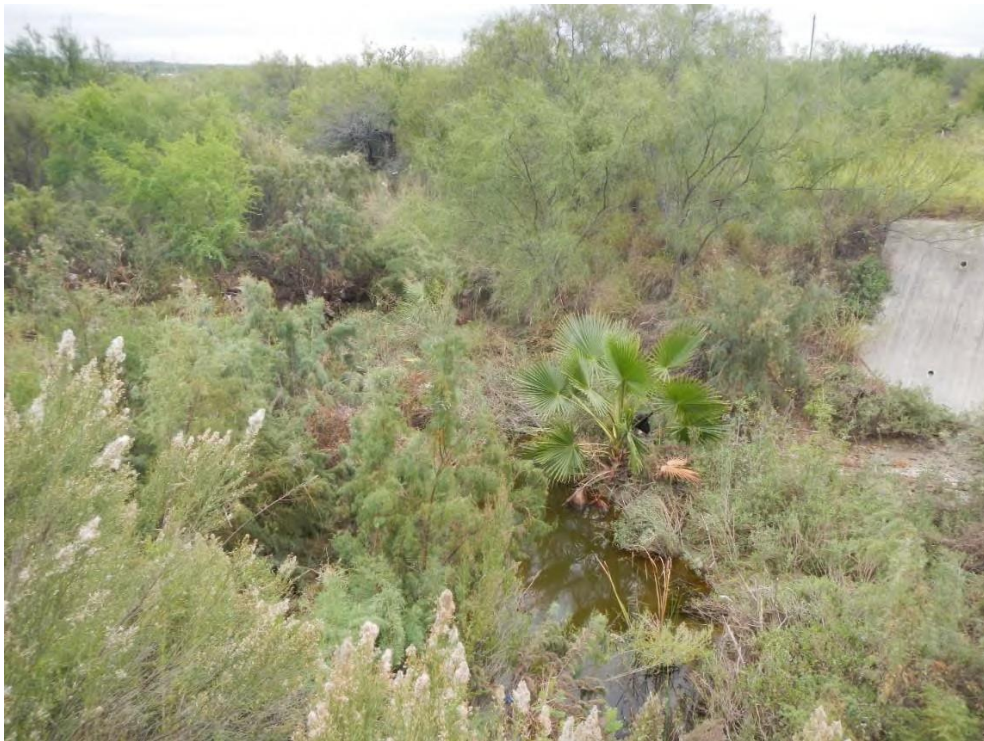
*Photo 4. View of Herbaceous Wetland 3, from bridge on Business U.S. Highway 59Z.
Note presence of saltcedar and baccharis on banks.*

had no discernable flow, and the banks were dominated by saltcedar, buffelgrass, and other woody species included baccharis (*Baccharis* spp.), Jerusalem thorn, sweet acacia, and big sacaton (*Sporobolus wrightii*), all of which may occur in uplands and wetlands (**Photo 4**). As with HW2, HW3 wetland is degraded and inundated with flood debris and trash. The remainder of the reach was not accessible.

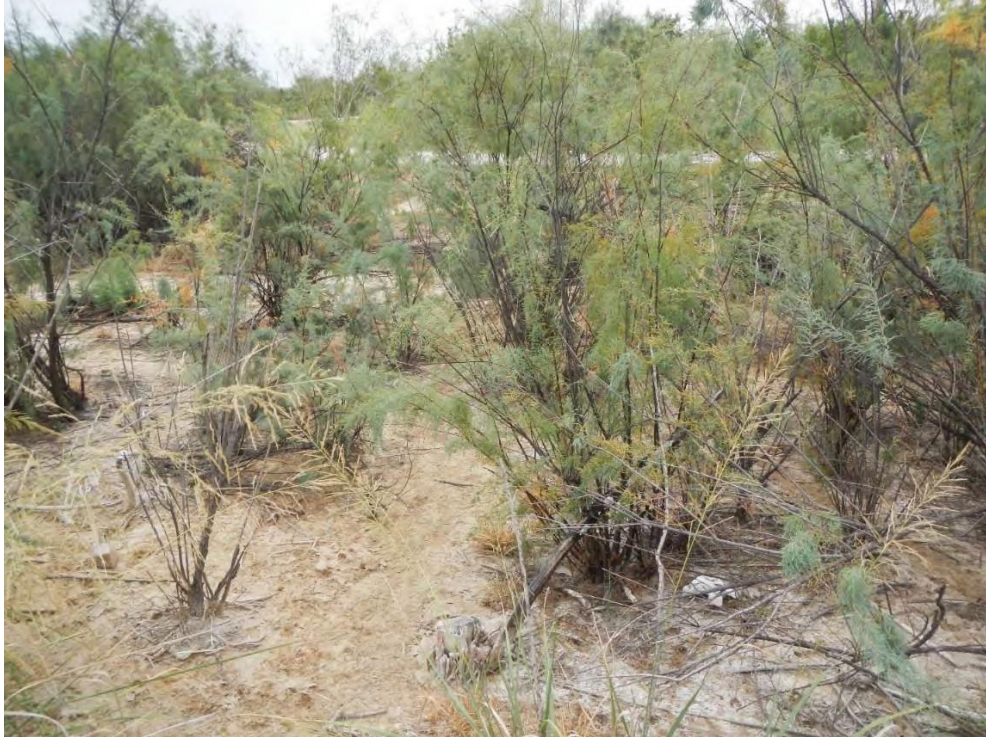
Photo 5. Point 911, looking south. Note hike and bike trail in background. Shrubs dominated by honey mesquite.

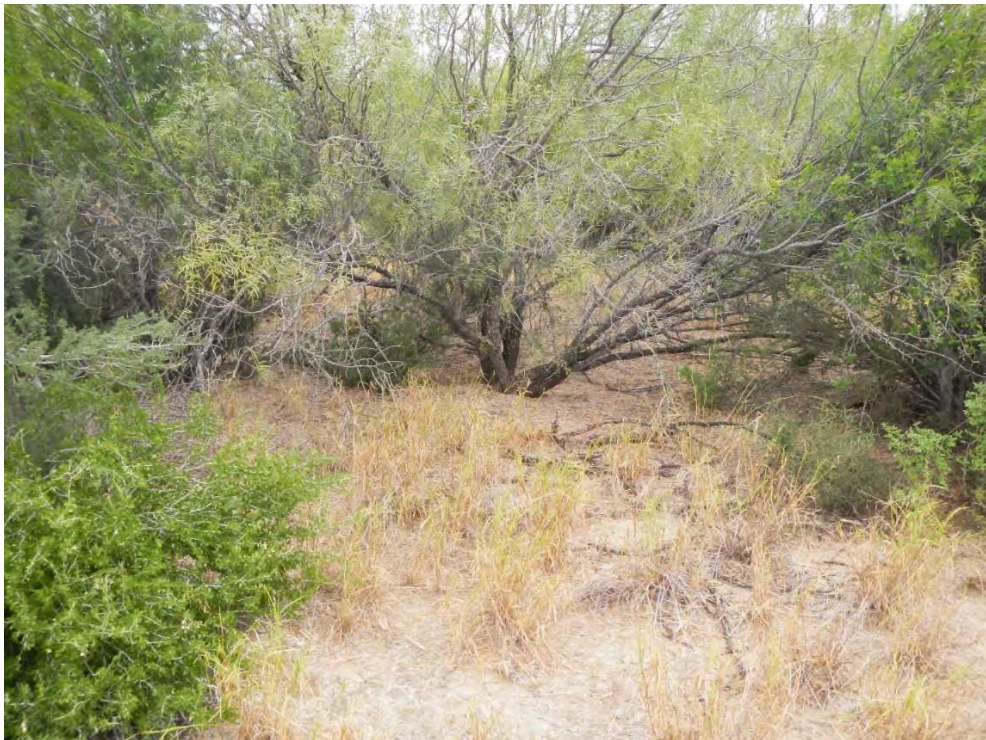
Photo 6. Plot 910, looking east. Note diversity of shrubs.

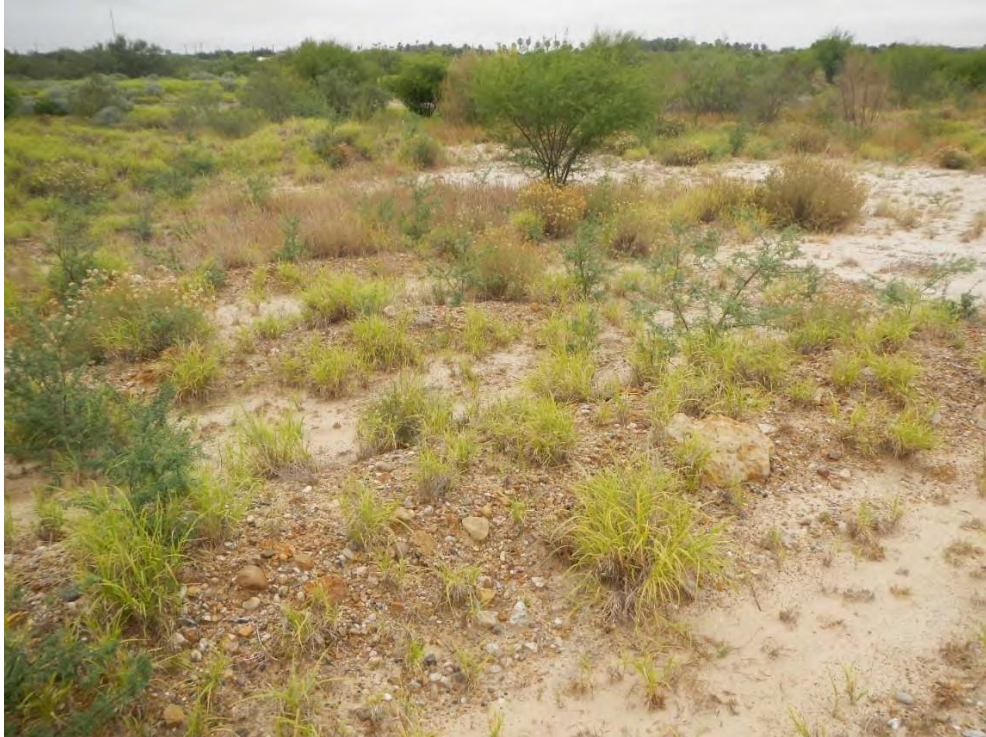
Photo 7. Plot 909, looking north. Note shorter stature shrubs and more open spaces.

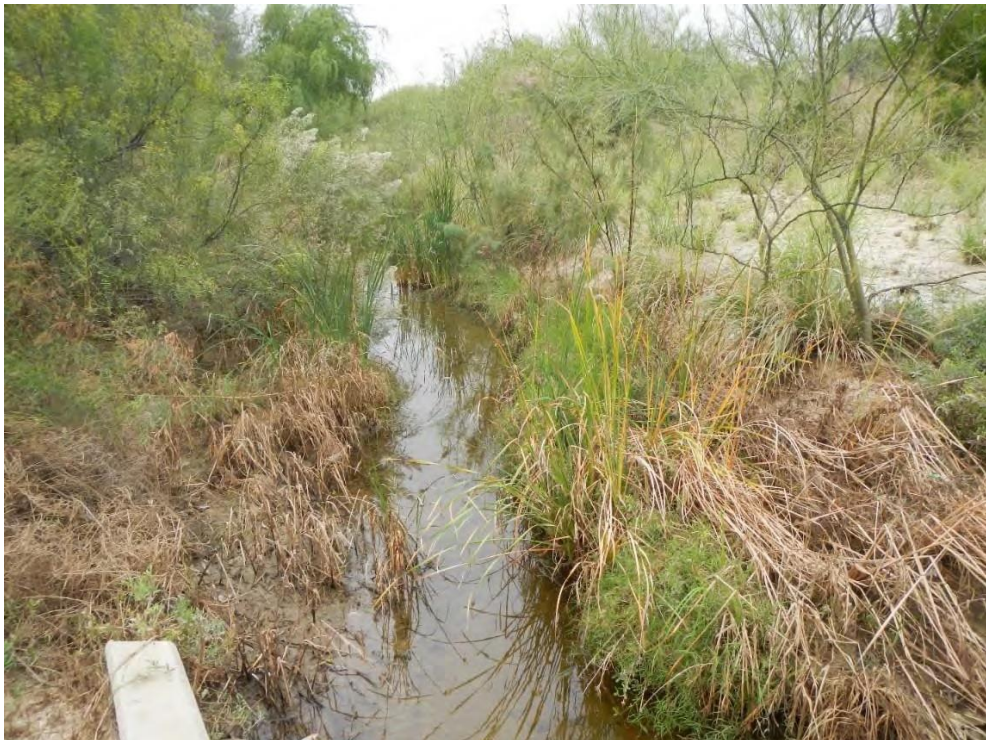
Photo 8. Herbaceous Wetland 7, Point 808, looking west. Note saltcedar and big sacaton on banks.

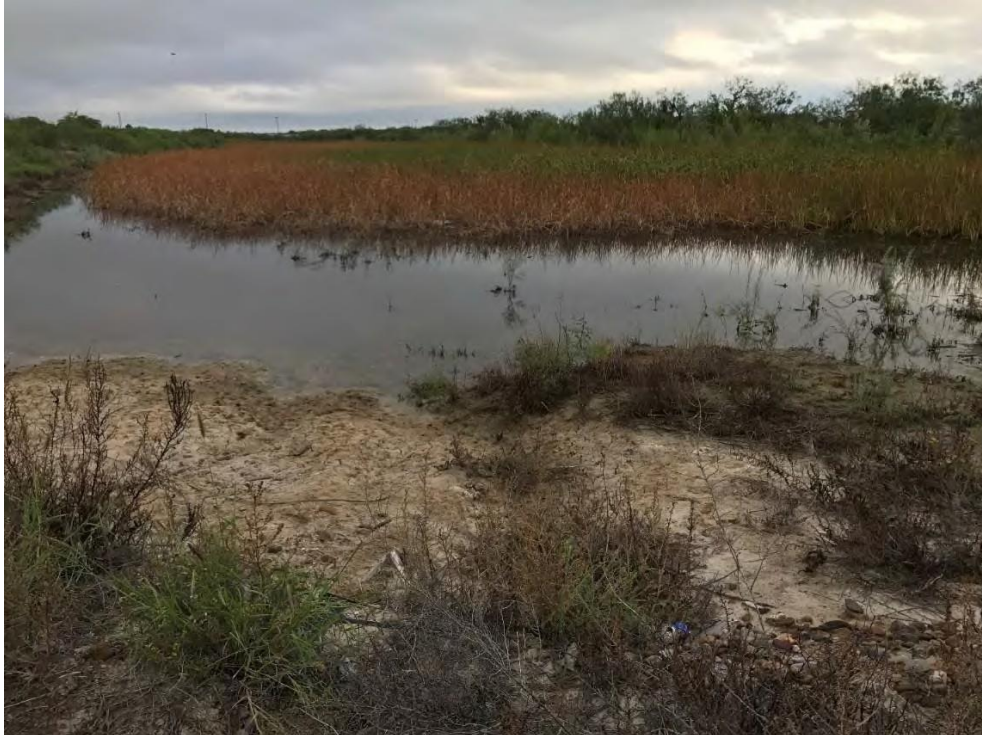
Photo 9. Clark Road wetland restoration. Note extensive stands of cattail in the background and water in foreground. Water in foreground is not typically present. American coots were observed swimming in this area.
