Chacon Creek, Laredo, Texas

Feasibility Report and Environmental Assessment

April 2024

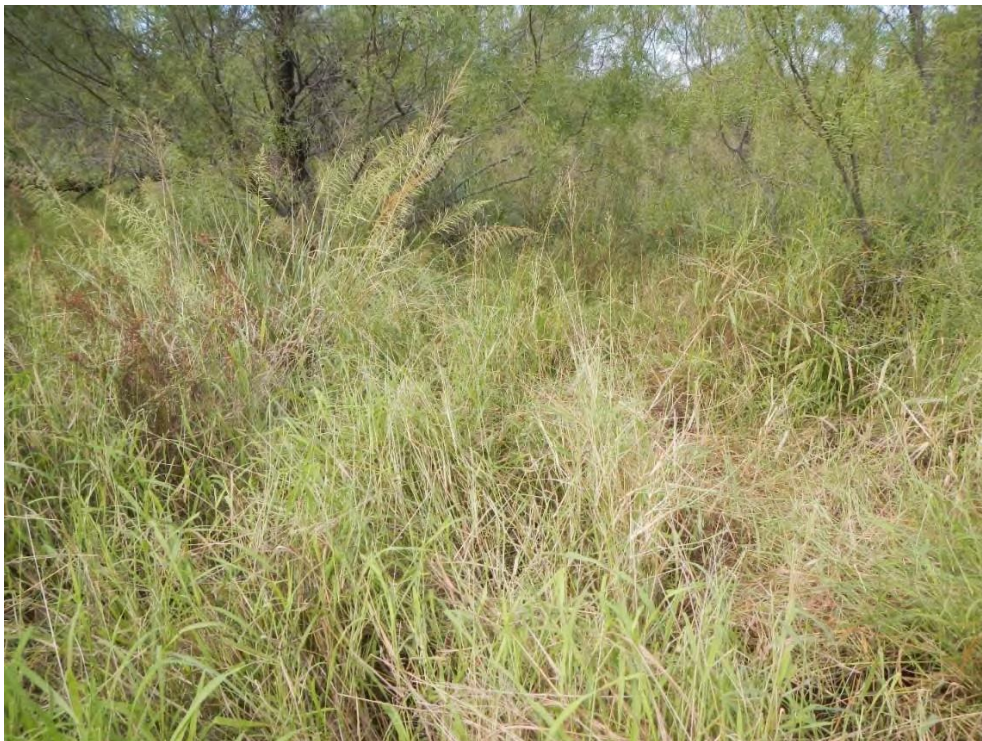
Photo 10. Plot 518, looking west. Note big sacaton on left, and buffelgrass in foreground. Shrubs are primarily honey mesquite.

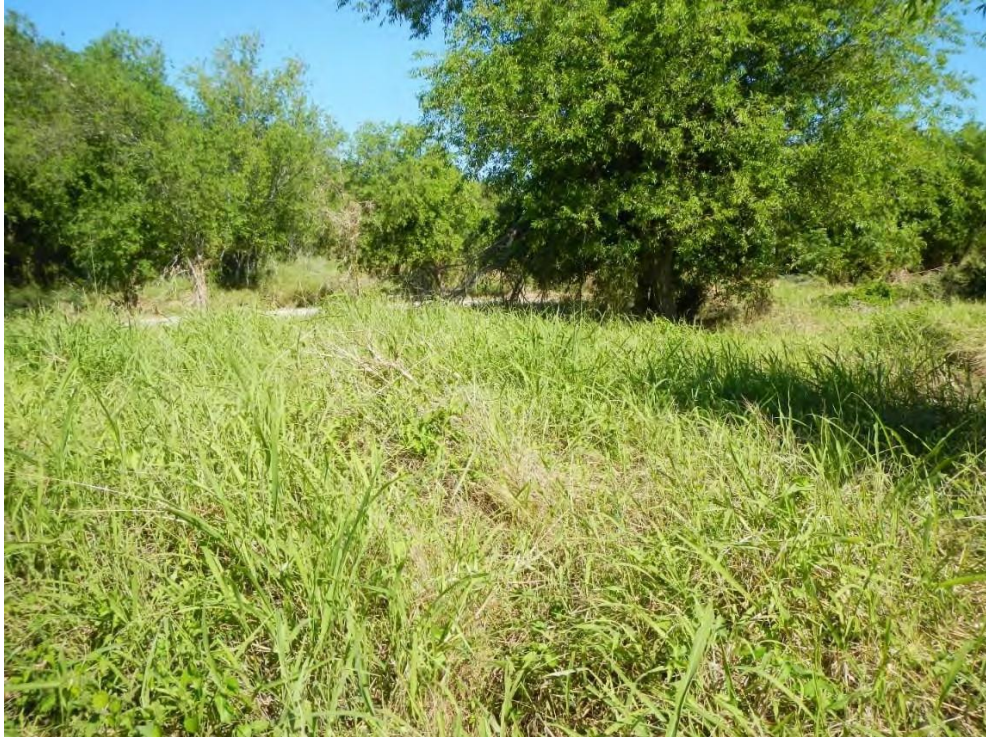
Photo 11. Plot 367, looking west. Area reclassified as DS35. Note absence of large overstory trees. Foreground is buffelgrass.

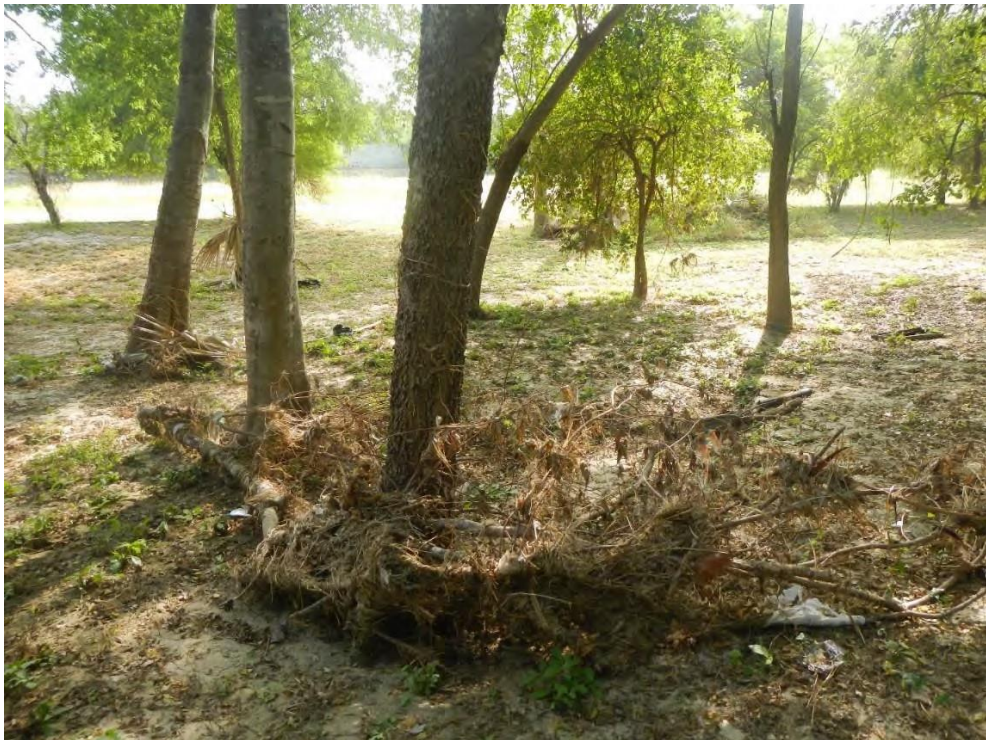
Photo 12. Plot 52, looking east. Classified as deciduous forest. Note absence of herbaceous layer.

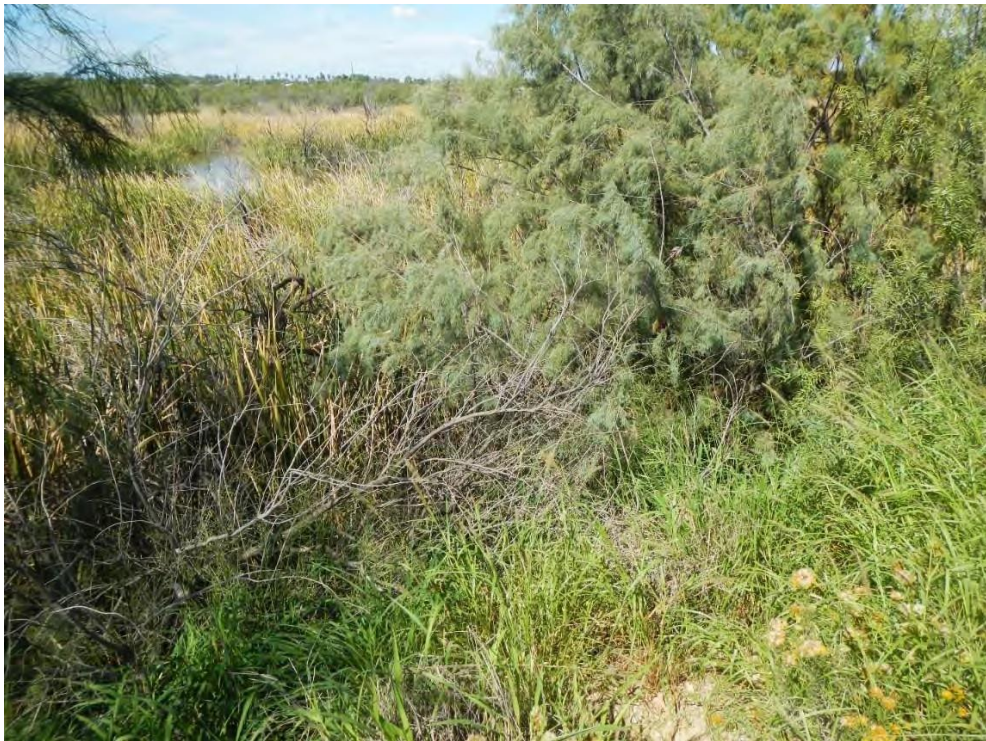
Photo 13. Plot 25, looking west, in Chacon Bat Park. Note terraces in foreground. Opposite bank is dense stand of giant reed.

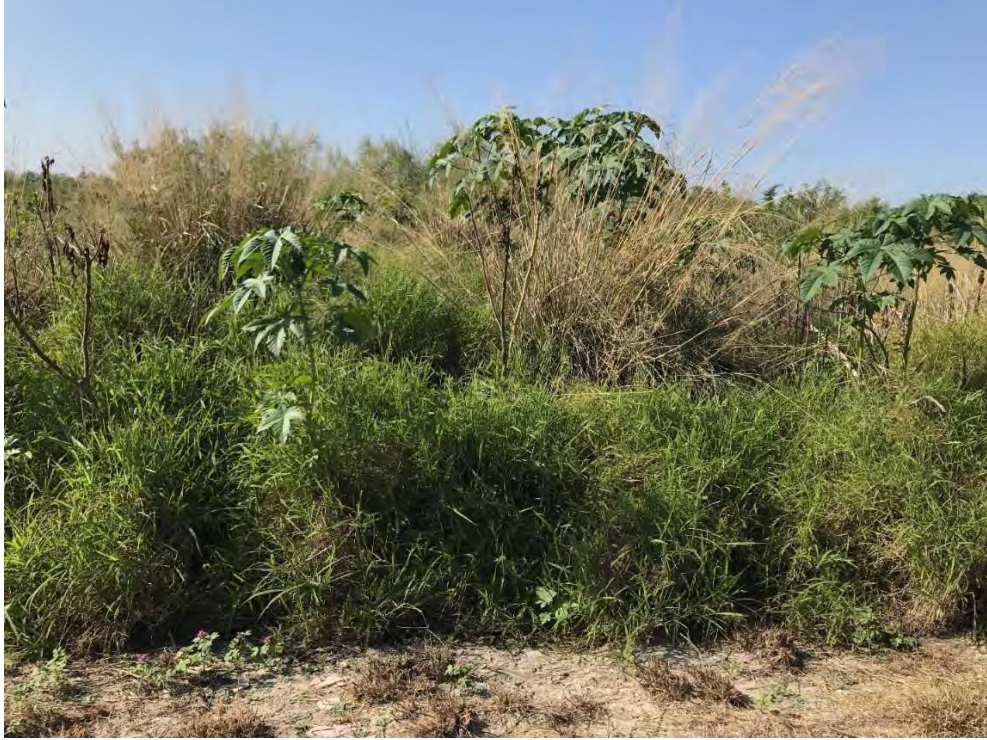
Photo 14. Herbaceous wetland, plot 289, looking north into Clark Road restoration area, showing wetland in background.

Castor bean was observed near the railroad tracks (**Figure 4.4**) and within some of the sampling points south of this area. Castor bean is a plant of roadsides and disturbed areas, and is an annual shrub or small tree that can grow to 10 feet or more during the growing season (**Photo 14**). The seeds and to a lesser degree, the foliage, contain ricin which is highly toxic to humans and animals. The seeds disperse near the parent plant, or can be moved short distances by ants. Due to rapid growth, castor bean will outcompete native shrubs for space and water. Effective eradication can be conducted with mechanical methods such as pulling or digging small plants, or chemical control (DiTomaso et al 2013).

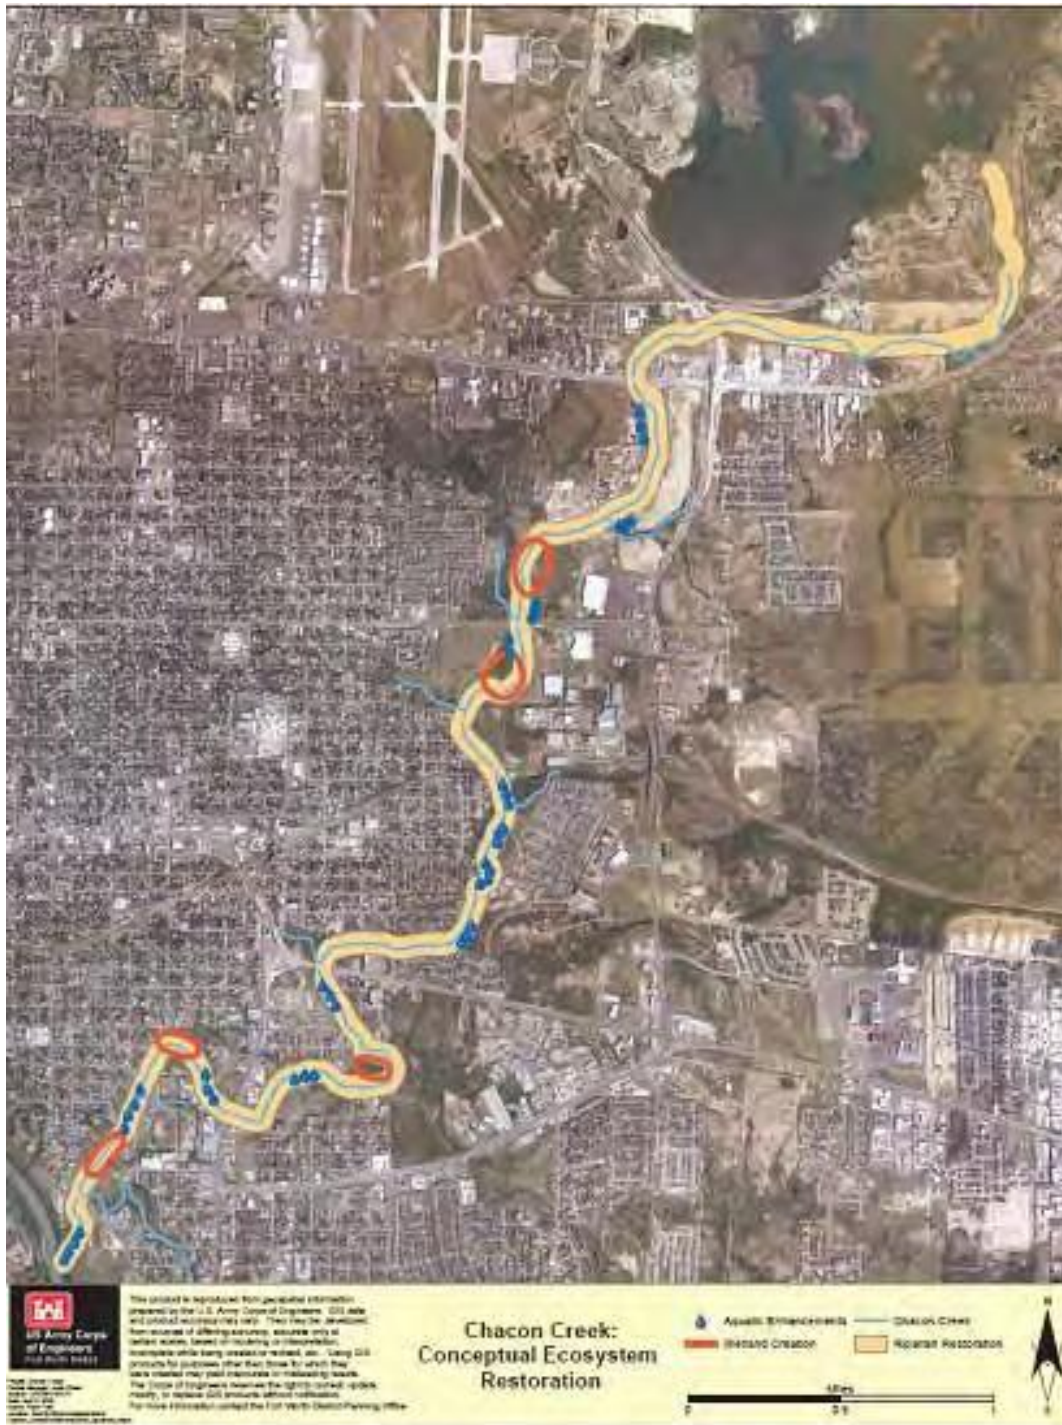
Figure 1: Proposed Project Area for Laredo Flood Control Project (USACE 2010)

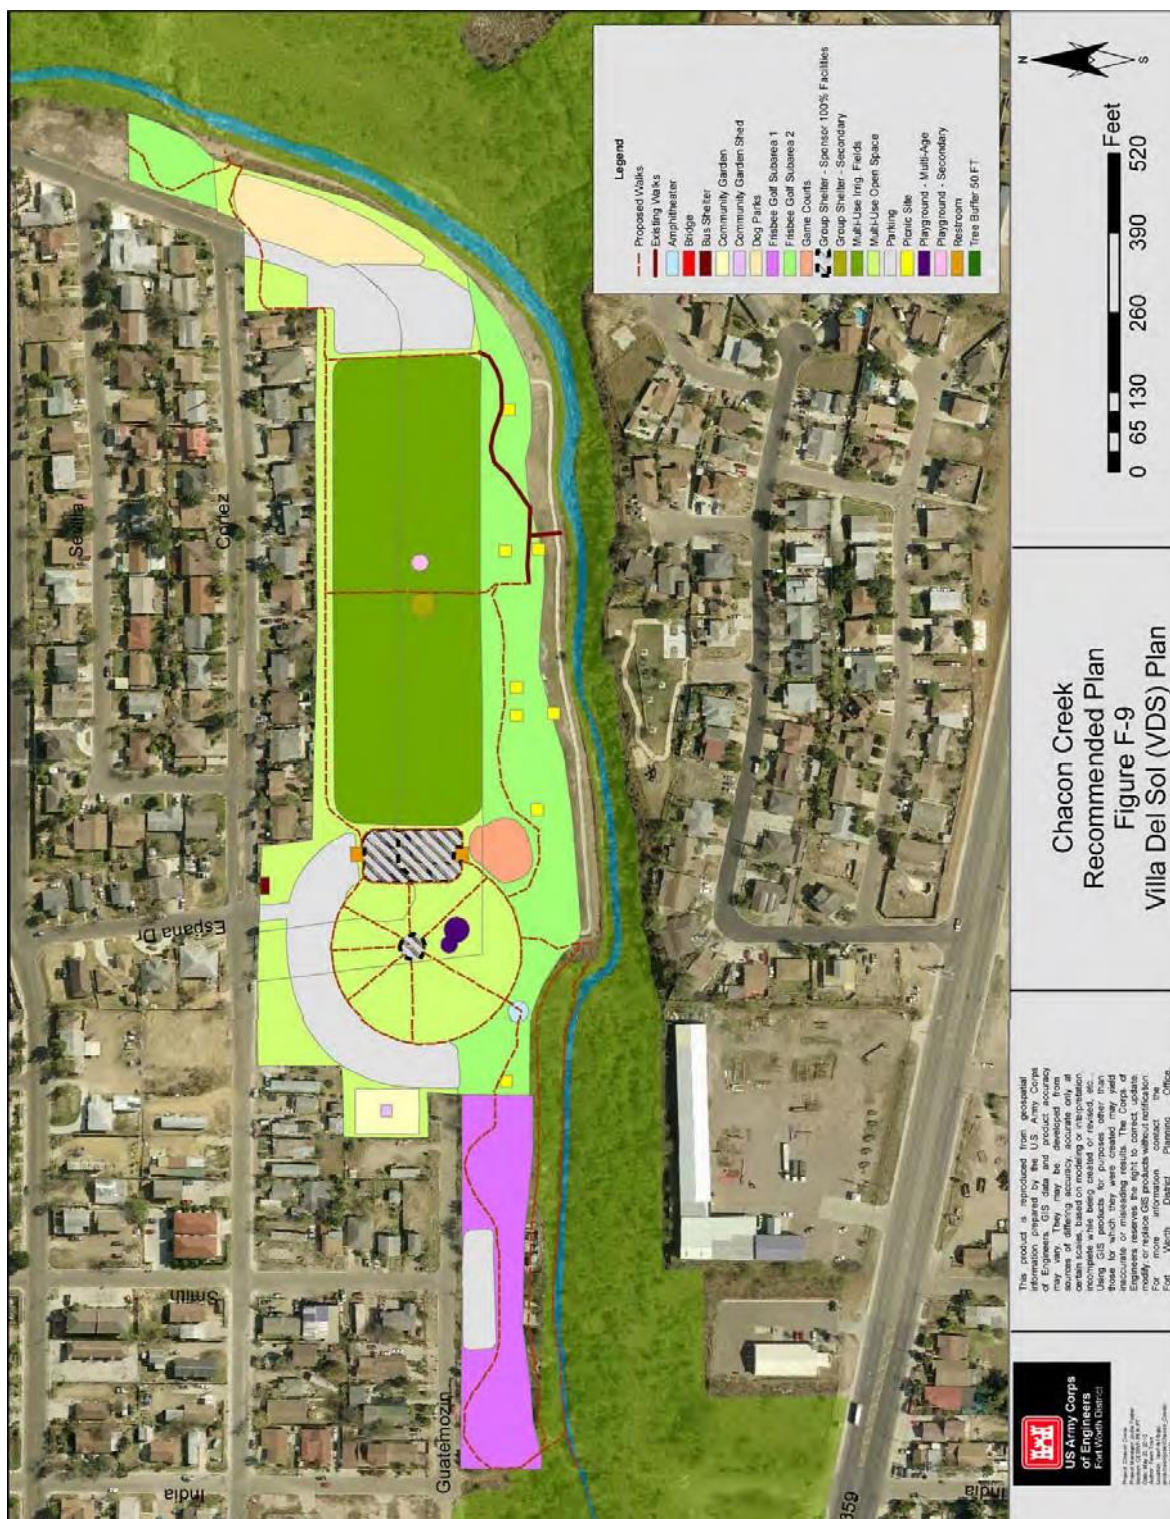
Subarea	Amenities Considered
1, 2, 3, 4	Parking and Access Roads (includes all associated amenities)
2	Amphitheater
1, 2	Part of Multi-use Open Space, possible Frisbee Golf (18-hole)
2, 3	Game Courts
2	Individual Picnic Sites (8)
4	Metro Bus Shelter/Trailhead
1	Part of Multi-use Open Space, possible Community Garden and Shed (Some not cost-shared, such as fence)
3, 4	Part of Multi-use Open Space, possible Dog Parks (fence not cost-shared)
3, 4	Large Group Picnic Shelter (rentable, income generation for maintenance)
3	Small Group Picnic Shelters (2)
1, 2, 3, 4	Multi-use Open Space (possible practice fields, soccer fields, festival and concert grounds (limited cost share)
3	Playground – large, multi-age themes
3	Playground – small, secondary
3, 4	Comfort Stations (2 Restrooms) may also be designed with concessions, group picnic with restrooms
1, 2	Tree Buffer (50 feet)
	Circulation System (5-8' wide concrete paths)

NER	Two Pedestrian Bridges (refer to the NER Multi-use trail plan) – linkage to trails planned to community center in eastern non-project lands

Figure F-9. Villa Del Sol (VDS) Plan

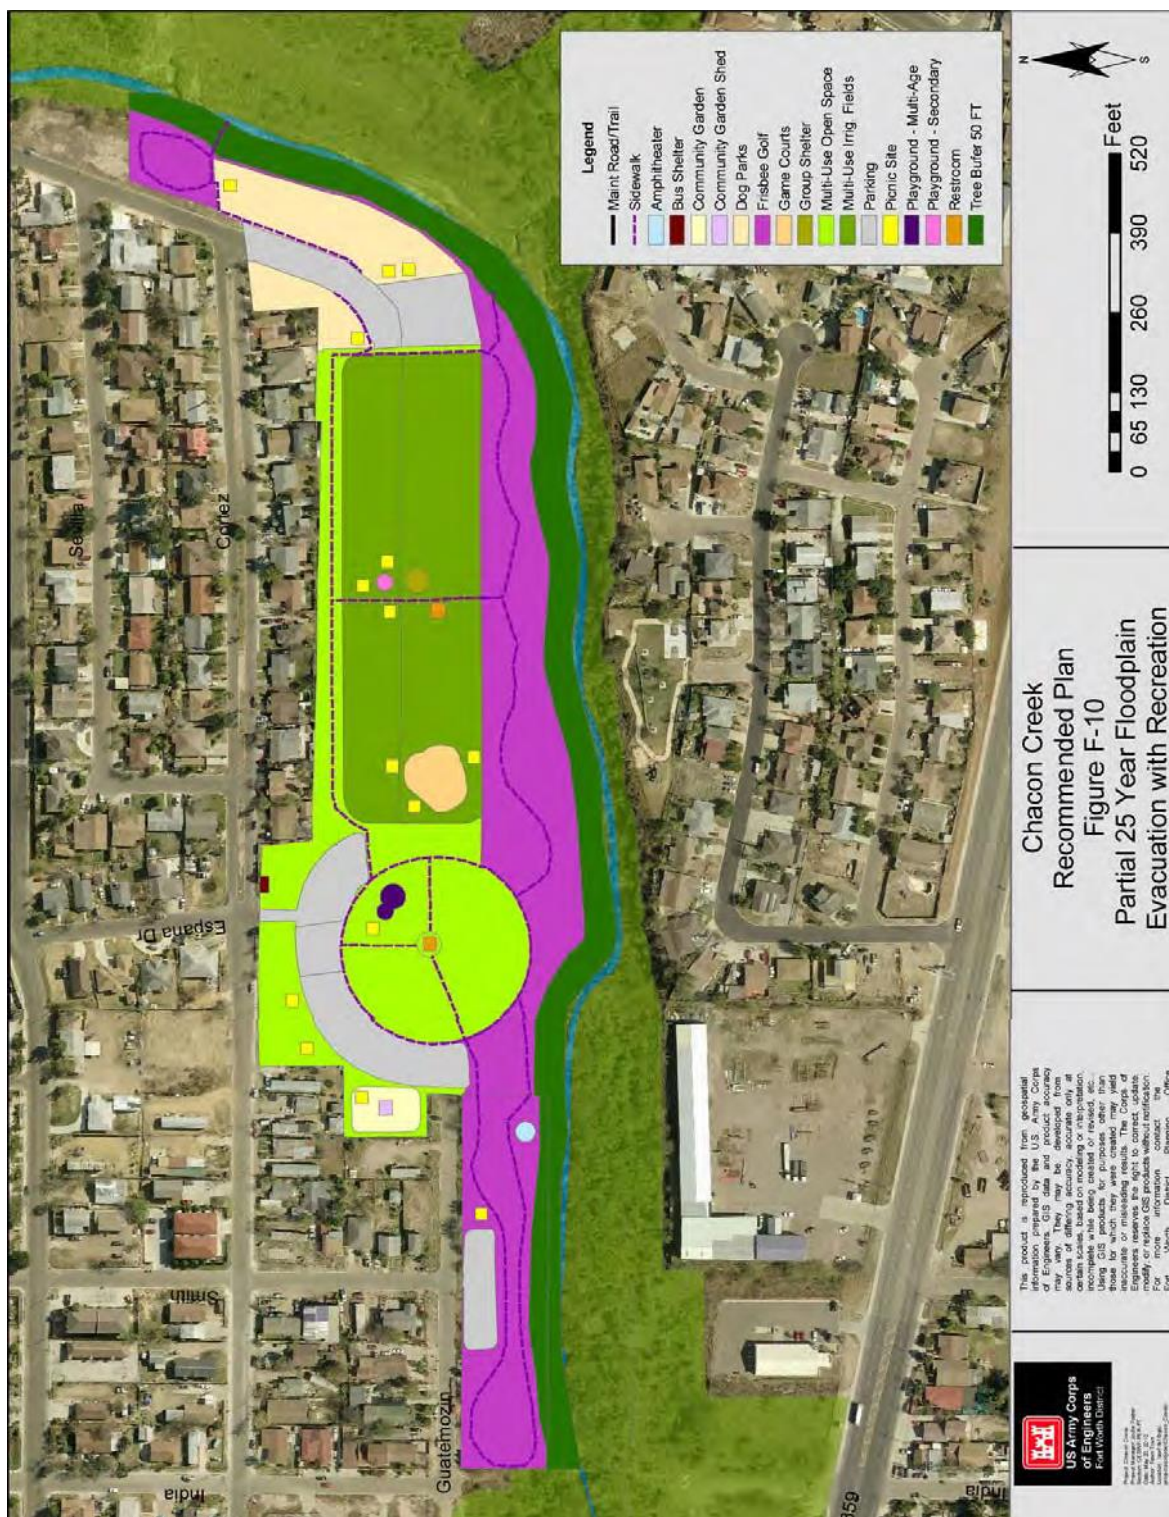
Subarea	Amenities Considered
1, 3, 4	Parking and Access Roads including all associated amenities (Subarea 2 100% sponsor cost)
1	Amphitheater
2	Subarea 2, if multi-use conversion 100% sponsor; possible Frisbee Golf (18-hole)
3	Game Courts
1, 3, 4	Picnic Sites (15) including all associated amenities (Subarea 2 100% sponsor cost)
4	Metro Bus Shelter/Trailhead
1	Multi-use Open Space, possible Community Garden and Shed
1, 3, 4	Multi-use Open Space, possible festival area, concert space, dog parks
3, 4	Large Group Picnic Shelter and Basketball Court
3	Small Group Picnic Shelters (2)
4	Playgrounds – large, multi-age themes, small, secondary
3, 4	Comfort Stations (Restrooms 2) group picnic with restrooms
1, 2	Tree Buffer (50 feet min., Ecosystem Restoration cost-share)
1, 2, 3, 4	Circulation System (5–8' wide concrete paths)
2	Maintenance Road/Multi-use Trail (within park only, 10-foot-wide concrete, 2 2-foot shoulders)

NER	Two Pedestrian Bridges and Trail (refer to the NER Multiuse trail plan) - linkage to trails planned to community center in eastern non-project lands

Figure F-10 Partial 25 Year Floodplain Evacuation with Recreation

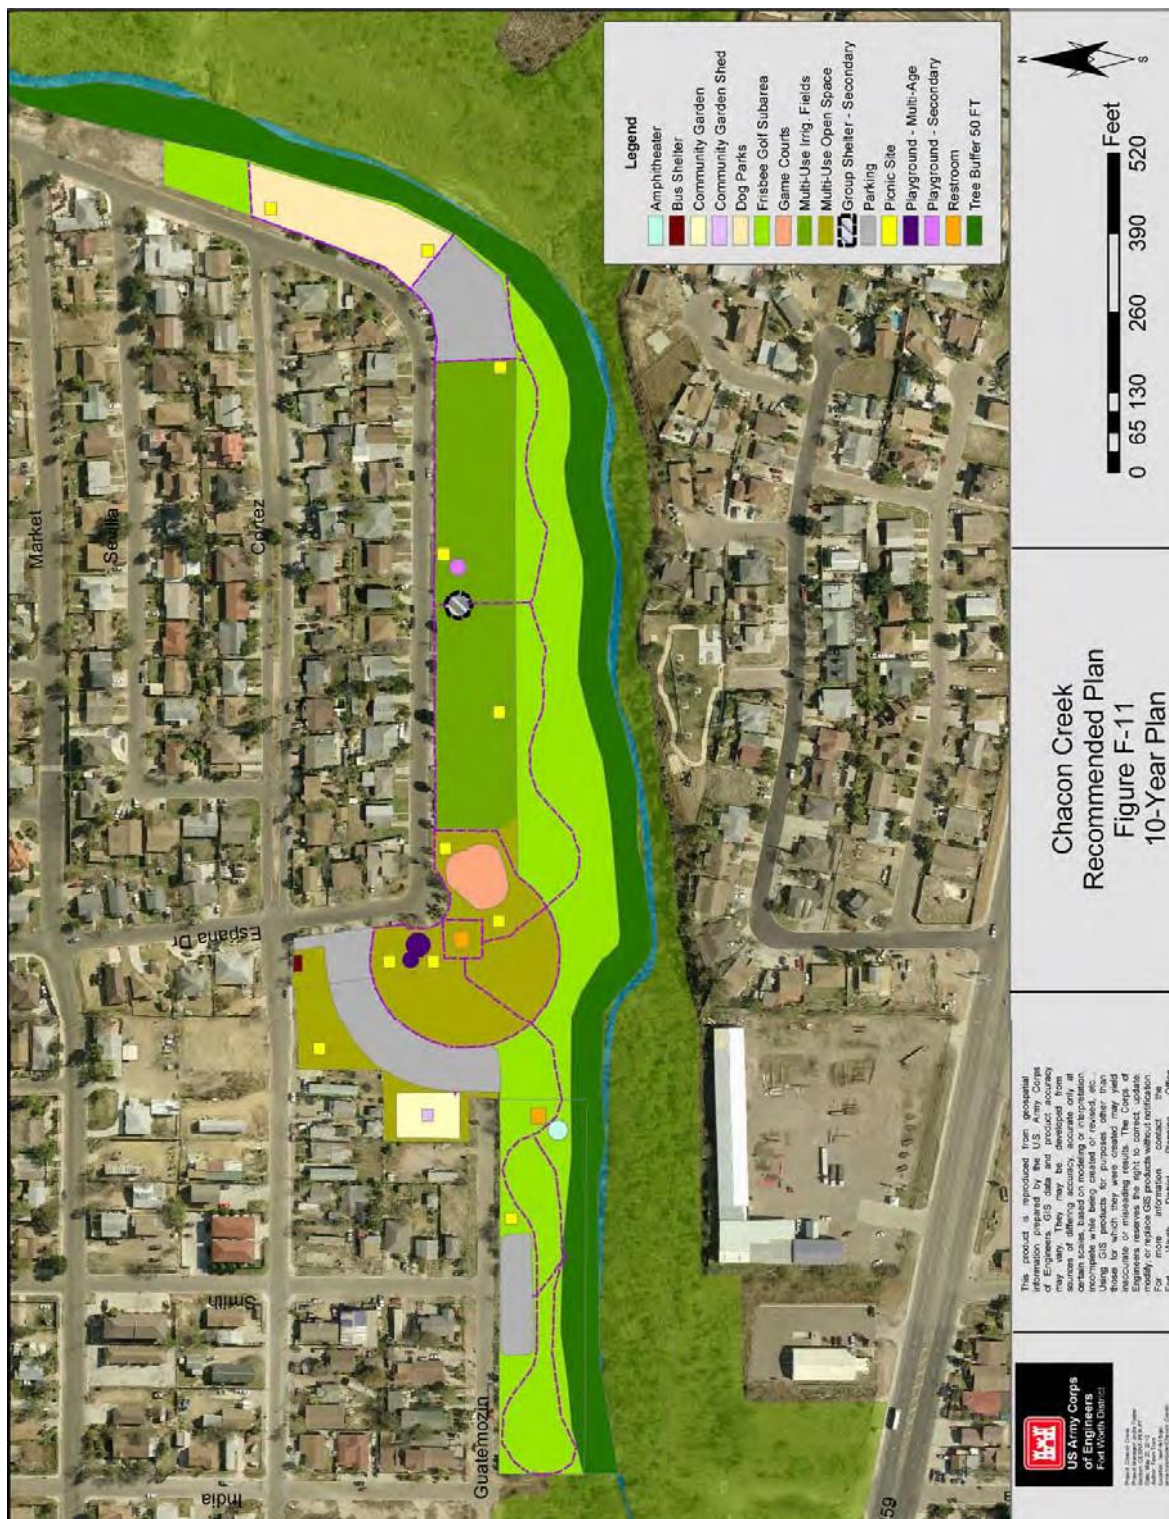
Subarea	Amenities Considered
1, 2, 3, 4	Parking and Access Roads (includes all associated amenities)
1	Amphitheater
1, 3	Multi-use Open Space, possible Frisbee Golf (18-hole), <i>Subarea 2 if redesigned</i>
3	Game Courts
1, 3	Picnic Sites (11)
4	Metro Bus Shelter
1	Multi-use Open Space, Community Garden and Shed
3	Multi-use Open Space, possible Dog Parks, practice fields
3	Large Group Picnic Shelter and Basketball Court
3	Small Group Picnic Shelters (2)
1, 2, 3	Multi-use Open Space (possible practice or sports fields, festival, concert usage, dog parks, existing park playground, shelters, basketball court, community garden, and shed)
3	Playground – large, multi-age themes
3	Playground – small, secondary
3, 4	Comfort Stations (2 Restrooms) - may also be designed with concessions, group picnic with restrooms
1, 2	Tree Buffer (50 feet)
1, 3	Circulation System (5–8' wide concrete paths)
NER	Two Pedestrian Bridges and Trail (refer to the NER Multiuse trail plan) - linkage to trails planned to community center in eastern non-project lands

Figure 11. 10-Year Floodplain Evacuation Plan

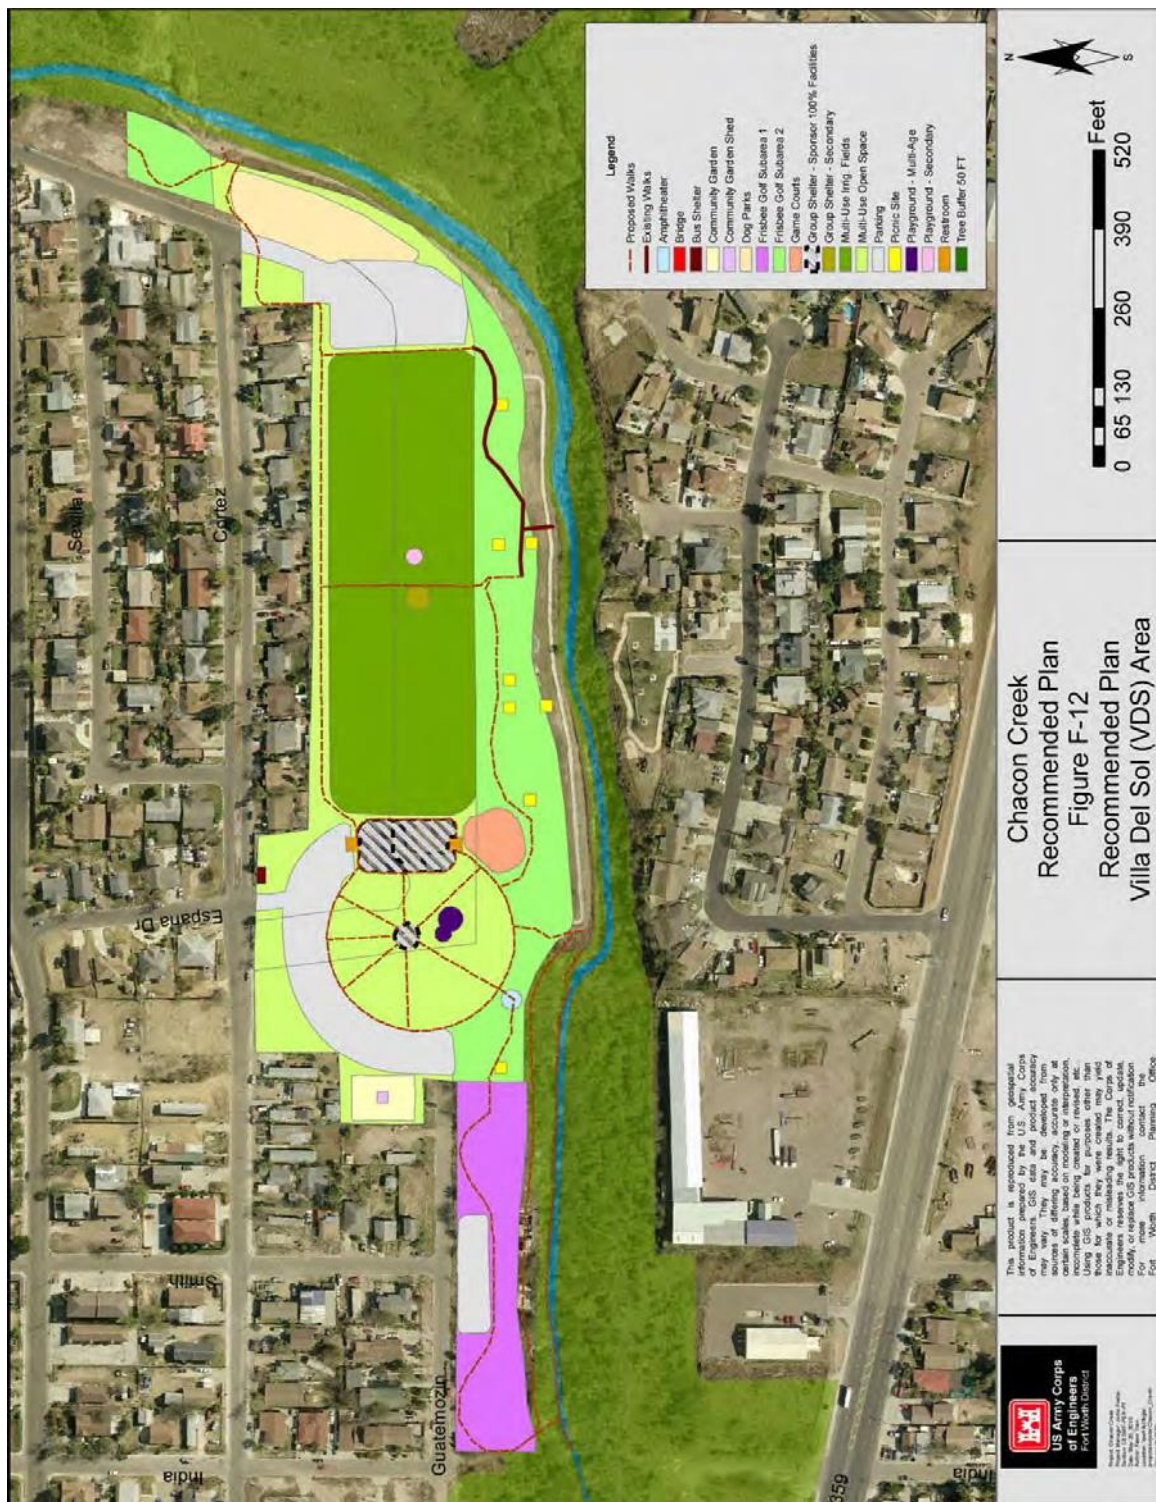
Area B	Amenities Considered
	Parking and Access Roads from India Street and Median
	Multiuse Open Space
	Playscape
	Restroom
	Boardwalk Trail linkage and Concrete Pathways

Figure 12. Recommended Plan, Villa Del Sol (VDS) Area

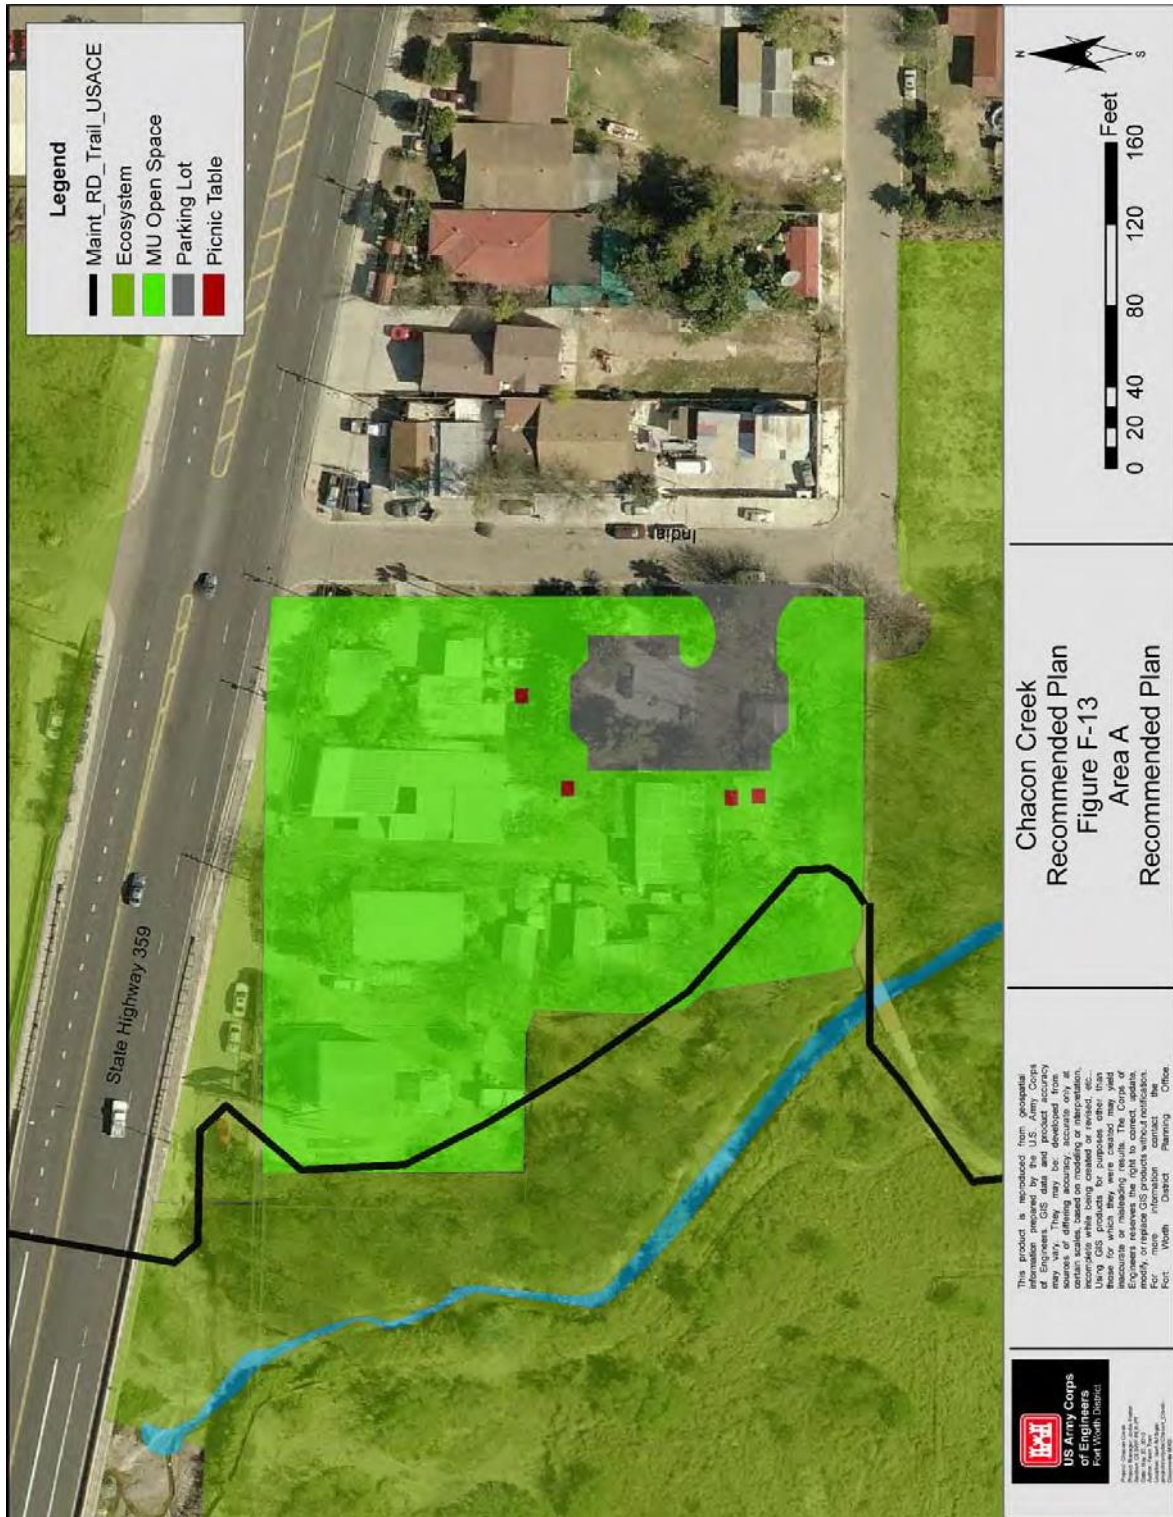
Area A	Amenities Considered
	Parking and Access Roads off of India Street
	Individual Picnic Sites (4)
	Multiuse Open Space
	Path to linkage with trail

Figure 13. Recommended Plan Area A

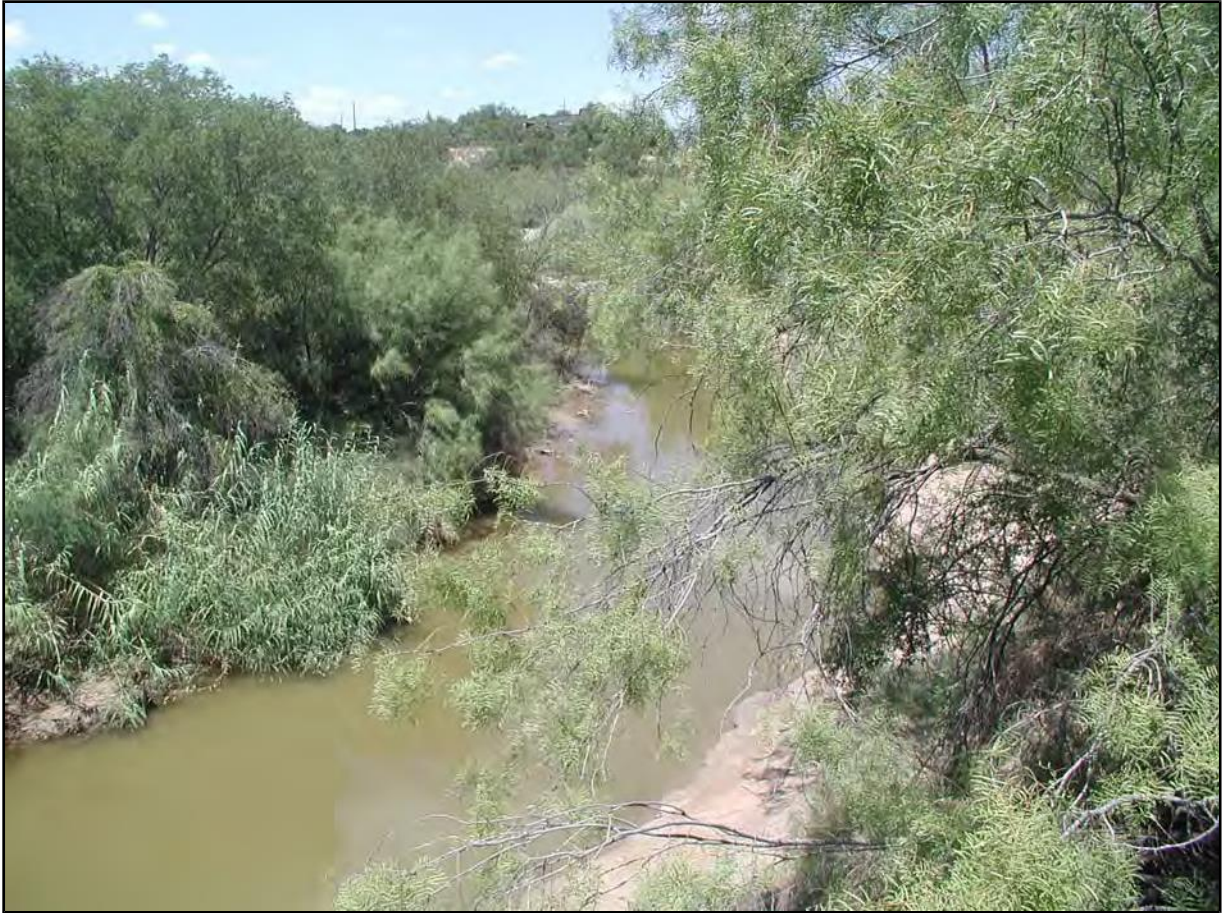
Figure G.1-1. Chacon Creek Study Area

This study was initiated by the City of Laredo to expand a previous flood control master plan into a multi-objective project. The upstream study limit is U.S. Highway 59, and the downstream study limit is the Rio Grande. On the next page, Figure G.1-1 is a typical view of the Chacon Creek channel.

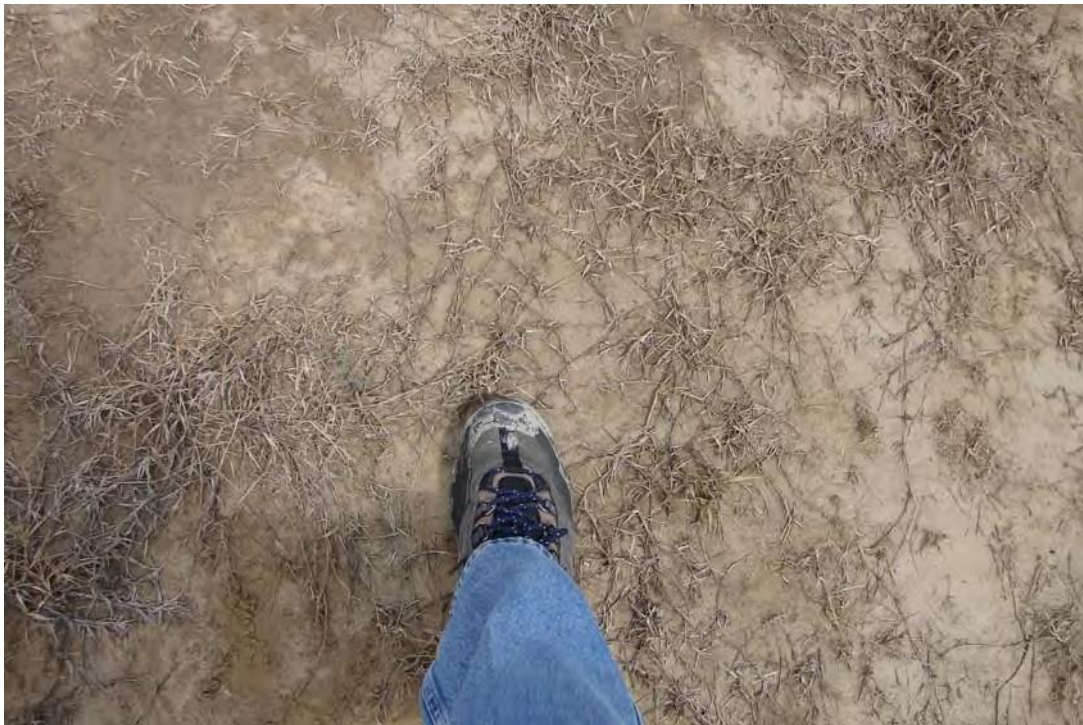
Soil on the north bank of Chacon Creek near Cortez St.
(14 September 2006 Site Visit)

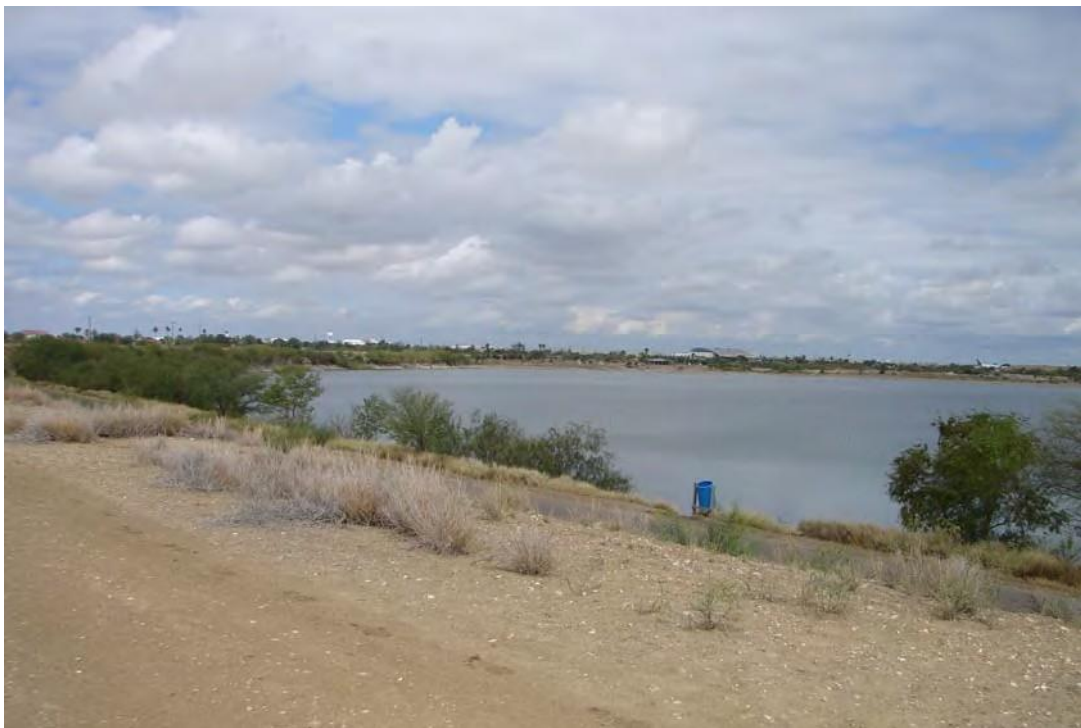
Casa Blanca Dam upstream slope next to east abutment.
(14 September 2006 Site Visit)

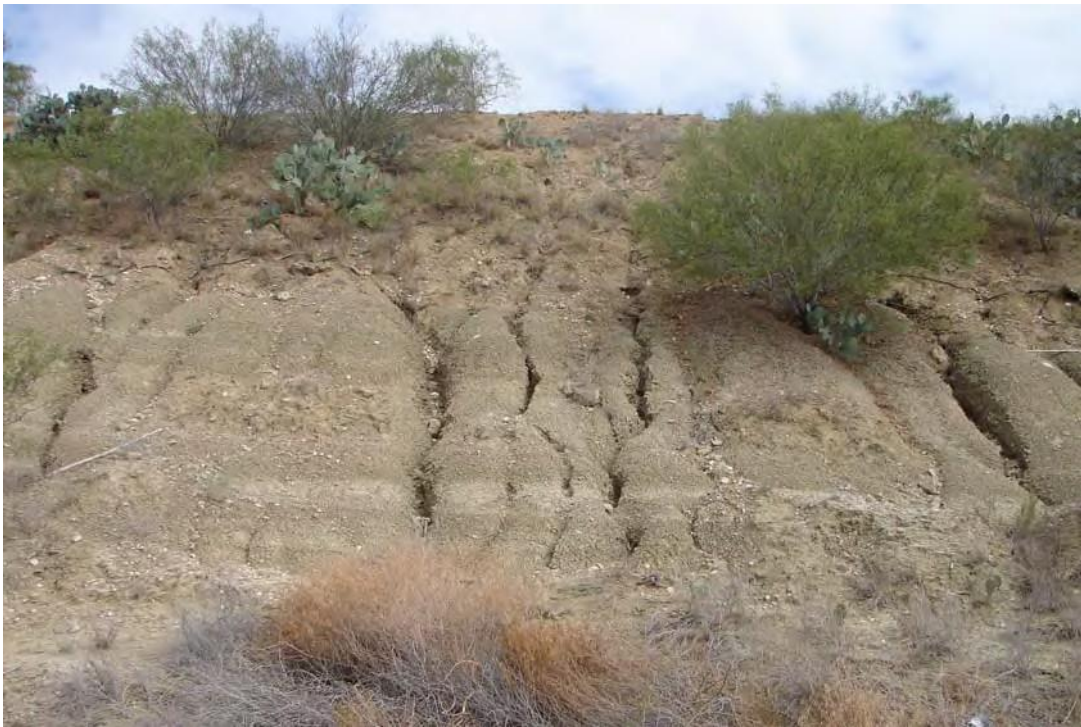
Casa Blanca Dam crest - east abutment looking west.
(14 September 2006 Site Visit)

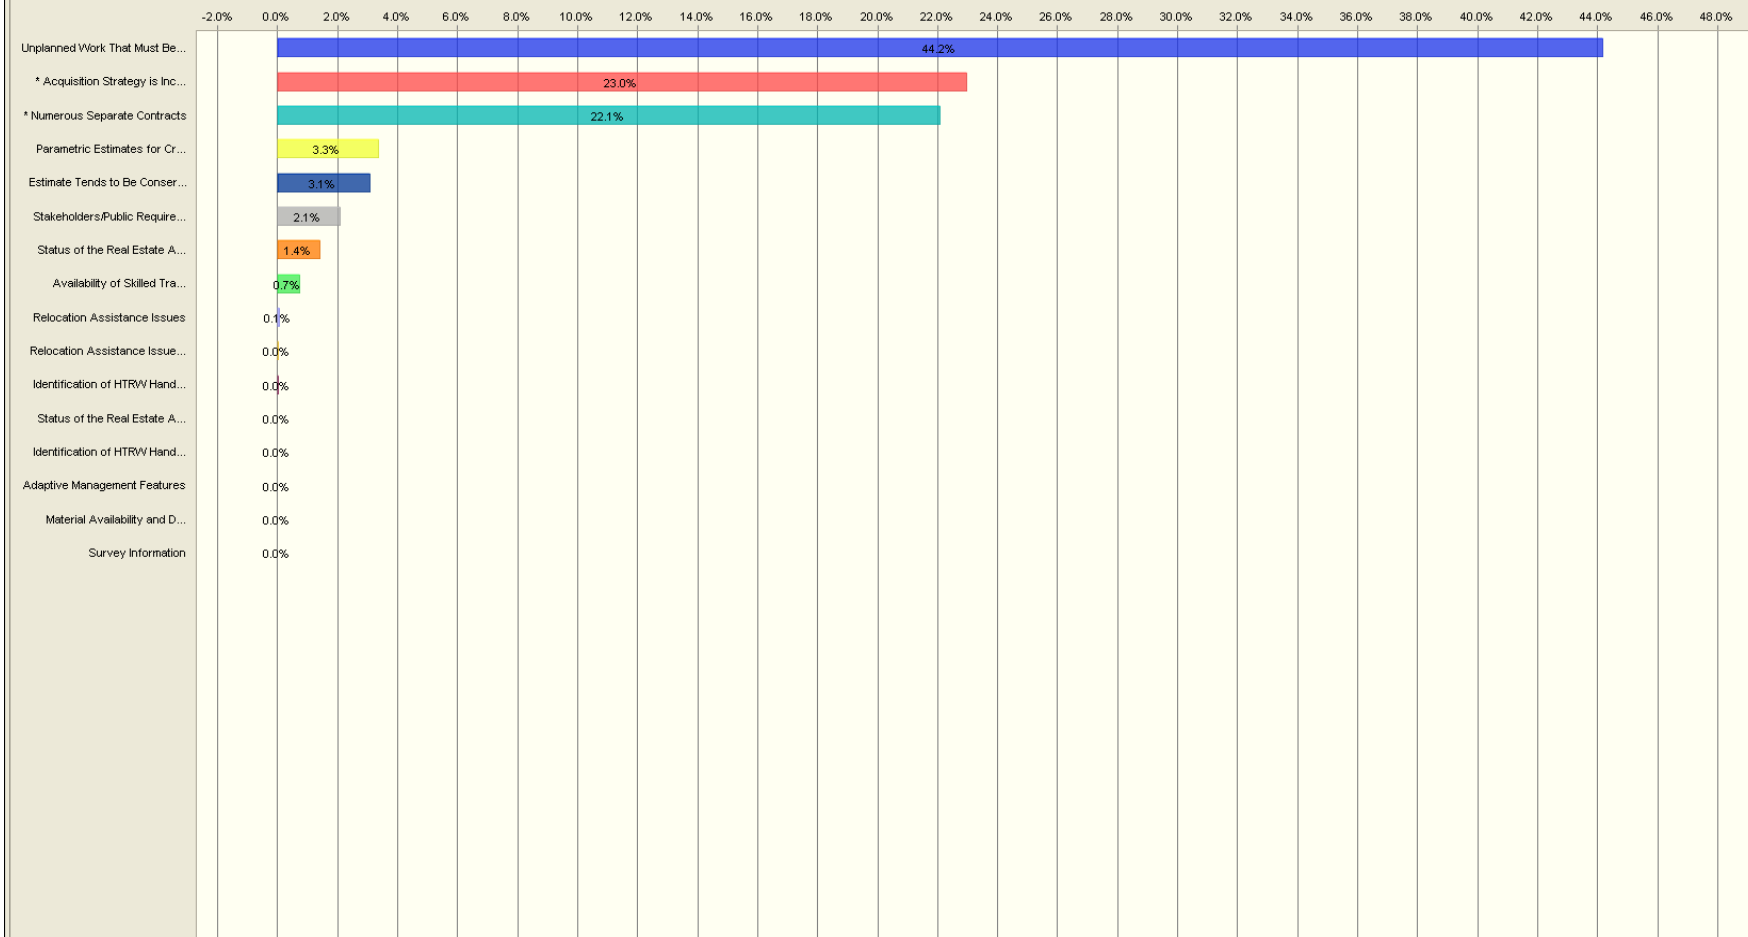
Contribution to Variance View

Sensitivity: PROJECT CONTINGENCY (BASELINE)

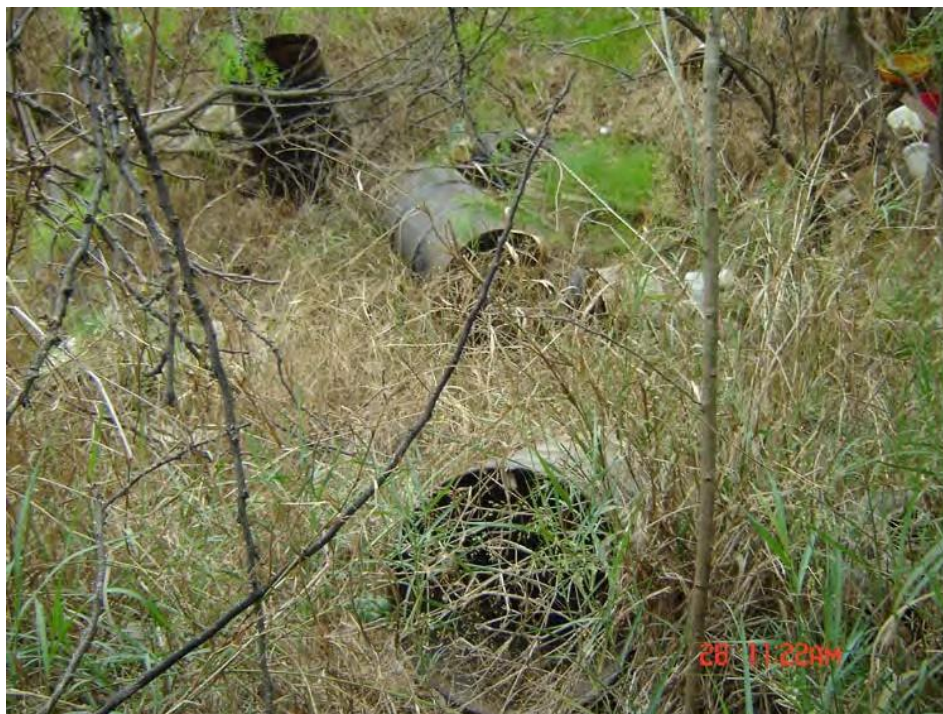
Stop 3a. 28-Mar-2006, 10:15 a.m. Near baseball field. Empty drums.

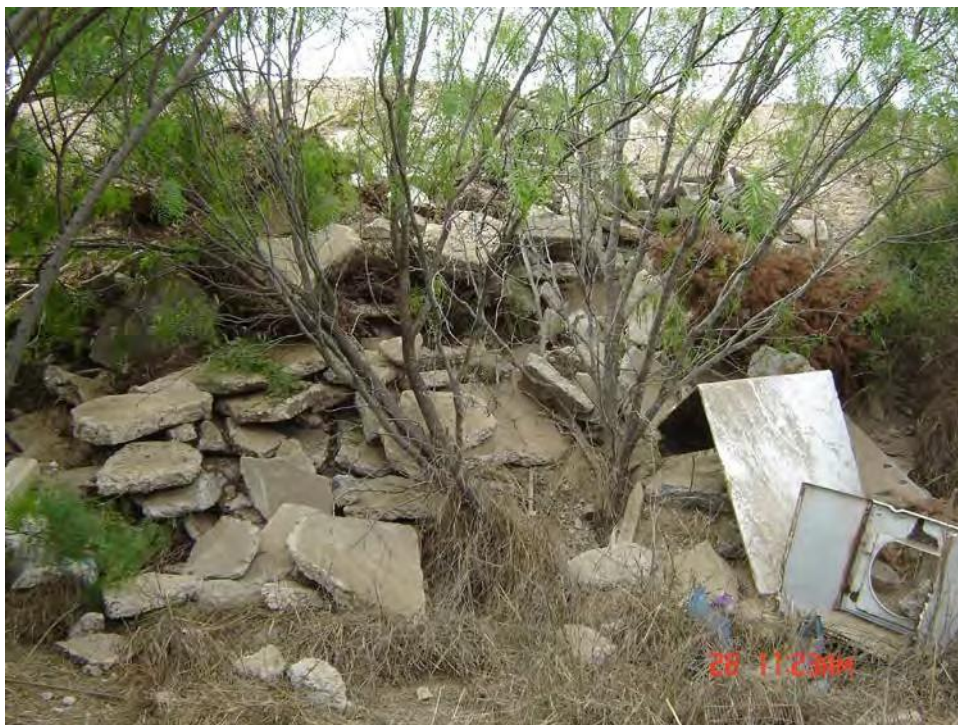
Stop 3b. 28-Mar-2006, 10:15 a.m. Near baseball field. Construction debris.

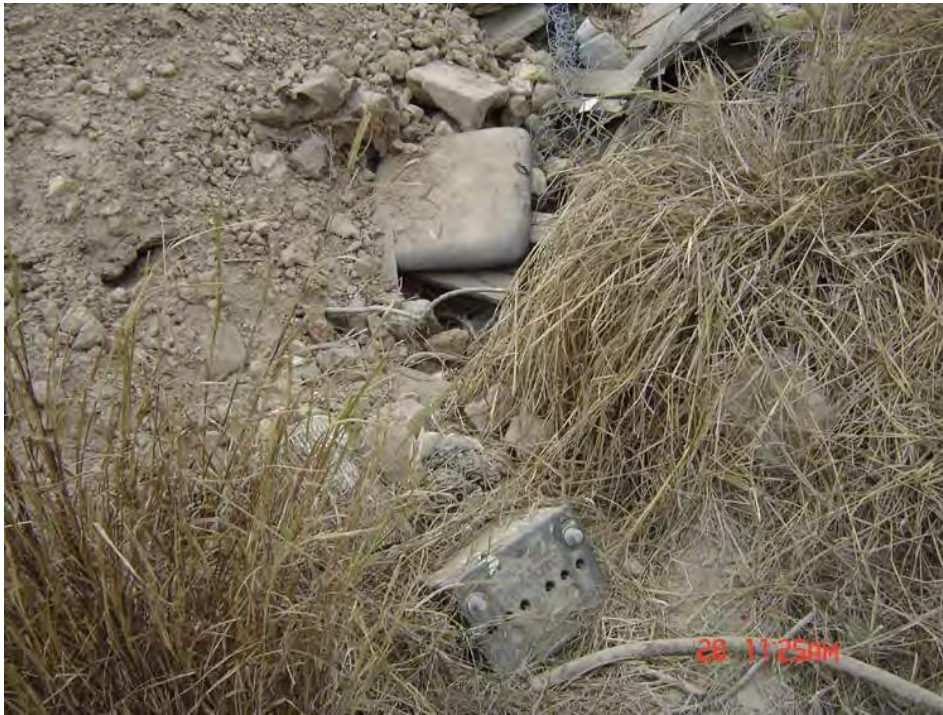
Stop 3c. 28-Mar-2006, 10:15 a.m. Near baseball field. Lead battery and construction debris.
