Chacon Creek, Laredo, Texas

Feasibility Report and Environmental Assessment

April 2024

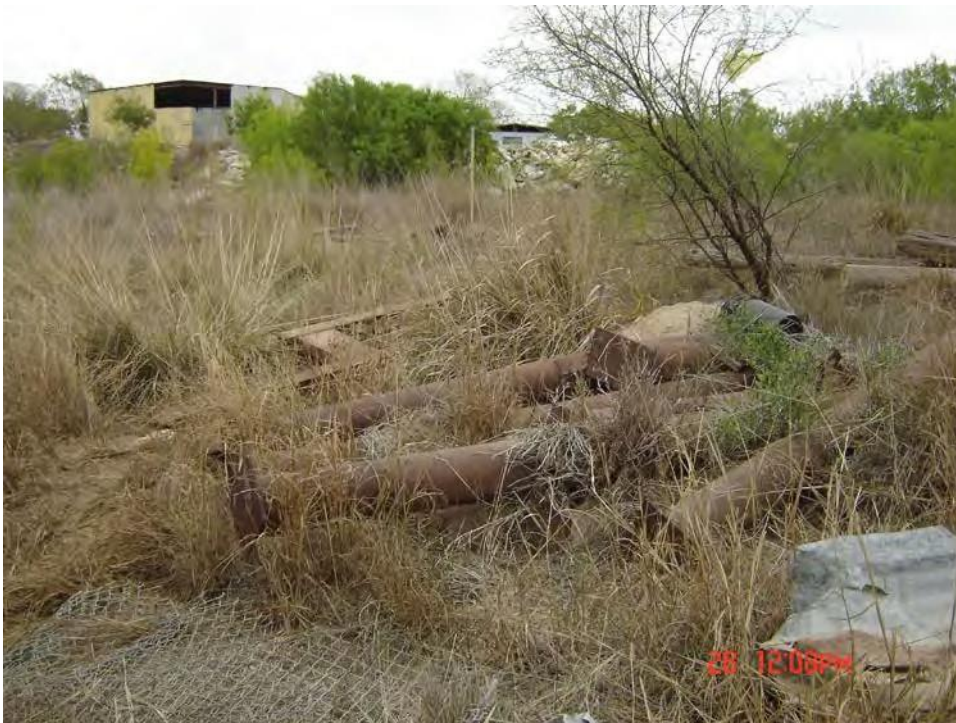
Stop 4. 28-Mar-2006, 11:00 a.m. Construction debris site owned by 3G Demolition. Near HW 83 Bridge.

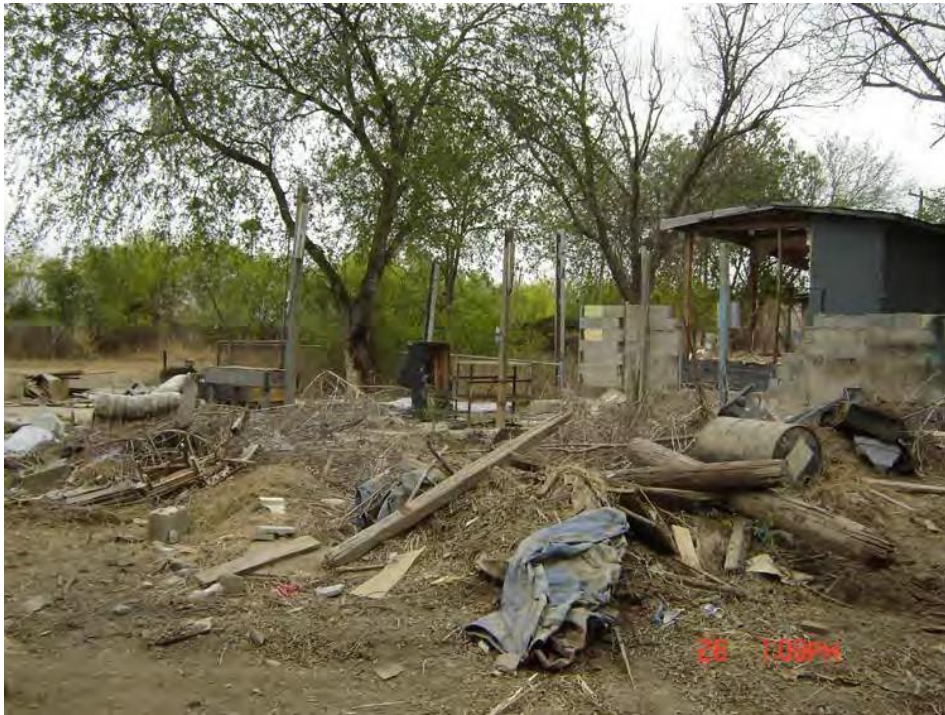
Stop 7a. 28-Mar-2006, 12:00 p.m. Active dump area north of HW 359. Torn down houses nearby.

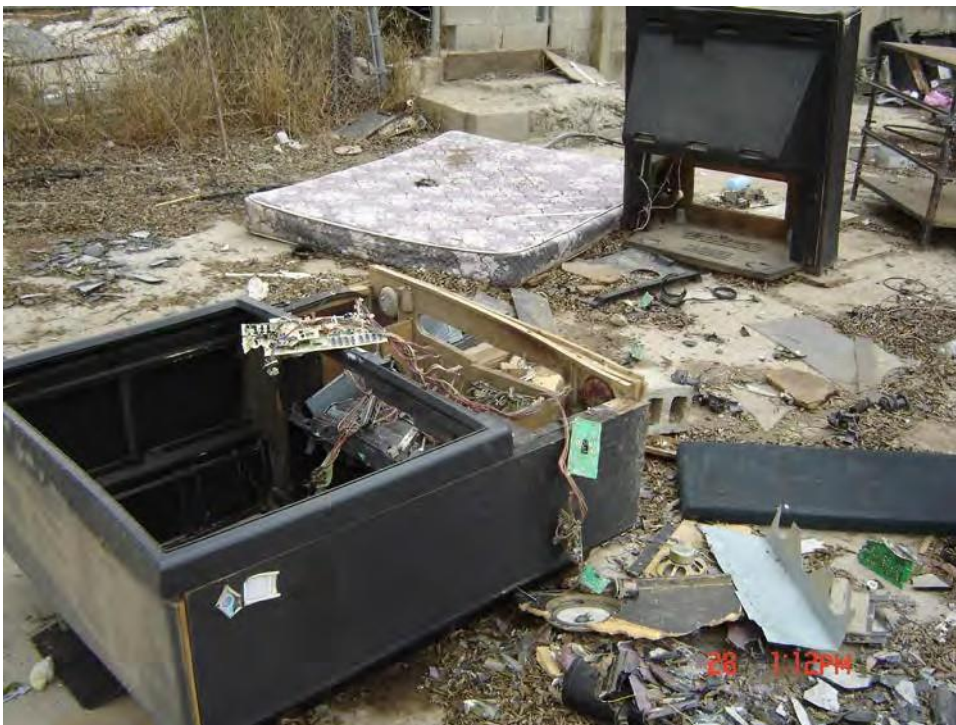
Stop 7b. 28-Mar-2006, 12:00 p.m. Discarded electronics litter the area.

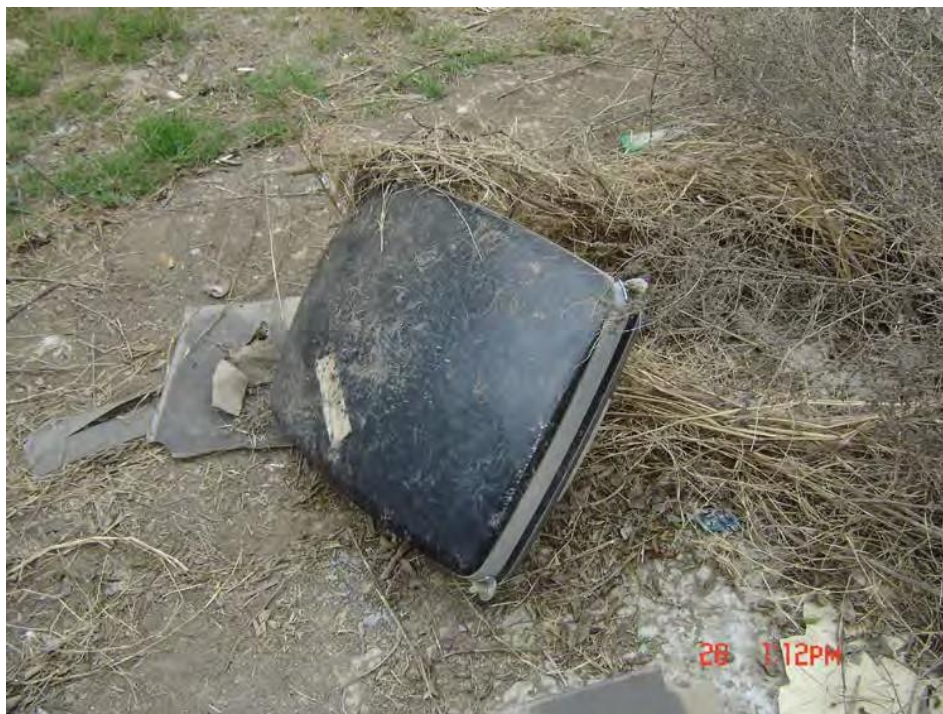
Stop 7c. 28-Mar-2006, 12:00 p.m. Discarded picture tube.

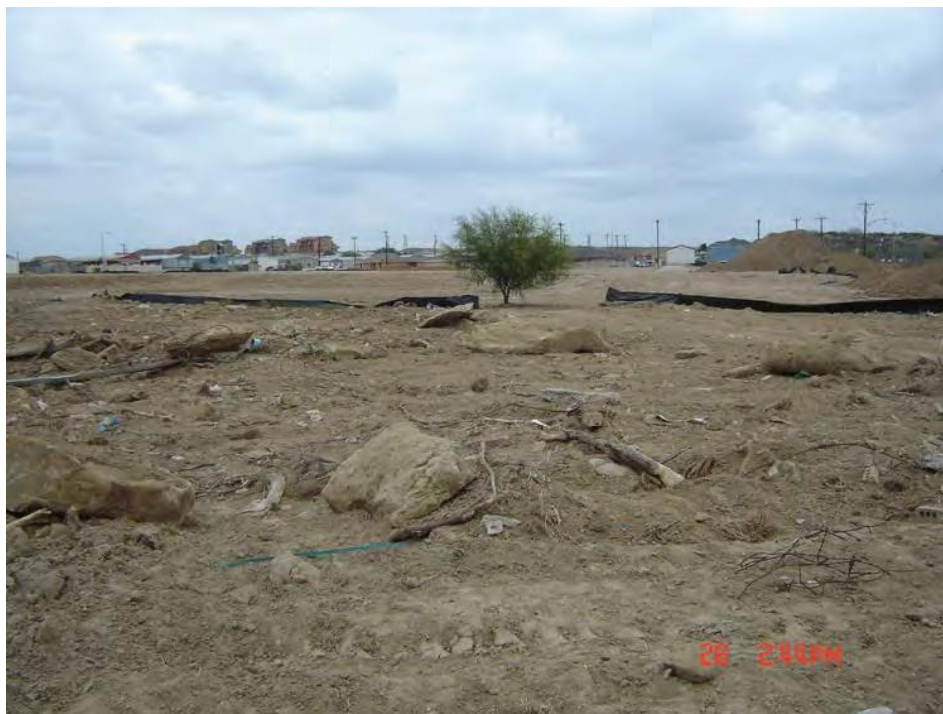
Stop 9. 28-Mar-2006, 1:40 p.m. Oil spill area from 2001 report (photo 11). Since then the drums and visibly contaminated soil were removed.

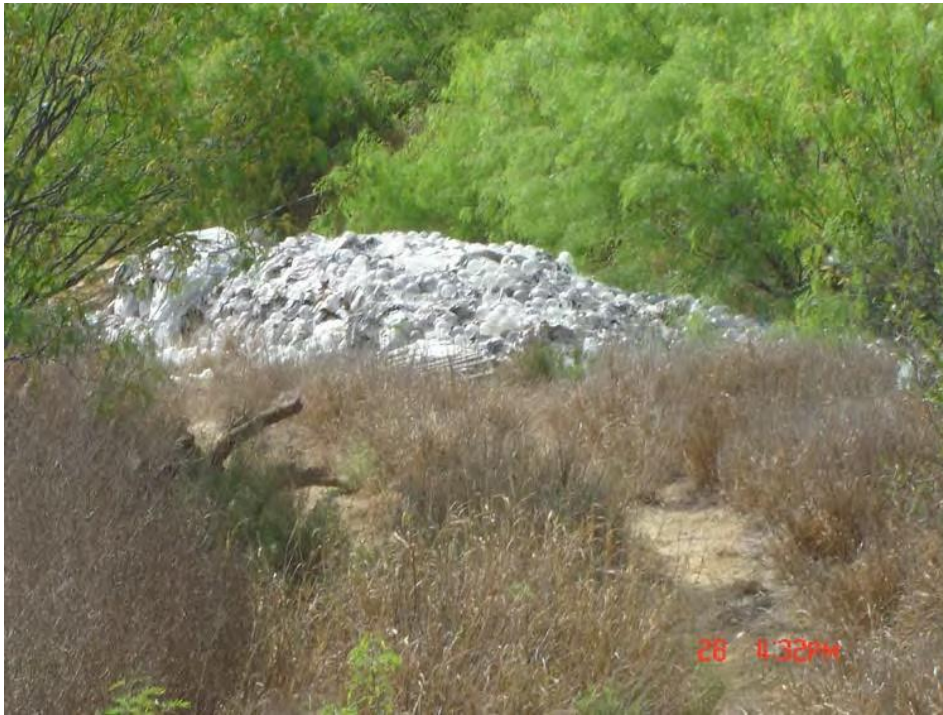
Stop 11a. 28-Mar-2006, 3:00 p.m. Dump area near backside of Homeland Security building.

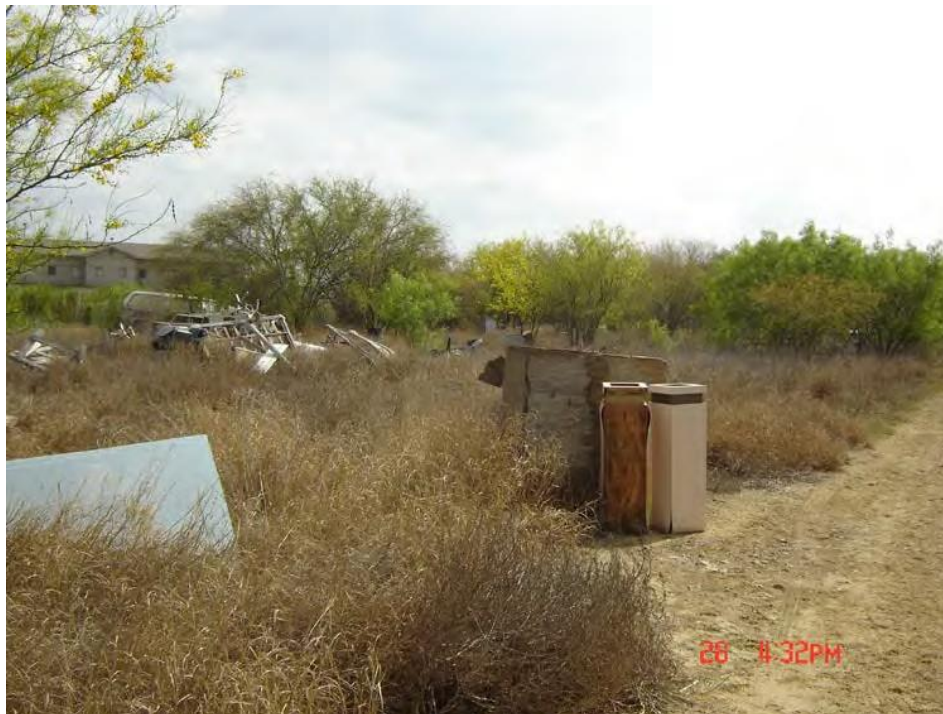
Stop 11c. 28-Mar-2006, 3:00 p.m. Dump area continued.

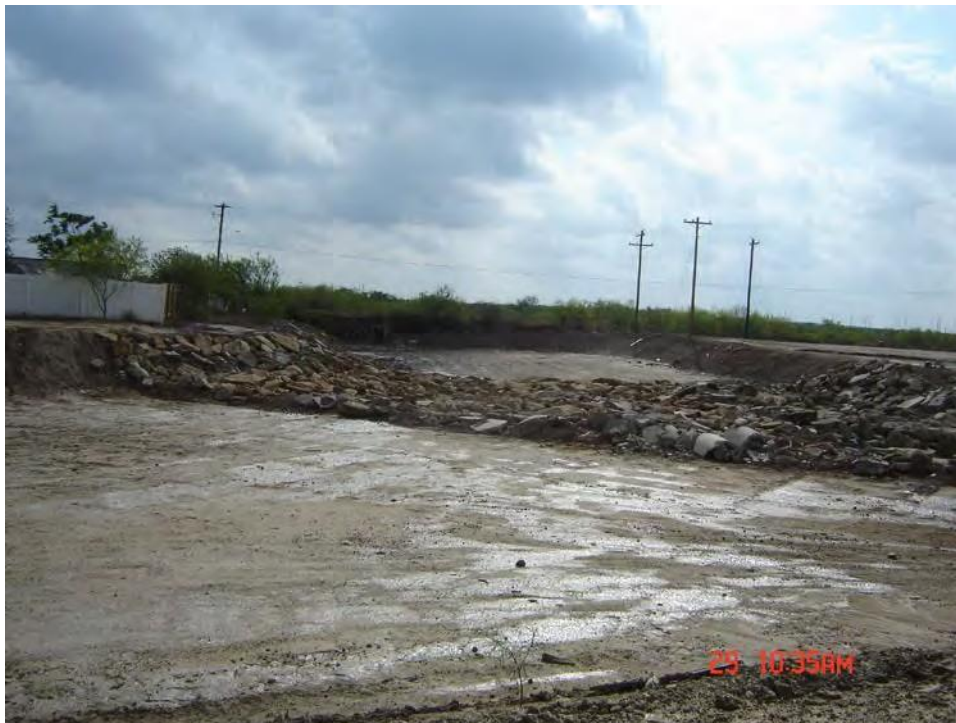
Stop 12a. 29-Mar-2006, 9:30 a.m. Tributary to Chacon Creek off Casa del Sol Blvd. Channel has been widened. Mobile home park on both sides.

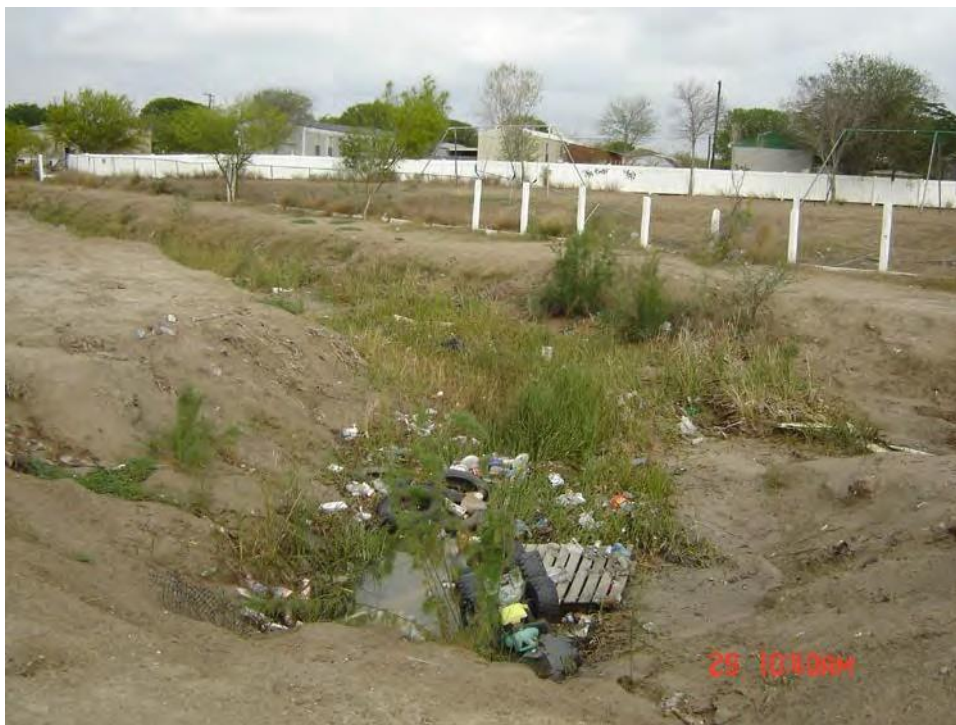
Stop 12c. 29-Mar-2006, 9:30 a.m. Tributary to Chacon Creek off Casa del Sol Blvd continued. Further downstream channel narrows and trash is present.

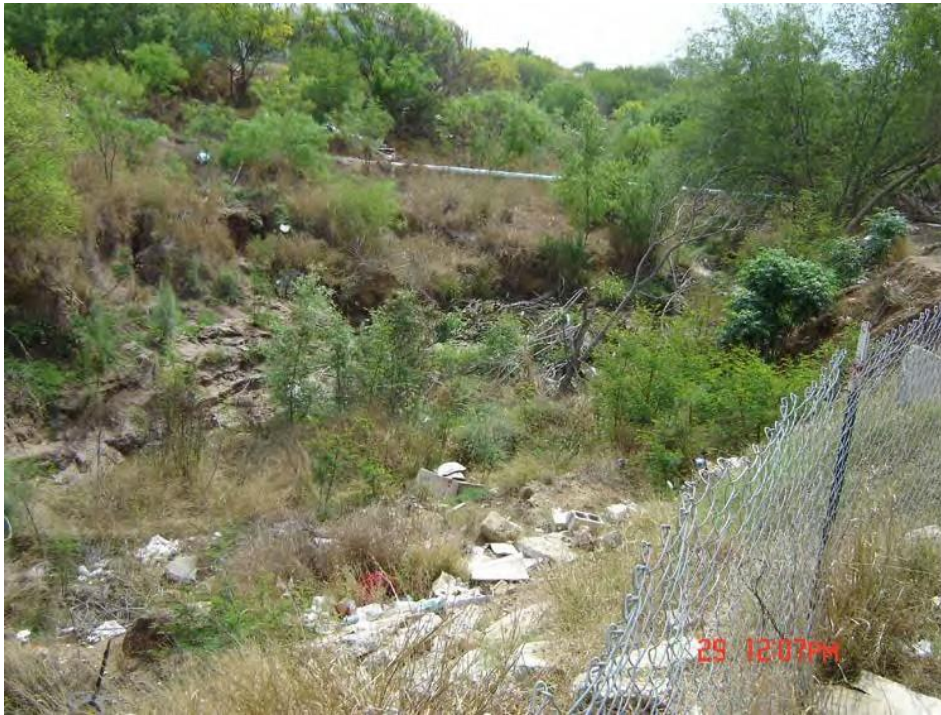
Stop 16. 29-Mar-2006, 11:00 a.m. Southern most tributary into Chacon Creek. Construction debris and trash along channel. Further upstream this tributary flows underground through an older neighborhood.
