Subj: DRINKING WATER LEAD SAMPLING RESULTS AT IKEGO ELEMENTARY SCHOOL

Overview of Testing Results for Lead in Drinking Water and Corrective Actions for Fleet Activities Yokosuka Ikego Elementary School *(*Building 824)

Sample Summary Results Table
Priority Areas Lead Testing and Corrective Actions (July 2022)
FLEACT Yokosuka - Ikego Elementary School Building 824

Floor Plan - Ikego Elementary School (Building 824)

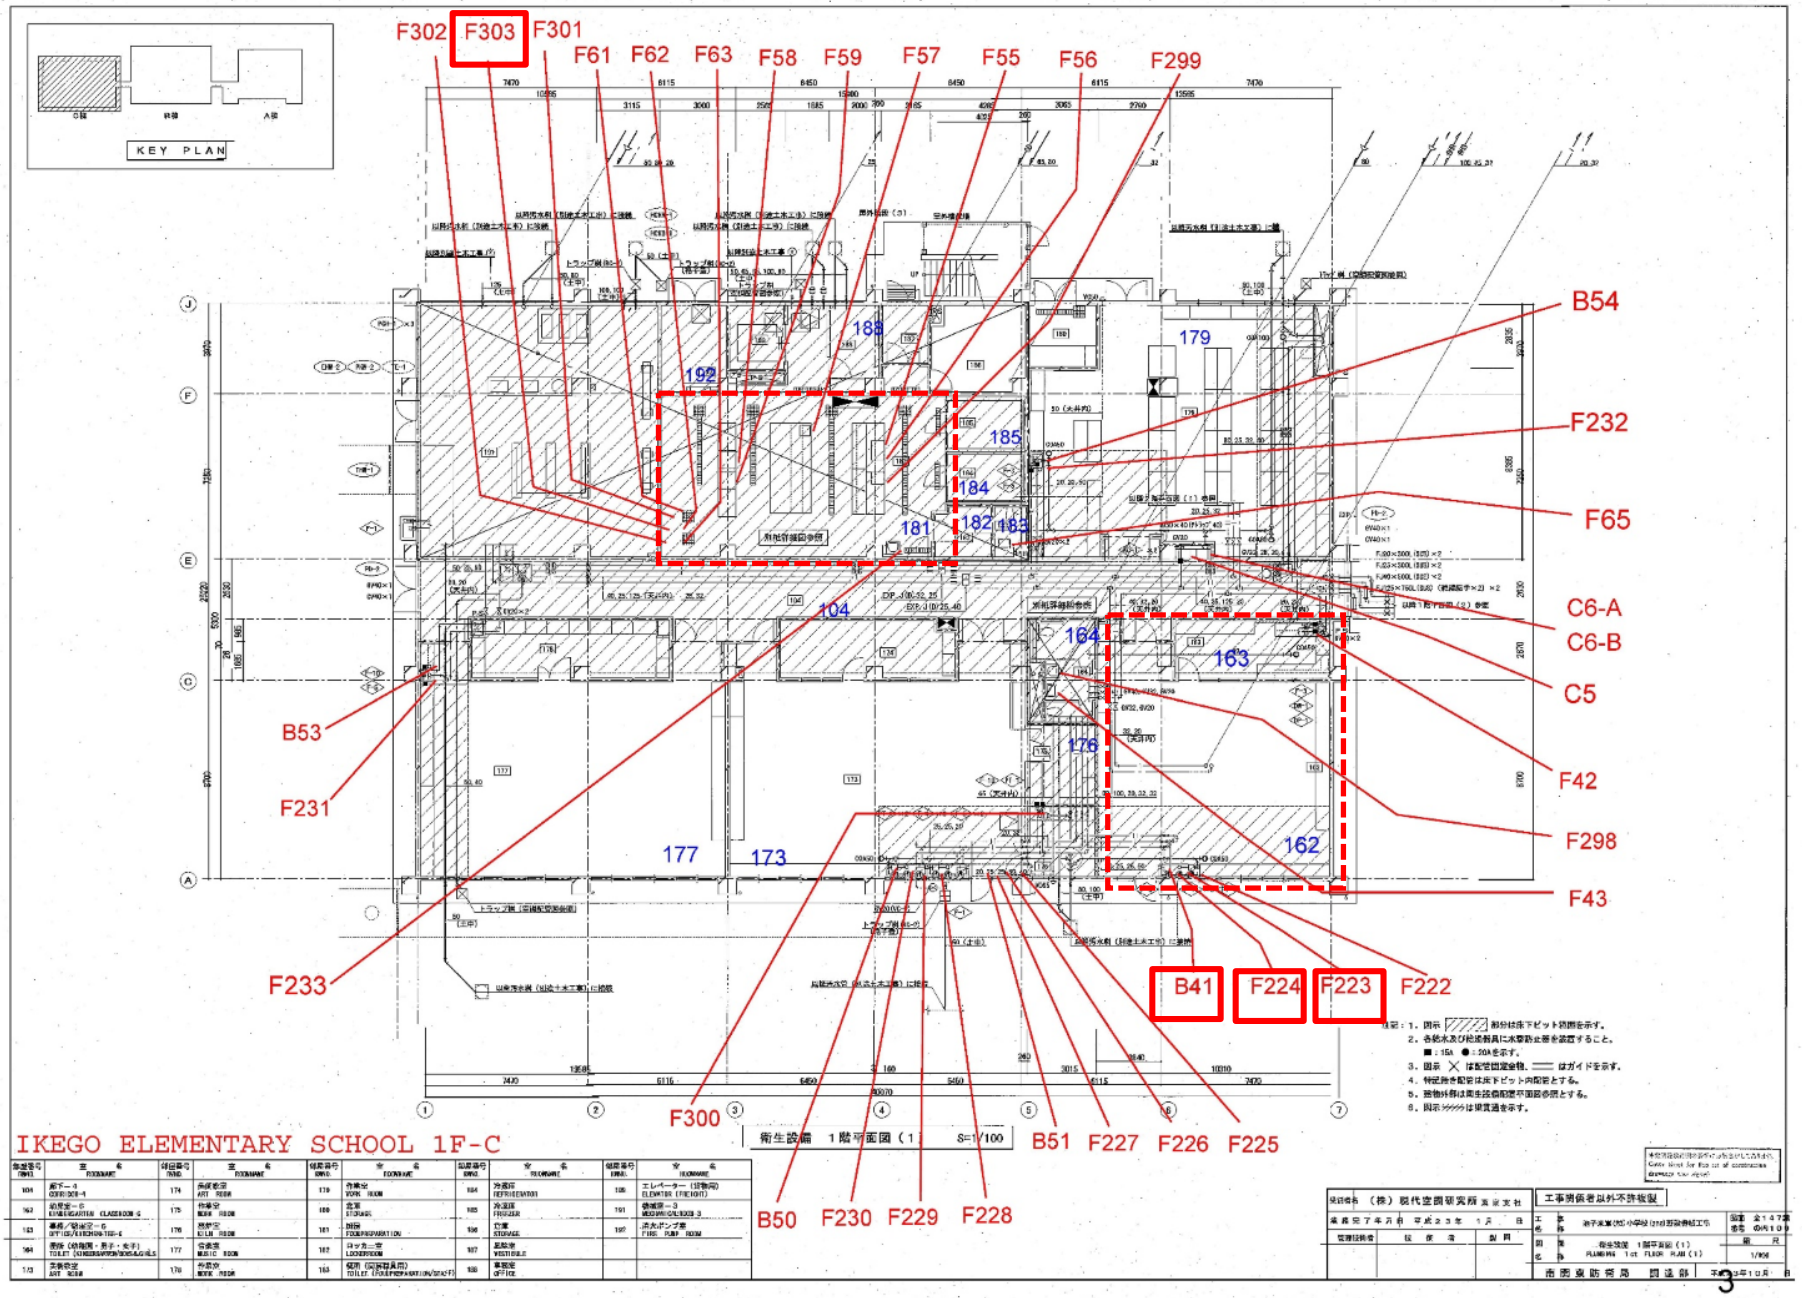
One (1) outlet that exceeded the screening level of 15 ppb was a faucet used for cleaning, located in room **181 (Kitchen)**, which tested at 26 ppb. The outlet was flushed and resampled. Follow-up sampling indicates that this outlet is below the screening level. Although, this outlet was installed for cleaning purposes and is not used for consumption, the outlet will be replaced with a certified lead free outlet.

Two (2) hand washing outlets that exceeded the screening level of 15 ppb were motion sensor faucets located in room **162 (Care Room)**, which tested at 29 ppb and 48 ppb, respectively. One (1) motion sensor faucet in room **320 (Classroom 1)** initially tested at the screening level of 15 ppb. Out of an abundance of caution, follow-up sampling was conducted and results provided confirmation that the outlets exceeded the 15 ppb screening level. Based on follow up results, elevated levels in motion sensor faucets appear to be caused by components of the faucets. Supply valves to these faucets were closed and new certified lead free motion sensor faucets will be installed.

The remaining two (2) outlets that exceeded the screening level of 15 ppb were bubbler water fountains located in rooms **162 (Care Room)** and **225 (Recess Room)**, which tested at 19 ppb and 35 ppb, respectively. Since follow-up testing indicated that the elevated levels of lead appeared to be caused by the components of the bubbler water fountains, the supply valves to these fountains were closed. New lead free certified bubbler water fountains will be installed.

The supply valves to outlets that exceeded the screening level of 15 ppb will remain secured rendering them unusable. Per EPA guidance, these outlets will remain out of service until corrective actions are completed. Testing will be conducted after implementation of corrective measures.
