Report No. DODIG-2012-132 September 14, 2012

Project Planning Resulted in Outstanding Building Deficiencies and Decreased Functionality of the Main Fire Station at Naval Station Great Lakes

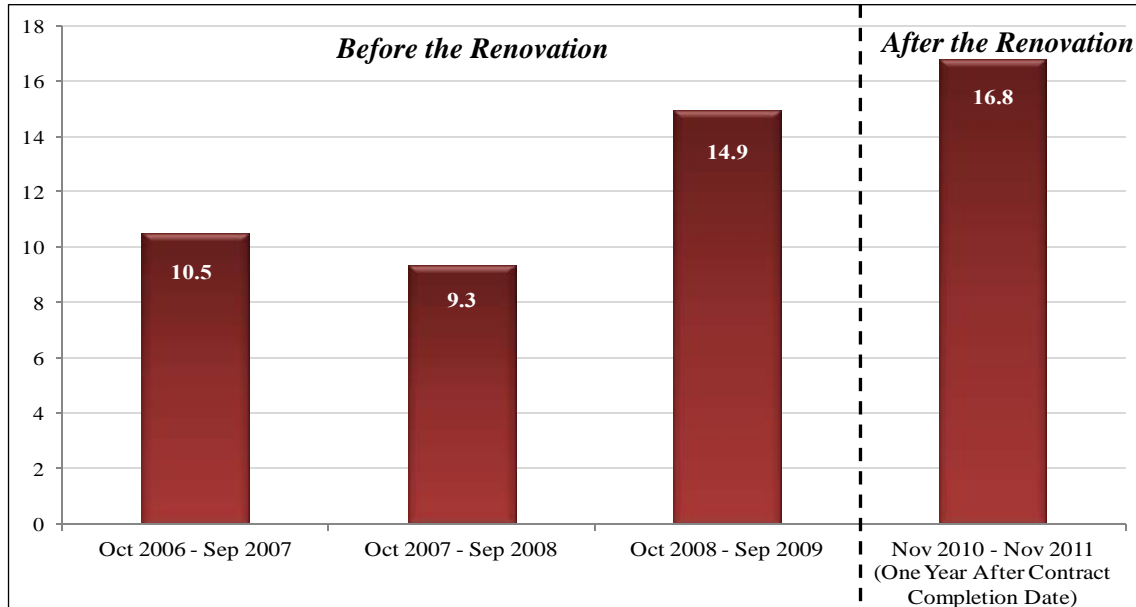
**Figure 6. Average Number of Monthly Maintenance Requests*
for the Fire Station**

We evaluated the average number of monthly maintenance requests before and after the renovation and determined that the average number of monthly maintenance requests increased after the contractor completed the renovation. Post-renovation maintenance logs identified repetitive problems occurring throughout the fire station, including problems with pest control, electricity, plumbing, and HVAC, as well as water leaking from the roof of the fire station. Figure 6 (on page 20) displays the average monthly number of the maintenance requests before and after the renovation.

As shown in Figure 6, the average number of monthly maintenance requests recorded after the renovation was higher than the average number of monthly maintenance requests for any of the 3 years before the renovation. Additionally, the average number of monthly maintenance requests for the 1 year after the renovation increased 13 percent, when compared to the year before the contract start date. Consequently, even after spending \$5.48 million on the renovation project, the Navy had to invest additional funds to address increased maintenance requests.
