DODIG-2015-013

U.S. Department of Defense

Military Housing Inspections – Republic of Korea

October 28, 2014

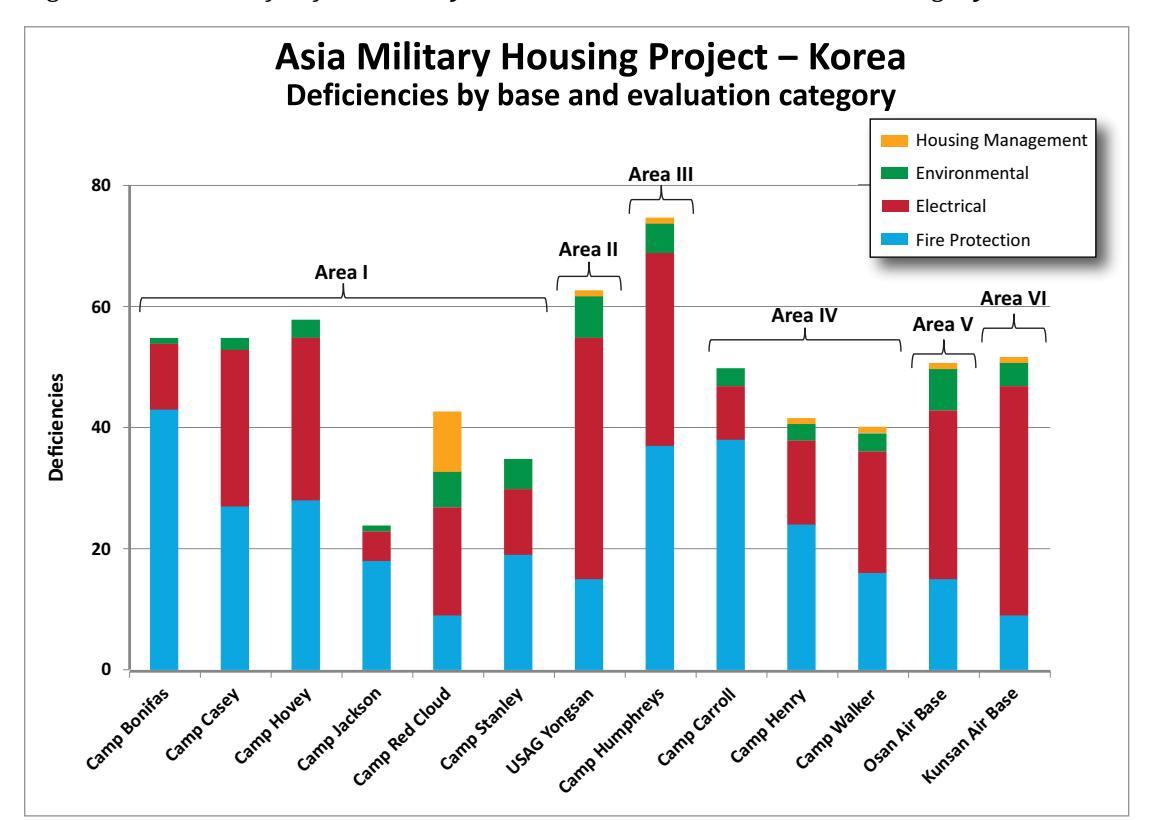
Figure 2. Number Of Deficiencies By Base Installation And Evaluation Category

housing policies. Figure 2 shows deficiencies in the four evaluation categories. Based on our radiation measurements, the estimated individual annual doses at each USFK installation were very low. At these levels, there are no demonstrable radiation-induced health effects.

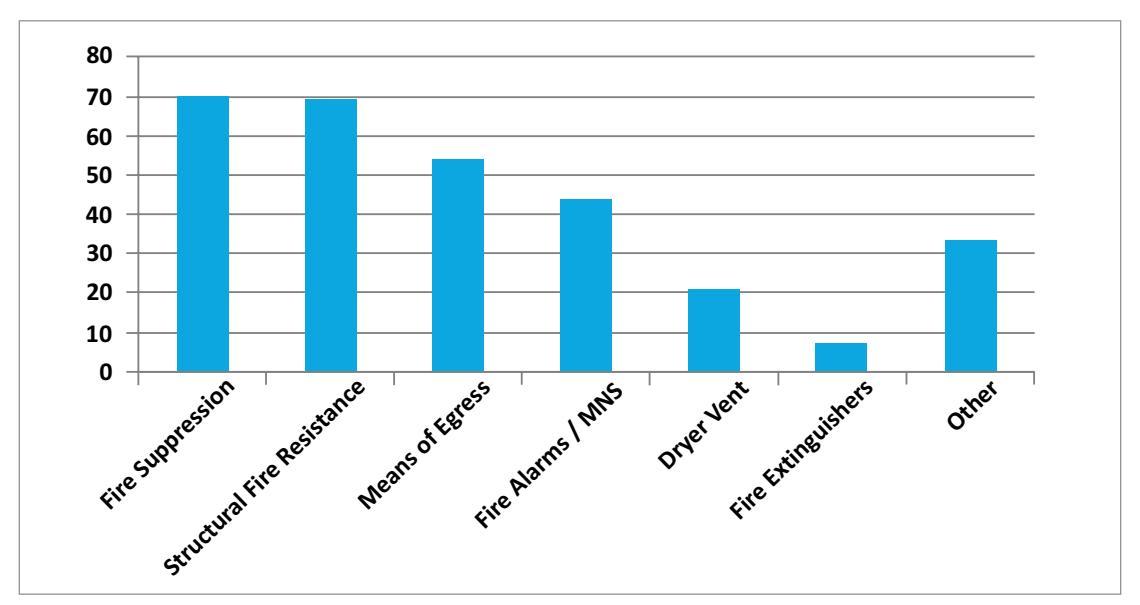
Figure 12. Fire Protection Deficiencies

We found deficiencies in the fire suppression systems throughout installations in Korea. For example, many buildings had sprinkler systems that were broken, not maintained, improperly installed, or missing altogether. In the area of structural fire resistance, we found fire doors that were propped open, damaged, not rated, or were missing closers. We also found deficiencies in the means of egress. For example, many buildings did not have adequate emergency lighting in the fire escape stairways and hallways. Fire alarm deficiencies included missing carbon monoxide detectors and missing or broken fire alarms. Dryer vent transition ducts were bent, crushed, disconnected, pinched, or clogged and were not constructed of fire rated material. We found a lack of periodic inspection of fire extinguishers, many with low levels of extinguishing agent. Other deficiencies were items stored in prohibited locations, heating oil leakage in areas where ignition is probable, and excessive lint build-up in laundry rooms. These deficiencies increase the risk of fire, loss of life, and property.

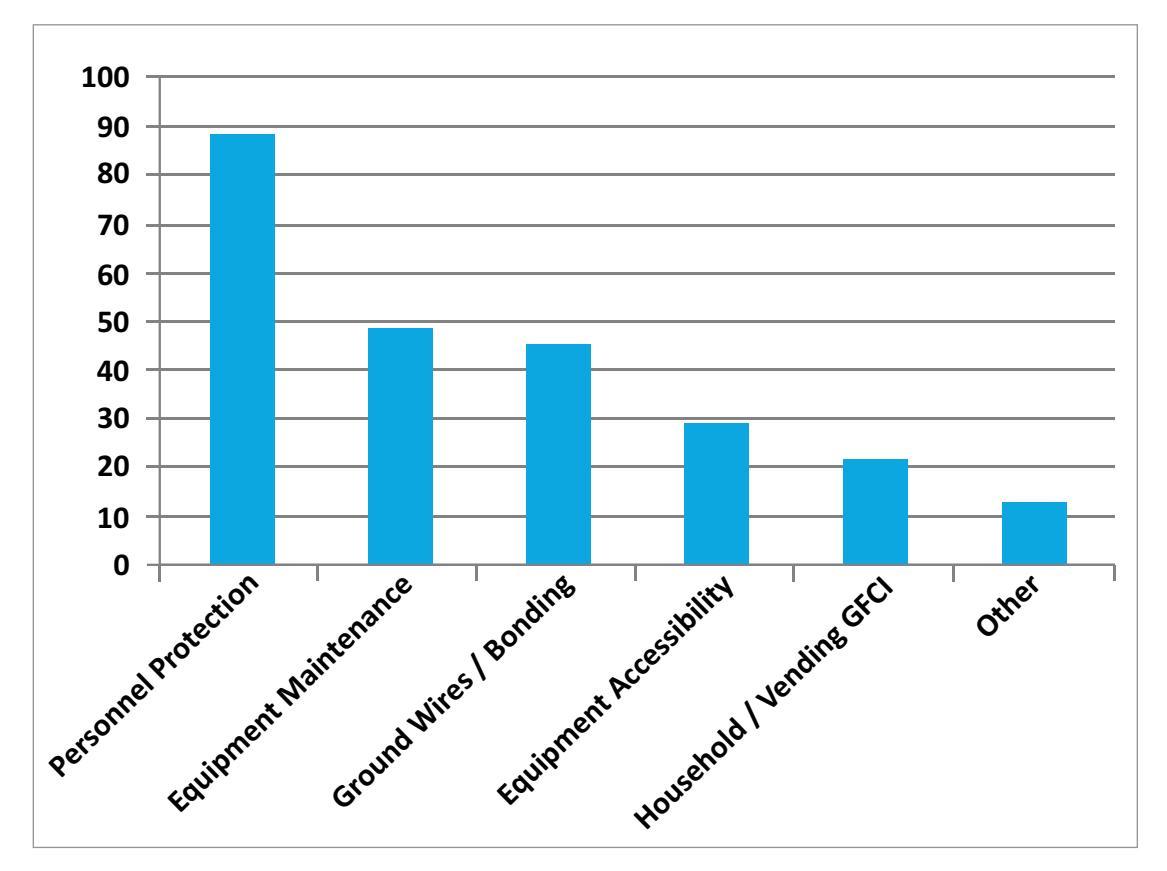
Figure 13. Electrical Deficiencies

Personnel protection deficiencies included exposed wires not contained or protected by junction boxes in mechanical rooms, missing electrical service panel breaker blanks or broken electrical covers, incomplete or broken electrical conduits, missing light fixture covers in damp and wet locations and within reach of personnel in the shower, and missing knockout seals and covers in a junction box. In the area of equipment maintenance, we found electrical service-drop conductors providing electricity to the main electrical panel of the house that were too low, corrosion on junction boxes, and many buildings being served by multiple service drops. Also, we found inadequate or nonfunctioning climate control for electrical rooms and equipment. Ground wires/bonding issues included unbonded main electrical panels, and water circulating pumps with disconnected ground wires. Equipment accessibility deficiencies included junction boxes and electrical panels that were obstructed and inaccessible. We found lack of GFCI protection in laundry rooms, outside areas, vending machines, and water coolers. Other deficiencies included electrical panels with missing or incorrectly labeled directories, incorrect fittings being used to connect a conduit, and receptacles wired for incorrect voltage. These deficiencies create a risk of fire, electric shock, or electrocution for installation personnel and occupants.

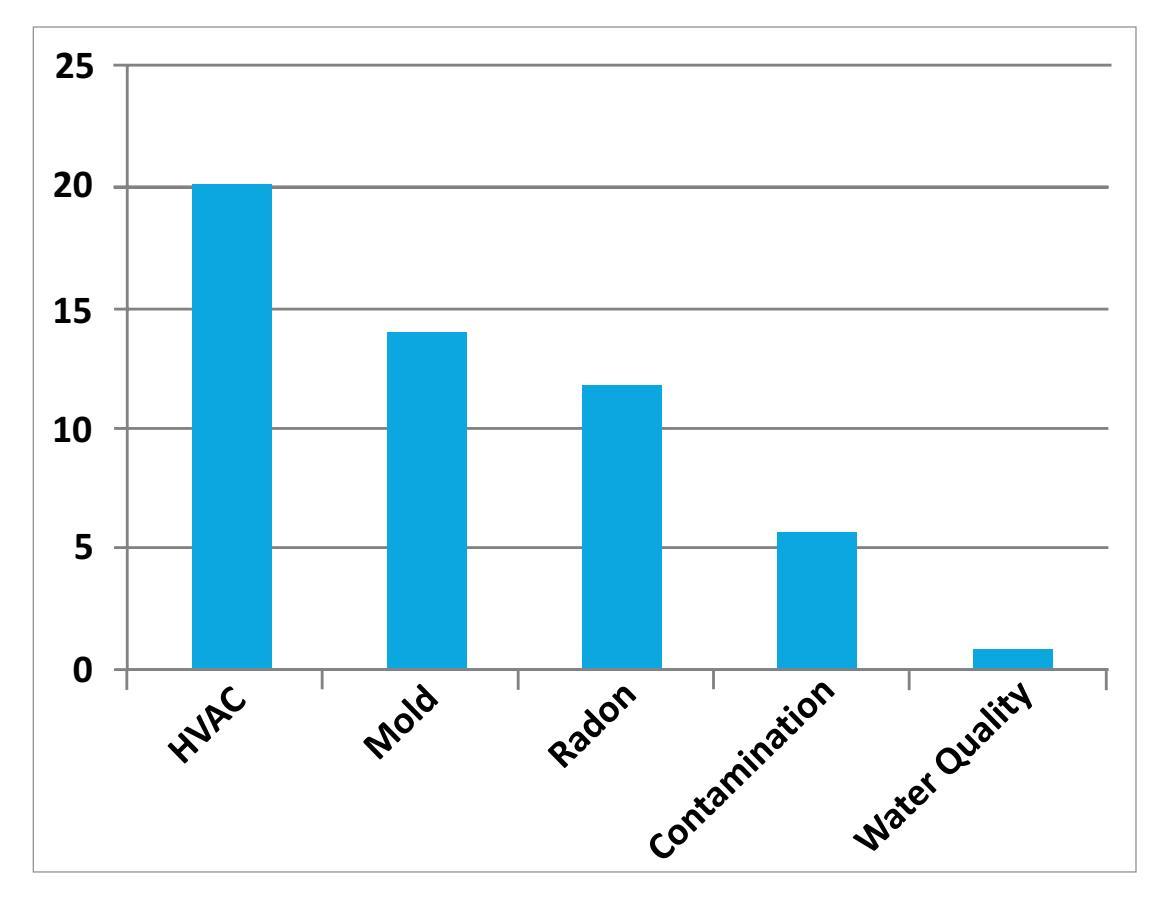
Figure 14. Environmental Health and Safety Deficiencies

We found a lack of properly maintained HVAC units, fan coil units, filters, and plumbing system pipes. Air handling units (AHU) were broken and out of service for extended periods, which could allow moist air to enter the building through negative pressure and cause mold growth. In unaccompanied units, responsibilities were not clearly defined between building occupants and managers for operating and maintaining air handling system components in living quarters or for addressing water leaks and mold problems. In addition, there is no DoD-wide policy or guidelines on mold mitigation and control. Mold may increase the potential for respiratory illness and other mold and indoor air quality-related health issues.
