INSPECTOR GENERAL

SEPTEMBER 30, 2014

Military Housing Inspections – Japan

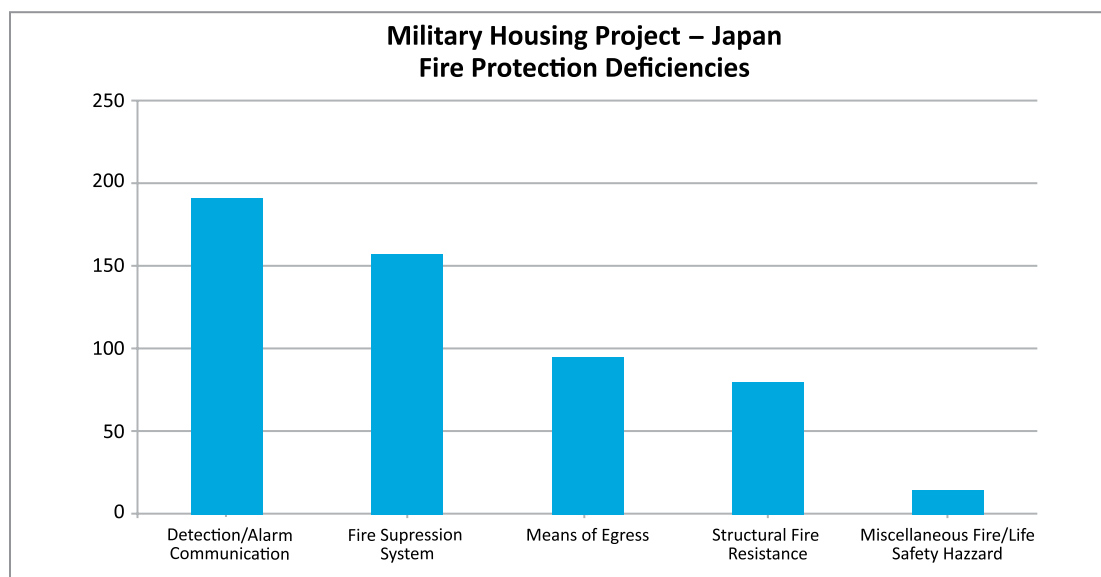
Figure 11. Fire Protection Deficiencies

We identified inadequate detection, alarm, and communication systems throughout installations in Japan. For example, smoke alarms and detectors were not installed in most sleeping rooms. Several buildings with fire alarm control systems were out of service, lacked periodic testing, or could not monitor or detect the disconnected smoke detectors. We identified inadequate fire suppression systems that were missing important components such as standpipe riser locks and sprinklers. Many buildings did not have operational identification signs and emergency lighting in the fire escape stairways and hallways. Lastly, fire doors

in housing units did not automatically close or latch to separate the exit access corridor from the laundry rooms, sleeping rooms, and lounges. These deficiencies pose a risk that an uncontrollable fire will result in loss of life and property. Inadequate signage and emergency lighting can result in delayed evacuation or emergency response time, increasing the risk of injury or death to the occupants.

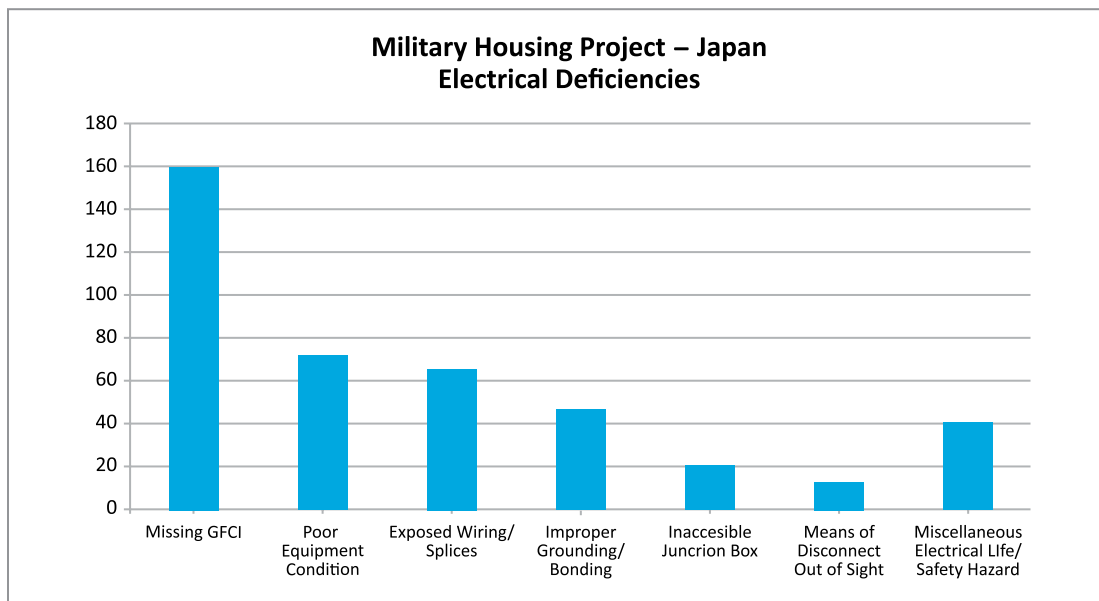
Figure 12. Electrical Deficiencies

Some GFCIs were incorrectly installed or missing. The lack of repair and maintenance was evident by broken or missing shower light fixture covers and improperly weatherproofed outdoor electrical boxes. In several buildings inspected, energized wiring and splicing was exposed. We identified noncompliant grounding and bonding that included open ground circuits on receptacles. Junction boxes were obstructed and inaccessible. Electrical disconnects were not located in sight of the powered unit. Lastly, we identified low-hanging electrical service-drops providing electricity to the main electrical panel of the house. These deficiencies pose an electrocution hazard for installation personnel and occupants.

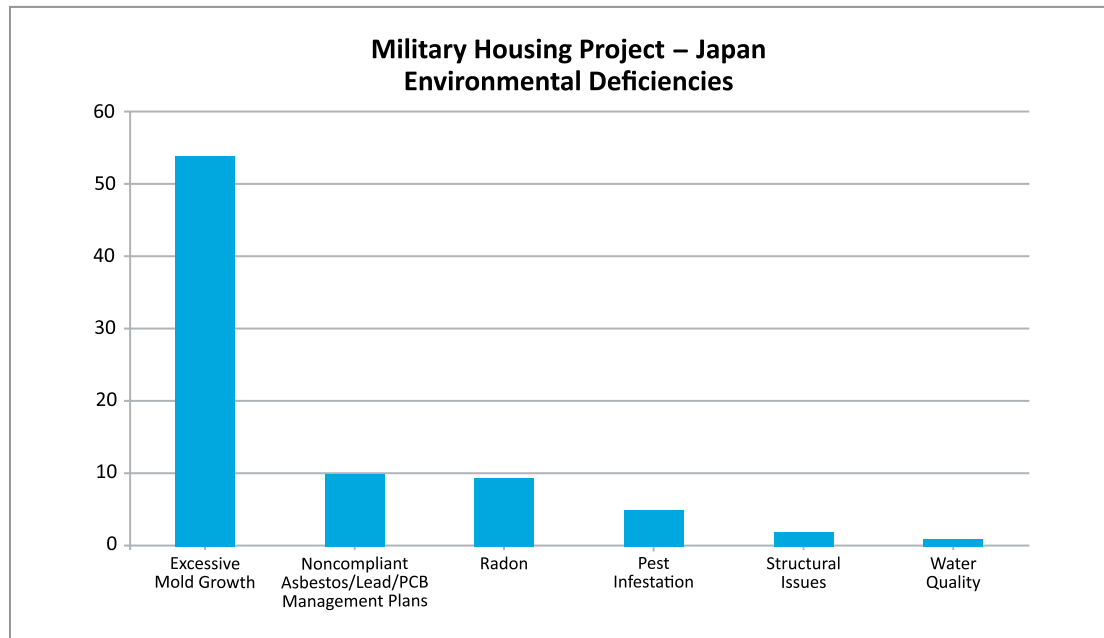
Figure 13. Environmental Health and Safety Deficiencies

We identified excessive mold growth in occupied buildings. When mold issues were identified, rarely was the source of water intrusion addressed. In addition, there is no DoD-wide policy or guideline on mold mitigation and control. We found that most installations had adequate asbestos and lead-based paint hazard management programs. However, some installations had not updated their inventories to identify materials with more than 0.1 percent asbestos content per the latest asbestos-containing material standards (refer to JEGS, Section C15.2.3). In addition,

lead-based paint inventories did not include newly constructed buildings or buildings that had been modified. Water quality was in compliance with JEGS. Lastly, pest infestation and poor eradication and control were evident in some occupied buildings.

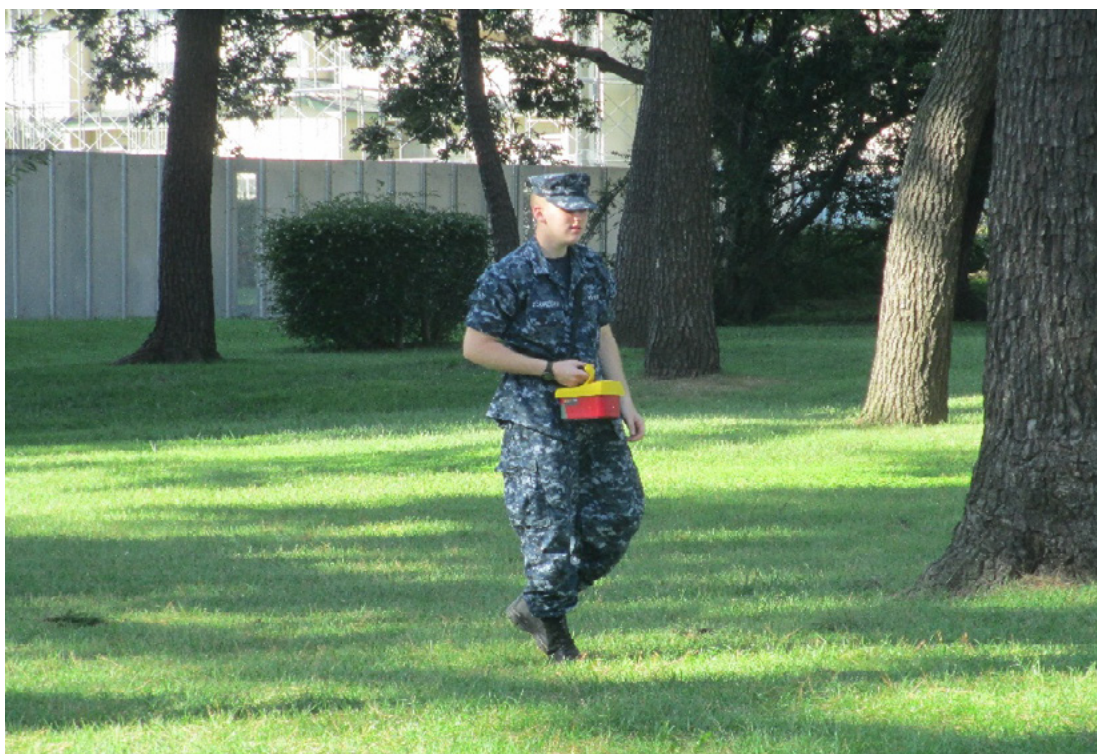
Figure 15. Scanning survey of park area, NAF Atusgi
Source: DoD OIG
