INSPECTOR GENERAL

SEPTEMBER 24, 2015

Continental United States Military Housing Inspections – Southeast

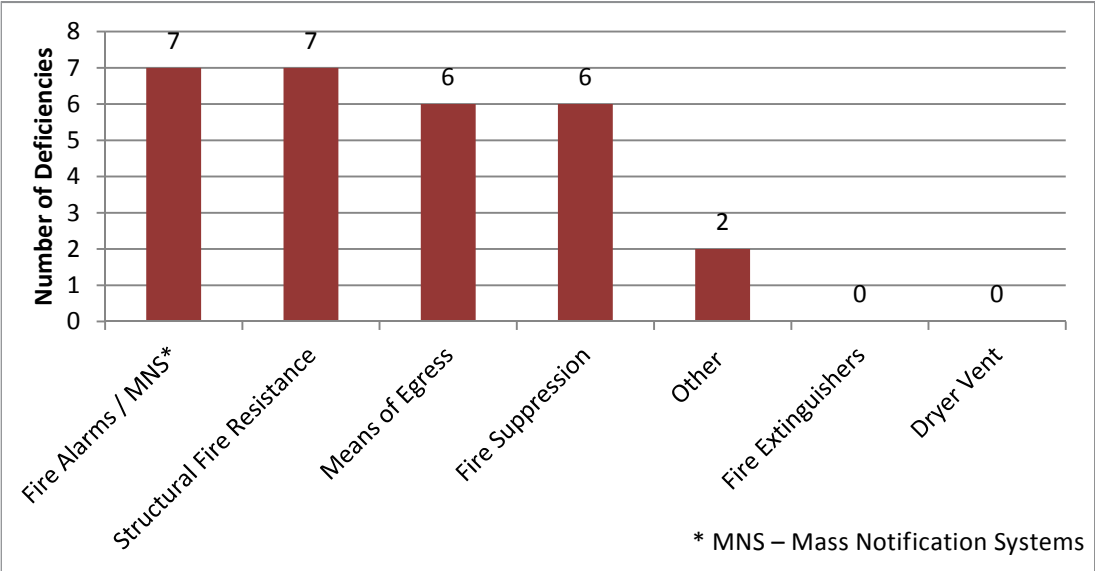
Figure 2. Patrick AFB Fire Protection System Deficiencies by Category

At Patrick AFB, we documented a total of 28 deficiencies (see Figure 2) related to fire protection and fire suppression systems: 17 in family housing units and 11 in the unaccompanied housing building.

The majority of the deficiencies discovered in accompanied housing units at Patrick AFB were related to problems with structural fire resistance, means of egress, and smoke alarms. We found numerous instances of disabled or otherwise ineffective self-closing fire doors separating garages from living spaces, door locks and latches that could potentially trap children in closets and enclosed patios in the event of an emergency, and improperly installed and maintained stairway handrails. Our inspection team also identified that all homes inspected throughout the River’s Edge neighborhood lacked smoke alarms in their bedrooms⁶ in addition to a few issues related to incorrectly located carbon monoxide detectors and

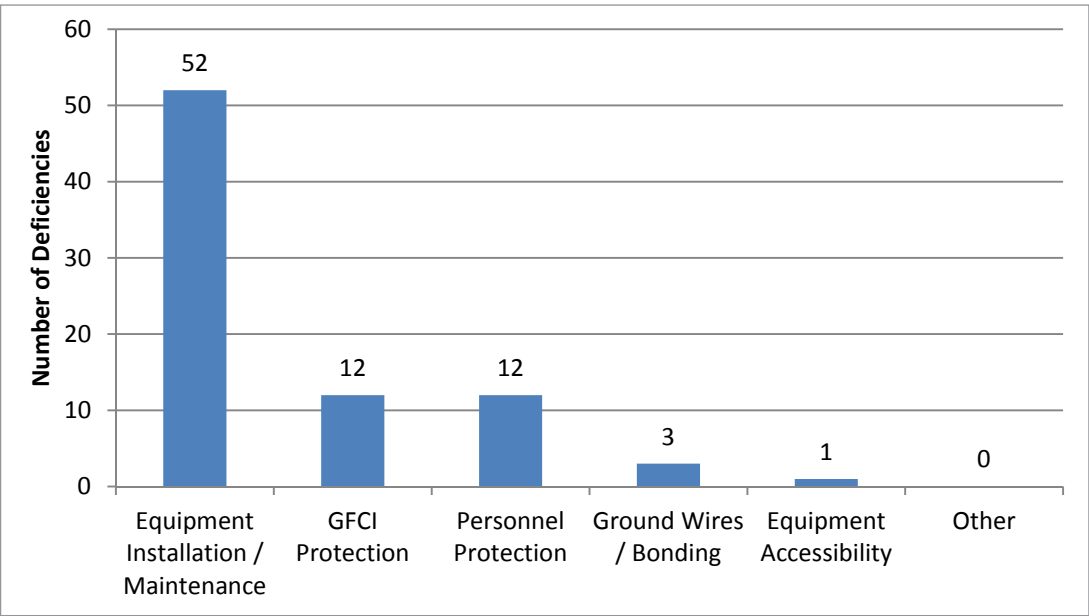
Figure 7. NS Mayport Electrical System Deficiencies by Category

Our team identified a total of 80 electrical system safety deficiencies (Figure 7) at NS Mayport: 35 in family housing units and 45 in the unaccompanied housing facilities. The majority of deficiencies found in both family housing units and the unaccompanied housing facilities were related to equipment installation/maintenance, GFCI protection, and personnel protection.¹³

In family housing units, we found numerous problems with electrical receptacles, including instances of defective wiring, incorrectly secured and loose receptacles, unprotected wall openings, and broken or improperly installed receptacle faceplates. Several electrical conduits and junction boxes were unsupported and unsecured. Additionally, we identified several outdoor electrical receptacles

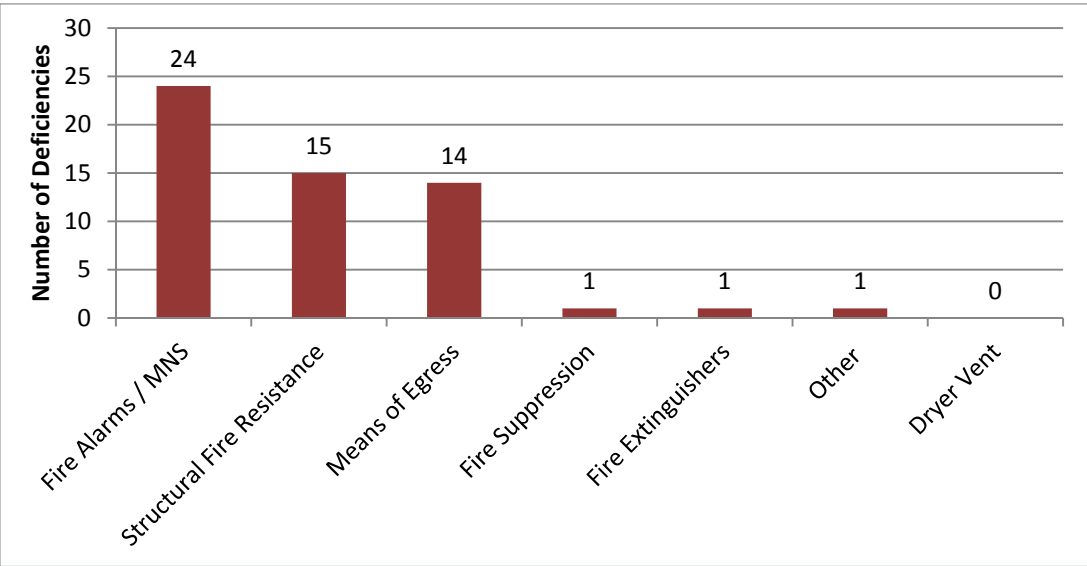
Figure 10. Fort Gordon Fire Protection System Deficiencies by Category

At Fort Gordon, we documented a total of 56 deficiencies (Figure 10) related to fire protection and fire suppression systems: 6 in family housing units and 50 in the unaccompanied housing facilities (including 13 deficiencies associated with the previously discussed NOC).

In family housing units at Fort Gordon, we discovered a few locations that lacked the required carbon monoxide detectors and one home that was missing smoke alarms in all of its bedrooms. We also found a few smoke alarms with dead batteries and disconnected hard-wired power. Inadequate fire alarm and notification systems greatly increase the occupants’ risk of injury or death in the event of an emergency.

In the unaccompanied housing facilities, we also found numerous deficiencies related to fire/smoke detection, alarm, and mass notification systems. For instance, we identified missing, obstructed, and nonfunctional fire alarm system

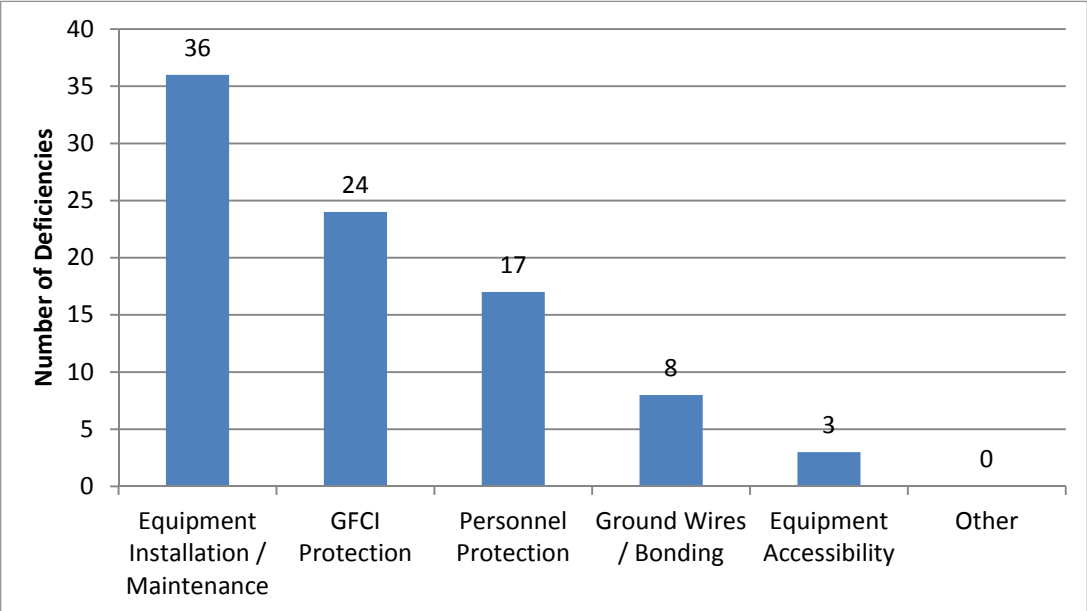
Figure 12. Fort Gordon Electrical System Deficiencies by Category

Our team identified a total of 88 electrical system safety deficiencies (Figure 12) at Fort Gordon: 9 in family housing units and 79 in the unaccompanied housing facilities. The majority of deficiencies found in both family housing units and the unaccompanied housing facilities were related to equipment installation/maintenance and GFCI protection.

The most significant issue we found was the ground conductors on light switches (see Figure 13) were not connected throughout the homes inspected in the Gordon Terrace, McNair Terrace, and Olive Terrace neighborhoods. In the event of a short circuit to the metallic light switch body, the ground conductor would prevent an individual from being exposed to potentially lethal voltages. We also identified problems with electrical receptacles and wiring as well as the lack of GFCI-protected receptacles in the kitchen areas of a few homes inspected.
