INSPECTOR GENERAL

JULY 7, 2016

U.S. Military-Occupied Facilities Inspection—King Abdullah II Special Operations Training Center

U.S. Military-Occupied Facilities Inspection— King Abdullah II Special Operations Training Center

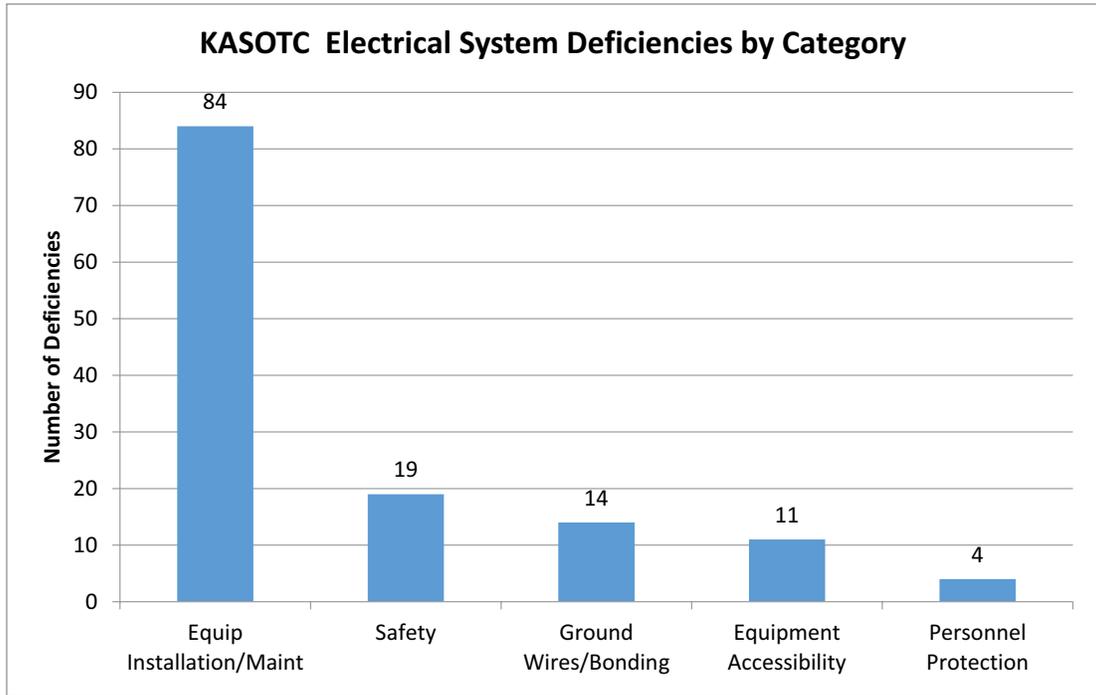
Figure 2. Electrical Deficiencies

We documented a total of 132 deficiencies (see Figure 2) related to electrical systems. Based on our evaluation, the deficiencies found were related to equipment installation and maintenance, safety, ground wires and bonding, equipment accessibility, and personnel protection, posing a risk of electrocution, injury, or death. The deficiencies included unprotected and exposed electrical wires and physically compromised lightning protection systems throughout KASOTC. The electrical systems also lacked equipment groundings and bonding jumpers at main service panels. In many instances equipment grounding was disabled or cut, suggesting a lack of proper knowledge and training of the local electricians contracted to perform installation and maintenance.

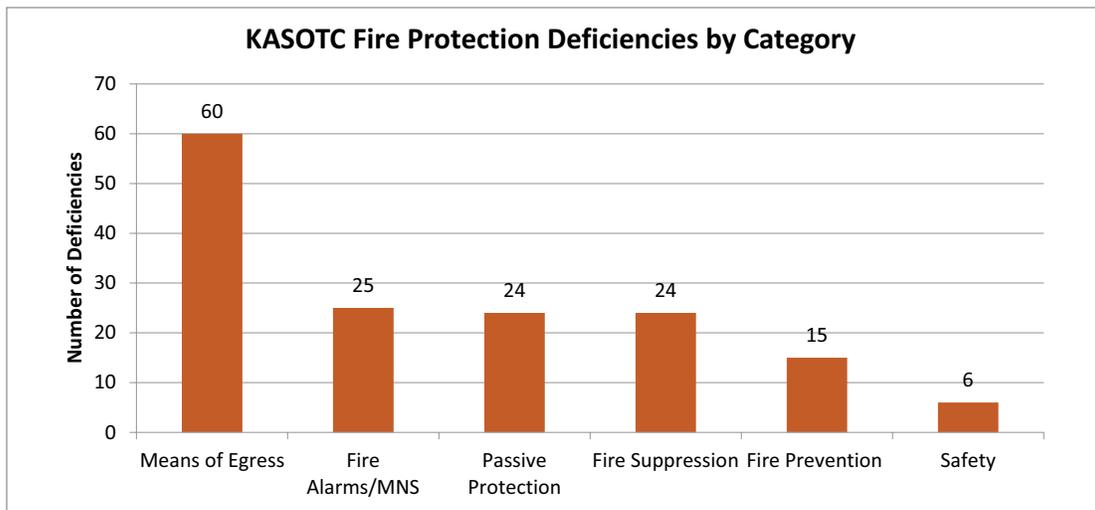
Figure 6. Fire protection deficiencies

We identified 154 deficiencies related to fire protection systems (see Figure 6). The majority of deficiencies found were related to the means of egress, passive protection, fire alarm and mass notification system (MNS), fire suppression, and fire prevention. These deficiencies in fire protection systems pose a significant risk of fire and loss of life or property.

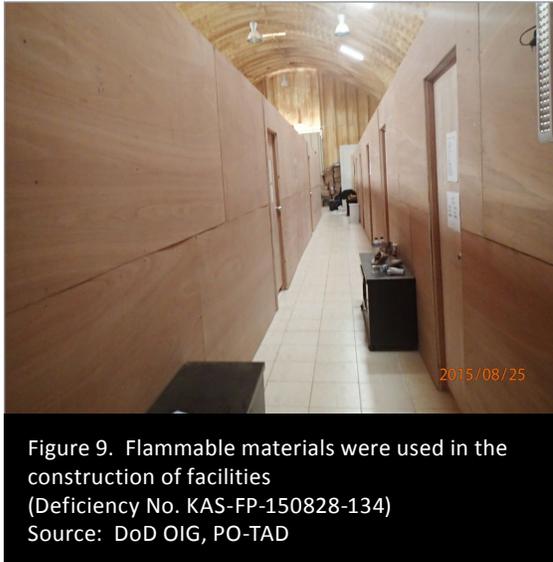
We found that four sleeping quarters had flammable foam insulation on the walls and ceiling that was not encapsulated, and that seven facilities had used non-fire-rated plywood to construct corridor walls and fire exit doors (see Figure 9). We burned a piece of the spray foam used on the walls and the ceiling and found that it produced a thick black smoke when burning. The use of flammable materials could compromise the means of egress through these corridors and could create toxic smoke in the event of a fire.

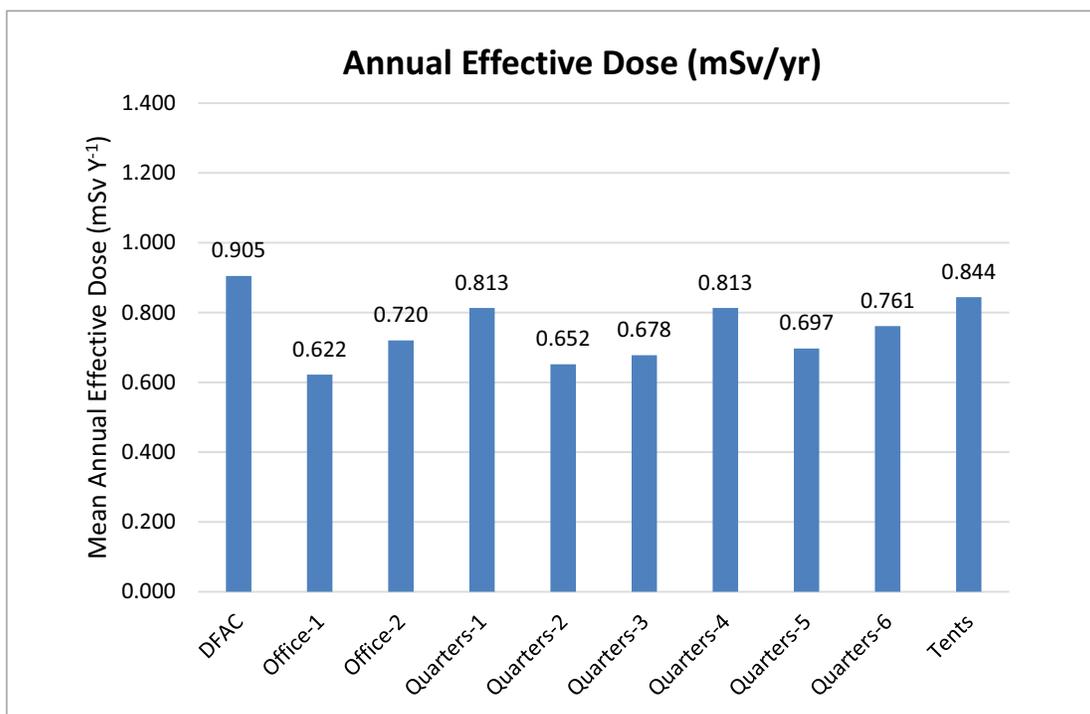
Figure 14. Estimated annual mean effective dose for individual at KASOTC

The determined annual mean effective dose values for each location inspected are shown graphically in Figure 14. Determined mean values were all less than a 1.0 mSv annual effective dose. The overall mean dose was determined to be 0.76 mSv. The results of this assessment suggest that the mean effective dose an individual receives from external background radiation in one year while assigned to KASOTC is less than 1.0 mSv. Currently, there are no regulatory dose limits from external, naturally occurring background radiation exposure.
