INSPECTOR GENERAL

JUNE 2, 2017

U.S.-Controlled and -Occupied Military Facilities Inspection – Camp Lemonnier, Djibouti

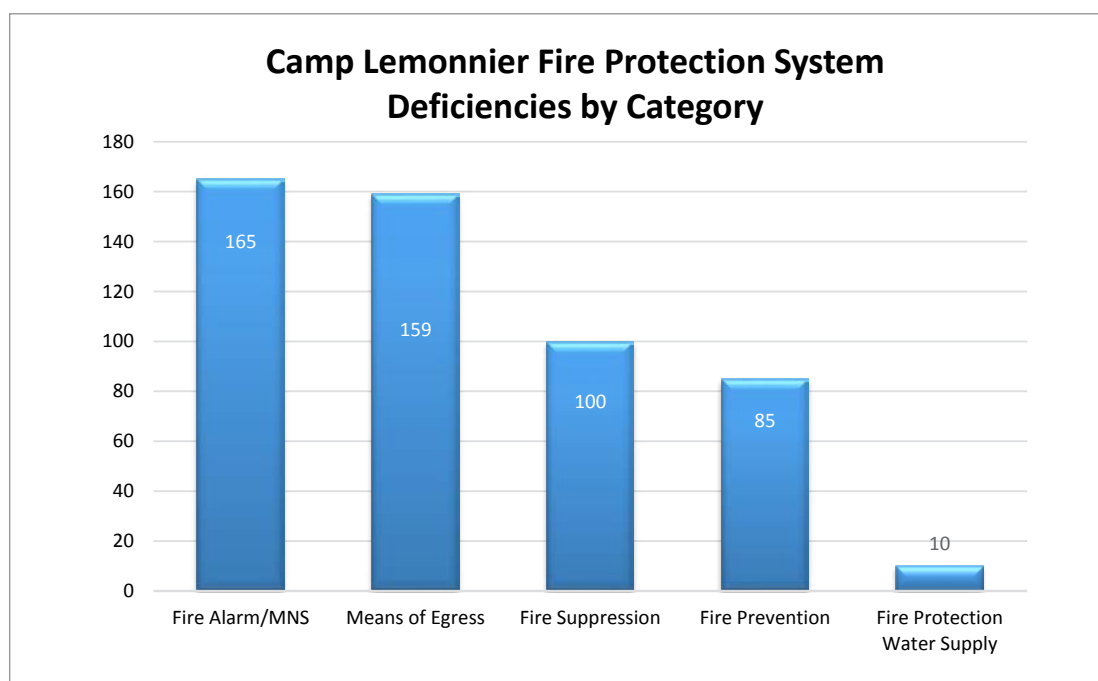
Figure 6. Fire Protection Deficiencies

We documented 519 fire protection deficiencies. The deficiencies found were related to fire alarm or mass notification, means of egress, fire suppression, fire prevention, and fire protection water supply. These deficiencies increase the risk of fire, injury, or death.
