United States
Coast Guard

FINAL ACTION FOR THE MAJOR INCIDENT INVESTIGATION REPORT ON THE VESSEL KOLINA SAR RESPONSE

Subj: MAJOR INCIDENT INVESTIGATION (MII) INTO THE SAR RESPONSE ON 5
NOVEMBER 2015 APPROXIMATELY 20 NM SOUTH OF MAUI INVOLVING
THE SAILING VESSEL KOLINA AND ONE FATALITY

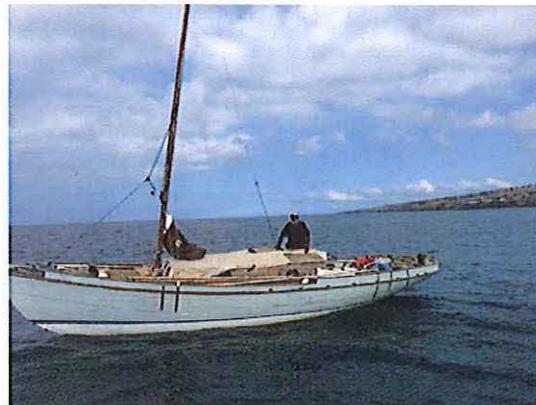
Figure 1: KOLINA and Mishap Victim (Exhibit 79)

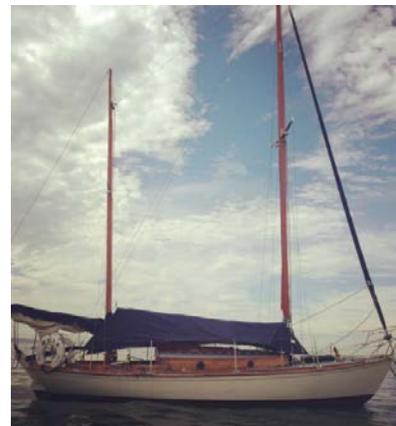
(a) KOLINA was a wood-hulled, ketch rigged sailing vessel built in Thailand in 1952 based on the design of the Herreshoff H-28 model. The vessel was sailed to the Hawaiian Islands prior to 1984 under the name MEKALA. A few months later the vessel was sold, brought to Kona, and renamed KOLINA (Exhibit 70). During this period, the owner conducted a major refit of unknown scope to the vessel. The owner passed away and in August 2008 his widow transferred KOLINA, at no cost, to the mishap victim. At this point, the vessel had been out of the water for several years (Exhibit 70).

Figure 7: Herreshoff H-28
(Exhibit 84)

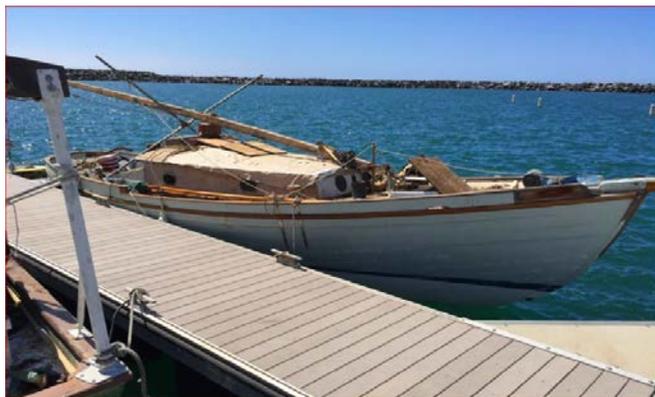
(d) On 7 October 2015, the mishap victim hired a different crane operator, who used a spreader bar configuration, to float KOLINA at Kawaihae South Harbor (Exhibit 72). Again, KOLINA's watertight integrity was compromised and the flooding exceeded the capacity of the mishap victim's portable dewatering pump. KOLINA was subsequently placed back on the rock embankment at Kawaihae South Harbor. After the second failed attempt to float the vessel, the mishap victim resorted to coating the underwater body of KOLINA with a roofing epoxy (Exhibit 67, 71).

Figure 9: KOLINA moored at Kawaihae South Harbor loading dock berth (Exhibit 86)

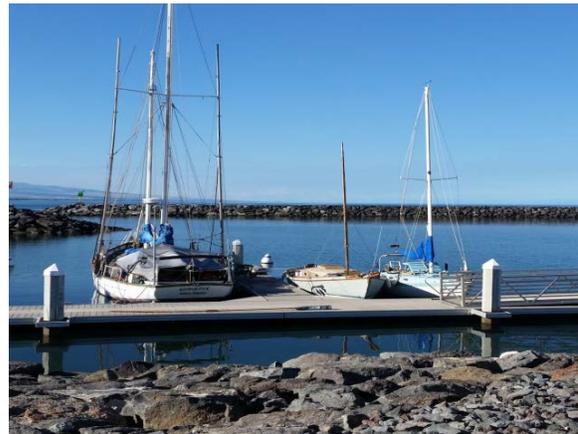
(3) The mishap victim was also cited for living aboard his vessel without permission (Hawai'i §13-231-21). The mishap victim stated that he had too many valuables aboard KOLINA to leave it unattended and continued to live aboard the vessel while ashore and at the loading dock berth (Exhibits 58-59, 61).

Figure 12: KOLINA (center) at Kawaihae South Harbor loading dock berth (Exhibit 89)
