September 24, 2017

**STEAM SHIP EL FARO (O.N. 561732)
SINKING AND LOSS OF THE VESSEL
WITH 33 PERSONS MISSING AND PRESUMED DECEASED
NORTHEAST OF ACKLINS AND CROOKED ISLAND, BAHAMAS
ON OCTOBER 1, 2015**

MARINE BOARD'S REPORT

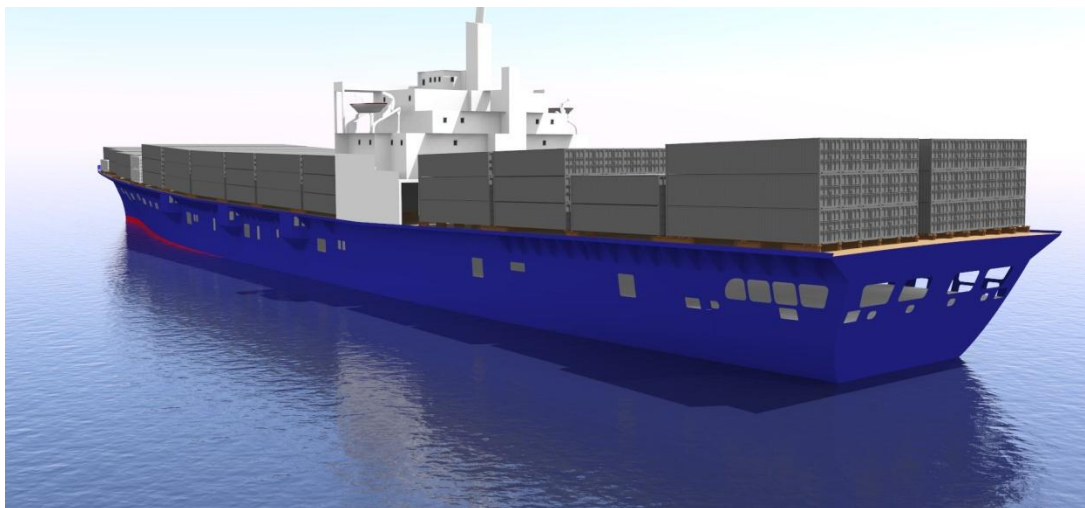
Figure 4. EL FARO computer rendering showing the vessel in the departure condition, with mean draft 30.1 feet, 0 degree list, and the stern trimmed down 5.0 feet. Illustration produced by the USCG Marine Safety Center.

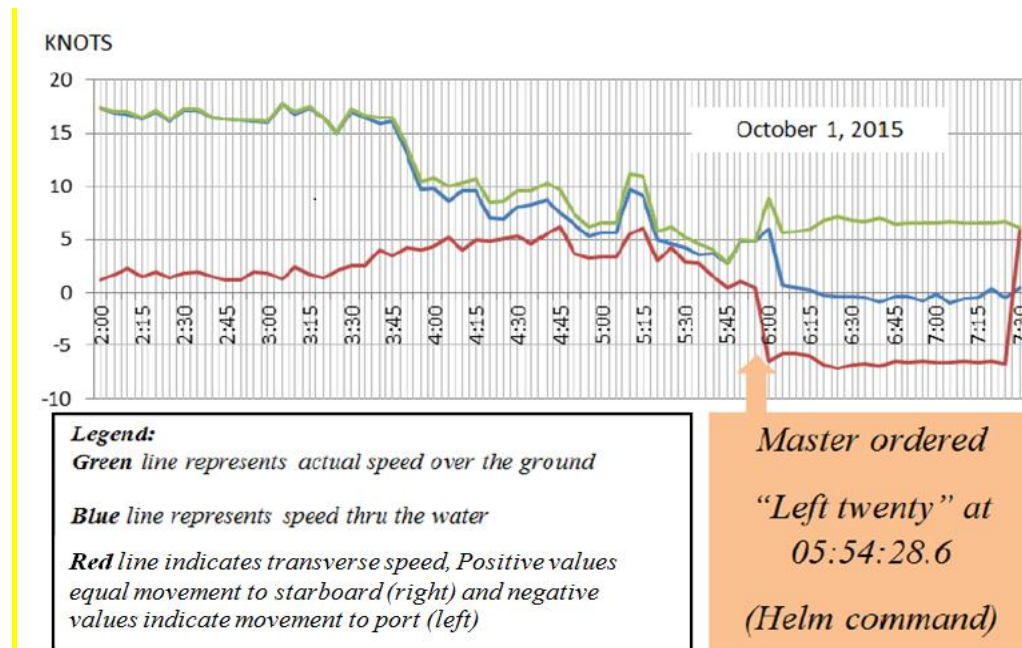
Figure 12. Graph of EL FARO's speed over ground and speed through the water on October 1, 2015.

The first discussion on the VDR audio regarding the actual loss of propulsion was at approximately 6:04 AM when the 2/M noted a reduction in RPMs and questioned whether the bridge or engine room initiated the reduction.

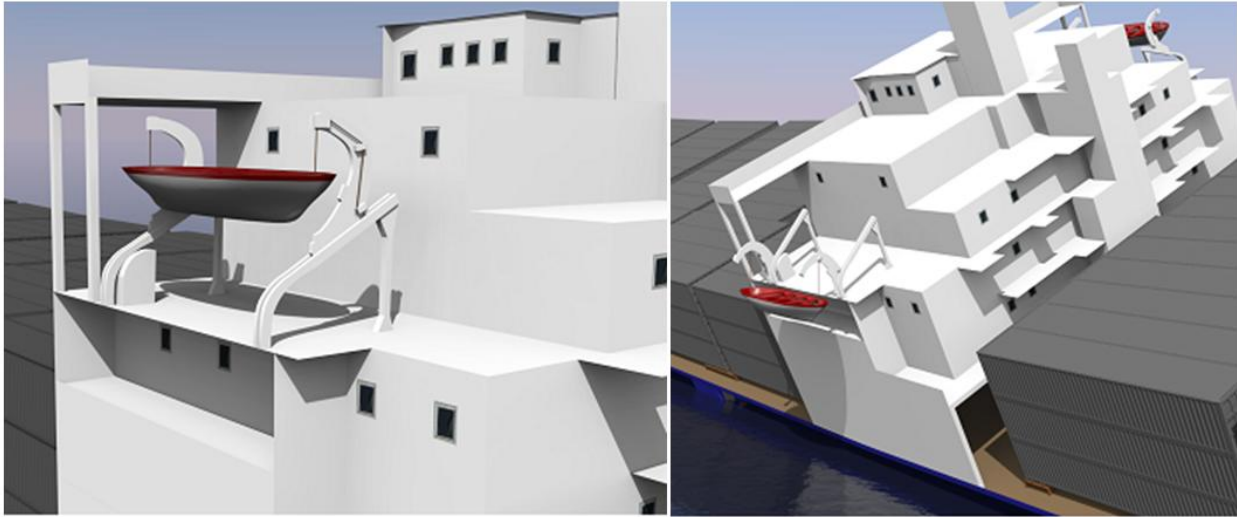
Figure 16. EL FARO computer rendering. On the left, the port lifeboat is shown in the davit in its normally stowed position with EL FARO on an even keel. On the right, the lifeboat is shown lowered to the embarkation deck with EL FARO listing 25 degrees to port. There is no evidence that the use of the lifeboats was discussed by the crew. Large life rafts were stored in close proximity to the lifeboats. Illustration produced by the USCG Marine Safety Center.

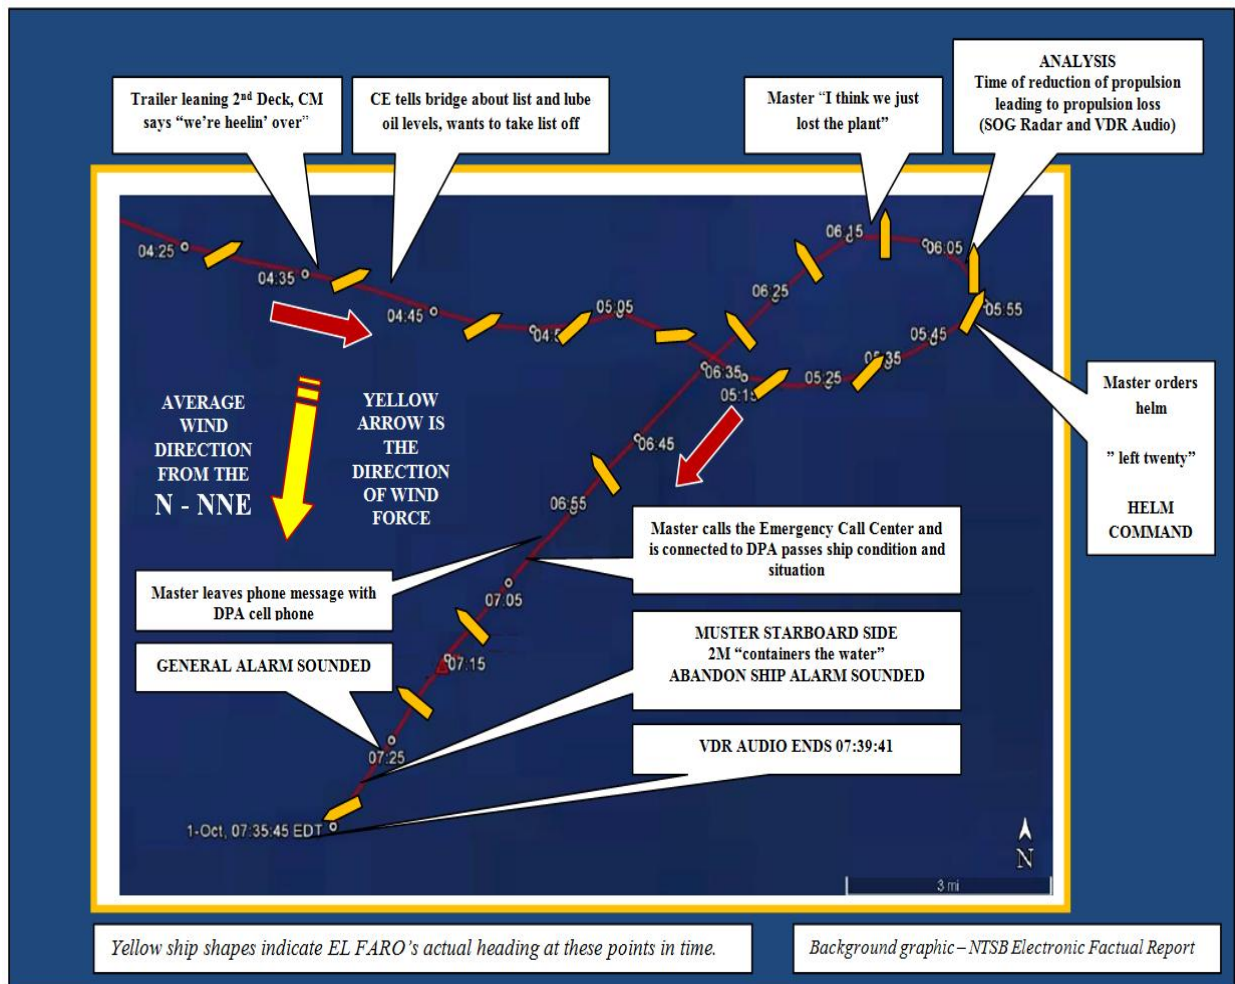
Figure 18. Illustration of significant events between 4:20 AM on October 1 and the sinking, showing ship heading and course over ground.

EL FARO’s last recorded position on the VDR parametric data, at 7:35 AM, was 23-23.4N, 073-54.0W. The main wreckage of EL FARO was located on October 31, 2015, approximately one nautical mile away, in position 23-22.9N, 073-54.9W, and at a depth of approximately 15,400 feet.

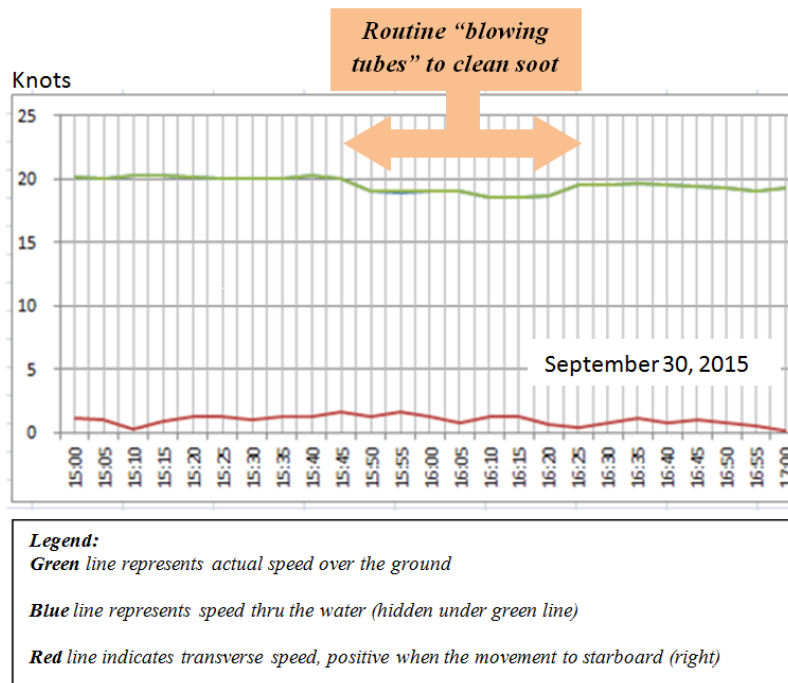
Figure 23. Speed graph from EL FARO showing the typical reduction in speed that resulted from "blowing tubes."

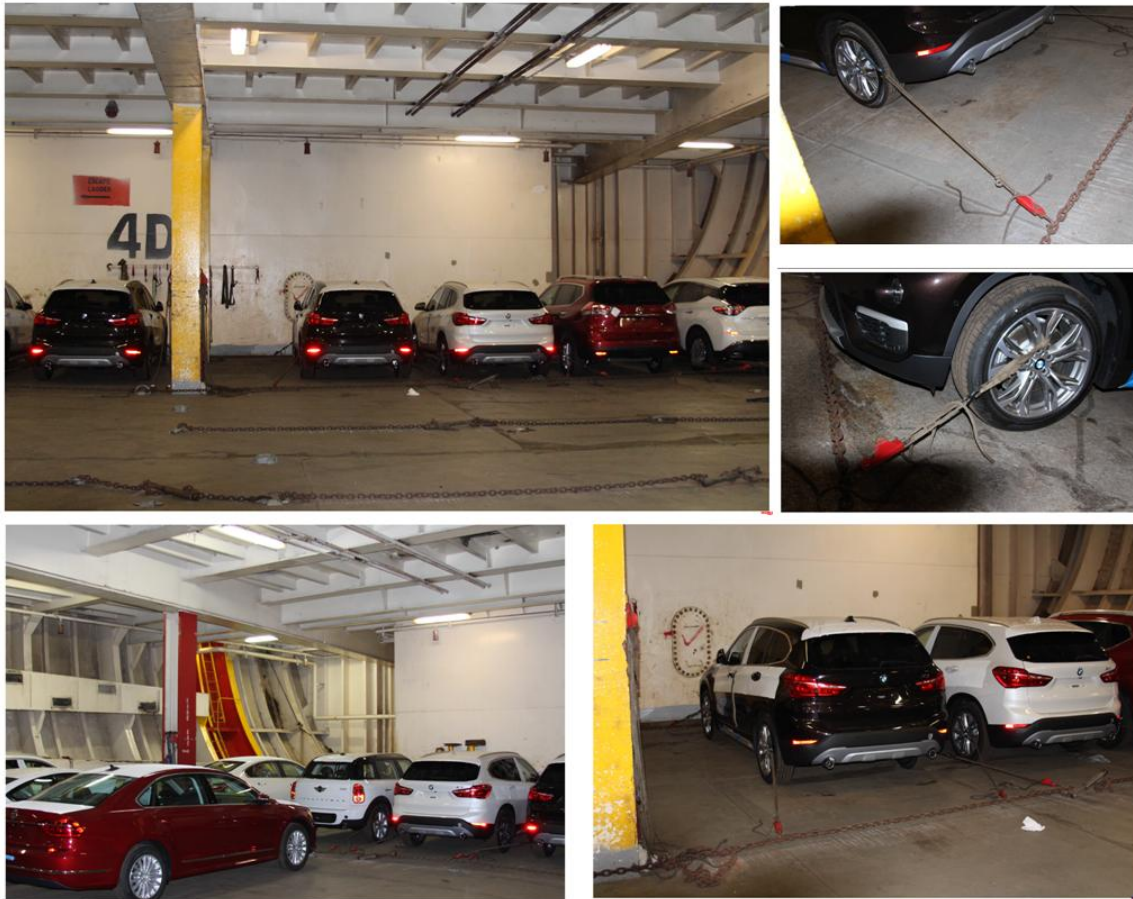
Figure 33. Select Coast Guard photographs from MBI Exhibit 109 that show examples of vehicle lashing methods aboard EL YUNQUE on December 1, 2015.

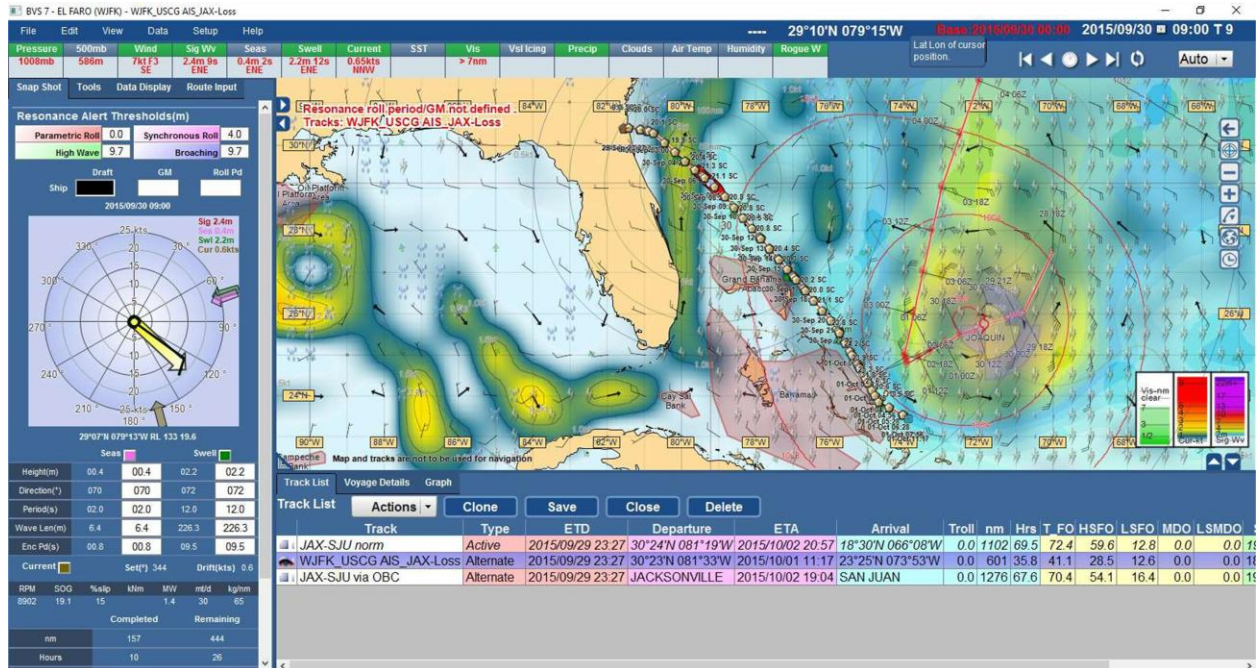
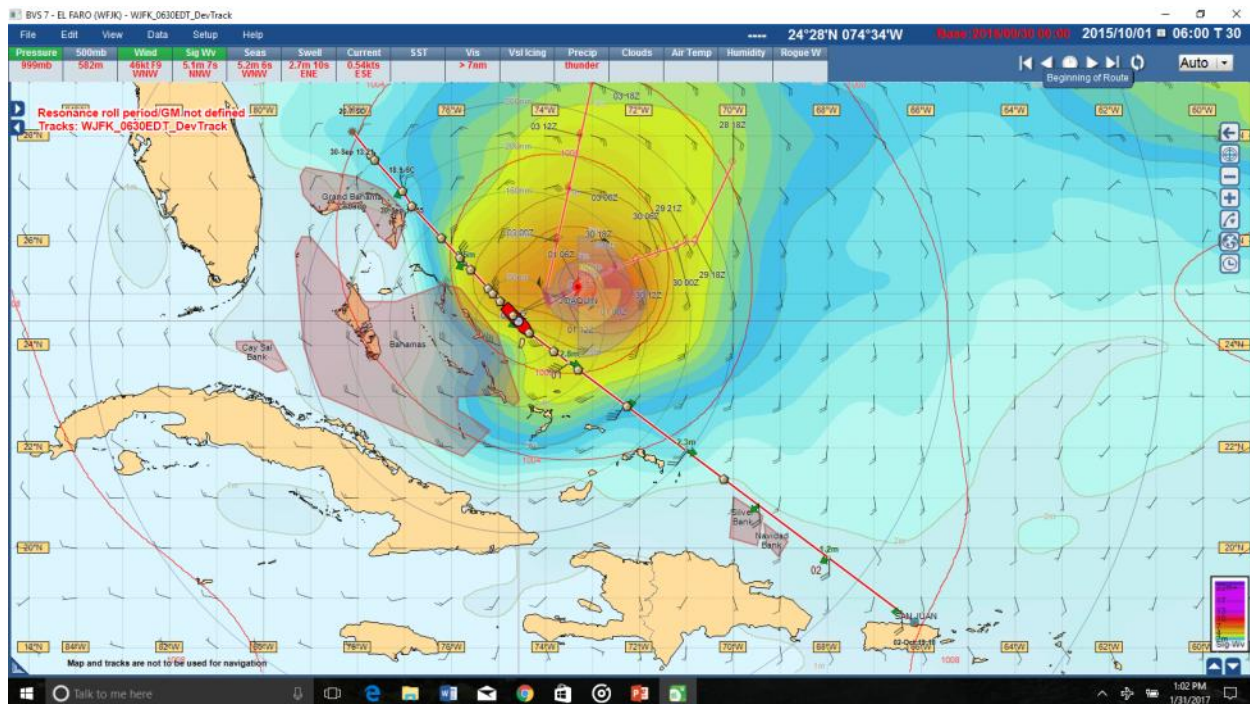
During the testimony from AWT, it was discovered that there was an error in one weather package sent on September 30, 2015. The message sent at about 0900Z (5:00 AM EDT) contained the same NHC forecast and advisory overlaid from the previous weather package sent at 0300Z (11:00 PM EDT) on September 29, 2015. The 0300Z weather package contained the

NHC forecast and advisory information published at the nominal time of 2100Z on September 29, 2015. This error meant that the 0900Z BVS weather package that was sent to EL FARO on September 30, 2015, still contained the NHC forecast and advisory from 12 hours prior. However, the 0900Z weather forecast with the duplicate NHC forecast did include properly updated oceanographic and atmospheric model data generated by AWT.²³³ The repeated hurricane forecast that was replicated in the error can be seen in the graphics above.

Beginning at about 6:14 AM on September 30, 2015, the C/M and Master discussed the weather and potentially altering EL FARO’s trackline.²³⁴ The route chosen provided two waypoints, waypoints “Alpha” and “Bravo.” The resulting trackline was then entered into BVS. The BVS screenshot below shows the new route with the weather forecast that was downloaded at 6:08 AM on September 30, 2015. This was the BVS forecast data package that was available to the Master and C/M at the time they were choosing waypoints “Alpha” and “Bravo.” The Tropical Cyclone forecasted track depicted in this package delivered to EL FARO is the duplicate report showing the NHC’s forecast from 5:00 PM on September 29, 2015.

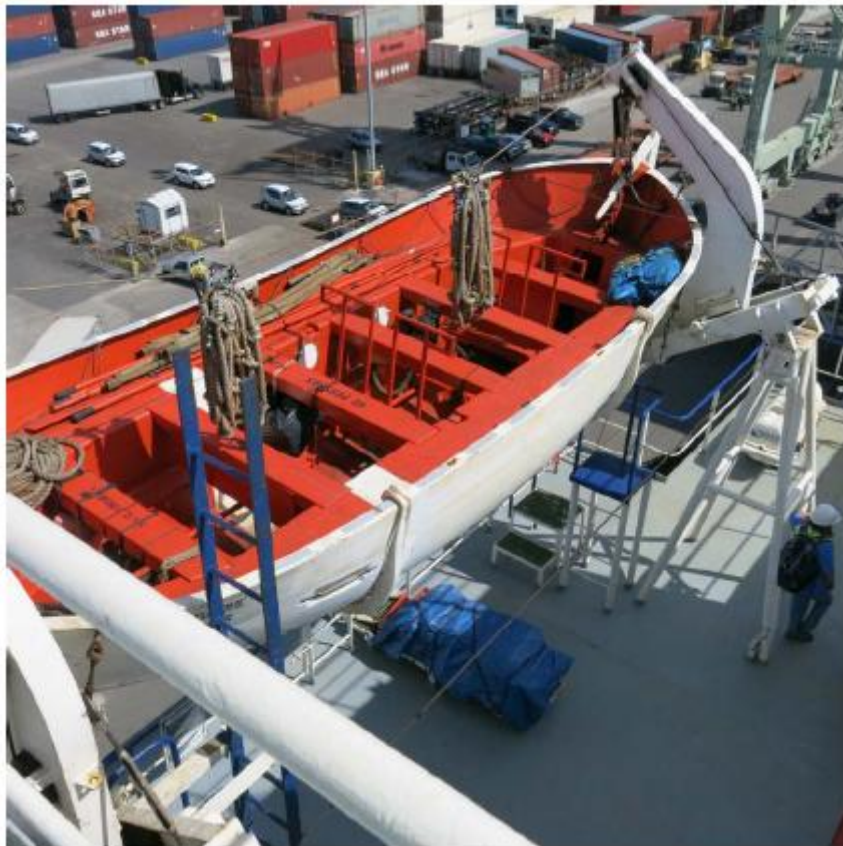
EL FARO’s starboard lifeboat, Boat 1, had a capacity of 43 persons and was propelled by the manual movement of levers which in turn operated a propeller. This propulsion system is known as Fleming gear.

Figure 47. EL YUNQUE starboard lifeboat. NTSB photo.

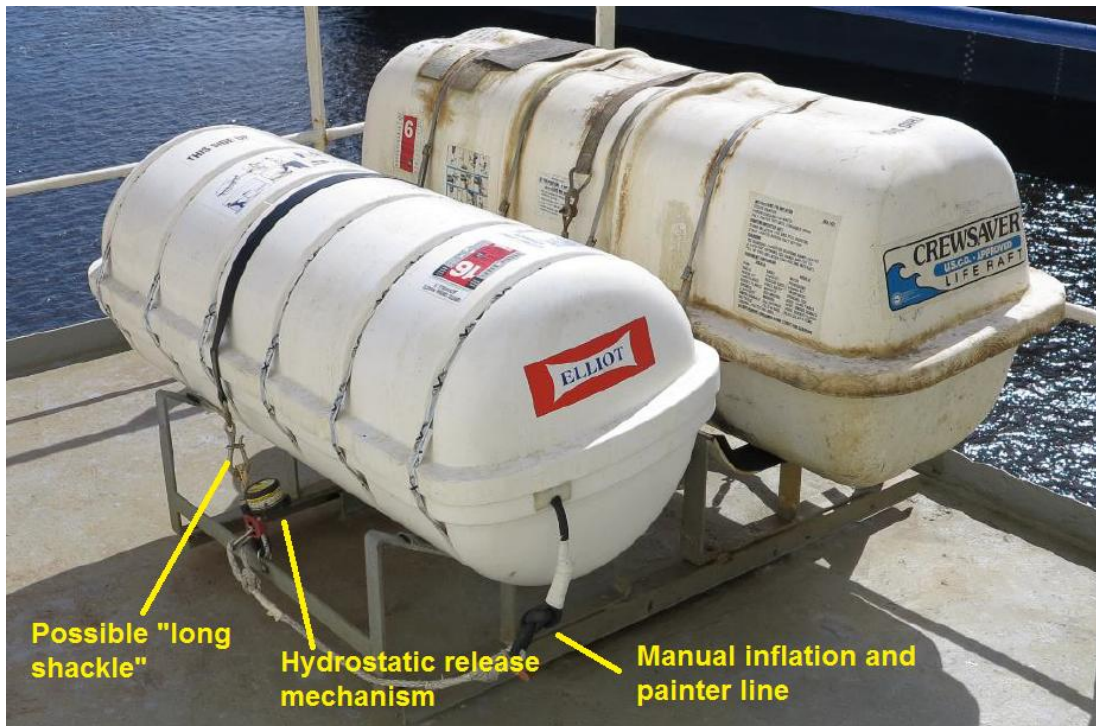
In addition to the required rafts, EL FARO had two additional 25-person rafts in cradles or lashed to the railings near the boat deck.³⁴⁸ The additional rafts were placed on EL FARO after issues with the davit deck foundations were discovered on EL YUNQUE in mid-summer 2015. These extra rafts were still onboard EL FARO when the ship departed Jacksonville on September 29.

Figure 50. Required 25 person life raft with extra raft on the port side of EL YUNQUE showing the storage of the rafts and the hydrostatic release mechanism.

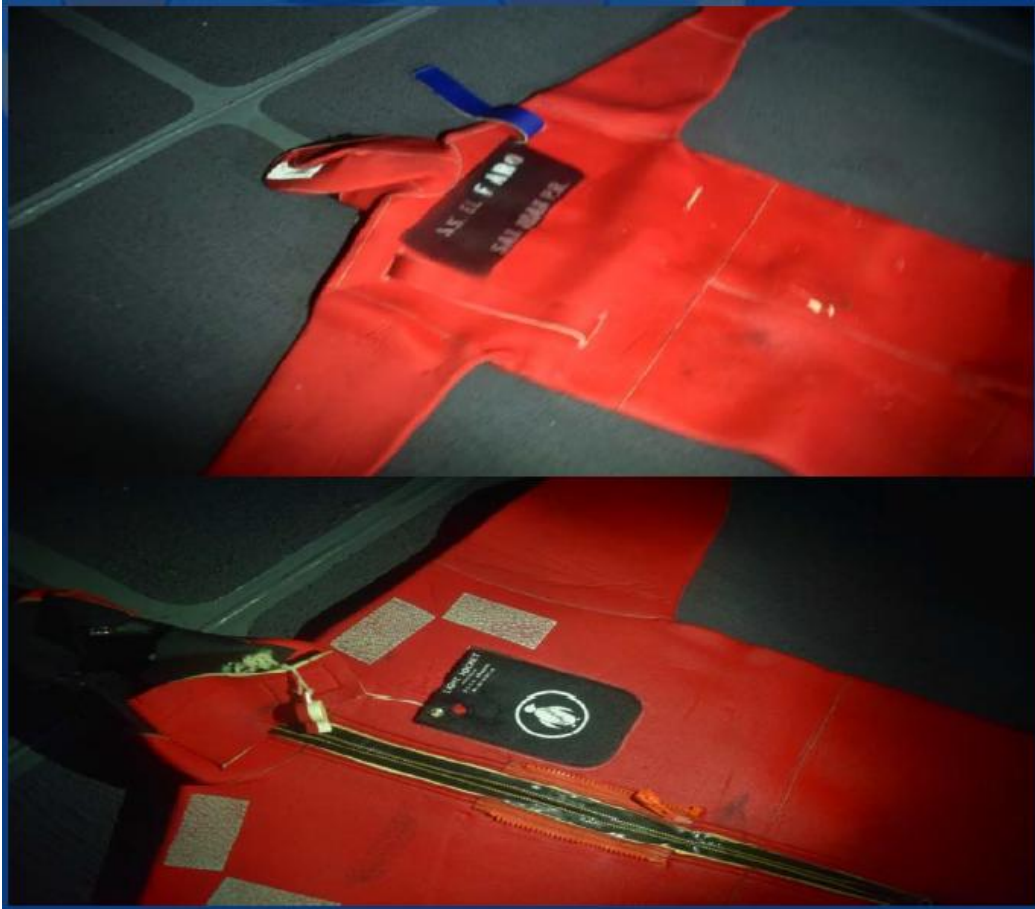
Three EL FARO immersion suits were located during search and rescue activities. One of the suits found floating at sea contained a deceased crew member’s remains, which were not able to be identified or recovered. Further details regarding that suit are discussed in the Search and Rescue section of this report. Two other empty immersion suits, found floating on the surface, were recovered and brought ashore. One of the recovered suits was undamaged. The other recovered suit had a large tear at the waist on the front right side extending from the zipper to the side of the suit. The two recovered immersion suits were manufactured in June of 1985.

Figure 51. One of the two immersion suits that were recovered during the EL FARO search.

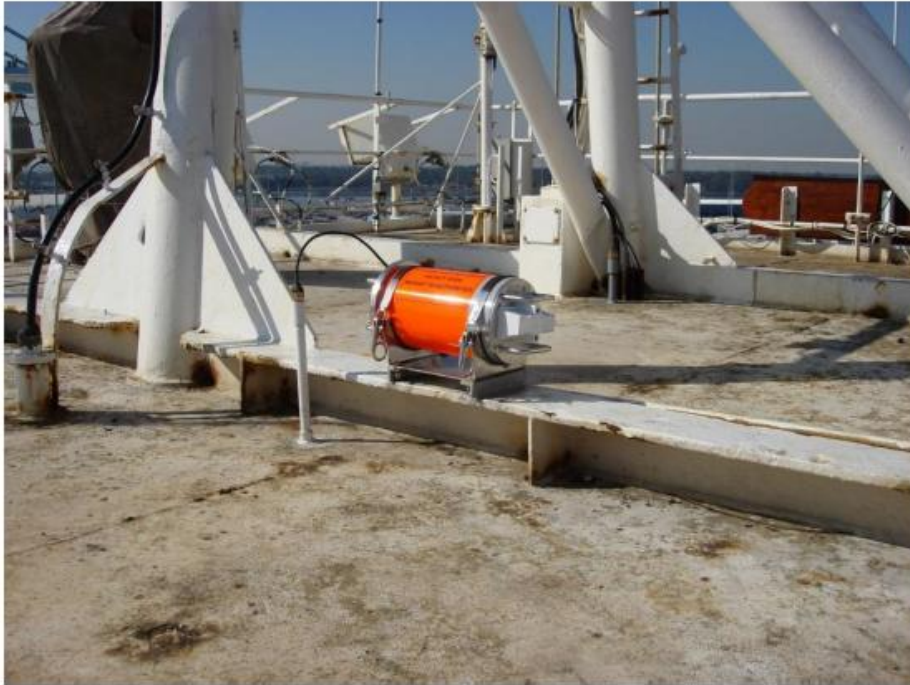
Figure 62. Archive photo of the EL FARO S-VDR capsule mounted on a beam on the flying bridge, port side. (Source: Radio Holland)

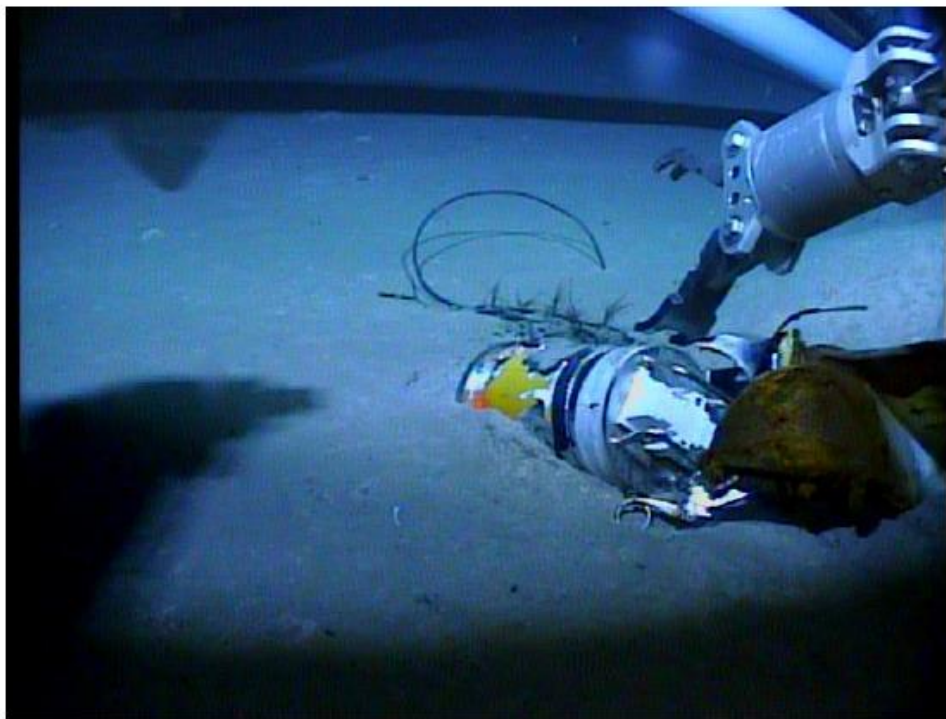
Figure 63. Remote operating vehicle (ROV) manipulator arm positioned above the EL FARO S-VDR capsule on the sea floor prior to the capsule recovery (Source: U.S. Navy Supervisor of Salvage).

accident site located the S-VDR capsule near EL FARO’s mast, which had broken away from the main wreckage. The capsule’s reflective tape aided in locating the capsule on the sandy bottom, as the tape was illuminated by the ROV’s camera strobe light system.

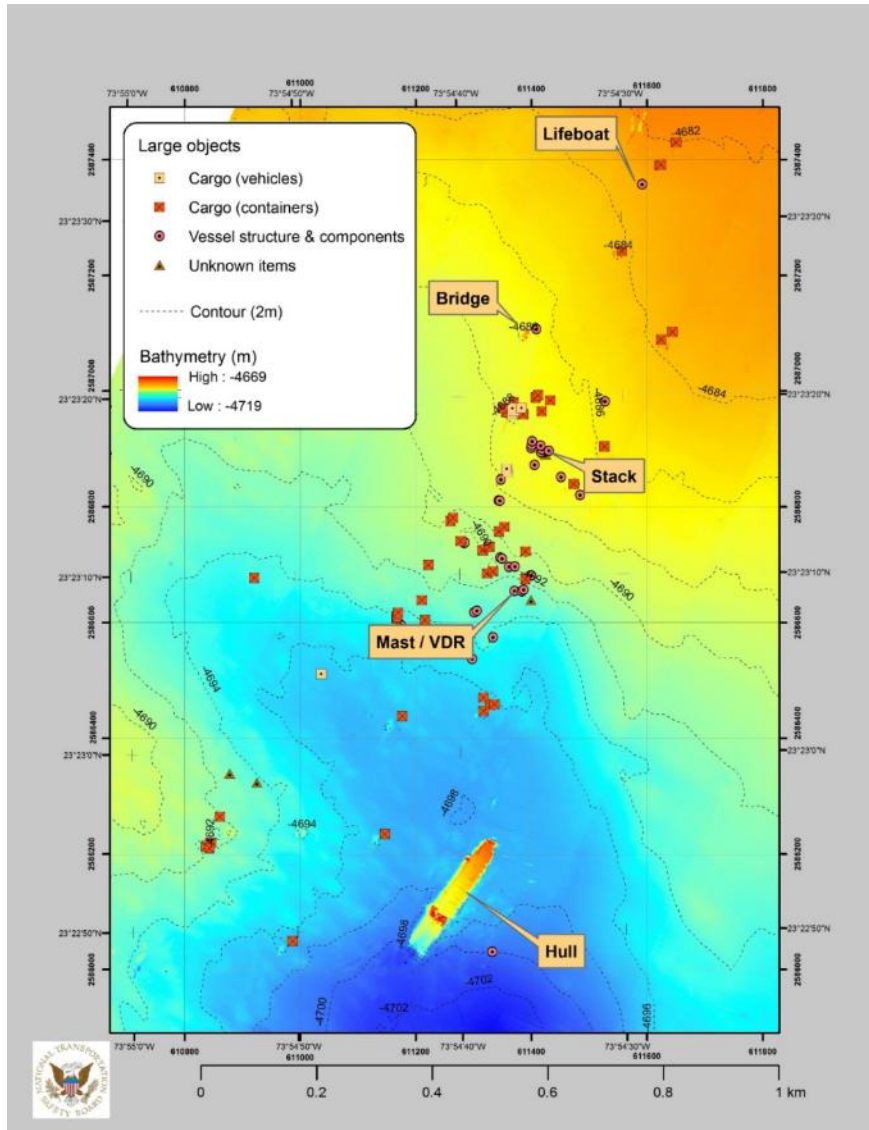
Figure 64. Composite EL FARO debris field chart (reproduced from NSTB Naval Architecture Group factual report).

The ship’s accommodations space, called the “house,” is partially intact, and the majority of that structure remains affixed to the hull. The navigation bridge was separated from the rest of the vessel and was located north of the vessel, as indicated in figure #64. The navigation bridge structure was damaged, but landed upright and structurally intact on the sea floor, about half a mile from the hull. The deck that housed the staterooms and offices for senior officers immediately below the bridge is missing, and the bulkheads for that portion of the superstructure are scattered around the wreck. The rest of the superstructure decks were still affixed to the hull along with ship fixtures, including the lifeboat davits, ladders, and lockers. There were large, arch-shaped scratches noticeable on the vertical surface of the exterior accommodation space on the port side of the vessel, in the vicinity of where the port lifeboat was cradled. The exterior starboard side vertical surface of the accommodation area does not have this same damage, and the starboard lifeboat davits were not as severely damaged as the portside davits.

The hull of EL FARO is sitting on the seafloor in an upright position with the bottom portion buried in the silt of the seabed. The upper portion of the ship’s stem and bulbous bow were left exposed with the forward draft marks indicating that about 14 feet of the bow section is buried in the seabed. The remainder of the hull gradually slopes to the stern where the bottom of the stern transom is partially visible. The containers that were located on the upper deck of the vessel are missing and there are a large number of containers located on the seafloor in EL FARO’s debris field. The transverse beams and the deck sockets for the container securing mechanisms are intact in some areas and missing and damaged in others. The portion of the hull that is buried in the silt, including the propeller, shaft, and rudder, could not be examined. There was visible damage to the bottom of the transom just above the rudder.

There are several fractures in the hull plating, most notably near bay 16 at frame 200. This crack, which has a maximum width of three feet, extends from the sediment line up to the main deck, and then continues athwartship across the vessel’s main deck.

EL FARO’s port diesel-powered lifeboat was located on the seafloor in a severely damaged condition, the buoyancy tanks along the interior side of the hull, running fore and aft, are gone, but the hull shape remains mostly intact. The aft end of the port lifeboat was severed off at an oblique angle, in a position where the gripes would have secured the lifeboat in its cradle. The damaged starboard lifeboat was found floating on the surface in EL FARO’s debris field during search and rescue efforts, it was recovered and brought to shore for a full survey. The equipment that was used to secure the lifeboats in the launching appliances appears to be lying in close proximity to the hull wreckage. The davit systems for both lifeboats were twisted and heavily damaged by either the hurricane conditions, the forces incurred as the vessel sank to the bottom, or both. The launching rails for the starboard life boat are relatively intact, while the equipment for the port life boat appears more heavily damaged and is hanging off the decks where they were mounted.
