UNITED STATES AIR FORCE
AIRCRAFT ACCIDENT INVESTIGATION
BOARD REPORT

T-38C, T/N 64-3213

**87TH FLYING TRAINING SQUADRON
47TH FLYING TRAINING WING
LAUGHLIN AIR FORCE BASE, TEXAS**

DATE OF ACCIDENT: 20 NOVEMBER 2017

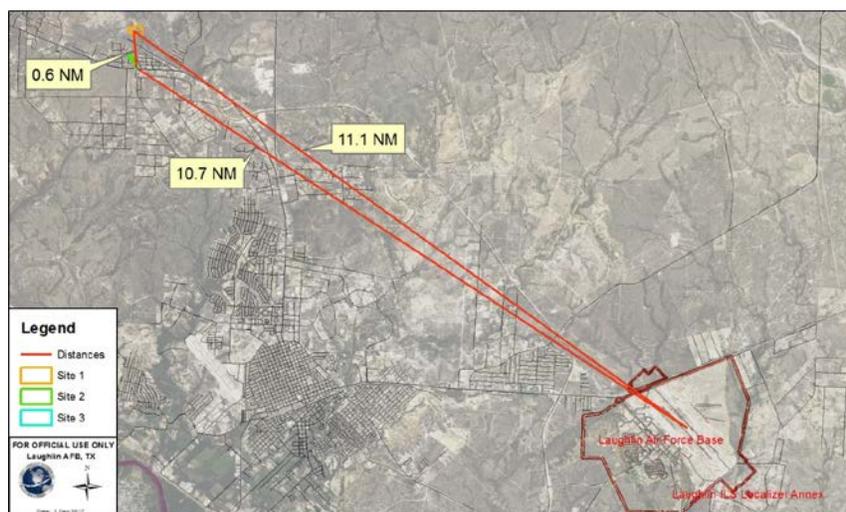
Figure 1: Impact Site Location (Tab S-9)

The MA crashed approximately twelve miles northwest of Laughlin AFB, TX at N 29 27'53.71", W 100 57'10.66", at 1,127 feet MSL (Tab DD-5). The crash site surface was flat, dry desert terrain with sparse vegetation (Tabs S-2 to S-7). The MA impacted the ground in an estimated 60 to 70 degree nose low, near 90-degree right wing down attitude (Tab H-10).

Aircraft ground scarring was consistent with a steep impact angle (estimated 60-70 degrees nose down) and right wing down (90 degrees) (Tab H-10).
