UNITED STATES AIR FORCE
AIRCRAFT ACCIDENT INVESTIGATION
BOARD REPORT

WC-130H, T/N 65-0968

**LOCATION: 1.5 Miles Northeast of Savannah/Hilton Head
International Airport, Georgia**

DATE OF ACCIDENT: 2 May 2018

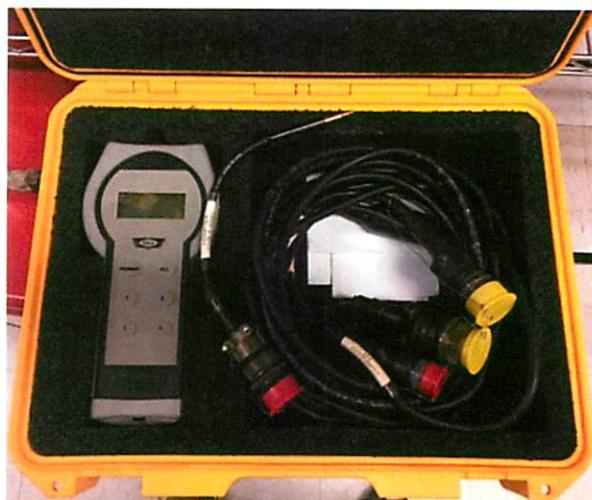
Figure 13 - 165th Airlift Wing Composite Tool Kit Program Precision Tachometer (Tab Z-4)

The model supplied by the 165 AW CTK was a different model than the version normally used by the Mishap Maintainers in Puerto Rico.²¹⁵ As a result, the Mishap Maintainers were unable to get this version to connect to the MA because the plugs were a different configuration.²¹⁶ The maintainers were unaware the precision tachometer supplied by the 165 AW contained an adapter plug that allowed the device to plug into the MA (see Figure 14).²¹⁷ The first step of the T.O. required connecting the precision tachometer and, thus, the Mishap Maintainers should not have continued the engine runs, as they had not completed the first step.²¹⁸ However, without using a precision tachometer, the Mishap Maintainers proceeded with the engine runs.²¹⁹

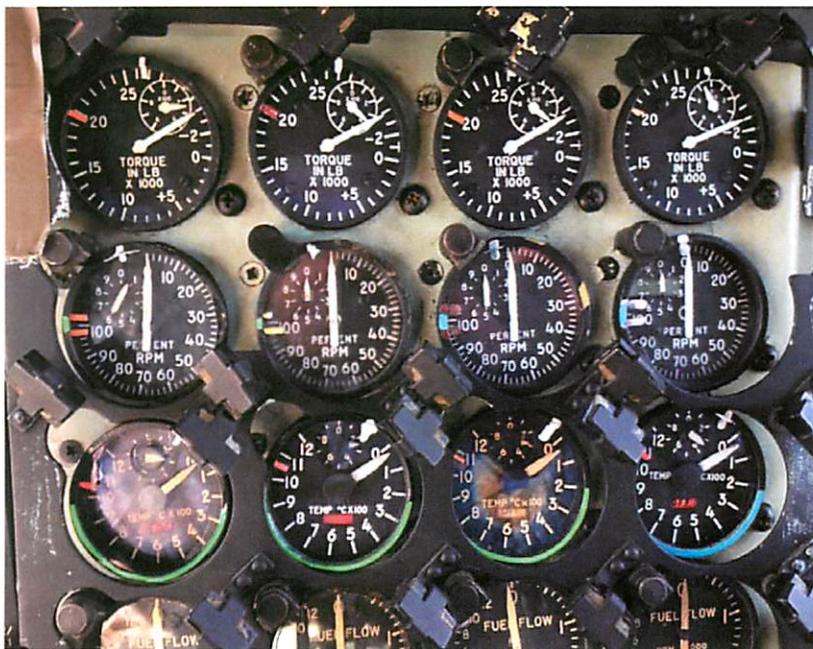
Figure 15 - WC-130H T/N 65-0984 Engine Performance Gauges (Torque, RPM, and Temperature) (Tab Z-13)

DFDR records engine performance, among other data, independent of cockpit flight instruments).²²³ The first troubleshooting method MM1 and MM2 took was to check the RPM tachometer gauge associated with the malfunctioning engine to ensure it was operating correctly.²²⁴ This is done by removing the gauge and replacing it with a new one, and C-130 maintainers commonly do this by swapping it with another tachometer gauge on the aircraft.²²⁵ Per T.O. guidance, this should only happen after the engine is shutdown to avoid damage to the gauge.²²⁶ Believing that swapping the gauges while the engines were running was appropriate, the Mishap Maintainers swapped the engine one tachometer gauge with the engine two gauge, but the replaced gauge still indicated 96% RPM on engine one.²²⁷

After verifying the indicator gauge was not malfunctioning, the Mishap Maintainers terminated the first engine run, reviewed the applicable T.O., and exited the MA to adjust the engine-one valve housing.²²⁸ MM2 made a 12-click clockwise adjustment up with the aim of increasing the engine RPM up to 99%.²²⁹ As the expected effect of each clockwise click is a .25% increase in RPM, the anticipated effect of the adjustment was an increase of 3% in RPM.²³⁰
