United States Air Force Accident Investigation Board Report

F-22A Mishap, Naval Air Station Fallon, NV

F-22A, T/N 07-4146
90TH FIGHTER SQUADRON
3RD WING
Joint Base Elmendorf-Richardson, Alaska

EXECUTIVE SUMMARY
UNITED STATES AIR FORCE
AIRCRAFT ACCIDENT INVESTIGATION
F-22A, T/N 07-4146
Naval Air Station Fallon, NV
13 April 2018

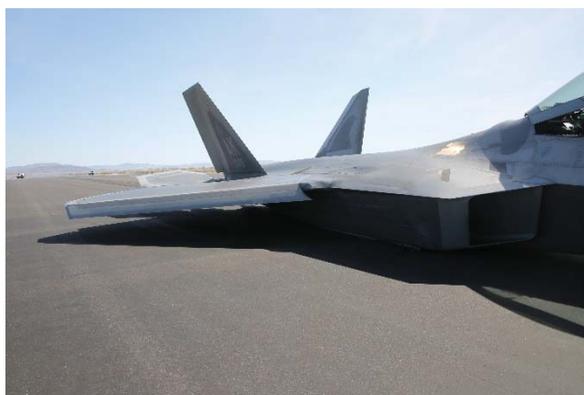
As the MA contacted the runway, the MP selected maximum afterburner (AB) thrust for one second then reduced the throttles to idle as the MA fully abutted the runway (Tabs J-13, V-1.6, V-1.3 to V-1.4). Both throttles were reduced so quickly that neither engine actually initiated AB (Tab J-13). At 4,877 ft from the runway threshold, the MP lowered the tail hook IAW abort procedures (Tabs S-13, V-1.3). As the MA slid down the runway, the MP shut off both engines (Tabs J-13, V-1.3). The tail hook continued to intermittently impact the runway surface until the aircraft came to a complete stop 9,419 ft from the runway threshold and offset several feet to the right of the runway centerline (Tab S-2 to S-4, S-13).
