United States
Coast Guard

**SUBSURFACE PROPERTY DAMAGE INVOLVING THE ARTICULATED TUG
CLYDE S. VANENKEVORT AND BARGE ERIE TRADER ON APRIL 1, 2018**

**CLYDE S. VAN ENKEVORT (O.N. 1232691) and ERIE TRADER (O.N. 1238380) Anchor
Strike Which Damaged Subsurface Transmission Cables and Pipelines
In the Straits of Mackinac Michigan on 01 April 2018**

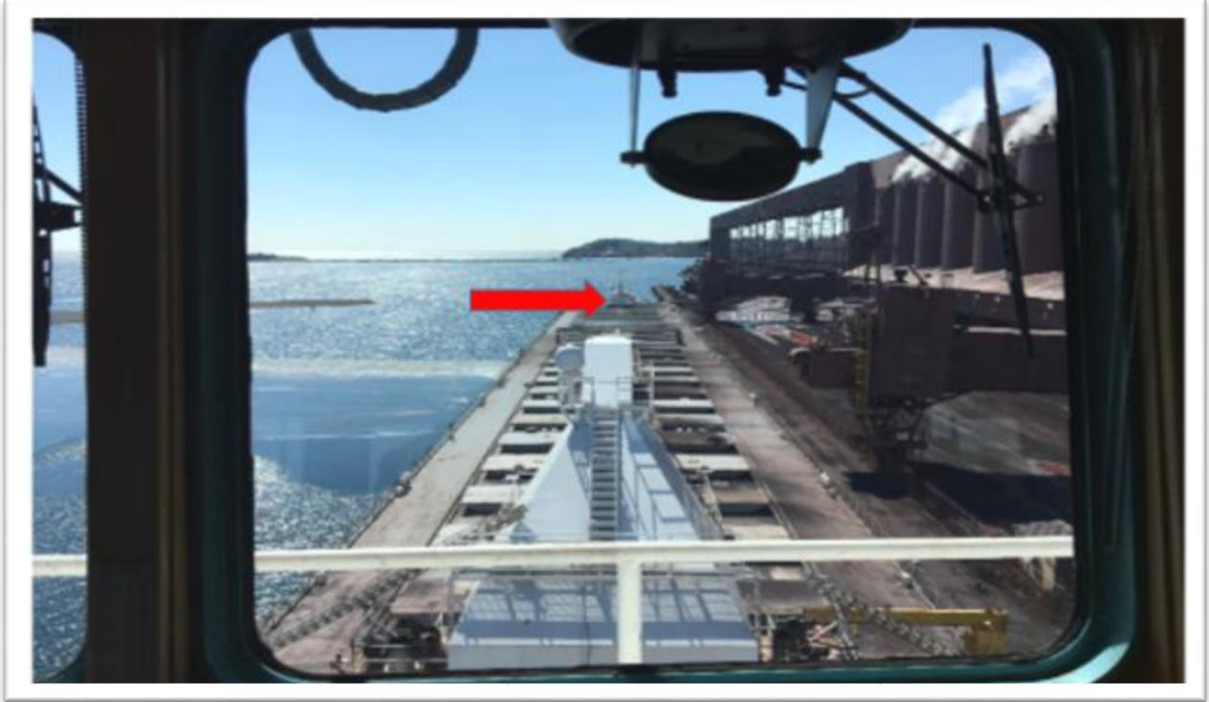
- 4.4 The ERIE TRADER is configured with the windlass, anchoring system, and associated tackle in an enclosed space on the bow main deck just above the forepeak. This space houses the windlass systems, associated controls, and tackle for both the port and starboard anchors. The windlass system (model: 2W26231-16-00) and associated parts were manufactured by Coastal Marine Equipment Inc. These systems are not visible while standing on the main deck of the barge, nor are they visible from the bridge of the CLYDE S. VAN ENKEVORT. There are no alarms or signals on the bridge or otherwise that verify the status of the anchors. The windlass space is approximately 845 feet from the bridge (see figure 4-1).

Figure 4-1 View from the bridge of the CLYDE S. VANENKEVORT to the main deck of the ERIE TRADER. The red arrow indicates the location of the windlass room.

It should be noted that since this incident Van Enkevort Tug and Barge Inc. has taken action to install a signaling system on the ERIE TRADER that alerts the bridge whenever an anchor had been deployed.

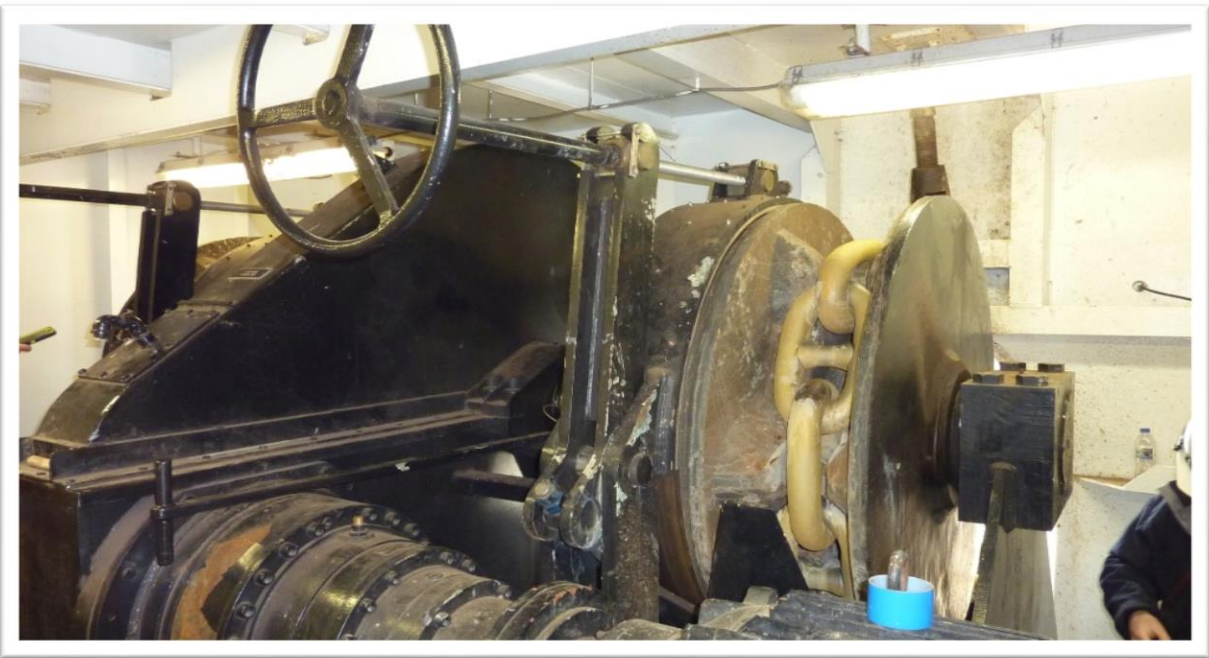
- 4.5 The windlass systems on ERIE TRADER cannot be remotely operated. This means that in order to drop an anchor the windlass system had to be powered up and controlled locally. These systems cannot be controlled from the tug. The windlass brake assembly is comprised of a manual hand crank/wheel and an upper and lower brake band that when tightened secure the windlass and anchor chain in place by means of friction (see figure 4-2 and 4-4).

Figure 4-2 Inside the windlass room on ERIE TRADER. starboard anchor chain, windlass, brake assembly, and brake hand wheel are shown.

- 4.14 11 March 2018- While the vessel was in winter lay-up at Frazier shipyard, CLYDE S. VAN ENKEVORT Chief Engineer [REDACTED] replaced the damaged starboard windlass brake band with a new brake band from the manufacturer Coastal Marine Equipment Inc (CMEI). While completing this replacement the Chief Engineer utilized a maintenance manual from CMEI. The manual contained diagrams of the system, however the manual did not contain specific instructions for the replacement of the brake band and associated parts. There was no technical oversight of the replacement by the Port Engineer. Furthermore, there was no assistance requested or provided by the manufacturer.

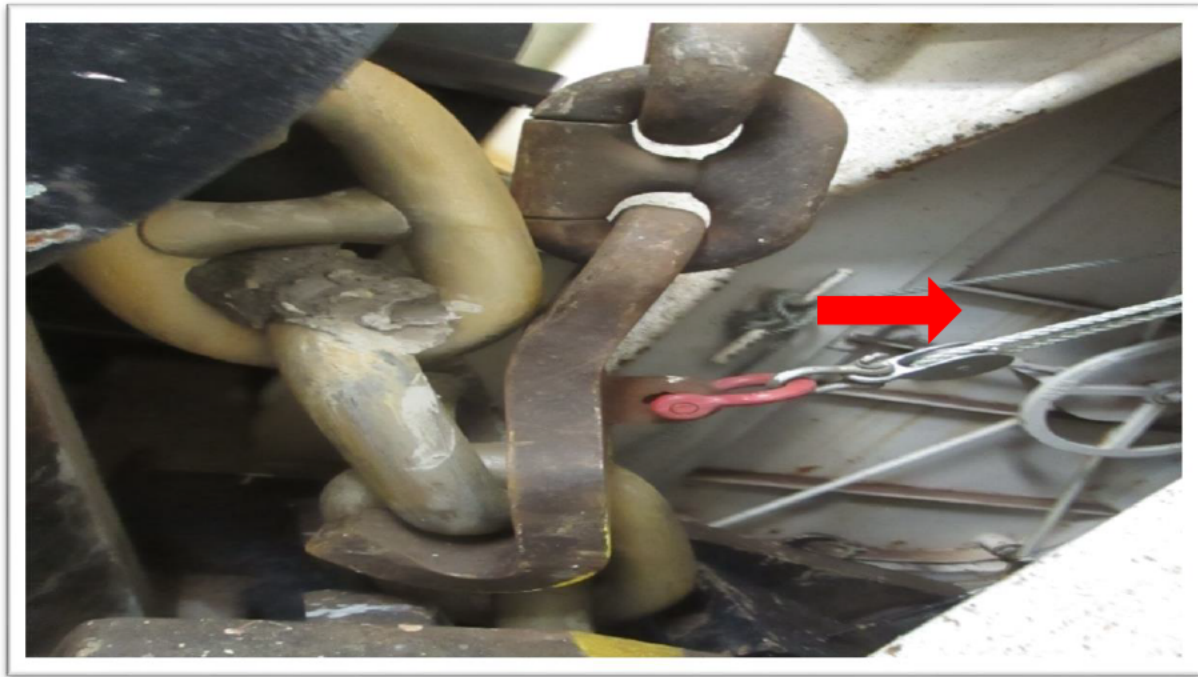
- 4.9 The barge ERIE TRADER is fitted with two stockless B-type anchors which weighed 12,000 pounds and are connected to a 2^{5/8} inch size chain. The brake holding capacity by design is 341,100 pounds. Each anchor chain is 6 shots (1 shot = 90 feet). The anchor was designed to have three mechanisms to protect against unintended release: the paw, the claw, and the brake (see figure 4-4). The claw and paw⁴ devices cannot be accessed from inside the windlass room. There is a separate space forward of the windlass room called the hawespipe locker that is accessed by a small hatch. In order to view the claw and paw the hawespipe locker hatch must be opened (see figure 4-3).

Figure 4-3 Inside view of the starboard hawespipe locker hatch. Red arrow indicates the hatch that provides access to the claw and paw. This image displays the hatch in the closed position.

- 4.39 3 April 0022- Mr. [REDACTED] opened the starboard hawespipe locker hatch that provided access to the paw and the claw and observed that both devices were disengaged from the anchor chain. The claw was disengaged and was manually tied off to a cleat on the bulkhead securing it up and away from the chain. Mr. [REDACTED] powered up the starboard windlass and brought up the anchor. Approximately 4 shots, or 360 feet of anchor chain were recovered. When the anchor stock came into sight, Mr. [REDACTED] discovered that the anchor flukes were missing and reported this to the bridge (see figure 4-11).

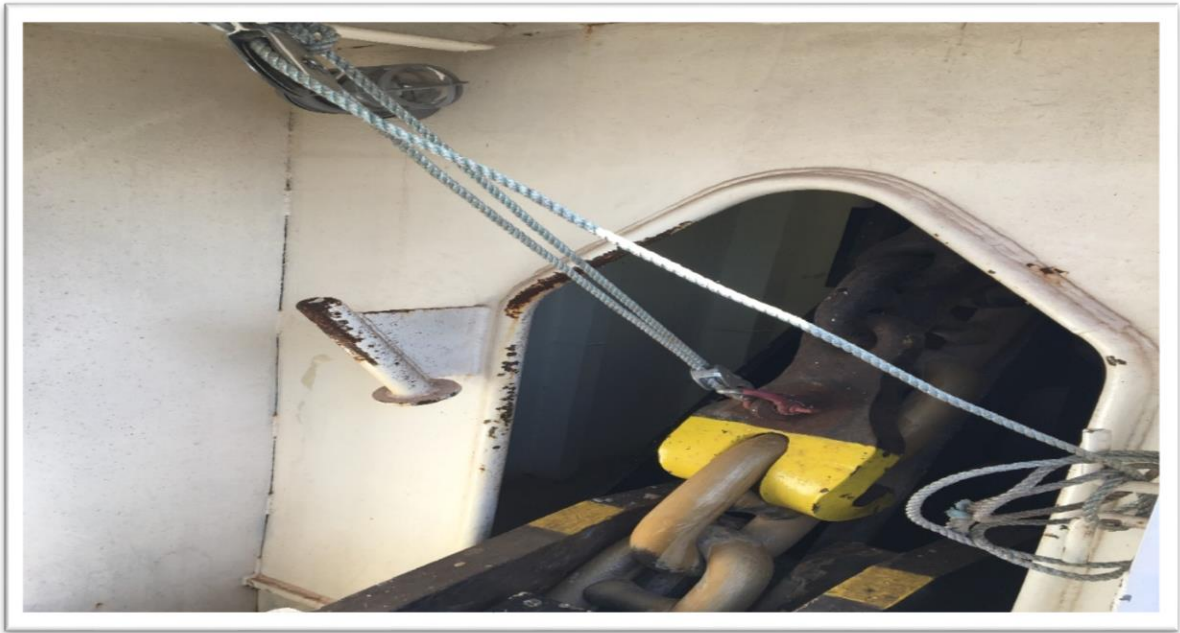
- 4.19 The arrangement of claw on the ERIE TRADER is set up so that when the claw is not engaged on the anchor chain it must be manually tied off to a cleat welded onto the bulkhead. If the claw is not tied onto the cleat, it will freely fall back onto the anchor chain (see figure 4-5).

Figure 4-5 In this image the starboard claw is engaged on the anchor chain. When the not engaged, it is lifted up by pulley and tied to a cleat on the bulkhead.

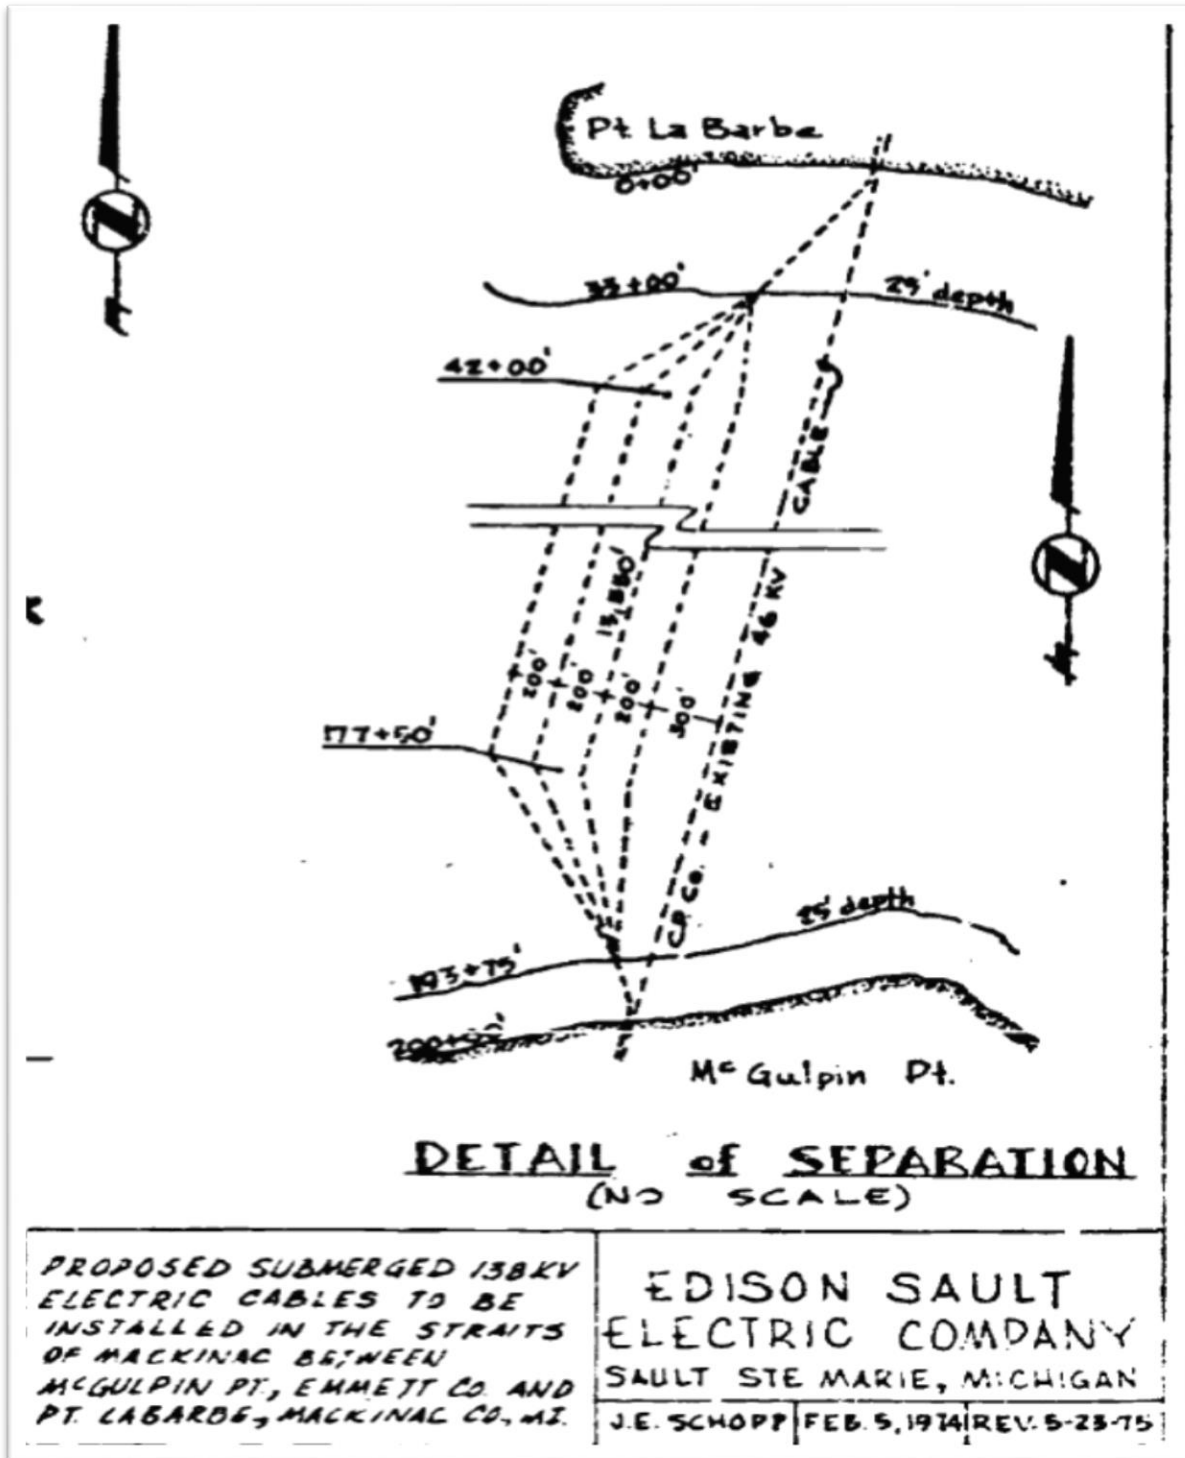
- 4.36 1 April 2018 1732- American Transmission Corporation (ATC) received a signal at their Systems Operations Center indicating that two protective relays connected to transmission cable circuits in the Straits of Mackinac had tripped offline less than a minute apart. American Transmission Company owns six underwater subsurface transmission cables that rest on the seabed in the Straits of Mackinac. These cables actively provide power to the upper peninsula of Michigan. The cables run between McGulpin Point, on the Lower Peninsula, to Pointe La Barbe, on the Upper Peninsula. The cables are spaced approximately 200 feet apart at depths of over 200 feet (see figures 4-8 and 4-9).

Figure 4-8 Diagram for the layout of ATC submerged cables west of the Mackinac Bridge. Image provided by U.S. Army Corps of Engineers. Cables originally owned by Edison Sault Electric Company..

- 4.37 2 April 2018- ATC determined that several of their subsurface transmission cables were damaged and leaking dielectric fluid into the Straits of Mackinac. ATC notified the National Response Center and the U.S. Coast Guard. ATC estimates that a potential 800 gallons of cable fluid had leaked into the Straits of Mackinac. Coast Guard pollution responders were dispatched to the incident location.
