**UNITED STATES AIR FORCE**  
**GROUND ACCIDENT INVESTIGATION**  
**BOARD REPORT**

**Mine Resistant Ambush Protected All-Terrain Vehicle (M-ATV),  
S/N 10L00282**

**386th Expeditionary Security Forces Squadron  
386th Air Expeditionary Wing  
Ali Al Salem Air Base, Kuwait**

**TYPE OF ACCIDENT: Motor Vehicle Accident  
LOCATION: Ali Al Salem Air Base, Kuwait  
DATE OF ACCIDENT: 12 September 2020**

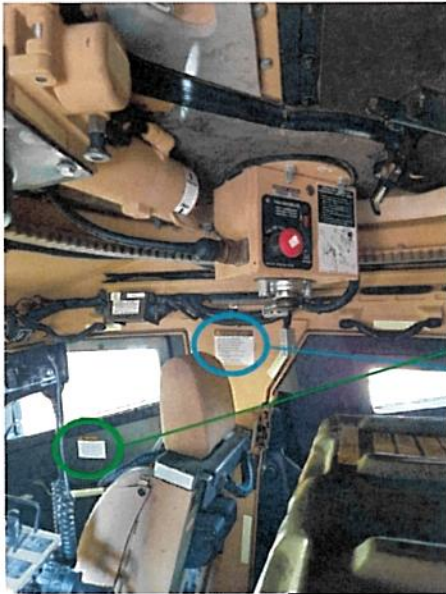
Image at Tab Z-9

Daily safety briefings were conducted at each shift change, which by witness accounts included vehicle safety. (Tabs R-135, V-12.10). Safety placards were affixed in multiple locations inside the M-ATVs reminding vehicle occupants to wear seatbelts and to use combat locks prior to operating the vehicle. (Tab Z-8).
