16711/OCS  
D8(ocs) Policy Ltr 01-2014  
10 Oct 2014

## MEMORANDUM

Subj: GUIDANCE ON POST-HURRICANE INSPECTION REQUIREMENTS FOR  
FLOATING OFFSHORE PRODUCTION FACILITIES

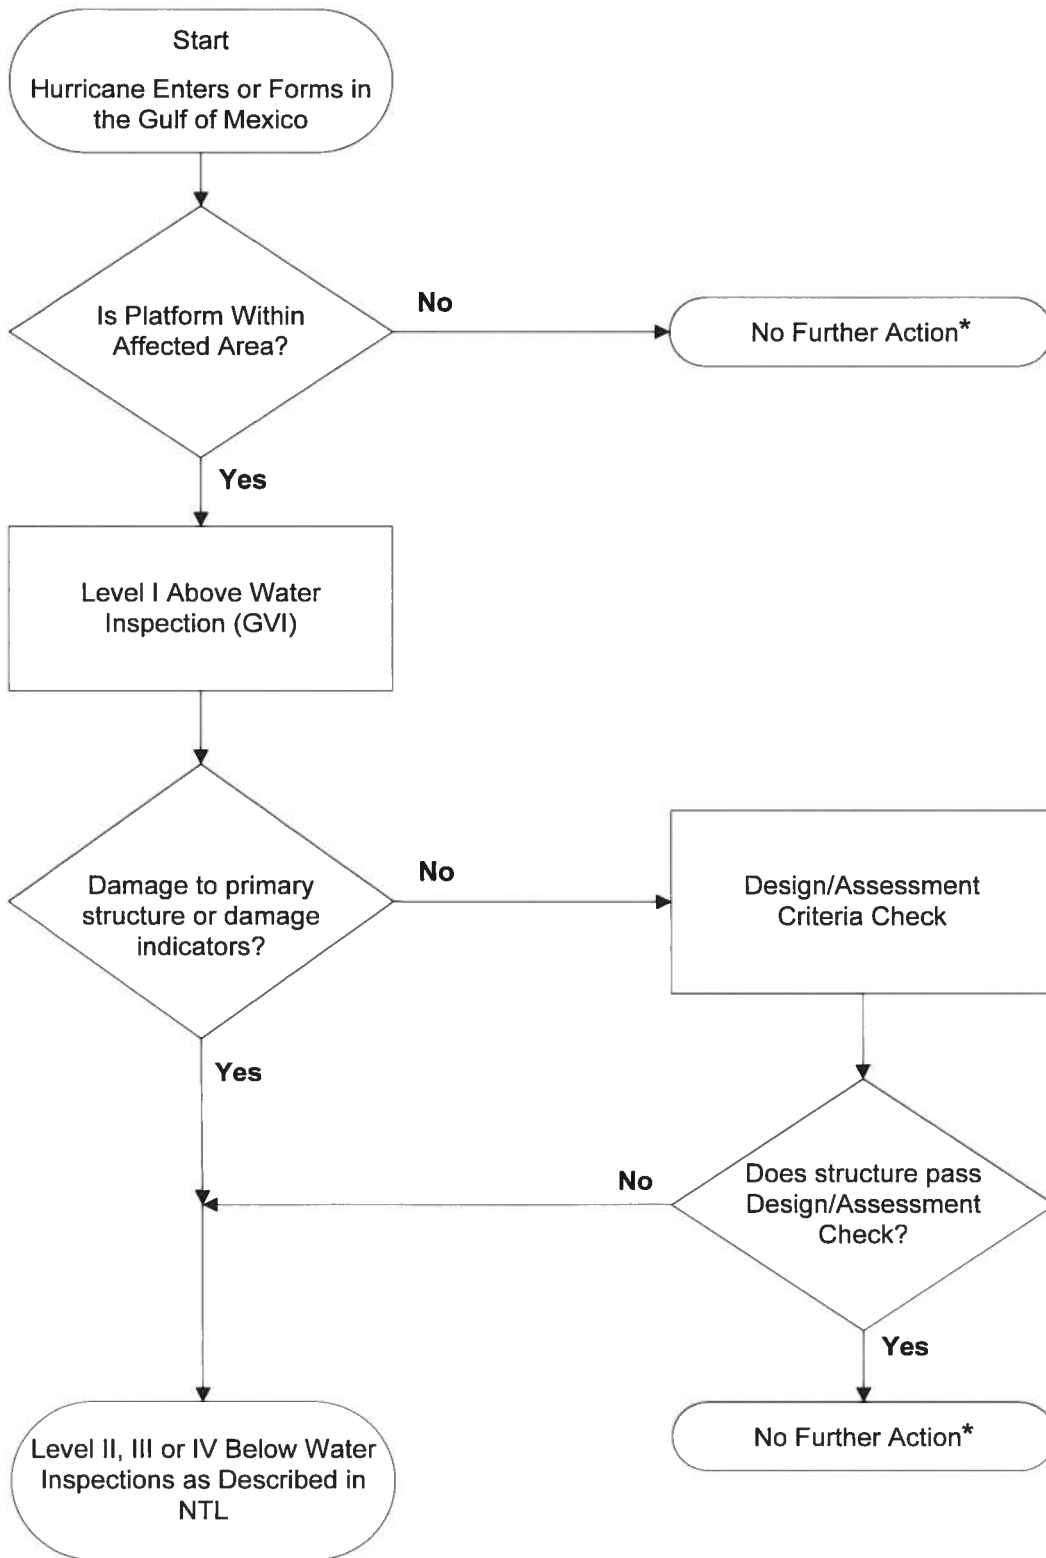
# Attachment No. 1

\*Unless structure specific inspections required by owner or regulator.
