**Fishermen's Maritime Services, Inc.**  
Capt. Erling E. (Jake) Jacobsen, B.Sc., M.Sc., Surveyor and Consultant

Condition and Valuation Survey

**F/V SCANDIES ROSE**

File Number: 602351-11

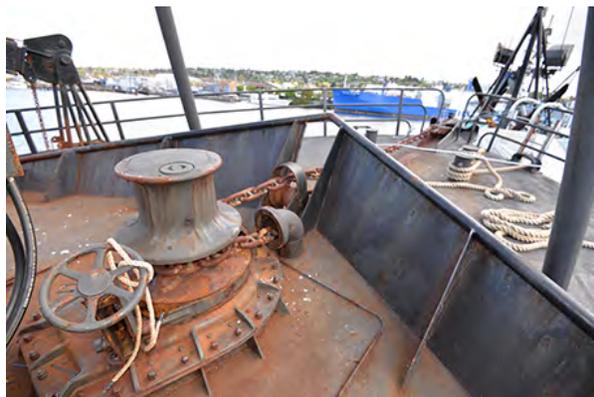
Anchor: A 3,000 lb. Baldt style anchor is fit with a swivel and hammerlock to a length of 1 3/4" stud link chain which rides over a stem roller, a second roller behind the wave break, and to a capstan and chain pipe leading to a chain locker below the forepeak.

The capstan is fit with a friction brake and is freewheel capable. The chain is stopped with a ratcheting type chain binder.

Port and starboard double bits serve closed chocks set in the bulwarks.

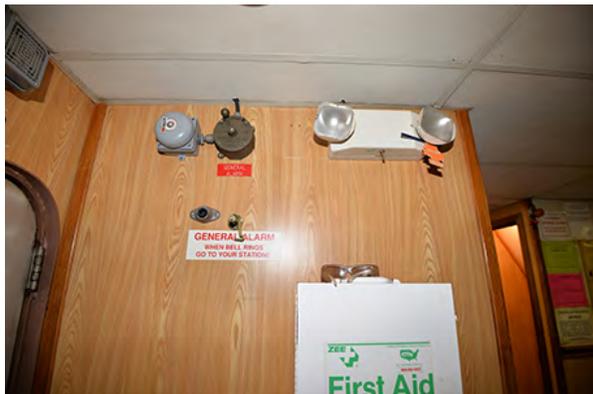
The General Alarm activators are Pauluhn Model 893 positive contact switches located in the wheelhouse, engine room and galley.

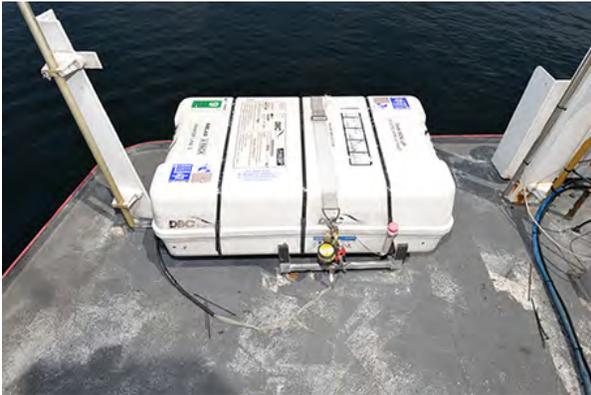
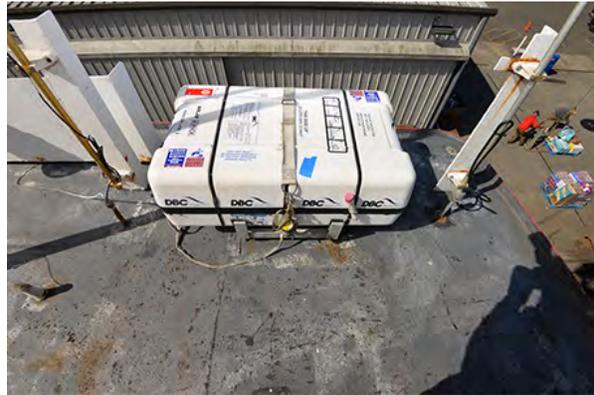
A DBC 8-person Solas A inflatable pack raft is held in a cradle on the port side of the wheelhouse top is fit with a with a Hammer, model H20R hydrostatic release. Raft next due for service 6/2020. The release is due for service 6/2020.

A DBC 8-person Solas A inflatable pack raft is held in a cradle on the starboard side of the wheelhouse top is fit with a with a Hammer, model H20R hydrostatic release. Raft next due for service 10/2019. The release is due for service 10/2020.

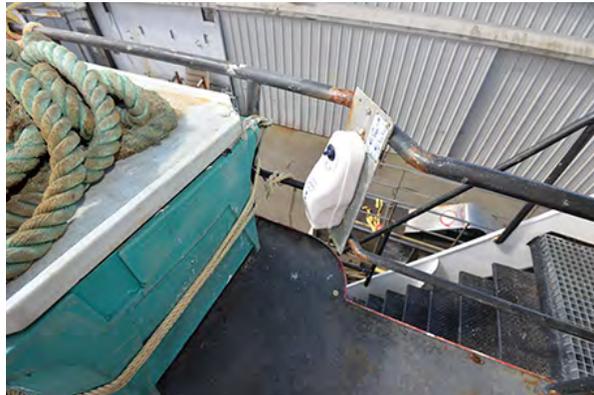
One (1) ACR "Global Fix" model V4 406 epirb is mounted on the port side of the lower (aft) step of the wheelhouse in a hydrostatic release bracket. Registration: 2DCD8 760D0 FFBFF Registration expires: 10/15/2019 Battery expires: 6/2027 The hydrostatic release is due for service by 10/2019

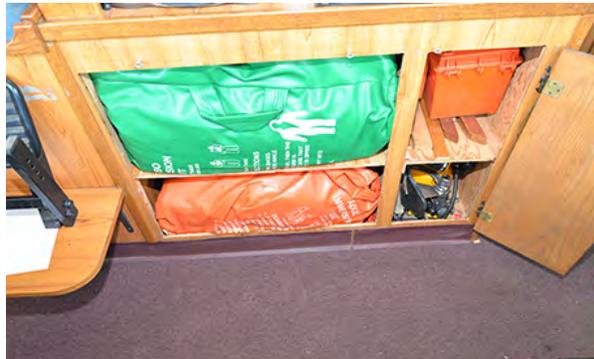
Four (4) adult universal suits, three (3) Jumbo suits and one (1) intermediate size suit are located in a marked location in wheelhouse. Two (2) adult universal suits are located in the Master's stateroom.

Each suit is equipped with a lifting ring, whistle, strobe light, retro-reflective material as required, and an inflatable pillow. The strobe lights are ACE Firefly "Waterbug" lights with batteries expiring 10/2021

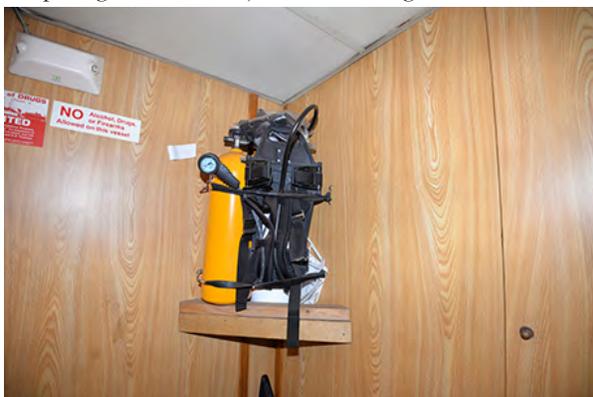
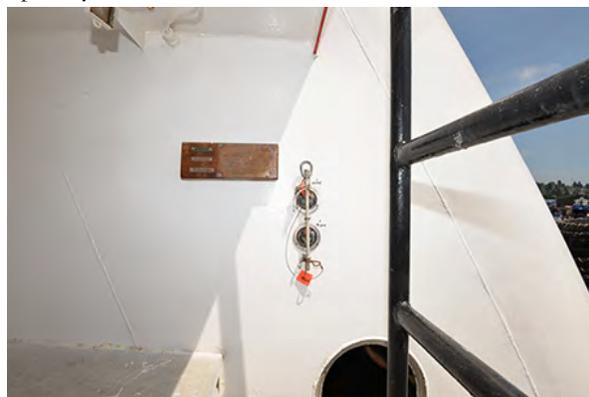
Fixed Fire Systems: The engine room is guarded by a 186 lb. Ansul Halon 1301 fixed fire suppression system located outside the protected space in a locker aft the wheelhouse. Warning alarms are integrated in the system. The actuator is located on the port side of the stack, aft the wheelhouse. Last inspected 5/2019.

SCBA: Racial face mask and compressed air cylinder units are located: one (1) in the starboard galley passage and one (1) in the wheelhouse. SCBAs are one (1) in a wheelhouse locker and one (1) mounted on a galley passage bulkhead adjacent to the engine room ladder. A spare cylinder is carried at each location.

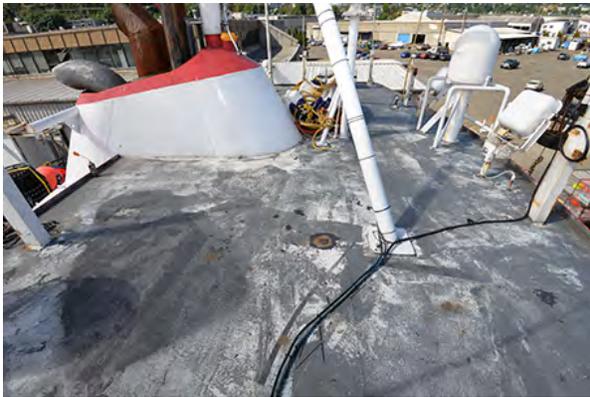
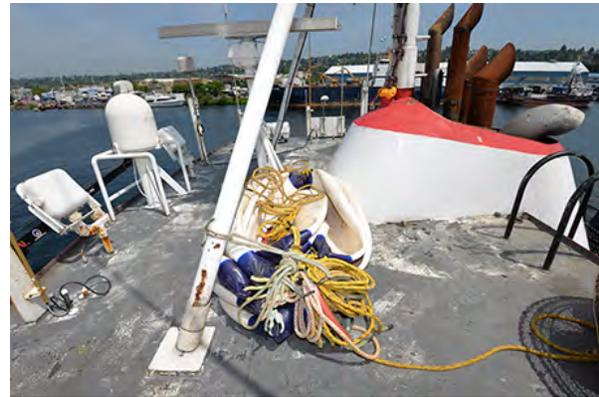
The top of the wheelhouse is unguarded. A visor runs across the forward and side aspects of the housetop. The housetop carries lights and antennas, including a radar scanner. An exhaust trunk fidley is aft. The housetop supports a tripod light mast that carries fishing, deck and navigation lamps as well as various antennas, including a radar scanner. Two (2) high-pressure sodium lamps are arranged at the front of the wheelhouse top to illuminate deck spaces below.

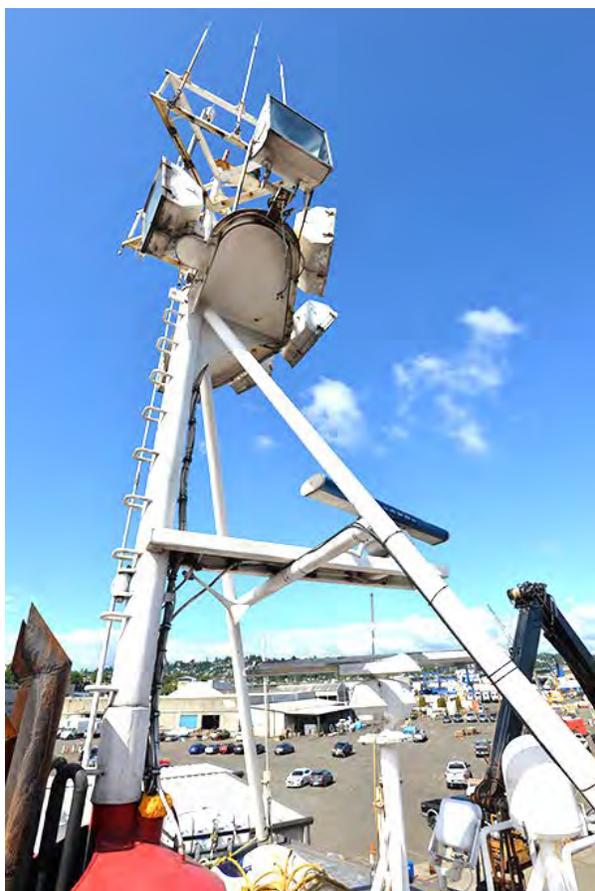
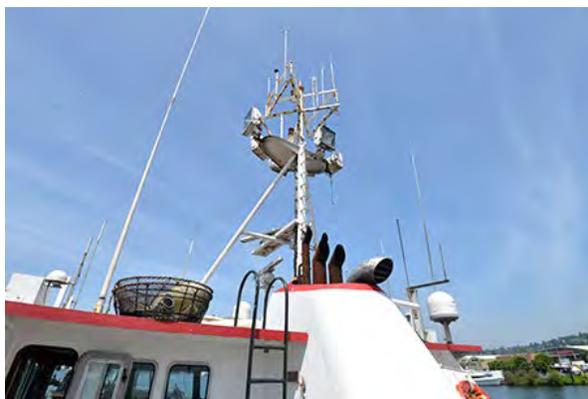
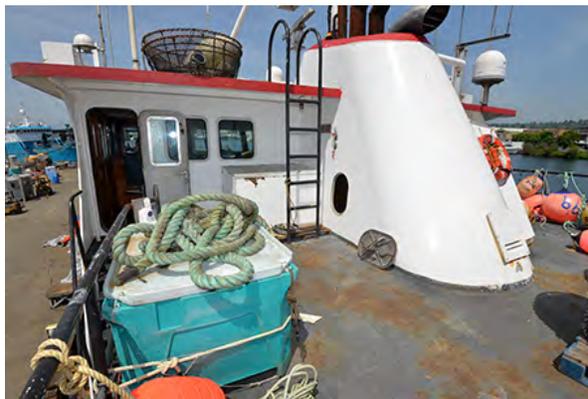
Antenna/light Mast: an 8" diameter pipe mast with 4" pipe stiffeners leading forward is atop the wheelhouse. Ladder rungs are up the aft aspect of the mast. The mast carries five (5) sodium lamps forward and one (1) aft, as well as navigation lamps, antennas and a forward extending radar antenna platform.

Entrance to the wheelhouse is up a ladder on either side and through weather tight doors.

Ventilation: vents are aft of house and port and starboard behind wheelhouse ladders. Two (2) blowers supply ducted forced air heat or vent to house. Two blowers vent the engine room.

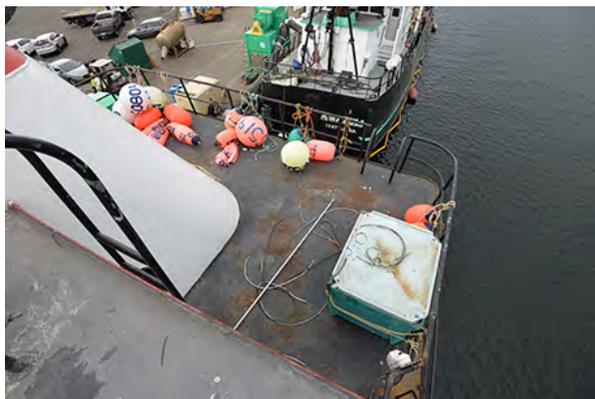
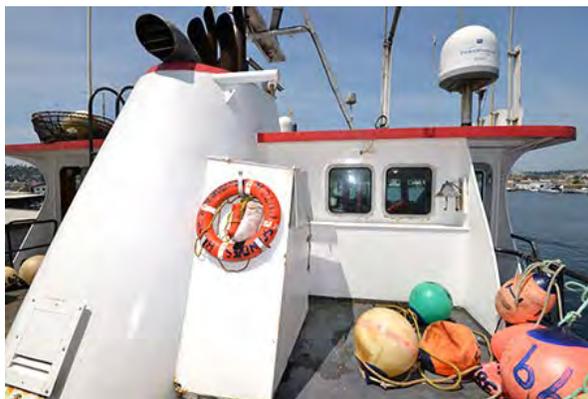
The 02 weather deck is aft the navigation bridge. The area is guarded by 38" high three-tier railing. Access is to a stack room with ventilation fans. A radar mast and an antenna light mast are forward the stack trunk with flanged stacks and a vent exhaust. Two (2) LED lamps are directed to the fishing deck. Ladder: port and starboard inclined ladders are to the 01 level weather galleries and to the wheelhouse top.

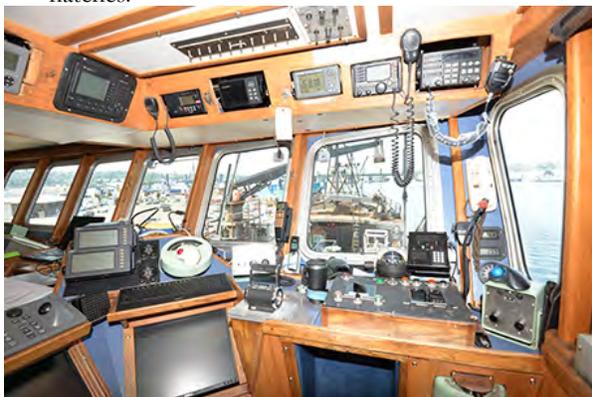
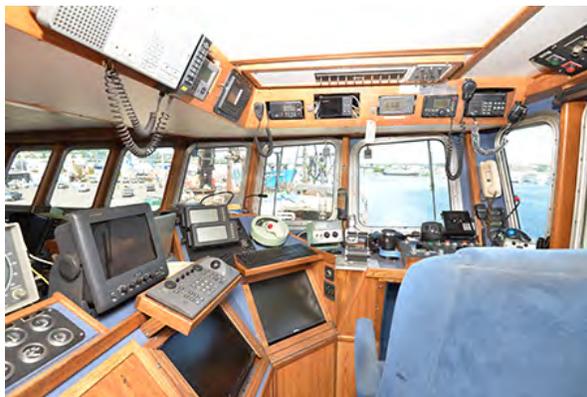
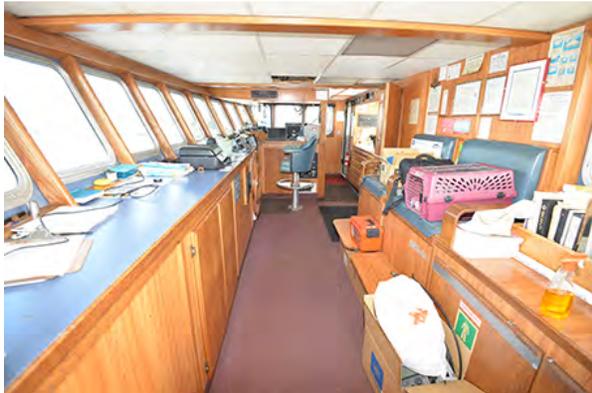
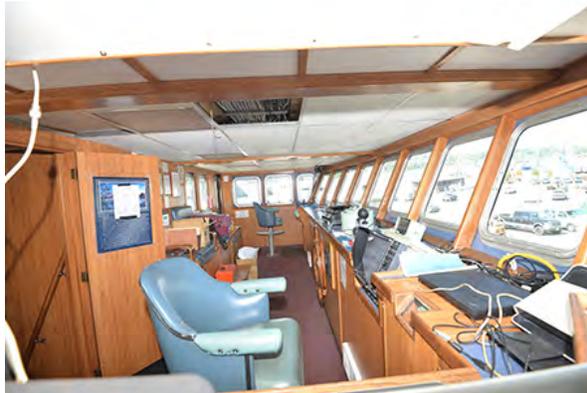
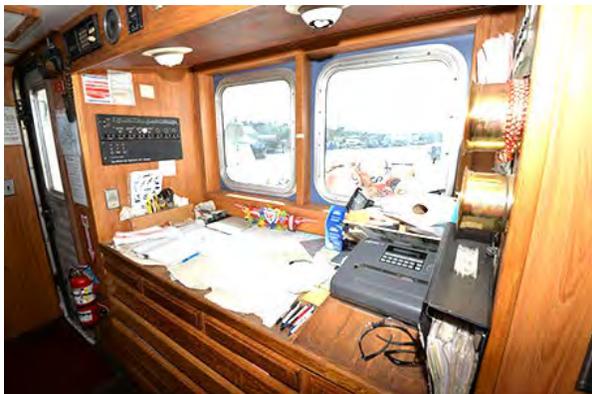
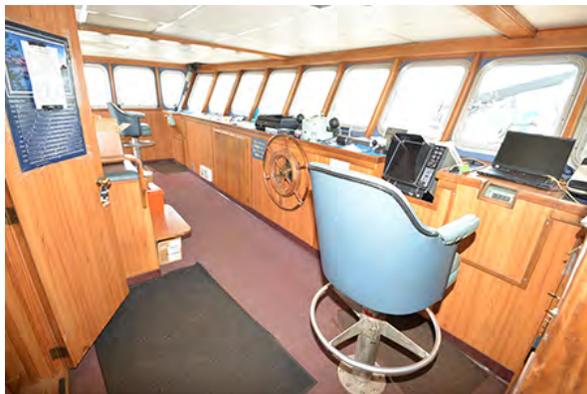
Wheelhouse Equipment and Electronics

Maneuvering stations with throttles and steering are port, starboard and center. Throttles operate a cable to pneumatic engine control system.

A Chart table is aft starboard. Eleven (11) viewports are found along the forward aspect of the wheelhouse. Three (3) are port and three (3) are starboard including opening ports two (2) port and two (2) starboard. Six (6) are aft. Four (4) forward viewports are fit with Timon, model S40 window heaters. Weather hatches are aft port and starboard. An inclined ladder to the 01 level is aft.

Chairs: port, starboard. and just starboard of center, two bench seats are aft. Access: port starboard and aft hatches.

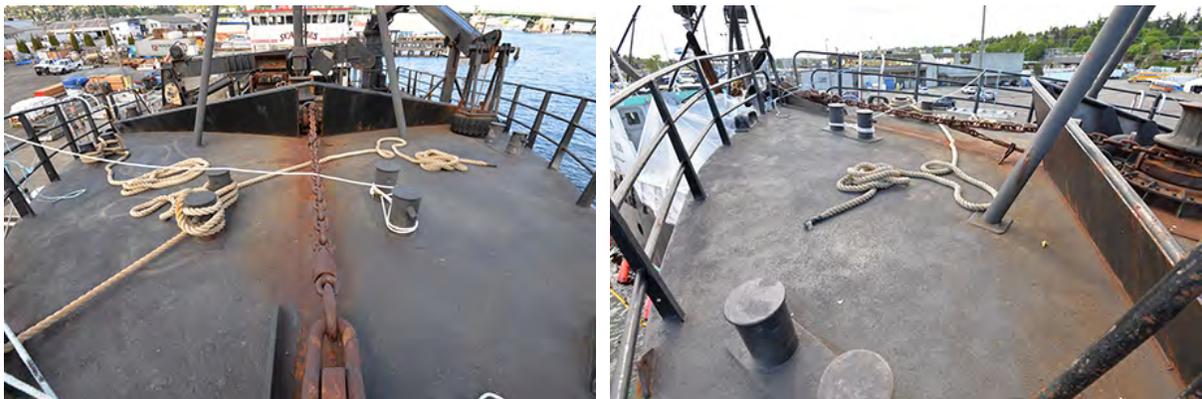
**Forward Weather Deck**

A full-width enclosed foc'sle carries a light mast, anchor gear, moorage tackle and other attachments as described below.

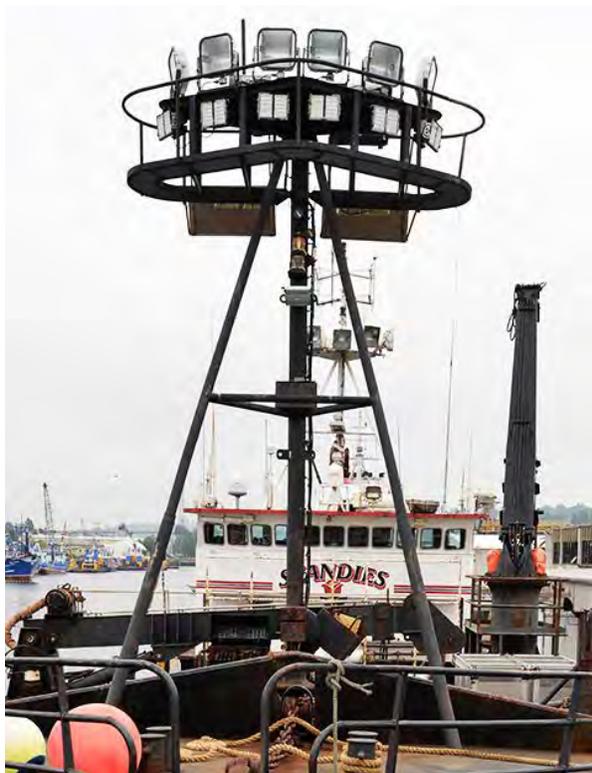
Light mast: Tripod style with a mast of 8" diameter pipe supported by 5" diameter pipe supports leading forward. The mast carries six (6) sodium fishing lamps and six (6) LED fishing lamps accessible from a guarded platform reached by a ladder up the aft side of the mast. Two (2) LED and one (1) sodium lamp are directed aft to the fishing deck.

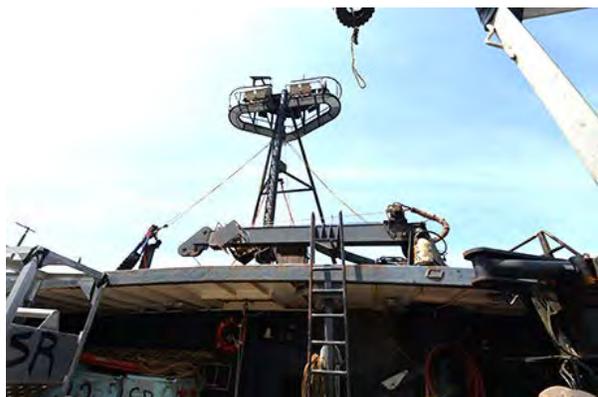
Railings: 3-tiered rail of 2" diameter pipe with a height of 43"

Wave Break: 40-1/2" high at center and 14" at the port and starboard rails

Ladders: a vertical ladder is through an opening in the deck starboard by the picking boom. A 56" x 48" hatch is aft in the shelter deck.

Crane and boom controls are starboard aft.

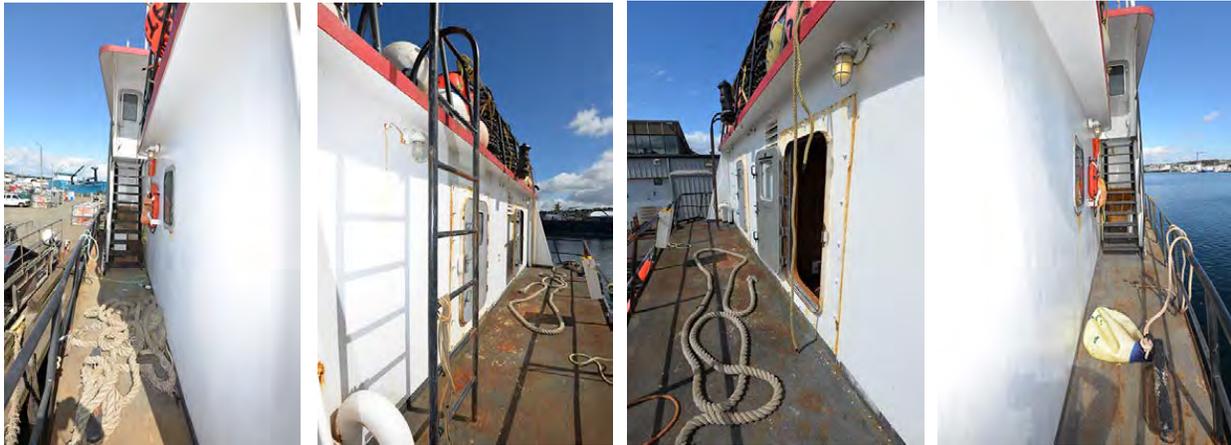
01 Level Aft House Deck

The 01 house level is a partial-width deckhouse with accommodations and utility spaces. Weather galleries with access ladderways are port, starboard and aft.

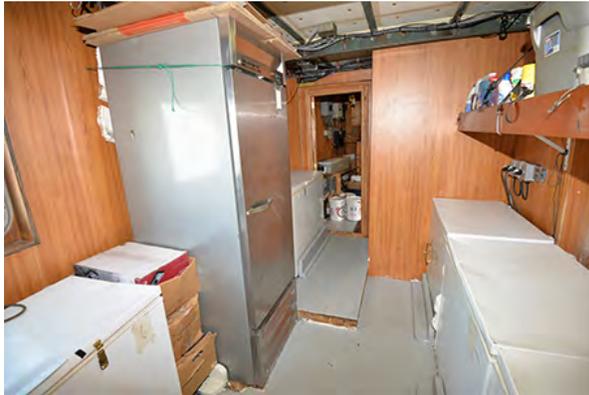
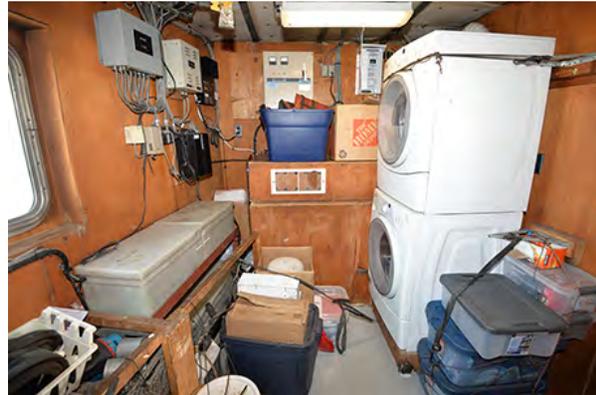
Forward starboard is an electrical equipment and utility space with DC systems, storage, high-pressure sodium lamp ballasts and supporting equipment for wheelhouse systems. The space also houses laundry equipment, including one (1) Whirlpool “Duet” stacked clothes washer and dryer. Port is a space with seven (7) chest freezers and a stainless steel “Beverage Air, model KR24-1AS upright freezer.

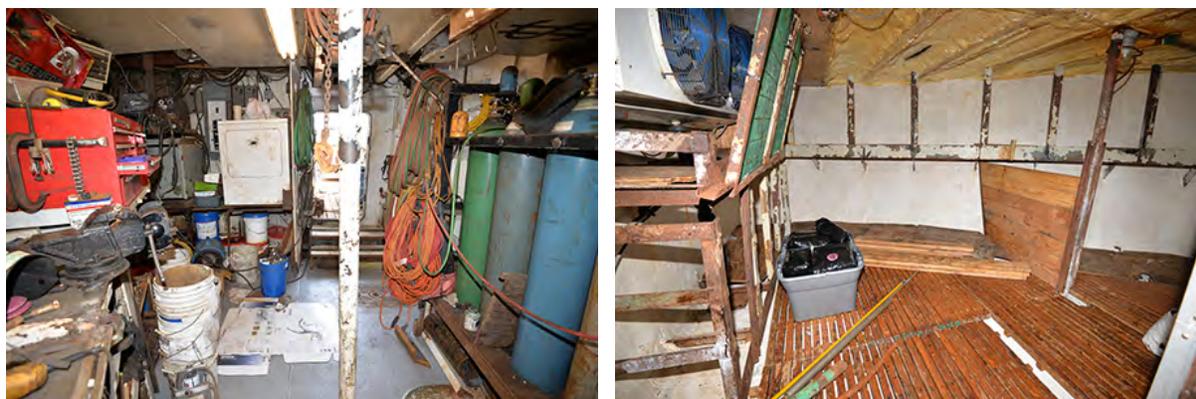
**Main Deck Forepeak**

Forward is storage. Aft starboard is a work and storage area with a workbench, parts bins, and equipment. Port is a bait freezer insulated with high density polyurethane foam coated on the bulkheads with FRP and a wood grate floor. Flush hatches in the deck are to a void forward, chain locker and gear storage below.

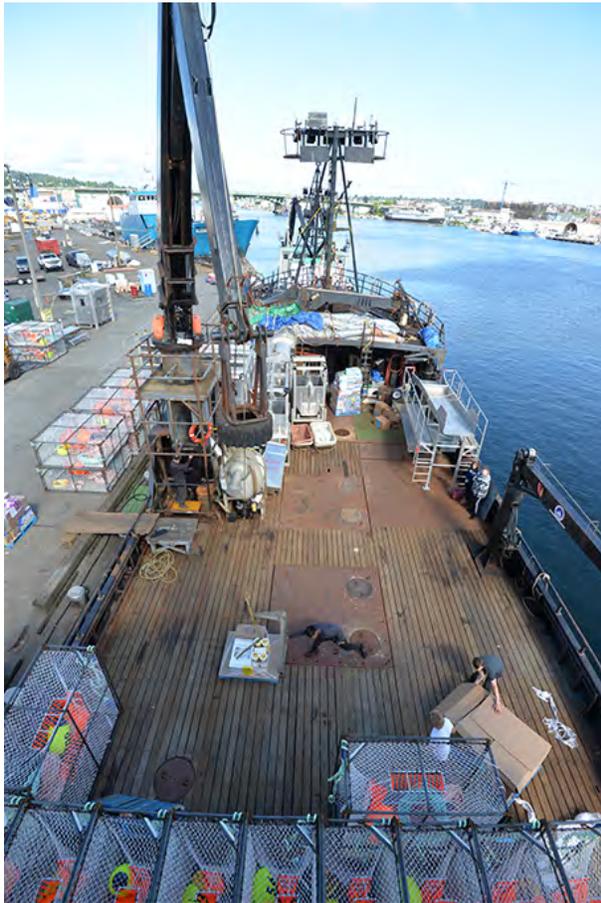
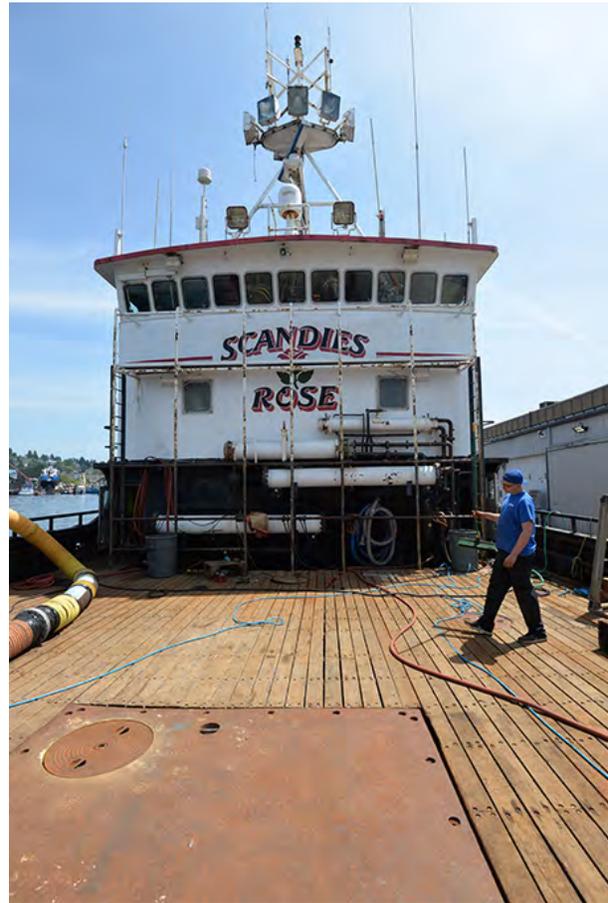
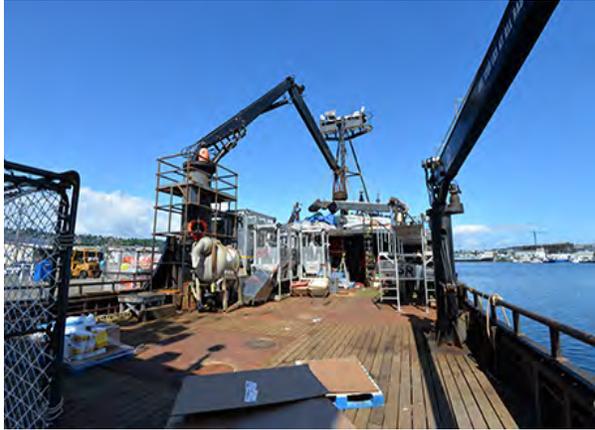
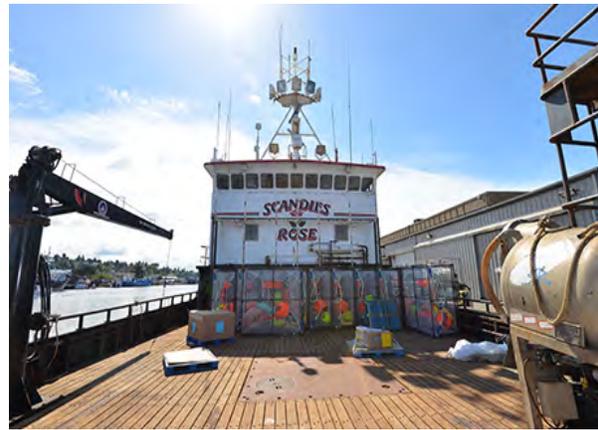
#### Main Weather Deck

Forward is a bulkhead with a watertight hatch to the forepeak. A shelter deck above extends aft 8-1/2 feet and is supported by a 4 x 4" steel post. A bait chopper and bait box is starboard. Crane and other hydraulic controls are starboard.

An aluminum crab sorting table on wheels is moved by a hydraulic pulley system running in a track below the work deck.

Aft are access hatched to anterooms port and starboard, each with a weather-tight hatch to the house. In front of the house are refrigeration chillers, a condenser and a receiver. A pot guard constructed of 2-1/2" pipe protects the house front and refrigeration machinery. Tonnage openings (2) are forward in the house bulwarks behind the chillers. Four (4) LED flood lamps are directed forward to illuminate the work deck.

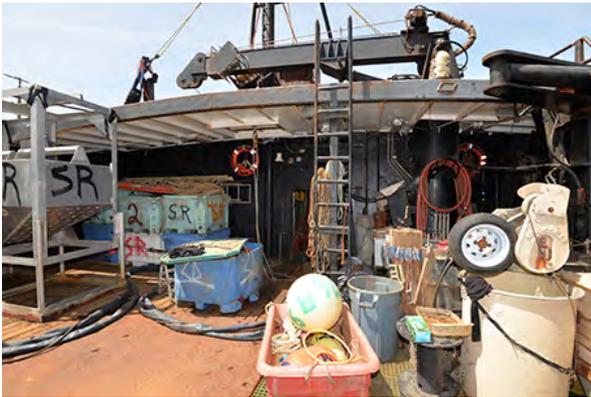
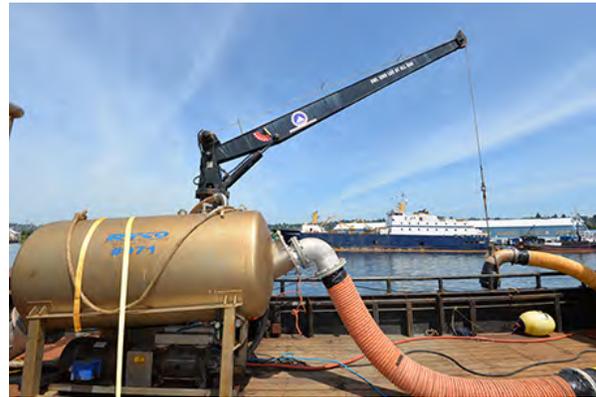
Tendering Gear:

- One (1) aluminum 3-station salmon sorting table
- One (1) aluminum dewatering box
- One (1) aluminum weigh box
- One (1) hydraulic power conveyor
- One (1) Transvac, single barrel model 4315A hydraulic driven auto-cycling fish pump.
- One (1) Ryan, single barrel model 971 electric auto-cycling fish pump.

Assortment 10" fish pump hoses and fittings.  
Salmon brailers and miscellaneous tender gear

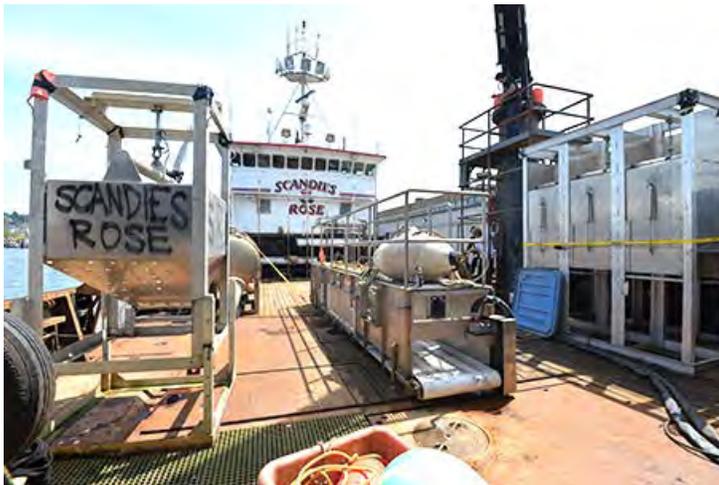
Starboard Crane - A straight-boom telescoping crane fit with two hydraulic rams on the main boom and two slewing motors is mounted atop a pedestal from the main deck and integral with the foc'sle deck. The boom carries a Pullmaster winch fit with 9/16" dia. braided line terminating with a safety hook. Controls are on the forepeak deck, forward starboard on the fishing deck, at the crane base and by a radio frequency portable control box.

Port Crane - A North American, model MCK 1250, 12-ton knuckle boom crane, is fit with two hydraulic rams on the main boom, a single knuckle ram and two slewing motors is mounted atop a pedestal of a 12' length of 40" diameter pipe and 5' length of 36" diameter pipe on the starboard mid-deck. The crane boom carries a hydraulic drum winch fit with braided line. Controls are on the forepeak deck, forward starboard on the fishing deck, at the crane base and by a radio frequency portable control box. The crane hydraulic power pack is in the base. The crane is fit with a rotating seal for 360-degree operation. The crane hydraulic power pack is in the base.

- e. A new deck crane was installed on the port fishing deck.
  - f. New stainless steel hydraulic tubing was installed below the wear deck to both deck cranes

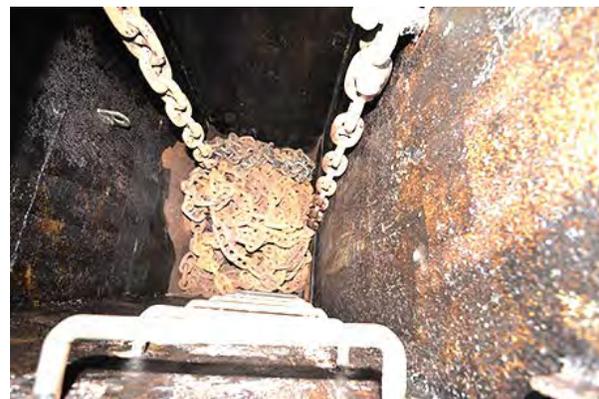
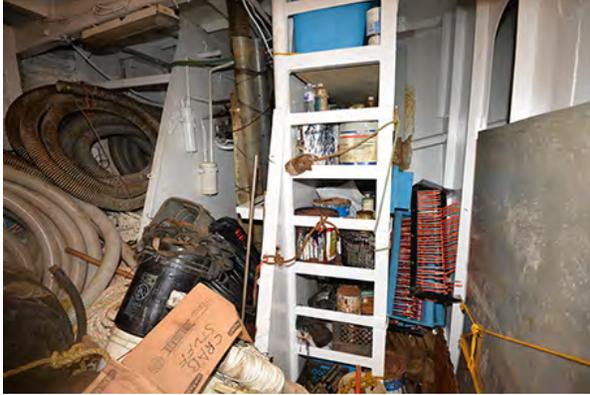
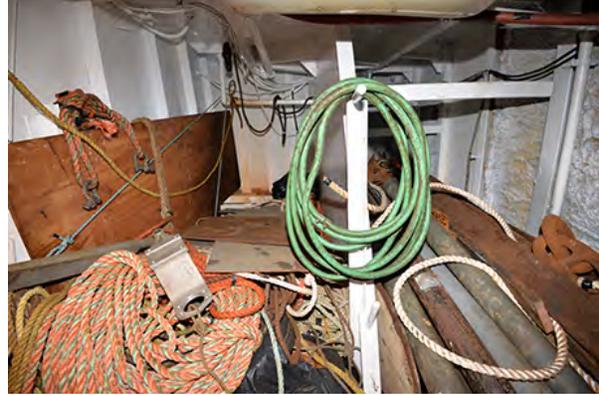
**Hull and Machinery Deck Arrangement**

A stem void is forward the collision bulkhead. Next aft is a chain locker. Next aft is gear storage accessed from the forepeak, fishing deck and forward hold. Next aft are centerline forward, center and aft flooded holds.

Fuel tanks are in the wings and below. Next aft is the main engine compartment with propulsion machinery, electrical power generation plants and ancillary machinery.

Aft is a steering room with the main AC switching panels, steering gear, workshop and part storage.

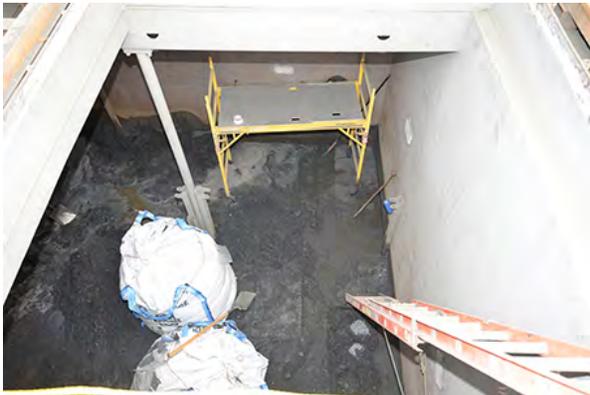
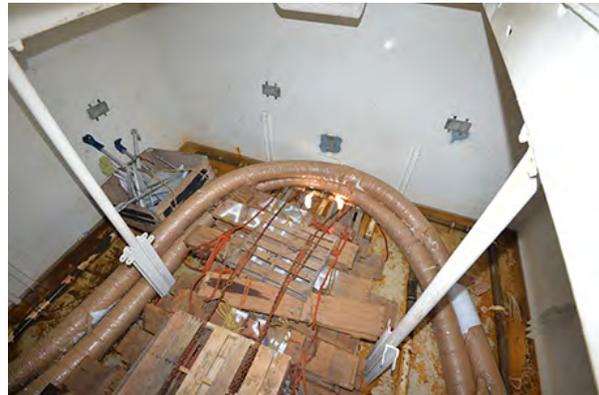
### Flooded Tanks

Flooded holds are arranged along the centerline forward, center and aft. Each tank is fit with 4" PVC circulation piping from 12" headers aft. A 10" PVC perforated drainpipe is aft in each tank. A sump is in the floor. Zinc anodes are spaced throughout. Tank bulkheads are double walled. Each has tank lights and bin-boards of 3" x 12" dimensional lumber.

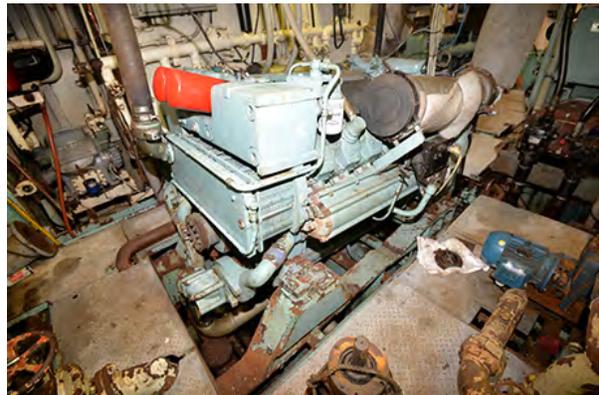
Reduction/Reverse gear: The engine is coupled to a Detroit Diesel Model DD-5202-V gear with a 5.04:1 reduction ratio.

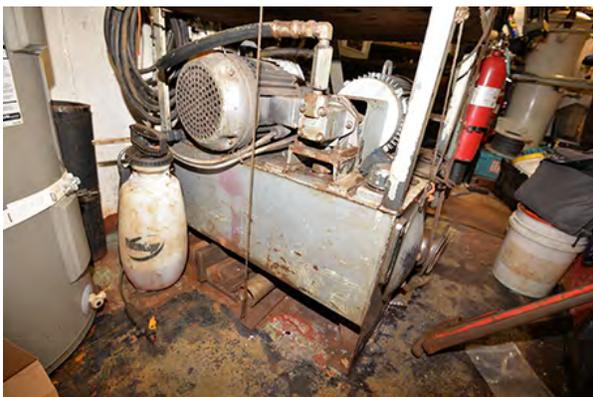
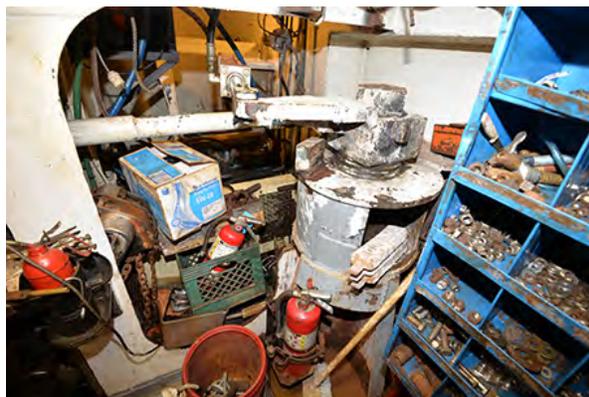
Rudders: Twin rudders are fitted with one (1) hydraulic ram each and are connected with a tie bar of 3" pipe. Each rudderpost is 3" stainless steel through a packing gland and supported by a rudder boot. Rudders are 82 x 58" steel with 4 x 5/8" longitudinal stiffeners. Rudders are bolted to the post and further secured with cement.

Steering Hydraulics: Sperry completely redundant system with Vickers directional solenoid valves and vane pumps driven by Lincoln 10 hp motors.

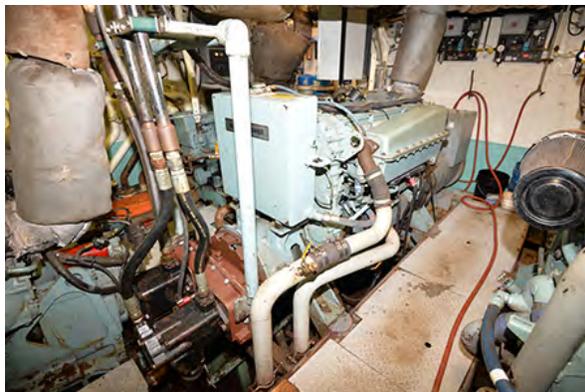
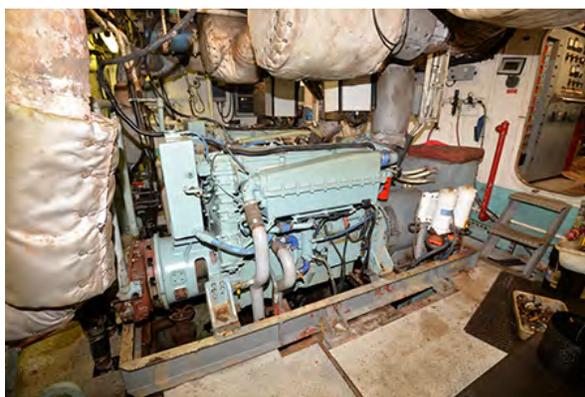
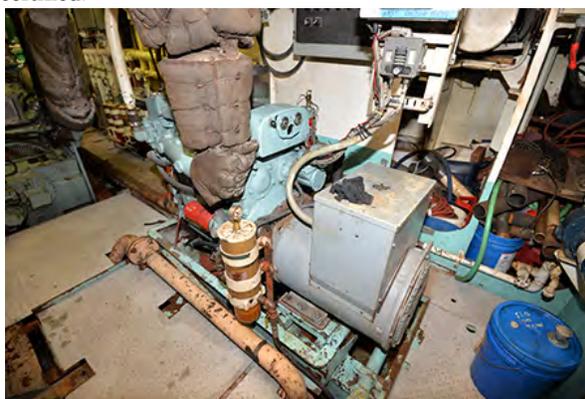
Family: CODXN14-0MCK 1R  
Serial Number: 06R1049889  
Horsepower: 525  
Service units: 19,409  
Armature: Magna Max 433 RSL 40 -294 kW: 300

Starboard side: Detroit Diesel 4-71  
Service units: 17,723  
Armature: Detroit Magna Max kW 75

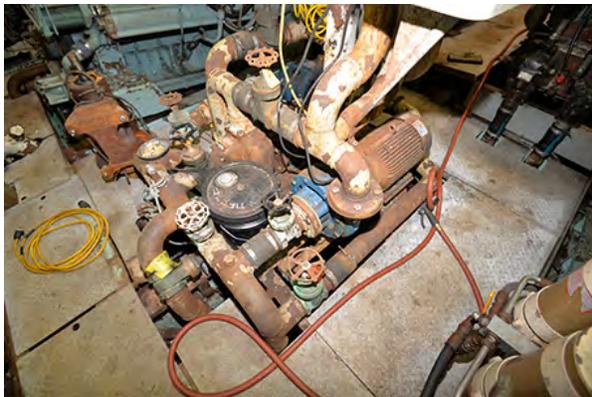
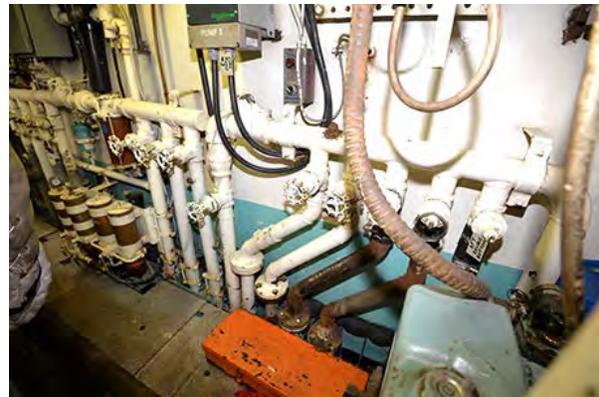
Bilge Pumps: a 10-hp motor drives a Carver centrifugal pump. A Barnes pump is driven by a 5-hp motor.  
Manifold: fire/wash-down and bilge – two (2) 3" headers with 2 ½ inch lines and gate valves.  
Suction locations: forward, center and aft in the steering room  
Suctions with screens: yes  
Suctions with openings 2.5 times the pipe diameter: yes  
Suction side strainer and manifold cleanouts: yes - Perko strainer on forward manifold.  
Emergency suction: two (2) 5" lines with knife valves from circulation pumps.  
The refrigeration condenser pump may be used as a bilge pump as well.

Waste oil pump: Roper pump driven by a Baldor, 2 hp motor.

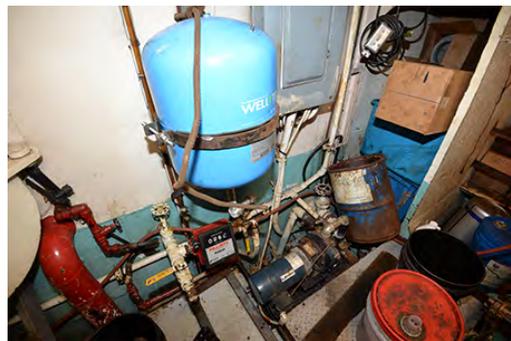
Flushing Pump: Jacuzzi "J-Class", model JRM1C1-C-SSI jetted pump with 1-hp motor. The discharge line is fit with a Well-X-Trol pressure vessel.

The pump is regulated by a demand pressure switch.

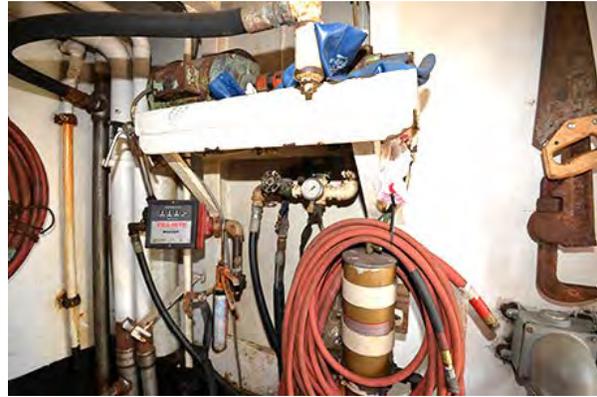
A fuel transfer pump is inside the port house deck hatch. A 3-hp Leeson motor drives a Roper pump. Attached are a Racor 75-1000 filter and a Fill Rite 800B fuel meter.

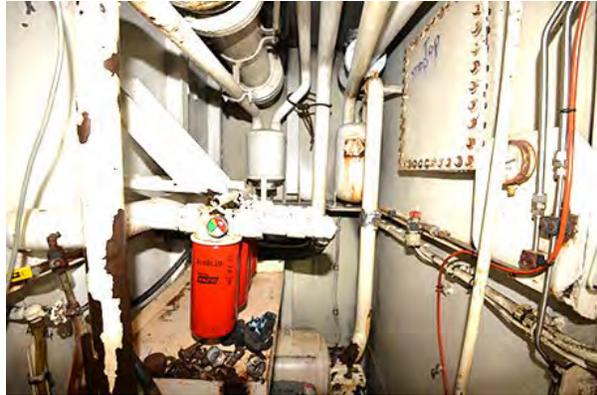
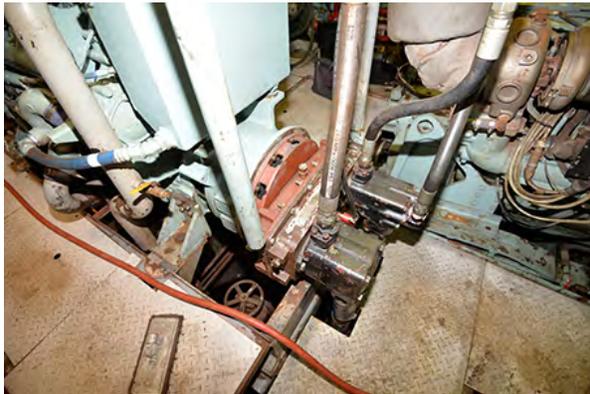
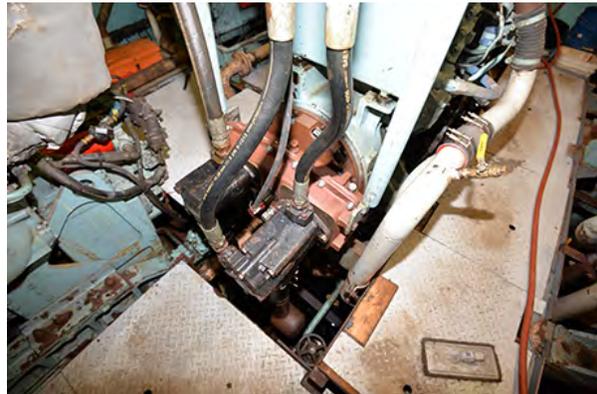
Each of the two (2) Detroit Diesel S60 engines is equipped with a Bevis air clutch driving a Vickers model 45V50A11A22R vane pump and a Vickers 3525V25A21111CC22R vane pump through a Marco Twin Drive model DC26-3-L211-1.1E-C4C4. The clutches are fit with Systems Engineering pneumatic controls.

The deck cranes have self-contained “power pack” units located in each crane base. The port crane contains a Denison, model T6CCWM-B17-014-2R pump driven by a 60kW motor.

Hydraulic oil tank: A 720-gallon integral tank is forward starboard, in the engine room. System filtration is through (4) Baldwin BT 388-10 return filters.

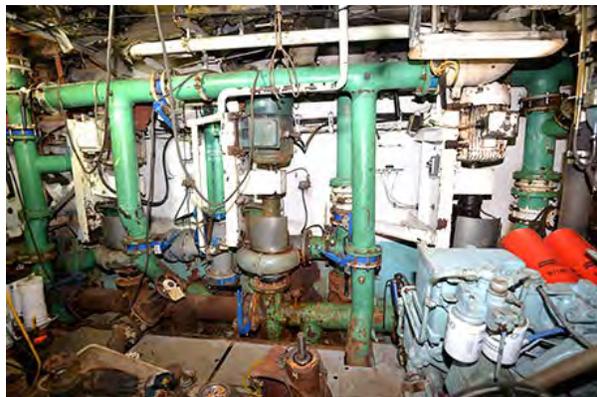
Pumps: Baldor 40-hp motors drive four (4) 8x6 Deming pumps. Lines to tanks are 8” with 6” diameter crossover piping and some 6” diameter steel pipe components to the RSW chillers. The steel piping has zinc sacrificial anodes and each pump is equipped with a flow alarm and butterfly valves. Each of the pump motors is controlled by a Schneider Electric “Altivar 212” AC Drive, model ATV 212HD37N4 6W1207000081.

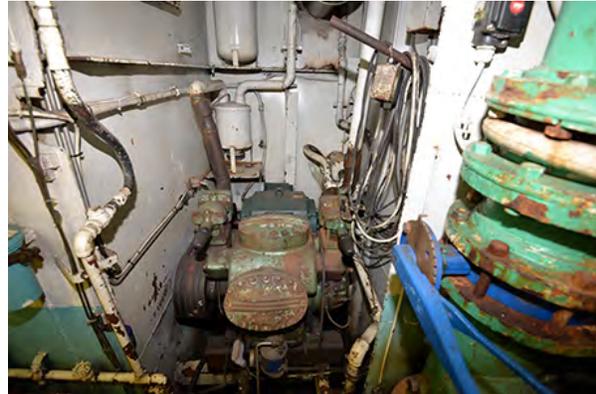
RSW system - three (3) Freon R-22 compressors (two Carrier 5H60 compressors and one Bitzner compressor) in the engine room are driven by a 50-hp motors via v-belts on pulleys. Each compressor is fit with a Schneider, model ATV212HD3704 variable frequency drive.  
The drives adjust the motor speed to the required flow of fluids.

The Bitzer system (one compressor) is independent from the Carrier system (of two compressors).
