INTENSIVE ENGINEERING INVENTORY AND ANALYSIS OF THE DALLAS FLOODWAY, DALLAS, TEXAS

Technical Report

This report is a cultural inventory and evaluation of the engineering components associated with the Dallas Floodway Project. It includes a historic context of the floodway as a flood control system and as the outgrowth of community planning. The historic context investigates the Dallas Floodway as a part of the larger Dallas Trinity Reclamation Project (1908–1959). This context is then used to identify the appropriate structural components of the floodway, record the current condition of each component, and evaluate the collective historical significance of these components and the floodway system as a whole.

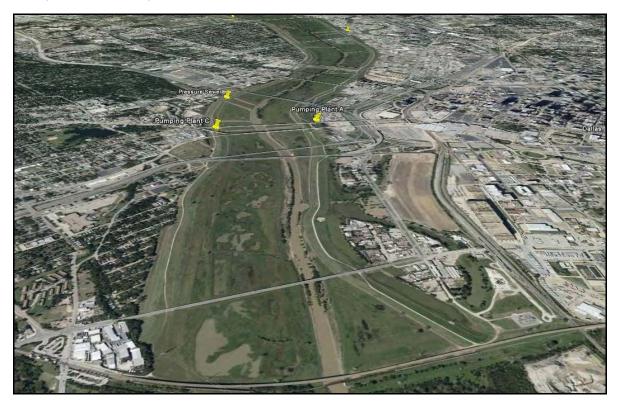
Figure 4-10. Dallas Floodway, 2009

Source: Google Maps

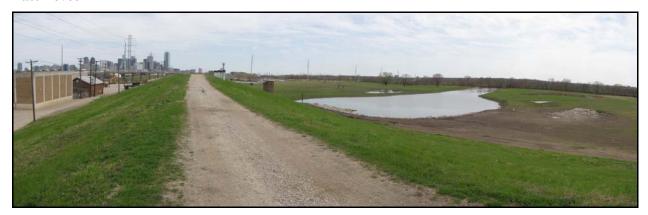
Figure 5-14. East Levee, Looking Northeast

The East Levee is an original resource to the 1929 floodway system (Figure 5-14). The levee runs a total of 11.9 miles to form the levee at the east and northeast side of the floodway system (HNTB 2009). It runs parallel with the West Levee for a distance of seven miles starting from the AT&SF Railroad crossing, Cockrell Avenue, and the DART line, running upstream in a northwest direction, turning toward the west before it curves sharply in the northeast direction in the vicinity of Irving Boulevard to follow the Elm Fork of the Trinity River's diversion channel. The East Levee along this latter northeast-southwest direction is also called the East Tie Back Levee, and terminates at the 60-inch E. B. I. Emergency Control Structure near Harry Hines Boulevard, due north of Regal Row. Two covered pipelines were observed during the field survey on the East Levee, and are located in the vicinity of the Hampton Road Bridge and the Westmoreland Road Bridge. Improvements in the late 1990s to improve drainage flattened the East Levee to a 4:1 slope and raised the crown by an average of two feet on the river side downstream of the Continental Street Viaduct. The fill used to buttress the levees was excavated materials from the diversion channel widening and from several borrow pits in the floodway (HNTB 2009).

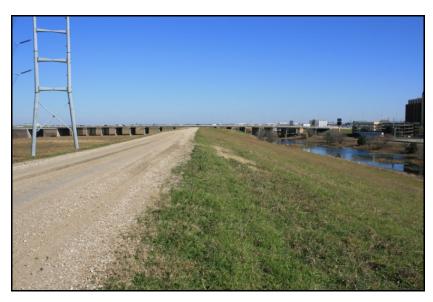
Figure 5-15. West Levee, Looking South

The West Levee, like the East Levee, is an original resource to the 1929 floodway system (Figure 5-15). The levee generally mirrors the East Levee and extends a total of about 10.9 miles to enclose the levee at the west and southwest sides of the floodway (USACE 1968). The West Levee runs parallel with the East Levee for a distance of seven miles starting from the AT&SF Railroad crossing at the south end, running upstream in a northwest direction, turning toward the west before it curves sharply to the south to follow the West Fork of the Trinity River to the Trinity Authority Waste Treatment Plant (USACE 1989). The West Levee terminates just beyond its intersection with IH-30. The West Levee runs adjacent to Oak Cliff at its southern end and borders West Dallas as it moves upstream and to the west. Two covered pipelines were observed during the field survey on the West Levee, and are located in the vicinity of the Hampton Road Bridge and the Westmoreland Road Bridge. Like the East Levee, improvements in the late 1990s to improve drainage flattened the West Levees to a 4:1 slope on the river side and added two feet to the crown in the vicinity south of the Continental Street Viaduct (HNTB 2009).

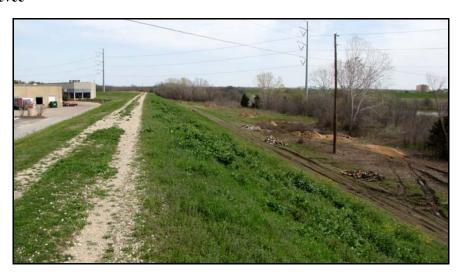
Figure 5-16. Northwest Levee, Looking North

The 2.8-mile-long Northwest Levee is located in the city of Irving at the northwest part of the Dallas Floodway system. Originally built in 1929 when the East and West Levees were built, the Northwest Levee was not significantly improved by the USACE in the 1950s (Figure 5-16). In 1974, the Irving Flood Control District No.1 raised and widened the levee from its original 2:1 slope to its current 3:1 slope. The Northwest Levee forms a continuous, angular semi-circle that extends approximately 2.8 miles around the city of Irving at the northwest portion of the Dallas Floodway. Although the Northwest Levee is continuous, the northwestern-most end of the levee, west of Loop 12, is called the North Levee Tie-In. The opposite southernmost portion is called the South Levee Tie-In. Both Tie-In segments are original to the Northwest Levee's design and construction in 1929-1932. The Northwest Levee currently has a 3:1 slope, but is slightly steeper in some places. The levee rises from 16 and 22 feet high from toe to crown, approximately 428 to 443 feet in elevation. The city of Irving's maintenance ends at the west bank of the Elm Fork diversion channel; Dallas controls the channel itself (Fennell, personal communication 2010). Although the USACE's 2008 Inspection Report found the levee's pumps and components in good working condition, the Northwest Levee's overall rating was "unacceptable" under FEMA's increased levee certification standards due to repair work that had not yet been completed (Sissom 2008). The Irving Flood Control District removed woody vegetation consisting mainly of mesquite trees from the North Levee Tie-In in 2006. In 2008, the Irving Flood Control District removed tree growth and woody vegetation from the South Levee Tie-In. After the vegetation was cleared, the levee was regraded and resurfaced with grass cover to its original design and construction. The levee was re-covered in grass and was reported in good condition in 2008 (Sissom 2008).

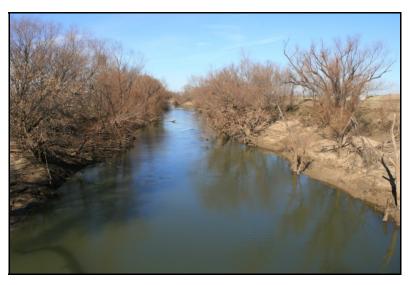
Figure 5-17. Main Diversion Channel

The Trinity River diversion channel is the relocated channel of the Trinity River (Figure 5-17). It is a manmade dredged channel that is partially lined with rock rip rap on its banks. The channel extends down the center of the floodway in a northwest-to-southeast direction, and is designed to carry redirected water from the original river bed and from stormwater outfalls of the Dallas Floodway interior drainage system for purposes of flood control and water supply. The Trinity River diversion channel also receives water aided by the pressure sewers and sluiceways that carry stormwater to the channel. Within the Dallas Floodway system, 15 miles of diversion channels and two miles of auxiliary channels divert waters draining to the Trinity River. This system includes the seven-mile main diversion channel that runs in between the East and West Levees from the approximate location of the AT&SF Railroad Bridge upstream to the northwest where the channel divides into the West Fork and the Elm Fork.

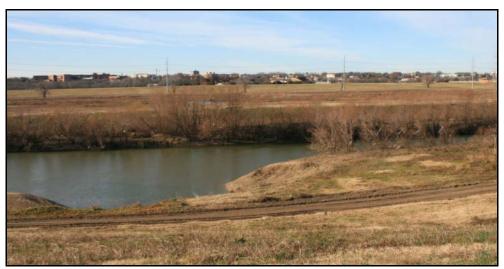
Figure 5-18. Main Diversion Channel

The main diversion channel extends approximately seven miles down the center of the Trinity River floodway from the channel's fork downstream to the approximate location of the AT&SF Railroad Bridge (Figure 5-18). This channel runs down the floodway's center, parallel with and in between the East and West Levees at the overbank edges.

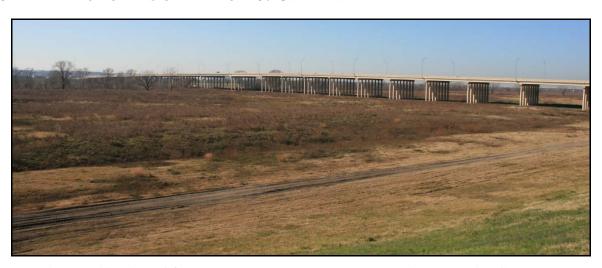
Figure 5-19. View of Overbank near the Hampton Road Bridge, Looking Southwest

The overbank is the area of land between the diversion channel and the levees throughout the floodway system (Figure 5-19). The overbank contains the Trinity River channel at its center and measures approximately 2,000 to 3,000 feet between the levee toes. The overbank encompasses the area between the West Fork Diversion Channel and the West Tie Back Levee, and the land between the East Tie Back Levee and the Northwest Levee at either side of the Elm Fork Diversion Channel. Beginning at the confluence of these two channels, the main Trinity River Diversion Channel extends the 7-mile distance

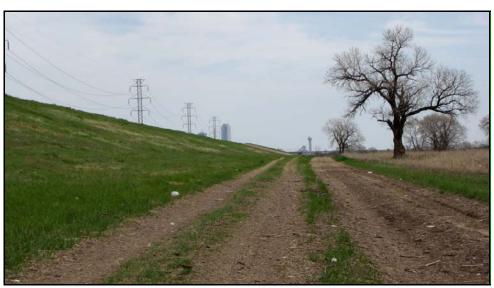
Figure 5-21. Roadway at the East Levee toe

Roadways within the overbank consist of the unpaved dirt or aggregate roadways at the levee toes (Figure 5-21). These roadways extend virtually the entire length of the overbank along the East and West Levees, and maneuver around the bridge footings as necessary. The only connection between these two levee roadways is via an unpaved east-west road that runs underneath the Hampton Road Bridge and crosses over the Trinity River diversion channel on a low bridge. All of these roadways are restricted access by the city of Dallas maintenance and monitoring, and are not open for public use.

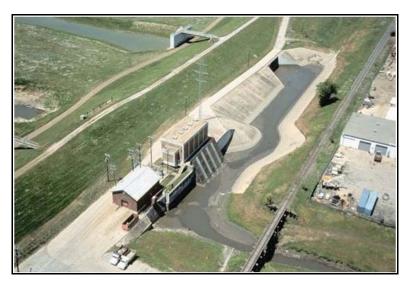
Figure 5-22. Aerial View of the Pumping Plant B (Baker) Facility

Pumping plants are facilities that contain the pumps necessary for moving water from one location to another. Six plants are located adjacent to the land sides of the East and West Levees (Figure 5-22). The East and West Levee pumping plants hold anywhere from two to five pumps and serve to handle any water the sluiceways cannot store. Two pump stations are located at the Northwest Levee, and include one pump each. Pumping plants contain pumps in a room over a discharge chamber, which diverts the water from the plant into the overbank area through an underground sluiceway that leads to the outlet gate structures. Open sump areas are adjacent to the pumping plants to collect drained stormwater.

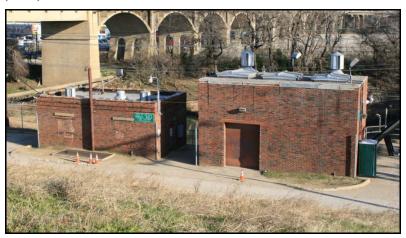
Figure 5-23. Pumping Plant A (Able)

The Pumping Plant A (Able) complex consists of two pump houses, one constructed in 1929 and one in 1953. The 1929 pump house, commonly referred to as Small Able, is a one-story, rectangular building clad in variegated red-brick masonry, with a flat, parapet roof, and a concrete foundation (Figure 5-23). The roof is covered in rolled asphalt with a course of tile covering the parapet cap. The tile includes the inscription *W.S. Dickey Texarkana*, possibly indicating where the tile was manufactured. The parapet is distinguished by a course of vertical stretcher-bond brick framed by a single band of protruding horizontal brick course around all four sides of the building. The building retains its original multi-light windows with concrete sills and lintels. The building's south façade contains two windows with concrete lintels that are filled in with brick. The west façade contains one four-light window on the northern bay of the façade, and a metal, overhead, rolling garage door on the southern bay; both have metal lintels. This pump house contains two axial flow pumps manufactured by Fairbanks Morse and Company, a 36-inch gate valve and a 36-inch check valve, two 4- x 4-foot sluice gates, and two 3- x 3-foot sluice gates. Pumping Plant A (Able)'s intake structure was built in 1932 (City of Dallas Flood Control District 2010).

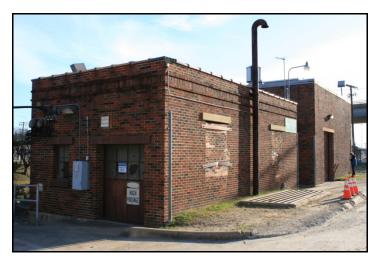
Figure 5-24. Pumping Plant A 1929 Pump House at Left, 1953 Pump House at Right

The 1953 pump house associated with Pumping Plant A is commonly referred to as Large Able. This building is a one-and-one-half story, rectangular structure clad in variegated, rough red brick with a flat roof (Figure 5-24). The south façade contains a one-bay overhead garage door with a metal lintel. The east façade contains a set of metal double-doors in its northern bay with a plaque stating "Addition to Pumping Plant 'A' Dallas Floodway Project, Constructed by Corps of Engineers, U.S. Army in Cooperation with Dallas County Flood Control District, 1953." This pump house contains three axial flow pumps manufactured by the Peerless Pump Division, Food Machinery & Chemical Corporation out of Los Angeles, California. Additionally, the pump households three lubricating oil reservoirs and oil lines, an 8-ton trolley-type, spur-geared hoist with bridge manufactured by Robbins & Myers, Inc. from Springfield, Ohio; two water level recorders manufactured by Leupold & Stevens Instruments, Inc. from Portland, Oregon; a water level control manufactured by Healy Ruff Company; and an air compressor manufactured by Binks Manufacturing Company from Chicago, Illinois.

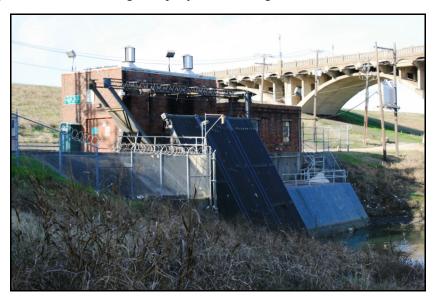
Figure 5-25. Pumping Plant A Trash Rack and Sump Area, at Right

The sump area for the Able Pumping Plant is located on the north side of the structure. This sump is served by an intake structure that adjoins the two pump houses on the north (Figure 5-25). This intake structure consists of approach wing walls and apron, a raking platform, and trash racks. The trash racks are located along the north façade of the pump houses, with the shorter of the two racks associated with Small Able and the larger of the two associated with Large Able.

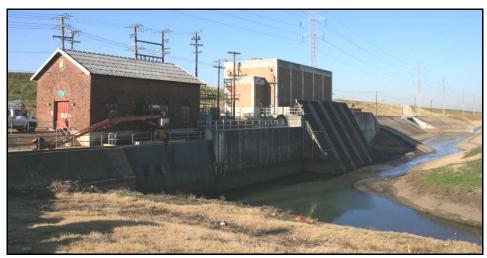
Figure 5-26. Pumping Plant B (Baker)

Figure 5-27. 1929 Pump House at Pumping Plant B (Baker)

Pumping Plant B consists of two pump houses (Figures 5-26 and 5-27), an intake structure, four gravity sluices, and an outlet structure. The original pump house, constructed in 1929, is a one-and-one-half story building clad in rough, variegated red brick with a concrete foundation. The building has a medium-pitch, front-gabled roof covered in concrete tiles. The primary entrance to the building is located on the east façade. This metal, double door is located under a brick-in-filled segmental arch and includes multi-light windows above it. Above this entrance is a sheet metal sign which reads "City of Dallas Old Baker Pump Station Flood Control Div." Four in-filled windows with segmental arches are located on the south façade, while three in-filled windows with segmental arches are located on the west façade. The north

façade contains four multi-light windows under segmental arches. These windows appear to be original, but the building's 1928 construction drawings indicate that fan lights were originally within the arched portion of the window openings that are now covered. Three circular brick design elements are interspaced between the window bays roughly two feet below the roofline. According to the original drawings, these portal window elements have always been blind, i.e. filled-in by a brick panel. The pump house contains four screw-type pumps manufactured by Fairbanks, Morse and Company; four gate valves one trolley type chain hoist with a chain operated bridge and two vacuum pumps.

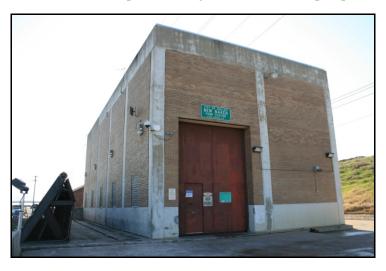
Figure 5-28. 1975 Pump House at Pumping Plant B (Baker)

The second pump house associated with the Baker Pumping Plant was constructed in 1975 (Figure 5-28). This building is a rectangular, poured-concrete structure with brick panels to match the exterior of the adjacent 1929 pump house. The south façade contains five bays of brick interspersed with concrete. A small, rectangular extension is located on the east façade that measures roughly 10 x 18 feet. The west façade contains an oversized garage bay with a metal door. Within the oversized bay is a personnel door. The north façade contains five vents located within the brick bays. Located along the north façade is the trash rack for the pumping plant.

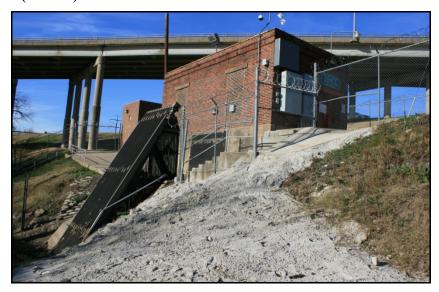
Figure 5-29. Pumping Plant C (Charlie)

Pumping Plant C consists of two pump houses, intake structures, two gravity sluices, and an outlet structure (Figure 5-29). The pump house, constructed in 1929, is a one-story, rectangular building clad in horizontal, variegated rough red brick with a flat, parapet roof and a concrete foundation. The flat, parapet roof is covered in rolled asphalt with a course of tile covering the apex of the parapet. Roughly one foot below the apex of the roof, a course of vertical brick flanked by a band of protruding horizontal brick wraps the building. The building contains in-filled window bays with concrete lintels. The north façade contains two in-filled window bays while the west façade contains one in-filled window bay. The east façade contains a metal overhead garage door in the northern bay. The pump house contains two open suction centrifugal pumps, two vertical pumps manufactured by Fairbanks, Morse and Company; two hand-operated gate valves; two sluice gates with two motor driven hoists; and two sluice gates with two hand-operated gates hoists.

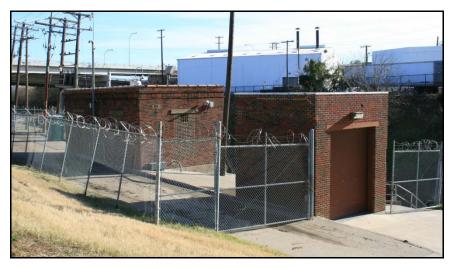
Figure 5-30. Pumping Plant C (Charlie), 1929 Pump House at Left, 1956 Pump House at Right

A second pump house, built in 1956, is located directly east of the 1929 pump house at Pumping Plant C (Figure 5-30). It is a utilitarian one-story, rectangular, brick-clad building with a flat roof and a metal overhead garage door on its east façade.

The remaining structures associated with Pumping Plant C include an intake structure that is adjacent to the pump house. The intake structure consists of concrete approach, wing walls, apron, a raking platform, and metal trash racks. Two gravity sluices measuring 4 x 4 feet pass through the levee at Plant C with a gated control structure and a flap gate on the outlet gate structure of each sluice. Additionally, the gated control structure on the riverside of the levee contains two 4- x 4-foot sluice gates run by two hand-operated gate hoists. Access to Pumping Plant C is restricted by a six-foot chain-link fence.

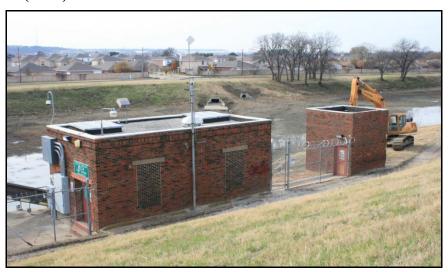
Figure 5-31. Pumping Plant D (Delta)

Pumping Plant D (Delta) consists of two pump houses, an intake structure, two gravity sluices, and an outlet structure. The pump house, constructed in 1929, is a one-story, rectangular building clad in horizontal, variegated red brick with a flat, brick-parapet roof (Figure 5-31). The roof parapet is ornamented by a course of vertical brick flanked by a band of protruding horizontal brick above and below it, and wraps around all sides of the building. The building contains two bricked-in window bays on the north façade, and a metal entrance door on the east façade. The pump house contains two vertical pumps manufactured by Fairbanks, Morse, and Company; two hand-operated gate valves; two sluice gates operated by two motor-operated gate hoists; and two sluice gates operated by two hand-operated gate hoists.

wing walls and apron, a raking platform, and metal trash racks. The two gravity sluices associated with Plant D were built in 1932 and are 4 x 4 feet in size. They have a gated control structure on the riverside of the levee and a flap gate on the outlet of each sluice. The gated control structure on the riverside of the levee consists of two 4- x 4-foot sluice gates which are run by two hand-operated gate hoists. The associated outlet structure consists of a concrete headwall, wing walls, and an apron. Access to Pumping Plant D is restricted by a six-foot chain-link fence.

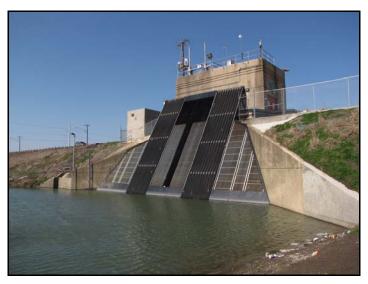
Figure 5-32. Pavaho Pumping Plant

The Pavaho Pumping Plant consists of a pump house and its adjoining building, a discharge chamber, an inlet structure, and an outlet structure (Figure 5-32). The pump house, built in 1954, is a two-story, concrete structure with a flat roof and a concrete foundation (Figure 5-33). The building contains no windows and has a double door entrance on the east façade. The pump households two vertical mixed flow pumps manufactured by Economy Pumps, Inc. from Philadelphia, Pennsylvania; two grease lubricating systems manufactured by the Farval Corporation of Cleveland, Ohio; a water level recorder manufactured by Leupold & Stevens Instruments, Inc. of Portland, Oregon; an 8-ton trolley type spur geared hoist with bridge; a water level control manufactured by Healy Ruff Co.; two motor-operated sluice gate hoists' and two 6- x 8-foot sluice gates. The associated building is a small rectangular building directly west of the pump house with a metal overhead door on the west façade.

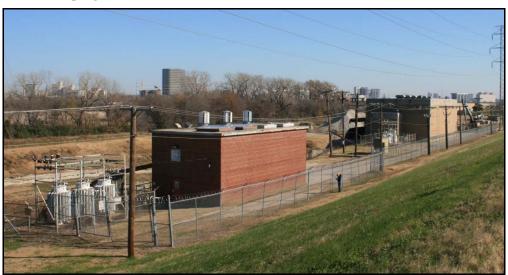
Figure 5-34. Hampton Road Pumping Plant

The Hampton Road Pumping Plant consists of two pump houses, an adjoining intake structure, four discharge pipes, and an outlet structure (Figure 5-34). The original pump house, known as Old Hampton, was constructed in 1956. It is a one-story, rectangular building clad in horizontal, variegated red-brick veneer with a flat roof and metal trim (Figure 5-35). The east and west façade each contain one metal door for entrance to the building. This building contains four vertical mixed flow pumps manufactured by

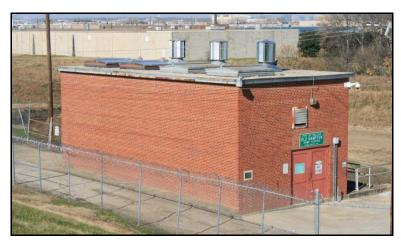
Economy Pumps, Inc. of Philadelphia, Pennsylvania, with three phase motors manufactured by Ideal Electric Company of Mansfield, Ohio; four grease lubricating systems manufactured by the Farval Corporation of Cleveland, Ohio; an 8-ton trolley type spur geared hoist; a top running hand-geared crane; a four-element float switch; six metal clad switchgear cabinets housing five oil circuit breakers, control switches and other control equipment; a 10 KVA single-phase dry type transformer; and a 24-volt battery and NEMCO battery charger.

Figure 5-35. 1956 Pump House

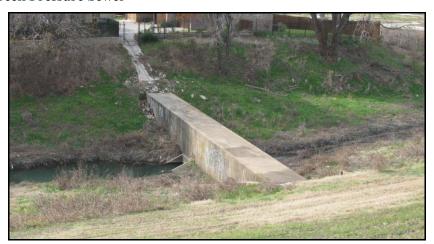
Figure 5-38. Enclosed Concrete Culvert Associated with the Coombs Creek Pressure Sewer

The "Old" Coombs Creek Pressure Sewer (also known as Little Coombs) is located at the West Levee, upstream from the Houston Street Viaduct (Figure 5-38). It consists of an emergency spillway, storm sewer, and conduit. The pressure sewer itself measures 18.5 feet with a 40-foot trash rack at the intake area. Near the riverside of the levee, an 18.5-foot semi-elliptical conduit transitions to four 8- x 10-foot passages into a gate well. Another four 9- x 11-foot passages lead from the gate well into the outlet, with four gate passages controlled by slide gates. The four associated slide gates are run by hand-operated floorstands or portable hoists provided at the Turtle Creek Pressure Sewer. The storm sewer measures 6 feet and has a gated control and a hand-operated hoist (USACE 1969). Two vertical intakes measuring 7 x 8 feet are protected by trash racks. Its capacity is a little more than 3.1 million gpm (Furlong et al. 2003, 5).

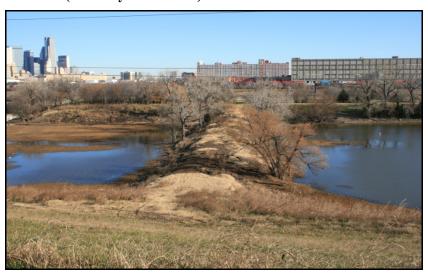
Figure 5-39. Berm Covering the Underground Belleview Pressure Sewer

The Belleview Pressure Sewer is located at the East Levee upstream from the Corinth Street Viaduct (Figure 5-39). Originally known as the Mill Creek Pressure Sewer, the Belleview Pressure Sewer differs from the other pressure sewers in the Dallas Floodway in design. This pressure sewer has a width of 16 feet and a height of 12.8 feet and is a modified horseshoe shape. The associated storm sewer is controlled by a gated control feature similar to the Dallas Branch Pressure Sewer in its operation; however, the gate on the Belleview Pressure Sewer measures 12 x 17 feet. The Belleview Pressure Sewer has more than 2.6 million gpm in capacity.

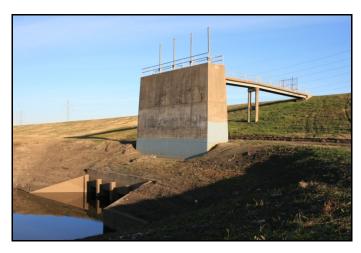
Figure 5-40. Turtle Creek Outlet Gate Structure

Outlet gate structures are outspill structures that carry stormwater from the pressure sewers and pumping plant facilities out to the river channel to avoid flooding. Although they are connected to the pumping plants and pressure sewers, they are physically separated from these facilities by the levee walls, and their location of the inside of the overbank. The outlet gate structures carry discharged stormwater to the interior of the floodway via concrete box culverts (Figure 5-40).

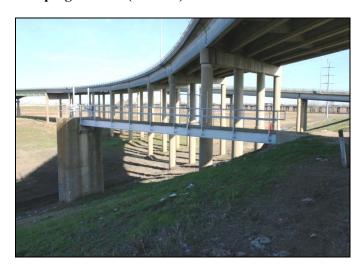
Figure 5-43. Pumping Plant C (Charlie) Outlet Gate Structure

Pumping Plant C has a gate control structure consisting of two 4- x 4-foot sluice gates with two 4- x 4-foot flap gates and corresponding control valves (USACE 1969) (Figure 5-43).

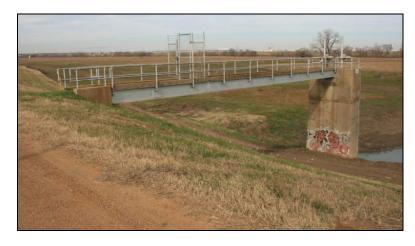
Figure 5-44. Pumping Plant D (Delta) Outlet Gate Structure

Like Pumping Plant C, Pumping Plant D has a gate control structure consisting of two 4- x 4-foot sluice gates with two 4-foot flap gates and corresponding control valves (USACE 1969) (Figure 5-44).

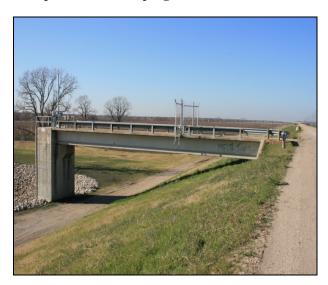
Figure 5-45. Hampton Road Pumping Plant Outlet Gate Structure

The Hampton Road Pumping Plant has a gate control structure consisting of one hoist and stem. The flap gates on the outlet are recessed at the back of retaining wingwalls. Large rip rap lines the top and sides of the end of the discharge channel.

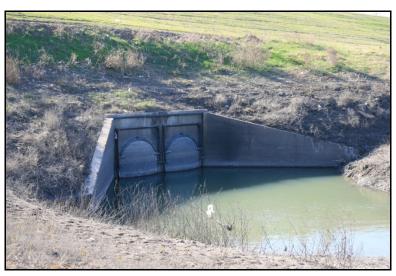
Figure 5-46. Pavaho Pumping Plant Outlet Structure

The Pavaho Pumping Plant's Outlet Gate Structure lacks a hoist tower, but consists of a headwall, wing walls, and apron with flap gates on the outlets (Figure 5-46). The discharge chamber consists of two 6- x 8-foot sluice gates for control of gravity flow with motor-operated floorstands to operate the gates located in the pump house.

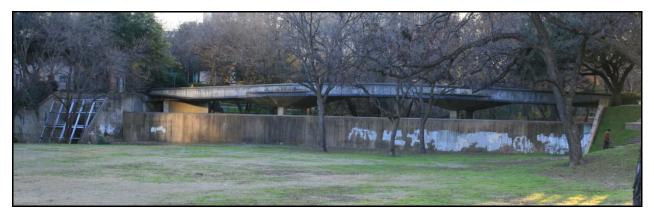
Figure 5-57. View toward Turtle Creek Intake and Adjacent Concrete Wall of its Diversion Dam

The Turtle Creek Intake structure is located near Fairmount Street. It consists of a diversion dam across Turtle Creek, with a 175-foot concrete spillway overflow as well as two earthen overflows that are 100-feet in length (Figures 5-56 and 5-57). Downstream of the spillway overflow is a concrete stilling basin with two rows of baffle blocks. The entrance to the intake is covered by an angled trash rack, which leads to an underground poured concrete approach channel to the East Levee that is 7,800 feet long (USACE 1969).

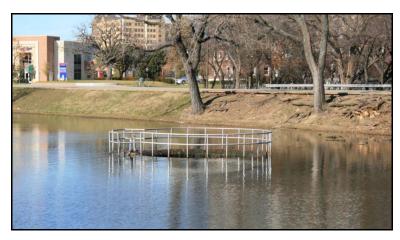
Figure 5-58. Lake Cliff Intake

The Lake Cliff intake structure is a circular spillway located within Lake Cliff in the Oak Park neighborhood of Dallas (Figure 5-58). A concrete, cylindrical stem structure rises from the lake bed and opens vertically and is flush with the surface water. The top of this opening is enclosed by a metal-pipe handrail. The base of the structure is then connected to a pressure sewer that runs under the lake and the adjacent Colorado Boulevard (USACE 1969).

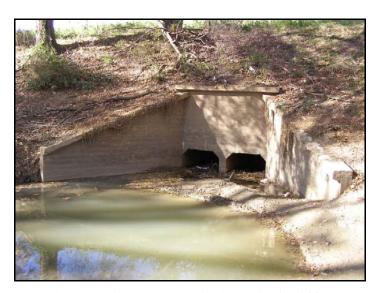
Figure 5-59. Eagle Ford Sluice (USACE 2007)

The Eagle Ford Sluice is located in the 2,000-acre Eagle Ford and West Fork area adjacent to the West Levee. The sluice is a two-cell 4-foot, 6-inch by 4-foot, 6-inch box conduit with an automatic flap gate and a hand-operated sluice gate (Figure 5-59). It includes an outlet structure (USACE 1969).

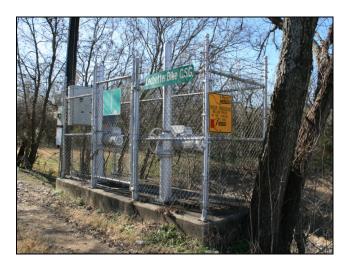
Figure 5-60. Ledbetter Dike C.S.G.

Located in the old channel of the West Fork of the Trinity River adjacent to the intersection of Kilgore Street and Ledbetter Drive, the Ledbetter Dike C.S.G. (also known as Canada Drive Sluice and Dike) contains two drainage ditches with an earthen causeway between them and two pumps within the berm. As designed, the Ledbetter Sluice and Dike is an earth dike with a maximum height of 30 feet with a 10-foot crown, seal coating, and a 3:1 side slope (Figures 5-60 and 5-61). Additionally, the Ledbetter Dike was designed to contain two 48- x 72-inch concrete sluices with hand-operated hoists to control the gates (USACE 1960). A later modification in the 1960s added a gate-control structure, a two-cell 4- x 6-foot conduit, and an intake and outlet structure for that conduit (USACE 1969). In the 1990s, automated gate operators were added to allow for remote operation and pressure transducers were installed for reading water levels on both the upstream and downstream sides (City of Dallas Flood Control District 2010). The Ledbetter Dike C.S.G. is connected to Pumping Plant D (Delta) via the old river channel of the West Fork

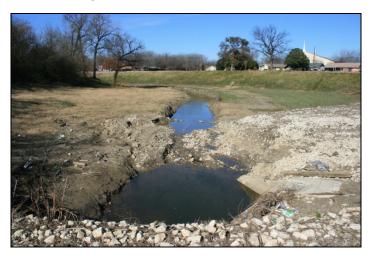
Figure 5-61. View West of Ledbetter Dike C.S.G. Drainage Ditch

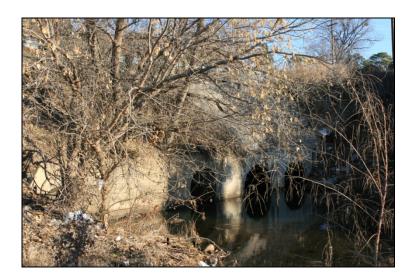
Figure 5-62. Grauwyler C.S.G.

The Grauwyler C.S.G., or culvert, located at Grauwyler Road, consists of an intake structure with a 60-inch diameter sluice gate at the opening of a 60-inch diameter concrete pipe culvert (USACE 1969) (Figure 5-62). The original culvert was modified with a Control Gate Structure in 1960. As with the Ledbetter Dike C.S.G., automated gate operators to allow for remote operation and pressure transducers for reading water levels on both the upstream and downstream sides were installed in the 1990s (City of Dallas Flood Control District 2010). The Grauwyler C.S.G. is connected to the Hampton Pumping Plant via the old river channel of the Elm Fork of the Trinity River, where the stormwater collects at the pumping plant's sump for drainage into the floodway.

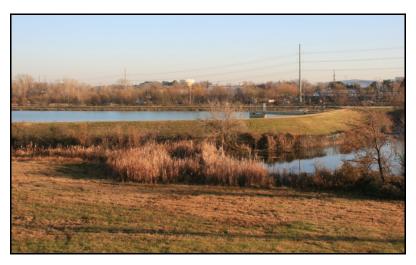
Figure 5-63. Sump Ponds near Harry Hines Boulevard

The sumps are drainage ditches that collect local stormwater runoff and discharge it into culverts throughout the floodway system (Figure 5-63). They are most often located next to the land side of the levee walls where stormwater collects, with a 15- to 40-foot distance between the levee toe and the sump. The sump's angled sidewalls range from 1:1 to 1.5:1 or 1:3 in slope, and are an average of 20 feet deep. Their shape can vary widely to accommodate the topography or structures in their location. Sumps are typically located adjacent to pumping plants where large sumps exist outside of the levees. Low-lying sumps, or wetland sumps, often contain permanent water and thus also contain vegetation.

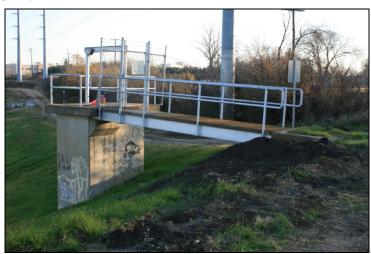
Figure 5-64 60-inch E. B. I. Emergency Control Structure

The 60-inch E. B. I. Emergency Control Structure is located at the end of the East Tie Back Levee near Harry Hines Boulevard, due north of Regal Row (Figure 5-64). The structure is adjacent to a sump pond and the Park Cities Water Treatment Plant. This facility is a bulkhead gate structure surrounding a 5-foothigh horseshoe conduit, and measures 5 feet, 8 inches by 6 feet in 9-inch-thick concrete (USACE 1969). The structure includes a small outlet gate structure including a concrete tower housing gate hoists for the sanitary sewer culvert below it (USCAE 1956).

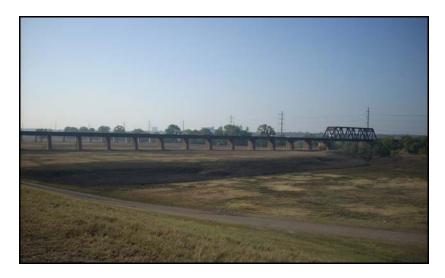
Figure 5-67. Union Pacific Railroad Bridge, Looking Southwest

Twenty-two bridges, including the ruins of a former bridge, cross over the floodway (see Table 3-3 Bridges over the Dallas Floodway). The bridges' supporting piers' footprint within the overbank varies by bridge, but generally consists of concrete footings underneath the bridge spans (Figure 5-67). These footings do not impact the function of the floodway's overbank area during flood events.

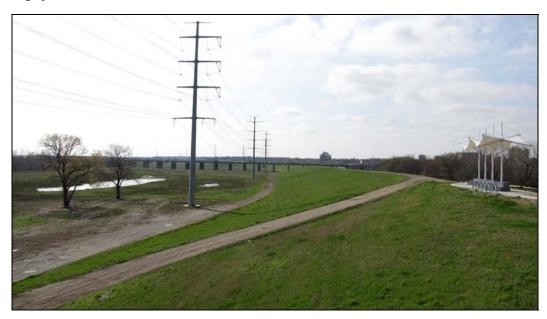
Figure 5-68. Power Line on the Overbank next to the West Levee due South of the Commerce Street Viaduct, Looking Southeast

Power lines and electrical towers were included in the original plans set forth in 1928 and again were accommodated in the USACE's plans in 1955. They currently still exist within the floodway overbank. Many of these towers and lines have since been replaced with upgraded structures since the USACE's improvements in the 1950s, as necessary. The towers' footprint within the overbank consists of single piers set into concrete footings (Figures 5-68 and 5-69; see historical and current locations of overhead electrical lines in Figure 5-70). Like the bridges, the power lines are non-hydraulic physical features within the Dallas Floodway that neither enhance nor detract from the floodway's function as an engineering system for flood control.

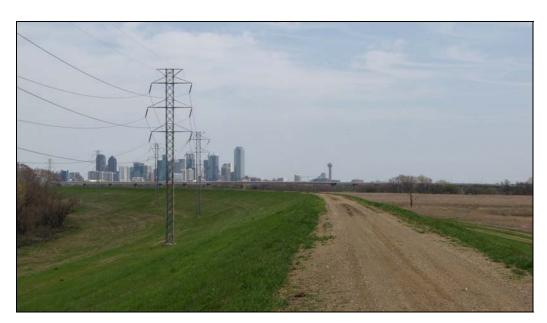
Figure 5-69. Power Line on the Outside of the East Levee, Looking Southeast

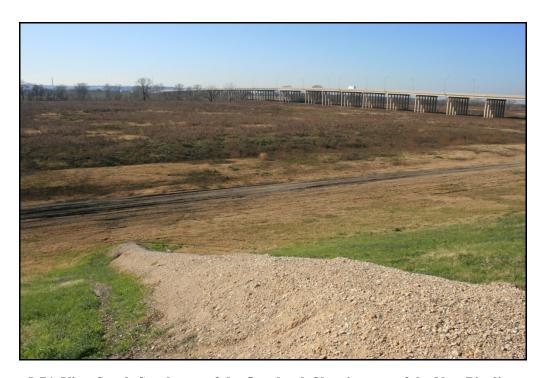
Figure 5-74. View South-Southwest of the Overbank Showing one of the New Pipelines on the Riverside Wall of the East Levee

The Dallas Floodway retains all the hydraulic physical features from its original *design*. Most importantly, the essential physical features of the floodway—the East and West Levees, the diversion channels, and the overbanks—are intact. However, the configuration of two segments of the levees has been altered by the addition of two new pipelines within the past ten years (Figure 5-74). Earth and gravel cover the pipes as they extend over the levees. The pipes are approximately four feet tall and 12 feet wide. The pipes are then buried beneath the floodway proper (the overbanks). Given their relatively small size and scale in comparison to the levees (28 feet high and 10.9 and 11.7 miles long [West and East Levee, respectively]), the pipelines have an inconsequential impact on the design of the floodway (Figure 5-75).

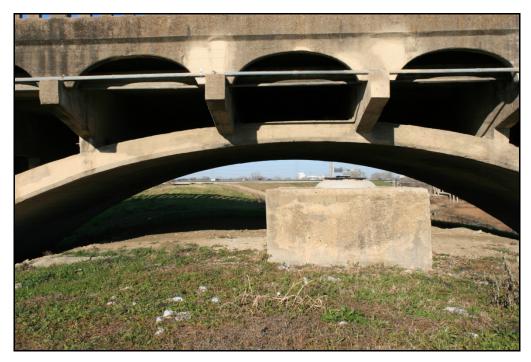
Figure 5-76. View Northwest of Arch of Houston Street Viaduct Spanning the East Levee

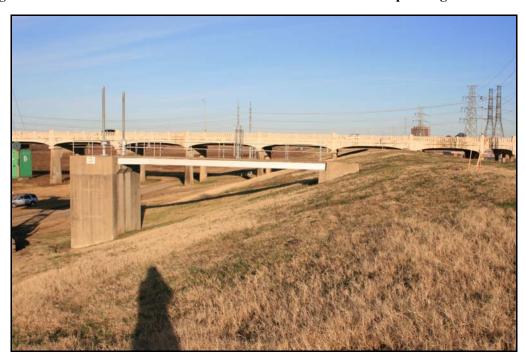
Figure 5-77. View Northwest of Continental Street Viaduct (behind Woodall Rodgers Pressure Sewer Outlet Gate) Spanning the East Levee

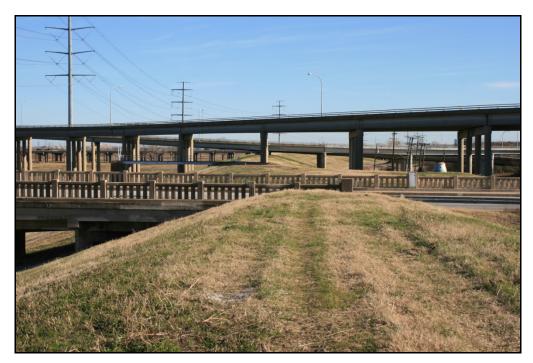
Figure 5-78. View East-Southeast of the Houston Street Viaduct, Jefferson Boulevard Viaduct, and IH-35 Bridge (from front to back) on and over the West Levee

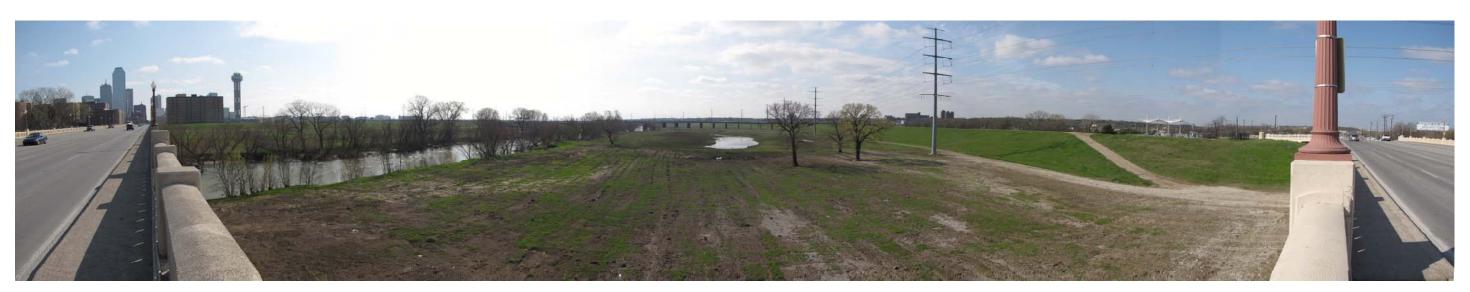
Figure 5-79. Panoramic View Southeast from the Commerce Street Bridge

The feeling of this system is most apparent in the middle of the floodway, whether at grade or on a bridge overlooking the overbank. Here, the feeling of this massive public works project, with its long levees, linear river channels, drainage structures, and wide, open basin, is apparent (Figures 5-79 and 80). It is clearly evident when the floodway is full and the levees contain stormwater (Figure 5-81).

The setting inside the floodway is still largely characterized as a broad swath of flat, open grassy land with extensive views within and beyond the floodplain landscape (Figures 5-79, 5-80, 5-82, and 5-83).

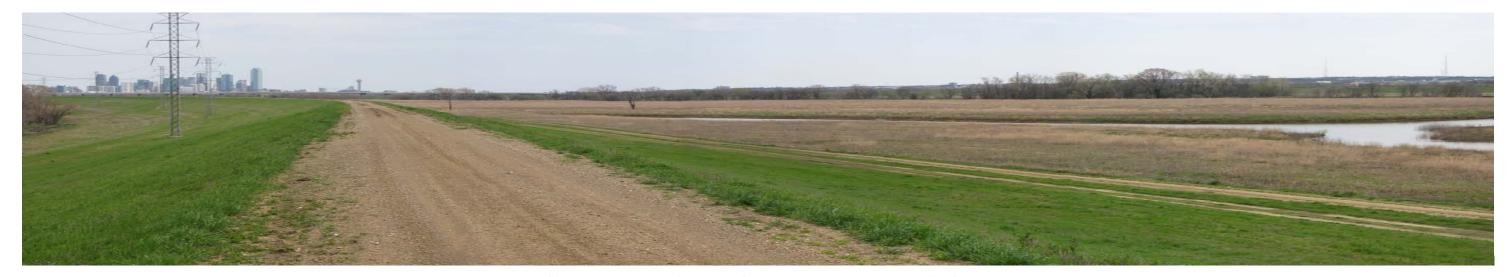
Figure 5-80. Panoramic View Southeast from the East Levee near the Confluence

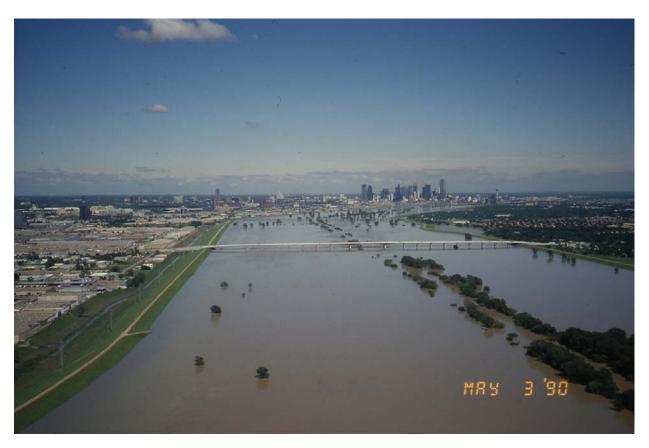
Figure 5-81. View East-Southeast of the Dallas Floodway During 1990 Flood (photo provided by the City of Dallas)

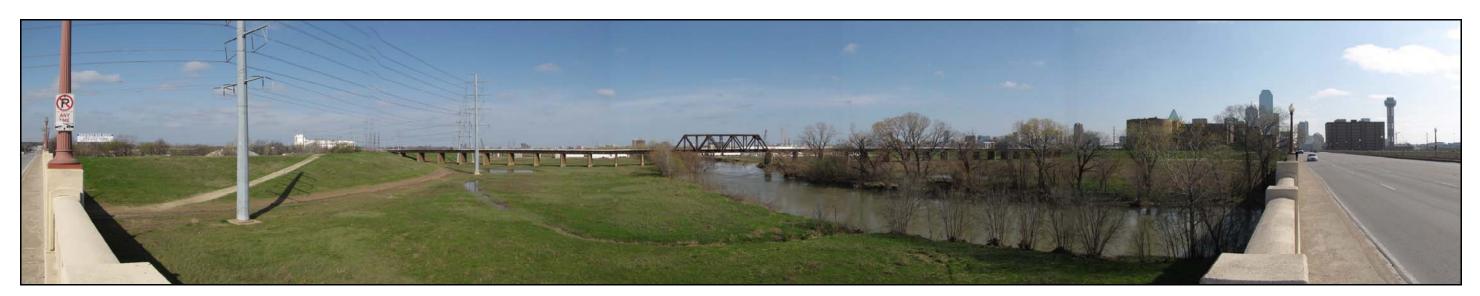
Figure 5-82. Panoramic View Northwest from Commerce Street Bridge

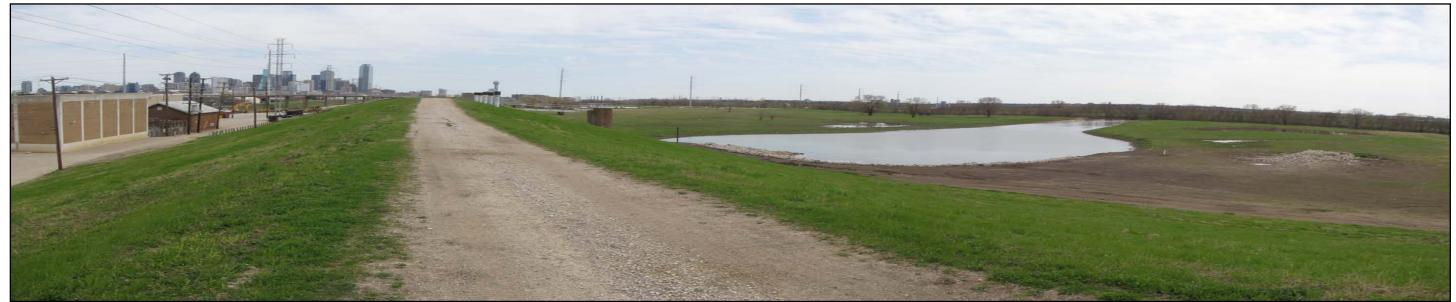
Figure 5-83. Panoramic View East from East Levee at Hampton Pumping Plant

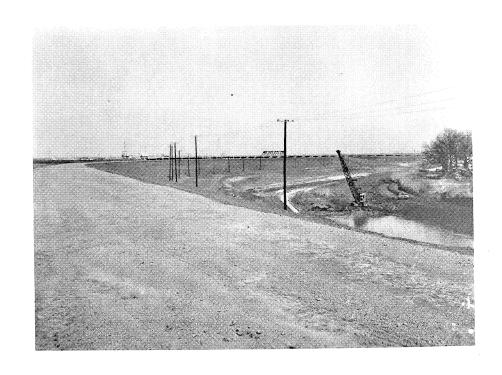
East Levee, Completed Embankment and Excavation of Sump "A" Area

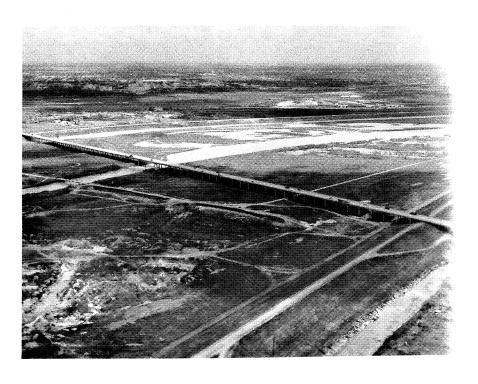
Sylvan Street Bridge

25 April 1957

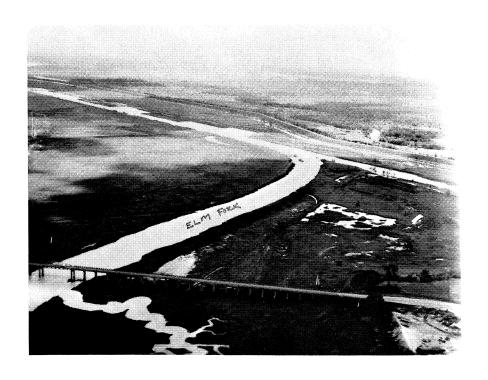
Westmoreland Street Bridge

25 April 1957

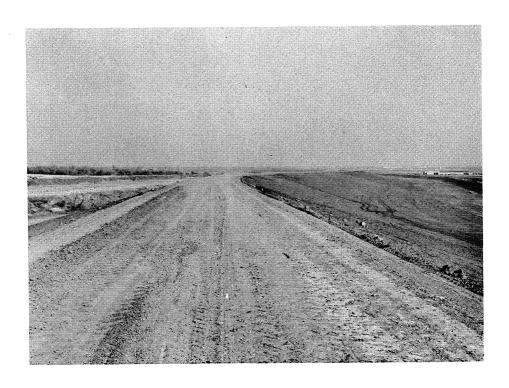
East Levee, CRI&P RR

25 April 1957

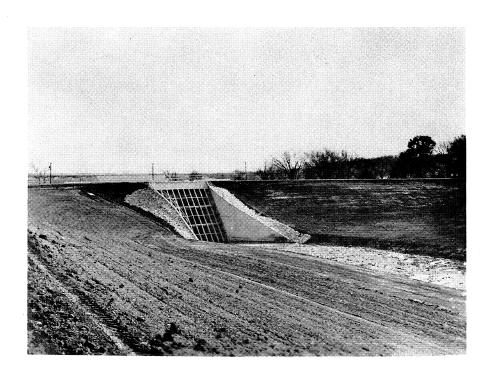
Coombs Creek, Intake

6 June 1956

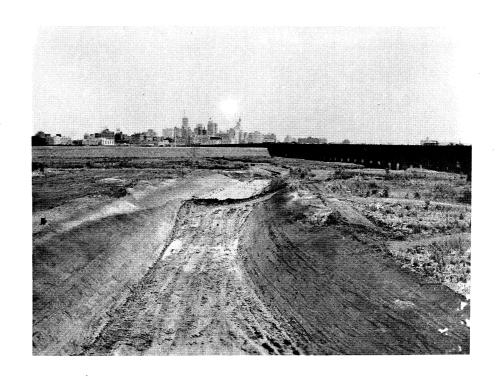
Coombs Creek, Intake and Levee

10 December 1956

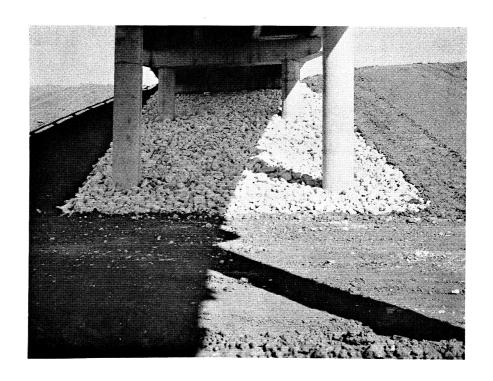
Lake Cliff, Excavated Outlet Channel

_6 June 1955...

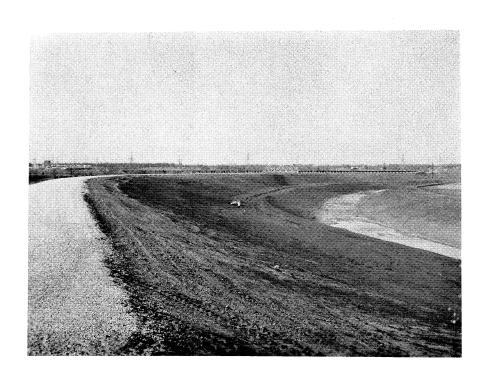
East Levee and Sump

6 June 1955

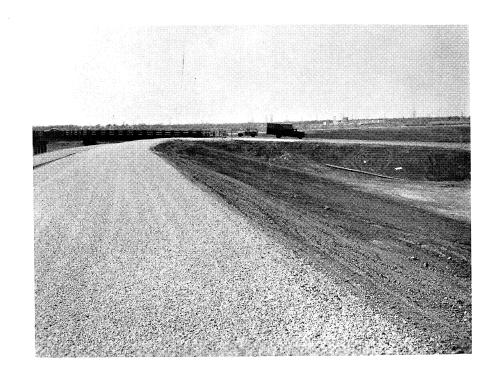
East Levee and Sump above Irving Blvd.

16 March 1956

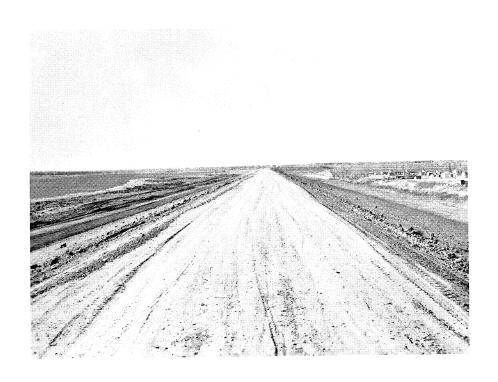
East Levee, Irving Blvd.

16 March 1956

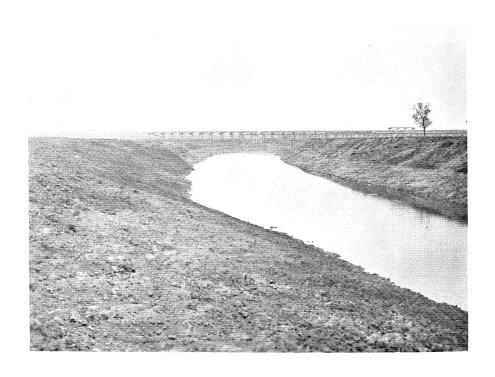
Channel Improvement, Completed Channel, Downstream from Cadiz Street

5 May 1959

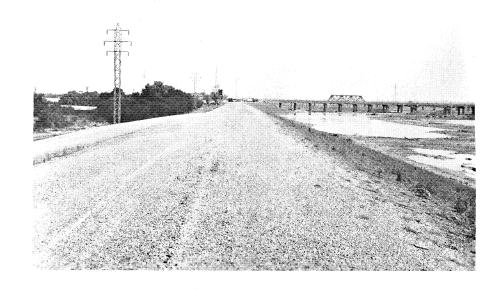
Belleview, Gate Structure

6 June 1958

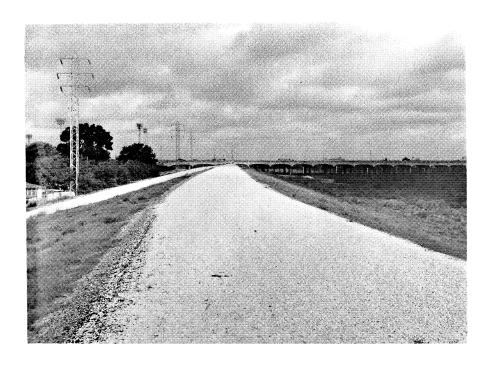
West Levee, Select Material Placed on Completed Embankment

6 June 1958

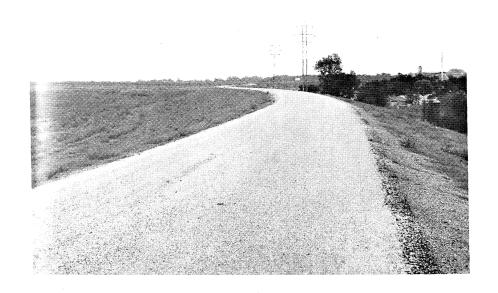
West Levee and Ramp

6 June 1958

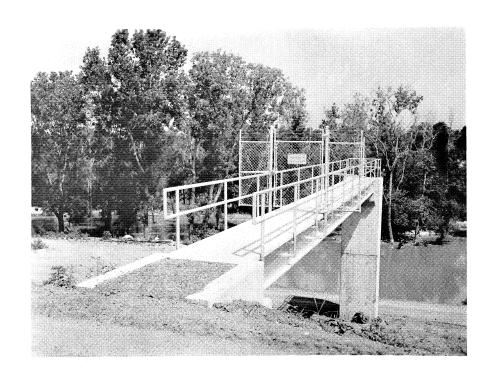
Pumping Plant C, Outlet Gate Structure

6 June 1958

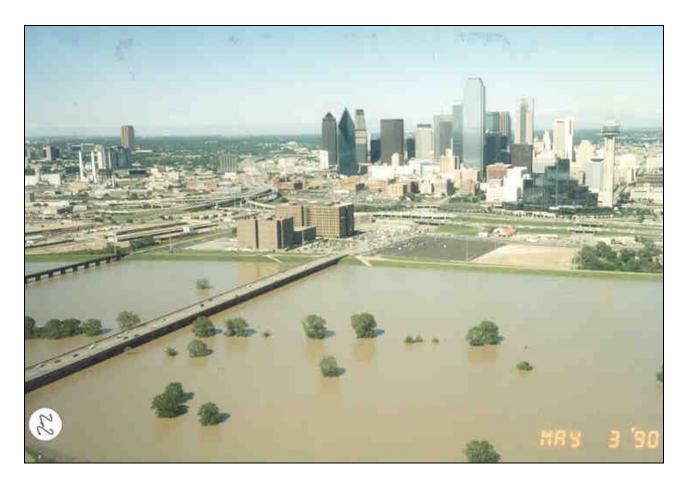
Dallas Floodway during the 1990 flood (City of Dallas)

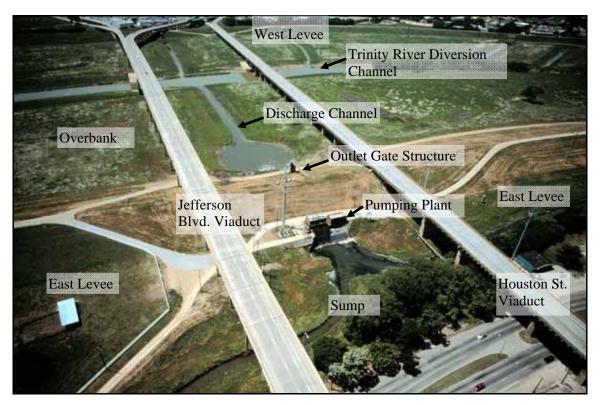
Figure E-15. Floodway Operations at Pumping Plant A (Able), Looking Toward the Floodplain

Stormwater that is directed to pumping plants gets pumped through the levee walls into the overbank. The floodway first consisted of four pumping plants (A, B, C, and D), with two on each bank of the floodway, plus three pressure sewers (Belleview, Coombs Creek, and Dallas Branch). The USACE improved this system during the 1950s by building two new pressure sewers (Lake Cliff and Turtle Creek), and by adding additional pumping stations at three of the existing pumping plants (A, C, and D). The USACE also built two new pumping plants (Pavaho and Hampton Road), one on each side of the floodway. Figures E-14 and E-15 below illustrate the floodway features at a pumping station, here Pumping Station A (Able).

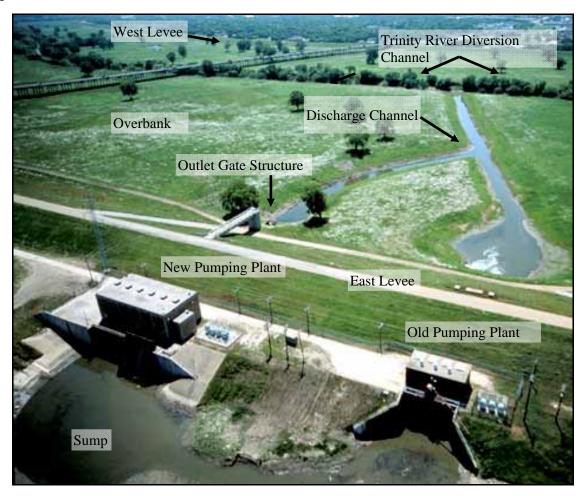
Figure E-16. View of the Hampton Pumping Plant, Looking Southeast Downstream

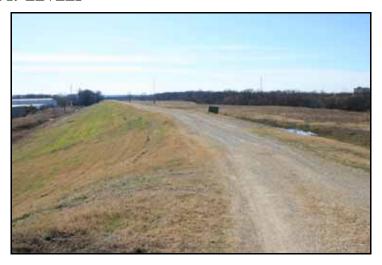
Figure F-12. Levee, viewed from the crown

Between 1953 and 1959, the USACE Fort Worth District strengthened the East and West levees as part of an undertaking to improve the entire floodway system (see Figure F-12). The USACE did not strengthen the Northwest Levee at this time. Documentary evidence that explains why the Northwest Levee, which was probably in the same condition as the East and West Levees, was not included in the USACE strengthening project was not found. The project involved stripping six inches of surface material on the river side of the levees plus four feet off the crown. The USACE then added an average of three feet of compacted fill on the levees' river side to widen the base by 25 feet and raise the levee to an average height of 28 feet, and a maximum height of about 35 feet (USACE 1969). The USACE designed the new height to have eight feet of levee freeboard in an 800-year flood event as estimated at that time. This 800year Standard Project Flood (SPF) was uncommon at the time, as a 100-year SPF or 500-year SPF was more universal for flood control levee systems. The USACE used these exceptional design parameters in their improvements due to the Dallas Floodway's location at the confluence of multiple forks of the volatile Trinity River (DMN 1993). The USACE's additional fill also accounted for shrinkage that was expected to occur. The levee crowns were widened from 6 feet to 16 feet with a loose-aggregate roadway atop the crown to facilitate maintenance and monitoring. The USACE buttressed the levees' slopes to 3:1 by adding fill to make them wider and flatter. This project consisted of leveling off the levees' surface layer and adding new layers of dirt fill to the crown and river side only. As a result, the levee's base increased toward the river side, and the crown's center point shifted from between 2 to 45 feet toward the river side as well. The average shift in the position of the crown was 20 feet. The USACE then planted Bermuda sprigs for turfing (HNTB 2009).

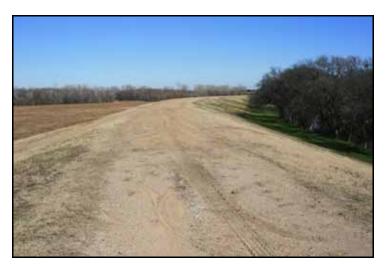
Figure F-14. East Levee, looking northwest

The East Levee is an original resource to the 1929 floodway system (Figure F-14). The levee runs a total of 11.9 miles to form the levee at the east and northeast side of the floodway system (HNTB 2009). It runs parallel with the West Levee for a distance of seven miles starting from the AT&SF Railroad crossing, Cockrell Avenue, and the DART line, running upstream in a northwest direction, turning toward the west before it curves sharply in the northeast direction in the vicinity of Irving Boulevard to follow the Elm Fork of the Trinity River's diversion channel. The East Levee along this latter northeast-southwest direction is also called the East Tie Back Levee, and terminates at the 60-inch E. B. I. Emergency Control Structure near Harry Hines Boulevard, due north of Regal Row. Two covered pipelines were observed during the field survey on the East Levee, and are located in the vicinity of the Hampton Road Bridge and the Westmoreland Road Bridge. Improvements in the late 1990s to improve drainage flattened the East Levee to a 4:1 slope and raised the crown by an average of two feet on the river side downstream of the Continental Street Viaduct. The fill used to buttress the levees was excavated materials from the diversion channel widening and from several borrow pits in the floodway (HNTB 2009).

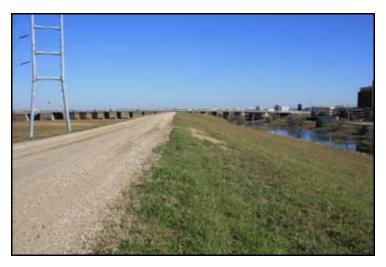
Figure F-15. West Levee, looking south

The West Levee, like the East Levee, is an original resource to the 1929 floodway system (Figure F-15). The levee generally mirrors the East Levee and extends a total of about 10.9 miles to enclose the levee at the west and southwest sides of the floodway (USACE 1968). The West Levee runs parallel with the East Levee for a distance of seven miles starting from the AT&SF Railroad crossing at the south end, running upstream in a northwest direction, turning toward the west before it curves sharply to the south to follow the West Fork of the Trinity River to the Trinity Authority Waste Treatment Plant (USACE 1989). The West Levee terminates just beyond its intersection with IH-30. The West Levee runs adjacent to Oak Cliff at its southern end and borders West Dallas as it moves upstream and to the west. Two covered pipelines were observed during the field survey on the West Levee, and are located in the vicinity of the Hampton Road Bridge and the Westmoreland Road Bridge. Like the East Levee, improvements in the late 1990s to improve drainage flattened the West Levees to a 4:1 slope on the river side and added two feet to the crown in the vicinity south of the Continental Street Viaduct (HNTB 2009).
