INTENSIVE ENGINEERING INVENTORY AND ANALYSIS OF THE DALLAS FLOODWAY, DALLAS, TEXAS

Technical Report

This report is a cultural inventory and evaluation of the engineering components associated with the Dallas Floodway Project. It includes a historic context of the floodway as a flood control system and as the outgrowth of community planning. The historic context investigates the Dallas Floodway as a part of the larger Dallas Trinity Reclamation Project (1908–1959). This context is then used to identify the appropriate structural components of the floodway, record the current condition of each component, and evaluate the collective historical significance of these components and the floodway system as a whole.

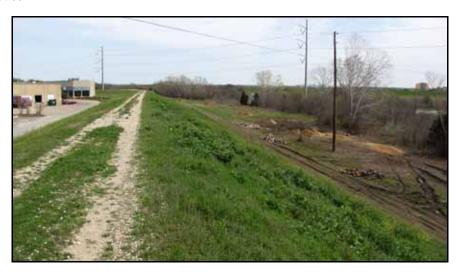
Figure F-16. Northwest Levee, looking north

The 2.8-mile-long Northwest Levee is located in the city of Irving at the northwest part of the Dallas Floodway system. Originally built in 1929 when the East and West Levees were built, the Northwest Levee was not significantly improved by the USACE in the 1950s (Figure F-16). In 1974, the Irving Flood Control District No.1 raised and widened the levee from its original 2:1 slope to its current 3:1 slope. The Northwest Levee forms a continuous, angular semi-circle that extends approximately 2.8 miles around the city of Irving at the northwest portion of the Dallas Floodway. Although the Northwest Levee is continuous, the northwestern-most end of the levee, west of Loop 12, is called the North Levee Tie-In. The opposite southernmost portion is called the South Levee Tie-In. Both Tie-In segments are original to the Northwest Levee's design and construction in 1929-1932. The Northwest Levee currently has a 3:1 slope, but is slightly steeper in some places. The levee rises from 16 and 22 feet high from toe to crown, approximately 428 to 443 feet in elevation. The city of Irving's maintenance ends at the west bank of the Elm Fork diversion channel; Dallas controls the channel itself (Fennell 2010). Although the USACE's 2008 Inspection Report found the levee's pumps and components in good working condition, the Northwest Levee's overall rating was "unacceptable" under FEMA's increased levee certification standards due to repair work that had not yet been completed (Sissom 2008). The Irving Flood Control District removed woody vegetation consisting mainly of mesquite trees from the North Levee Tie-In in 2006. In 2008, the Irving Flood Control District removed tree growth and woody vegetation from the South Levee Tie-In. After the vegetation was cleared, the levee was regraded and resurfaced with grass cover to its original design and construction. The levee was re-covered in grass and was reported in good condition in 2008 (Sissom 2008).

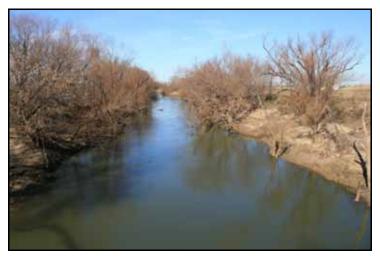
**Figure F-17. Main Diversion Channel**

The Trinity River diversion channel remains mostly unchanged since the USACE's improvements in the 1950s. Ongoing maintenance concerns include silt deposits, the collection of debris, and areas of erosion at its banks (USACE 2007). The channel's current condition relative to its conception in the 1950s remains unchanged overall.

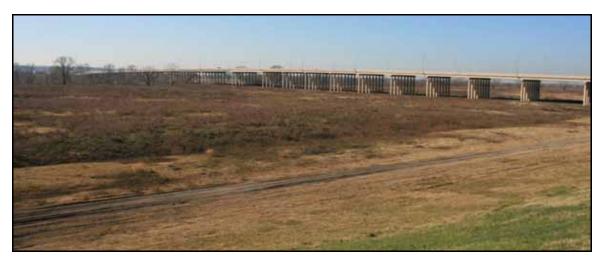
Figure F-19. View of overbank near the Hampton Road Bridge, looking southwest.

The overbank primarily consists of a wide, undeveloped stretch of land that is relatively flat. Riparian areas and wetland depressions lie adjacent to wide expanses of open areas with native grasses. Tree growth is dispersed throughout the overbank, and is primarily found in the wetland areas along the banks of the Trinity River diversion channel.

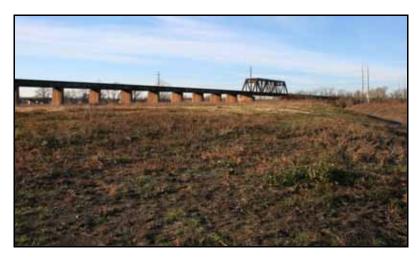
Figure F-20. View of open space near the DART Bridge, looking southwest.

The vast majority of the overbank is open, undeveloped space (Figure F-20).

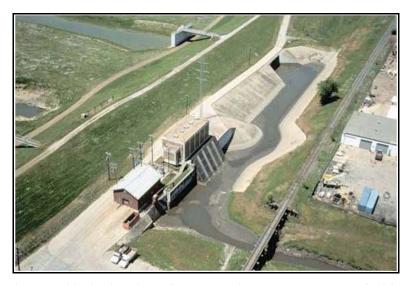
Figure F-22. Aerial view of the Pumping Plant B (Baker) facility

The four pumping plants that comprise the first generation of plants built in 1929 are A (Able), B (Baker), C (Charlie), and D (Delta). These original ca. 1929 pumping plants are typically composed of red-brick masonry walls, a rectangular footprint, concrete foundation, and either a flat roof enclosed by a low brick parapet, or, as seen in Pumping Plant B (Baker), a gable-front roof that is covered by concrete tiles. The windows are rectangular with concrete headers, with the exception being Pumping Plant B (Baker), which has arched openings. All of the windows have been filled-in with brick. This likely occurred when new pumping plants were built during the USACE's floodway improvement project in the 1950s.

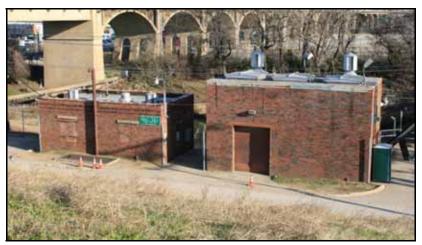
Figure F-23. Pumping Plant A (Able)

The Pumping Plant A (Able) complex consists of two pump houses, one constructed in 1929 and one in 1953. The 1929 pump house, commonly referred to as Small Able, is a one-story, rectangular building clad in variegated red-brick masonry, with a flat, parapet roof, and a concrete foundation (Figure F-23). The roof is covered in rolled asphalt with a course of tile covering the parapet cap. The tile includes the inscription *W.S. Dickey Texarkana*, possibly indicating where the tile was manufactured. The parapet is distinguished by a course of vertical stretcher-bond brick framed by a single band of protruding horizontal brick course around all four sides of the building. The building retains its original multi-light windows

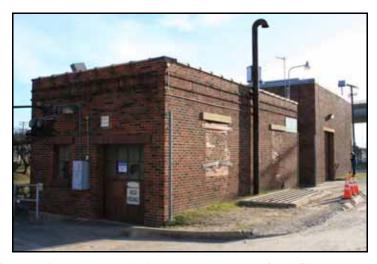
Figure F-24. Pumping Plant A 1929 Pump House at left, 1953 Pump House at right.

The 1953 pump house associated with Pumping Plant A is commonly referred to as Large Able. This building is a one-and-one-half story, rectangular structure clad in variegated, rough red brick with a flat roof (Figure F-24). The south façade contains a one-bay overhead garage door with a metal lintel. The east façade contains a set of metal double-doors in its northern bay with a plaque stating "Addition to Pumping Plant 'A' Dallas Floodway Project, Constructed by Corps of Engineers, U.S. Army in Cooperation with Dallas County Flood Control District, 1953." This pump house contains three axial flow pumps manufactured by the Peerless Pump Division, Food Machinery & Chemical Corporation out of Los Angeles, California. Additionally, the pump house holds three lubricating oil reservoirs and oil lines, an 8-ton trolley-type, spur-geared hoist with bridge manufactured by Robbins & Myers, Inc. from Springfield, Ohio; two water level recorders manufactured by Leupold & Stevens Instruments, Inc. from Portland, Oregon; a water level control manufactured by Healy Ruff Company; and an air compressor manufactured by Binks Manufacturing Company from Chicago, Illinois.

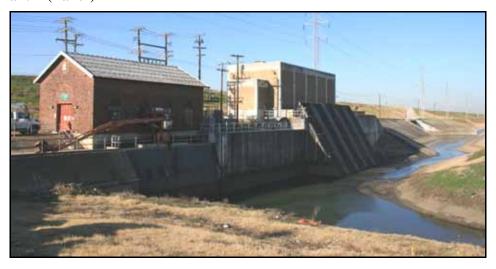
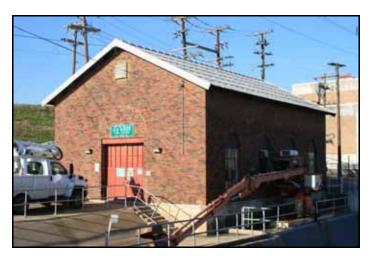
Figure F-26. Pumping Plant B (Baker)

Figure F-27. 1930 Pump House at Pumping Plant B (Baker)

Pumping Plant B consists of two pump houses (Figures F-26 and F-27), an intake structure, four gravity sluices, and an outlet structure. The original pump house, constructed in 1929, is a one-and-one-half story building clad in rough, variegated red brick with a concrete foundation. The building has a medium-pitch, front-gabled roof covered in concrete tiles. The primary entrance to the building is located on the east façade. This metal, double door is located under a brick-in-filled segmental arch and includes multi-light windows above it. Above this entrance is a sheet metal sign which reads "City of Dallas Old Baker Pump Station Flood Control Div." Four in-filled windows with segmental arches are located on the south façade, while three in-filled windows with segmental arches are located on the west façade. The north façade contains four multi-light windows under segmental arches. These windows appear to be original, but the building's 1928 construction drawings indicate that fan lights were originally within the arched portion of the window openings that are now covered. Three circular brick design elements are interspaced between the window bays roughly two feet below the roofline. According to the original drawings, these portal window elements have always been blind, i.e. filled-in by a brick panel. The pump house contains four screw-type pumps manufactured by Fairbanks, Morse and Company; four gate valves; one trolley type chain hoist with a chain operated bridge; and two vacuum pumps.

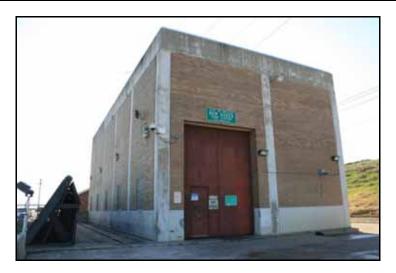
Figure F-28. 1975 Pump House at Pumping Plant B (Baker)

The second pump house associated with the Baker Pumping Plant was constructed in 1975 (Figure F-28). This building is a rectangular, poured-concrete structure with brick panels to match the exterior of the adjacent 1929 pump house. The south façade contains five bays of brick interspersed with concrete. A small, rectangular extension is located on the east façade that measures roughly 10 x 18 feet. The west façade contains an oversized garage bay with a metal door. Within the oversized bay is a personnel door. The north façade contains five vents located within the brick bays. Located along the north façade is the trash rack for the pumping plant.

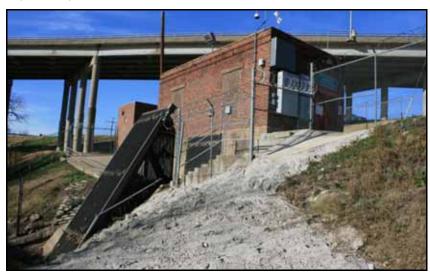
Figure F-29. Pumping Plant C (Charlie)

Pumping Plant C consists of two pump houses, intake structures, two gravity sluices, and an outlet structure (Figure F-29). The pump house, constructed in 1929, is a one-story, rectangular building clad in horizontal, variegated rough red brick with a flat, parapet roof and a concrete foundation. The flat, parapet roof is covered in rolled asphalt with a course of tile covering the apex of the parapet. Roughly one foot below the apex of the roof, a course of vertical brick flanked by a band of protruding horizontal brick wraps the building. The building contains in-filled window bays with concrete lintels. The north façade contains two in-filled window bays while the west façade contains one in-filled window bay. The east façade contains a metal overhead garage door in the northern bay. The pump house contains two open suction centrifugal pumps, two vertical pumps manufactured by Fairbanks, Morse and Company; two hand-operated gate valves; two sluice gates with two motor driven hoists; and two sluice gates with two hand-operated gates hoists.

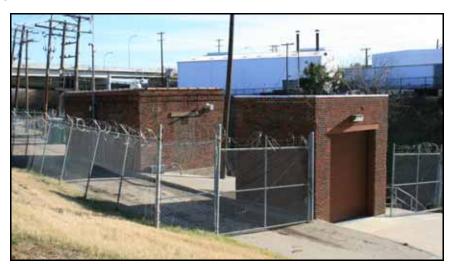
Figure F-30. Pumping Plant C (Charlie), 1929 Pump House at left, 1956 Pump House at right.

A second pump house, built in 1956, is located directly east of the 1929 pump house at Pumping Plant C (Figure F-30). It is a utilitarian one-story, rectangular, brick-clad building with a flat roof and a metal overhead garage door on its east façade.

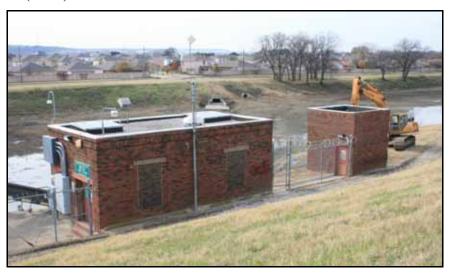
Figure F-31. Pumping Plant D (Delta)

Pumping Plant D (Delta) consists of two pump houses, an intake structure, two gravity sluices, and an outlet structure. The pump house, constructed in 1929, is a one-story, rectangular building clad in horizontal, variegated red brick with a flat, brick-parapet roof (Figure F-31). The roof parapet is ornamented by a course of vertical brick flanked by a band of protruding horizontal brick above and below it, and wraps around all sides of the building. The building contains two bricked-in window bays on the north façade, and a metal entrance door on the east façade. The pump house contains two vertical pumps manufactured by Fairbanks, Morse, and Company; two hand-operated gate valves; two sluice gates operated by two motor-operated gate hoists; and two sluice gates operated by two hand-operated gate hoists.

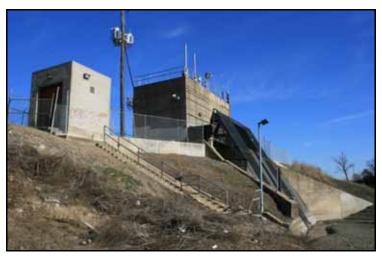
Figure F-32. Pavaho Pumping Plant

The Pavaho Pumping Plant consists of a pump house and its adjoining building, a discharge chamber, an inlet structure, and an outlet structure (Figure F-32). The pump house, built in 1954, is a two-story, concrete structure with a flat roof and a concrete foundation (Figure F-33). The building contains no windows and has a double door entrance on the east façade. The pump house holds two vertical mixed flow pumps manufactured by Economy Pumps, Inc. from Philadelphia, Pennsylvania; two grease lubricating systems manufactured by the Farval Corporation of Cleveland, Ohio; a water level recorder manufactured by Leupold & Stevens Instruments, Inc. of Portland, Oregon; an 8-ton trolley type spur geared hoist with bridge; a water level control manufactured by Healy Ruff Co.; two motor-operated sluice gate hoists; and two 6- x 8-foot sluice gates. The associated building is a small rectangular building directly west of the pump house with a metal overhead door on the west façade.

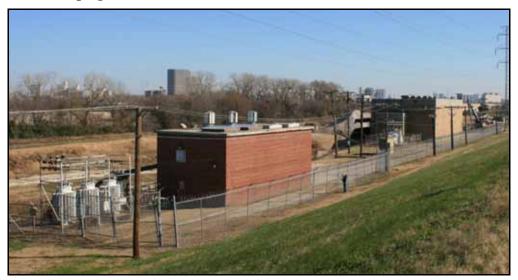
Figure F-34. Hampton Road Pumping Plant

The Hampton Road Pumping Plant consists of two pump houses, an adjoining intake structure, four discharge pipes, and an outlet structure (Figure F-34). The original pump house, known as Old Hampton, was constructed in 1956. It is a one-story, rectangular building clad in horizontal, variegated red-brick veneer with a flat roof and metal trim (Figure F-35). The east and west façade each contain one metal door for entrance to the building. This building contains four vertical mixed flow pumps manufactured by Economy Pumps, Inc. of Philadelphia, Pennsylvania; with three phase motors manufactured by Ideal Electric Company of Mansfield, Ohio; four grease lubricating systems manufactured by the Farval Corporation of Cleveland, Ohio; an 8-ton trolley type spur geared hoist; a top running hand-geared crane; a four-element float switch; six metal clad switchgear cabinets housing five oil circuit breakers; control switches and other control equipment; a 10 KVA single-phase dry type transformer; and a 24-volt battery and NEMCO battery charger.

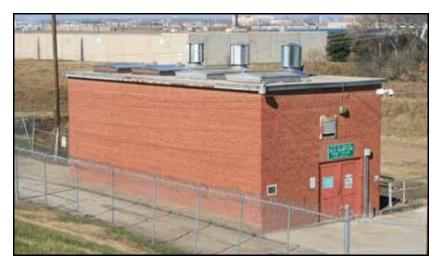
Figure F-35. 1956 Pump House

The intake structure adjoins this building and consists of approach wing walls and apron, a raking platform, and twelve trash racks. Also located at this site are four discharge pipes which run over the levee. Each pipe is provided with a 4-inch air-relief valve and 7-inch vacuum breaker at the top of the levee. The pipes are housed in two square and one rectangular concrete box structures. These structures are located on the crown of the East Levee (Figure F-36).

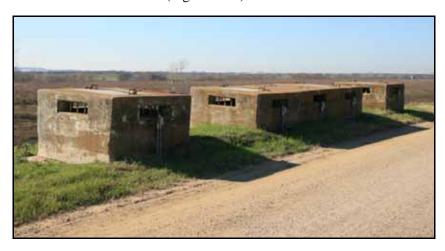
Figure F-36. Concrete Vents Structures Housing the Air Relief Valves on the East Levee

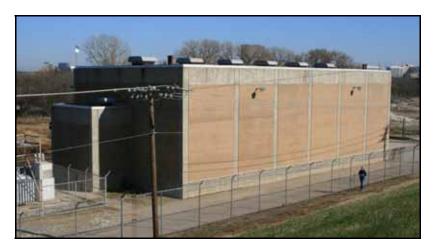
Figure F-37. 1975 Pump House

A secondary building, known as New Hampton, was constructed due east of Old Hampton in 1975 (Figure F-37). This structure is a utilitarian two-story, rectangular building constructed of poured concrete with a flat roof. This building contains one entrance on the east façade of the building and a small rectangular extension on the west façade. Old Hampton and New Hampton are enclosed by a 6-foot chain-link fence.

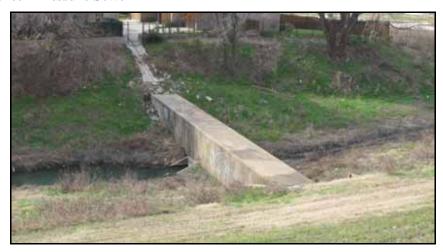
Figure F-38. Enclosed Concrete Culvert Associated with the Coombs Creek Pressure Sewer

The "Old" Coombs Creek Pressure Sewer (also known as Little Coombs) is located at the West Levee, upstream from the Houston Street Viaduct (Figure F-38). It consists of an emergency spillway, storm sewer, and conduit. The pressure sewer itself measures 18.5 feet with a 40-foot trash rack at the intake area. Near the riverside of the levee, an 18.5-foot semi-elliptical conduit transitions to four 8- x 10-foot passages into a gate well. Another four 9- x 11-foot passages lead from the gate well into the outlet, with four gate passages controlled by slide gates. The four associated slide gates are run by hand-operated floorstands or portable hoists provided at the Turtle Creek Pressure Sewer. The storm sewer measures 6 feet and has a gated control and a hand-operated hoist (USACE 1969). Two vertical intakes measuring 7 x 8 feet are protected by trash racks. Its capacity is a little more than 3.1 million gpm (Furlong et al. 2003, 5).

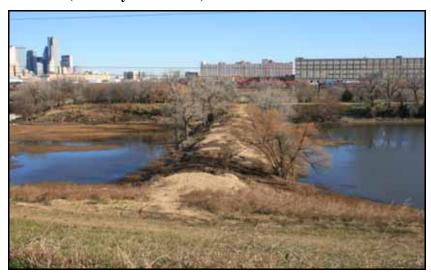
Figure F-39. Berm Covering the Underground Belleview Pressure Sewer

The Belleview Pressure Sewer is located at the East Levee upstream from the Corinth Street Viaduct (Figure F-39). Originally known as the Mill Creek Pressure Sewer, the Belleview Pressure Sewer differs from the other pressure sewers in the Dallas Floodway in design. This pressure sewer has a width of 16 feet and a height of 12.8 feet and is a modified horseshoe shape. The associated storm sewer is controlled by a gated control feature similar to the Dallas Branch Pressure Sewer in its operation; however, the gate on the Belleview Pressure Sewer measures 12 x 17 feet. The Belleview Pressure Sewer has more than 2.6 million gpm in capacity.

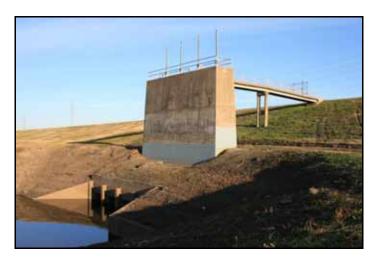
Figure F-40. Turtle Creek Outlet Gate Structure

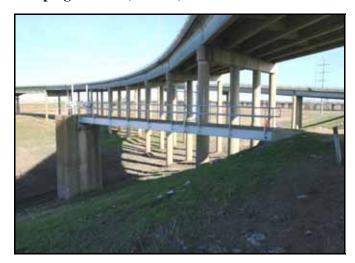
Figure F-43. Pumping Plant C (Charlie) Outlet Gate Structure

Pumping Plant C has a gate control structure consisting of two 4- x 4-foot sluice gates with two 4- x 4-foot flap gates and corresponding control valves (USACE 1969) (Figure F-43).

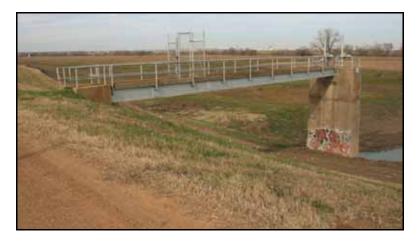
Figure F-44. Pumping Plant D (Delta) Outlet Gate Structure

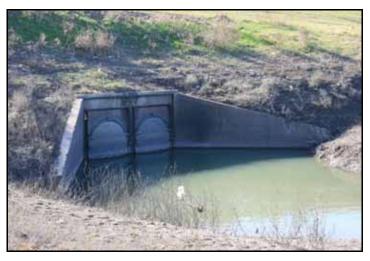
Figure F-46. Pavaho Pumping Plant Outlet Structure

The Pavaho Pumping Plant's Outlet Gate Structure lacks a hoist tower, but consists of a headwall, wing walls, and apron with flap gates on the outlets (Figure F-46). The discharge chamber consists of two 6- x 8-foot sluice gates for control of gravity flow with motor-operated floorstands to operate the gates located in the pump house.

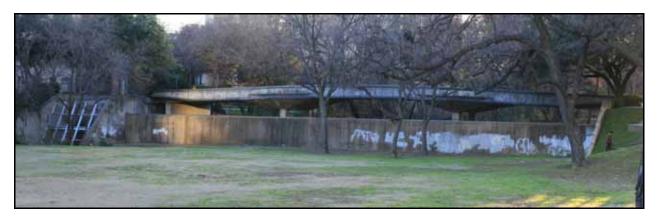
Figure F-57. View toward Turtle Creek Intake and adjacent concrete wall of its diversion dam

The Turtle Creek Intake structure is located near Fairmount Street. It consists of a diversion dam across Turtle Creek, with a 175-foot concrete spillway overflow as well as two earthen overflows that are 100-feet in length (Figures F-56 and F-57). Downstream of the spillway overflow is a concrete stilling basin with two rows of baffle blocks. The entrance to the intake is covered by an angled trash rack, which leads to an underground poured concrete approach channel to the East Levee that is 7,800 feet long (USACE 1969).

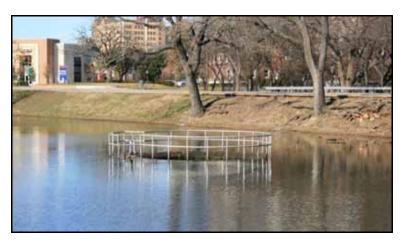
Figure F-58. Lake Cliff Intake

The Lake Cliff intake structure is a circular spillway located within Lake Cliff in the Oak Park neighborhood of Dallas (Figure F-58). A concrete, cylindrical stem structure rises from the lake bed and opens vertically and is flush with the surface water. The top of this opening is enclosed by a metal-pipe handrail. The base of the structure is then connected to a pressure sewer that runs under the lake and the adjacent Colorado Boulevard (USACE 1969).

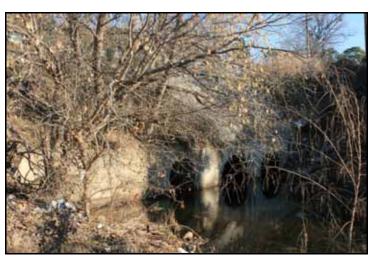
Figure F-620. Grauwyler C.S.G.

The Grauwyler C.S.G., or culvert, located at Grauwyler Road, consists of an intake structure with a 60-inch diameter sluice gate at the opening of a 60-inch diameter concrete pipe culvert (USACE 1969) (Figure F-62). The original culvert was modified with a Control Gate Structure in 1960. As with the Ledbetter Dike C.S.G., automated gate operators to allow for remote operation and pressure transducers for reading water levels on both the upstream and downstream sides were installed in the 1990s (City of Dallas Flood Control District 2010). The Grauwyler C.S.G. is connected to the Hampton Pumping Plant via the old river channel of the Elm Fork of the Trinity River, where the stormwater collects at the pumping plant's sump for drainage into the floodway.

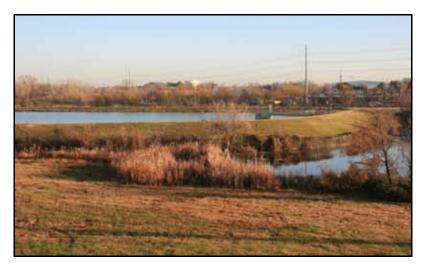
Figure F-63. Sump ponds near Harry Hines Boulevard

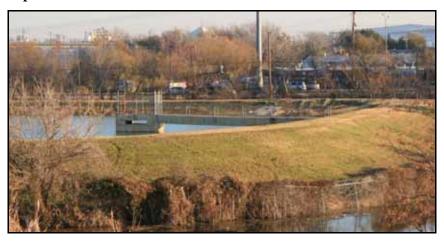
Figure F-65. East Bank Interceptor

The East Bank Interceptor is located at the East Tie Back levee along with the Emergency Control Building (Figure F-65). It is a valve structure housing a 36-inch diameter concrete pipe. It appears to be

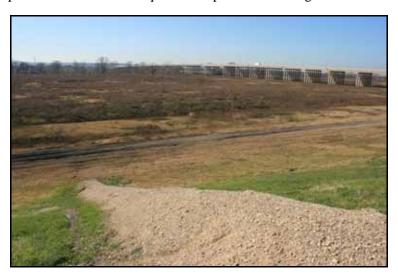
Figure F-72. View South-Southwest of the Overbank Showing one of the New Pipelines on the Riverside Wall of the East Levee

The Dallas Floodway retains all the hydraulic physical features from its original *design*. Most importantly, the essential physical features of the floodway—the East and West Levees, the diversion channels, and the overbanks—are intact. However, the configuration of two segments of the levees has been altered by the addition of two new pipelines within the past ten years (Figure F-72). Earth and gravel cover the pipes as they extend over the levees. The pipes are approximately four feet tall and 12 feet wide. The pipes are then buried beneath the floodway proper (the overbanks). Given their relatively small size and scale in comparison to the levees (28 feet high and 10.9 and 11.7 miles long [West and East Levee, respectively]), the pipelines have an inconsequential impact on the design of the floodway (Figure F-73).

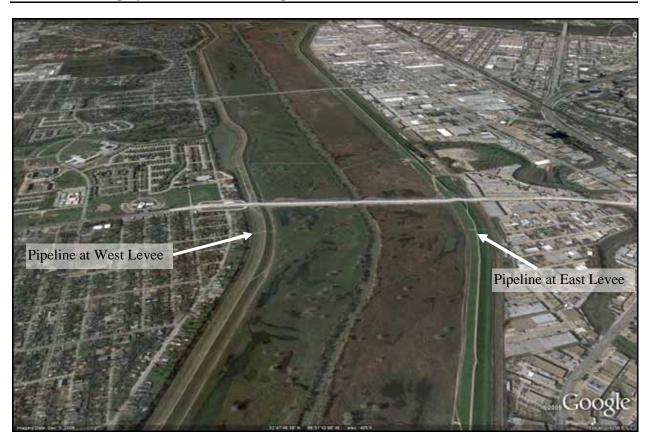
Figure F-73. Aerial View Looking West Showing Scale of Pipelines Relative to Dallas Floodway

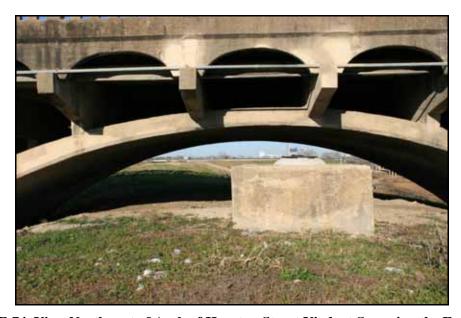
Figure F-74. View Northwest of Arch of Houston Street Viaduct Spanning the East Levee

The original design for the floodway took into account crossings by five major viaducts and four minor roads, as one of the goals of preventing floods was to allow more reliable connections between Dallas and West Dallas and Oak Cliff. The levees were originally designed around the existing Houston Street Viaduct (Figure F-74), and the foundation of the viaduct was protected during construction of the main diversion channel (Myers, Noyes and Forrest Engineers 1926). During the 1950s strengthening project, the USACE designed the crown of the levees to be at or below the superstructure of existing bridges and viaducts and the side slopes to envelope existing bridge piers (USACE 1954b) (Figure F-75). The design also took into account the structures of bridges and roads that were under construction in the mid 1950s: U.S. 67 (the current westbound IH-35E/U.S. 67/U.S. 77), the Dallas Fort Worth Turnpike (the current IH-30), and the Sylvan Avenue at-grade crossing.

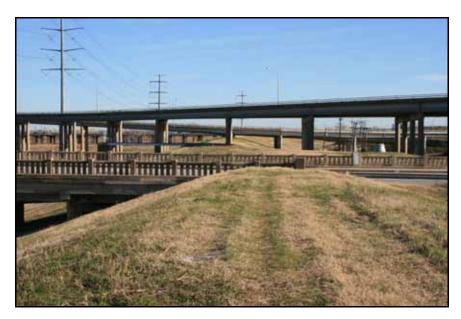
Figure F-76. View East-Southeast of the Houston Street Viaduct, Jefferson Boulevard Viaduct, and I-35 Bridge on and Over the West Levee

Several more bridges (e.g., Jefferson Viaduct, Westmoreland Road, Irving Boulevard, SR 356, westbound SH 482, Loop 12, and DART) presently cross over the floodway, but the heights of the new bridges are nearly the same as that of the older bridges, so the spatial relationship of the new bridges to the floodway is quite similar. The decks of the post-1959 bridges are several feet above the crown of the levees (Figure F-76). Nonetheless, construction of these bridges did not alter the form, structure, or plan of the levees or other floodway component structures. Furthermore, the City and County of Dallas Levee Improvement District and the Dallas County Levee Improvement District No. 5 accounted for future bridges to cross over the floodway, and as such, specified in the Joint Plan of Reclamation certain design guidelines for bridges to protect the function of the levees, diversion channels, and overbank. The plan states: "Existing and future structures such as bridges, viaducts, trestles, etc., crossing the floodway shall be without embankment between the levees with a channel span of approximately 150 feet, the balance of the structure to be trestle or pier and girder construction. The bottom of the superstructure of all bridges or other structures crossing the floodway shall be at or above levee grade and the structures shall be free from longitudinal bracing below levee grade" (Myers, Noyes and Forrest Engineers 1926). The foresight of the districts to plan for and provide specific design attributes for the inevitable addition of more bridges over the floodway has ensured the historic design and overall historic character of the floodway remain intact.

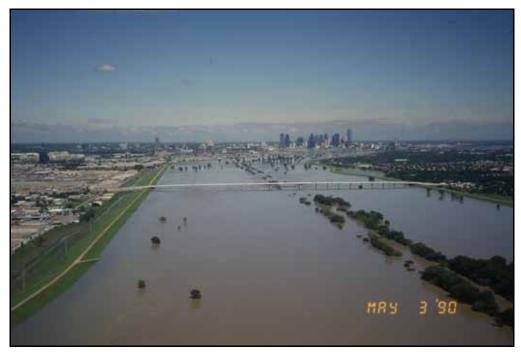
Figure F-79. View East-Southeast of the Dallas Floodway During 1990 Flood (photo provided by the City of Dallas)

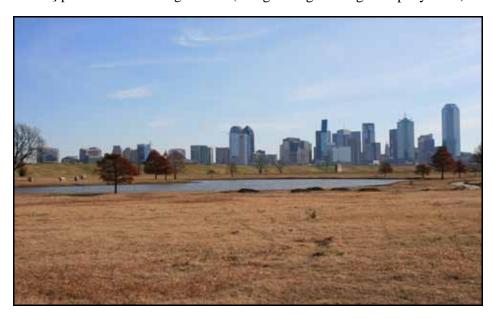
Figure F-82. View East of Trammell Crow Lake Park

Within the overbank, the only material change noted was the addition of two asphalt-paved parking areas at Trammell Crow Lake Park. The function and character of the overbank is not affected by the parking lots because it is still a flat stretch of open land. Additionally, these paved surface areas cover a

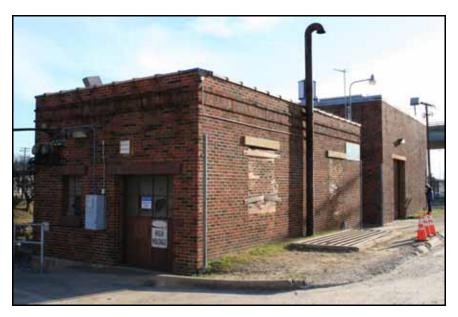
Figure F-84. View East of 1929 Able Pumping Plant (1953 Able Pumping Plant in Background)

These hydraulic physical features of the floodway retain sufficient original *materials*. Records were not found concerning repairs or improvements to the gates of the outlet structures. However, it can be assumed that some of the gates have been repaired or replaced over the years with ones of the same or similar materials and design. Changes of this nature are expected and do not impair the ability of the structures to convey their function and significance to the system. Due to natural material degradation, riprap has been removed or replaced around intakes and outlet structures and new riprap had been added at the outlet gate structure of the Hampton Road Pumping Plant's discharge channel to prevent erosion. This is to be expected given the dynamic nature of these hydraulic features, and does not compromise the overall quality of materials lof the structures. The materials of the four 1929 pumping plants ("Old" Able, Baker, Charlie, and Delta) is somewhat diminished by the removal of some original windows and infilling the openings with brick, but the rest of these structures appear to be intact (Figure F-84). No alterations or modifications to the 1950s pumping plants were observed.

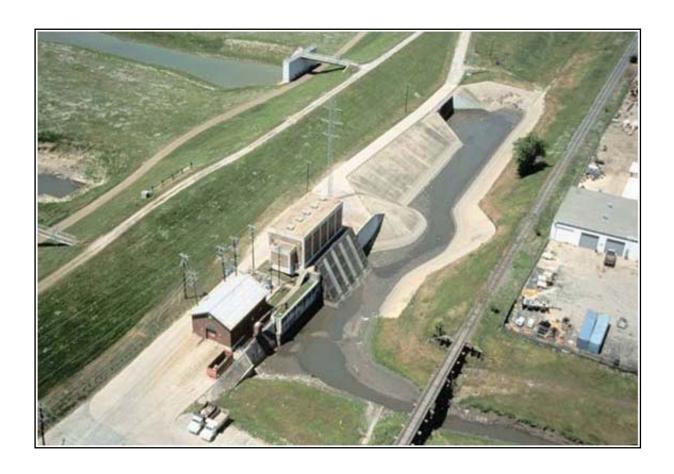
Baker Pump Stations, Levee and Pressure Sewers 2009
