# First Five-Year Review of Remedial Actions

Department of the Navy Base Realignment and Closure Program Management Office West San Diego, California

Prepared by: TriEco-Tt, a Joint Venture of TriEco LLC and Tetra Tech EM Inc. 1230 Columbia Street, Suite 1000 San Diego, California 92101

# First Five-Year Review of Remedial Actions Former Naval Station Treasure Island San Francisco, California

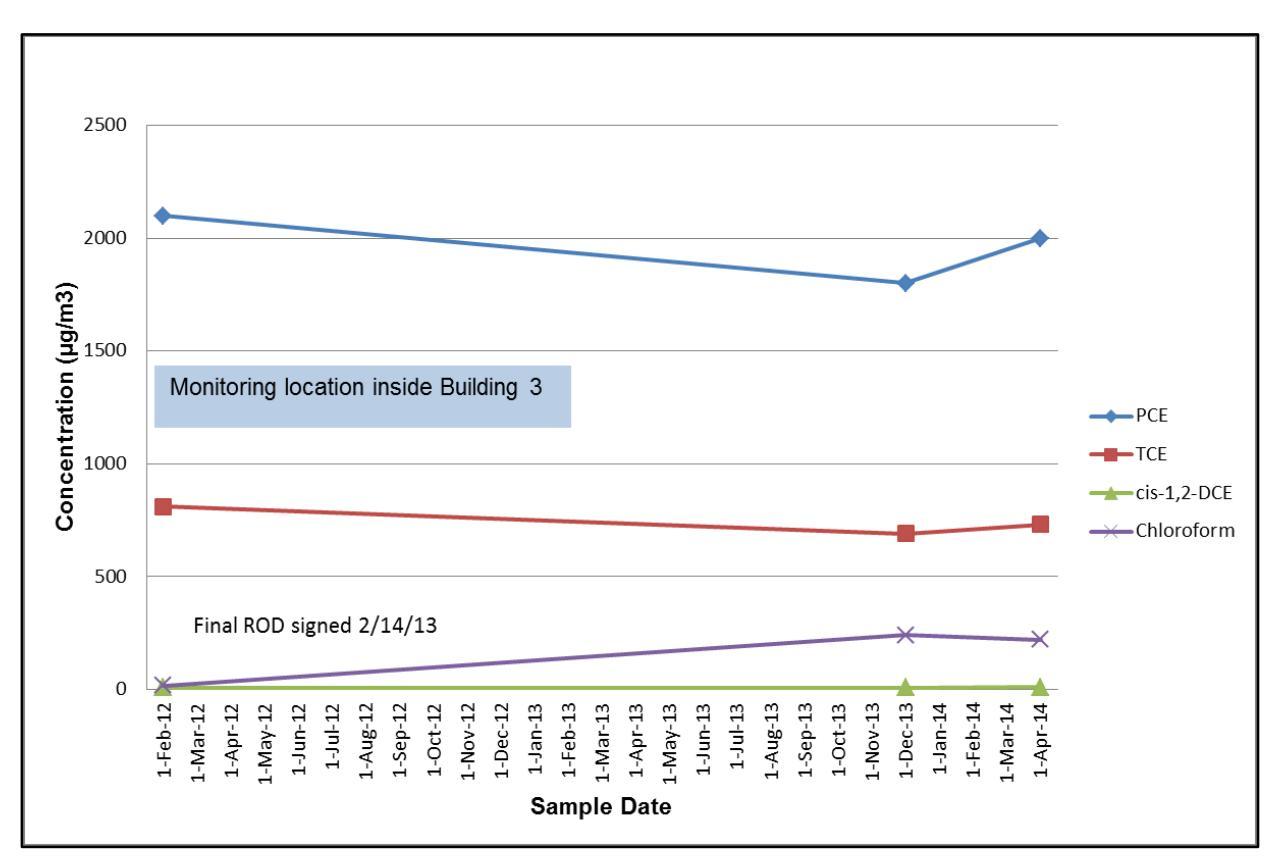
Exhibit 1. Soil Gas Concentrations at 21-SG-27

Although concentrations of VOCs in soil gas exceed risk-based SSSLs, concentrations are similar to when the ROD/Final RAP was signed and potential risk to human health remains the same as when the risk management decision embodied in the ROD/Final RAP was made. ICs are in place to prevent unacceptable exposures. Concentrations of VOCs in soil gas at location 21-SG-27 control the need for a deed notice inside this portion of Building 3 (see Figure 3). These concentrations currently indicate the need for a deed notice; however, concentrations show a stable trend and further monitoring is not necessary until there is a change in the use of this portion of Building 3 that fully encloses this area. Similarly, concentrations of VOCs in soil gas at location 21-SG-05 in the exterior area above the plume of VOCs in groundwater continue to indicate the need for the restriction on residential reuse of a portion of Site 21 (see Figure 3 for this area). Soil gas concentrations in this area show a stable trend, and further monitoring is not necessary at the plume of Site 21 (see Figure 3 for this area). Soil gas concentrations in this portion of Site 21.

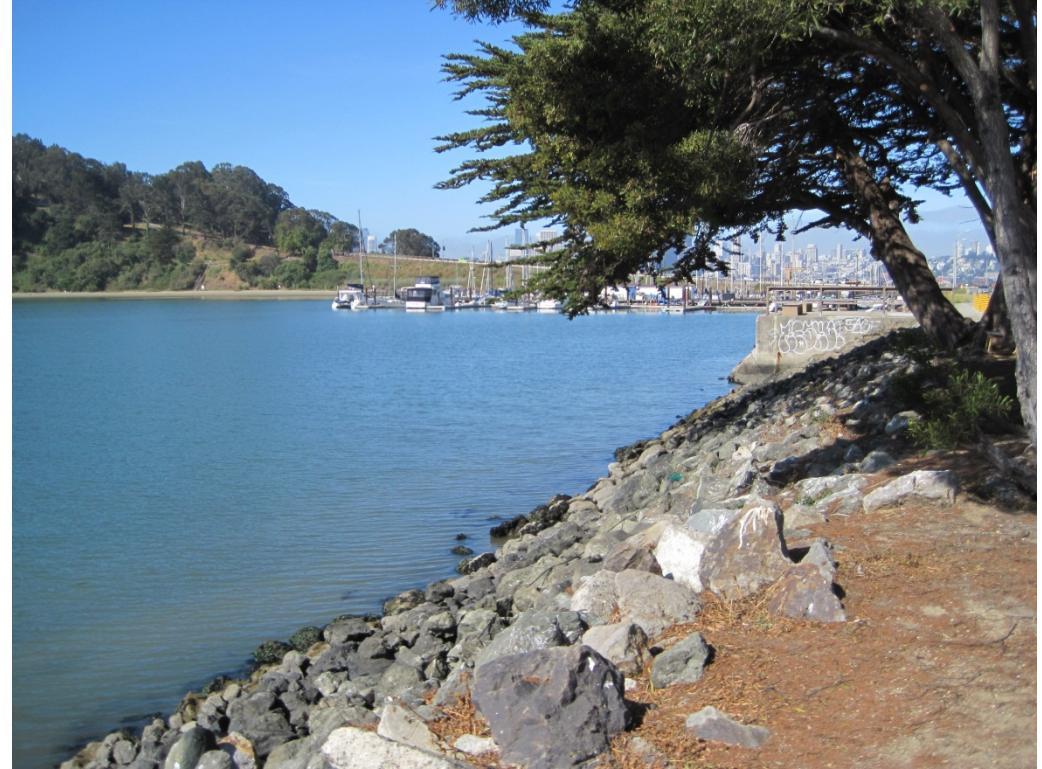
Photograph 1. Site 27. Looking west, riprap in foreground.

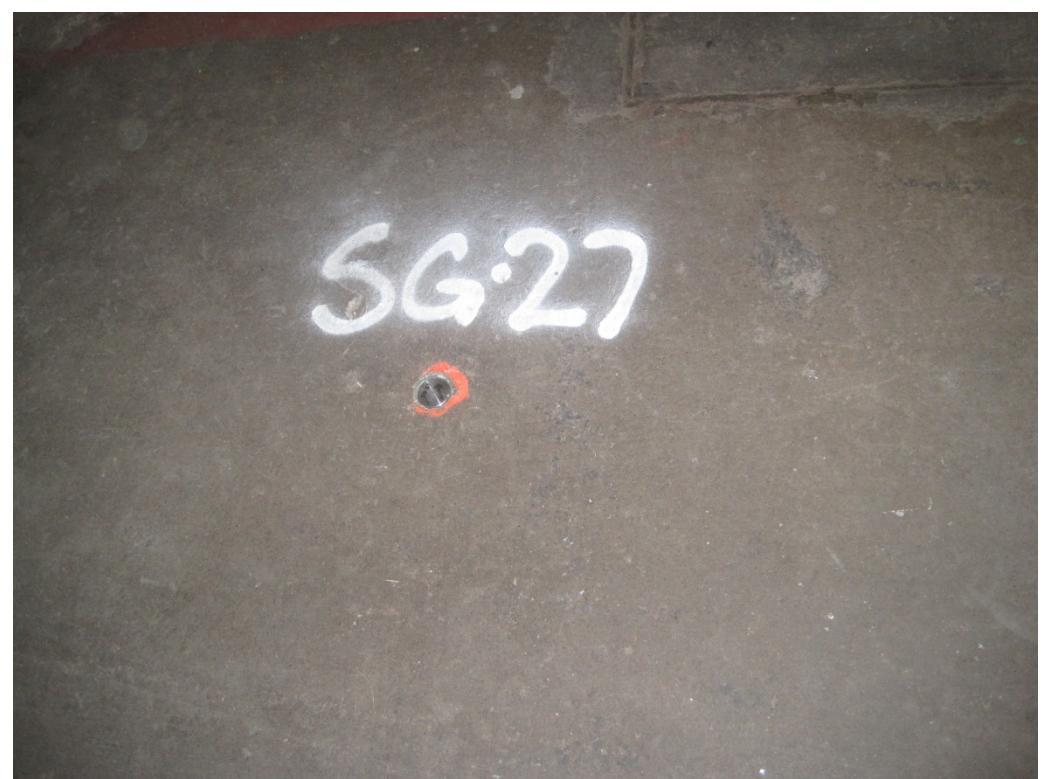
Photograph 5. Site 21. Soil gas monitoring well 21-SG-27 inside Building 3.

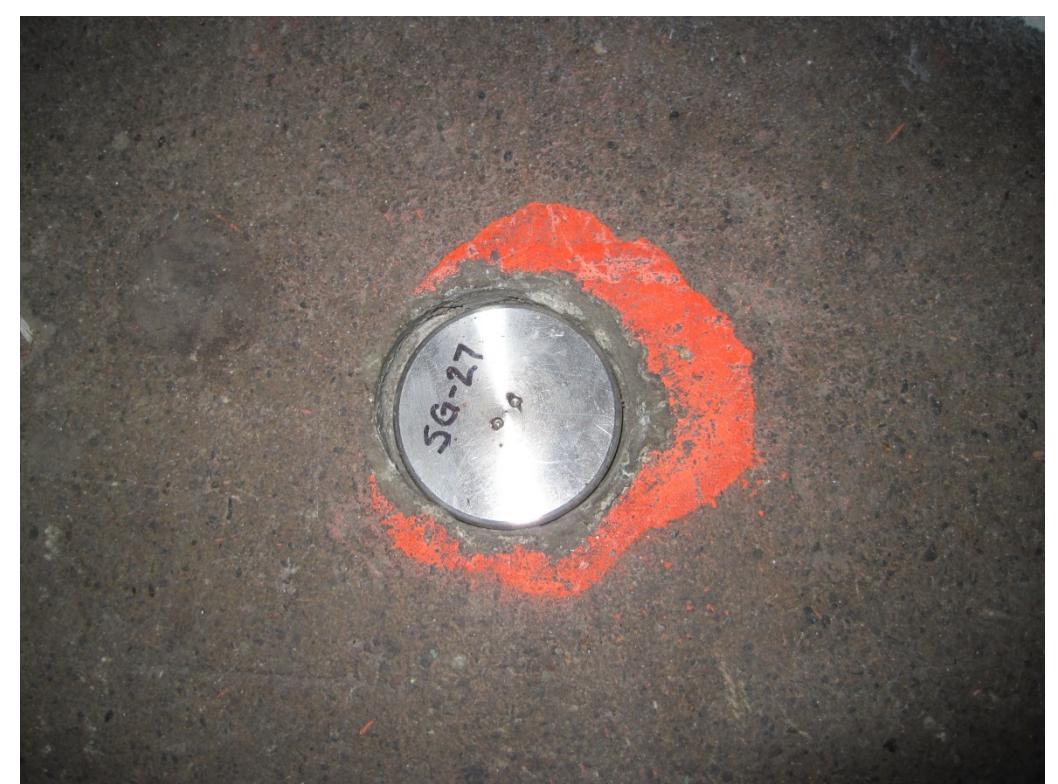
Photograph 6. Site 21. Close-up view of soil gas monitoring well 21-SG-27.

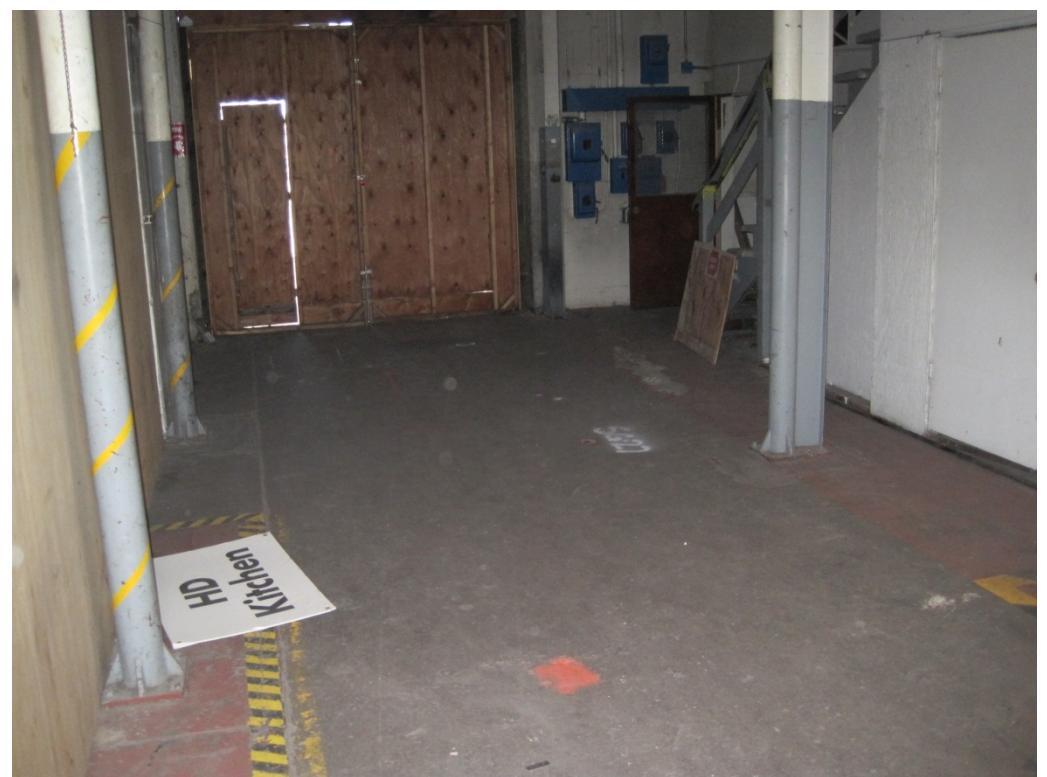
Photograph 8. Site 21. Vicinity of soil gas monitoring well 21-SG-27, looking south at the exterior wall of Building 3. Soil gas monitoring well 21-SG-27 label is in white paint near the center of the photograph.

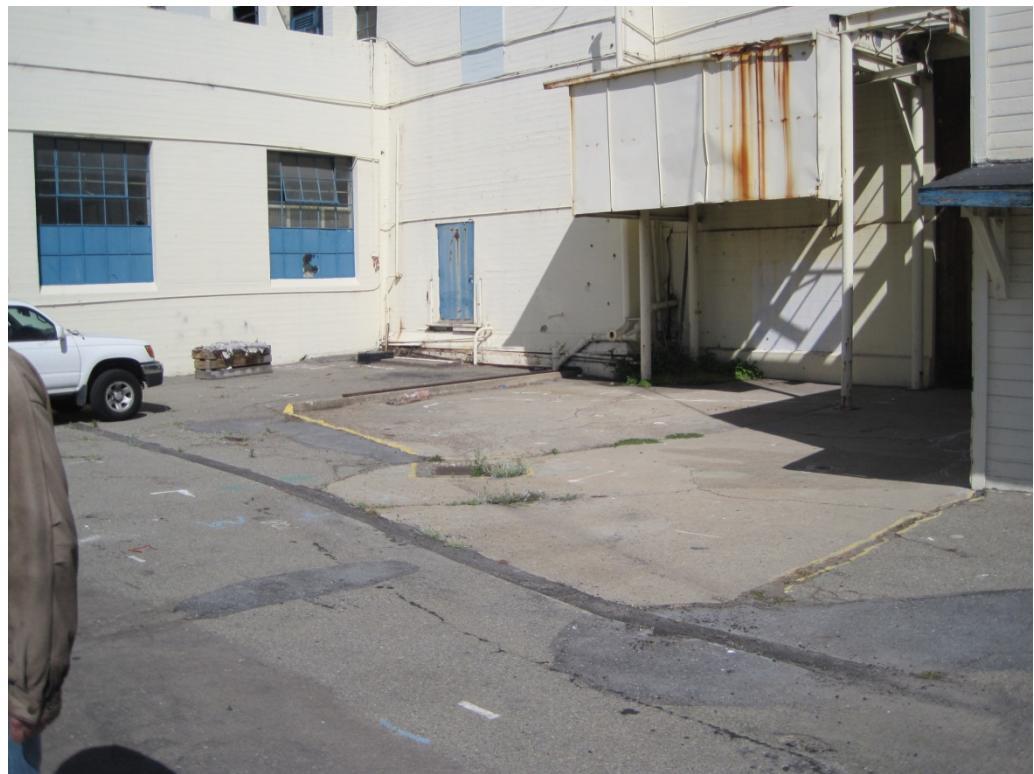
Photograph 11. Site 21. Location of the former dip tank (below rusty overhang) outside the south wall of Building 3.

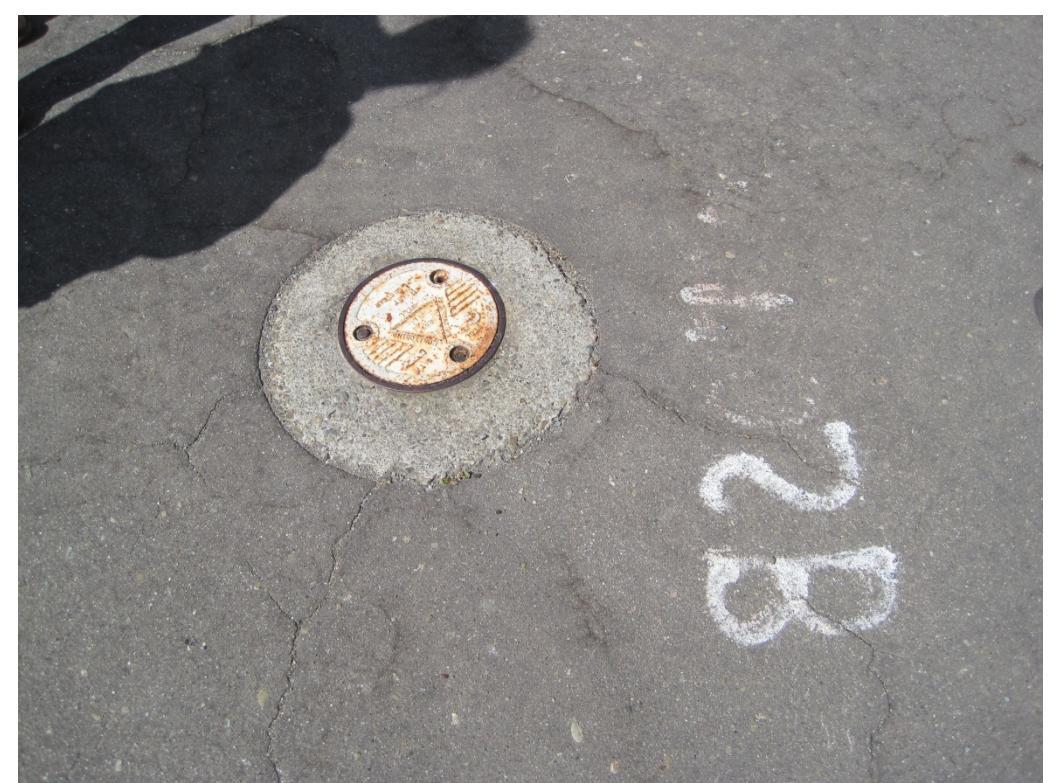
Photograph 12. Site 21. Groundwater monitoring well 21-MW02B. The well cover is in place, but two cover bolts were missing.

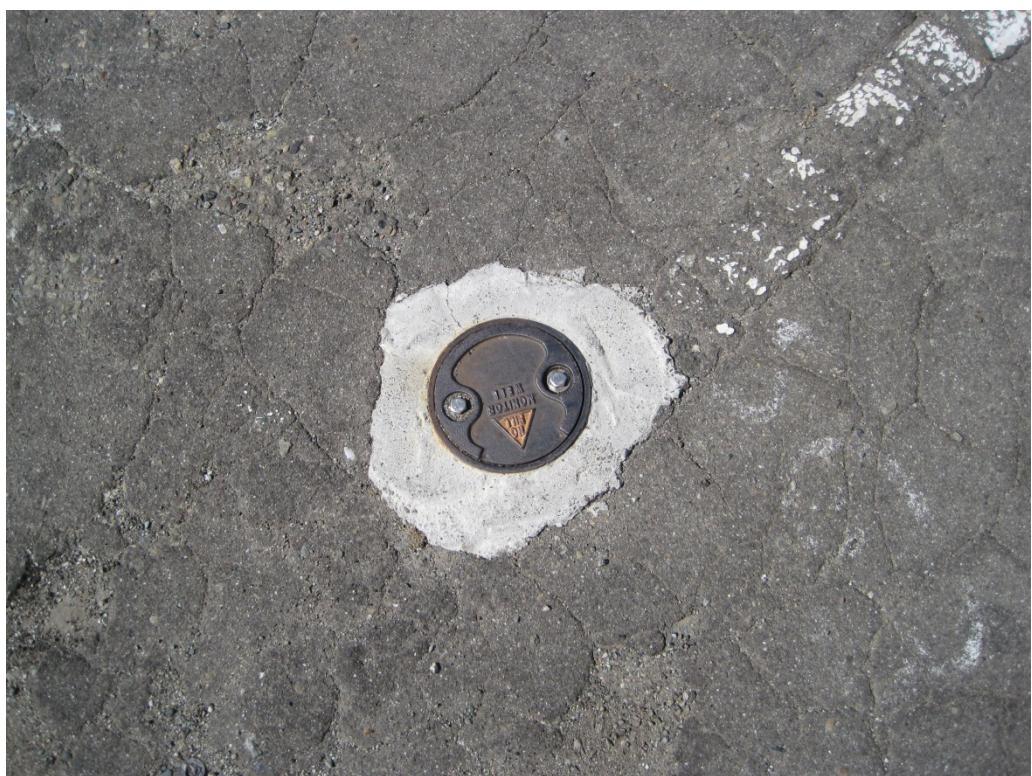
Photograph 13. Site 21. Soil gas monitoring well 21-SG-04 in good condition.

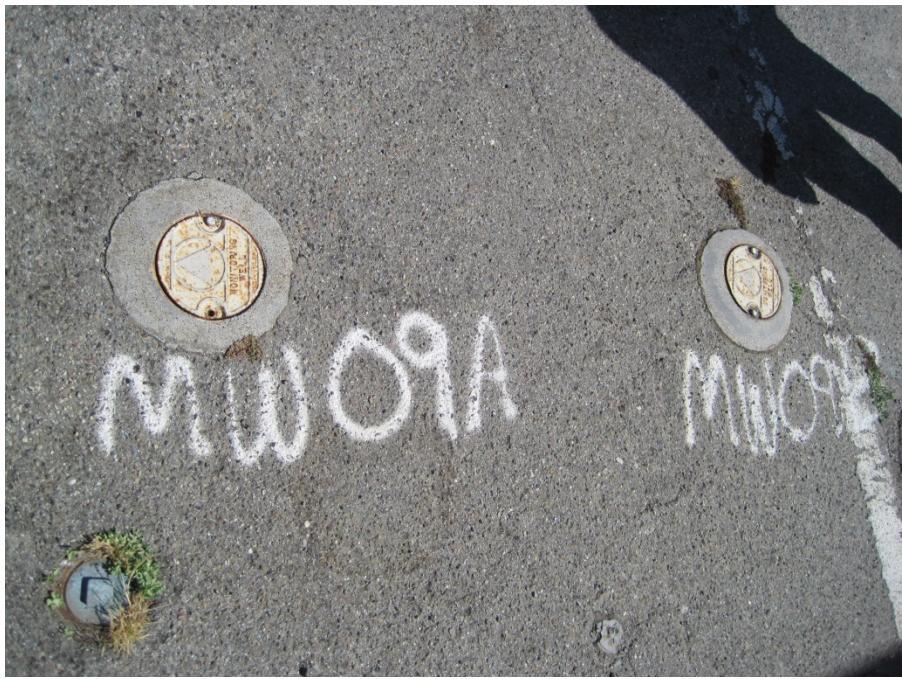
Photograph 16. Site 21. Groundwater monitoring wells 21-MW09A and 21-MW09B and injection point 21-IP19 (lower left corner). All in good condition, except that one bolt is missing from the cover of well 21-MW09A.

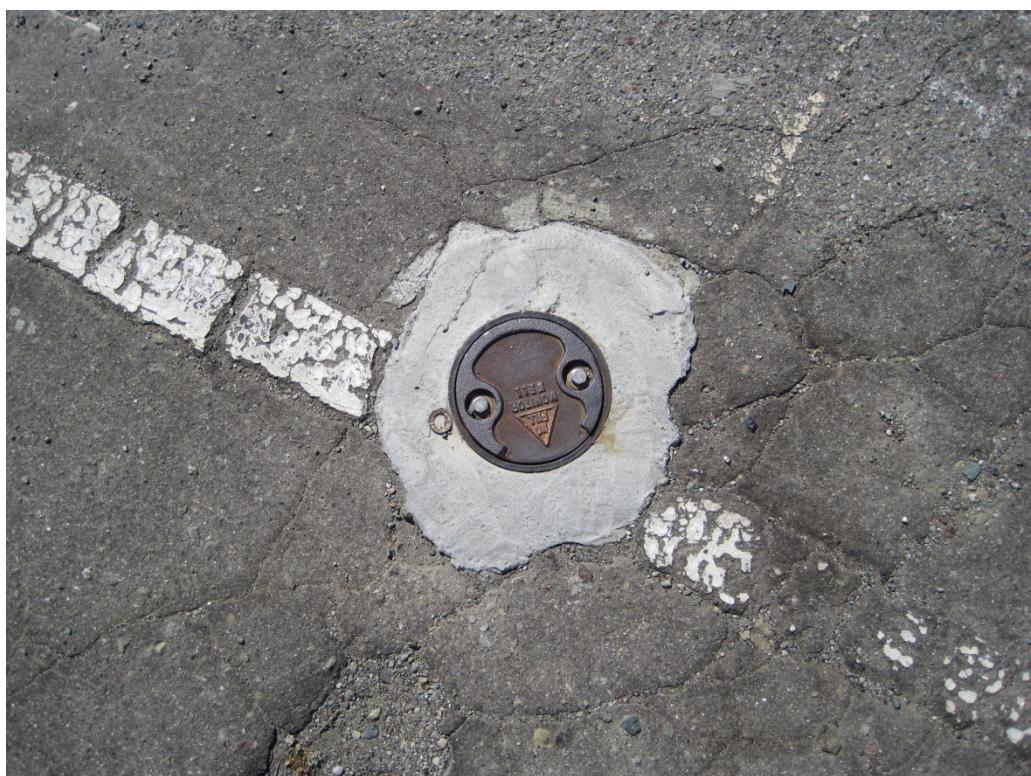
Photograph 17. Site 21. Soil gas monitoring well 21-SG-05 in good condition.

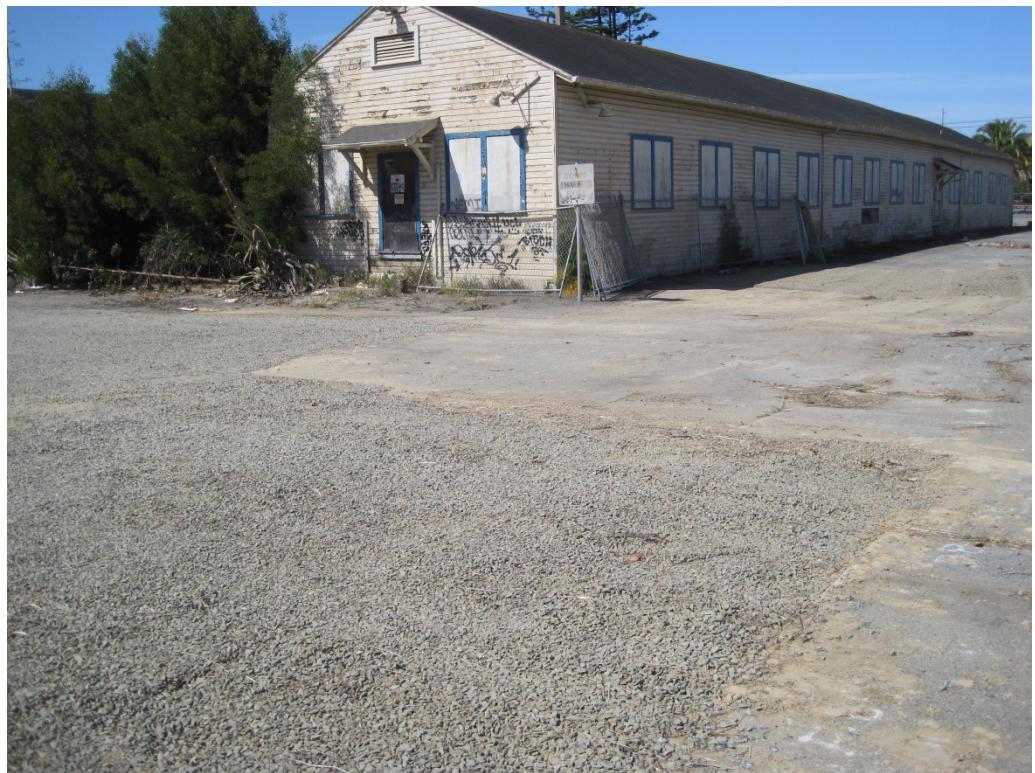
Photograph 18. Site 33. Looking southwest from the northeast corner of a backfilled excavation. Building 107 is in the background; and another backfilled excavation is just to the right of the building.

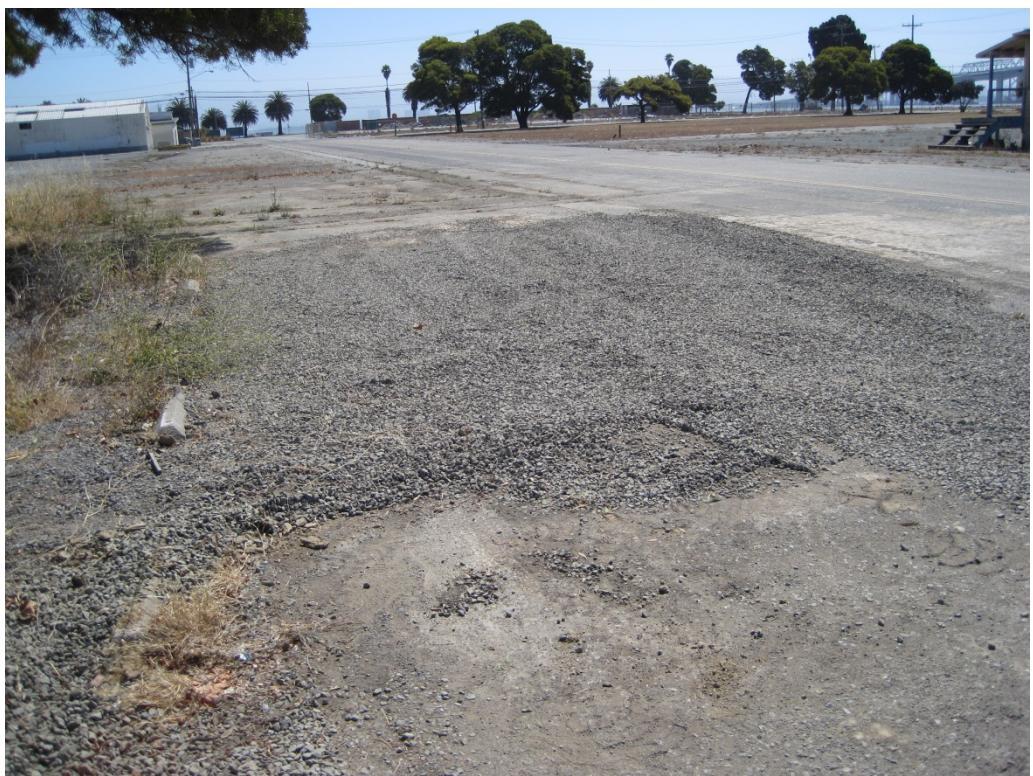
Photograph 19. Site 33. Looking east down 4<sup>th</sup> Street at the southernmost backfilled excavation at Site 33.

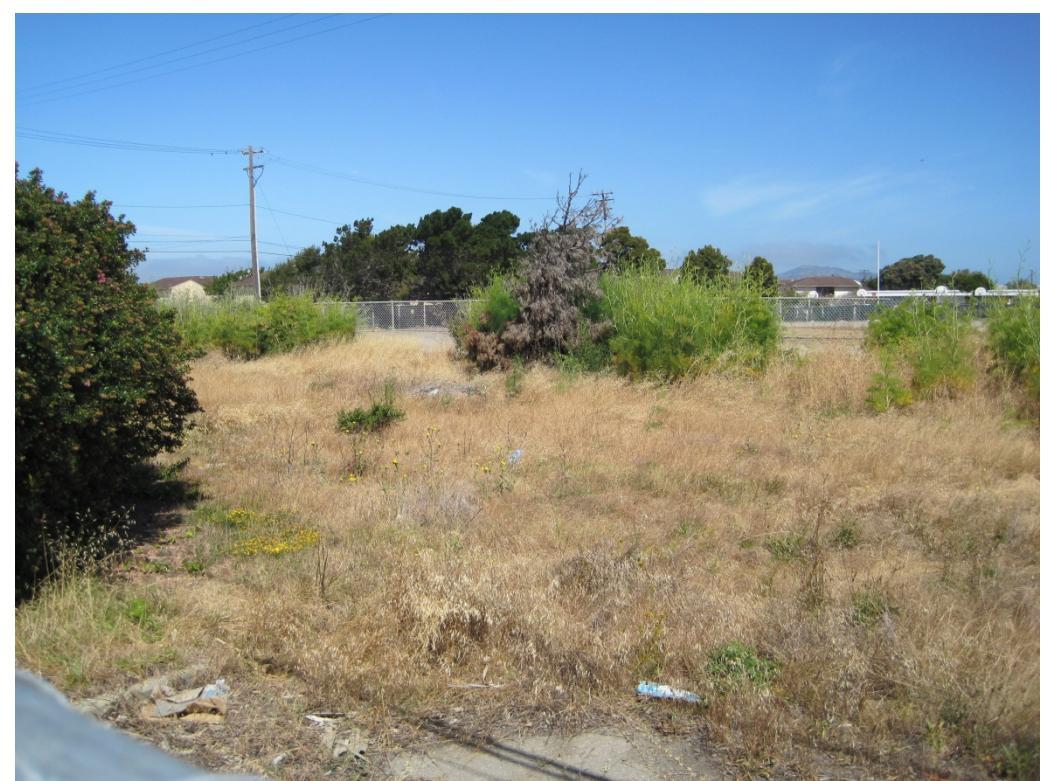
Photograph 20. Site 31. Looking northwest at previously backfilled areas from the southern boundary of Site 31, just east of Avenue E.

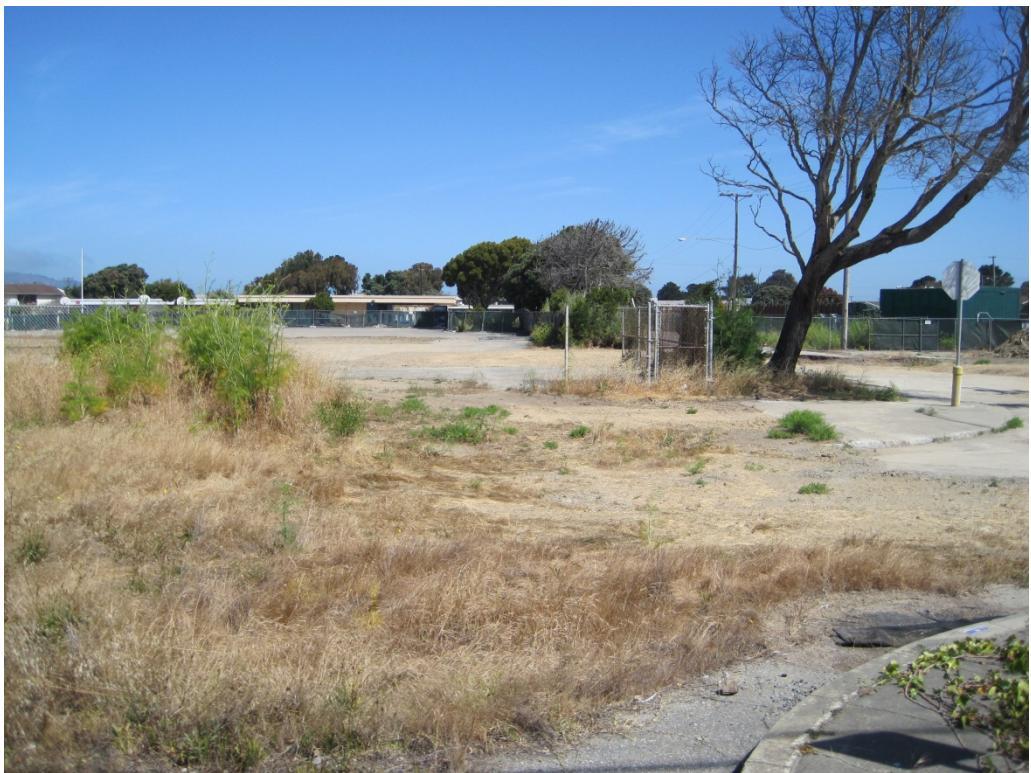
Photograph 21. Site 31. Looking north at backfilled areas from the southern boundary of Site 31, just east of Avenue E  $11^{\text{th}}$  Street is in the fore/middle ground.

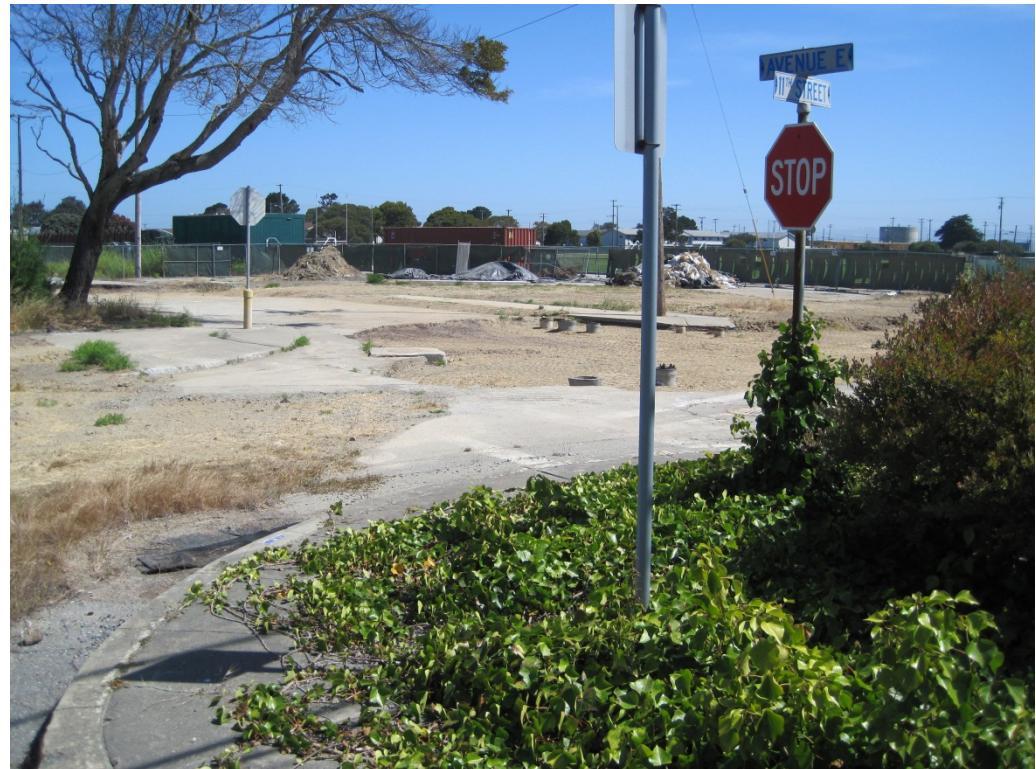
Photograph 22. Site 31. Looking northeast at backfilled areas from the southern boundary of Site 31. The intersection of Avenue E and 11<sup>th</sup> Street in the middle ground awaits repaying.

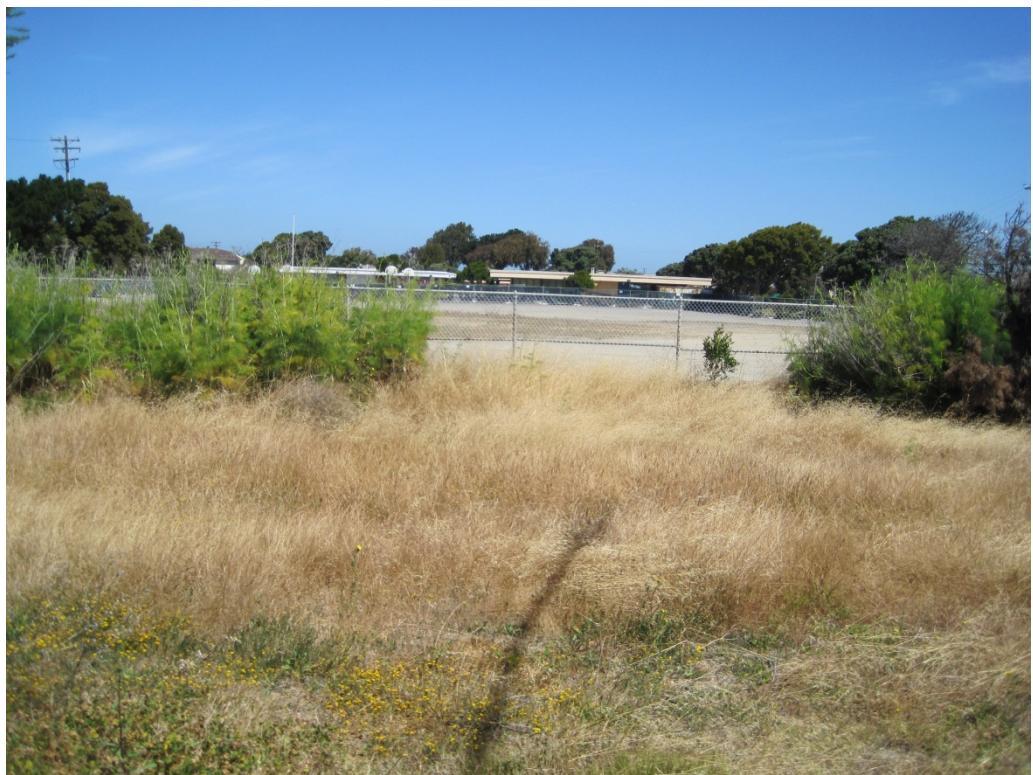
Photograph 23. Site 31. Looking north at backfilled areas from the northern boundary of Site 30.

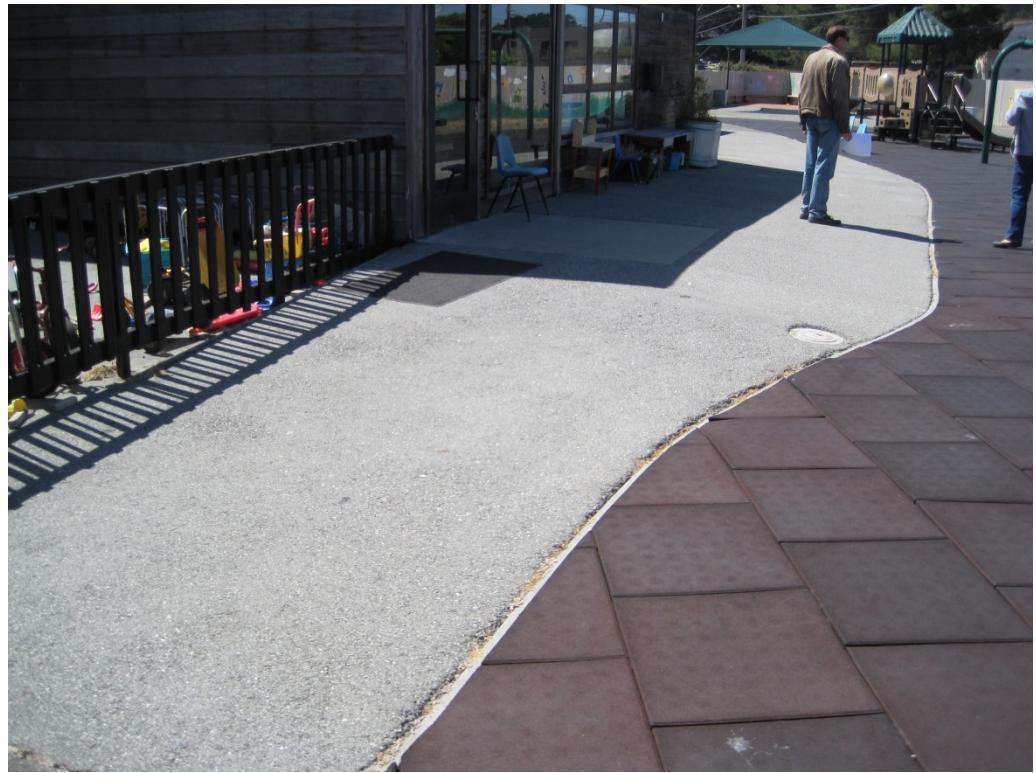
Photograph 26. Site 30. Exterior asphalt-covered concrete pad located west of Building 502. Photo taken looking south from northern end of the pad. The pad is in good condition.

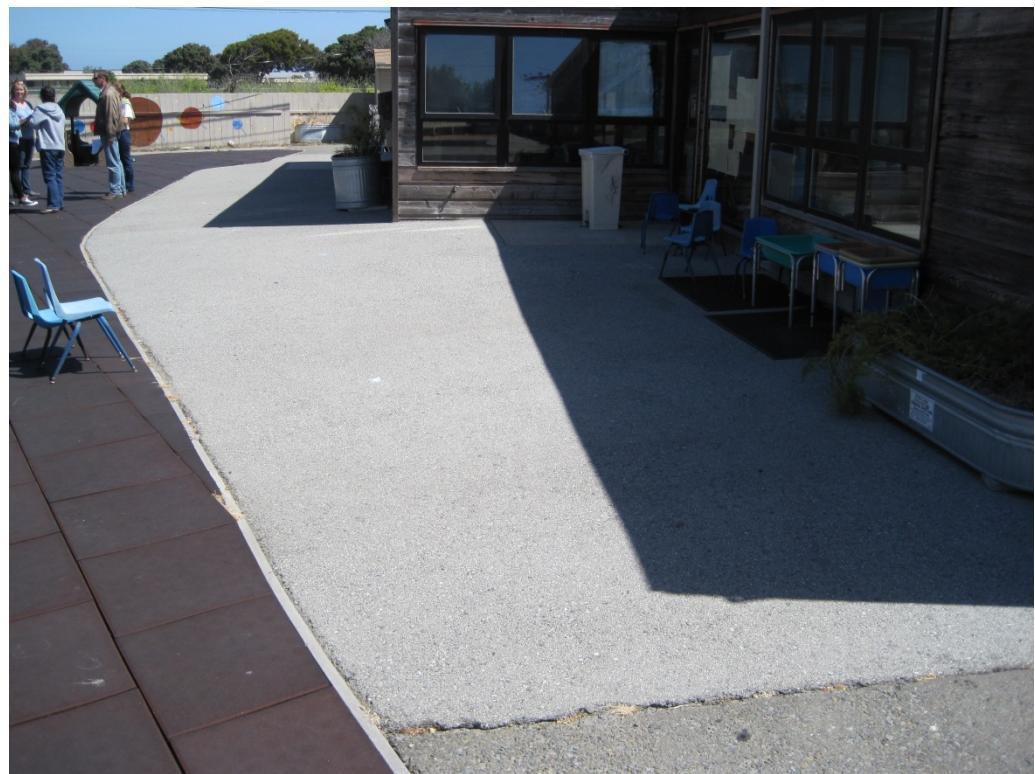
Photograph 27. Site 30. Exterior asphalt-covered concrete pad located west of Building 502. Photo taken looking north from southern end of the pad. The pad is in good condition.
