### Overview of Testing Results for Lead in Drinking Water and Corrective Actions for Naval Base Point Loma CDC, Patrick Wade CDC, Admiral Hartman Recreation Center, Gateway Village Recreation Center, Village at Serra Mesa Recreation Center, and Chesterton Community Center

# Sample Summary Results Table Priority Areas Lead Testing and Corrective Actions - June 2024 Naval Base Point Loma

## Sample Summary Results Table Priority Areas Lead Testing and Corrective Actions - June 2024 Naval Base Point Loma Patrick Wade Child Development Center

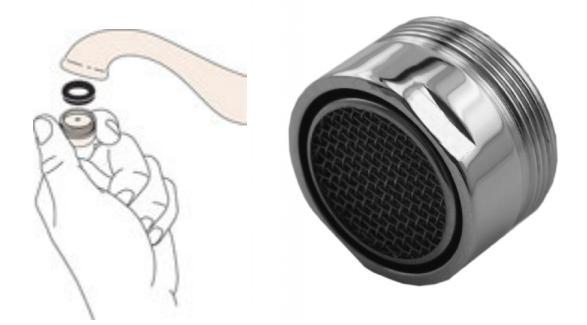
The *one* outlet that exceeded 10 ppb was a hand washing sink located in the Teacher Training Room (Room 116) inside the NBPL CDC (Building 377). Follow-up sampling at this outlet was conducted after removing and cleaning the faucet aerator. A faucet aerator (or tap aerator) is often found at the tip of modern indoor water faucets. Without an aerator, water usually flows out of a faucet as one big stream. An aerator spreads this stream into many little droplets, which helps save water, provides more uniform flow, and reduces splashing. However, the aerator and screen can trap debris which can accumulate lead.

After removing the faucet aerator, retesting showed that the sink in Room *116* at the NBPL CDC was below the screening level and the faucet was returned to service.

- If the lead concentration of the 30 second flush sample resulted in lower than 10 ppb lead, the <u>aerators</u> were the source of lead and the outlet can be used for drinking if the aerators are cleaned on a regular basis. The washing sinks in Room 116 at the NBPL CDC fit in this category.
