Figure 3. Proposed hydrologic units for New Mill Creek Tidal Wetland Mitigation Bank.

Figure 13. Conceptual Plan for the proposed New Mill Creek Tidal Wetland Mitigation Bank.

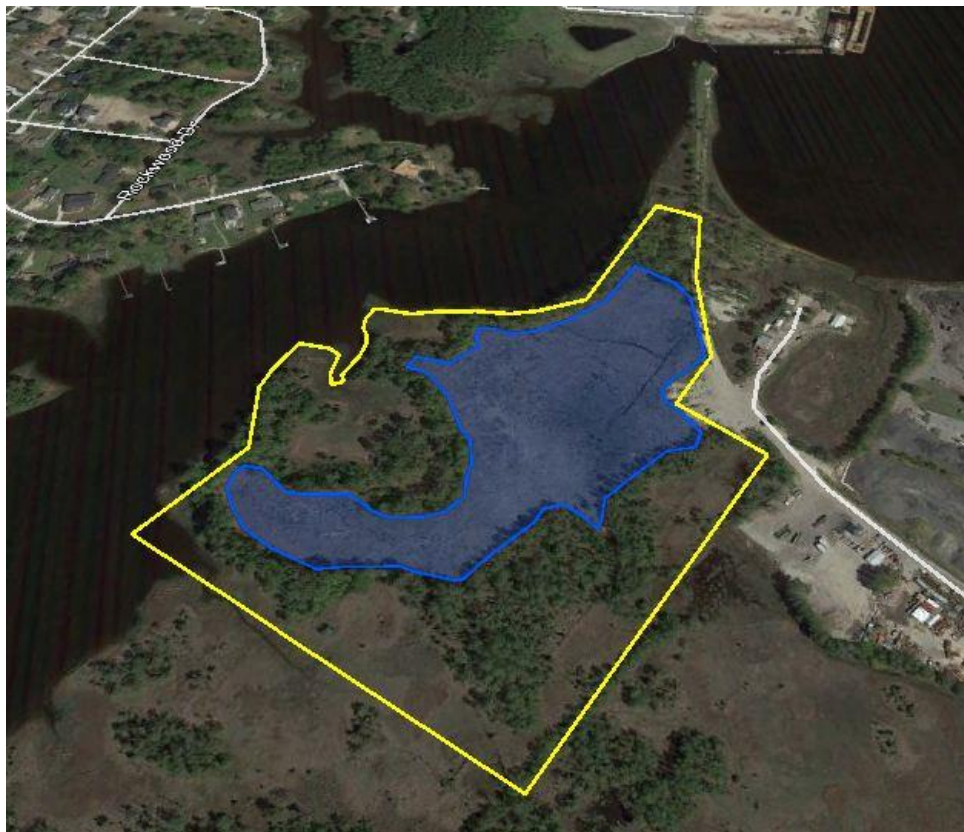
Figure 2. Property boundary and proposed mitigation area

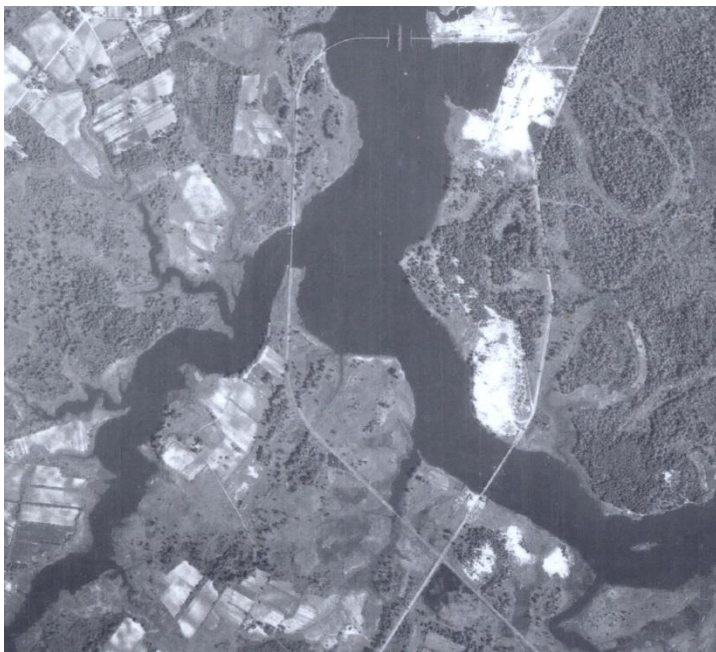
Figure 9. 1937 aerial photograph from the National Archives indicating farmed fields on the site.
