Final MARE ISLAND NAVAL SHIPYARD Restoration Advisory Board (RAB) Meeting Minutes

HELD THURSDAY, July 30, 2015

Restoration Advisory Board Meeting

July 30, 2015

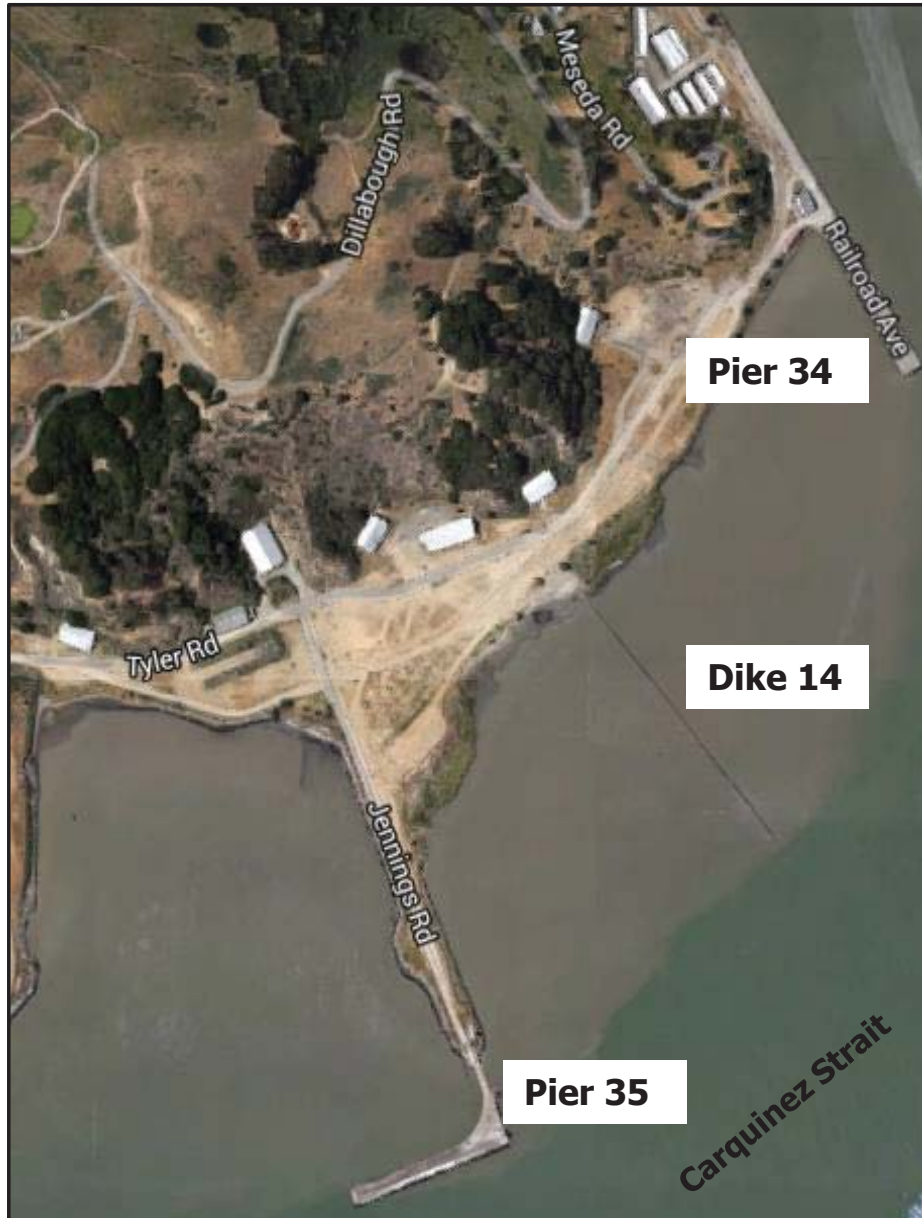
Site History/Land Use

- Approximately 38 acre site located at southern tip of Mare Island
- Created in several stages between 1930 and 1947
- Staging and loading/unloading of munitions from ships
- Some munitions repair work conducted, but munitions were not manufactured
- Limited use/storage of hazardous materials – mainly diesel fuel
- Munitions items and related debris was disposed of (buried) at some locations
- Current land use is industrial; future is park/wildlife preserve

Okay. So a brief history of the site. Approximately 38 acres located at the southern tip.

It was created in several stages using soil and rock from the upland areas to build it out, so most of the SSA is fill area.

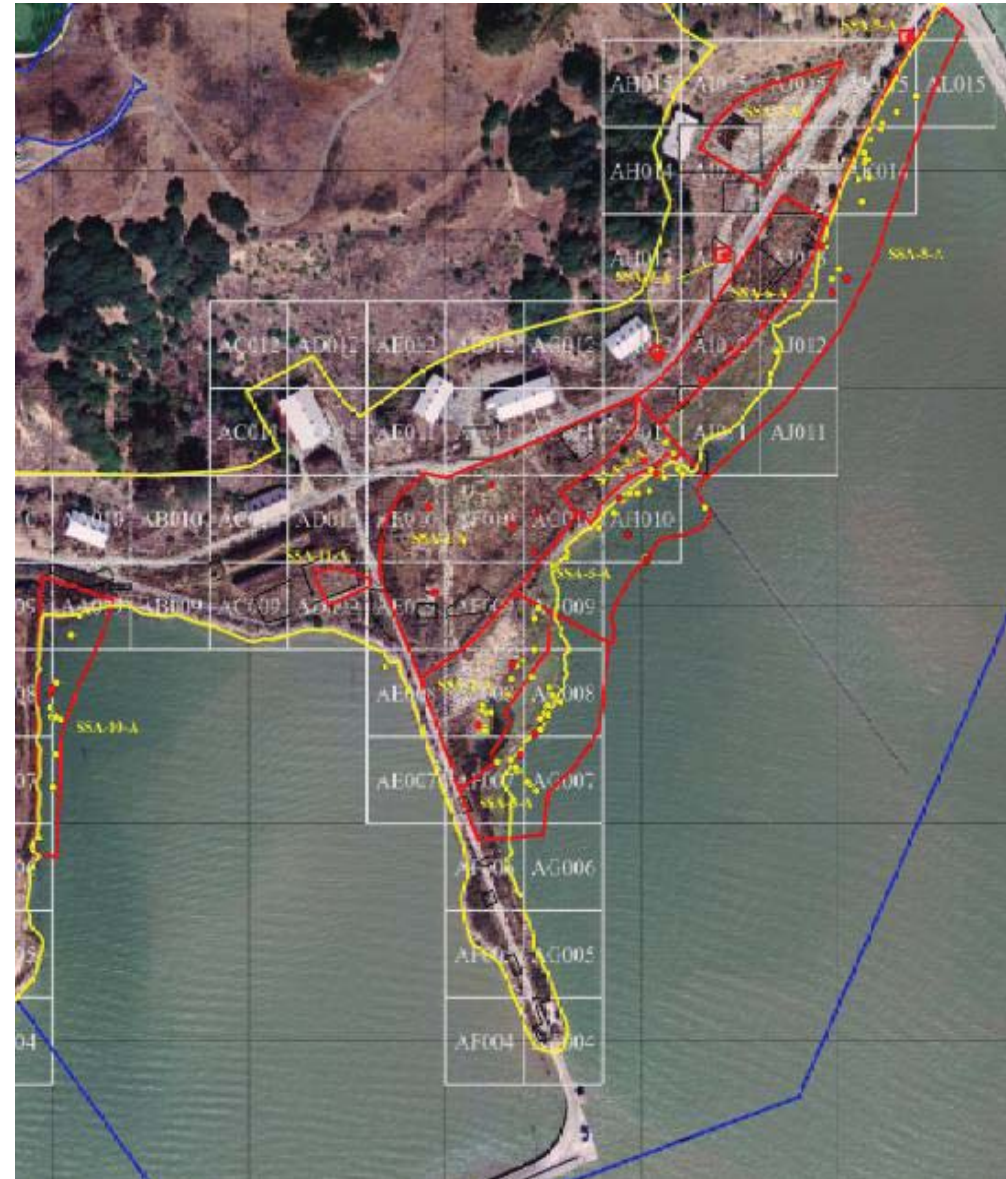
Digital Geophysical Mapping:

- A digital geophysical mapping (DGM) survey was conducted, which identified a total of 14,324 geophysical anomalies.
- Site history and results of DGM survey were used to distinguish areas where buried munitions and/or munitions debris most likely to be found (areas outlined in red designated as Category A; all else Category B)

And so the Navy obviously realized that additional -- I need to slow down -- additional digital geophysical mapping, or DGM, as I like to call it -- it's so much easier to say DGM -- surveys were conducted between 2003 and 2004, and then there was another one conducted in 2006. And we found, you know, over 14,000 subsurface geophysical anomalies, so metallic anomalies, and realized that there was even more probably, you know, mostly 98 percent metallic debris, but there's a potential for munitions items.

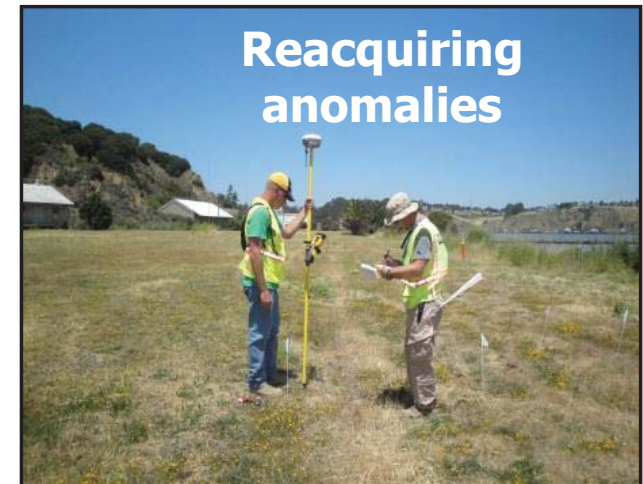
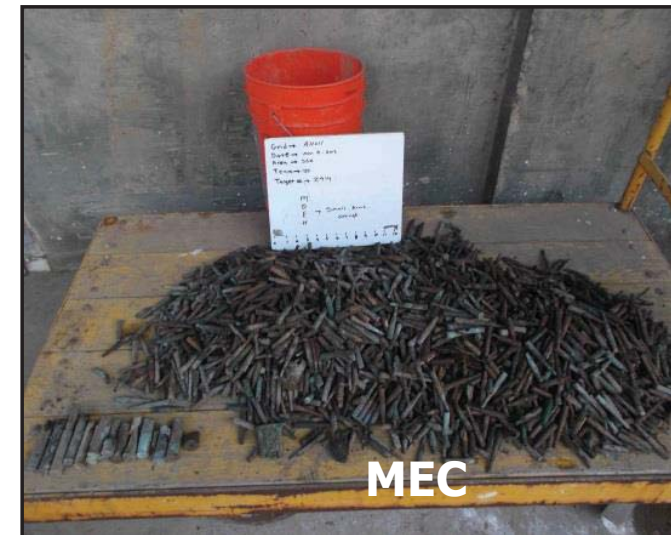
2012 – 2013 MEC NTCRA

- Comprehensive Non-Time Critical Removal Action (NTCRA) was conducted at SSA based on results of the 2006-2008 DGM Survey and additional 2012-2013 surveys.
 - 100% removal of metallic anomalies in Category A areas
 - 26 to 59% removal of metallic anomalies in Category B areas (minimum 20%)
 - 100% removal of metallic anomalies under accessible buildings
 - 17,000+ locations dug; 358 munitions items and thousands of munitions-related debris items (MDAS) removed
 - Primers, small fuses, small arms ammunitions, 50-caliber casings, projectile bases and primer flash tubes
- Several subsurface disposal areas identified and excavated

MS. PAULY: Okay. So going into a little bit about the munitions and NTCRA. So there's a few stats on the removal. So I introduced the idea of the Category A areas. We did a hundred percent removal of metallic anomalies in those areas. So these were the areas most likely to contain MEC. We still found tons and tons of just metal debris, but we did find some munitions items.

Again, 26 to 59 percent removal of metallic anomalies in the Category B area. And so these are the areas that we didn't think we'd find as much munitions, and we did not. So we had decided and agreed with the agencies that we would remove at least 20 percent of the anomalies in these areas. And, of course, we went over that just to be, you know, in an abundance of caution, and doing step-outs. When we found munitions items then we would say, okay, well, there's an indication of something that could be here, so then we'd step out and make sure until we didn't find anything that was a munitions item.

So this translated to over 17,000 dig locations. So you remember there were 14,000 anomalies identified actually, with the step-outs we did over 17,000 locations, and only 358 munitions items were found. So it's a pretty small percentage. But, again, we feel like we really got, got what we were going for. We wanted to get as much as we could.

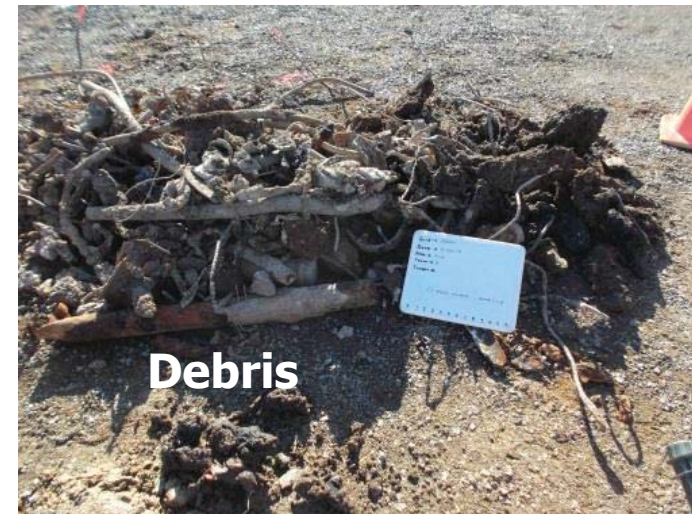
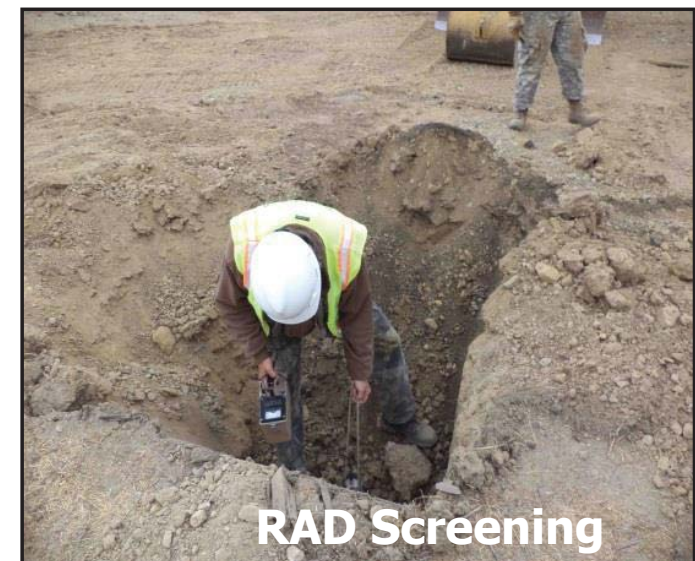
2012 – 2013 MEC NTCRA cont'd

- Sampling for munitions constituents (energetics & metals) conducted at 6 representative locations
 - No energetics detected
 - All detected metals below ambient/background levels for Mare Island
- Non-munitions items found during excavation include:
 - Buried drums (41 total found in 2 locations)-soil samples ND and drums appear to be filled with soil and used as fill
 - Three (3) USTs and 2 dry wells of unknown origin
- Radiological scanning was conducted at all excavations - No radiological items or materials identified

MS. PAULY: The explosive part, exactly. Exactly. So we didn't find any of that. Any detected metals that we found were below the ambient and background levels for Mare Island, so that was really good.

The munitions -- the metals that we -- the actual debris that we found we pick out; but when I talk about detected metals, I'm saying in soil samples. So we take soil samples, analyze them for metals, and energetics, munitions constituents. And those were, exactly right, below the ambient or background levels for Mare Island.

And because of that -- the other good news is because of that radioluminescent deck marker that we found, we did radiological scanning on all these 17,000 plus locations and did not find any other radiological material or items. So that was some good news.

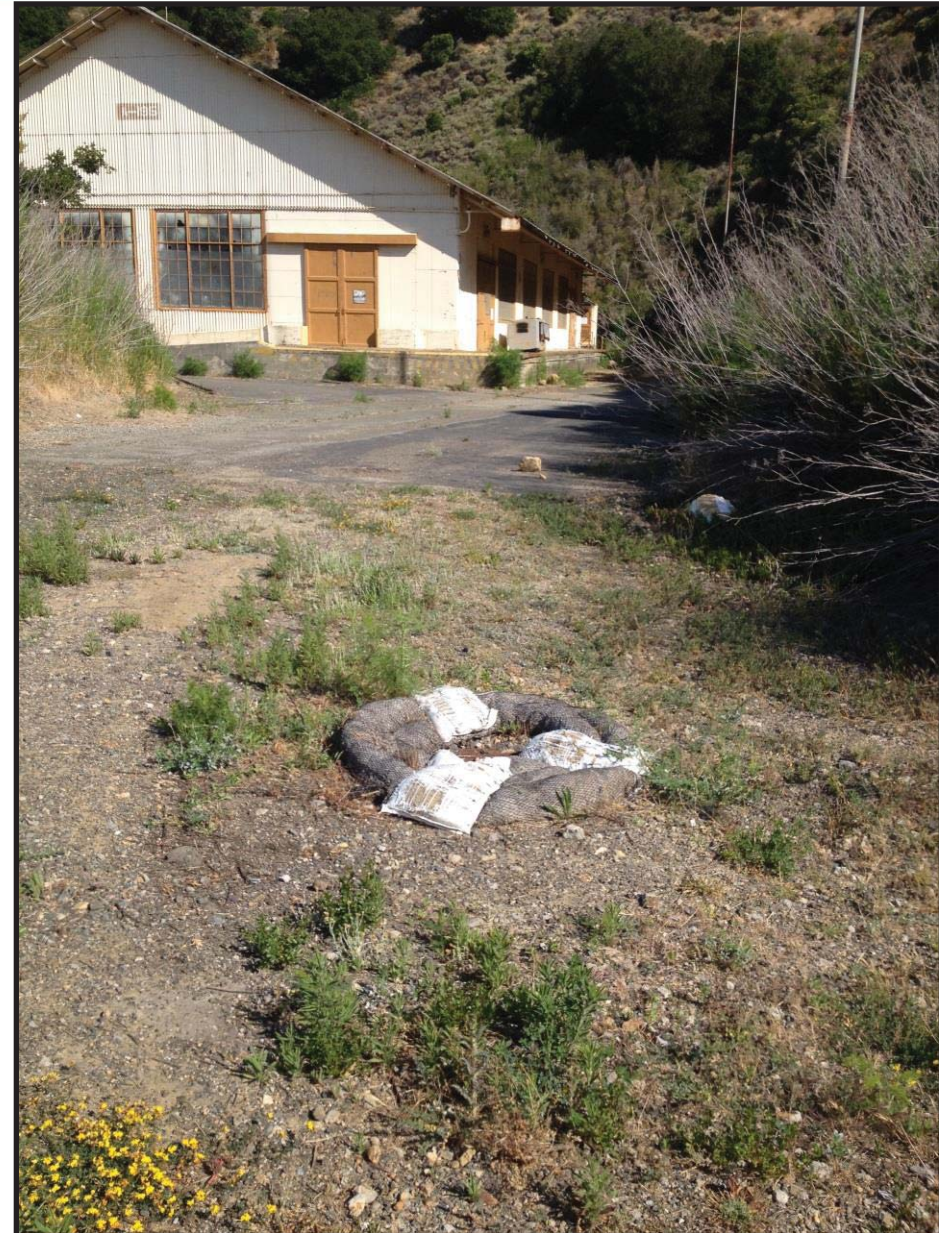
Conceptual Site Model

- SSA historically used for storage/handling of munitions and general shipyard items
- RI approach will consider all potential contaminant sources at SSA
- Most probable release mechanisms for potential contaminants include:
 - Direct release to subsurface (at depth) from leaking pipelines or tanks
 - Direct disposal to subsurface by burial with trash, debris, or MEC items
 - Surface releases in areas where hazardous materials stored and/or used (none known)

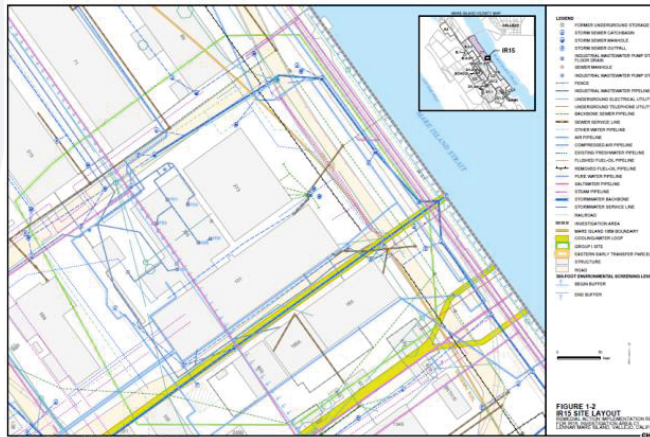
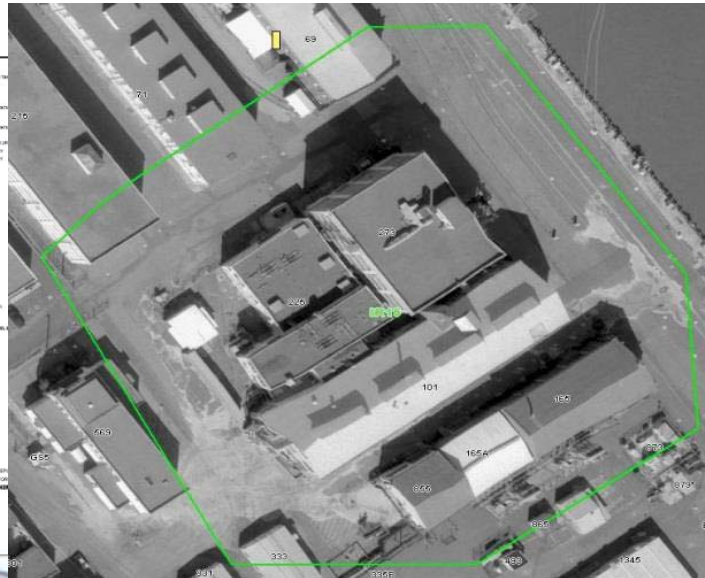
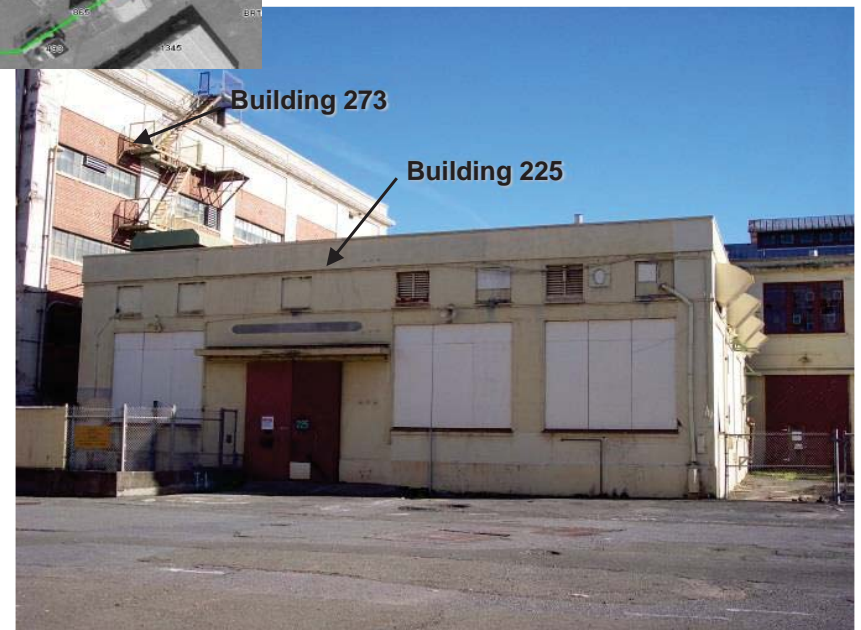
Site Location and Features

- **Four (4) Acres Industrial / Commercial Waterfront**
- **Historic Use**
 - Building 101 – 1899 - Pipe Cleaning
 - Building 225 – 1911 – Plating Shop
 - Building 273 – 1921 – Electrical and Optical Shop / Warehouse / Offices
- **Future Use**
 - Industrial / Commercial / Promenade
- **Constituents-of-Concern**
 - Metals – Arsenic, Cadmium, Lead and Hexavalent Chromium
 - Chlorinated Volatile Organic Compounds (CVOCs)
- **Previous Investigative and Remedial Actions**
 - 1983 – 2010 – Investigations
 - 1987 – Underground Storage Tank (UST) 225B Removal
 - 1993 – UST 225 and Building 225 Floor Drain Removal
 - 2008 – 2010 – Enhanced Reductive Dechlorination (ERD) Pilot Studies
 - 2010 – ? – Remedy Implementation

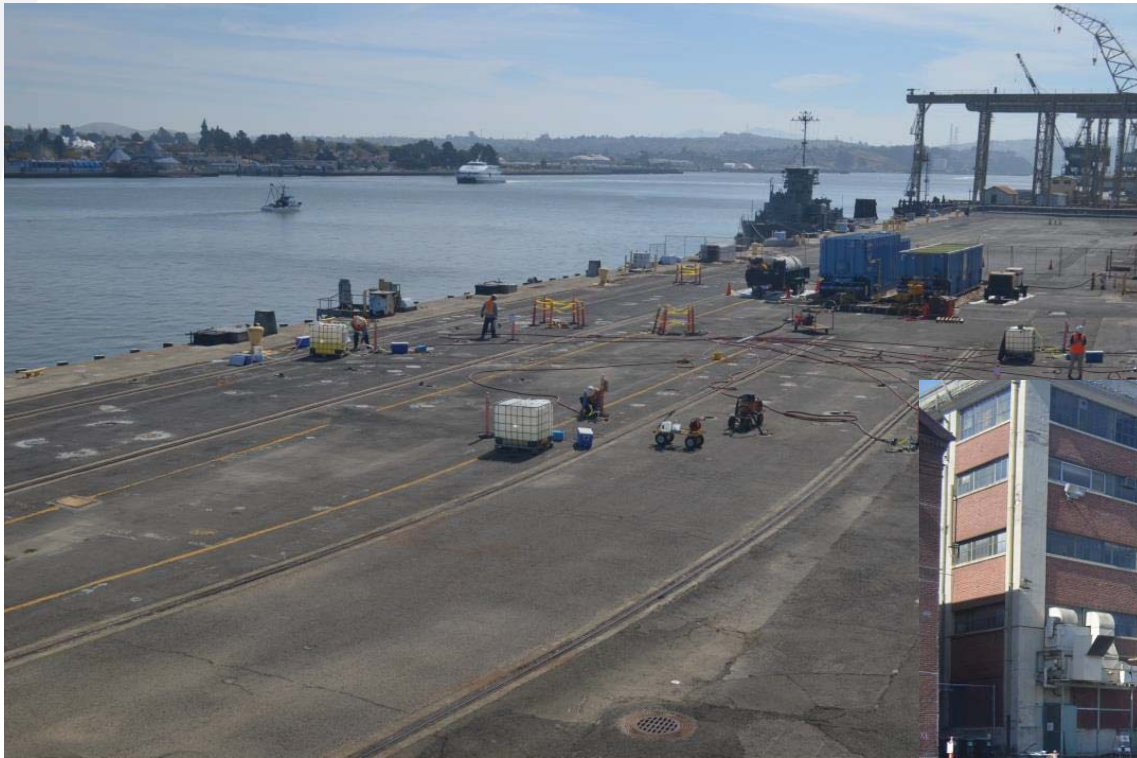
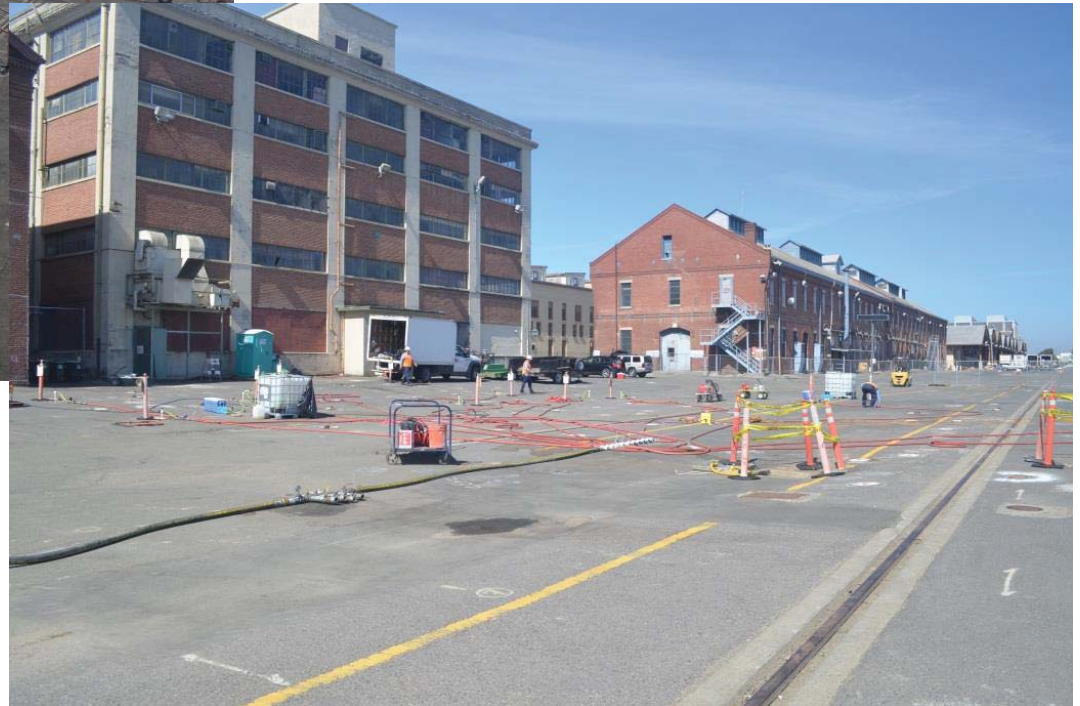
Third Injection Event at IR15 – September 2012 (Photographs)

- First Injection Event – First Quarter 2011
- Second Injection Event – Fourth Quarter 2011
- Third Injection Event – Third Quarter 2012
- What Was Injected?
 - Bioaugmentation – Microbe Addition
 - EHC – Zero-Valent Iron (ZVI) and Carbon Substrate
 - ✓ 37,000 Pounds
 - Cheese Whey – Additional Carbon Source
 - ✓ 29,000 Pounds
 - Nutrients, Stimulants, Stabilizers and Tracer
 - ✓ 105,000 Gallons

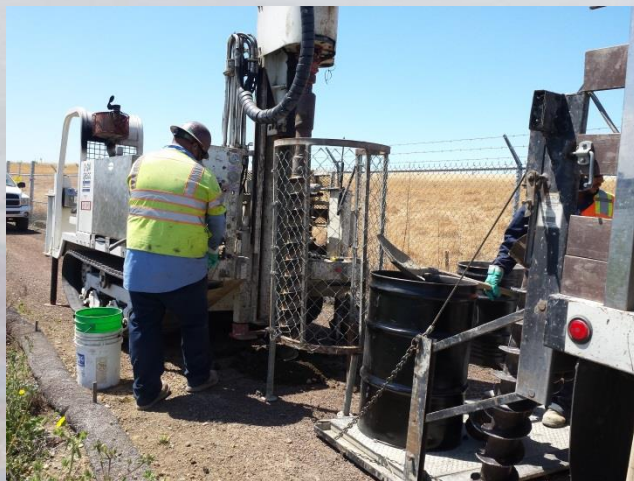
IA-H1 Well Replacement

During the month of June 2015, WESTON re-installed two monitoring wells suspected to have been damaged during the August 2014 Napa Earthquake. Monitoring well 01W19A and PZ32B were drilled out and re-installed as these wells are used to collect water level data semi-annually. Well 01W19A is located within the Containment Area (Landfill). The geosynthetic layers making up the cap system around the well penetration were reinstalled in accordance with the original design requirements.

And also, as I just mentioned, in June we replaced two wells that had obstructed casings, and those were drilled out and replaced. And you can see a photograph there in the upper right which also illustrates one of our new requirements that the operator needs to be as large as the drill rig.

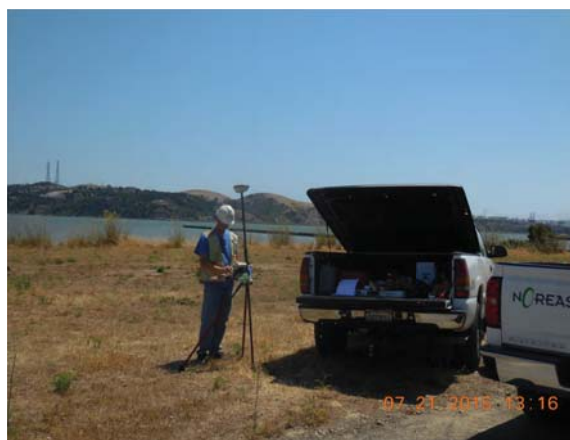
Initial land survey of potential soil boring location at the SSA

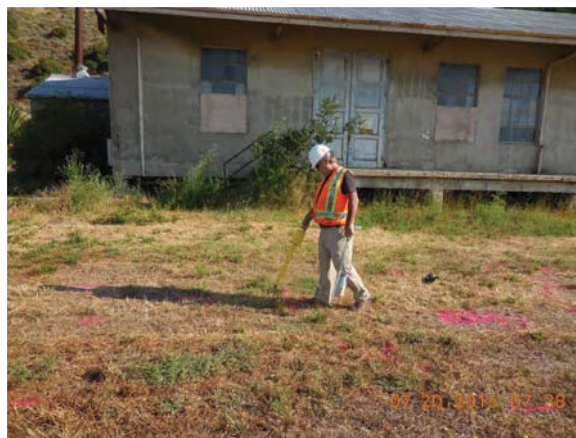
Geophysical survey of Debris Pit in Grid AF011 of SSA using electromagnetic methods
