Summary Report
1316 Gateview Avenue Unit A

Summary Report
1316 Gateview Avenue Unit B

Summary Report
1316 Gateview Avenue Unit C

Summary Report
1316 Gateview Avenue Unit D

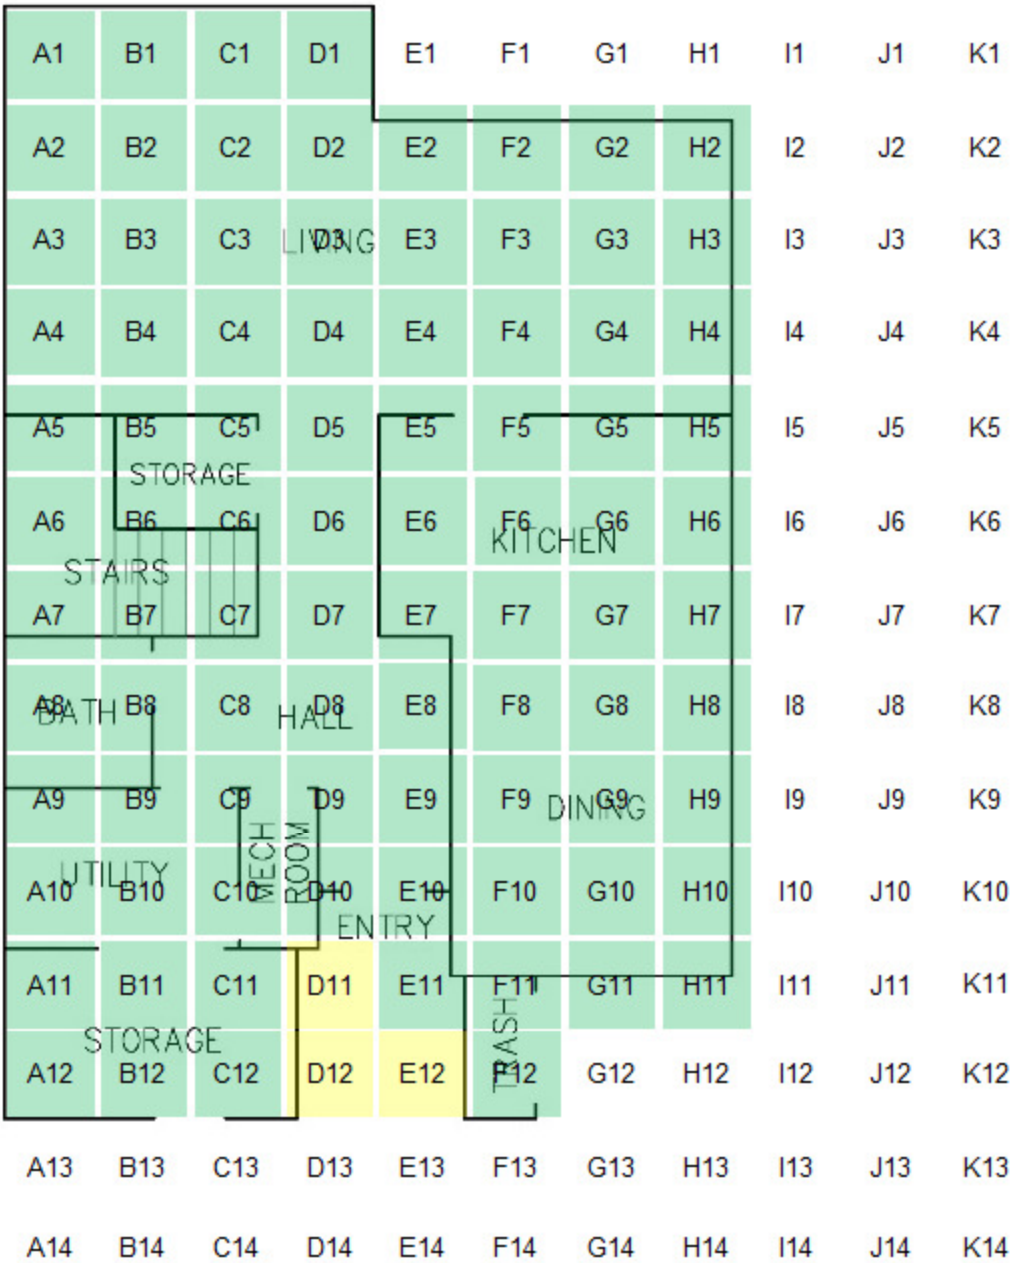
Completion Date: 8/19/2014 1:06 PM
Instrument: 193-6
Serial #: 309136
Layout: Floor Plan 7
Background Reading: 2.8 uR/hr
Dimensions (m): D 11.8 W 7.6
Unit Furnished: Yes
Tenant Present: Yes

Bed in living room (grids F3-H3 and F4-H4) moved for survey. Bath and utility converted into ADA compliant bathroom and tub. Storage is Utility Rm. Grids D11, D12 and E12 fall outside of floor plan.

Total # of Readings: 112
Average: 2.71 uR/hr
Standard Deviation: 0.32 uR/hr
Minimum: 2.00 uR/hr
Maximum: 4.40 uR/hr
Median: 2.40 uR/hr
Anomalies: 0

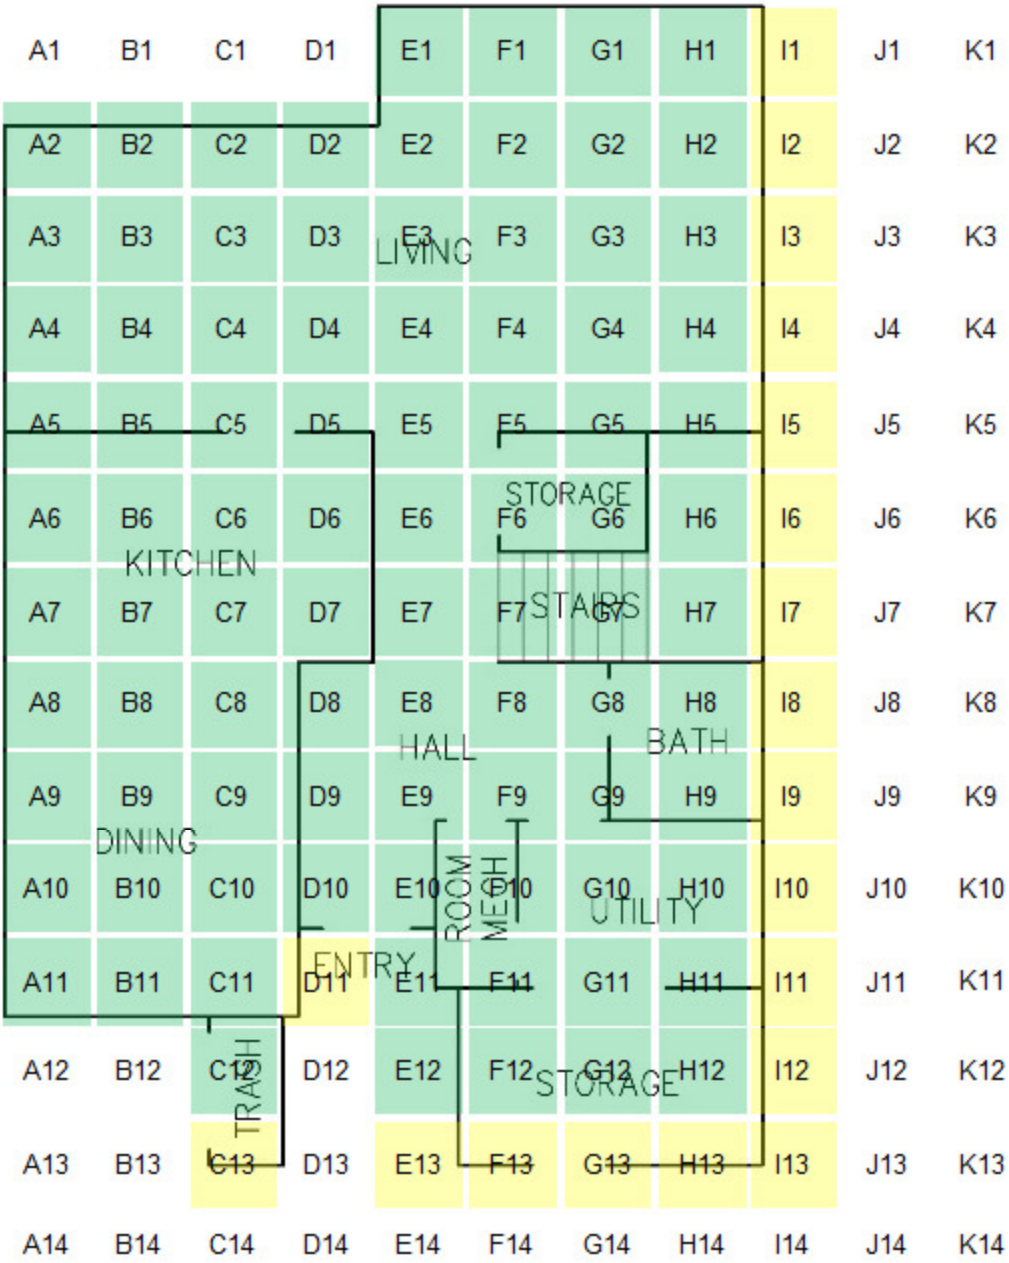
Completion Date: 8/12/2014 2:48 PM
Instrument: 193-6
Serial #: 309099
Layout: Floor Plan 7B
Background Reading: 2.8 uR/hr
Dimensions (m): D 11.8 W 7.6
Unit Furnished: Yes
Tenant Present: Yes

Grids in column I, row 13 and D11 are outside of floor plan.

Total # of Readings: 129
Average: 2.87 uR/hr
Standard Deviation: 0.28 uR/hr
Minimum: 2.00 uR/hr
Maximum: 4.00 uR/hr
Median: 2.40 uR/hr
Anomalies: 0

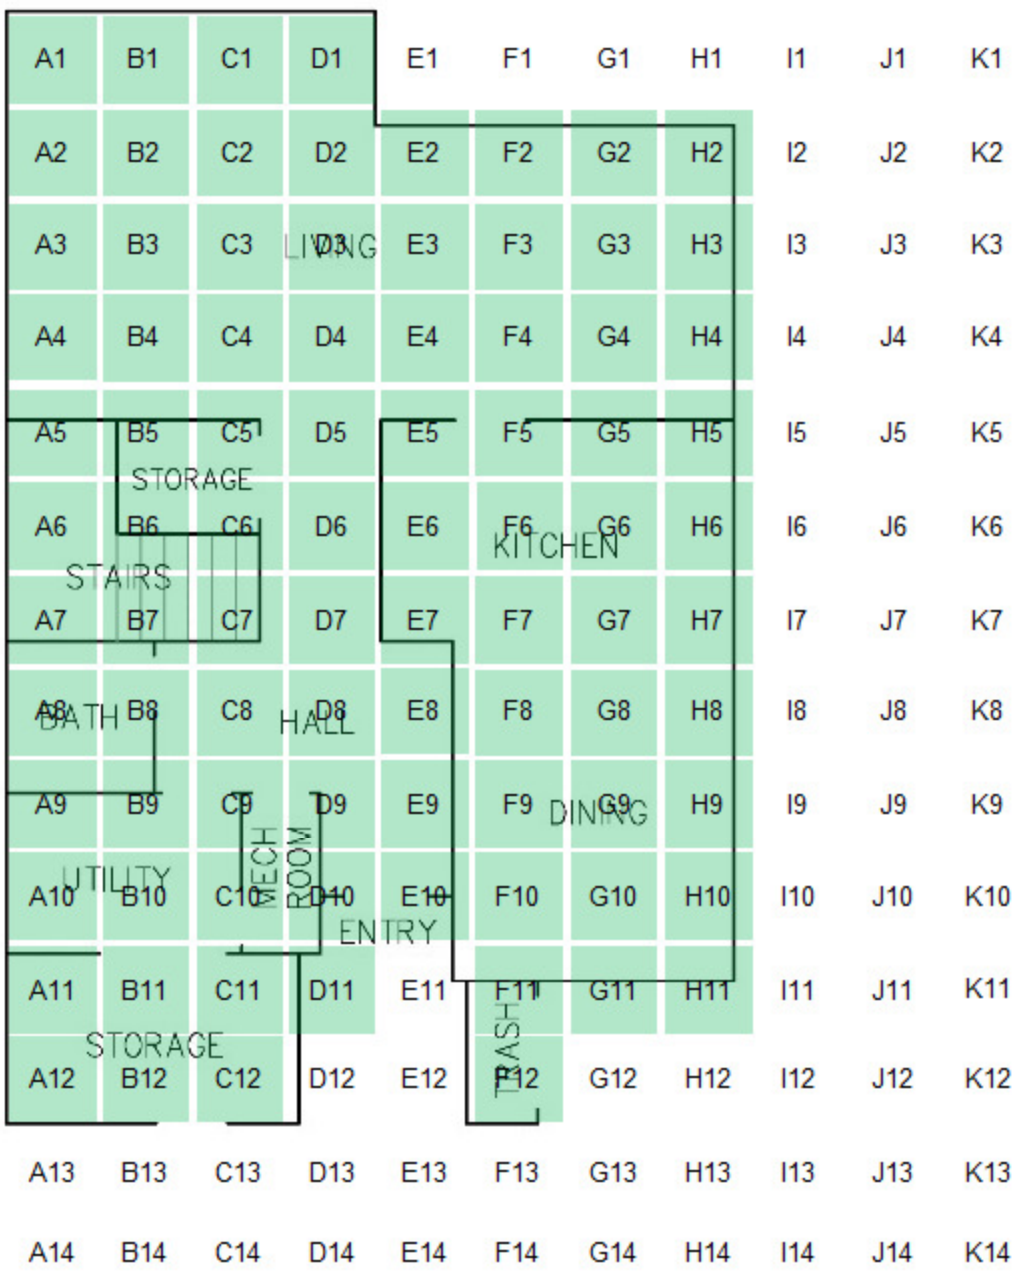
Completion Date: 7/9/2014 3:31 PM
Instrument: 193-6
Serial #: 309110
Layout: Floor Plan 7
Background Reading: 3.6 uR/hr
Dimensions (m): D 11.8 W 7.7
Unit Furnished: No
Tenant Present: No

Unit Notes:
Unit completely gutted.

Total # of Readings: 108
Average: 3.45 uR/hr
Standard Deviation: 0.19 uR/hr
Minimum: 3.20 uR/hr
Maximum: 3.60 uR/hr
Median: 3.40 uR/hr
Anomalies: 0

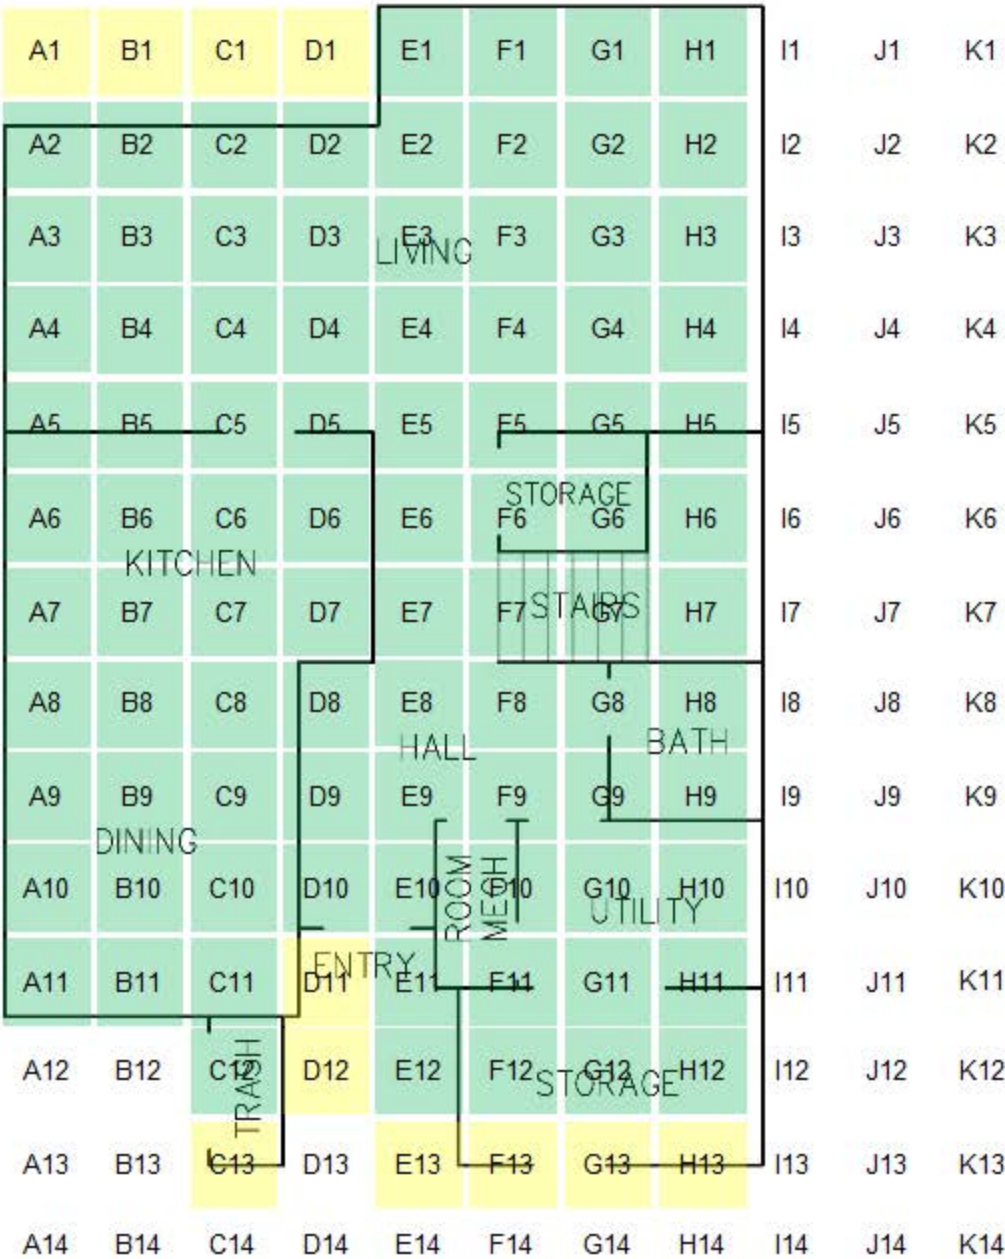
Grid	Primary Reading	Unit	Desc.	Cell Note	2nd Reading	Unit	Desc.	Cell Note	3rd Reading	Unit	Desc.	Cell Note	Anomaly	General Notes
A1		uR/hr	Living Room	Grids are outside unit interior boundary.		uR/hr				uR/hr			No	outside of floor plan
A2	3.6	uR/hr	Living Room	Percentage of grid falls outside of unit.		uR/hr				uR/hr			No	80% accessible.
A3	3.6	uR/hr	Living Room			uR/hr				uR/hr			No	
A4	3.2	uR/hr	Living Room			uR/hr				uR/hr			No	
A5	3.2	uR/hr	Living Room		3.2	uR/hr	Kitchen	Installed base cabinets.		uR/hr			No	70% accessible. Kitchen reading taken 12" from floor inside base cabinet.
A6	3.2	uR/hr	Kitchen	Survey performed within accessible base cabinet.		uR/hr				uR/hr			No	
A7	3.2	uR/hr	Kitchen	Installed Dishwasher.		uR/hr				uR/hr			No	40% accessible.
A8	3.2	uR/hr	Dining Room			uR/hr				uR/hr			No	
A9	3.2	uR/hr	Dining Room			uR/hr				uR/hr			No	
A10	3.2	uR/hr	Dining Room			uR/hr				uR/hr			No	
A11	3.2	uR/hr	Dining Room	Percentage of grid falls outside of unit.		uR/hr				uR/hr			No	30% accessible.

B1		uR/hr	Living Room	Grids are outside unit interior boundary.		uR/hr				uR/hr			No	outside of floor plan
B2	3.2	uR/hr	Living Room	Percentage of grid falls outside of unit.		uR/hr				uR/hr			No	80% accessible.
B3	3.6	uR/hr	Living Room			uR/hr				uR/hr			No	
B4	3.6	uR/hr	Living Room			uR/hr				uR/hr			No

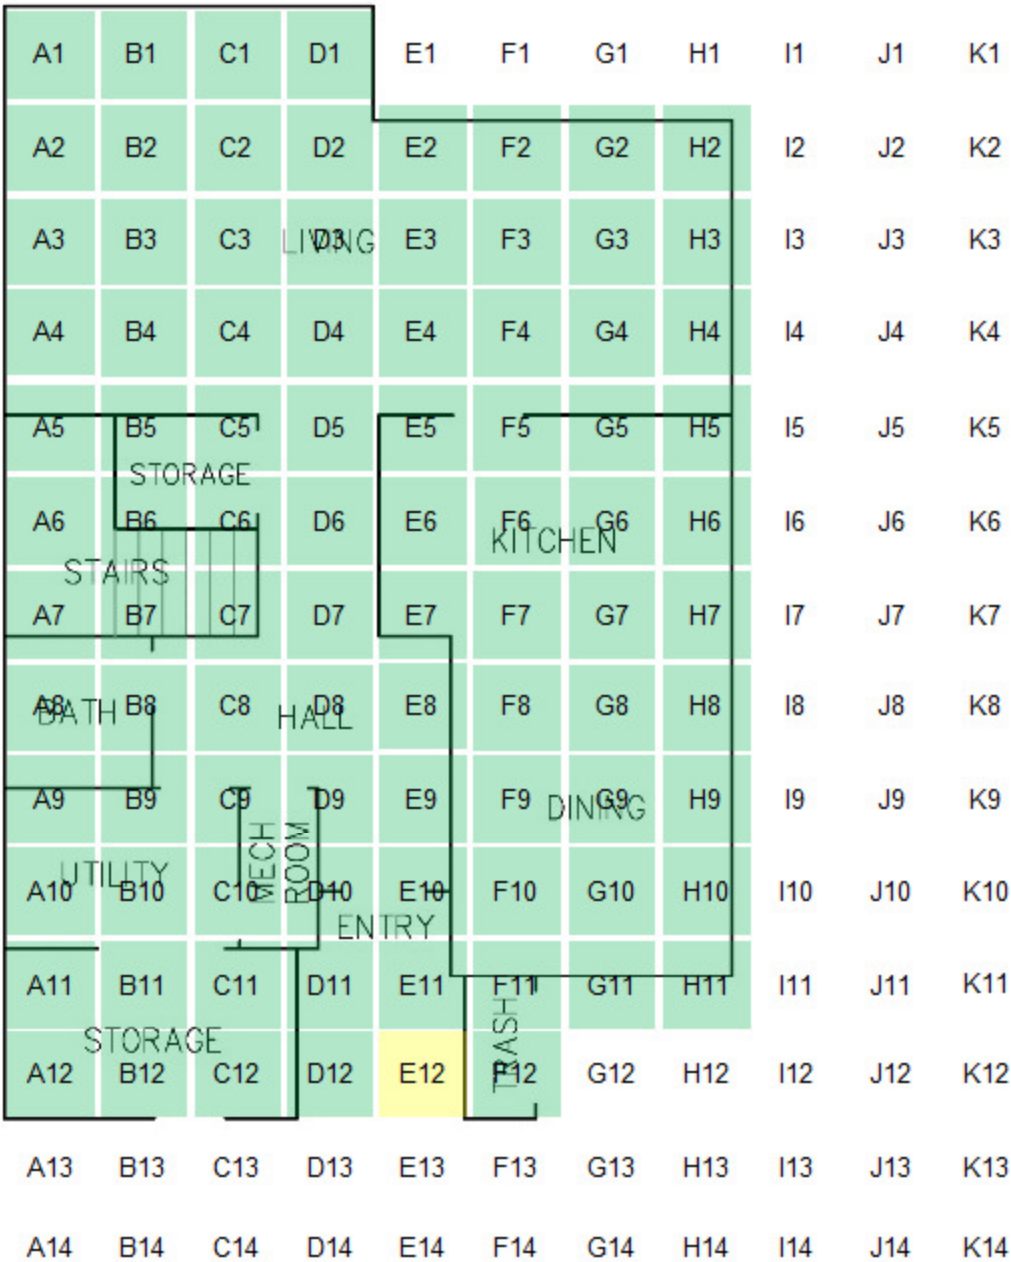
Unit modified ADA compliant. Bedroom included in living room, bathroom/utility room modified into handicap bathroom (bathtub in bathroom). E12 grid is outside unit interior boundary.

Total # of Readings: 108
Average: 3.28 uR/hr
Standard Deviation: 0.19 uR/hr
Minimum: 2.80 uR/hr
Maximum: 3.60 uR/hr
Median: 3.00 uR/hr
Anomalies: 0

Grid	Primary Reading	Unit	Desc.	Cell Note	2nd Reading	Unit	Desc.	Cell Note	3rd Reading	Unit	Desc.	Cell Note	Anomaly	General Notes
A1	3.2	uR/hr	Living Room			uR/hr				uR/hr			No	
A2	3.2	uR/hr	Living Room			uR/hr				uR/hr			No	
A3	3.6	uR/hr	Living Room			uR/hr				uR/hr			No	
A4	3.6	uR/hr	Living Room			uR/hr				uR/hr			No	
A5	2.8	uR/hr	Stairs		3.2	uR/hr	Living Room			uR/hr			No	reading 1.8 meters from floor for stairs
A6	2.8	uR/hr	Stairs			uR/hr				uR/hr			No	reading 1.8 meters from floor for stairs
A7	2.8	uR/hr	Stairs			uR/hr				uR/hr			No	reading 1.8 meters from floor for stairs
A8	3.6	uR/hr	Bathroom			uR/hr				uR/hr			No	
A9	3.2	uR/hr	Bathroom			uR/hr				uR/hr			No	
A10	3.2	uR/hr	Bathroom			uR/hr				uR/hr			No	static reading taken inside bathtub.
A11	3.2	uR/hr	Storage			uR/hr				uR/hr			No	moved washer to survey grid
A12	3.2	uR/hr	Storage	Percentage of grid falls outside of unit.		uR/hr				uR/hr			No	80% accessible. moved dryer to survey grid.

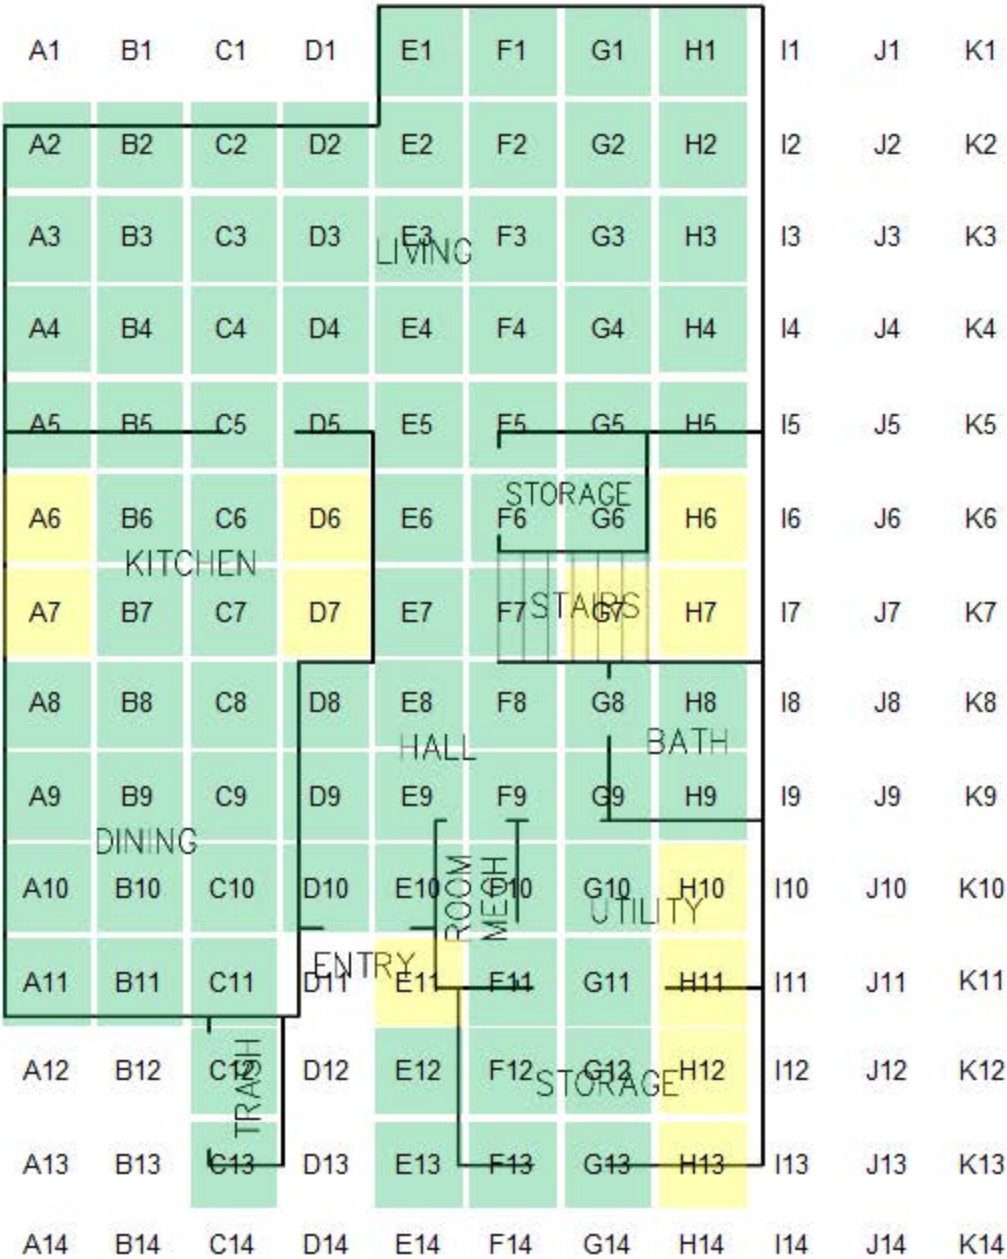
Total # of Readings: 93
Average: 3.49 uR/hr
Standard Deviation: 0.25 uR/hr
Minimum: 3.20 uR/hr
Maximum: 4.80 uR/hr
Median: 3.60 uR/hr
Anomalies: 0

Grid	Reading	Reading Units	Anomaly	Notes	Cell Description	Second Reading	Second Reading Units	Second Reading Cell Description
A2	3.6	uR/hr	No		Living Room		uR/hr	
A3	3.6	uR/hr	No	cabinet bolted to wall comprised of 1/2 inch composite wood; scanned w/out caster	Living Room		uR/hr	
A4	3.6	uR/hr	No	contains part of a small cabinet bolted to the wall; unable to survey due to cabinet height.	Living Room		uR/hr	
A5	3.6	uR/hr	No		Living Room		uR/hr	
A6		uR/hr	No	unable to scan due to dish washer. Adjacent scan is 3.6 uR/hr.	Kitchen		uR/hr	
A7		uR/hr	No	unable to scan due to cabinet. Adjacent scan is 3.6 uR/hr.	Kitchen		uR/hr	
A8	3.6	uR/hr	No		Dining Room		uR/hr	
A9	3.2	uR/hr	No		Dining Room		uR/hr	
A10	3.2	uR/hr	No		Dining Room		uR/hr	
A11	3.6	uR/hr	No		Dining Room		uR/hr	
B2	3.6	uR/hr	No		Living Room		uR/hr	
B3	3.6	uR/hr	No		Living Room		uR/hr	
B4	3.6	uR/hr	No		Living Room		uR/hr	
B5	3.6	uR/hr	No		Living Room		uR/hr
