**Overview of Testing Results for Lead in Drinking Water and Corrective Actions for Naval Base Point Loma CDC, Patrick Wade CDC, Admiral Hartman Recreation Center, Gateway Village Recreation Center, Village at Serra Mesa Recreation Center, and Chesterton Community Center**

Sample Summary Results Table  
Priority Areas Lead Testing and Corrective Actions - June 2024  
Naval Base Point Loma  
Admiral Hartman Recreation Center - Building 4649

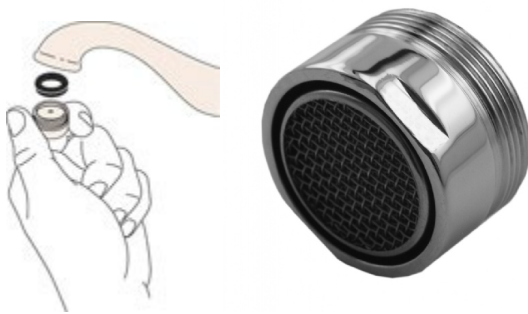
The **one** outlet that exceeded 10 ppb was a hand washing sink located in the Teacher Training Room (Room 116) inside the NBPL CDC (Building 377). Follow-up sampling at these outlets was conducted after removing and cleaning the faucet aerator. A faucet aerator (or tap aerator) is often found at the tip of modern indoor water faucets. Without an aerator, water usually flows out of a faucet as one big stream. An aerator spreads this stream into many little droplets, which helps save water, provides more uniform flow, and reduces splashing. However, the aerator and screen can trap debris which can accumulate lead.

After removing the faucet aerator, retesting showed that the sink in Room **116** at the NBPL CDC was below the screening level and the faucet was returned to service.
