DEPARTMENT OF THE NAVY  
NAVAL BASE POINT LOMA  
140 SYLVESTER ROAD  
SAN DIEGO, CALIFORNIA 92106-3521

## **Overview of Testing Results for Lead in Drinking Water and Corrective Actions for Naval Base Point Loma CDC, Patrick Wade CDC, Admiral Hartman Recreation Center, Gateway Village Recreation Center, Village at Serra Mesa Recreation Center, and Chesterton Community Center**

Priority Areas Lead Testing and Corrective Actions - June 2024

Naval Base Point Loma

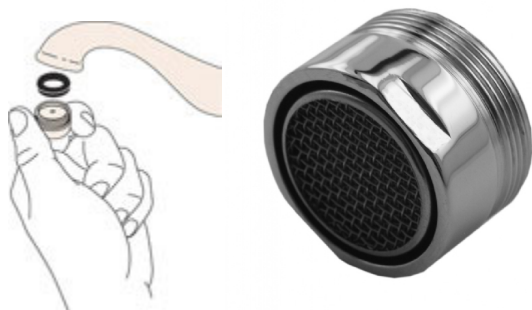
The **one** outlet that exceeded 10 ppb was a hand washing sink located in the Teacher Training Room (Room 116) inside the NBPL CDC (Building 377). Follow-up sampling at this outlet was conducted after removing and cleaning the faucet aerator. A faucet aerator (or tap aerator) is often found at the tip of modern indoor water faucets. Without an aerator, water usually flows out of a faucet as one big stream. An aerator spreads this stream into many little droplets, which helps save water, provides more uniform flow, and reduces splashing. However, the aerator and screen can trap debris which can accumulate lead.

After removing the faucet aerator, retesting showed that the sink in Room **116** at the NBPL CDC was below the screening level and the faucet was returned to service.
