**Figure 1**  
**Vicinity Map**

Maintenance Dredging Support  
 Vallejo Yacht Club

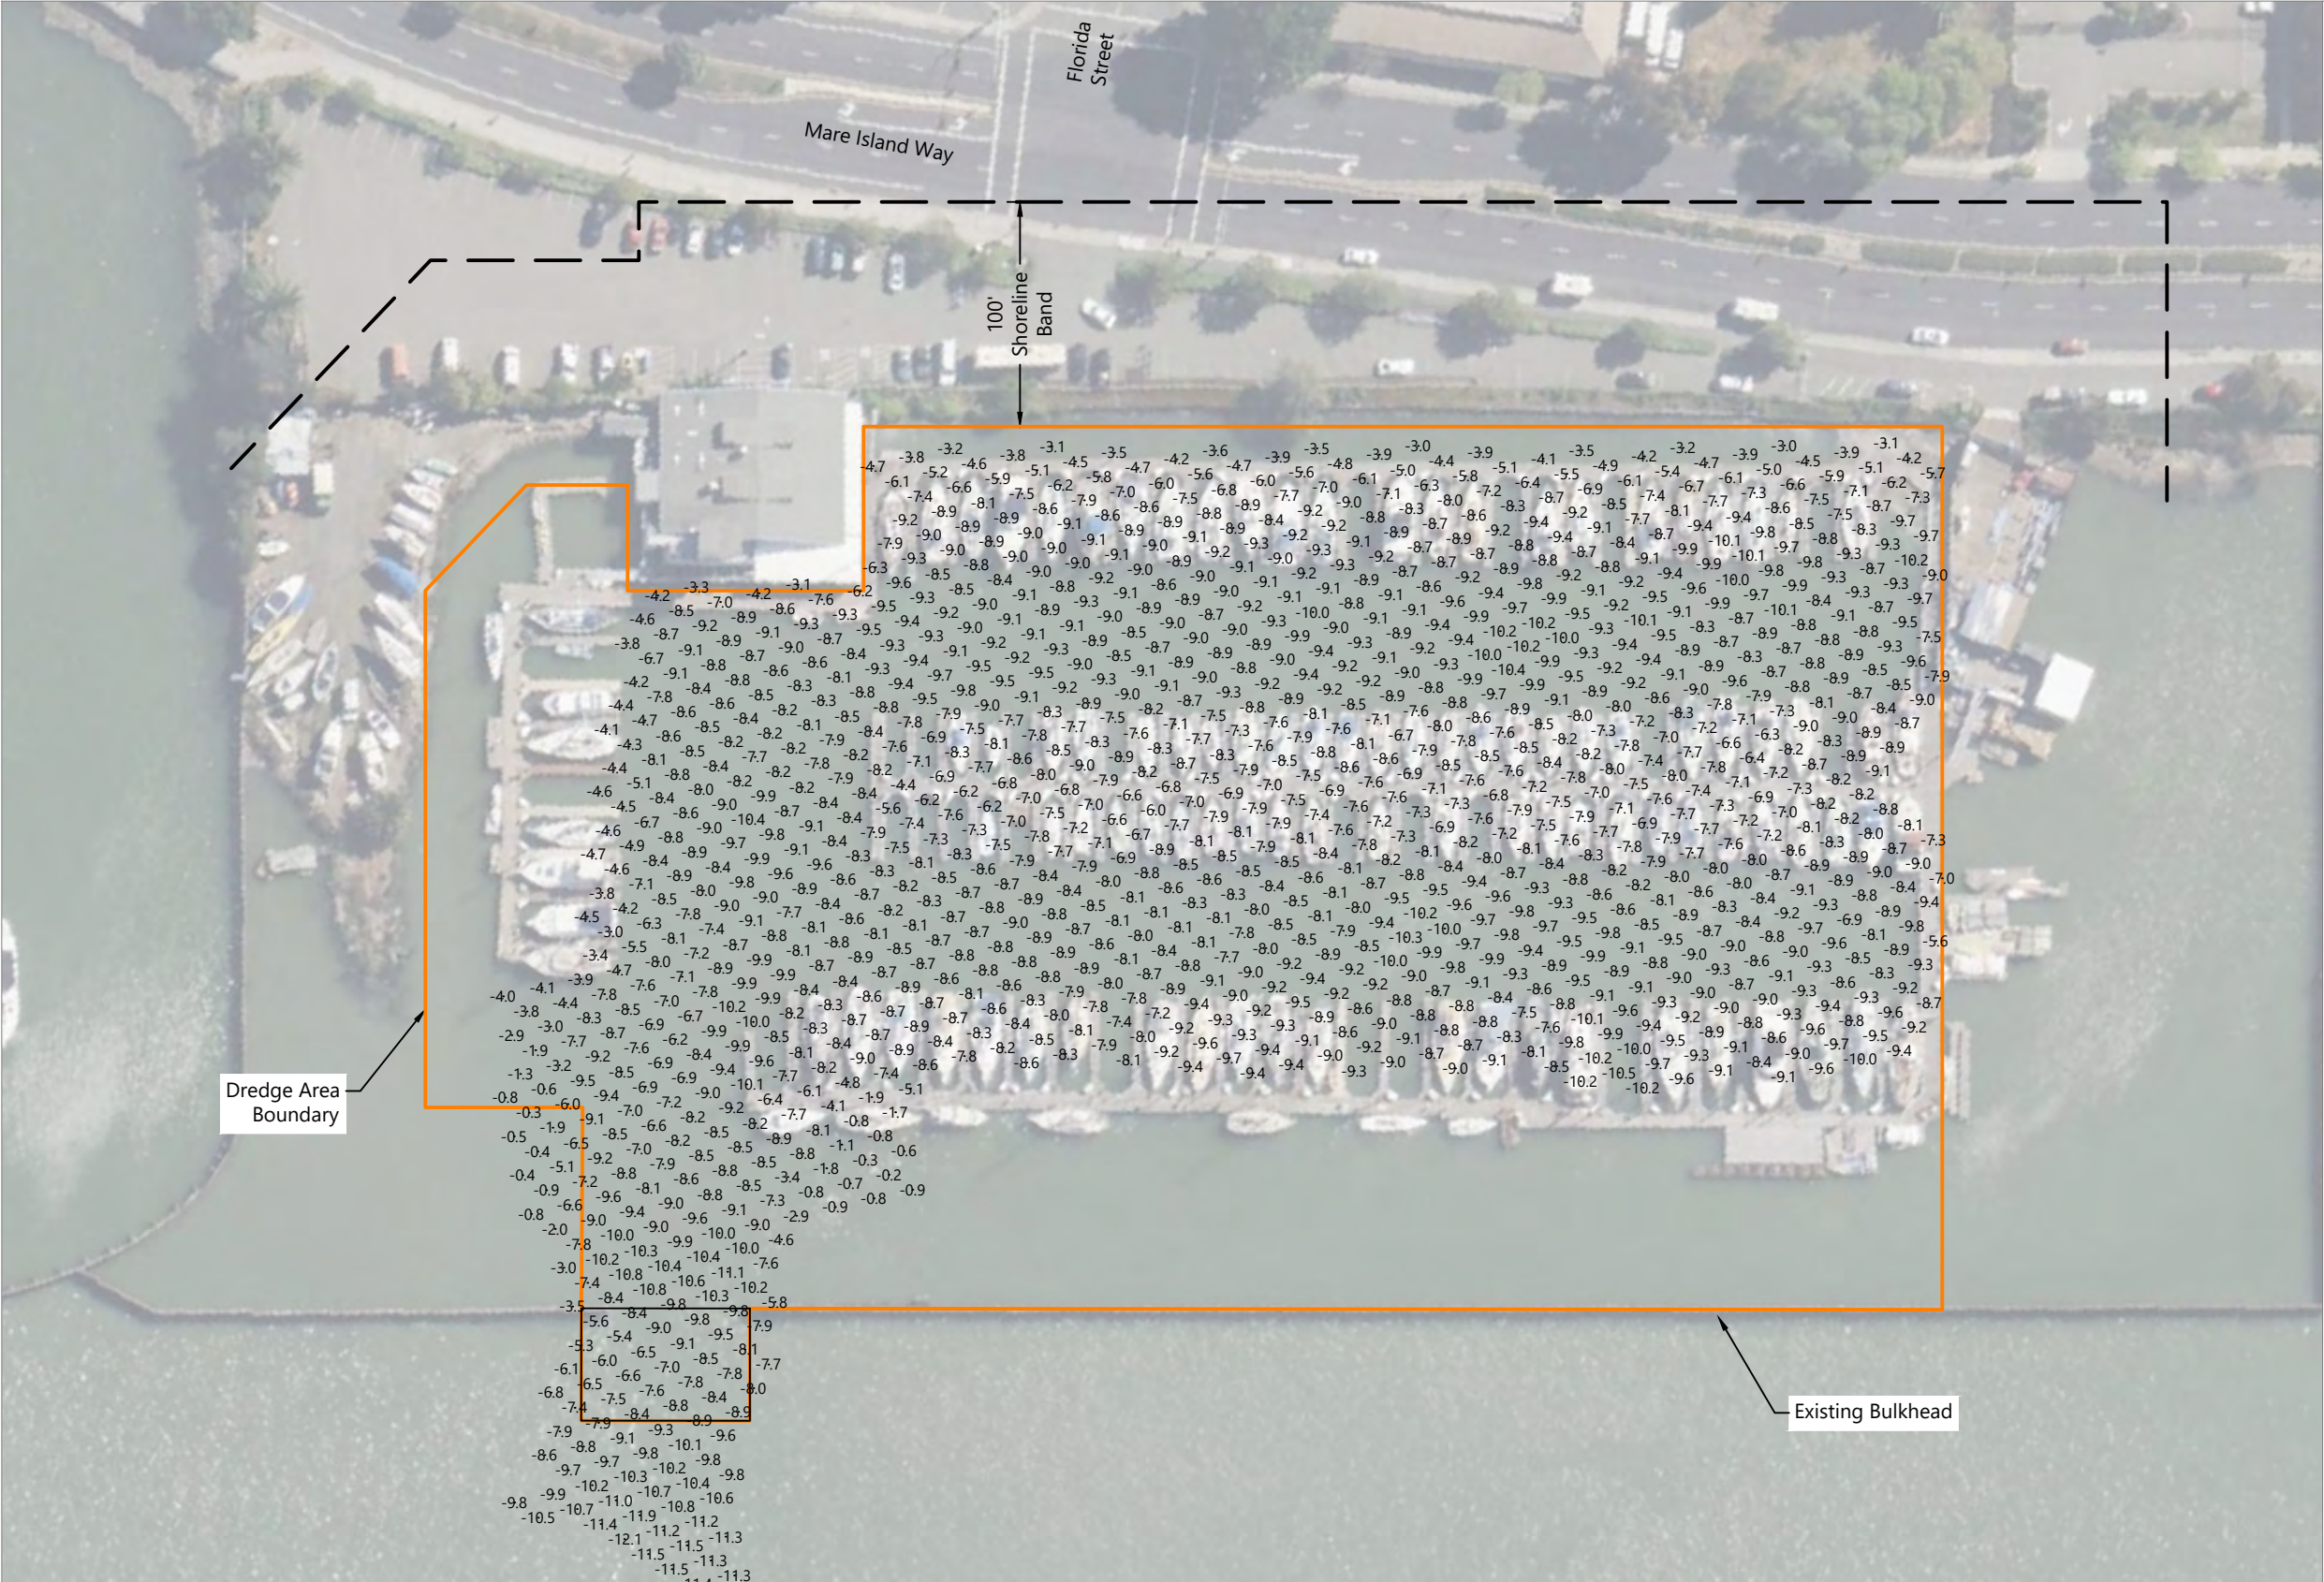
- SOURCES:**
- Aerial image ©2019 Microsoft Corporation ©2019 DigitalGlobe ©CNES (2019) Distribution Airbus (DS)
  - Bathymetric survey provided by Bay Marine Services dated July 19, 2019.

- LEGEND:**
- 9.1 Sounding Elevation in Feet (MLLW)
  - Dredge Area Boundary

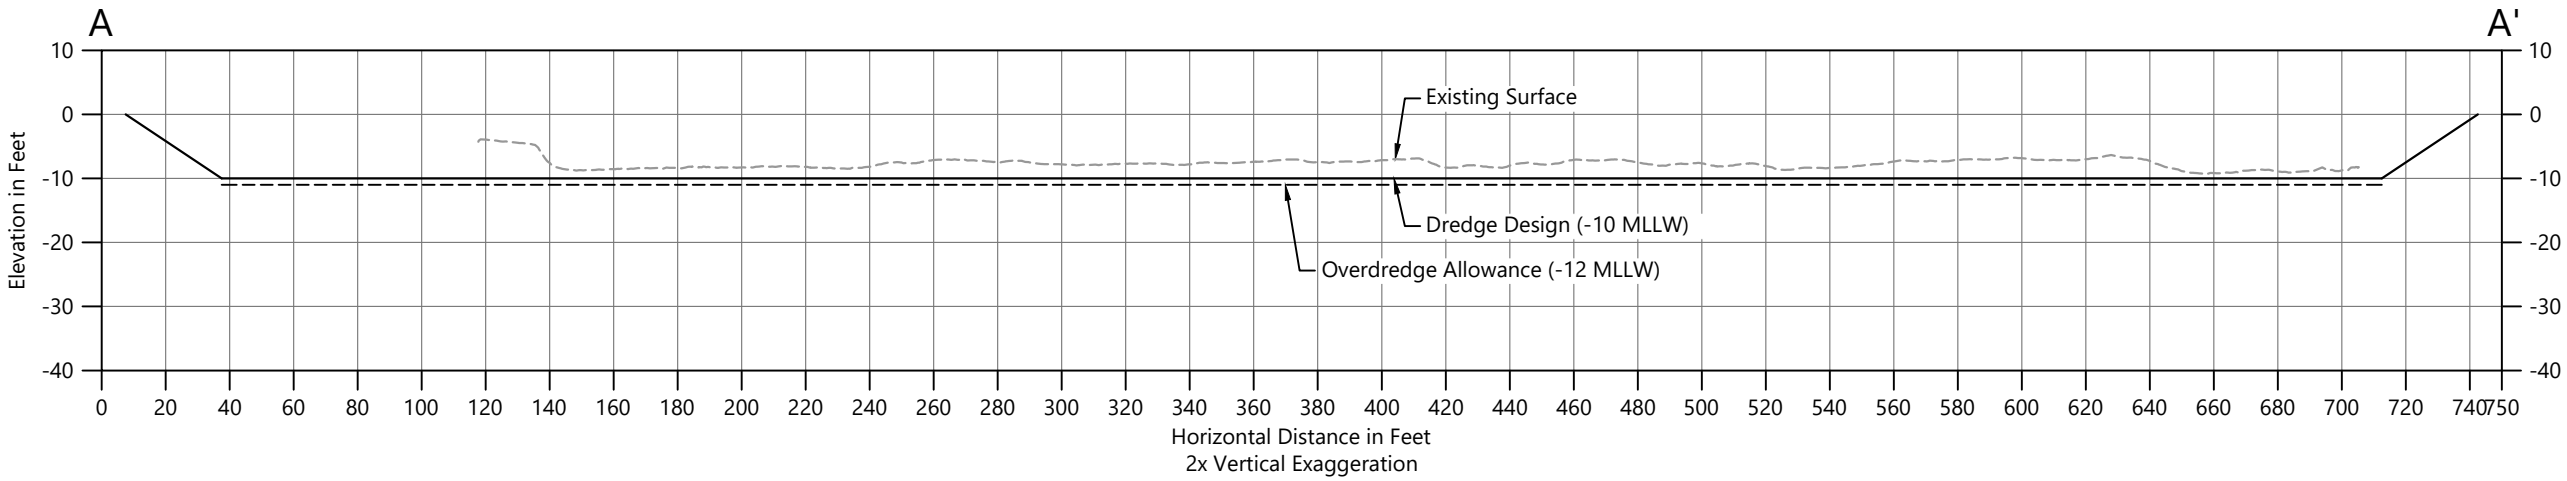
Maximum depth of -10 feet MLLW plus 2 feet of overdredge allowance (1 foot paid and 1 foot unpaid)
