# Fifth Five-Year Review Operable Units A and B-1 Former Adak Naval Complex

## **Naval Air Station Adak**

**Fifth Five-Year Review  
Operable Units A and B-1  
Former Adak Naval Complex  
NAVAL AIR STATION ADAK, ADAK ISLAND, ALASKA**

**December 2021**

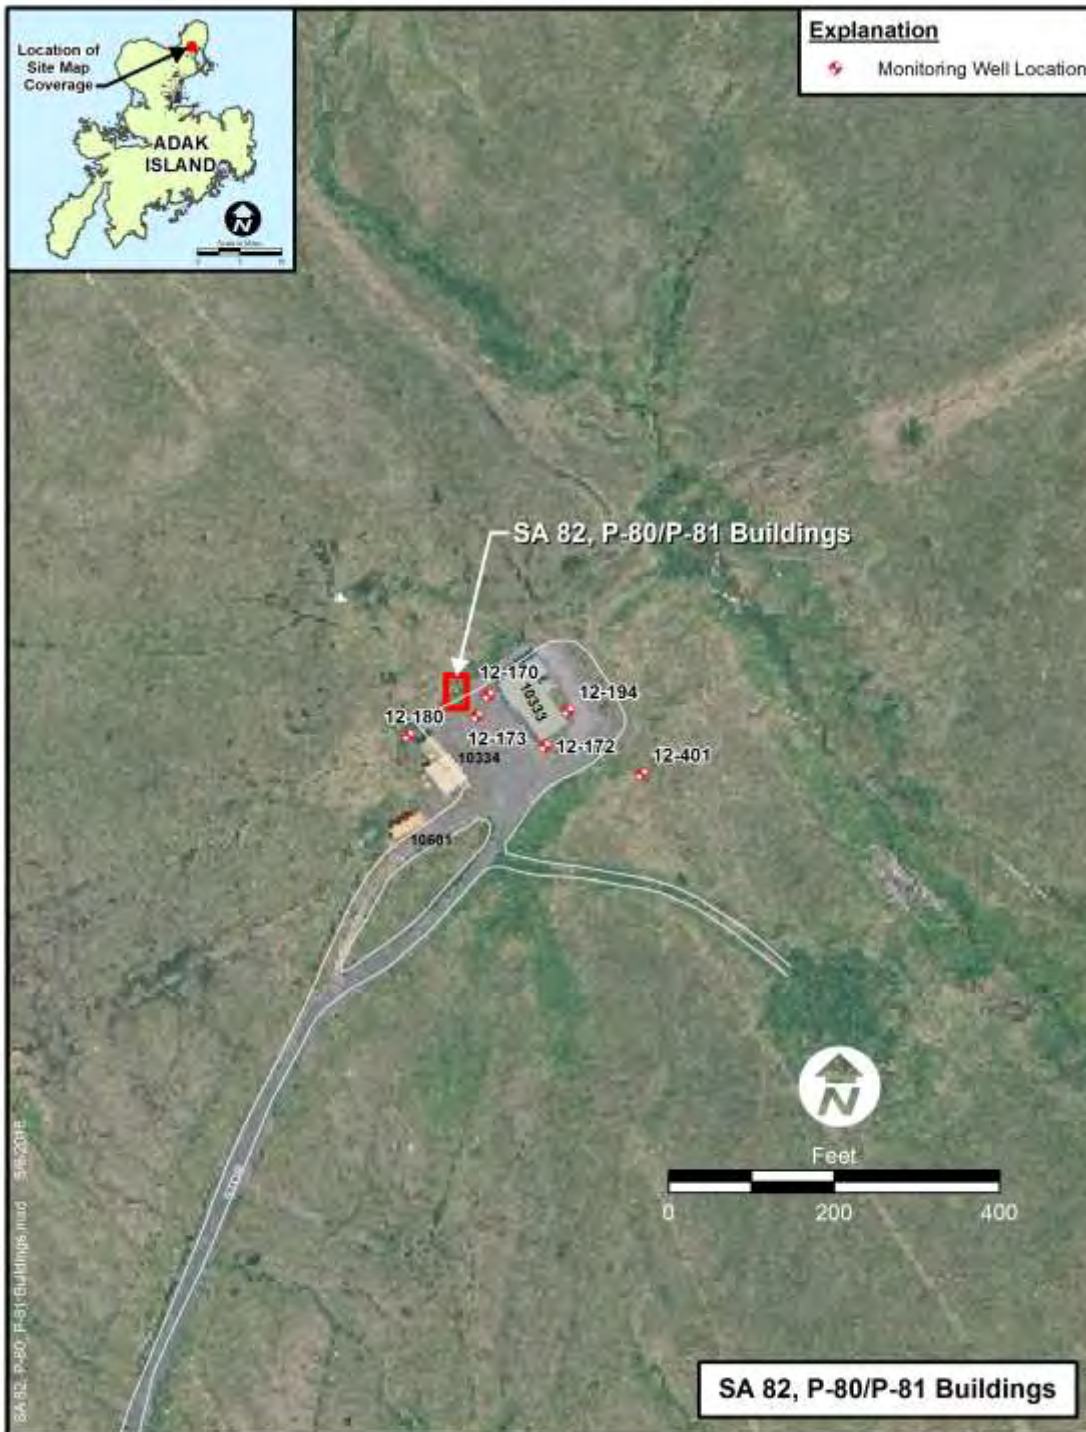
Free product was detected intermittently in the two wells (12-170 and 12-180) situated in the former UST locations. Passive-style skimmers were used at this site to recover product when detected at measurable quantities. Total product recovered from this site is 0.04 gallon. Free product has not been observed in any well in the vicinity of the P-80/P-81 Buildings since July 31, 1998. Since that time, the Navy has gauged the wells at this site for the presence of free product monthly, then quarterly. Because free product has not been found in any monitoring well since July 1998, the Navy believes that free product has been recovered at this site to the maximum extent practicable as required by 18 AAC 75.325(f)(1)(B).

Institutional Controls at SA 82, P-80/P-81 Buildings include land use restrictions, equitable servitude, soil excavation restrictions, signage, and IC inspections and reporting. During the IC inspection on September 6, 2019, no changes to the site were observed compared to the 2014 inspection results. No indications of a change in land use in this area were found and no residential construction had occurred at the site. No indications that groundwater was being used were found at the site. No indications of excavation were found, and excavation signs were clearly visible. The 2019 IC report indicated ICs appear to be functioning as intended to protect human receptors from exposure to contaminated soil or groundwater. The next IC inspection is scheduled to occur in 2024.

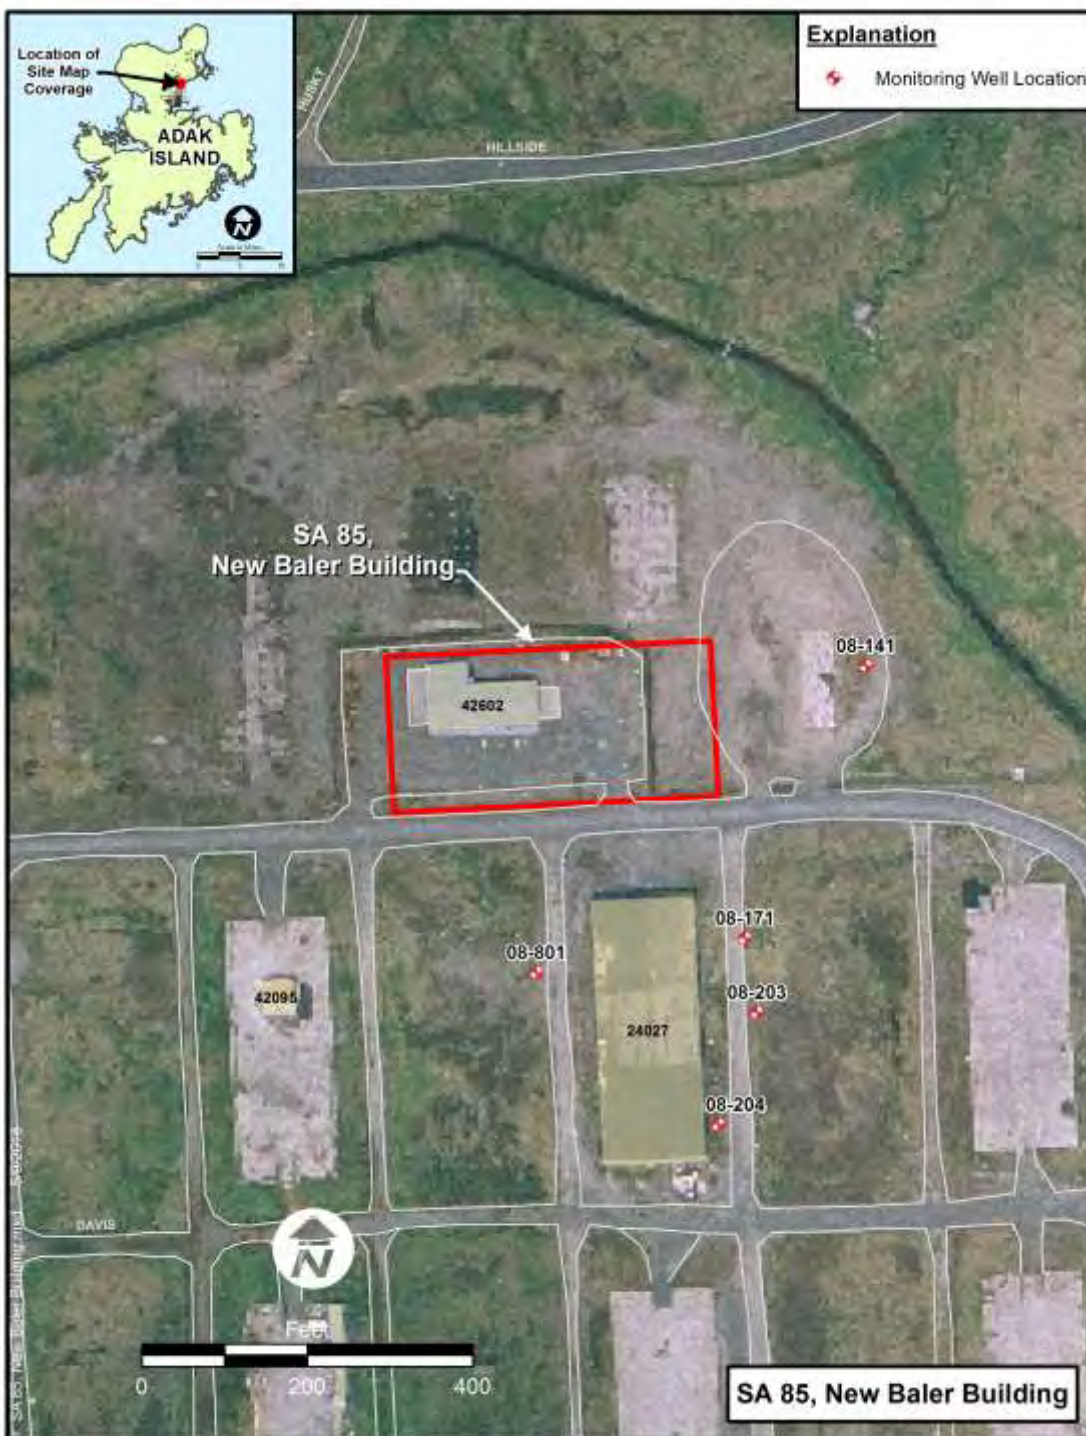
SA 85, New Baler Building is a no further action site that does not have any ICs. The site was inspected as part of the five-year review site visit. The site visit in August 2015 found that the site has had no changes in site conditions since the last five-year review.

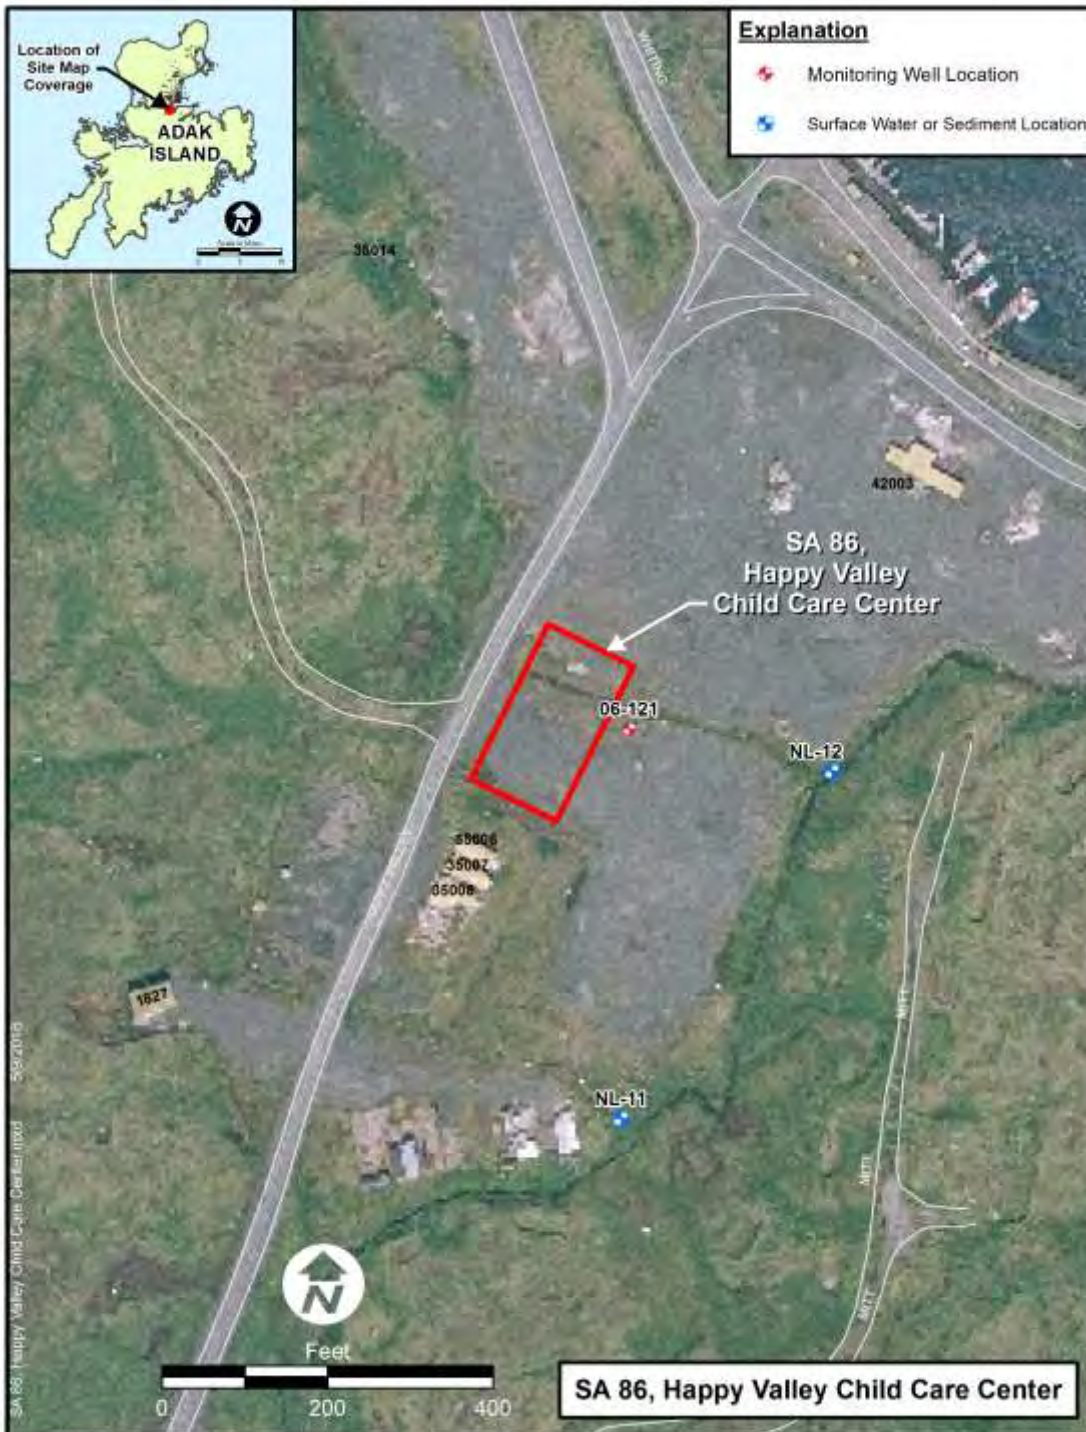
SA 86, Old Happy Valley Child Care Center

SA 86, Happy Valley Child Care Center is a no further action site that does not have any ICs. The site was inspected as part of the five-year review site visit. The site visit in August 2015 found that the site has had no changes in site conditions since the last five-year review.

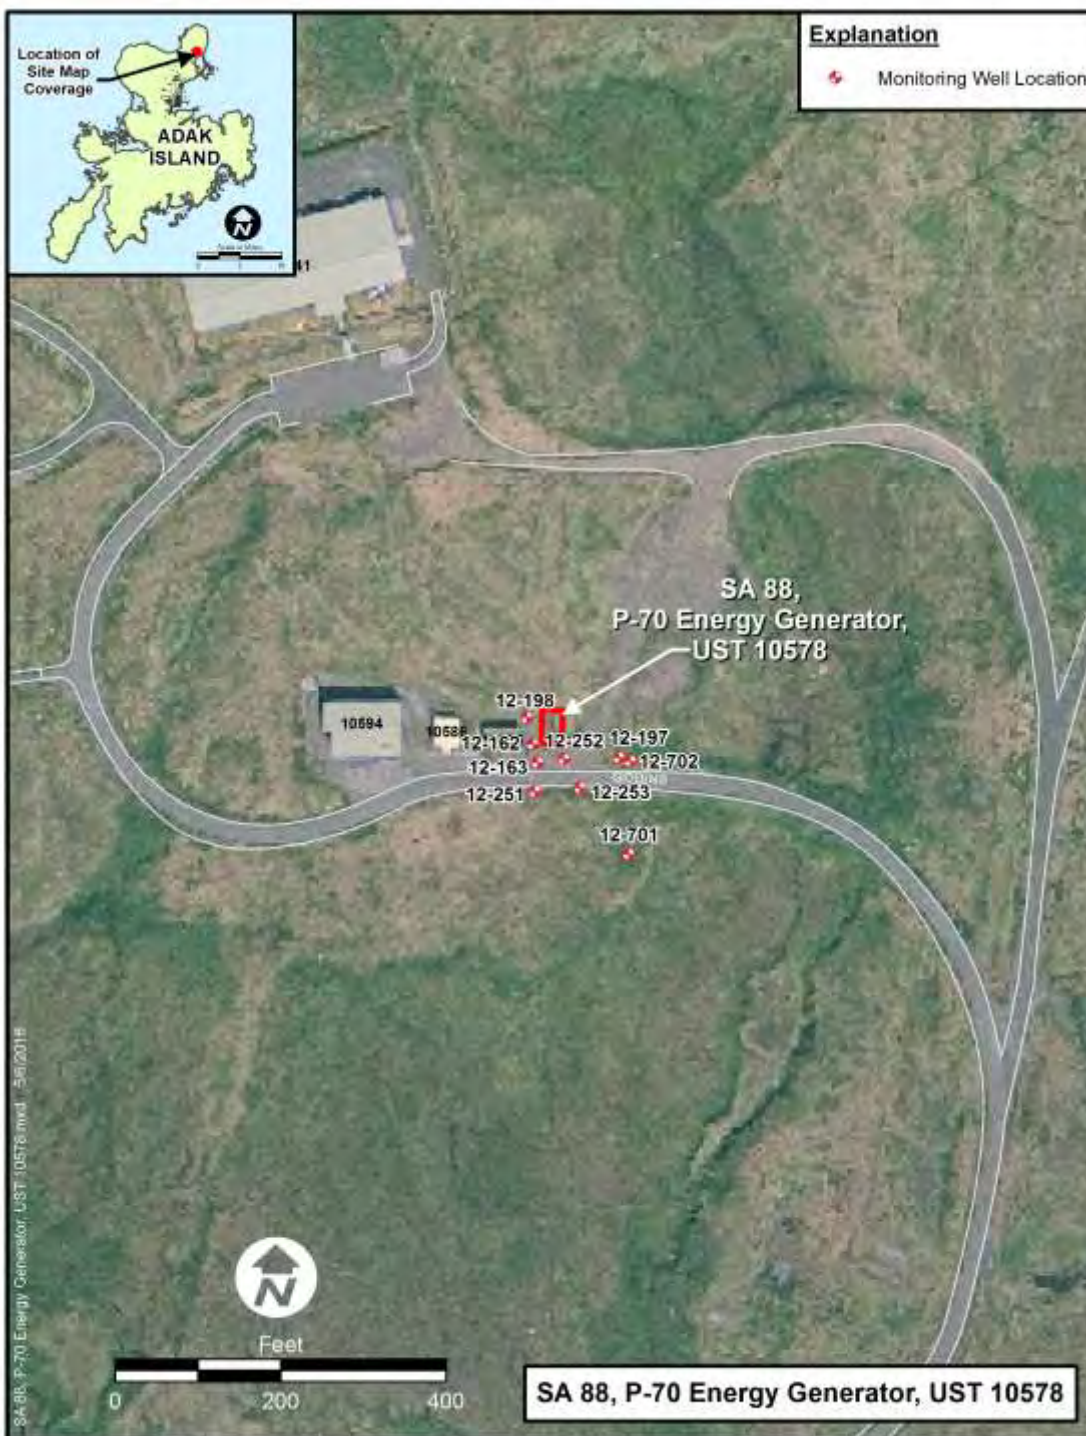
Free product was observed in four of 10 monitoring wells (12-162, 12-163, 12-198, and 12-252) at the P-70 Energy Generator site between 1996 and 2002. At least one passive-style skimmer was rotated between wells with measurable product thicknesses (12-162, 12-163, and 12-198) between January and December 1997. This recovery effort produced less than 5 gallons of product at the site during 1997. Approximately 26 gallons of free product was recovered at the site between January 1997 and June 2000. The Navy contends that free product has been recovered at this site to the maximum extent practicable as required by 18 AAC 75.325(f)(1)(B).

Institutional Controls at SA 88, P-70 Energy Generator include land use restrictions, equitable servitude, soil excavation restrictions, signage, and IC inspections and reporting. During the IC inspection on September 6, 2019, no indications of a change of a change in land use in this area were found in this area and no residential construction had occurred at the site. No indications of excavation were found, and excavation restriction signs were clearly visible. However, damage was observed at two of the three signs onsite. During the 2021 5-year review site walk it was noted that the damaged signs associated with the site from the 2019 IC inspection had been replaced. The 2019 IC report indicated ICs appear to be functioning as intended to protect human receptors from exposure to contaminated soil or groundwater. The next IC inspection is scheduled to occur in 2024.

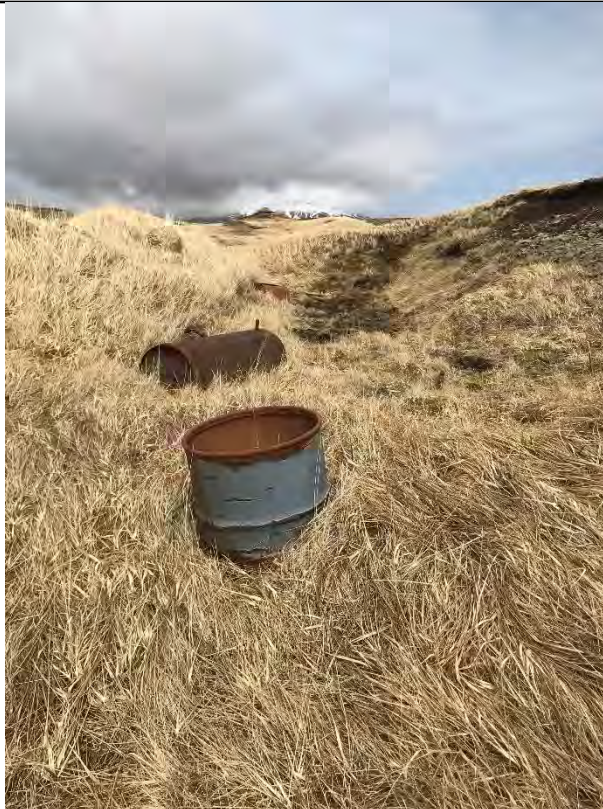
55-gallon drum, metal  
tank, and various metallic  
debris scattered  
throughout site and in  
bermed depression.

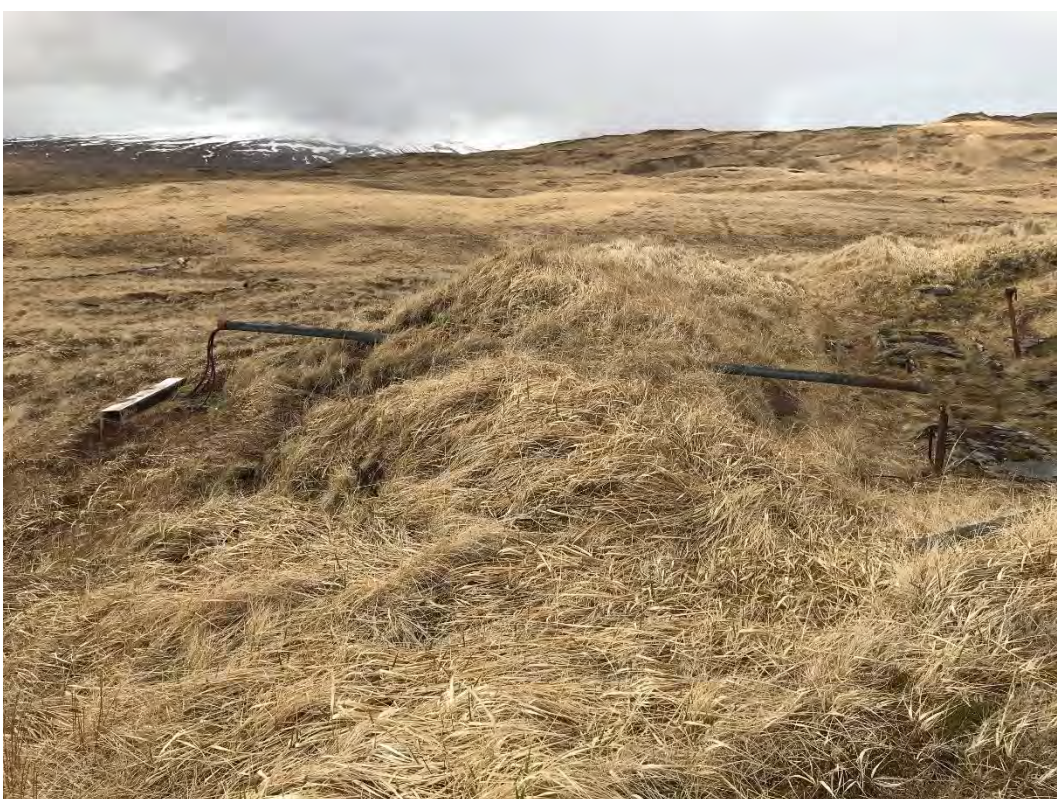
**Description:** Electrical  
conduit through western  
berm of former structure.  
Woody debris present  
throughout site.

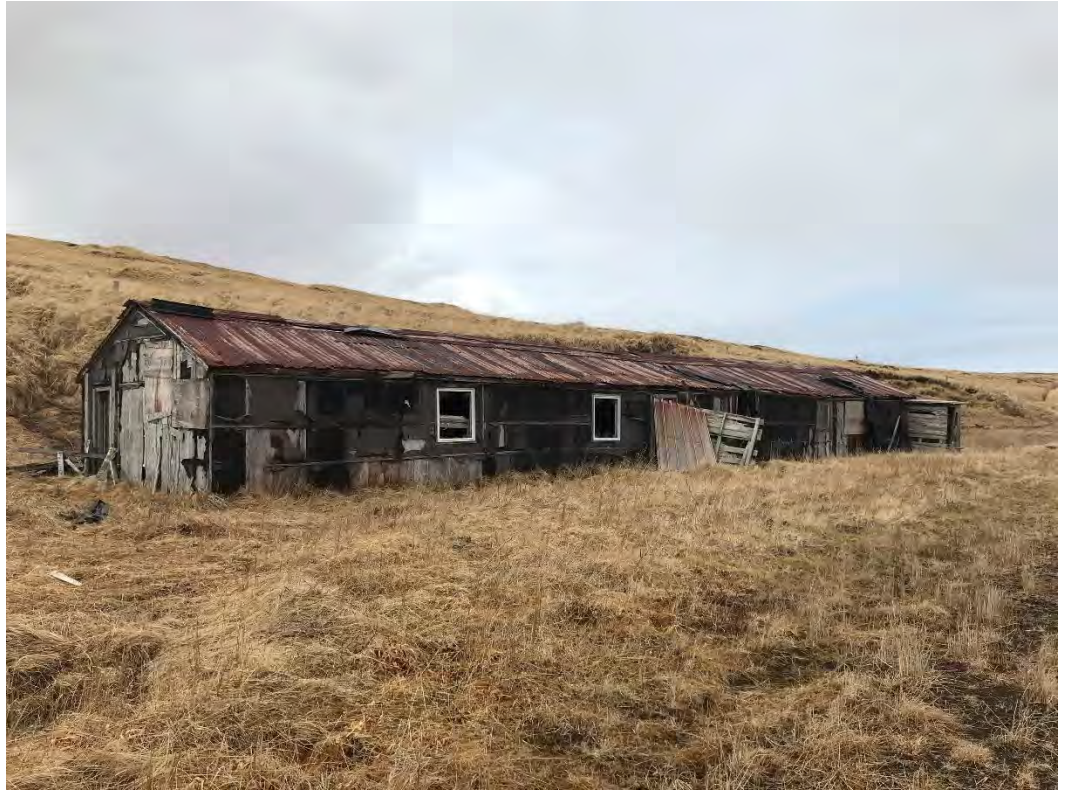
Former Boy Scout Camp  
structure. Photo is facing  
east side of structure.

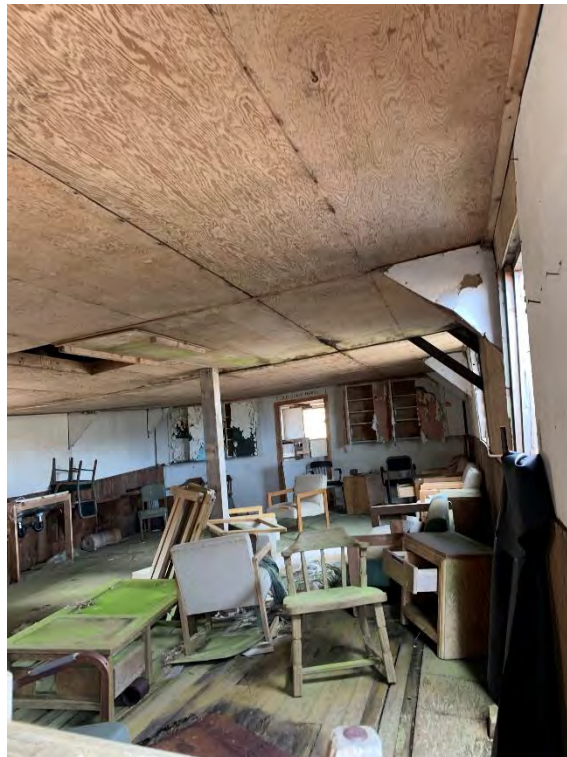
Interior of former Boy  
Scout Camp structure.

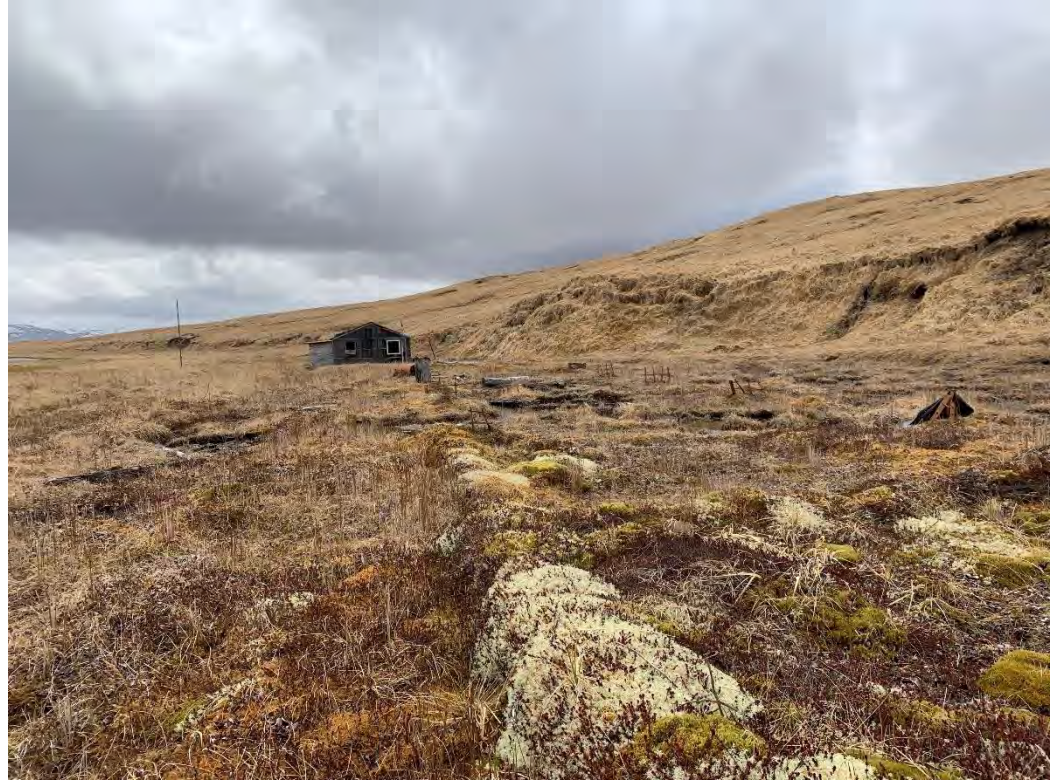
Foundation of former Boy  
Scout Camp structure.  
Metallic debris present  
throughout site.

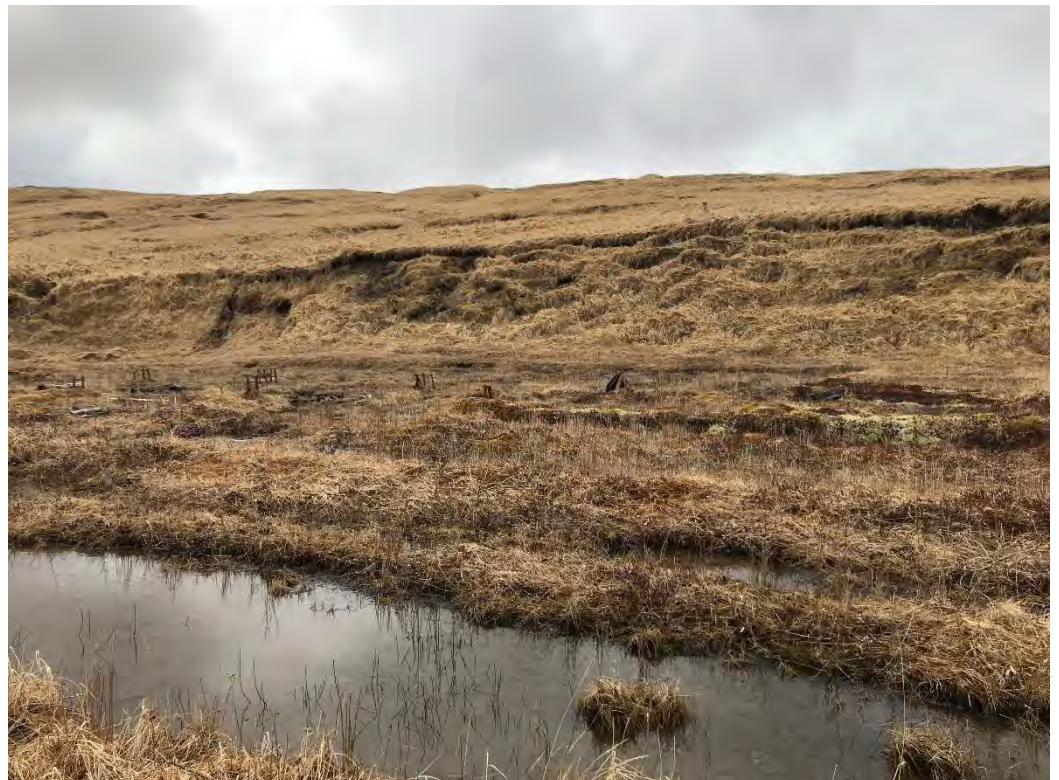
Foundation of Former Boy  
Scout Camp structure.  
Surface water present  
east of foundation draining  
into West Haven Lake.

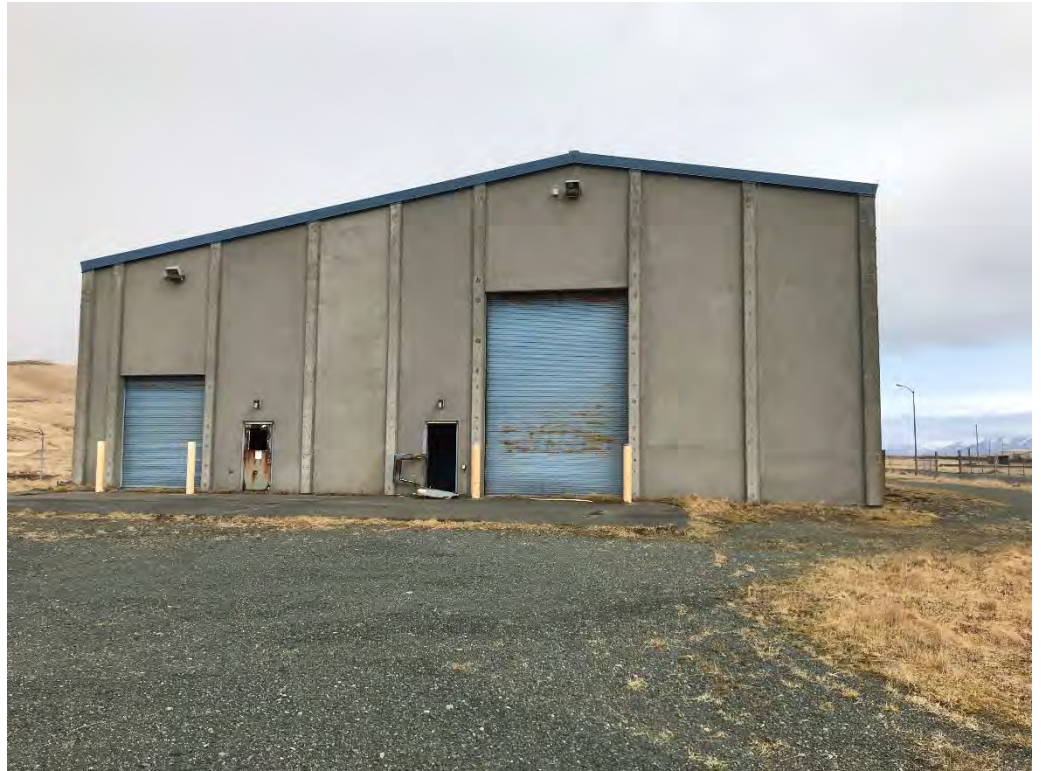
**Description:** West side of  
new baler building  
structure.

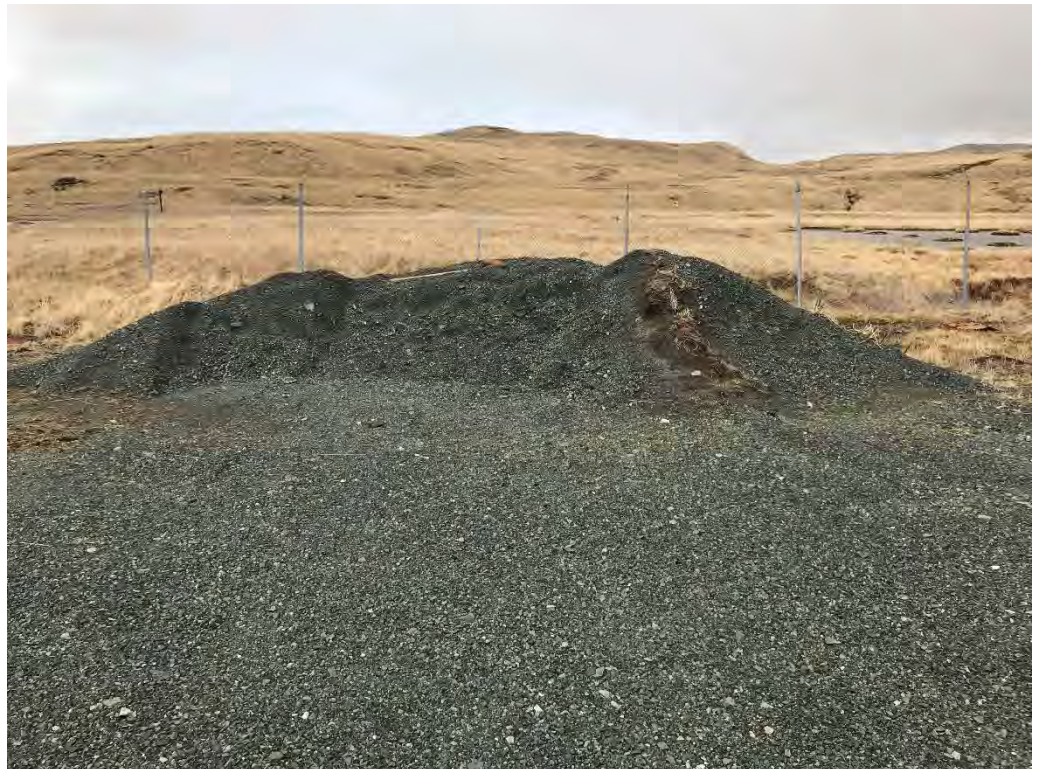
Visual evidence of active  
gravel pile/deposit with a  
new shovel placed on top  
of gravel pile. Pile is on  
the west side of new baler  
building structure.

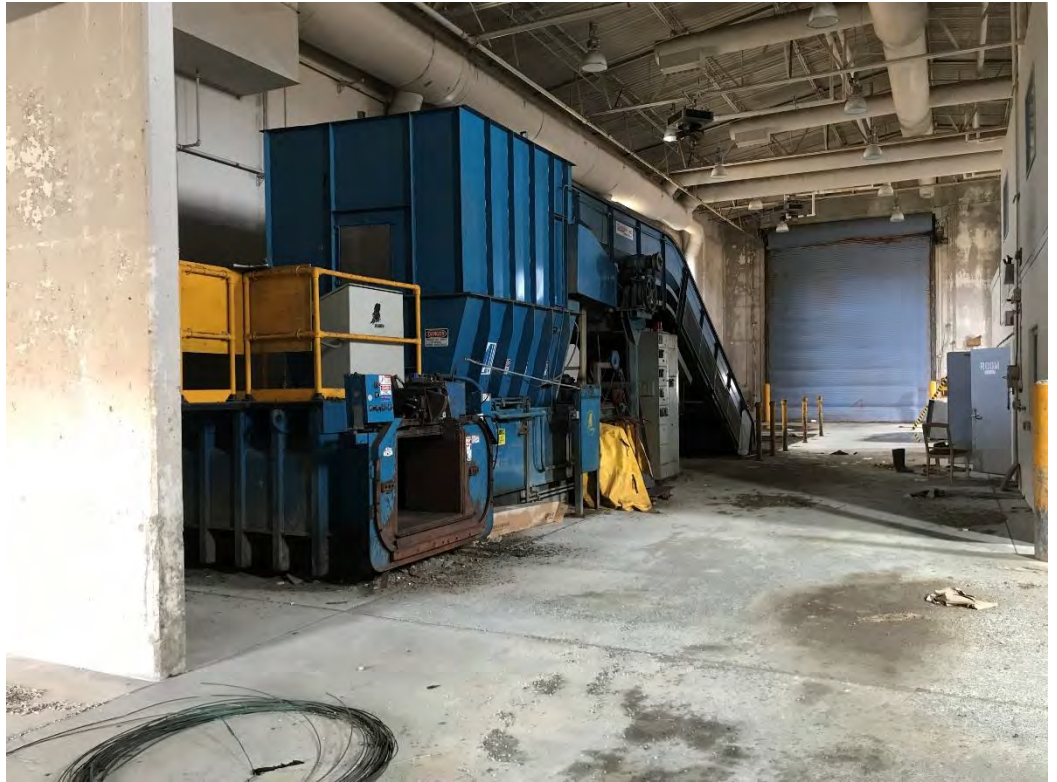
**Description:** Interior of  
new baler building  
structure. Good  
housekeeping practices  
inside building. Minimal  
signs of recreational  
disturbance.

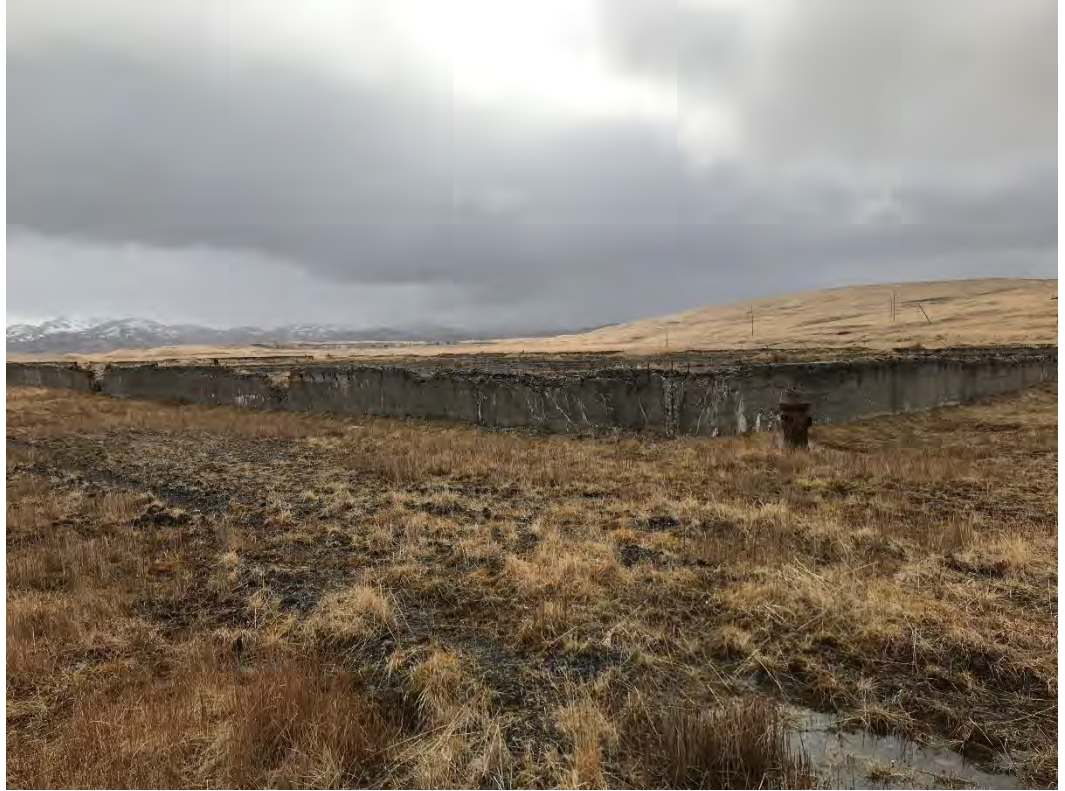
Northeast corner of  
contractor's camp burn  
pad.

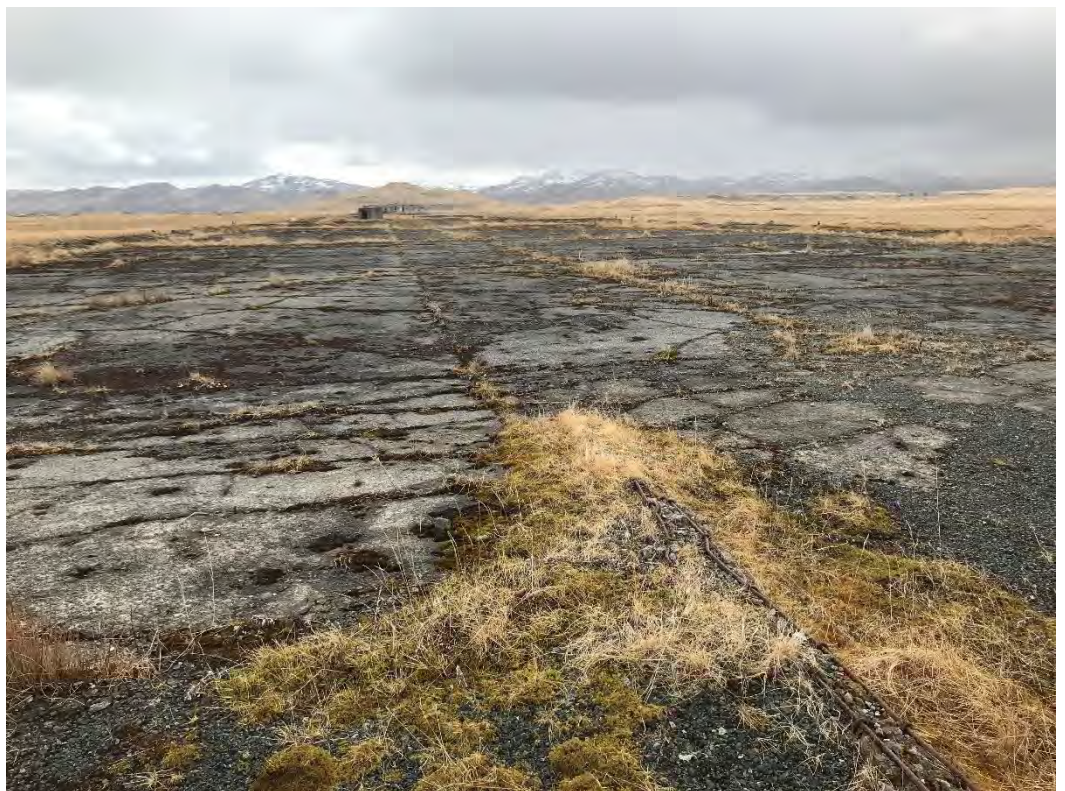
**Description:** Contractors  
camp burn pad looking  
south from the north end  
of pad.

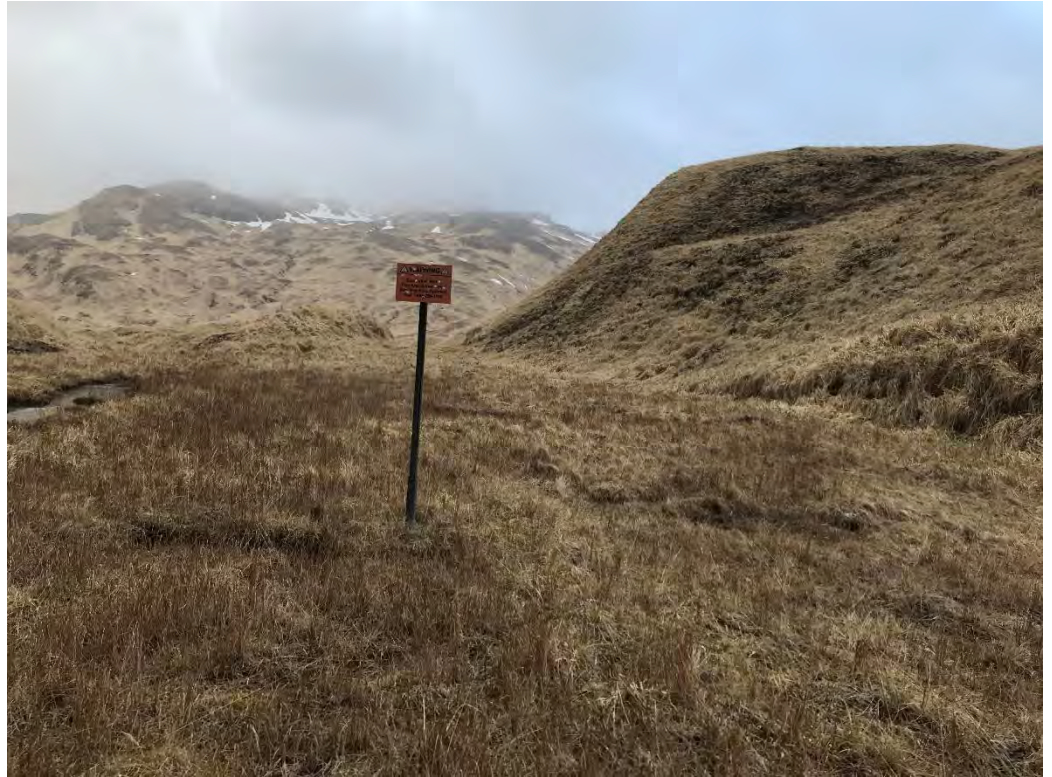
**Description:** Institutional  
control signage properly  
installed north of the  
former structure footprint.

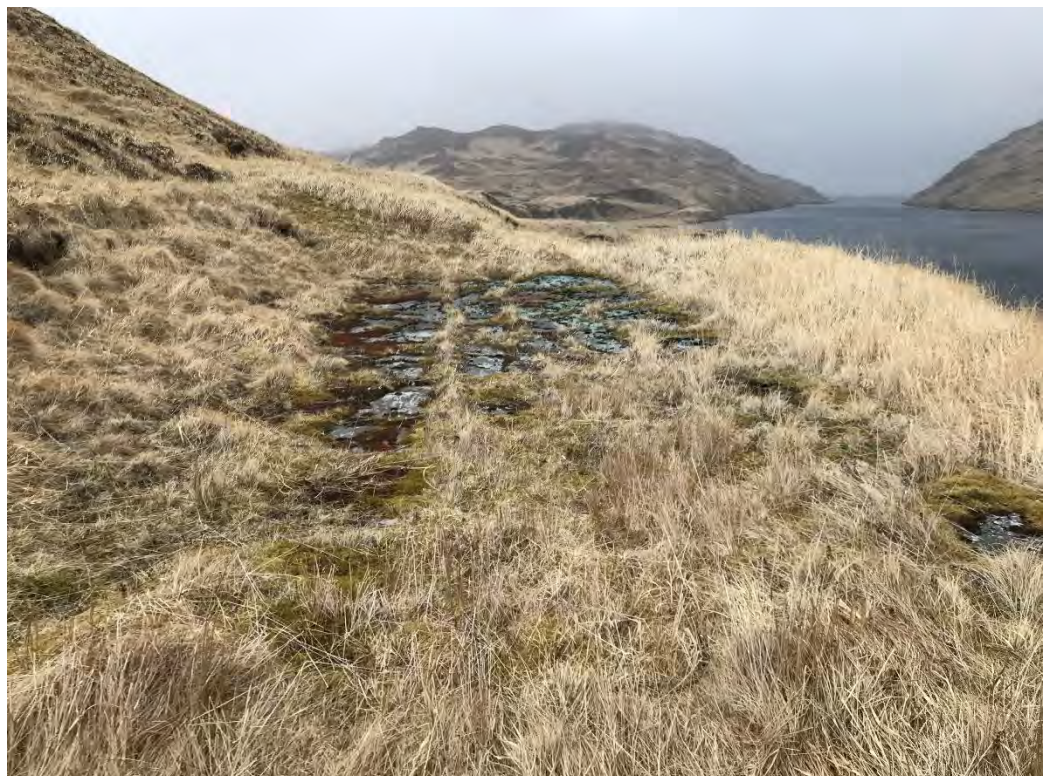
**Description:** Concrete  
pad/former foundation for  
finger bay Quonset hut  
looking east towards  
finger bay.

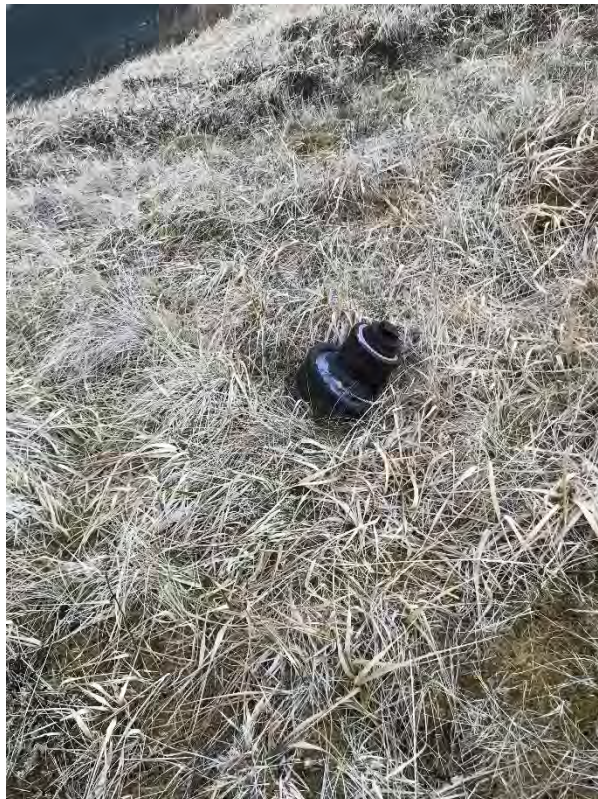
**Description:** Former  
pipeline tieoff for Quonset  
hut upgradient from road.

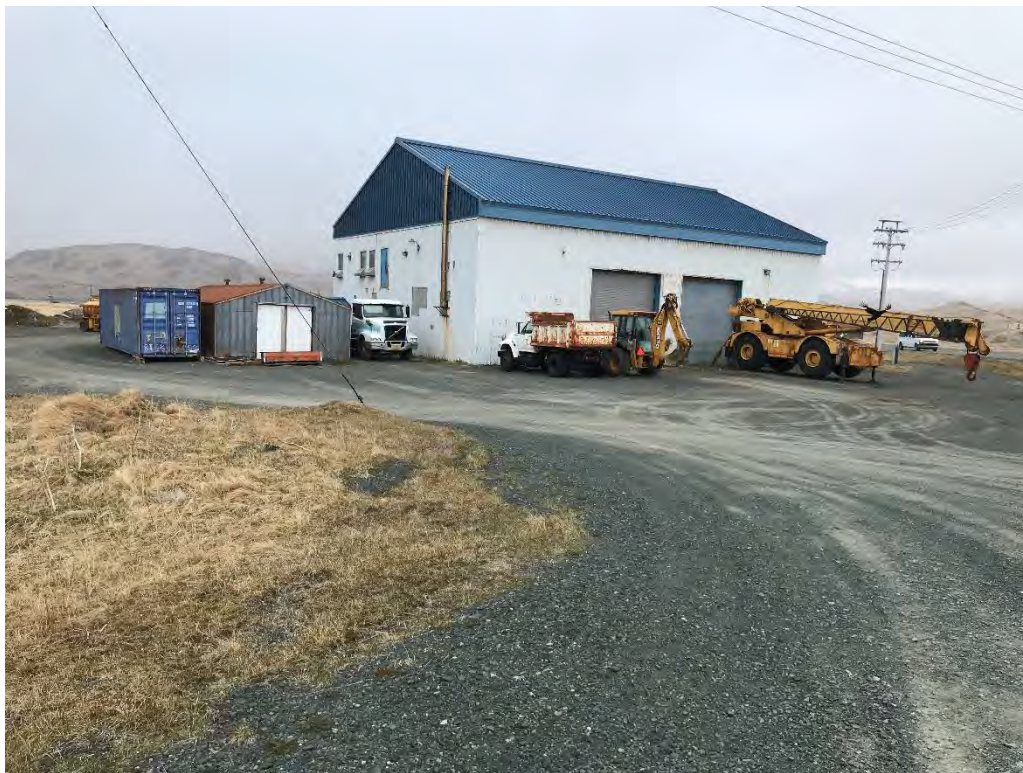
**Description:** Former  
power plant building  
looking south. Former  
building is in active use by  
the City of Adak for  
vehicle storage and  
maintenance activities.

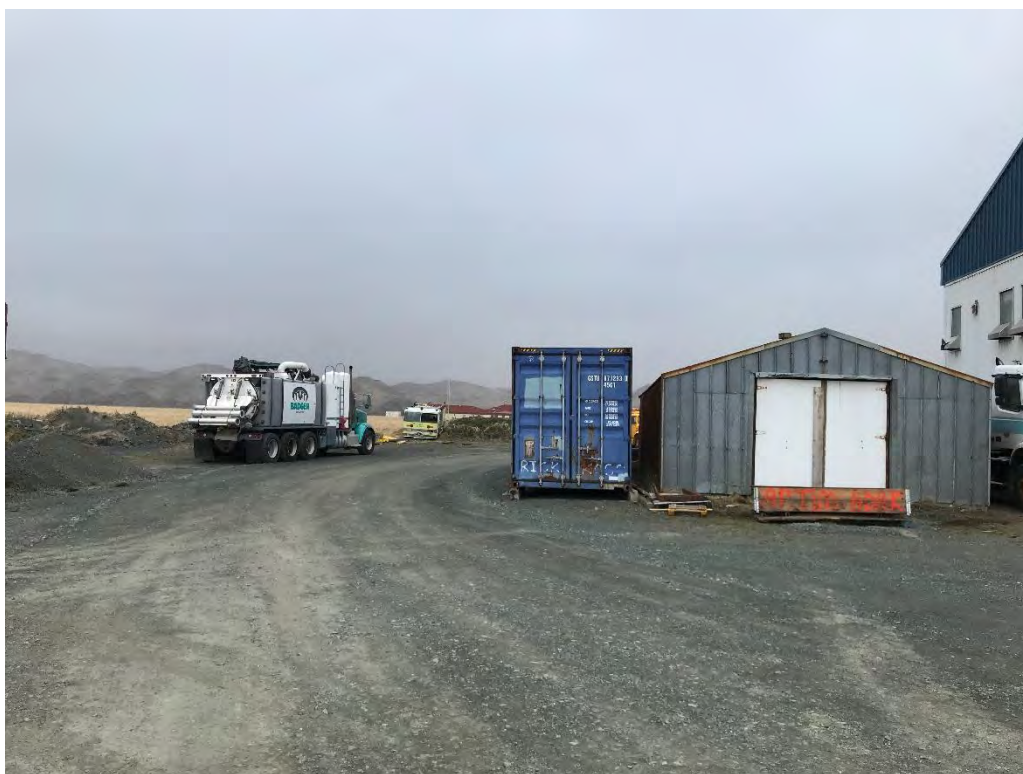
**Description:** East side of  
building which includes  
active work sheds,  
Conex's, and vehicle  
staging activities.

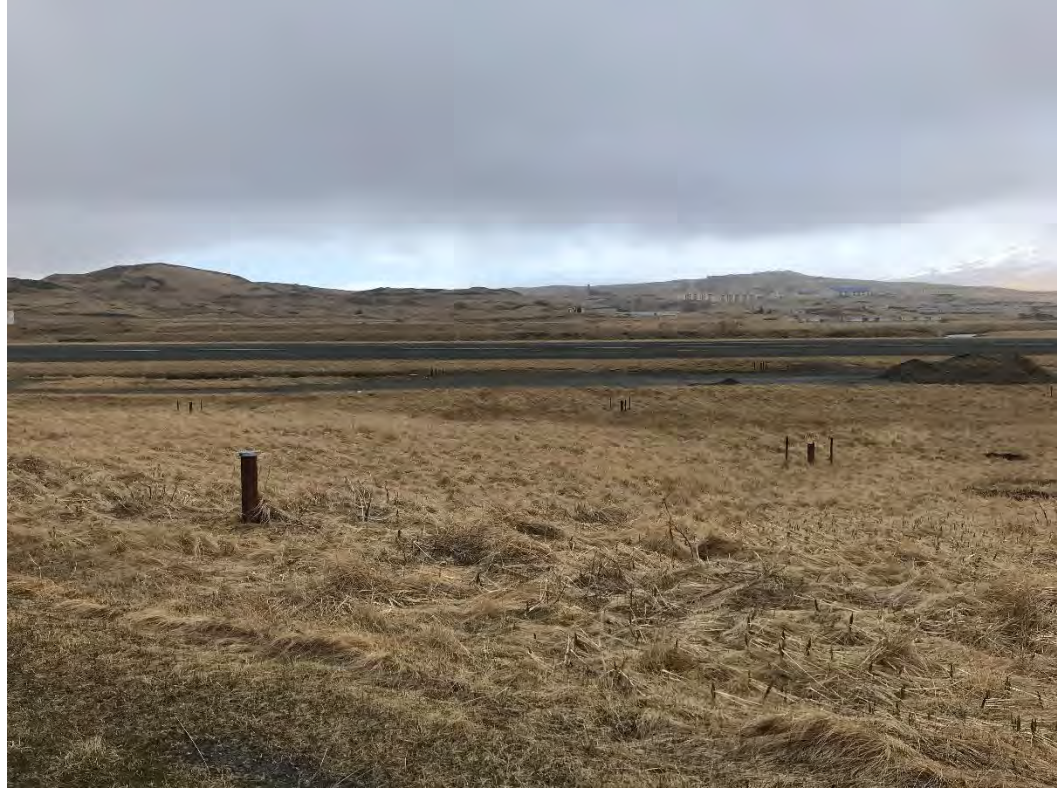
**Description:** Monitoring  
well field between main  
road and tarmac of  
runway 18-36.

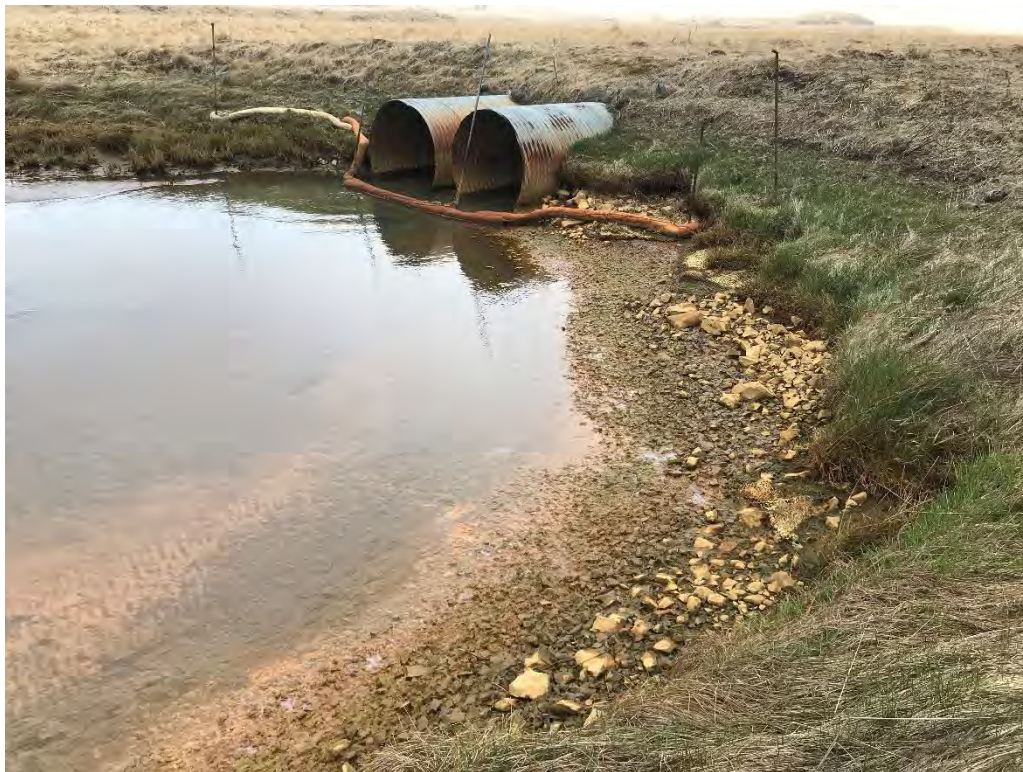
**Description:** East canal  
south culvert. Product  
boom present at mouth of  
culvert, sheen identified  
on eastern shoreline of  
east canal past product  
boom.

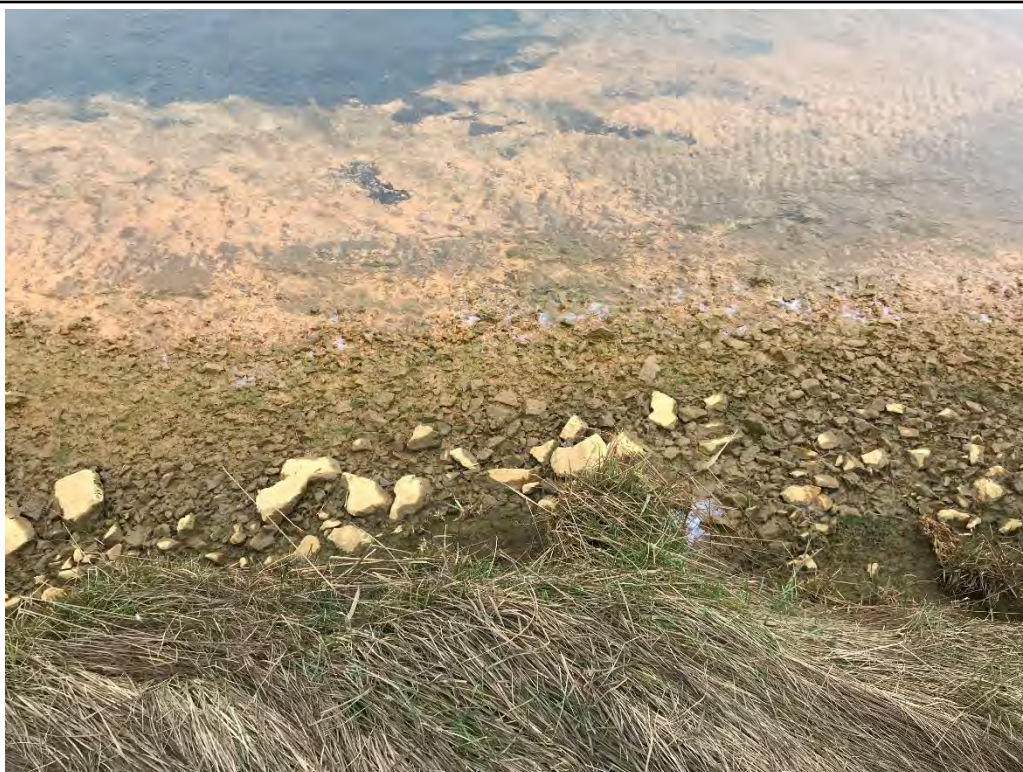
**Description:** Visual  
product sheen present on  
shoreline of east canal.

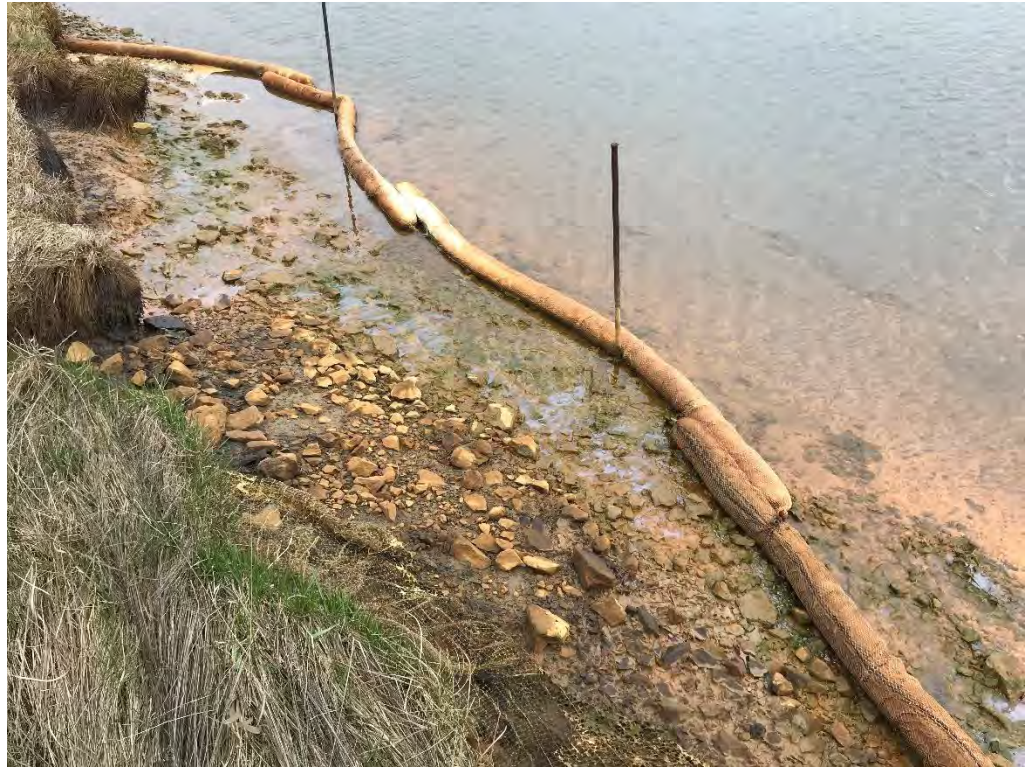
**Description:** Sheen seep  
on east side of east canal  
adjacent from former  
power plant building.  
Sheen seep  
approximately 200 feet  
south of culvert.
