# Fifth Five-Year Review Operable Units A and B-1 Former Adak Naval Complex

## **Naval Air Station Adak**

**Fifth Five-Year Review  
Operable Units A and B-1  
Former Adak Naval Complex  
NAVAL AIR STATION ADAK, ADAK ISLAND, ALASKA**

**December 2021**

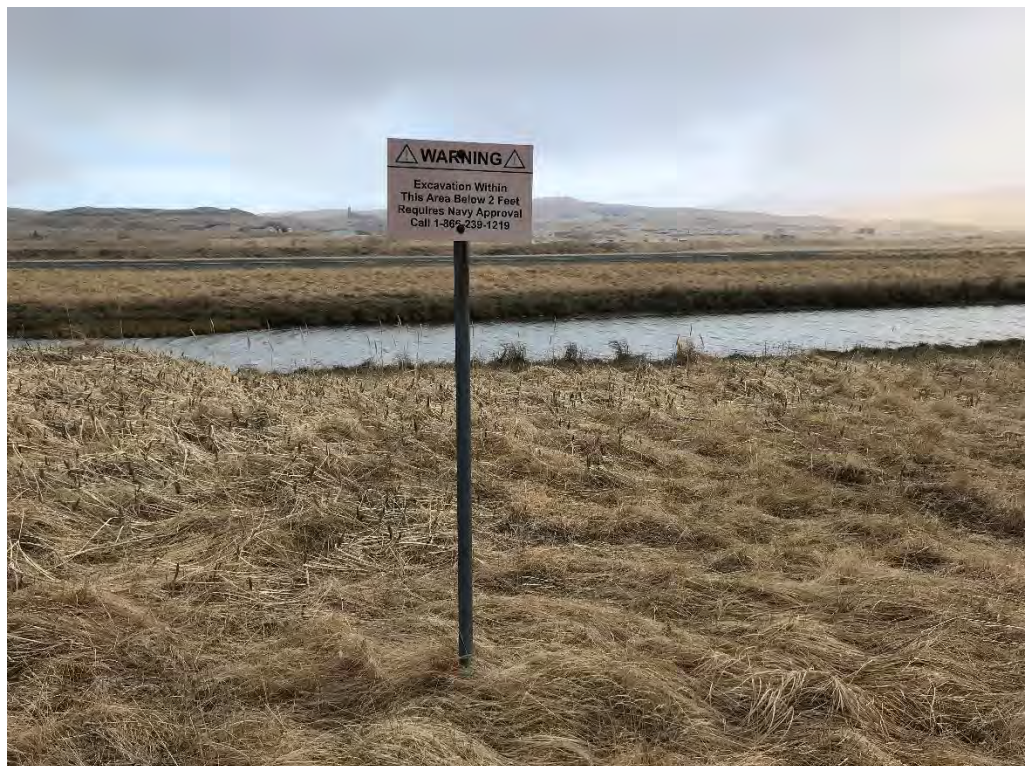
**Description:** Institutional  
control signage properly  
installed near east canal  
shoreline.

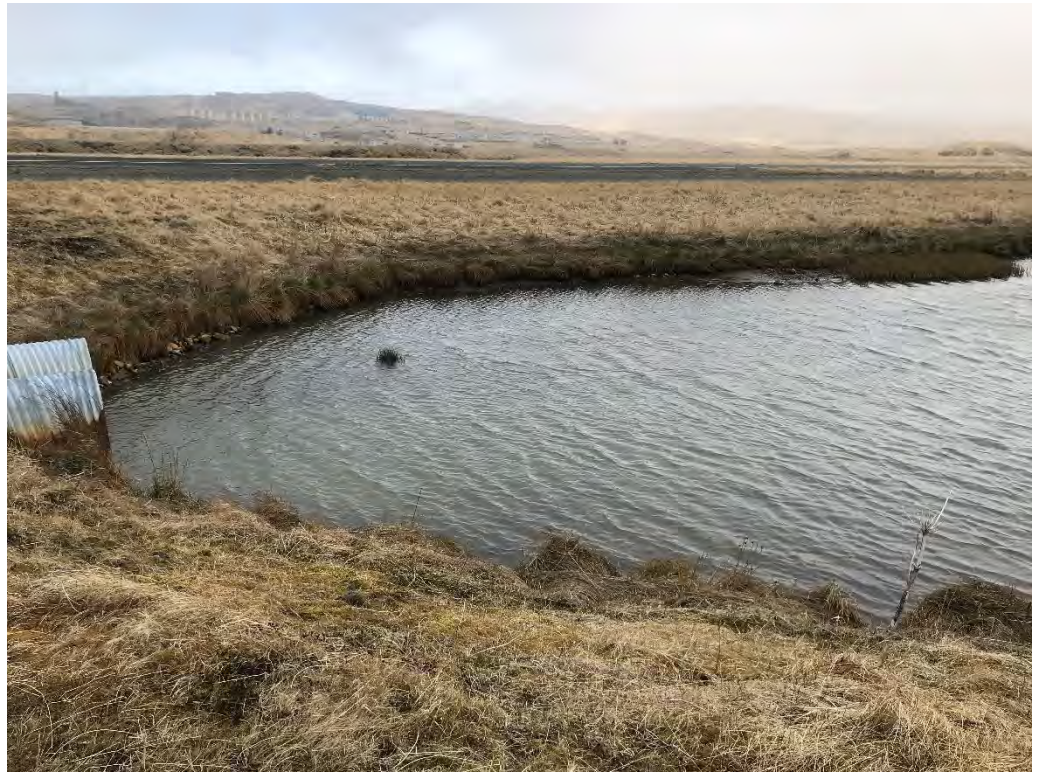
**Description:** East canal  
culvert, north side of  
culvert.

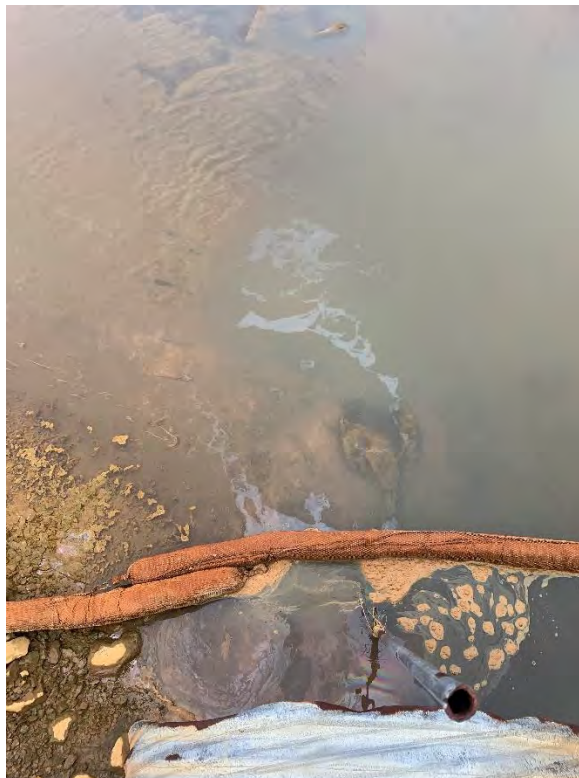
**Description:** Sheen  
present coming out of  
culvert and escaping  
product boom  
downstream.

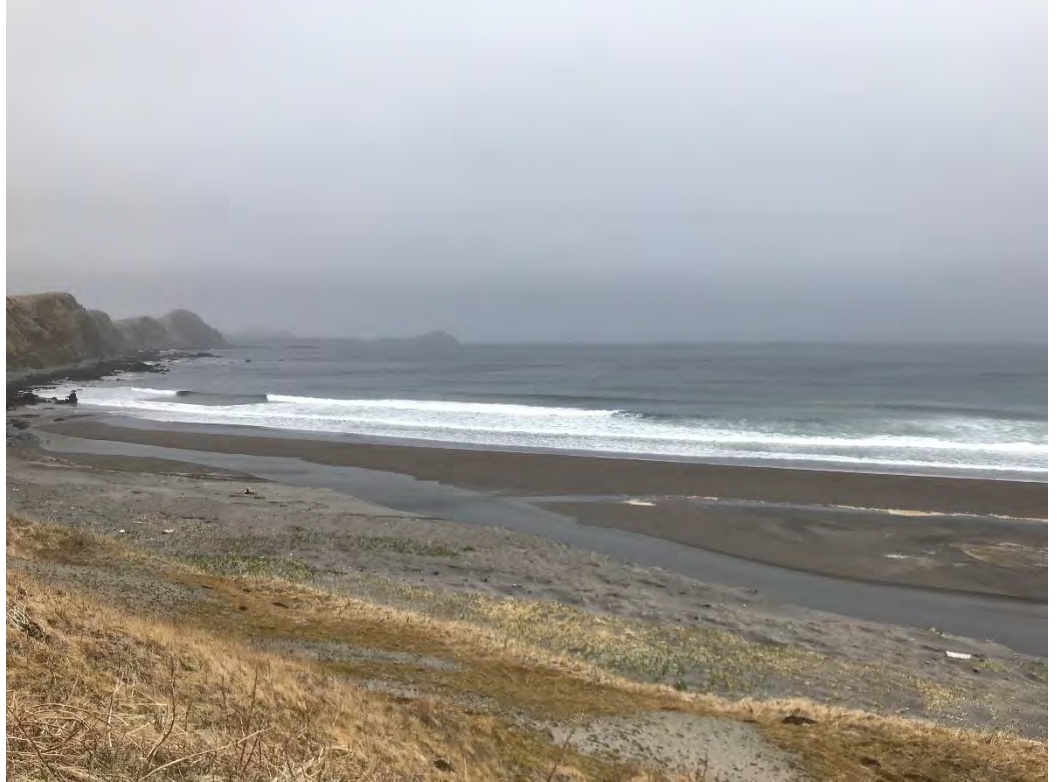
**Description:** Kuluk Bay  
from north bluff near  
palisades landfill.

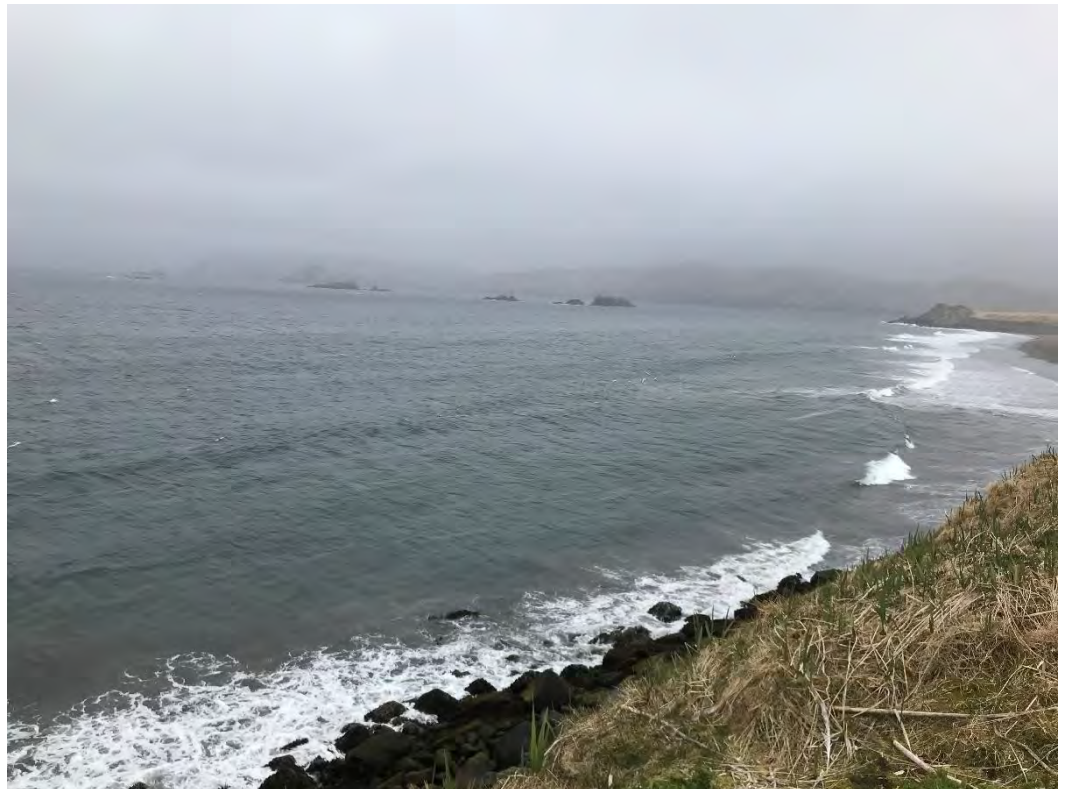
**Description:** Kuluk Bay  
looking east towards  
metals landfill from  
NORPAC Hill Seep Area.

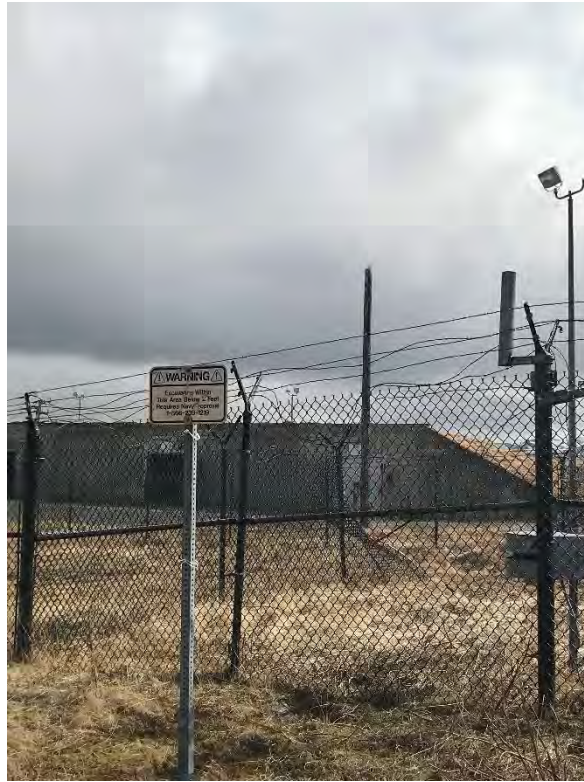
**Description:** Institutional  
control signage properly  
installed outside fenced  
site boundary.

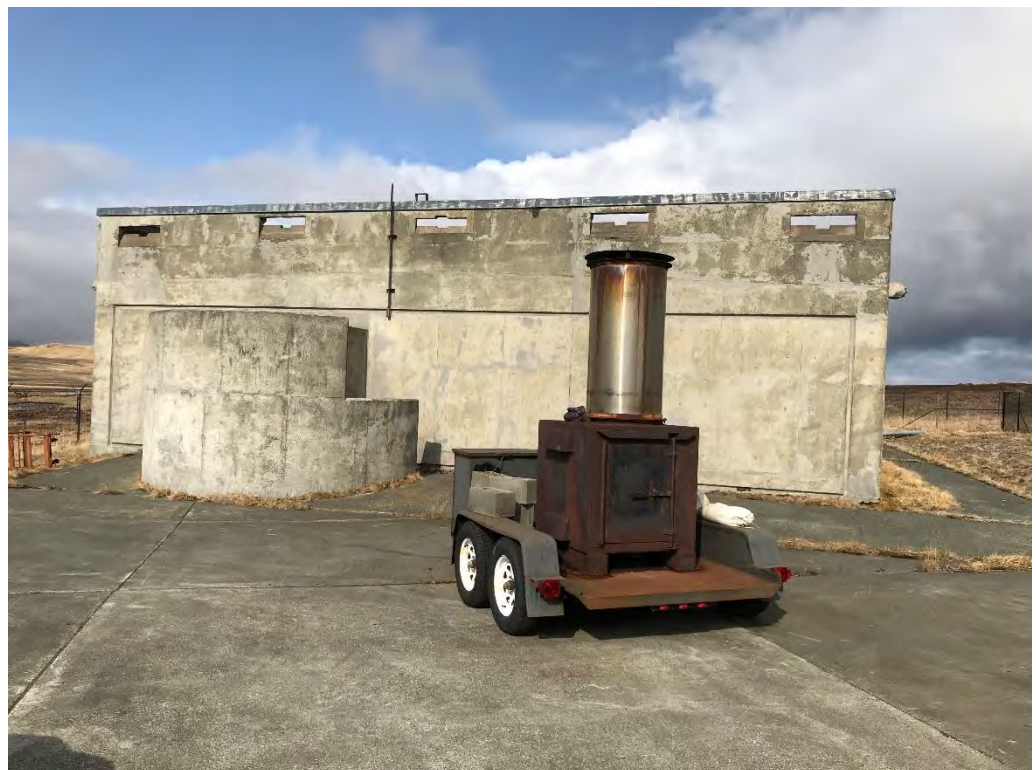
**Description:** MAUW  
Compound sleeping  
quarters on northeast side  
of site. Chemical burnoff  
equipment identified on  
site.

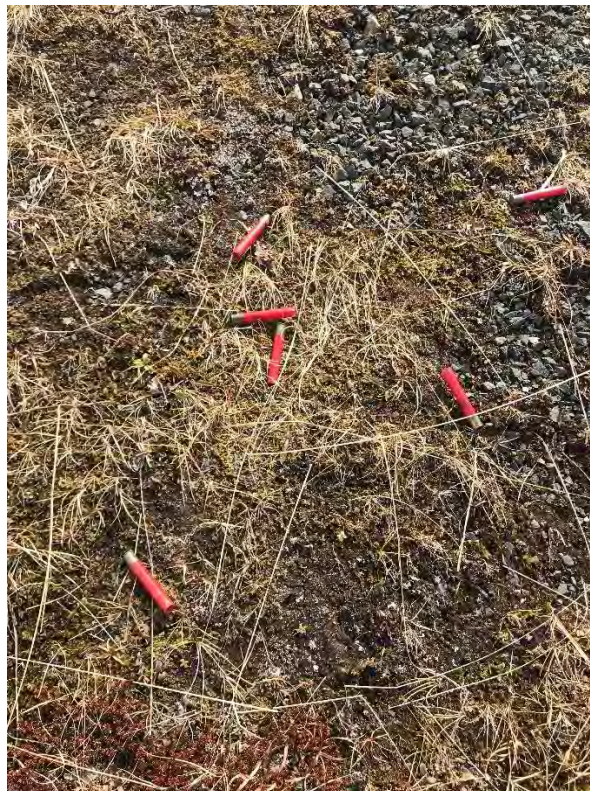
**Description:** Visual  
evidence of recreational  
activities onsite. Spent  
shotgun shells on ground  
near east corner of bomb  
storage bunker.

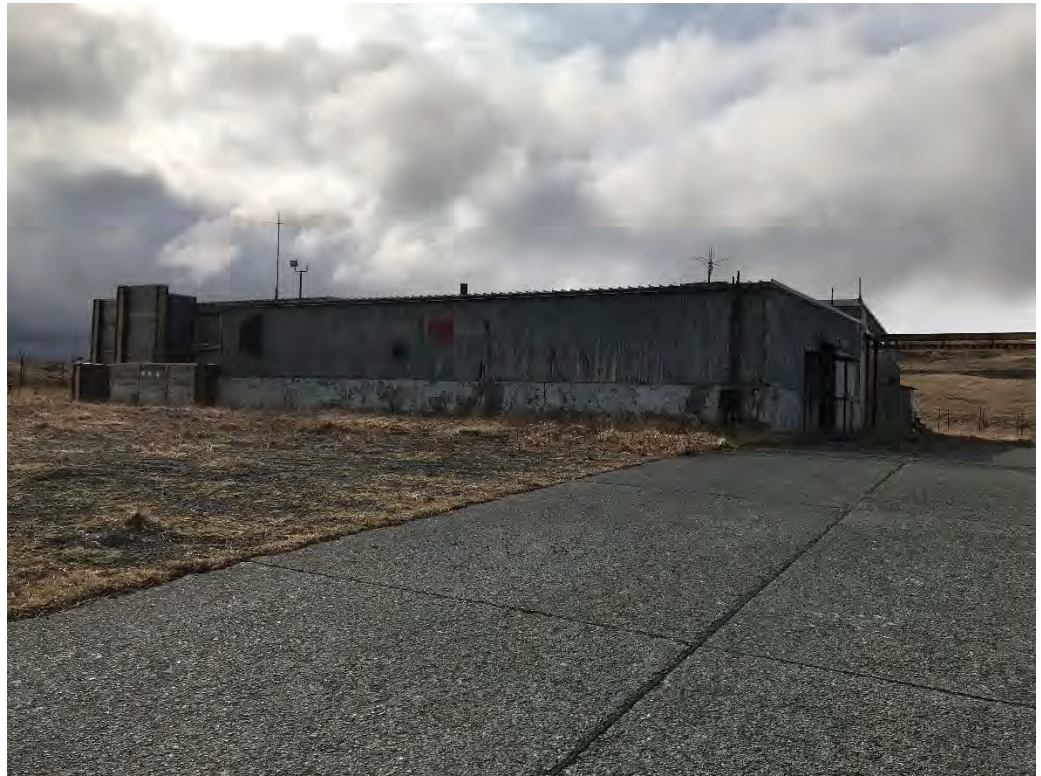
**Description:** Munitions  
storage facility on west  
side of site. Looking at  
east side of building.

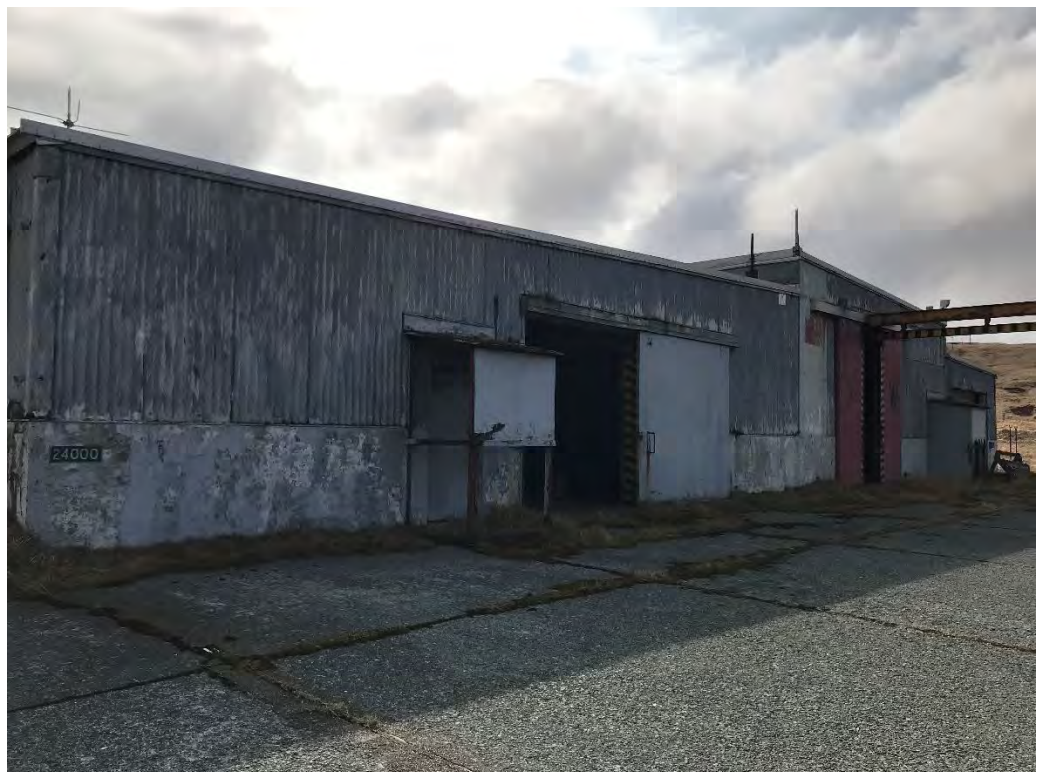
**Description:** Munitions  
storage facility, north side  
of building.

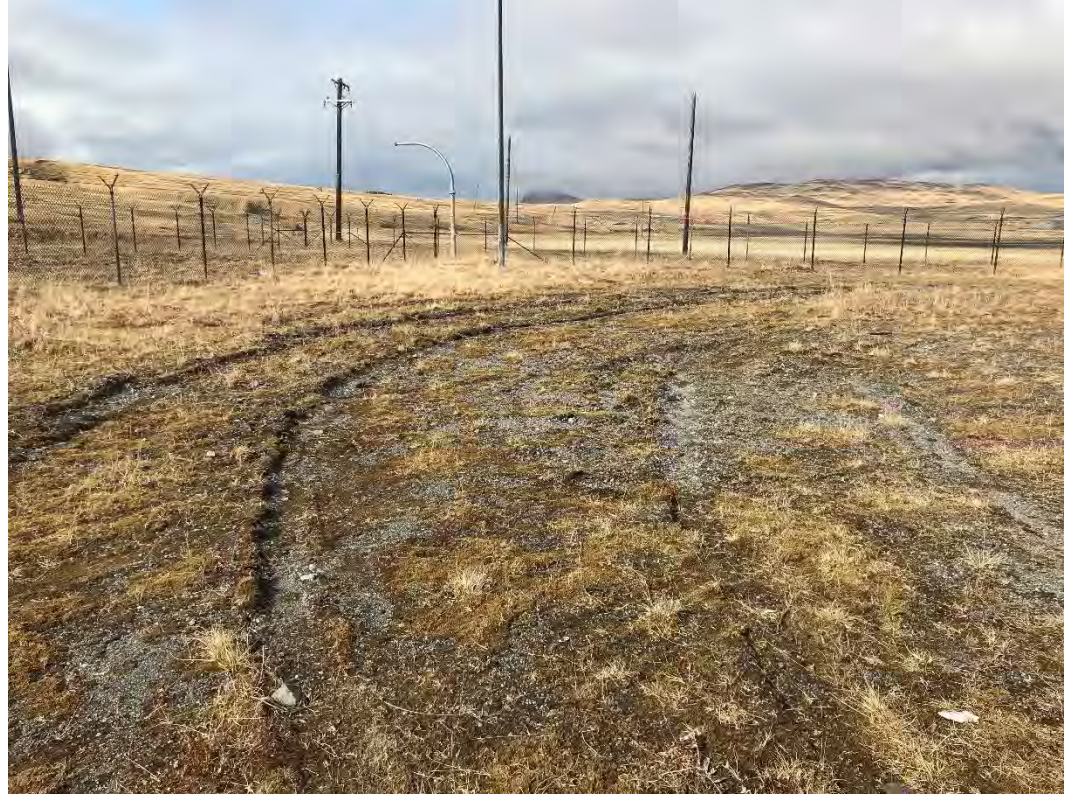
**Description:** Former UST  
excavation location.  
Heavy machinery tracks  
on surface visible.

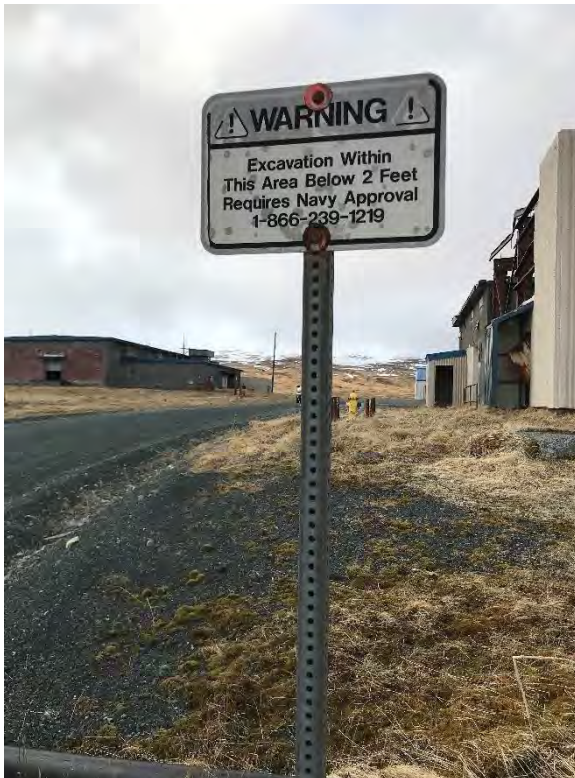
**Description:** Institutional  
control signage properly  
installed near southeast  
corner of building 5.

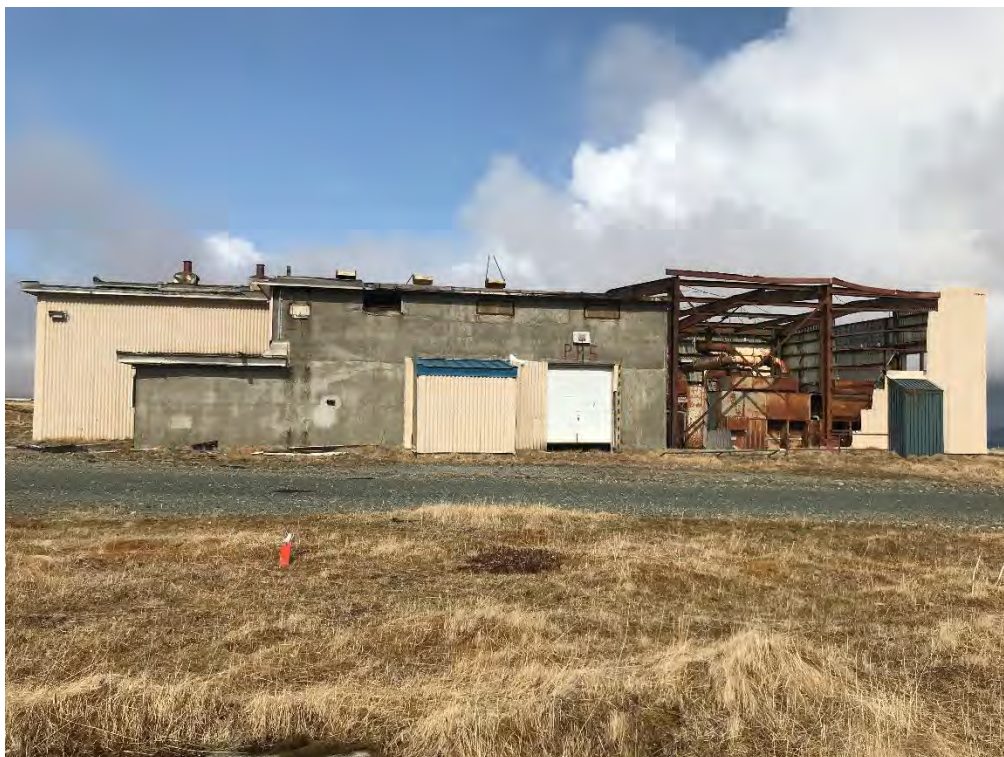
**Description:** South side  
of power plant building 5.

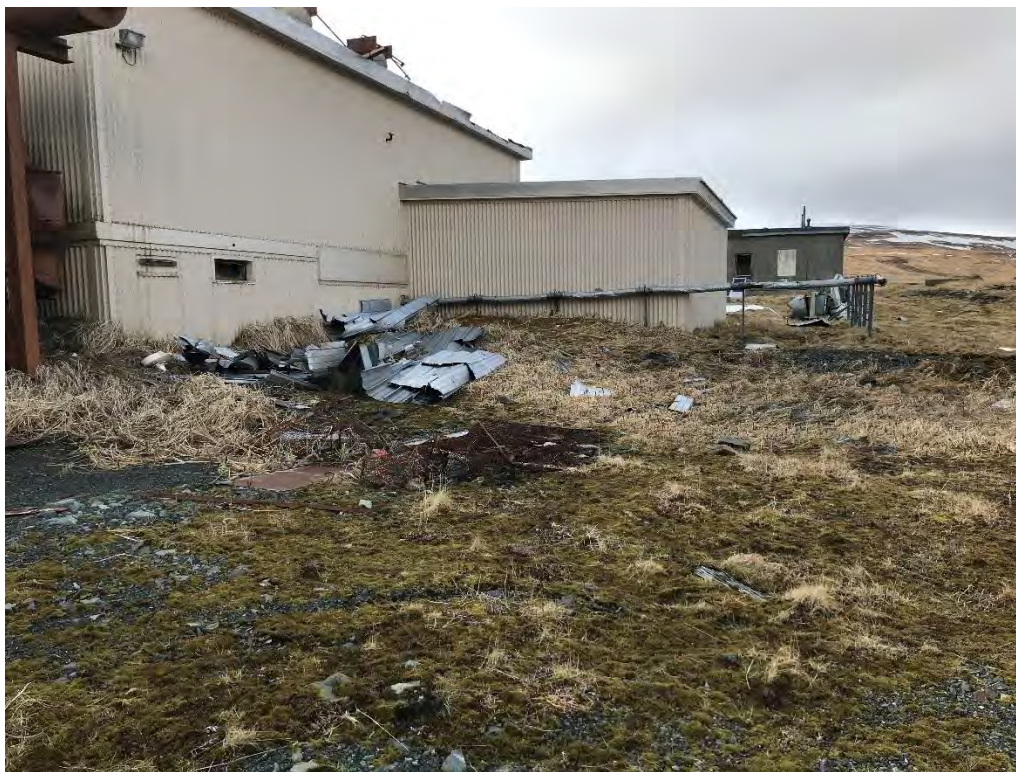
**Description:** North side of  
power plant building 5.  
Former UST excavation  
location. Observed fill  
material in area.

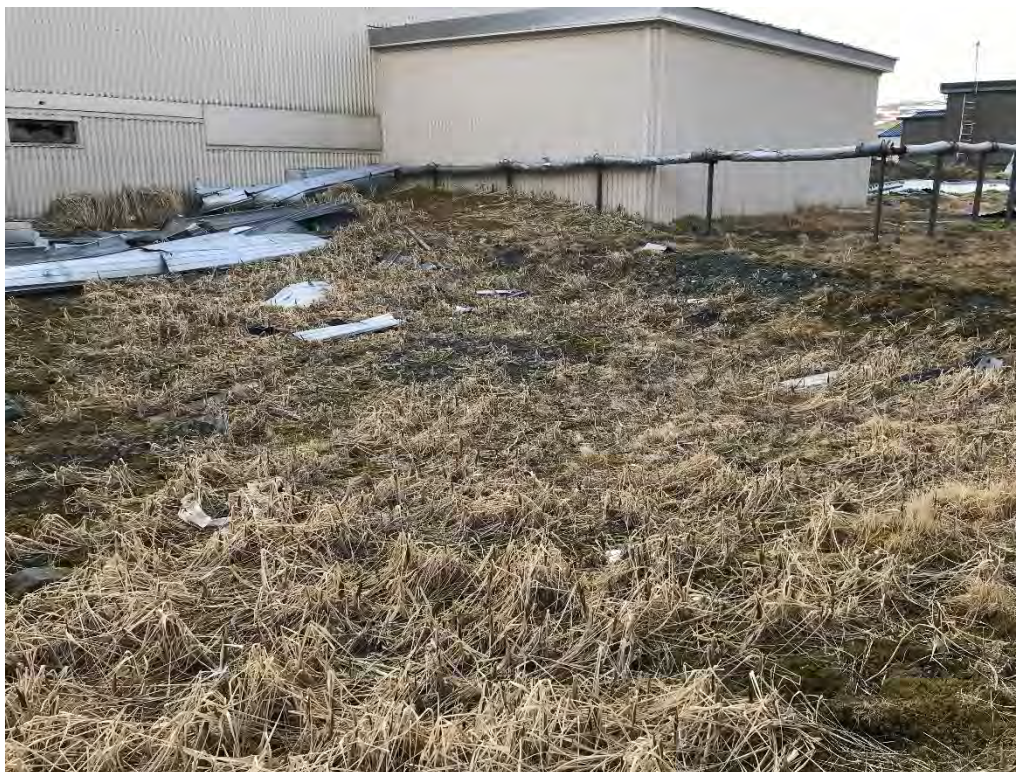
**Description:** North side of  
power plant building 5.  
Former UST excavation  
location. Observed fill  
material in area and  
vegetated depression.

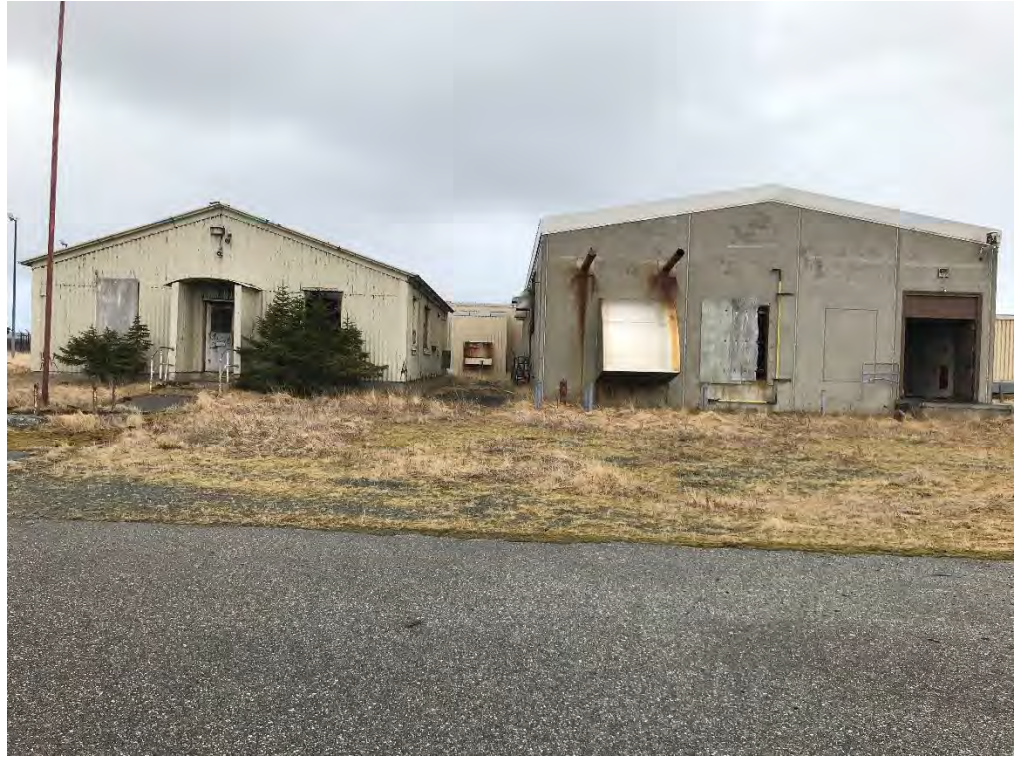
**Description:** West side of  
NAVFAC Compound  
building.

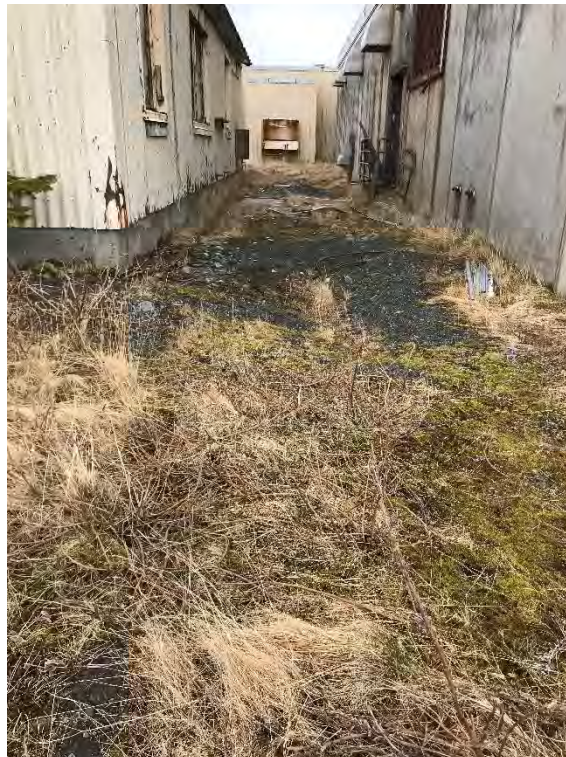
**Description:** Former UST  
excavation location on the  
south side of building. Fill  
material within depression  
in surface observed.

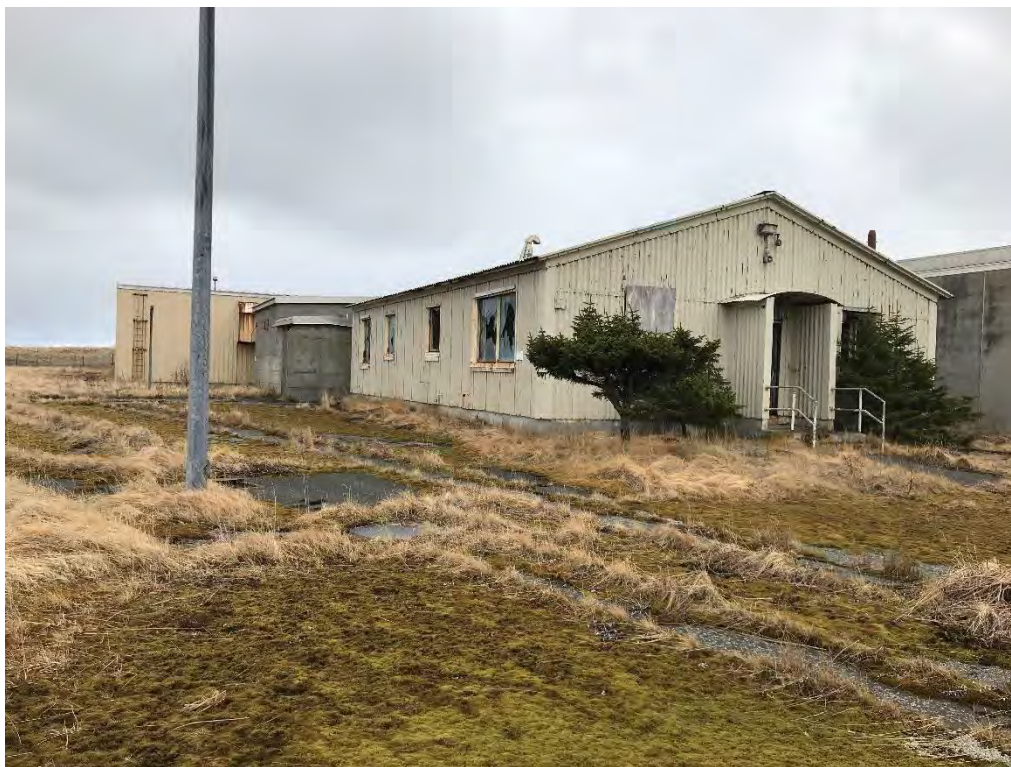
**Description:** North side of  
NAVFAC Compound  
building.

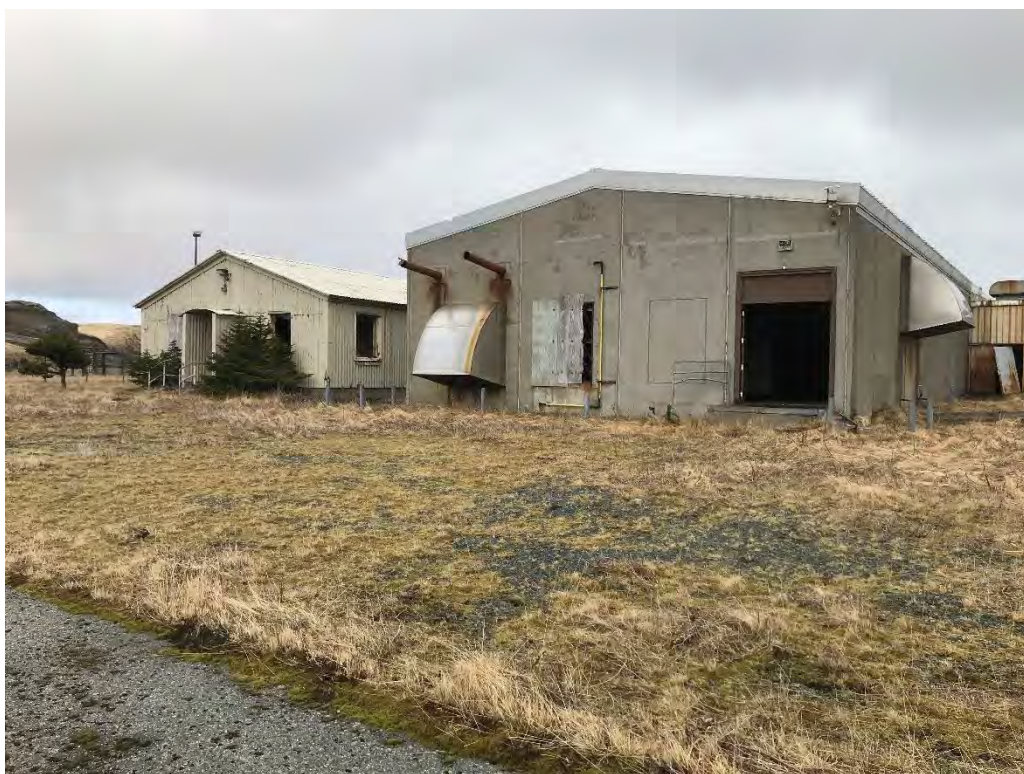
**Description:** West side of  
NAVFAC Compound  
building.

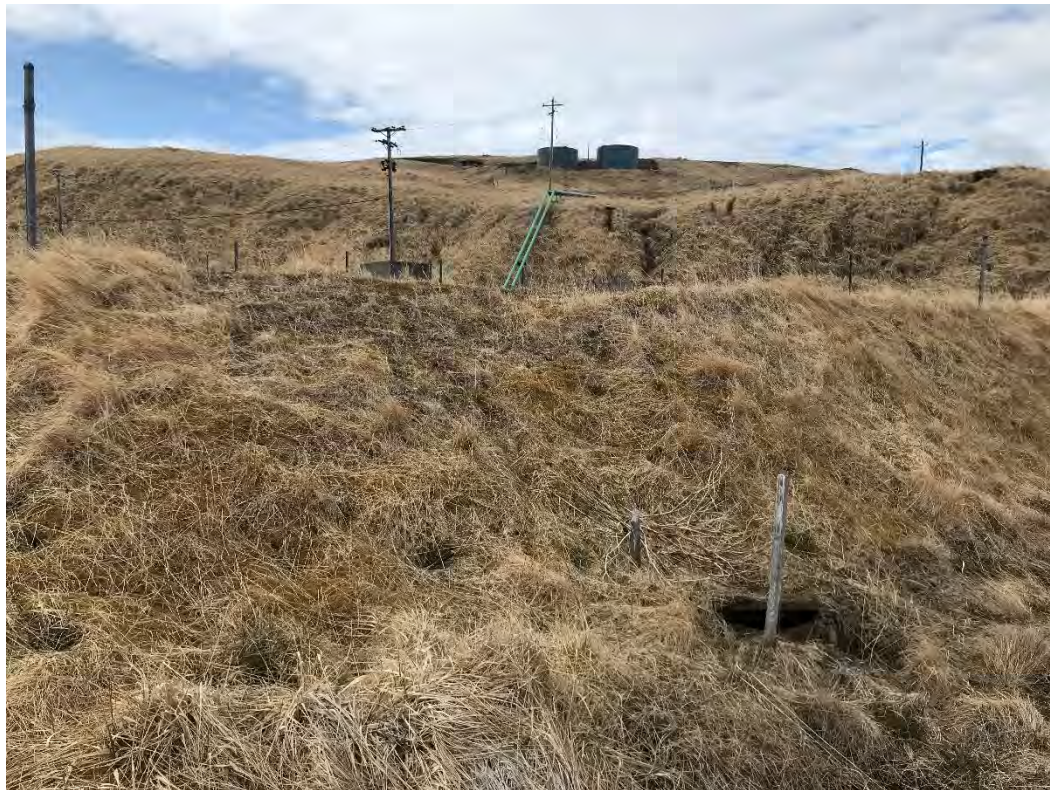
**Description:** East side of  
vegetated berm where  
former USTs were  
located.

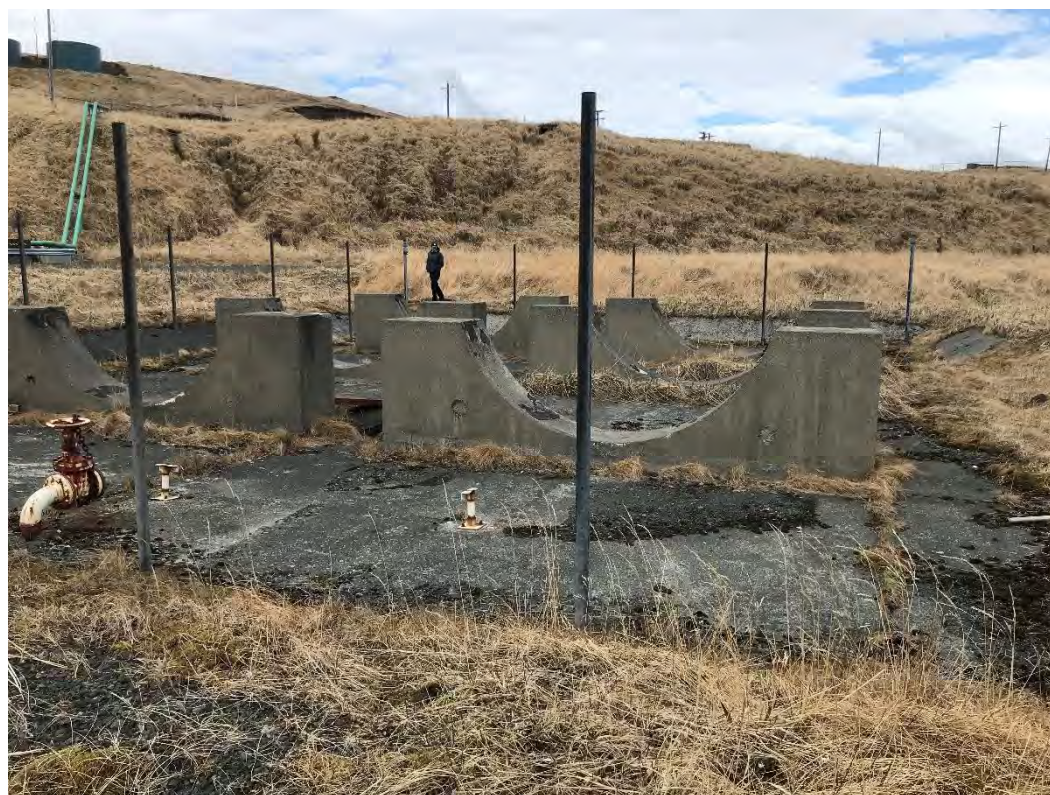
**Description:** Former tank  
holding area. No evidence  
of recreational usage.  
Minor pooling in concrete  
cutout in center of tank  
holding area.

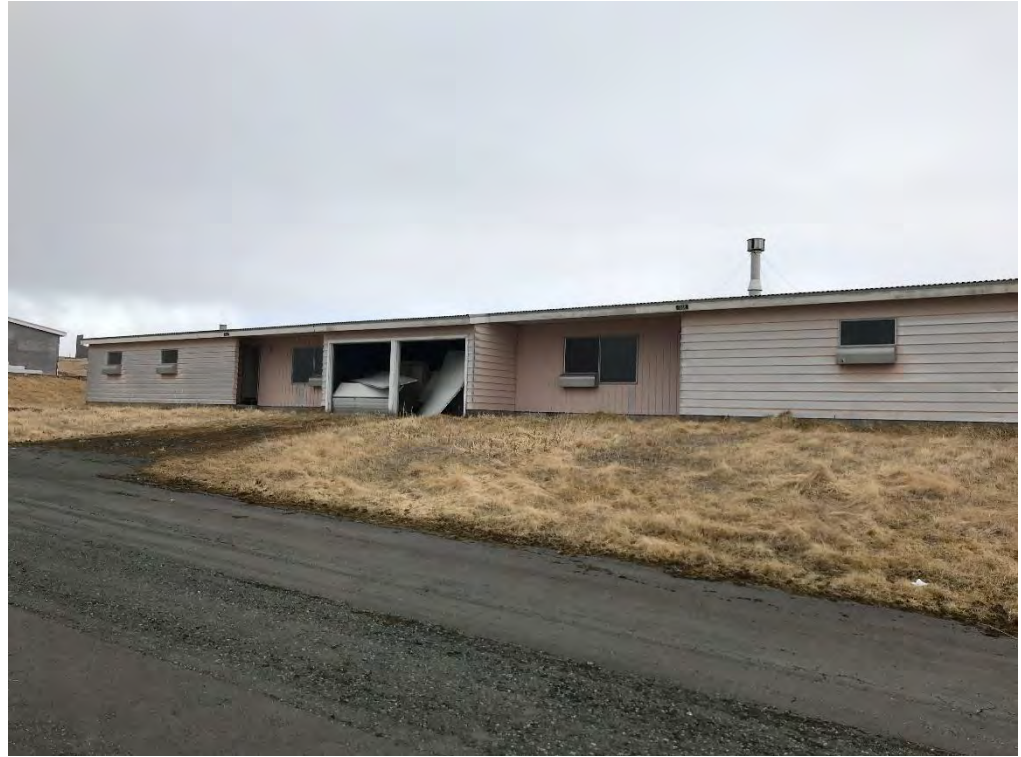
**Description:** Office hill  
housing structure. No  
evidence of recreational  
use/occupancy.

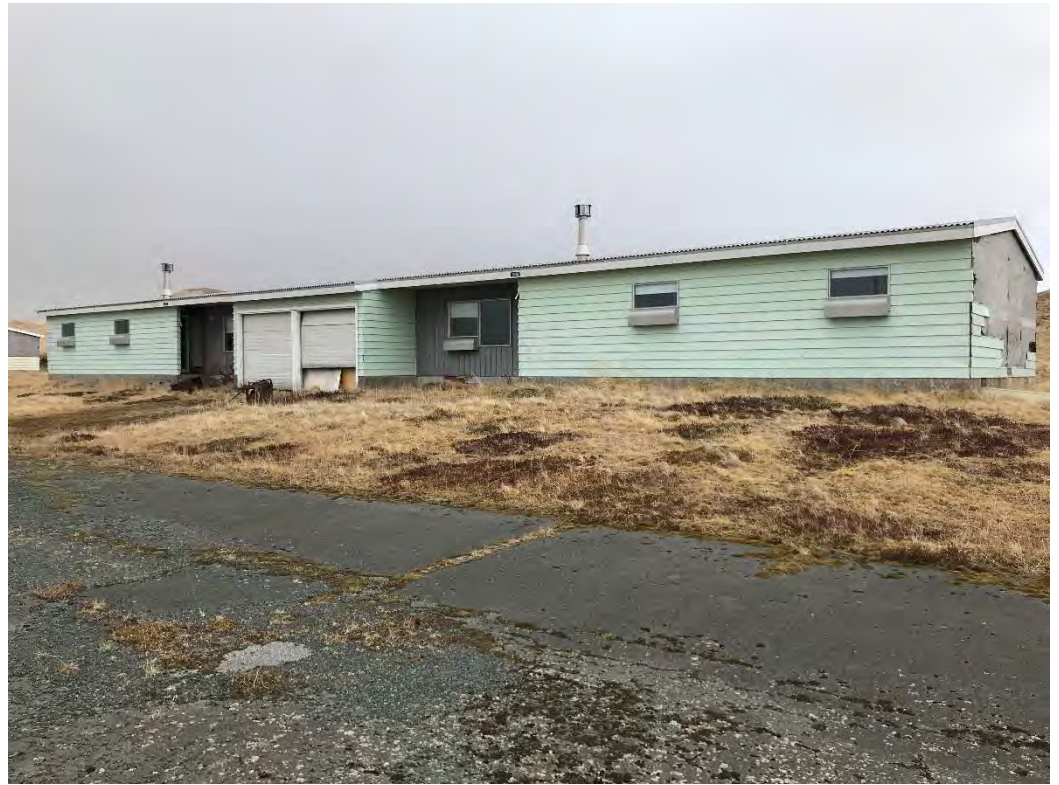
**Description:** Office hill  
housing structure. No  
evidence of recreational  
use/occupancy.

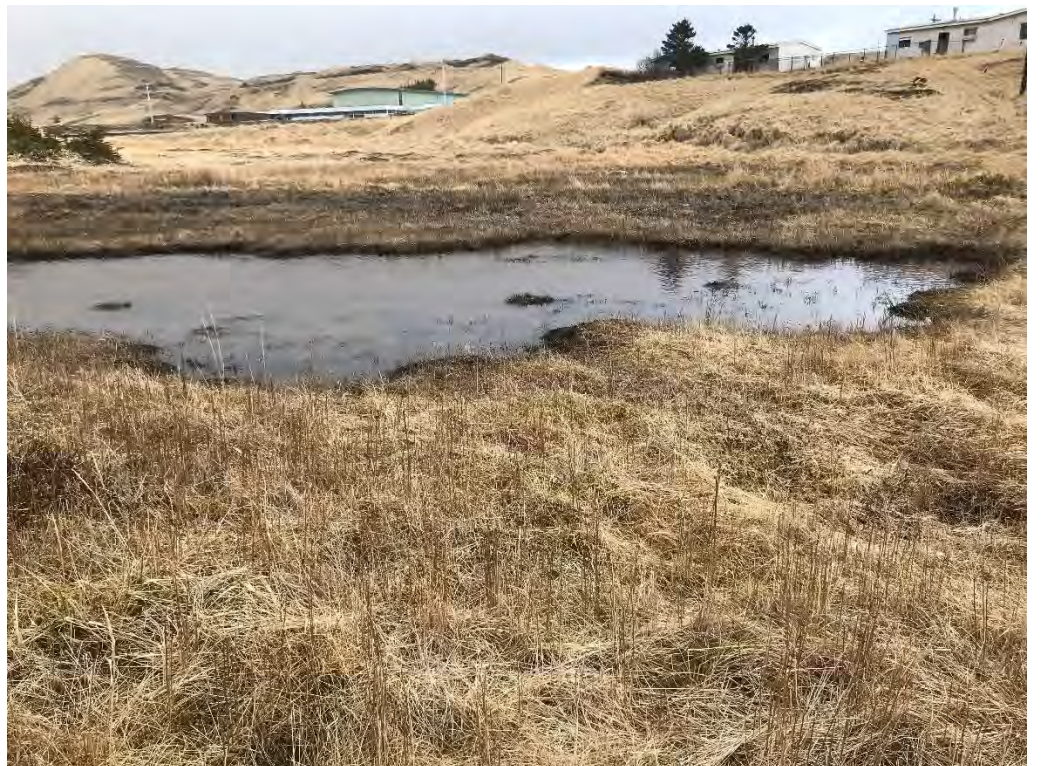
**Description:** Surface  
water pooling on west side  
of housing structure.

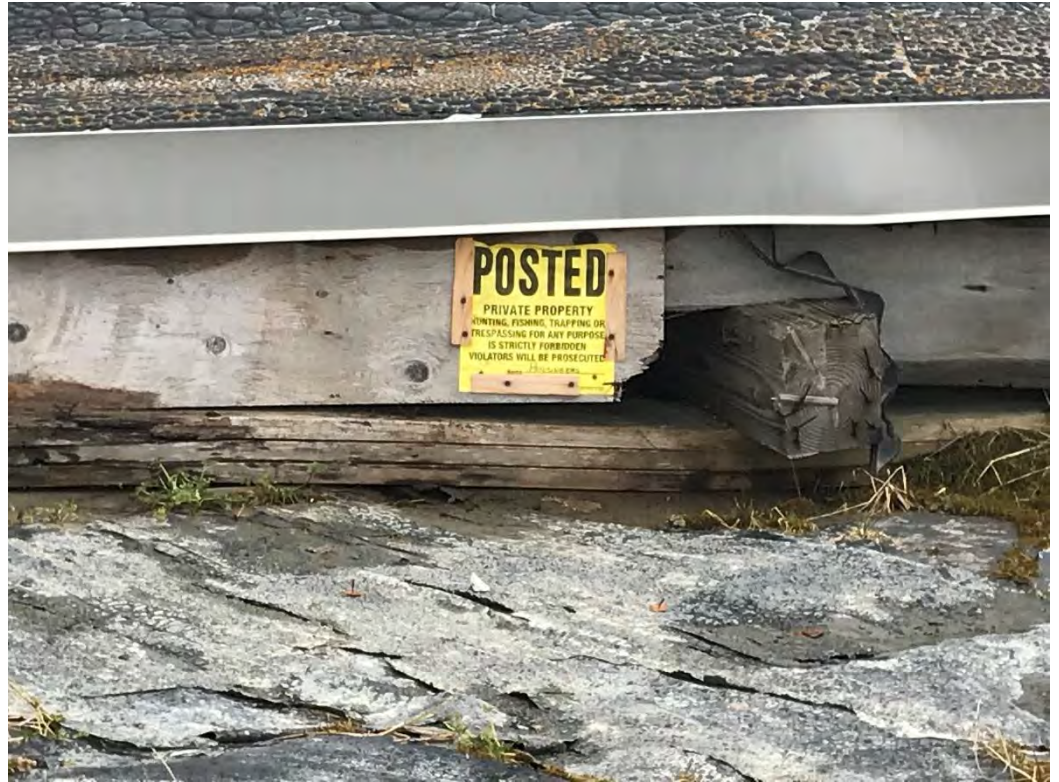
**Description:** No  
trespassing signage  
installed on north side of  
previously existing  
building. Signs visible  
from access road to site.

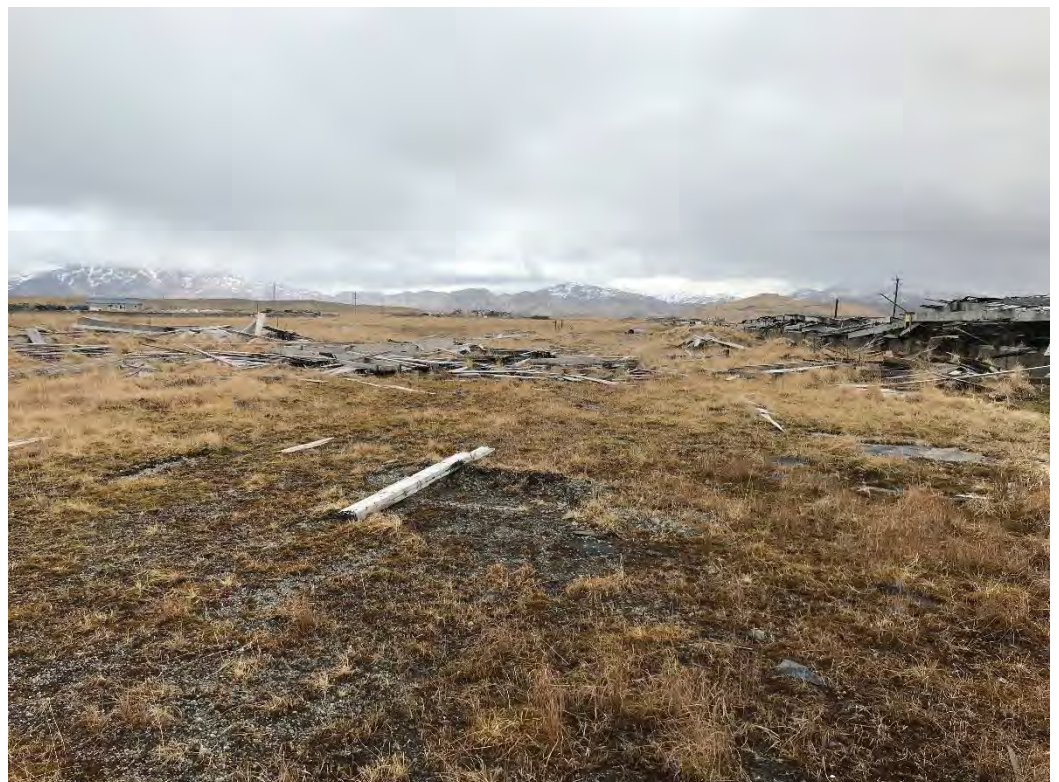
**Description:** ROICC-2  
location of former  
warehouse. Scattered  
woody and metallic debris  
throughout site.

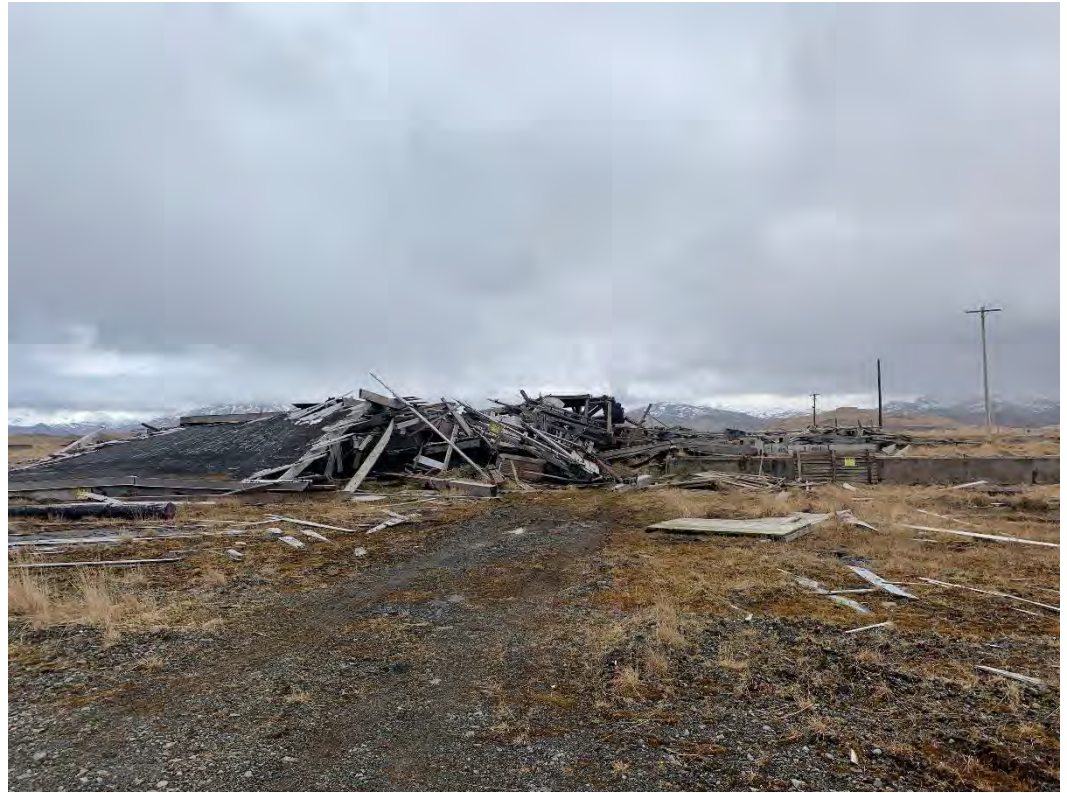
**Description:** Collapsed warehouse building within ROICC-3 site. Building collapsed due to a high wind event within the last five years.

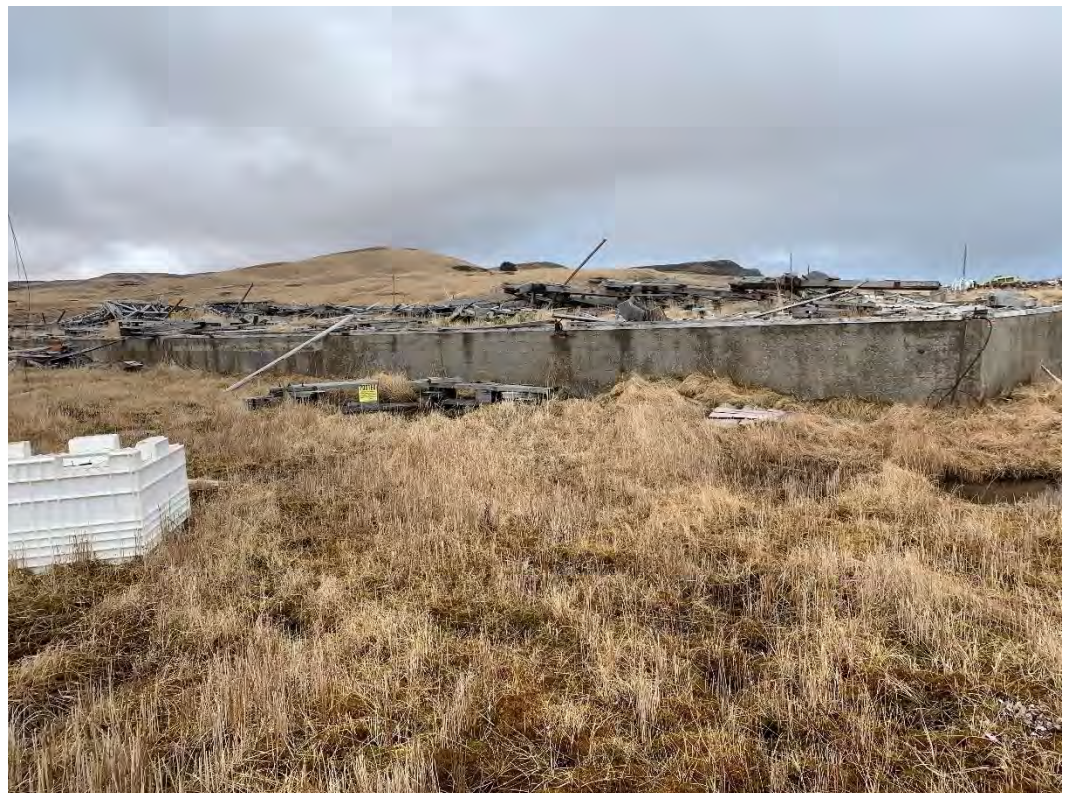
**Description:** Southwest corner of former ROICC-3 warehouse. Location of previous UST excavation on corner of building. Visual signs of recreational activity. Vehicle marks leading up to warehouse entrance on north side and individuals identified on site during review.

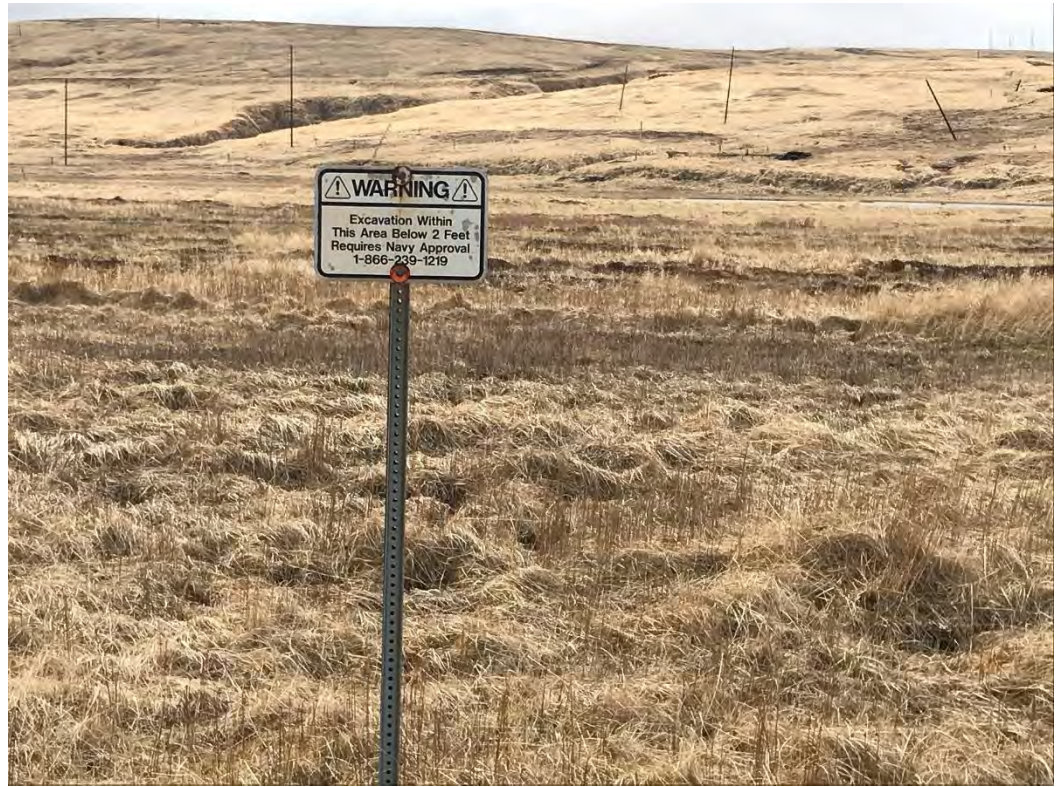
**Description:** Institutional  
control signage properly  
installed on the west side  
of the site.
