# Fifth Five-Year Review Operable Units A and B-1 Former Adak Naval Complex

## **Naval Air Station Adak**

**Fifth Five-Year Review  
Operable Units A and B-1  
Former Adak Naval Complex  
NAVAL AIR STATION ADAK, ADAK ISLAND, ALASKA**

**December 2021**

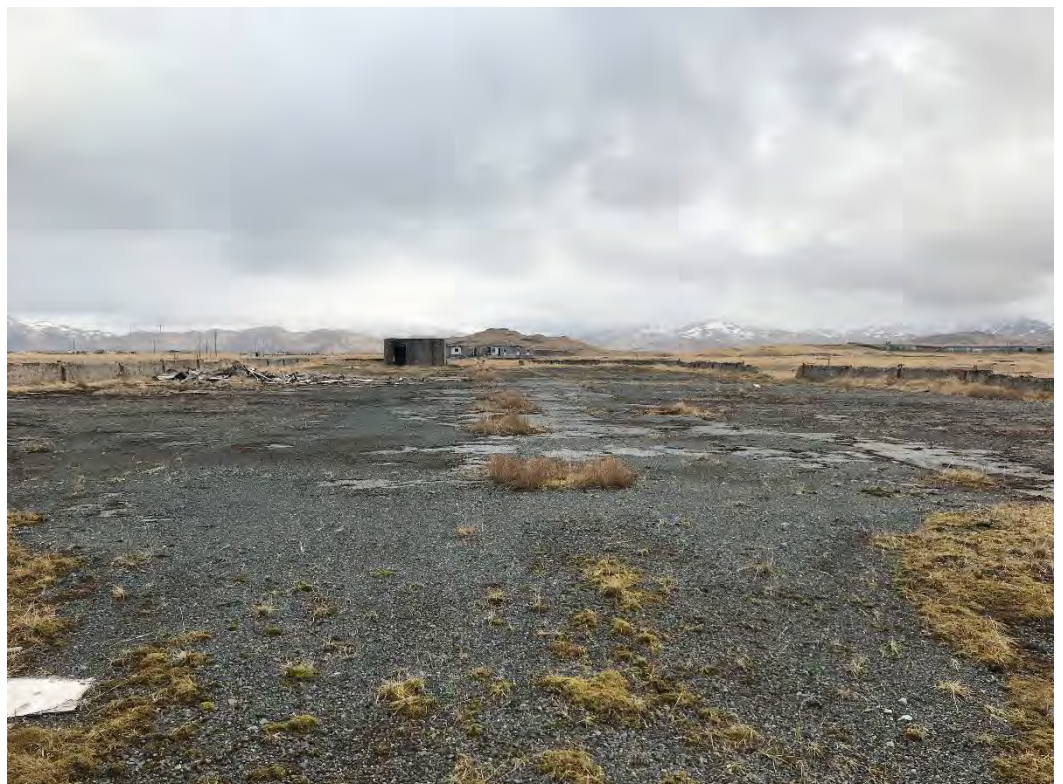
**Description:** ROICC 7 &  
8 concrete pad facing  
south. No visual signs of  
disturbance onsite.

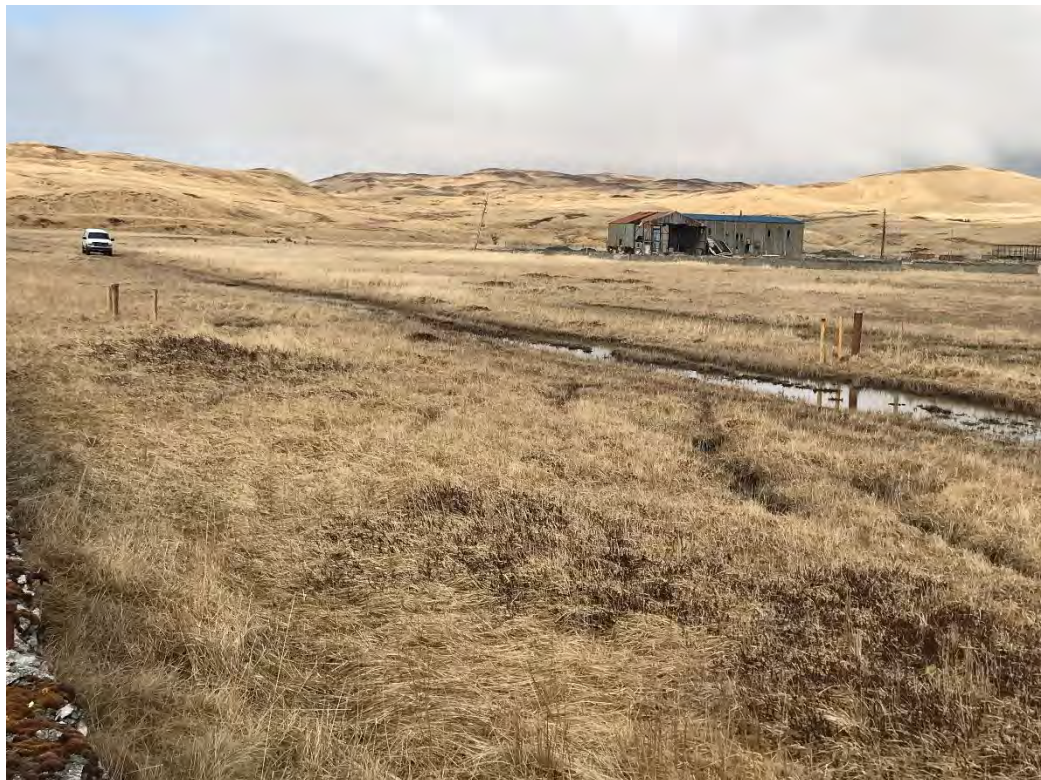
**Description:** Former UST excavation location on the southeast corner of concrete pad. Heavy machinery tracks identified leading up to corner of building with distressed vegetation.

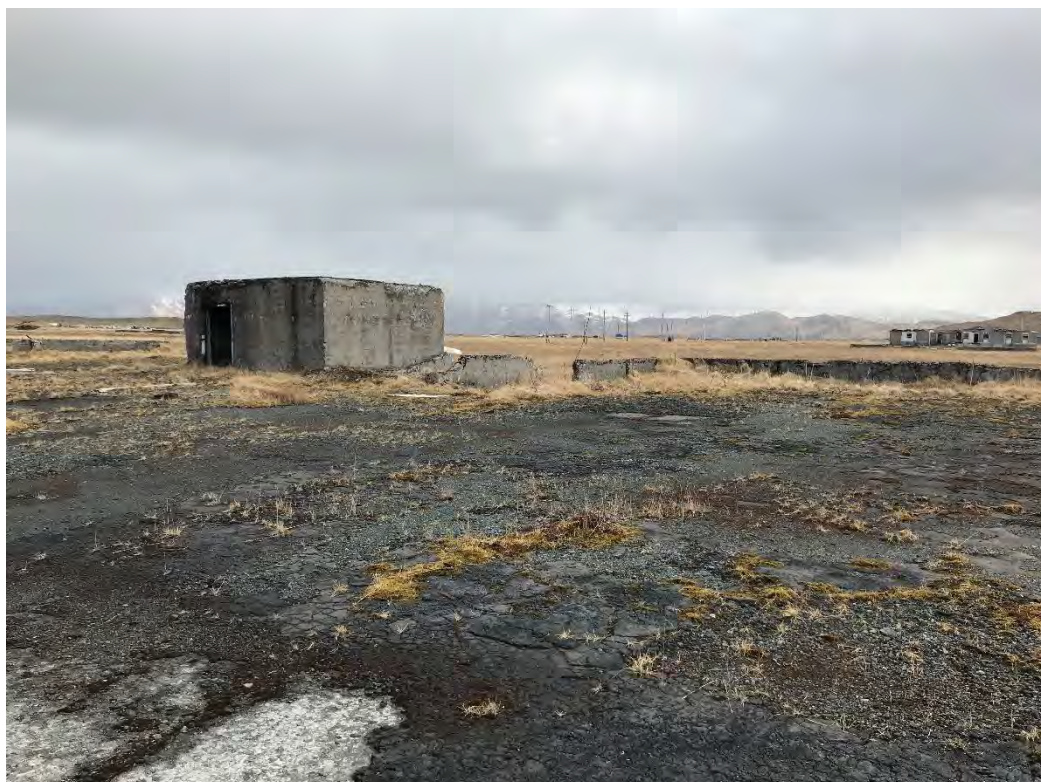
**Description:** Former UST excavation location on the southwest corner of concrete pad.

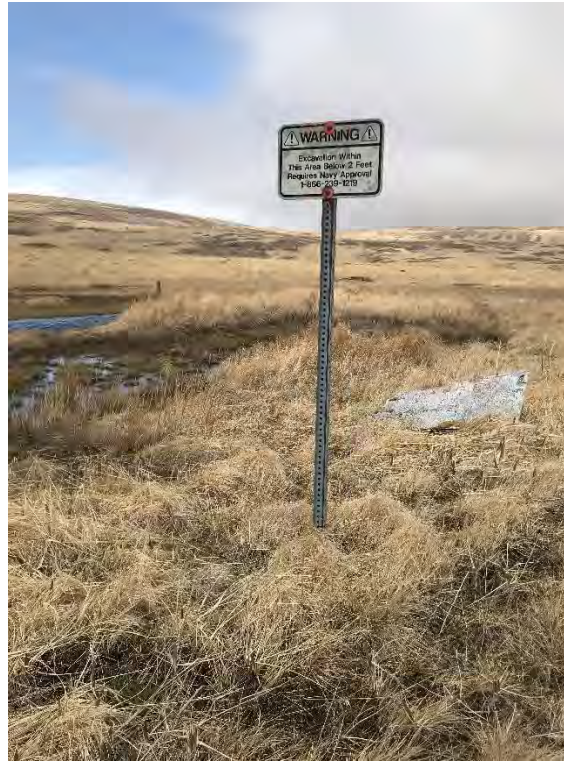
**Description:** Institutional  
control signage properly  
installed on the south side  
of site.

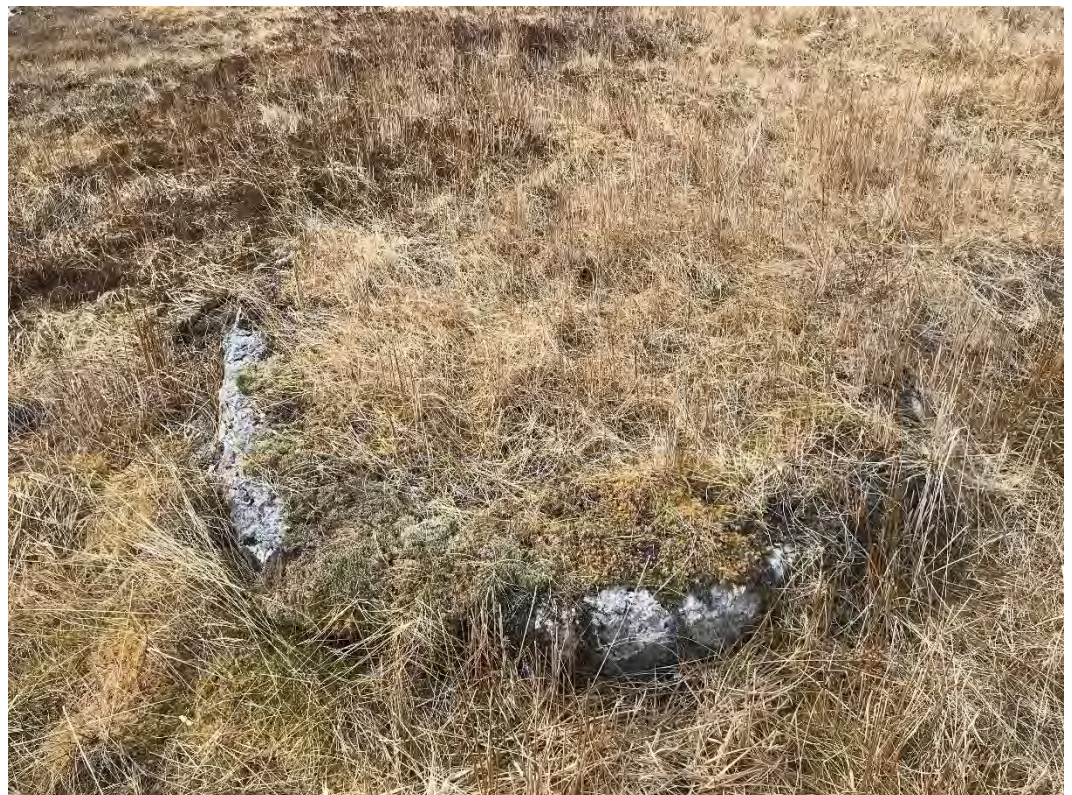
**Description:** Potential  
location of previous valve  
pit. No visual signs of  
disturbance on site.

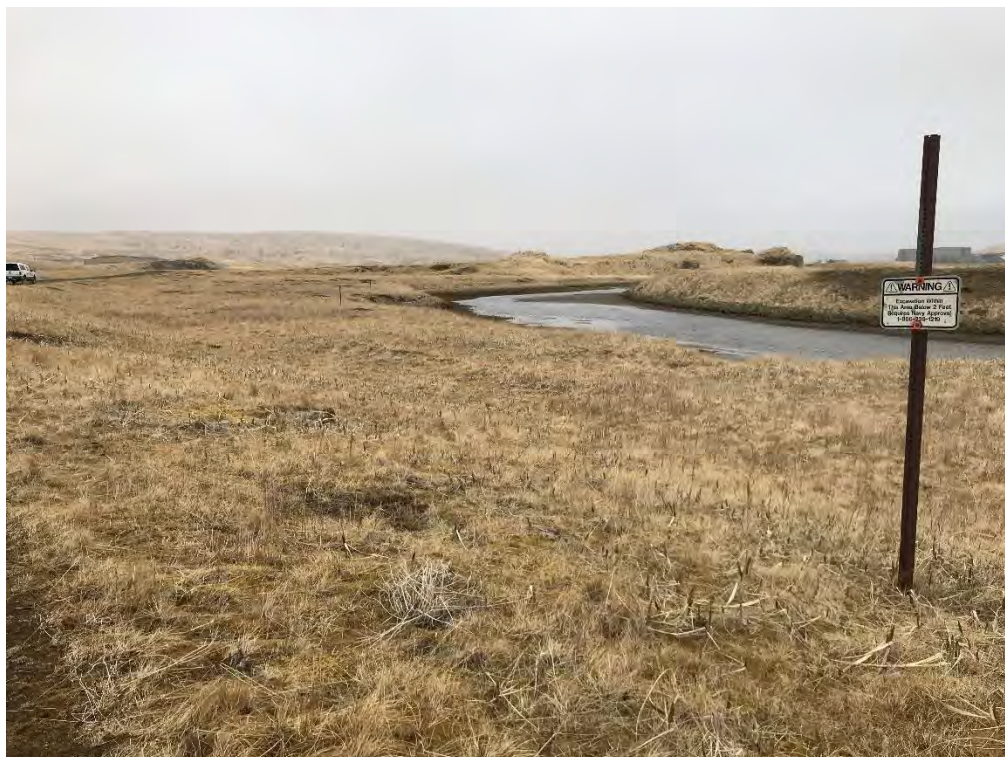
**Description:** Photo of  
excavation restriction sign  
along South Sweeper  
Creek adjacent to Amulet  
Housing Well AMW-706  
Area.

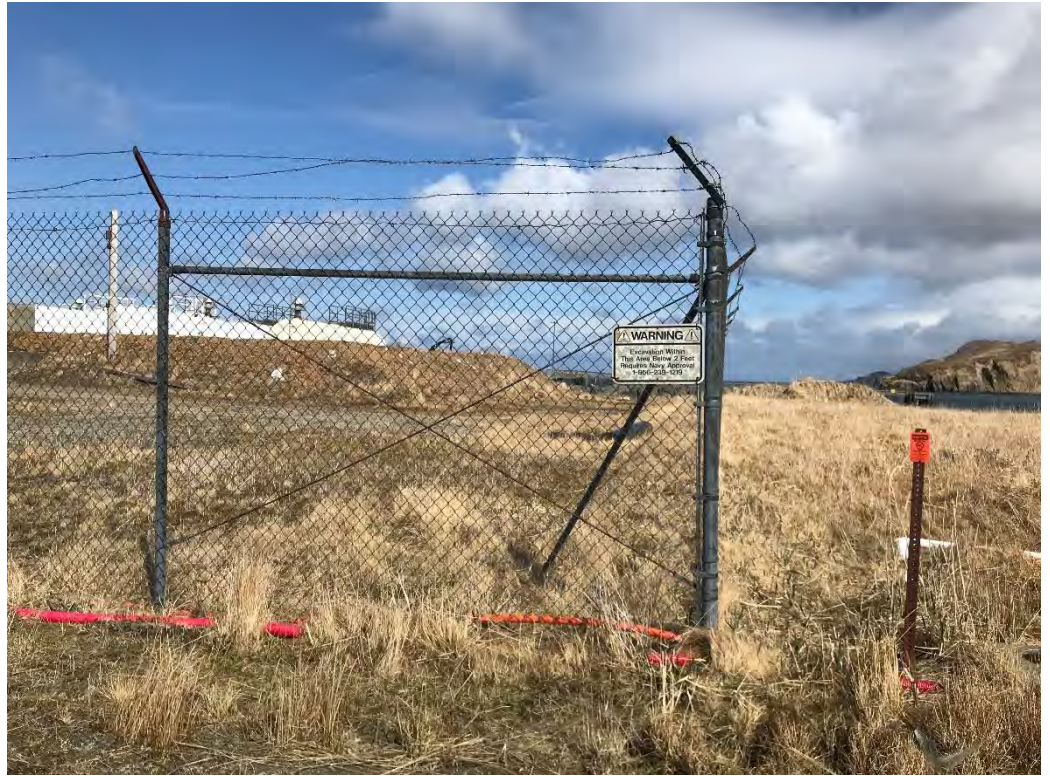
**Description:** Institutional  
control signage properly  
installed on the fencing of  
the site.

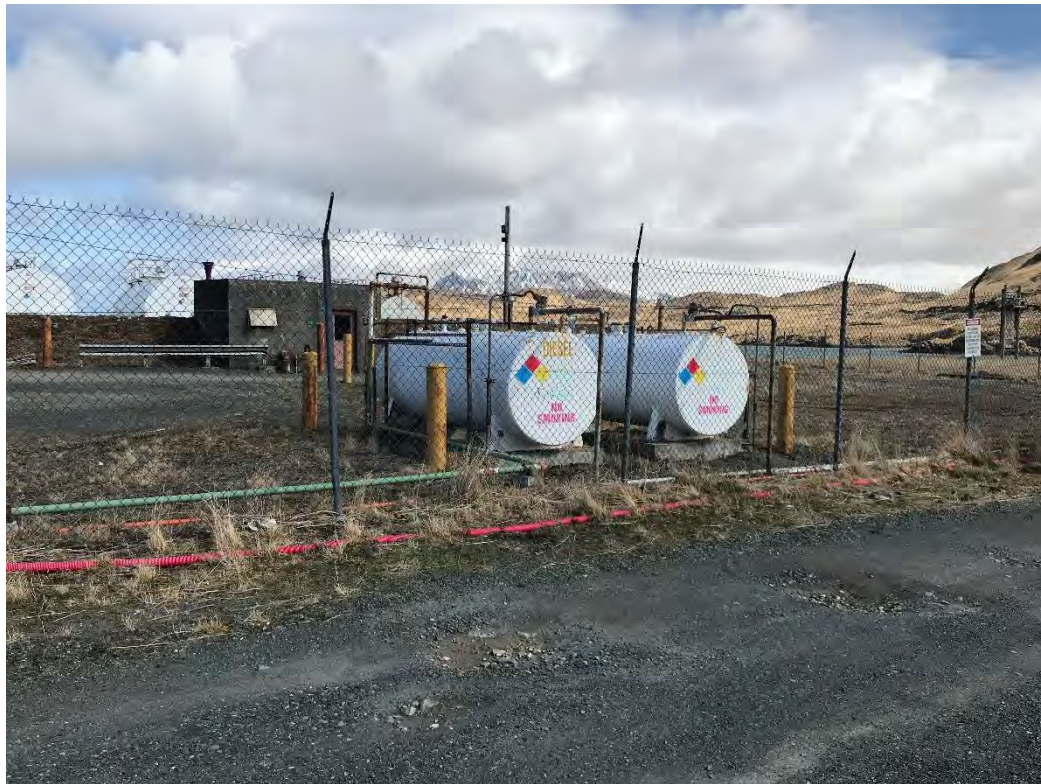
**Description:** AST's  
providing fuel to  
residential fuel pumps. No  
evidence of damage or  
leakage from AST's or  
pumps.

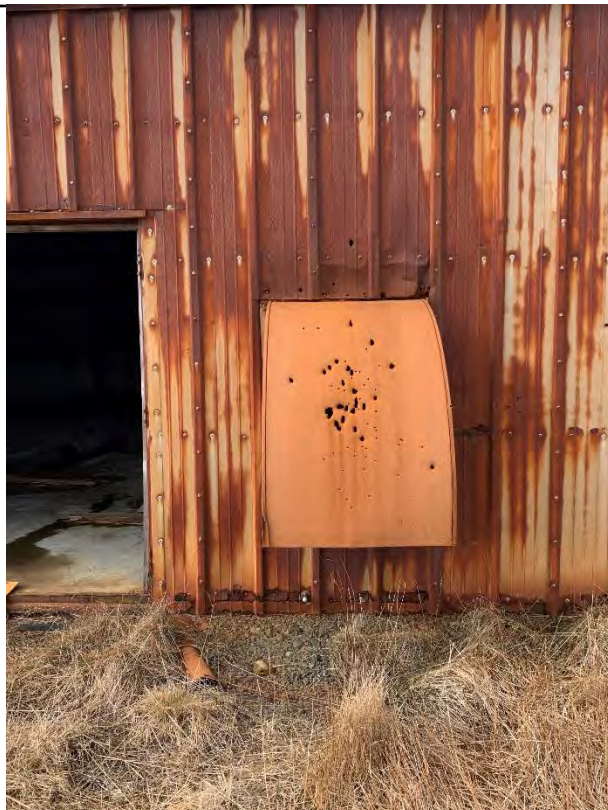
**Description:** Visual  
evidence of recreational  
activity within site. Bullet  
holes throughout wall of  
building.

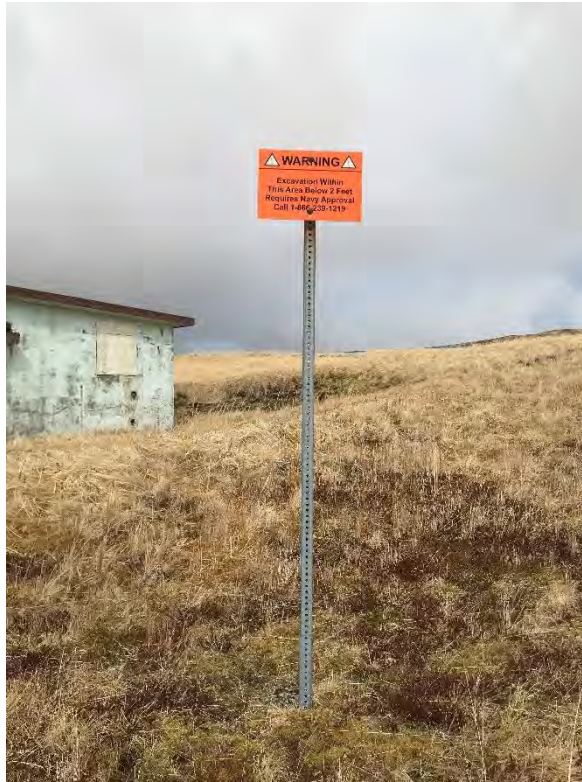
**Description:** Institutional  
control signage properly  
installed on east side of  
building near access road  
to site.

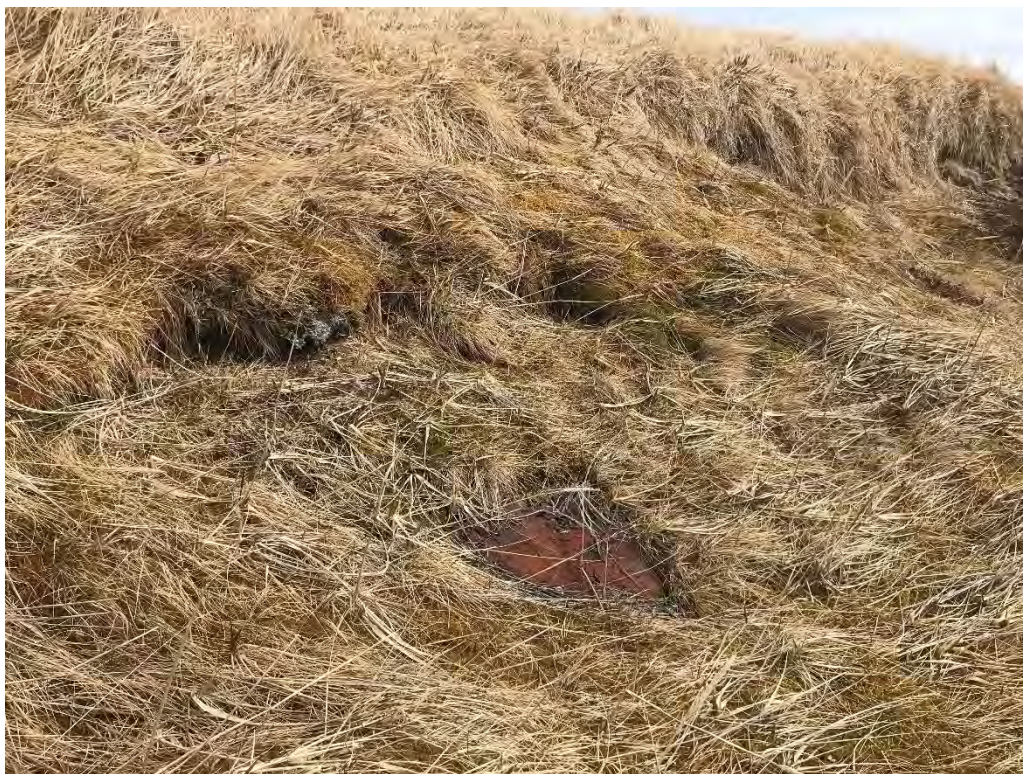
**Description:** Debris and  
plastic liner exposed on  
the north side of P70  
building near minor  
erosion.

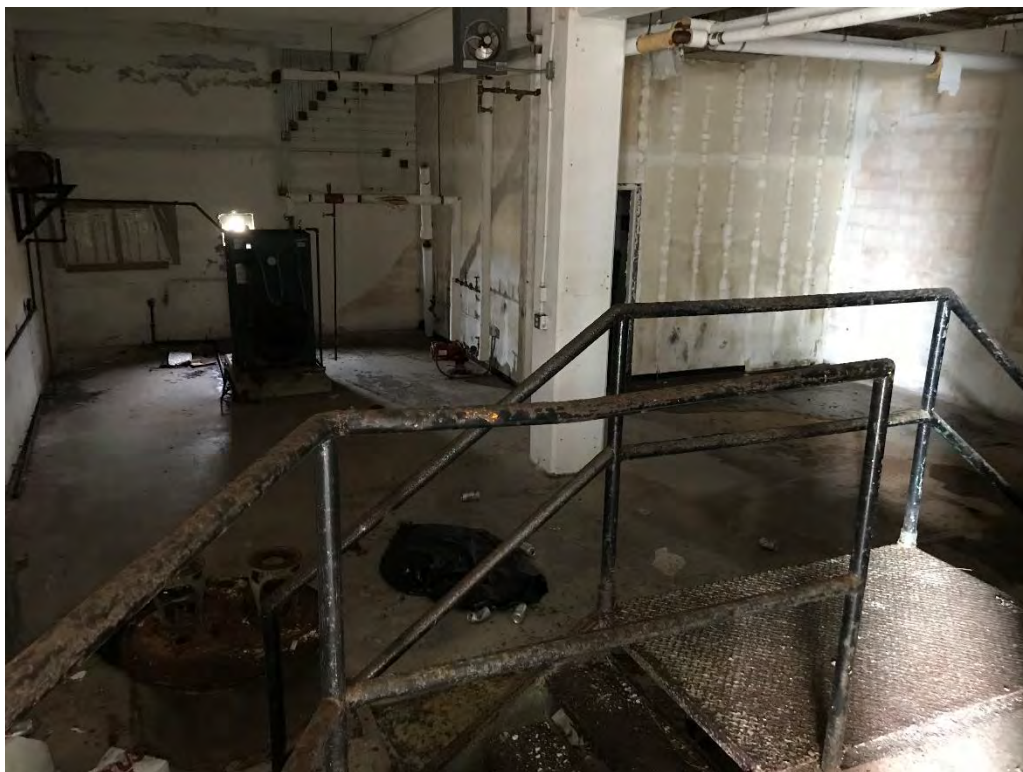
**Description:** Interior of P-  
70 building. No evidence  
of damage or disturbance  
of site.

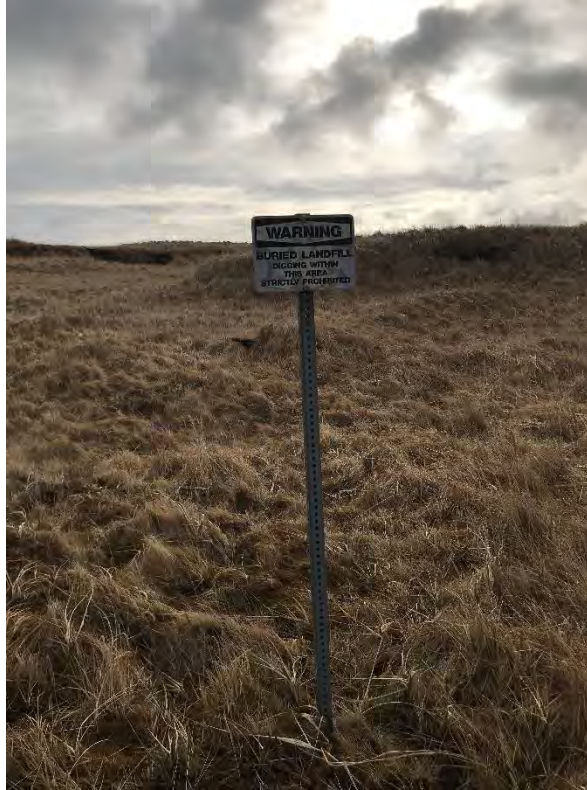
**Description:** Institutional  
signage properly installed  
on the south side of  
landfill.

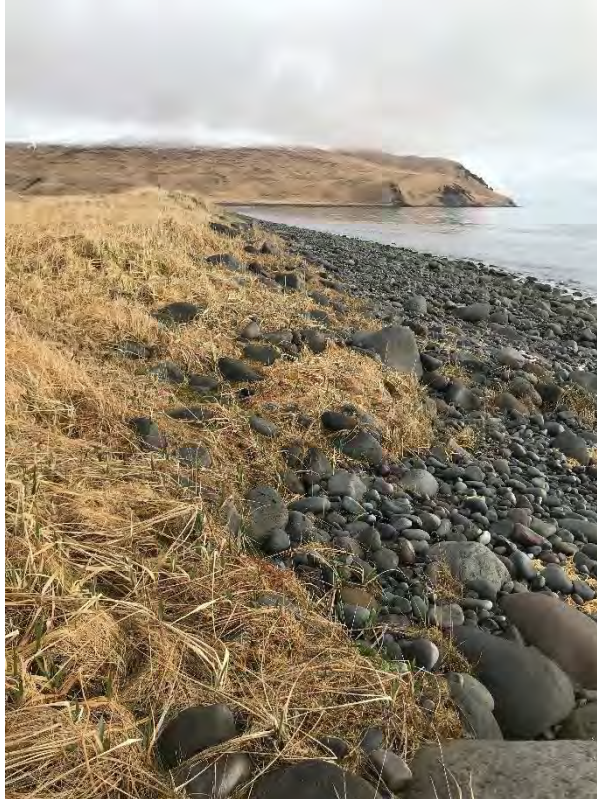
**Description:** Shoreline of  
landfill near the south end.  
No visual evidence of  
damage to liner or landfill  
boundary.

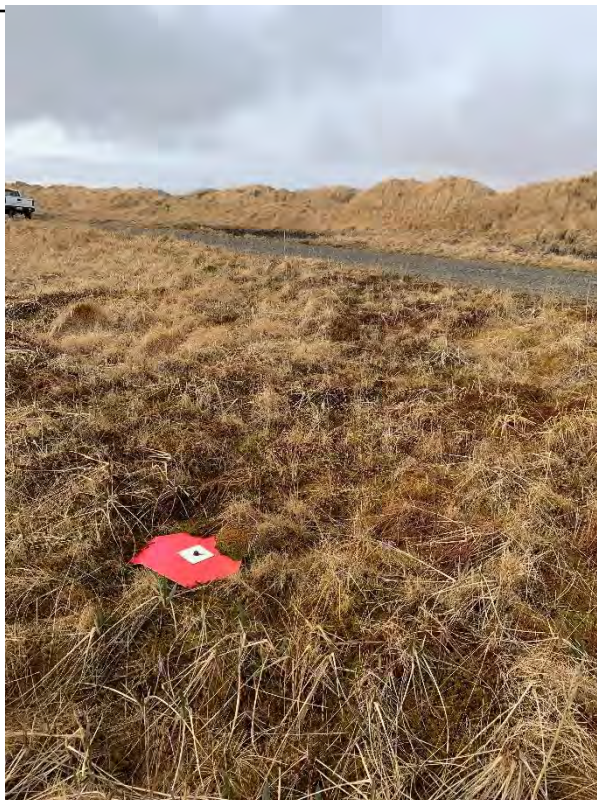
**Description:** Landfill  
boundary marker in the  
northwest corner of site.

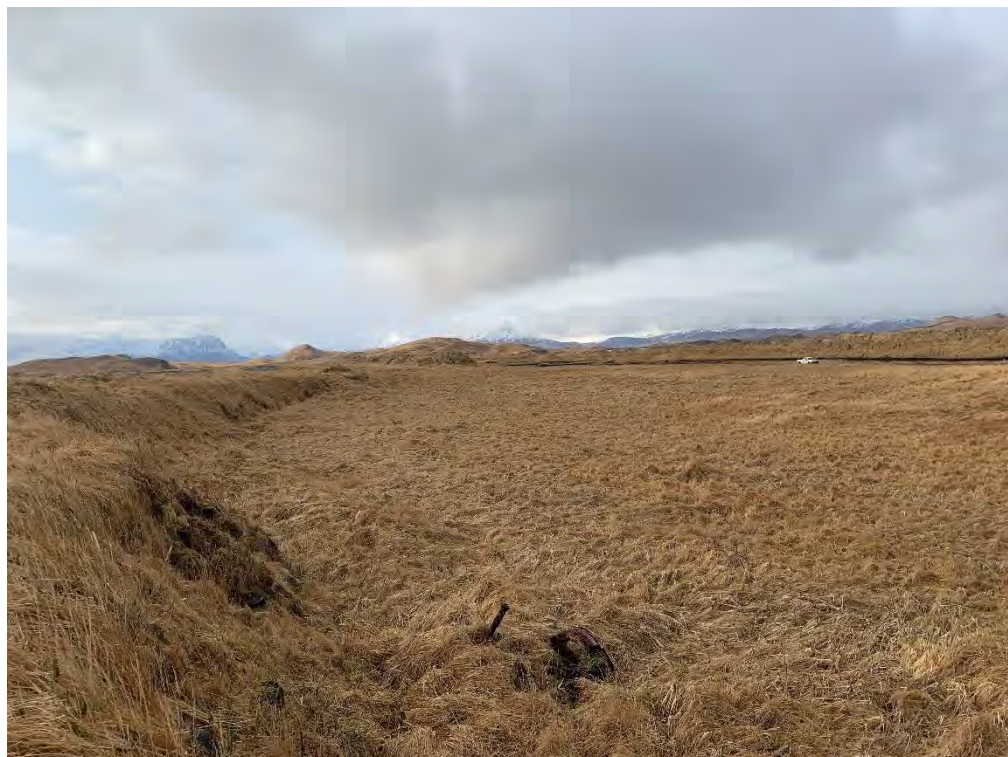
**Description:** Metallic Site  
overview of northern  
portion of landfill looking  
south.

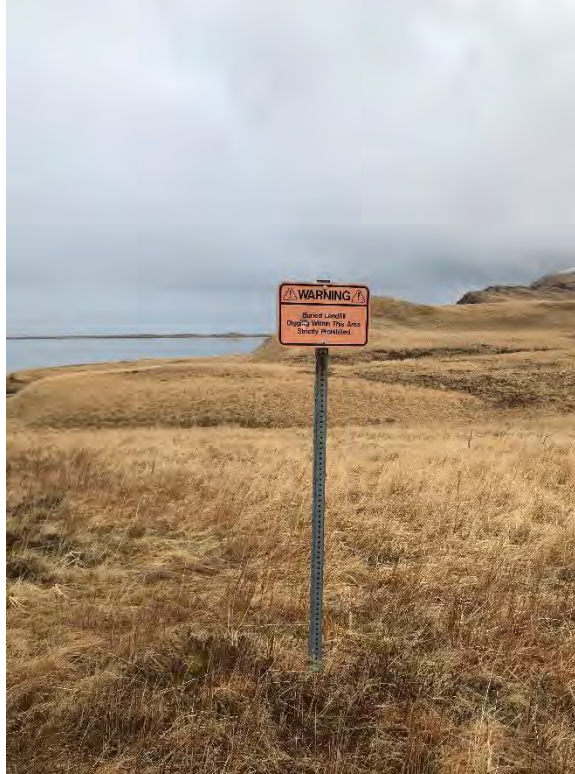
**Description:** Institutional  
control signage properly  
installed on access road to  
landfill.

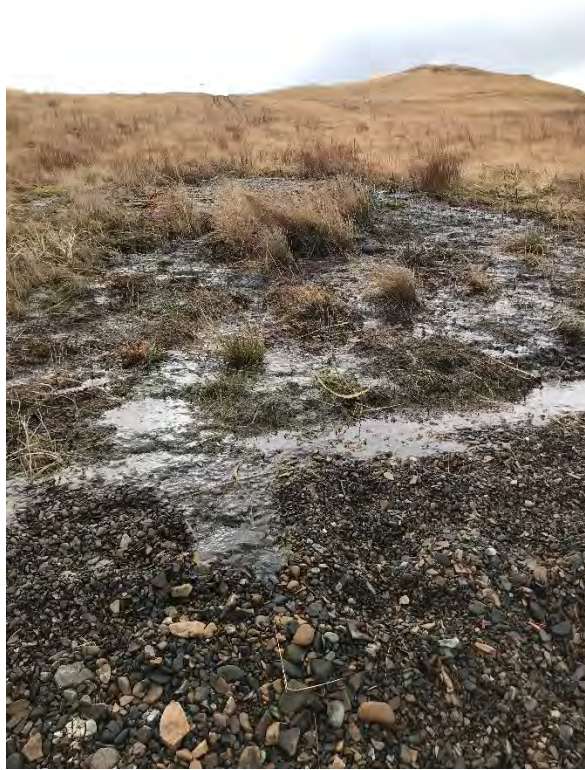
3.	<b>Current Overall Site Conditions</b> Remarks <u><i>Erosion present: seep present at the southeast end of the landfill. Surface water from swale repairs flowing into Andrew Lake. Metal debris present on beach and ponding adjacent to sign on north end of landfill.</i></u>

**Description:** Seep  
surfacing above shoreline  
near southern portion of  
landfill.

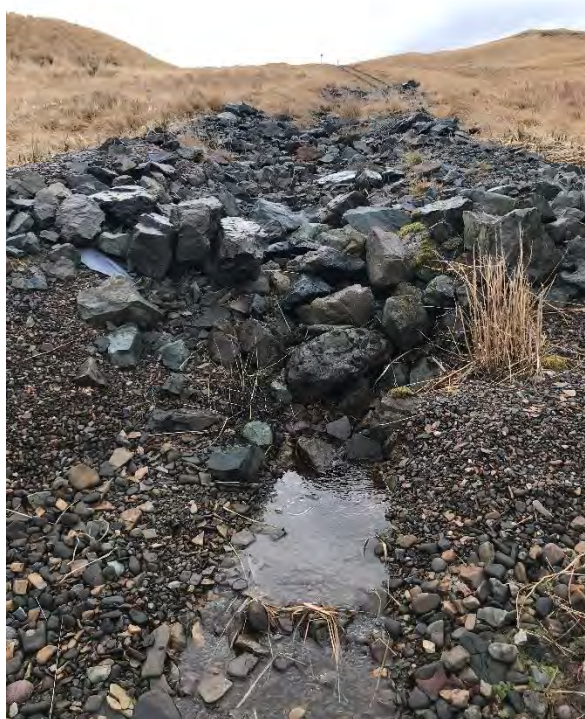
**Description:** Culvert with  
drainage leading into  
Andrew lake with liner  
exposed.

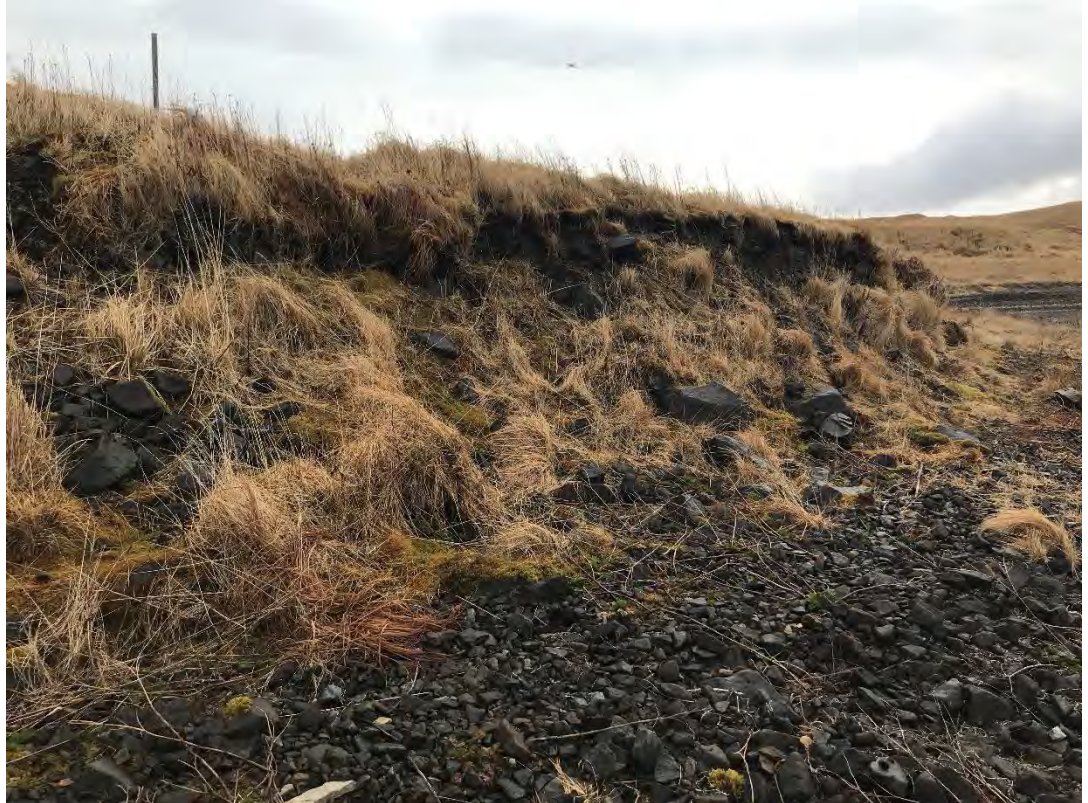
**Description:** Erosion  
present along north end of  
landfill near Andrew lake  
shoreline.

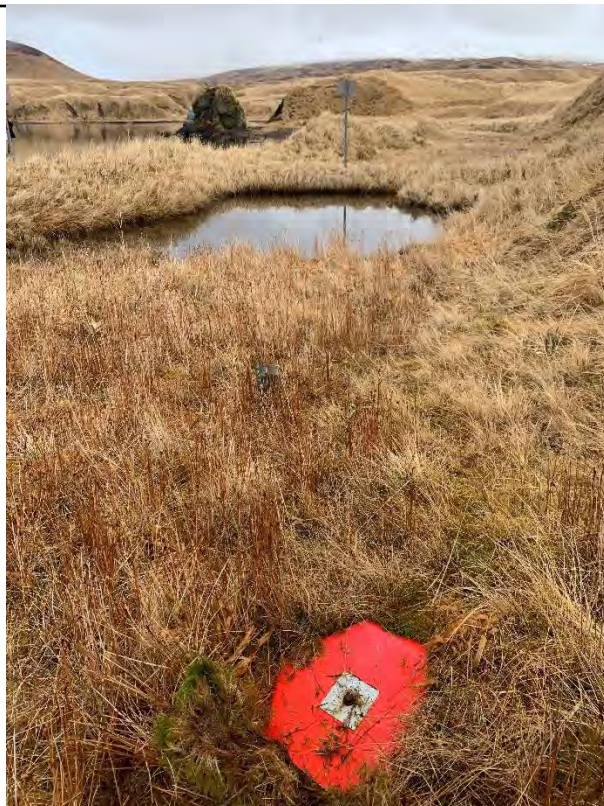
**Description:** Surface  
water pooling near north  
end of landfill at boundary  
marker.

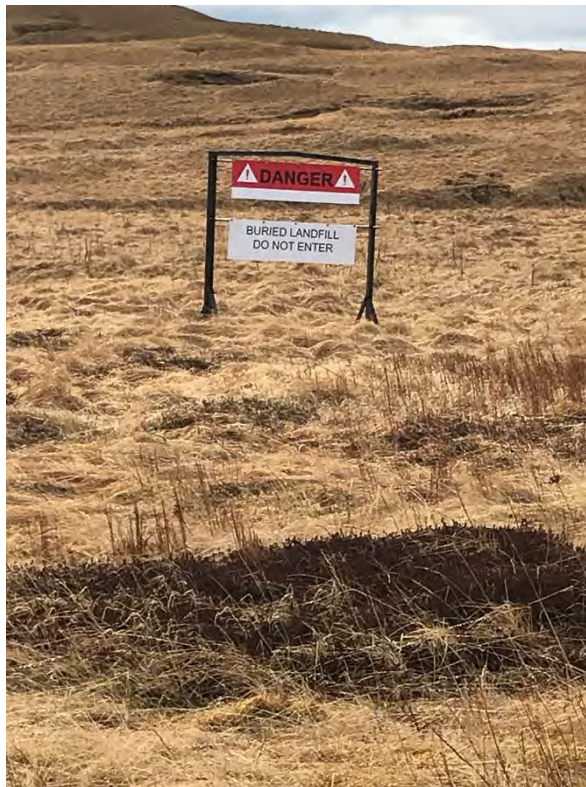
**Description:** Institutional  
control signage properly  
installed at beginning of  
access road to landfill.

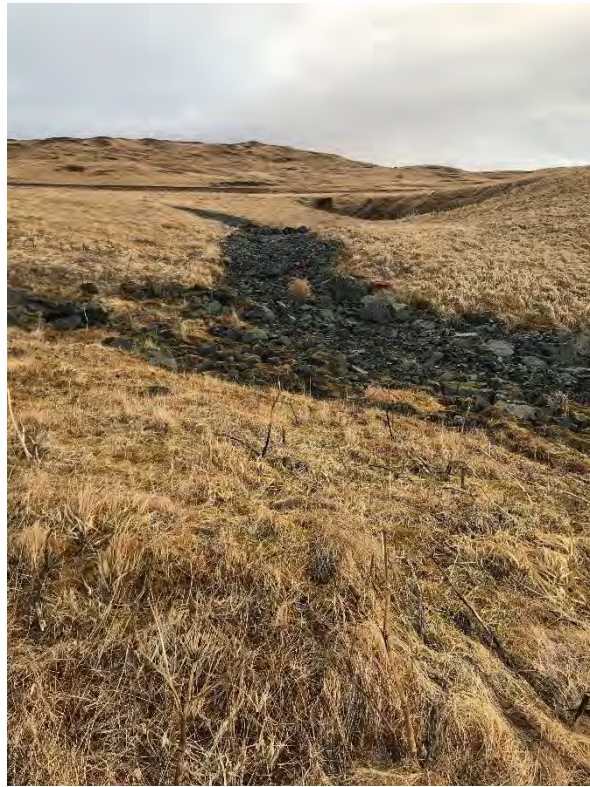
**Description:** Landfill liner  
properly installed after  
new construction to fix  
exposed section of liner.

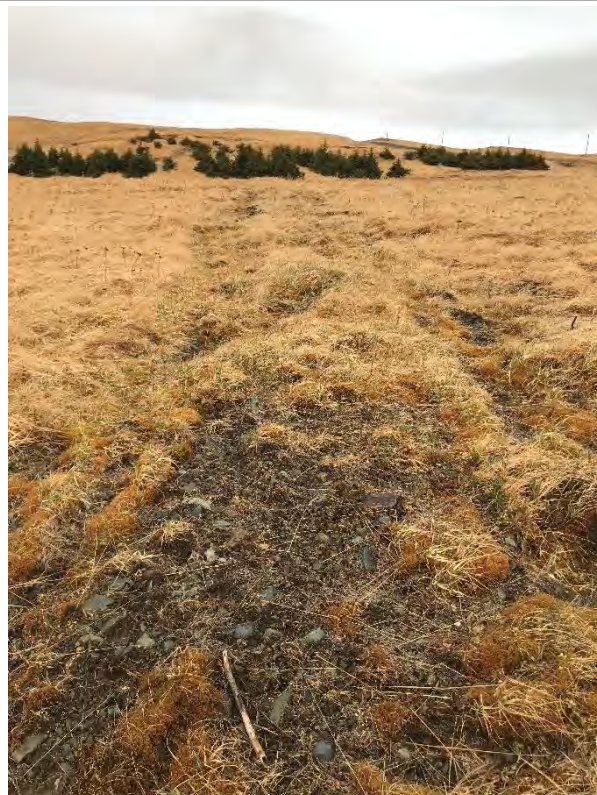
**Description:** Distressed  
vegetation marks from  
heavy machinery towards  
landfill liner construction.

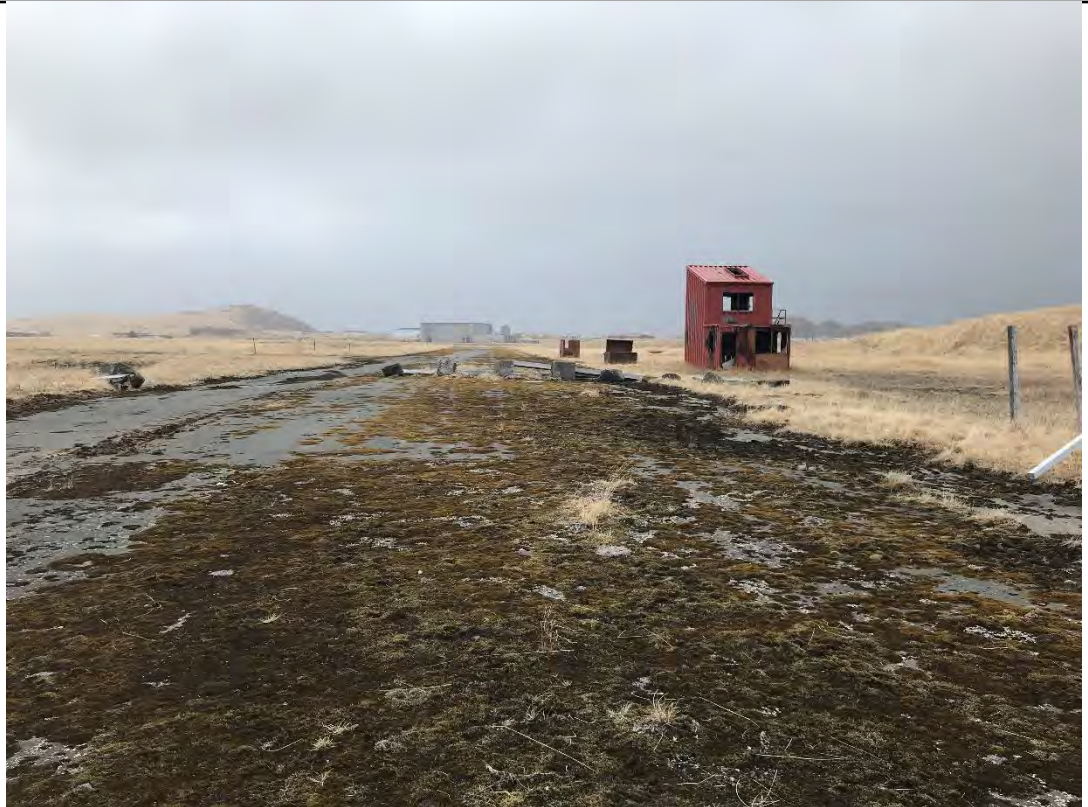
**Description:** Asphalt  
roadway towards airport,  
and former fire fighting  
training buildings.

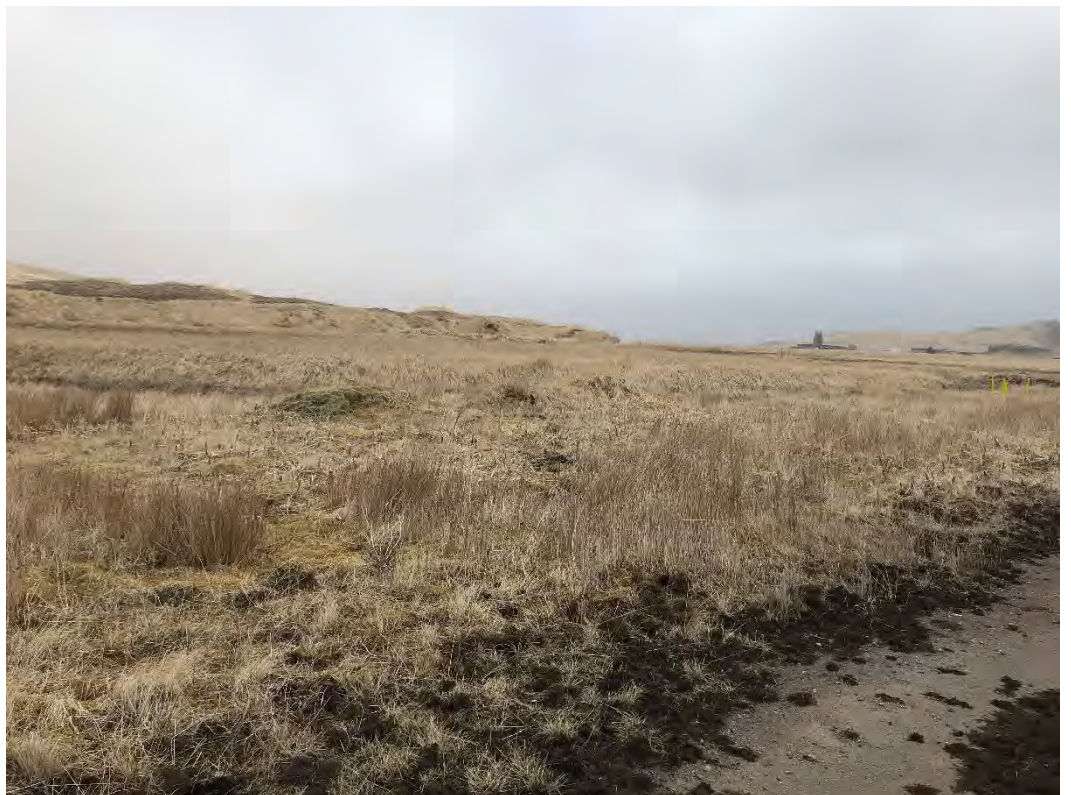
**Description:** Monitoring  
well field with six new  
installed monitoring wells  
for PFAS investigation.

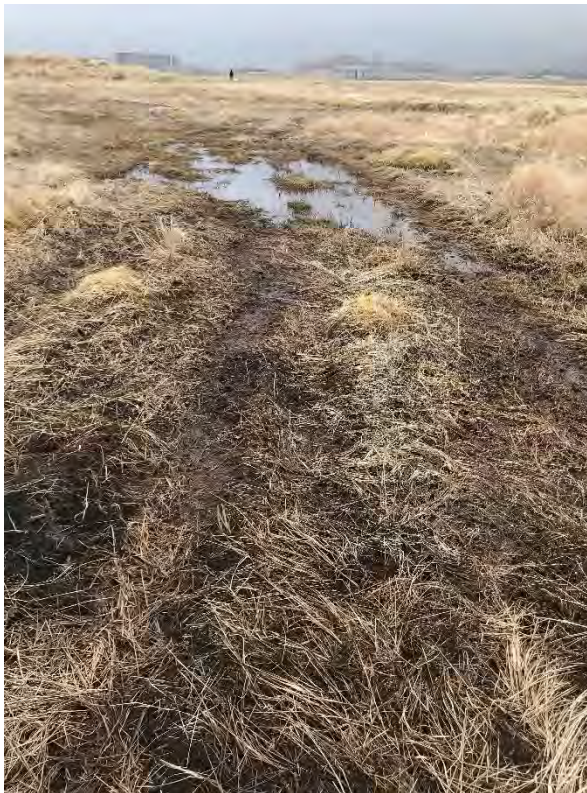
**Description:** Surface  
water pooling within  
monitoring well field north  
of former firefighting  
buildings.

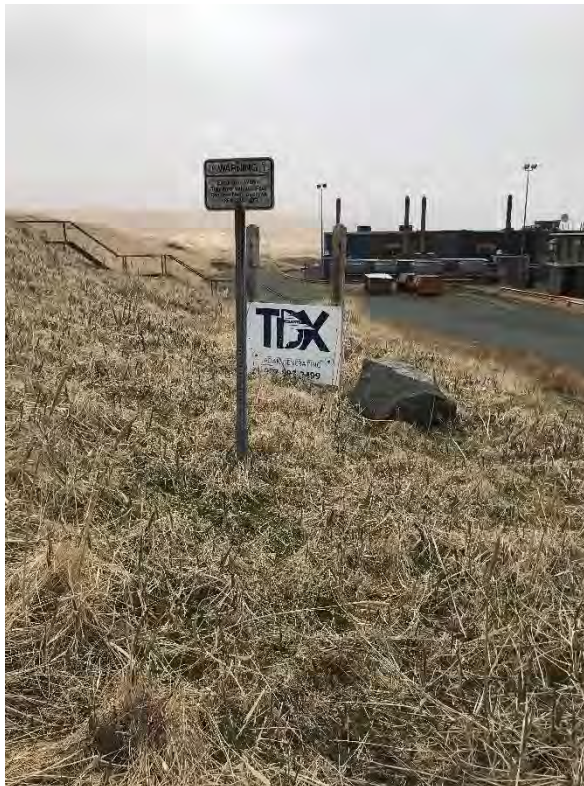
**Description:** Institutional  
control signage properly  
installed in front of access  
road to power plant.

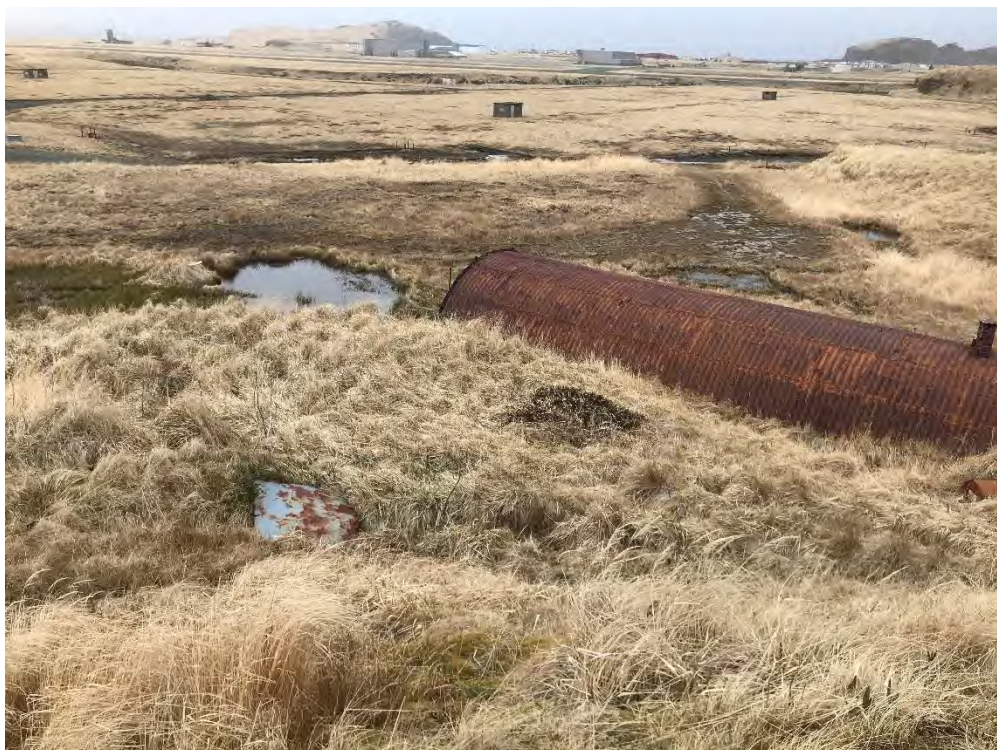
**Description:** Monitoring  
well field downgradient  
from power plant looking  
east. Surface water  
pooling identified and  
metallic debris.

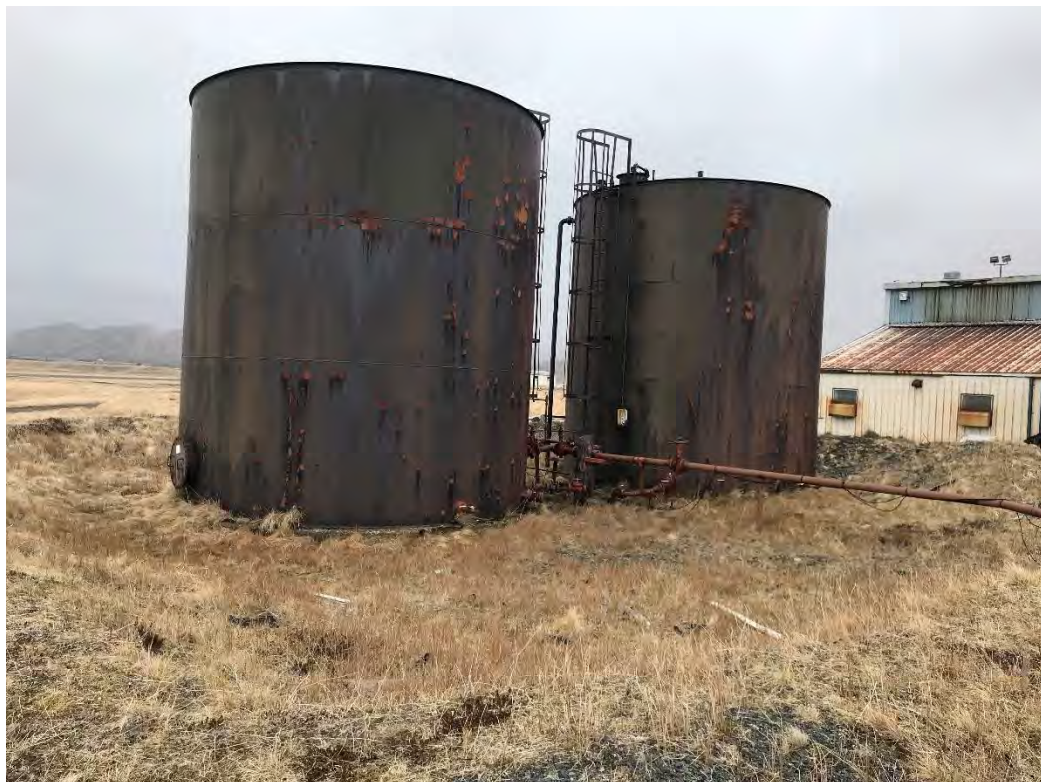
**Description:** Large  
storage tanks on northeast  
corner of site.

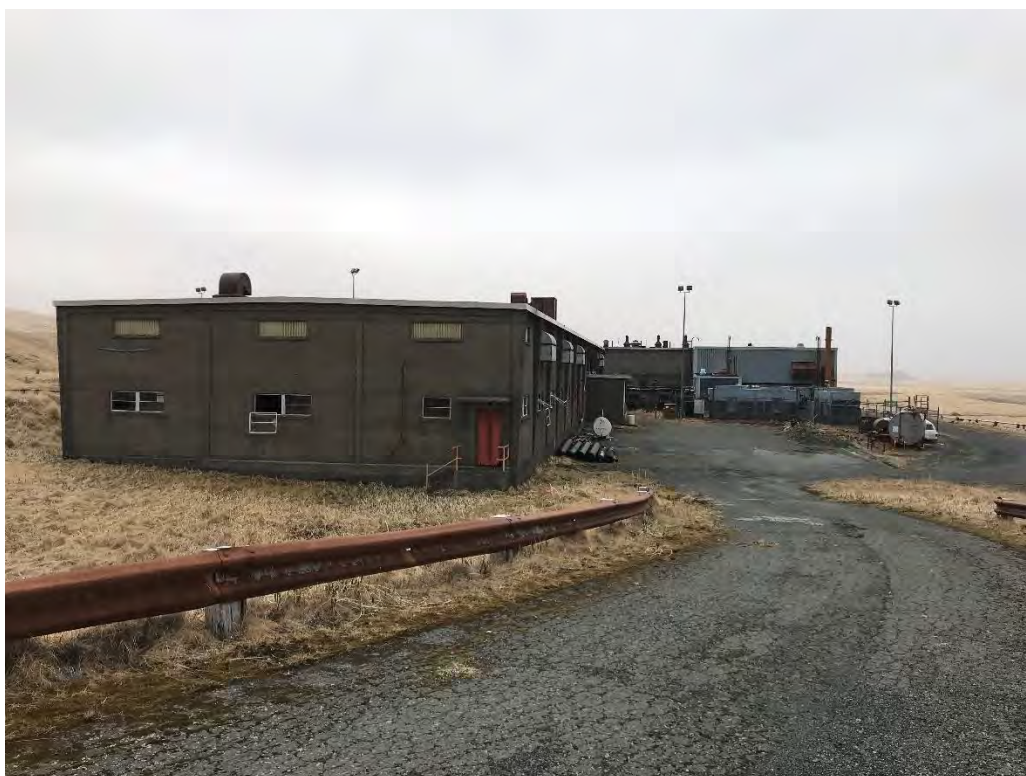
**Description:** South side of power plant building.

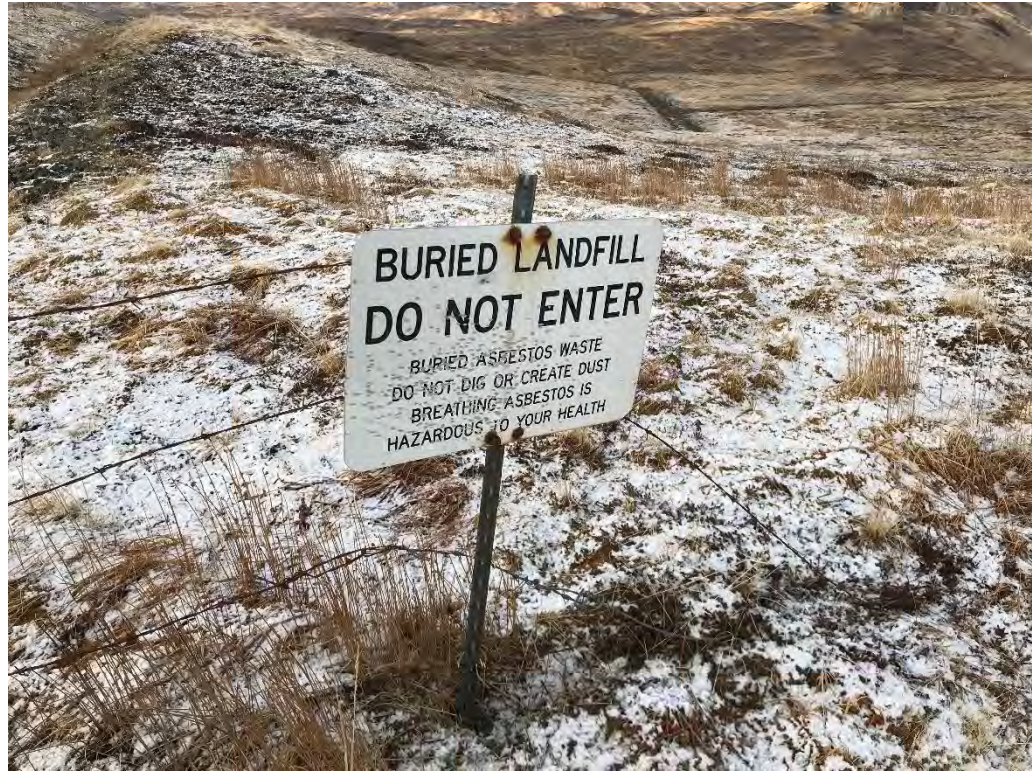
**Description:** Institutional  
control signage properly  
installed in the northwest  
corner of the landfill.

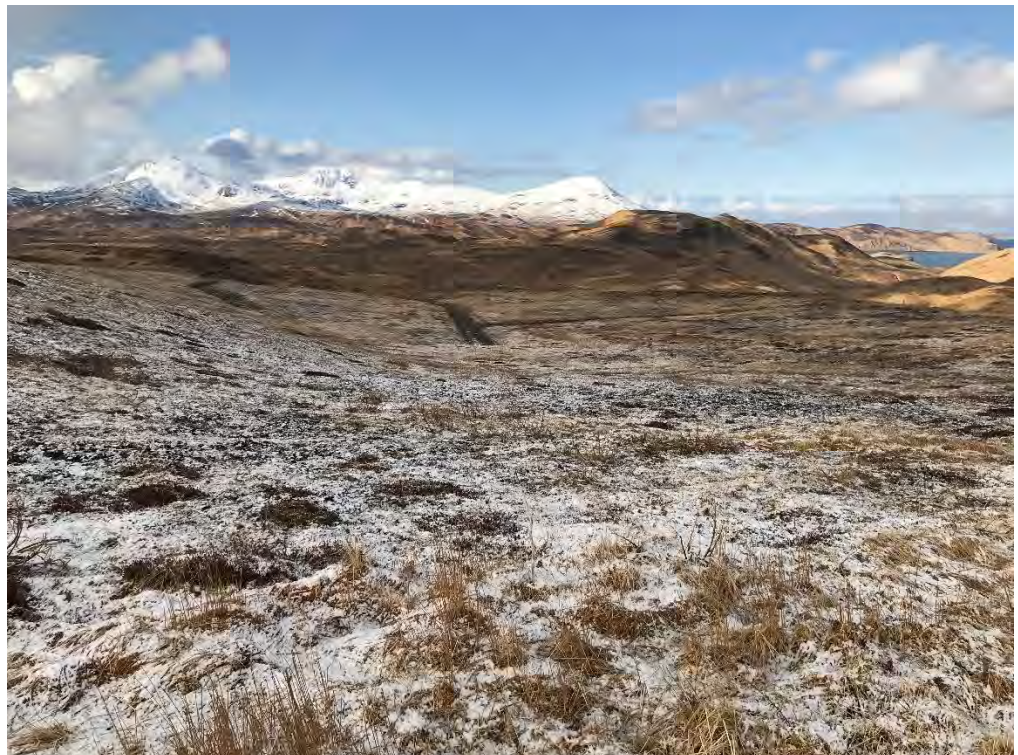
**Description:** Landfill  
overview looking  
southwest. Vegetation  
present over landfill.

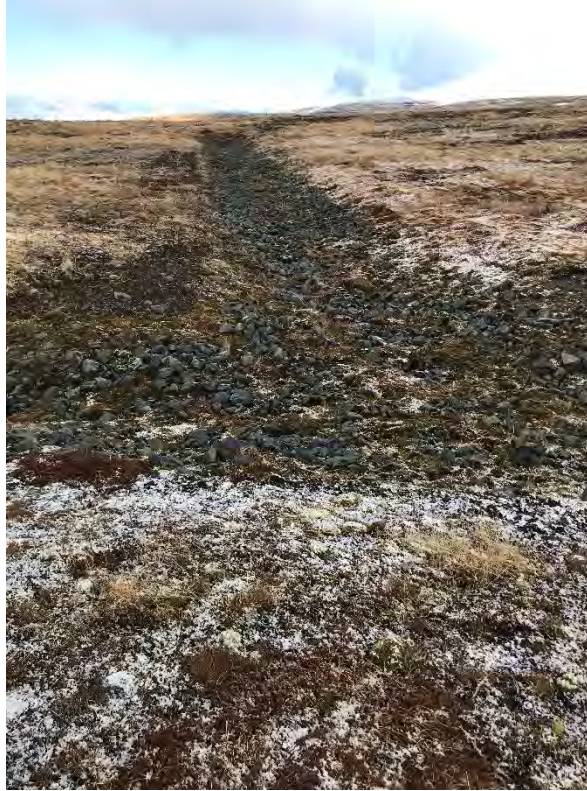
**Description:** Landfill  
culvert transect in the  
southeast corner of  
landfill. No evidence of  
damage.
