# Fifth Five-Year Review Operable Units A and B-1 Former Adak Naval Complex

## **Naval Air Station Adak**

**Fifth Five-Year Review  
Operable Units A and B-1  
Former Adak Naval Complex  
NAVAL AIR STATION ADAK, ADAK ISLAND, ALASKA**

**December 2021**

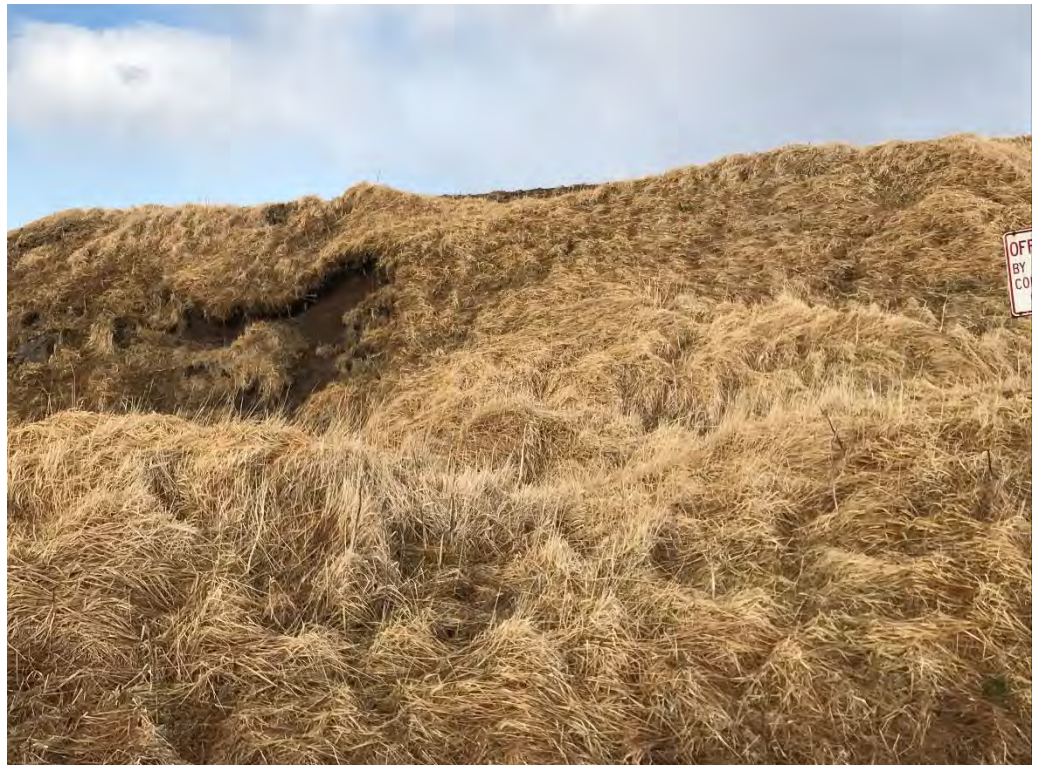
**Description:** Erosion  
present in the southeast  
corner of landfill near  
entrance.

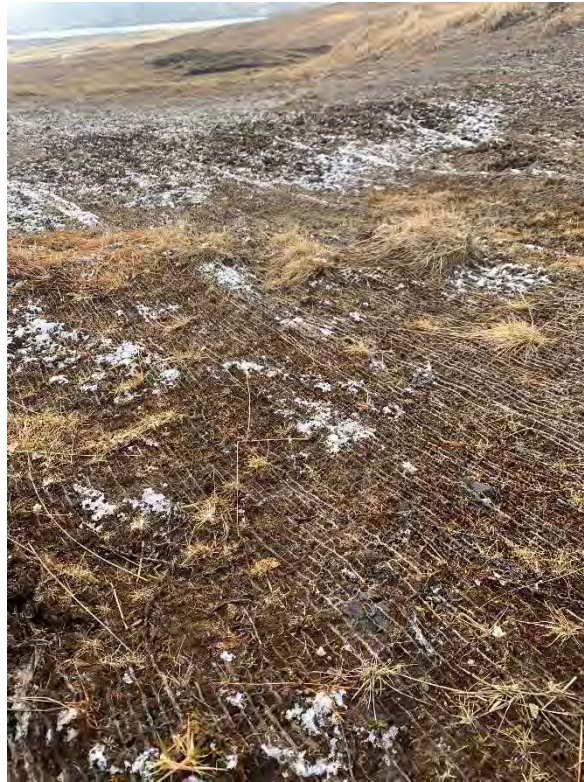
**Description:** Textile  
matting present to  
promote vegetation growth  
in southeast corner of  
landfill.

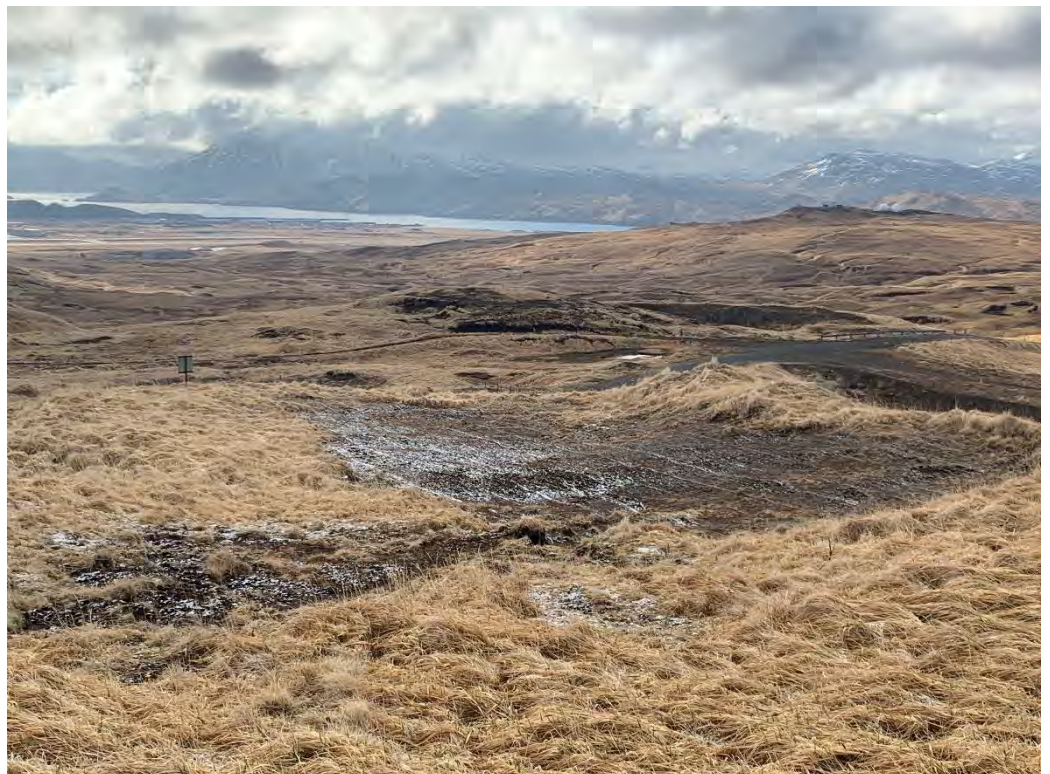
**Description:** Textile  
matting present to  
promote vegetation growth  
in southeast corner of  
landfill.

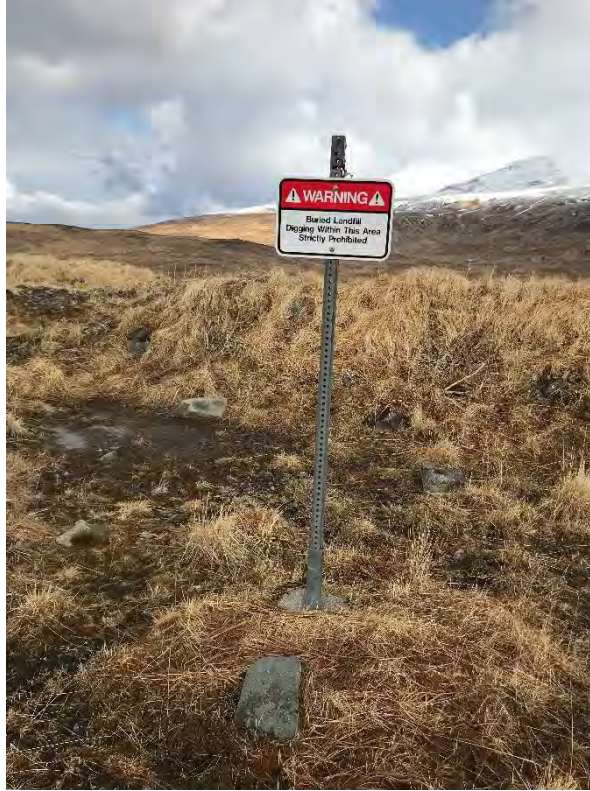
**Description:** Institutional  
control signage properly  
installed on bluff above  
disposal area.

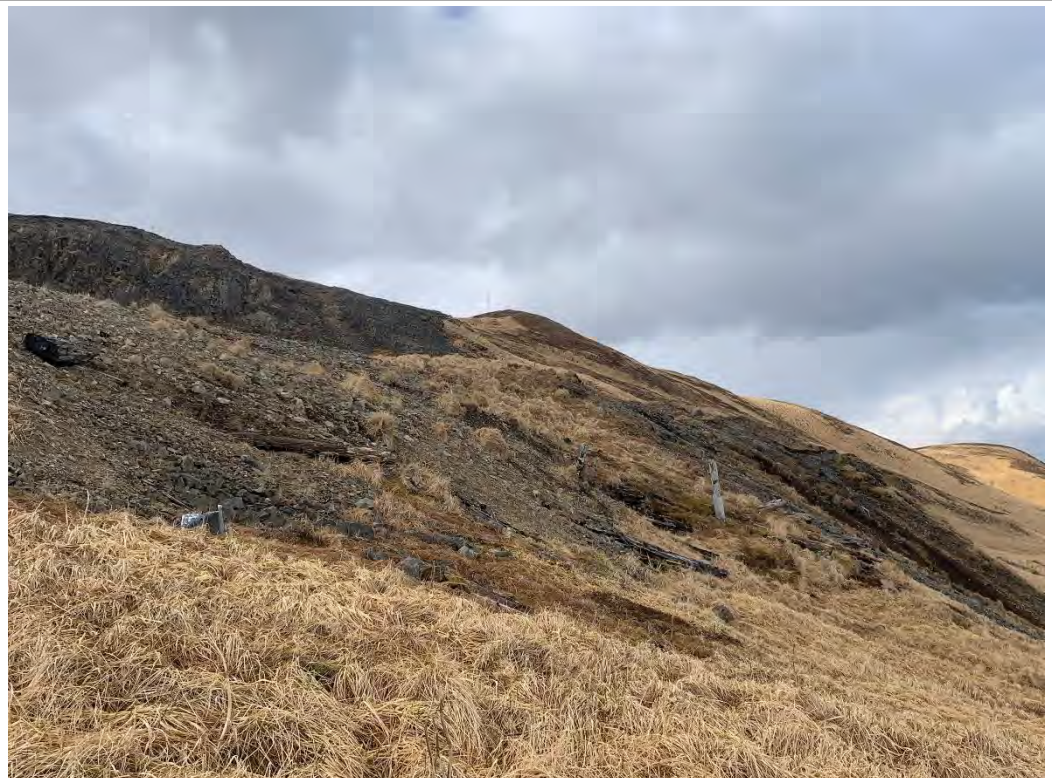
**Description:** Disposal  
area looking down bluff.  
Metallic debris present  
throughout site.

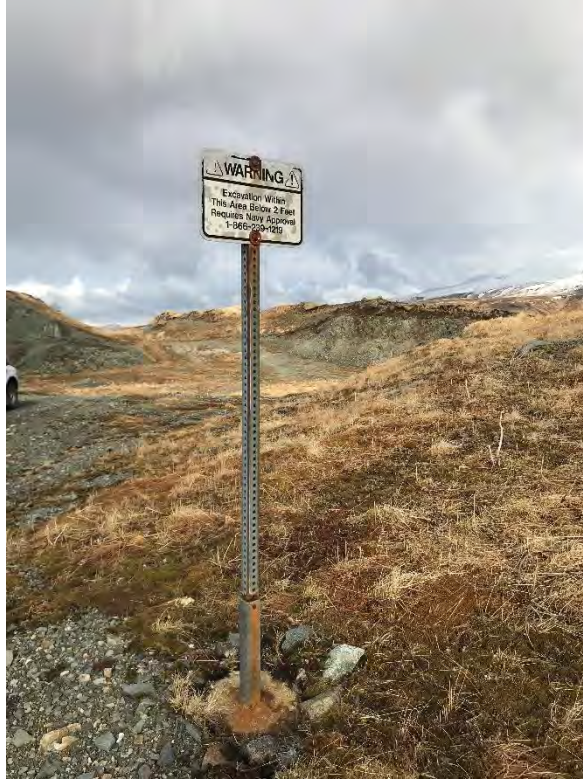
**Description:** Institutional  
control signage properly  
installed on access road to  
site.

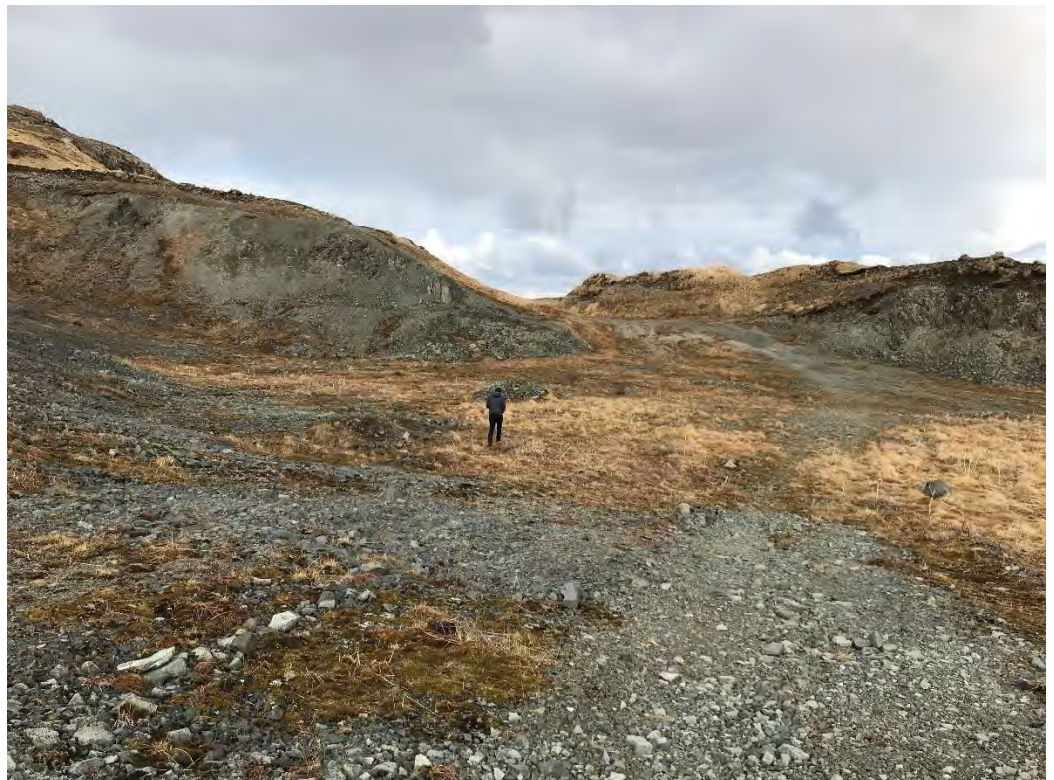
**Description:** Vegetation  
and erosion throughout  
site looking west.

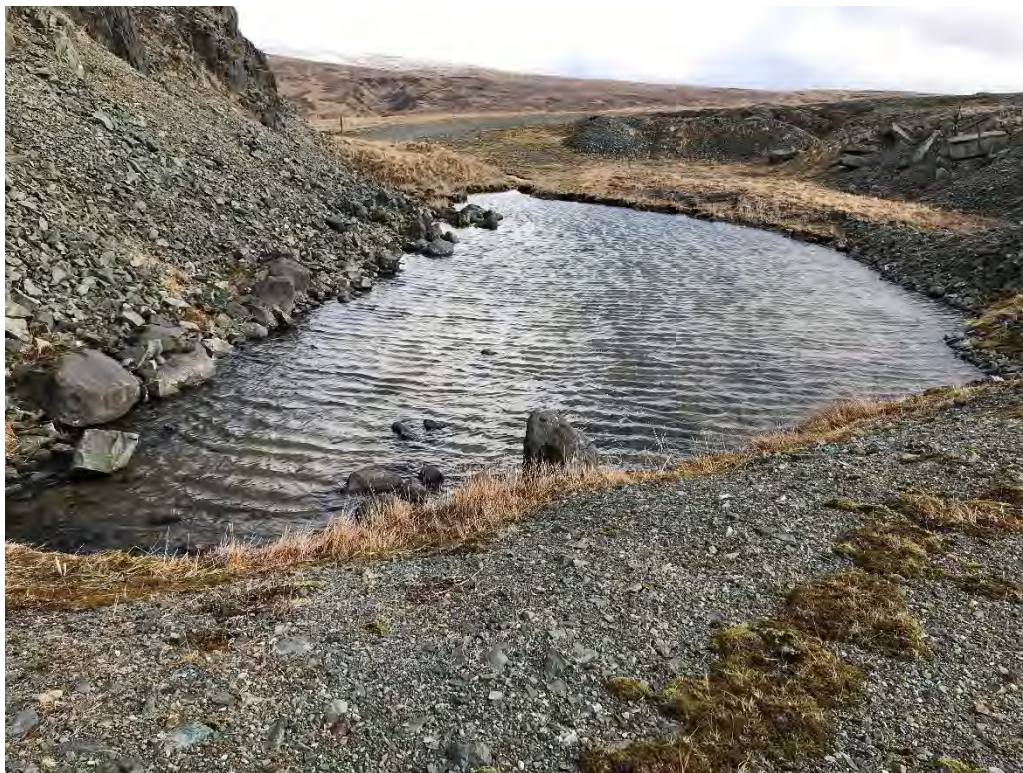
**Description:** Surface  
water pooling in northwest  
corner of quarry near  
sidewall and access road  
to trout creek disposal  
area.

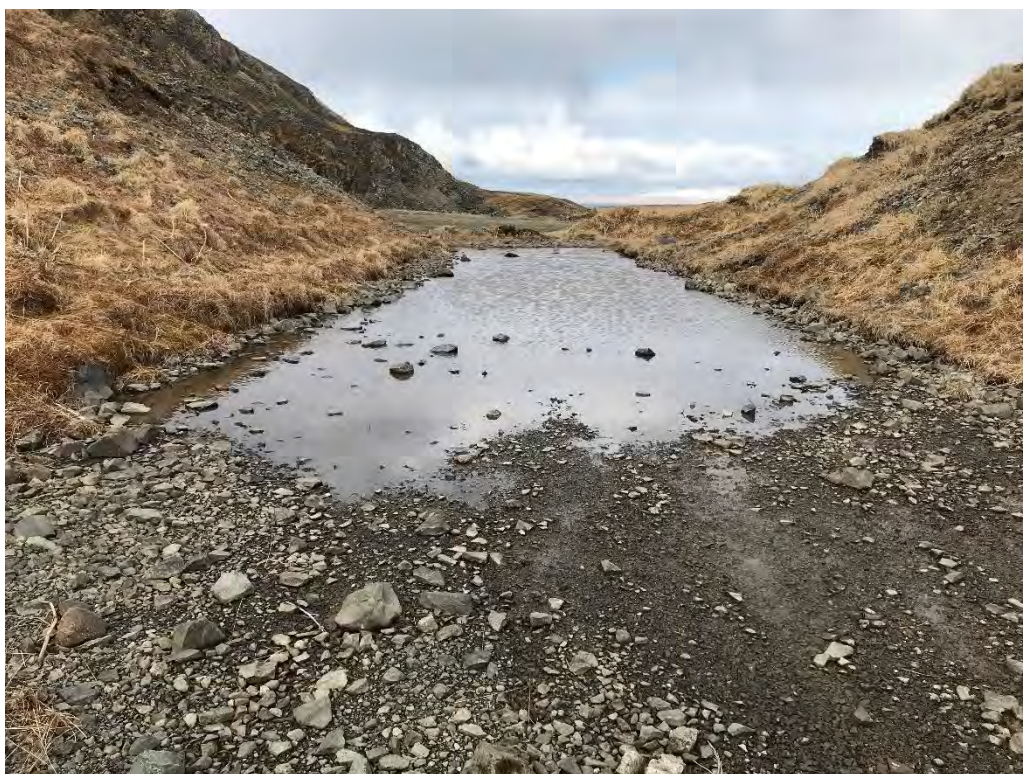
**Description:** Surface  
water pooling in between  
quarry sections from east  
to west.

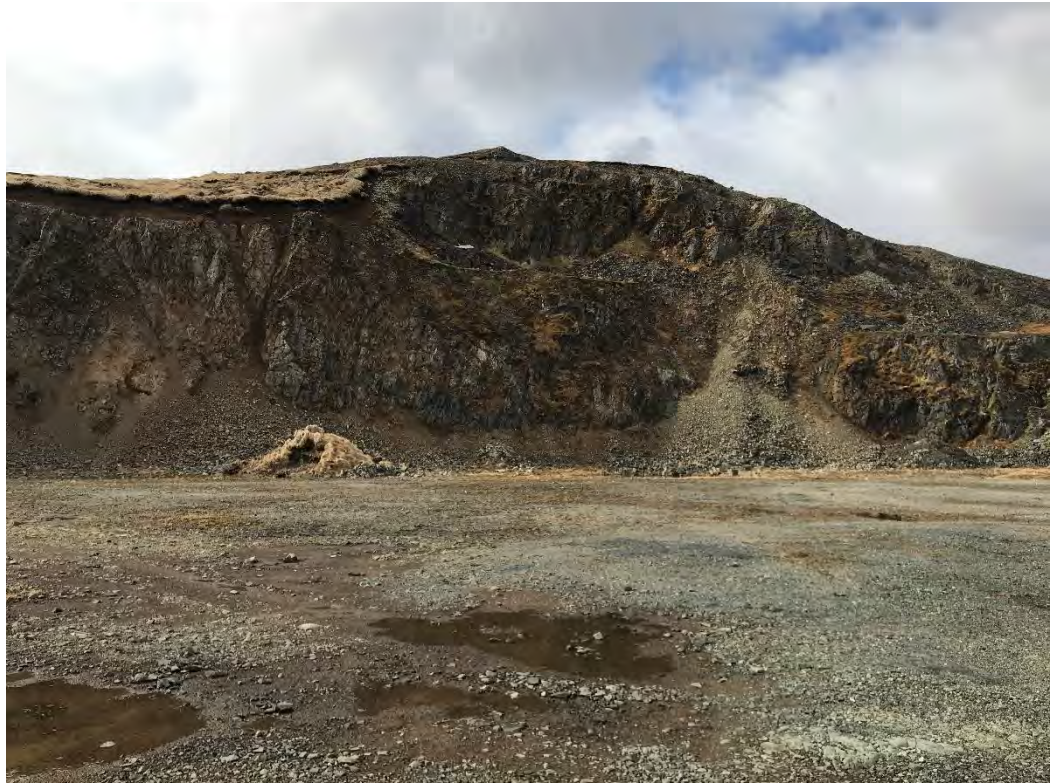
**Description:** West portion  
of quarry closest to access  
road up to White Alice.  
Frequent surface water  
pooling present in low  
elevation areas of quarry.

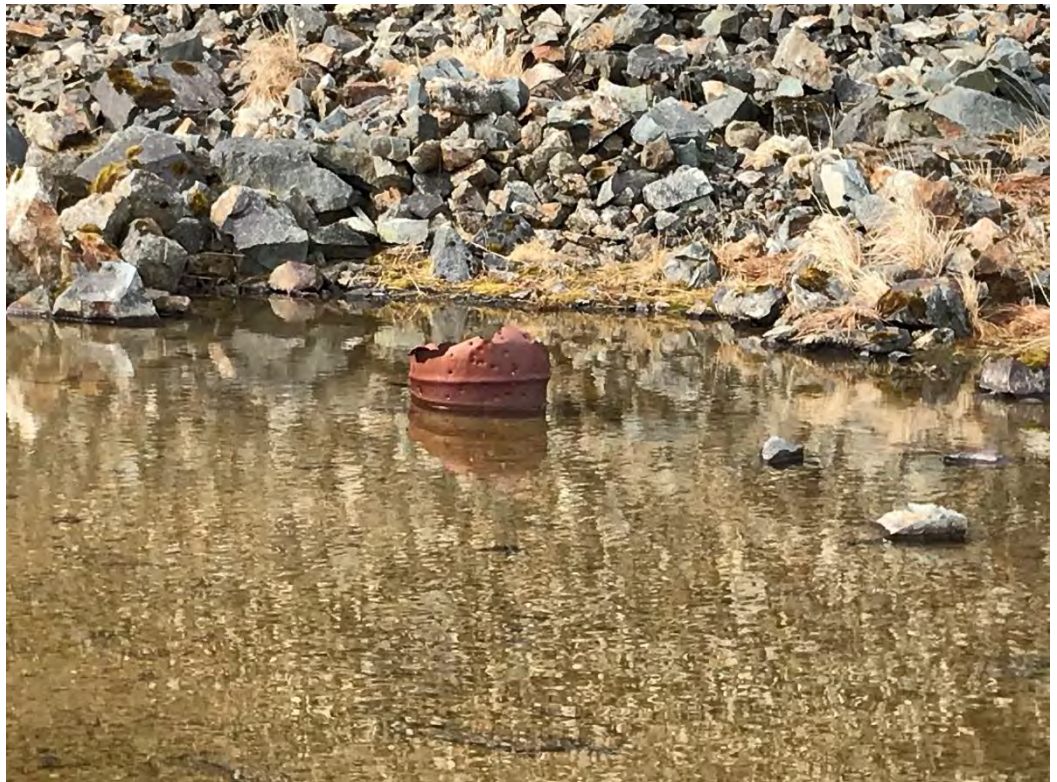
**Description:** Metallic  
debris near the west  
quarry wall near trout  
creek disposal area.  
Surface water pooling  
present near west side  
wall of quarry.

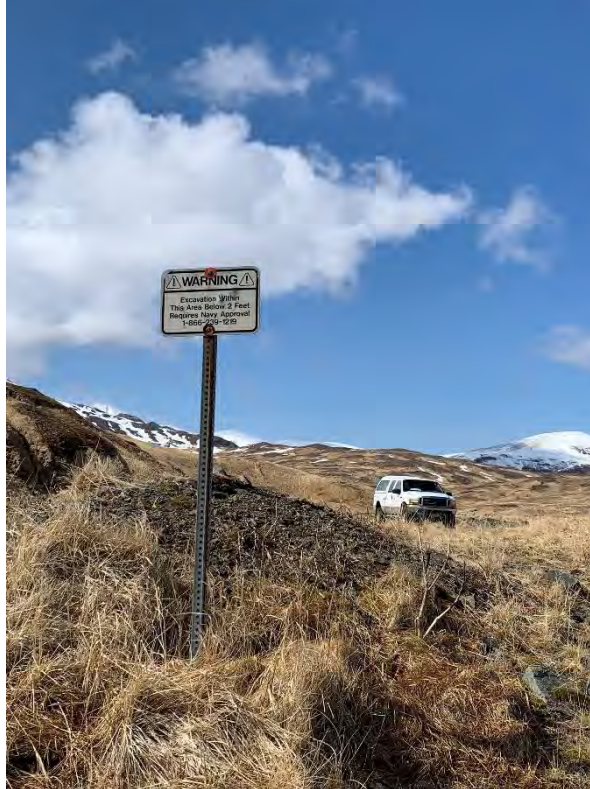
**Description:** Institutional  
control signage properly  
installed on access road to  
site.

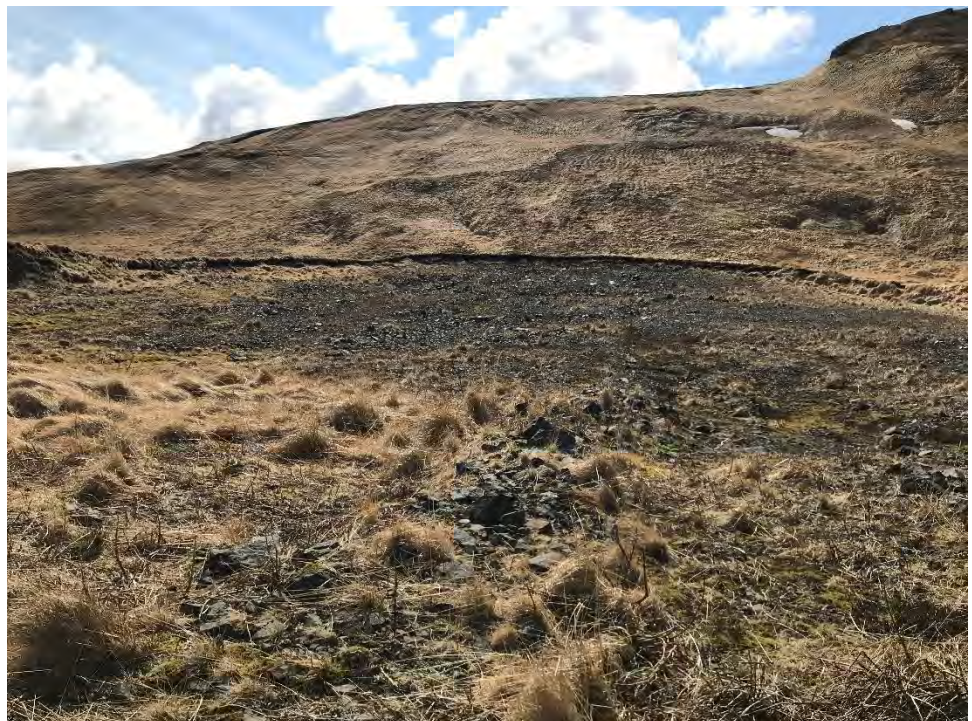
**Description:** Bermmed  
drum disposal area with  
vegetation and gravel/rock  
present on the surface.

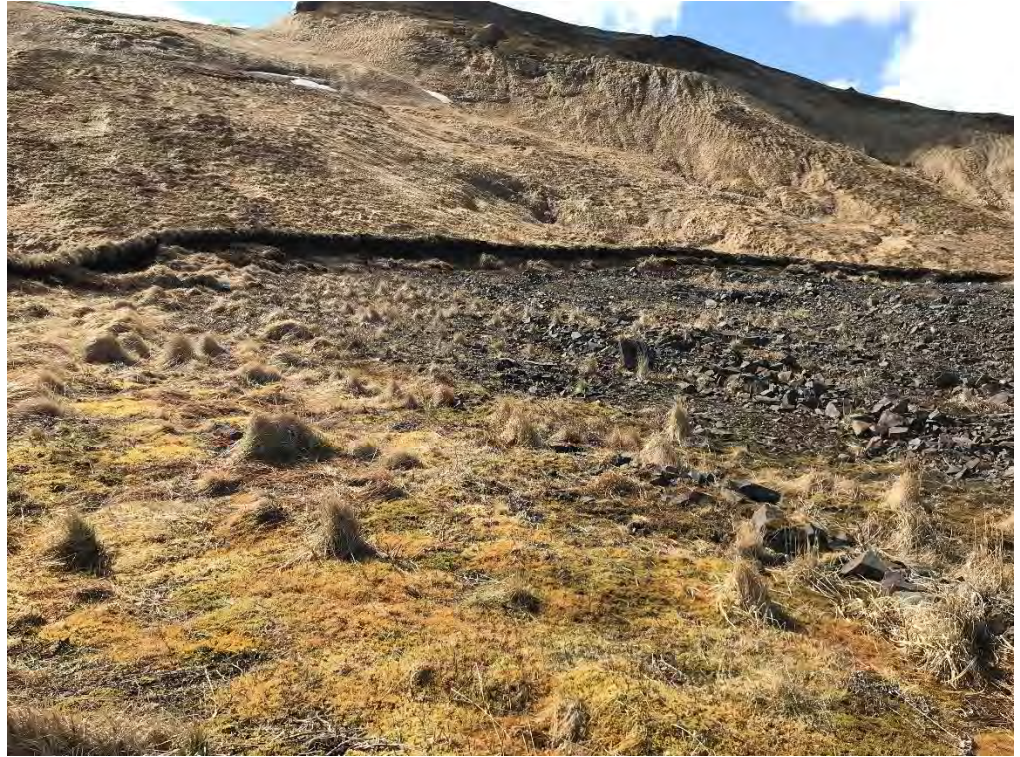
**Description:** Southeast  
side of disposal area  
facing south. Bermed  
sidewalls show signs of  
minor erosion.

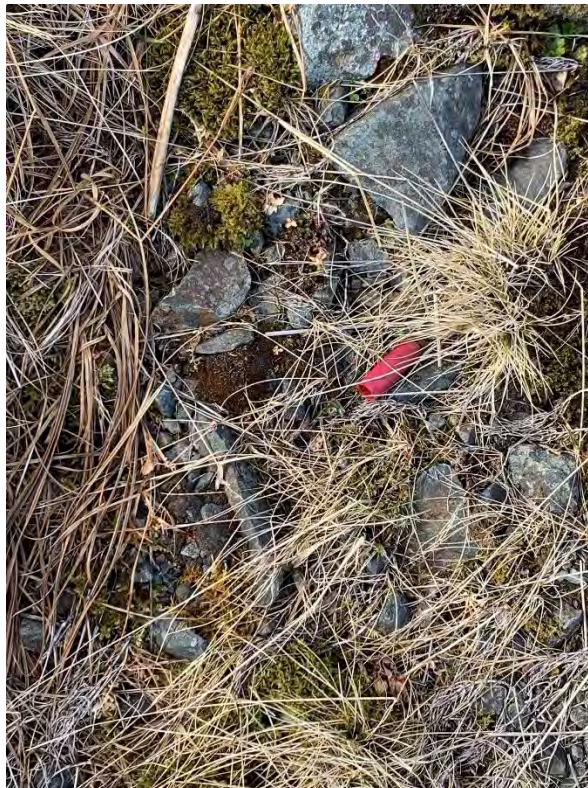
**Description:** Visual  
evidence of recreational  
use around site. Spent  
shotgun shells found on  
southwest corner of site  
near access road.

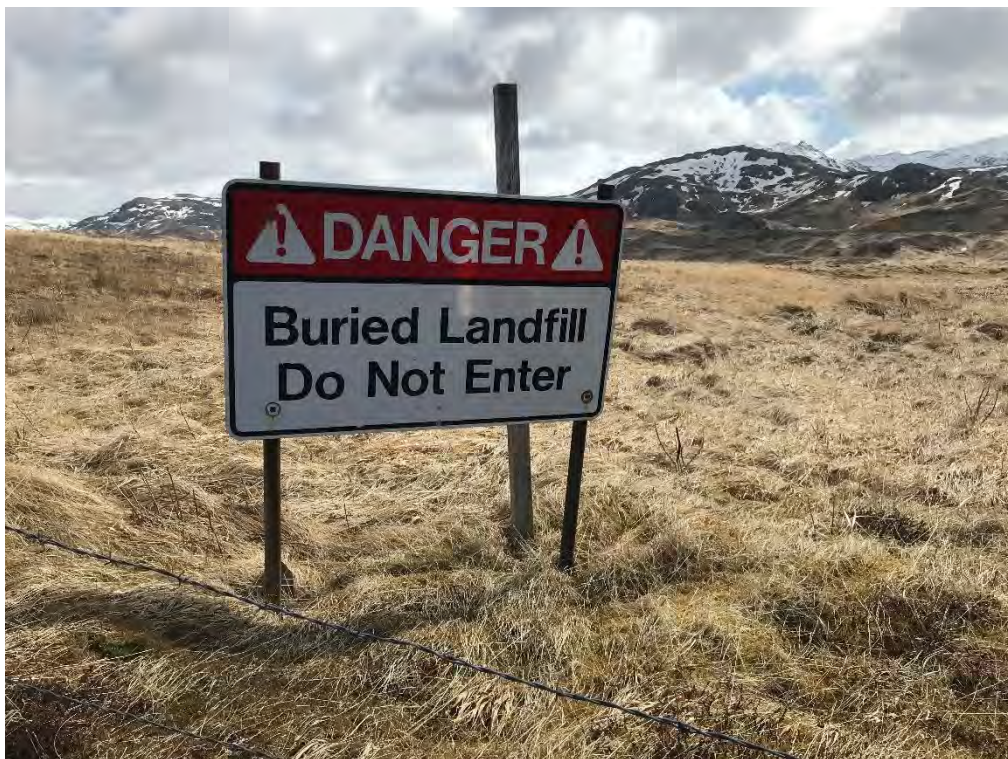
**Description:** Institutional  
control signage properly  
installed at the east side of  
the site.

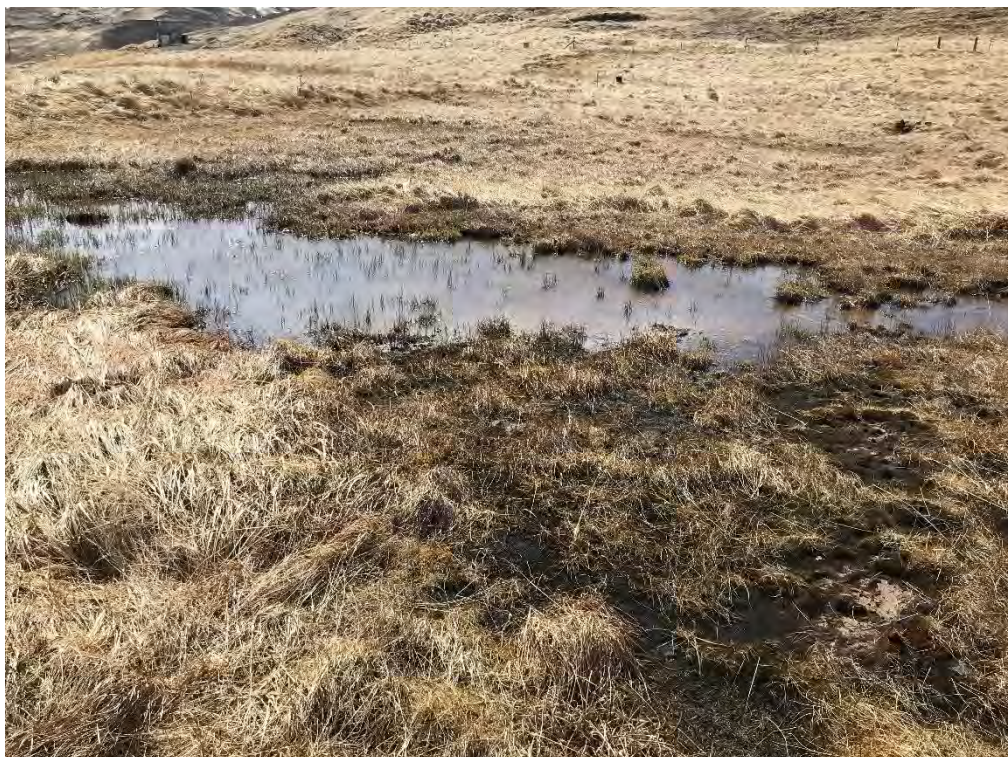
**Description:** Surface  
water pooling in the  
southwest portion of the  
landfill.

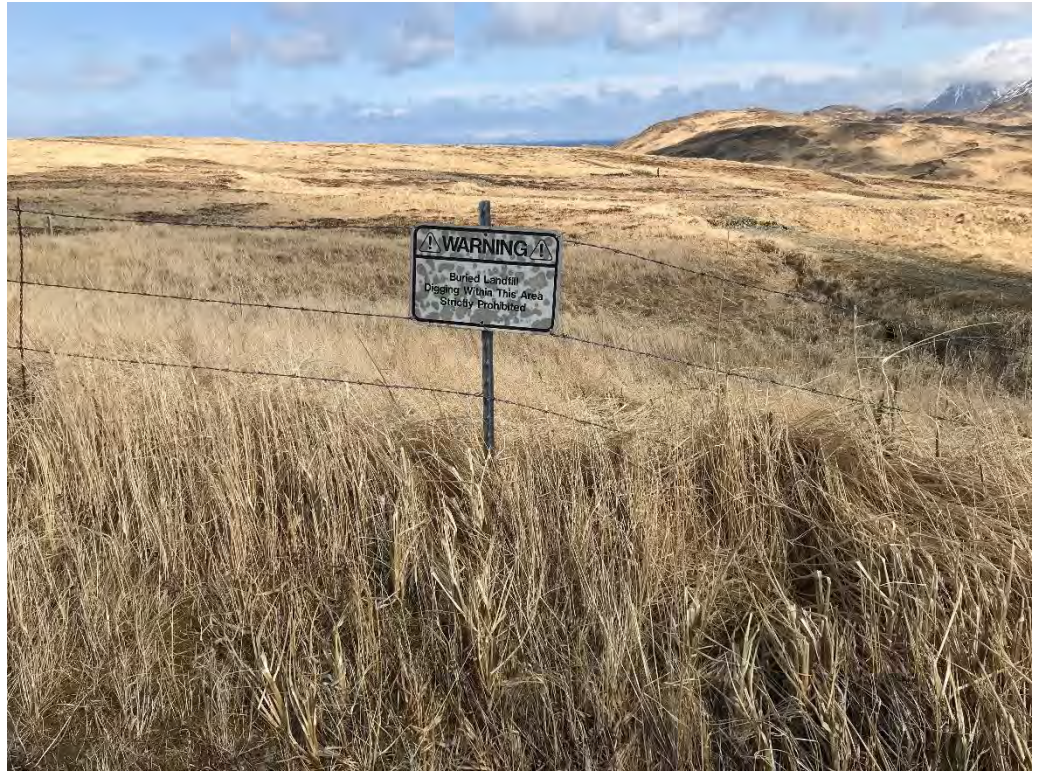
**Description:** Institutional  
control signage properly  
installed on fencing in the  
southwest corner of the  
landfill.

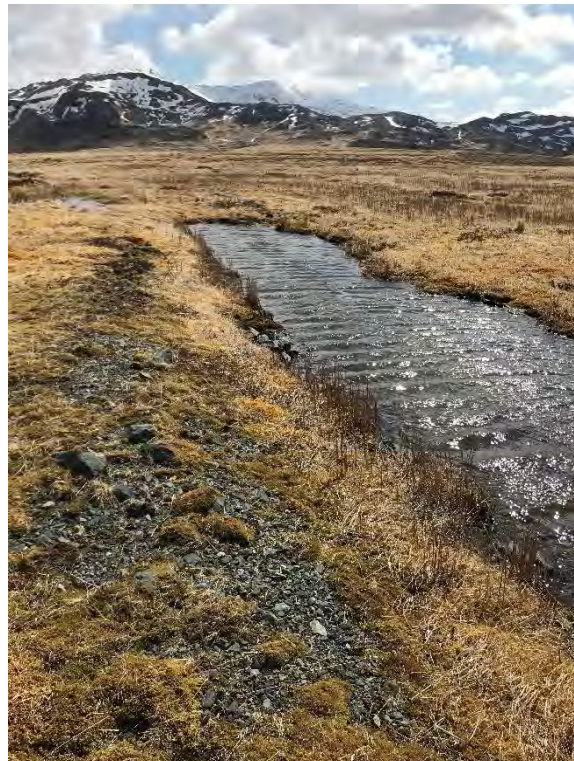
**Description:** Surface  
water pooling inside lined  
culvert used for drainage  
from landfill.

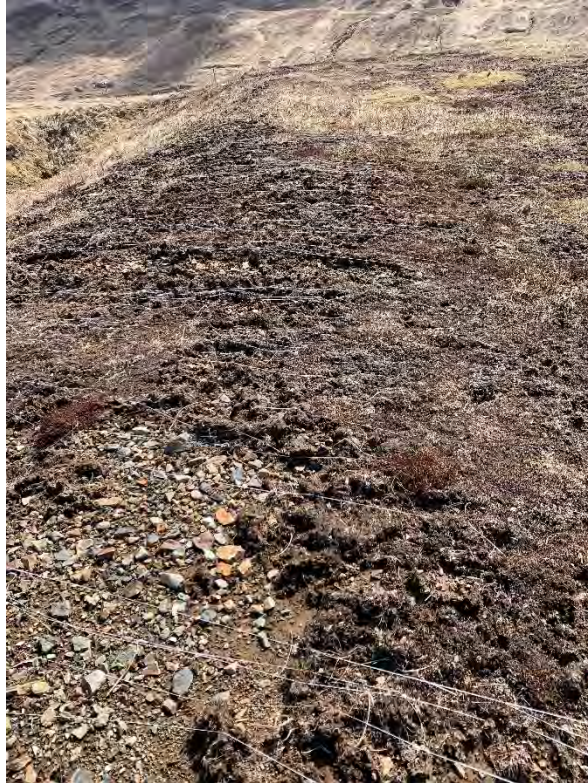
**Description:** Textile fabric  
covering non-vegetated  
surface in northern portion  
of landfill to promote  
vegetative growth.

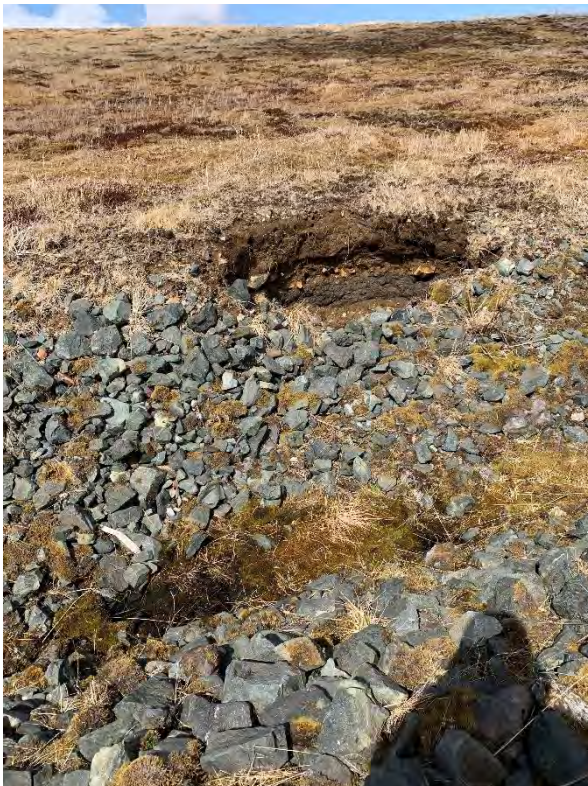
**Description:**  
Erosion/landslide  
underneath culvert liner in  
southern portion of landfill.

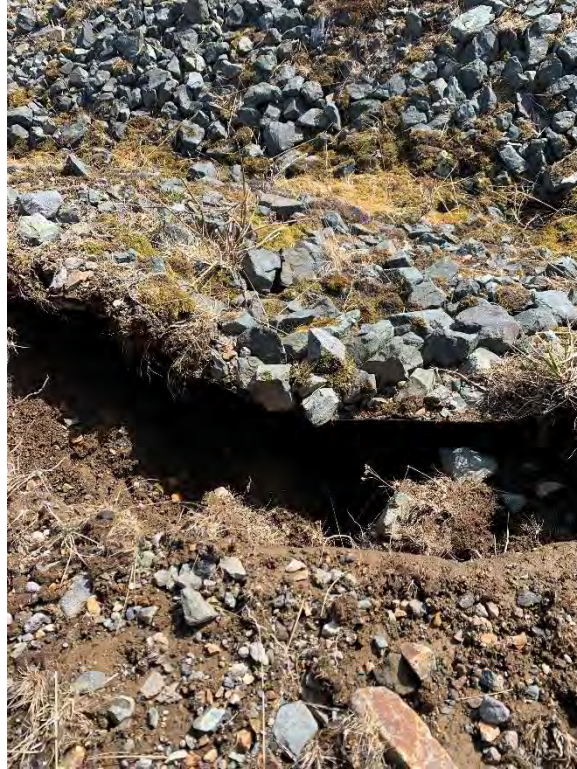
**Description:**  
Erosion/landslide  
underneath culvert liner in  
southern portion of landfill.

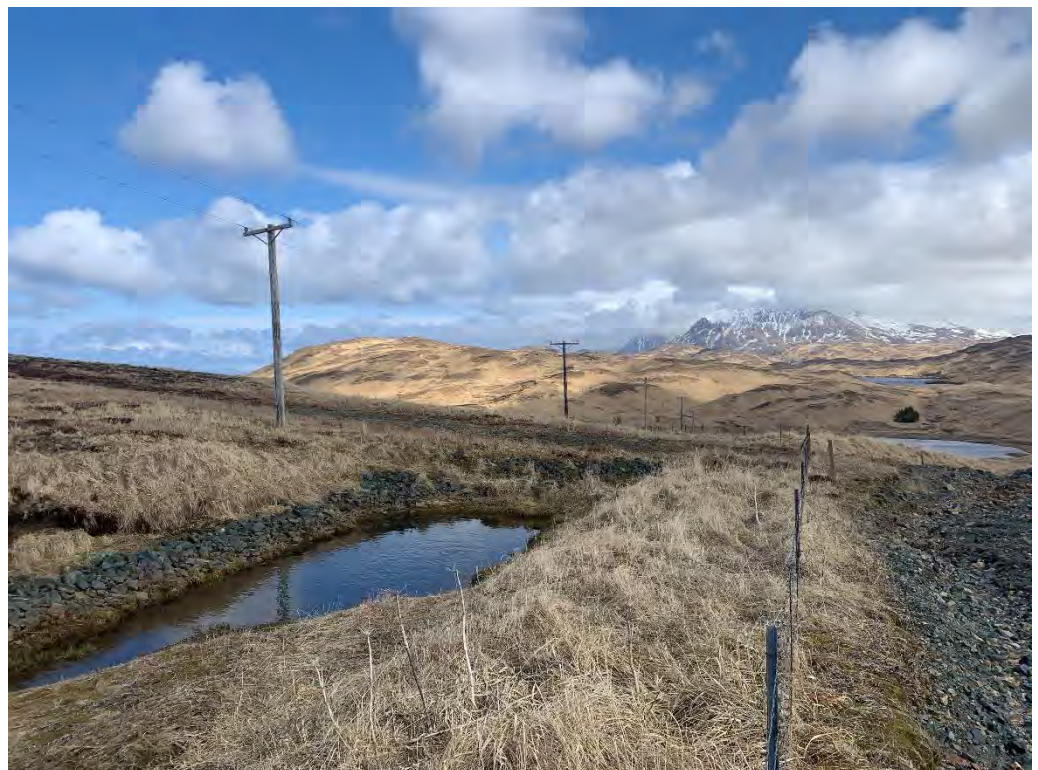
**Description:** Surface  
water pooling in southern  
portion of landfill near  
perimeter road.

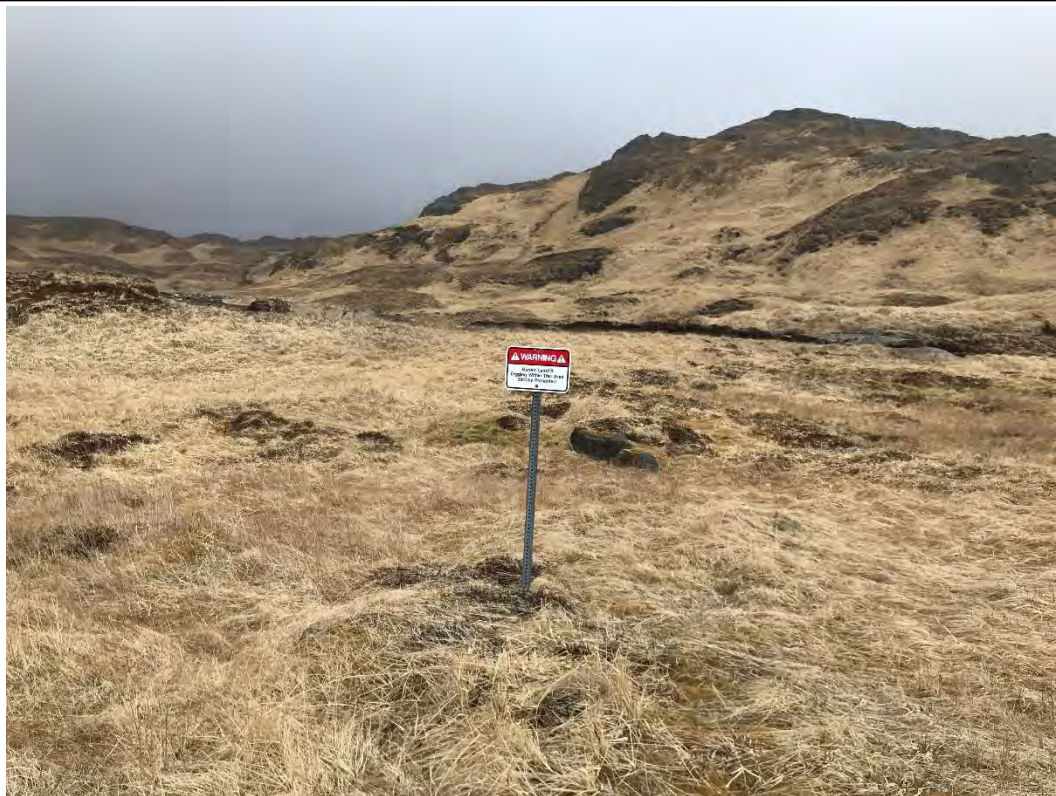
**Description:** Institutional  
control signage properly  
installed on access road to  
site.

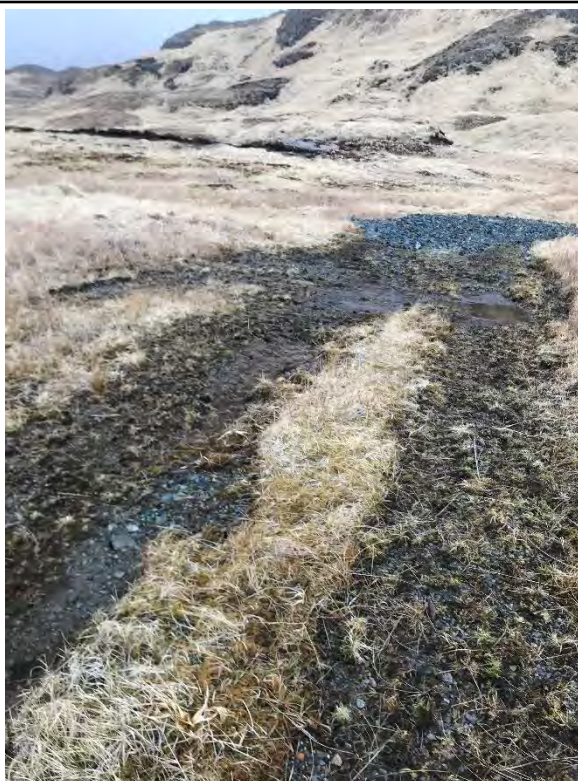
**Description:** Surface  
water pooling on access  
road to site just before  
recently completed road  
maintenance.

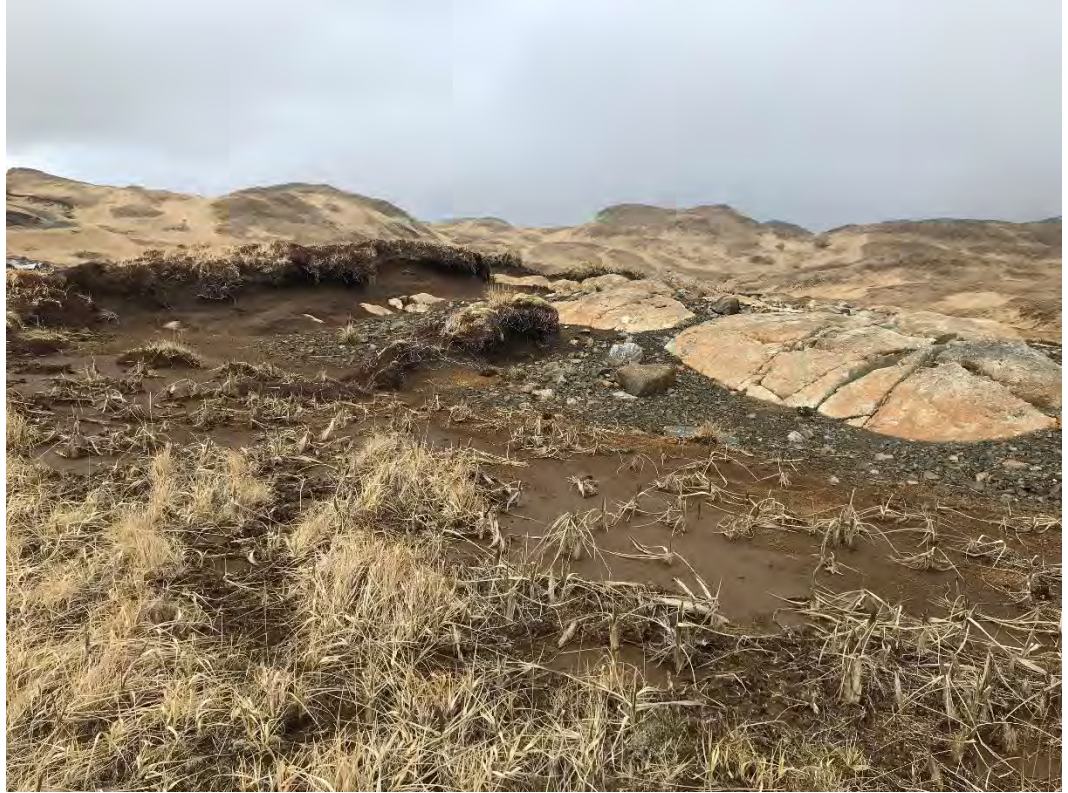
**Description:** Erosion  
present in northern portion  
of landfill upgradient from  
access road.

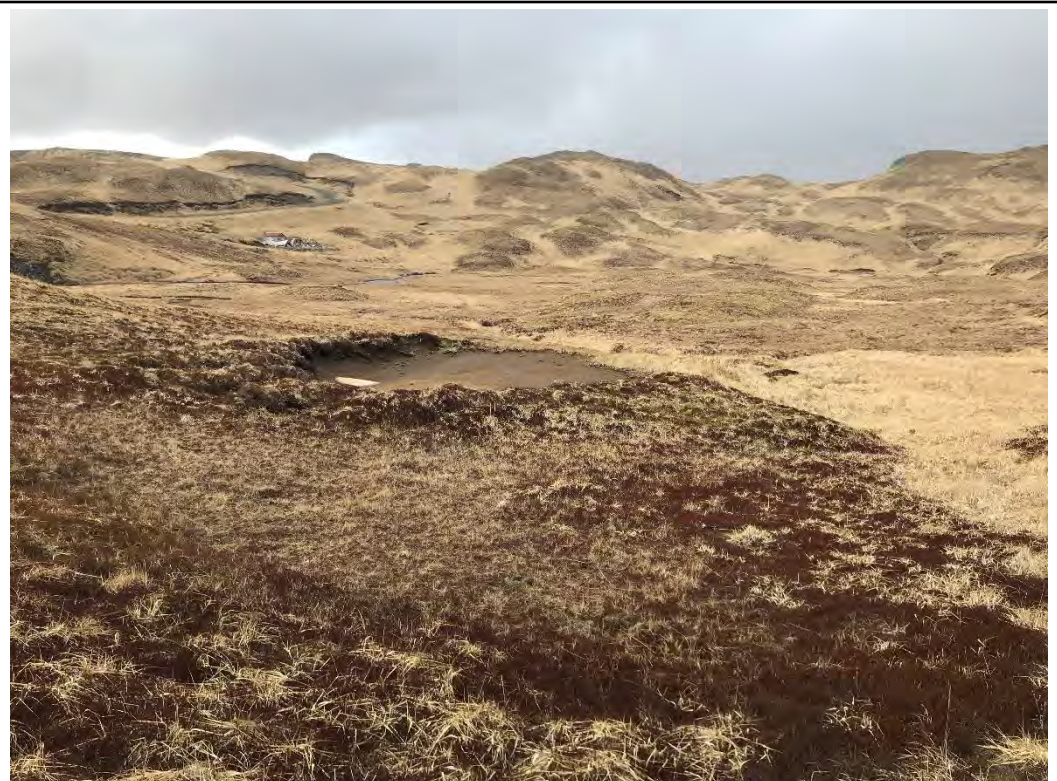
**Description:** Vegetated  
northern portion of landfill  
with bare patches and  
erosion visible.

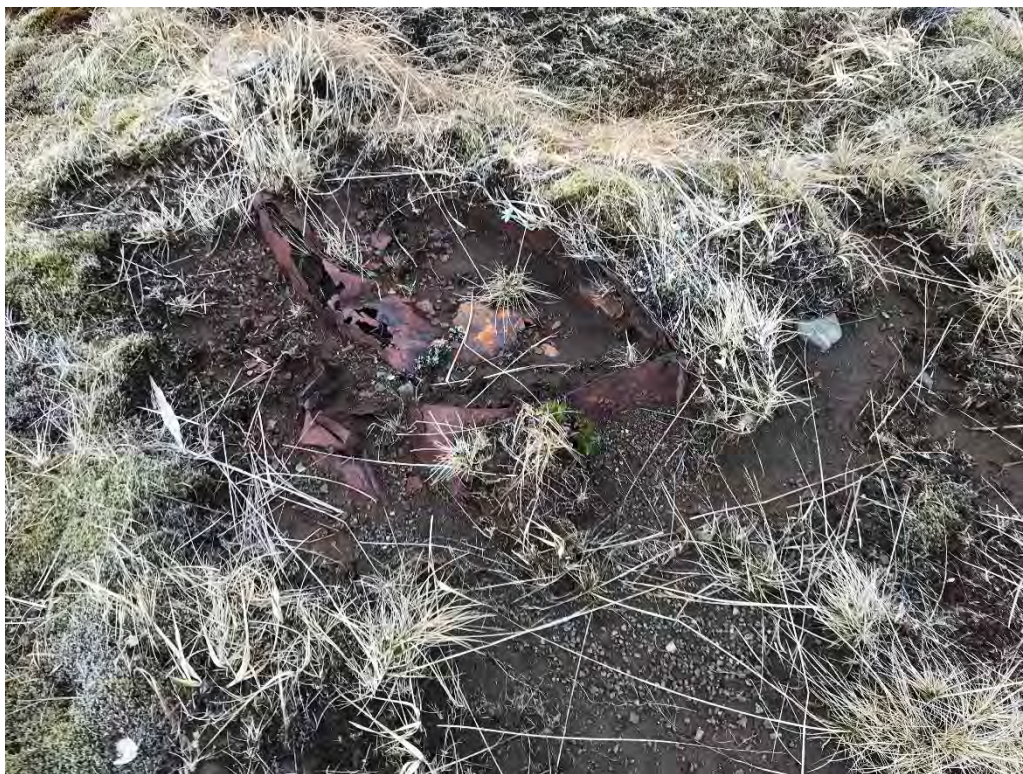
**Description:** Metallic  
debris present on surface  
in eastern section of  
landfill.

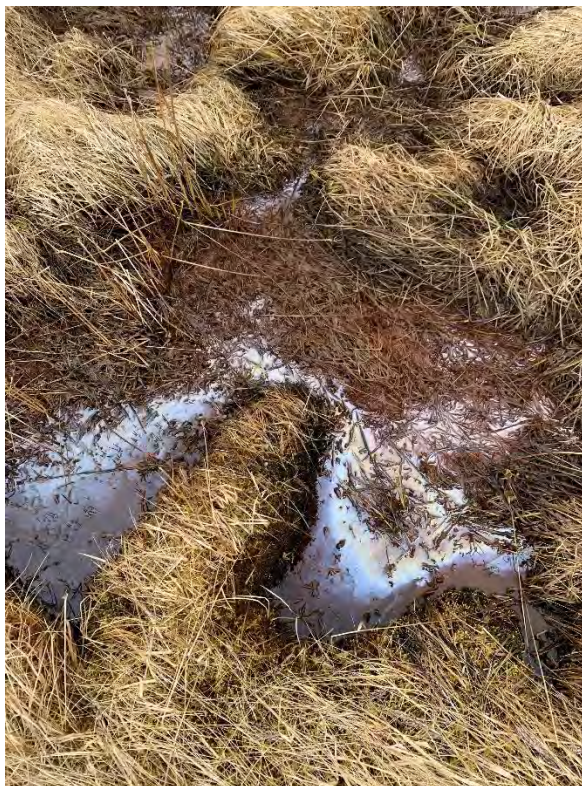
**Description:** Biological  
sheen identified in the  
southeast corner of site.  
Rock test applied in  
middle of photo and can  
observe sheen dispersing  
instead of reforming  
(reforming shows  
characteristics of product-  
related sheen).

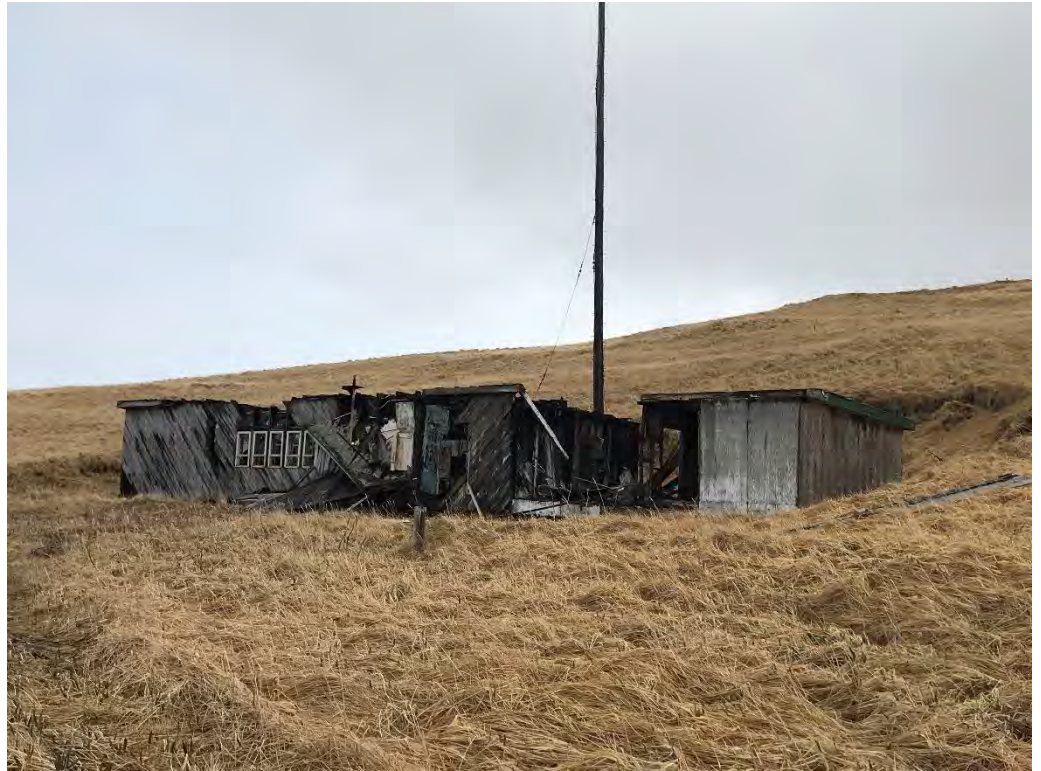
**Description:** Collapsed  
structure north of main  
Loran Station building.

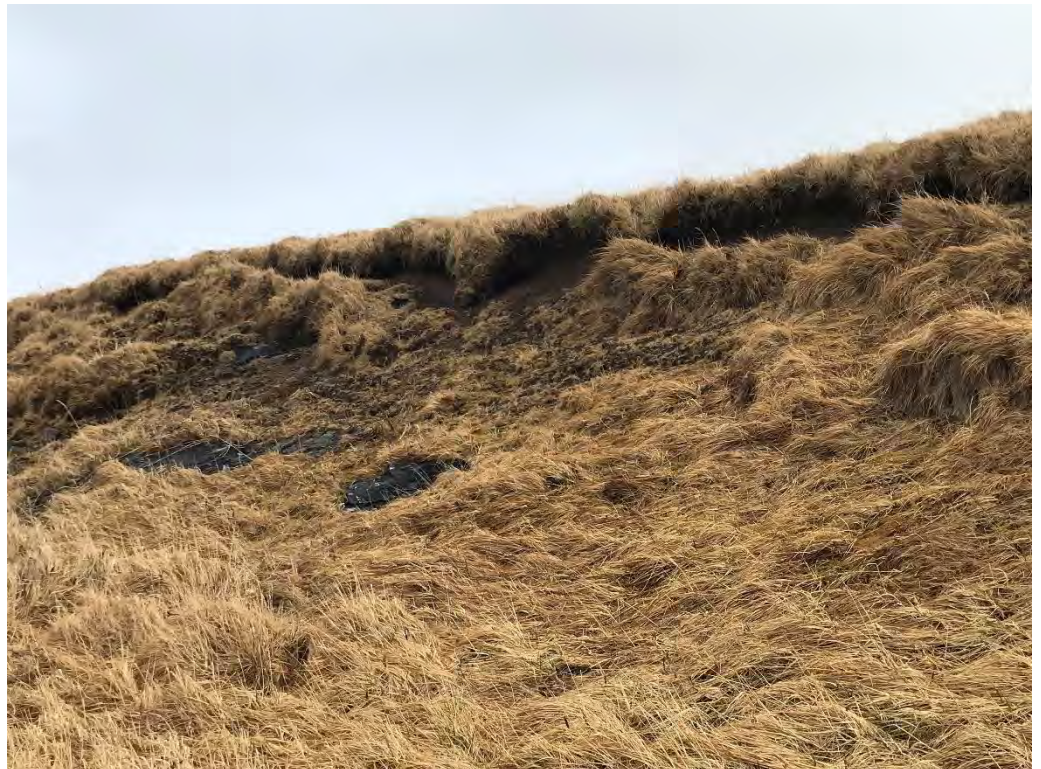
**Description:** Erosion and  
liner type material  
exposed from berm  
behind east side of  
building.

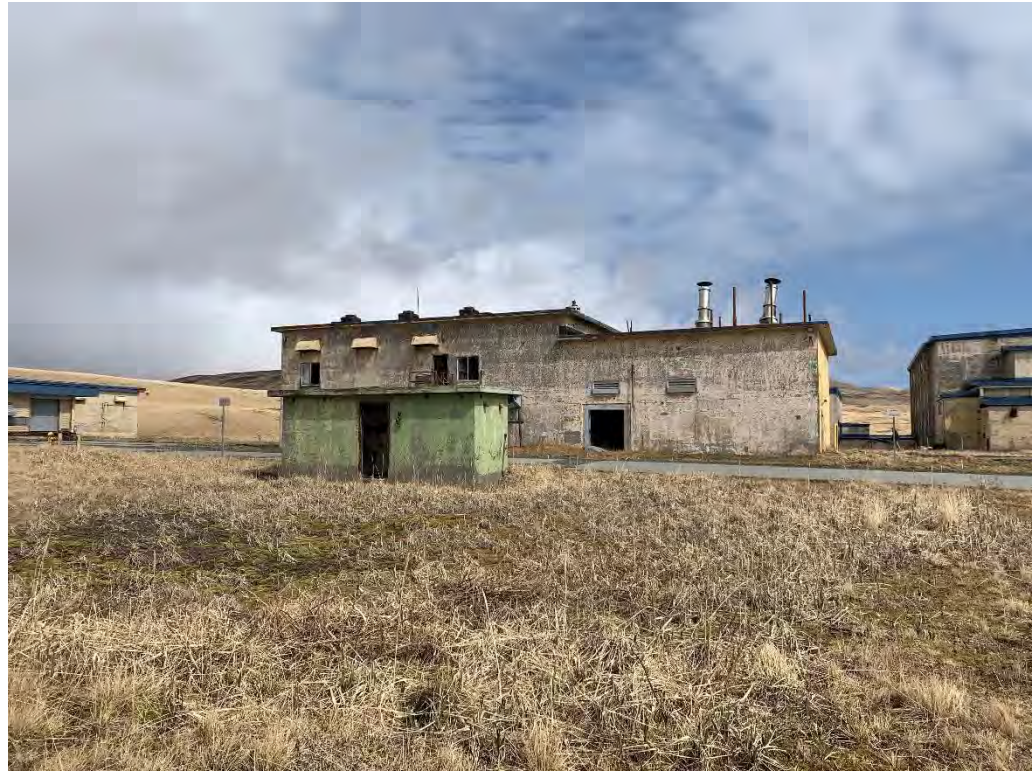
**Description:** Heating pit structure and building 1034 in the background of photo. Gravel/sand fill material observed on south side of heating pit structure.
