# Fifth Five-Year Review Operable Units A and B-1 Former Adak Naval Complex

## **Naval Air Station Adak**

**Fifth Five-Year Review  
Operable Units A and B-1  
Former Adak Naval Complex  
NAVAL AIR STATION ADAK, ADAK ISLAND, ALASKA**

**December 2021**

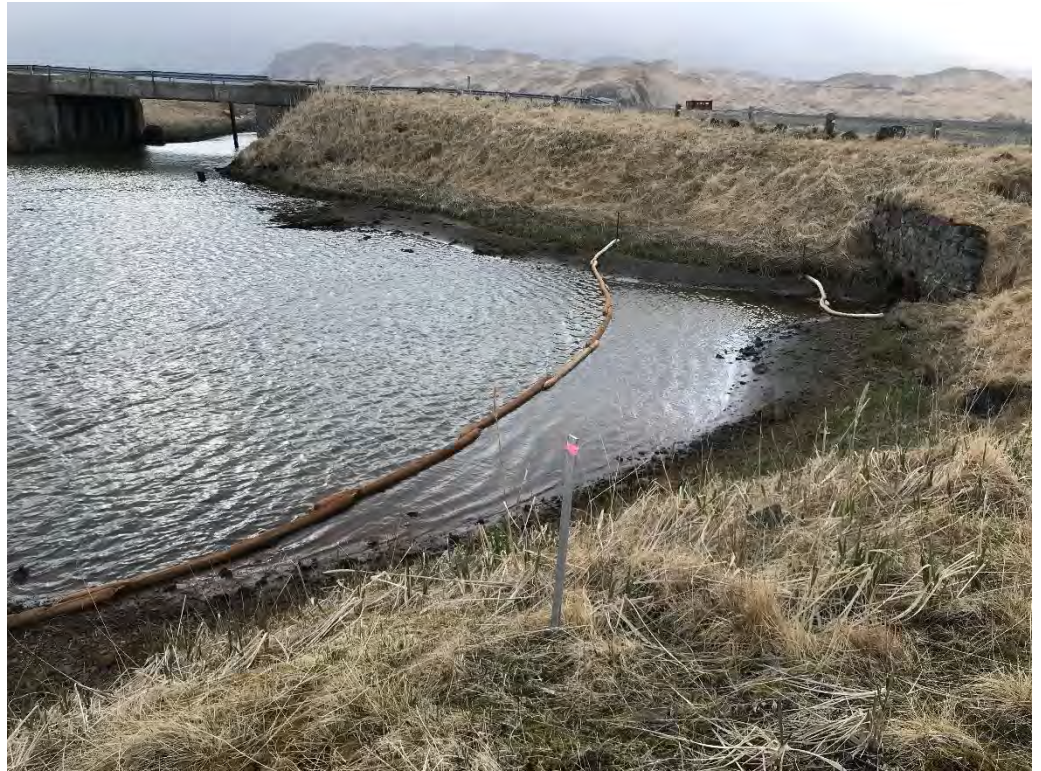
**Description:** Sweeper  
cove with product boom in  
place near culvert  
downgradient from SWMU  
60.

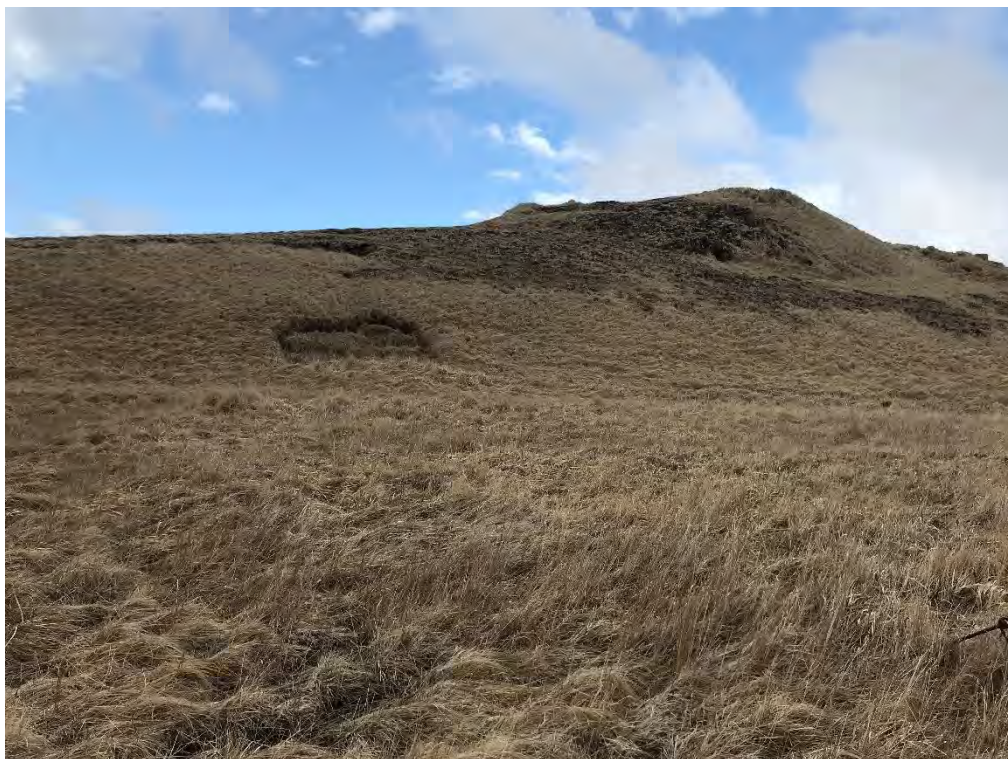
**Description:** Structural  
outcroppings in hillside of  
SWMU 60 upgradient  
area.

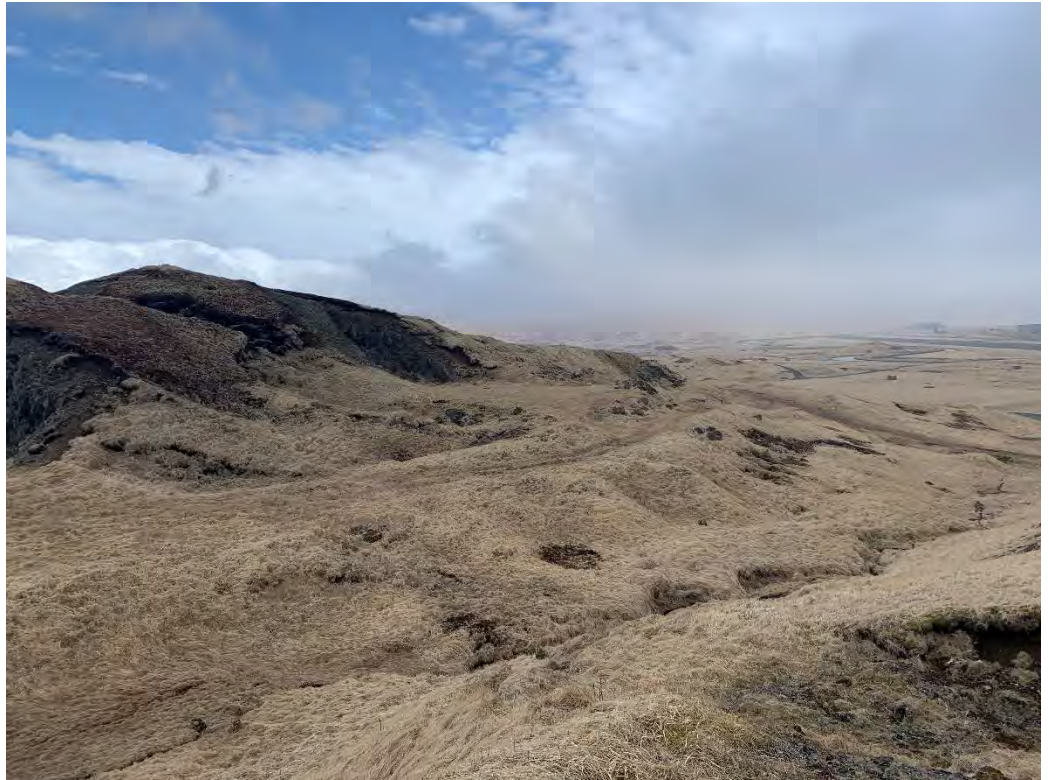
**Description:** Tank  
outcroppings in hillside on  
western portion of site.

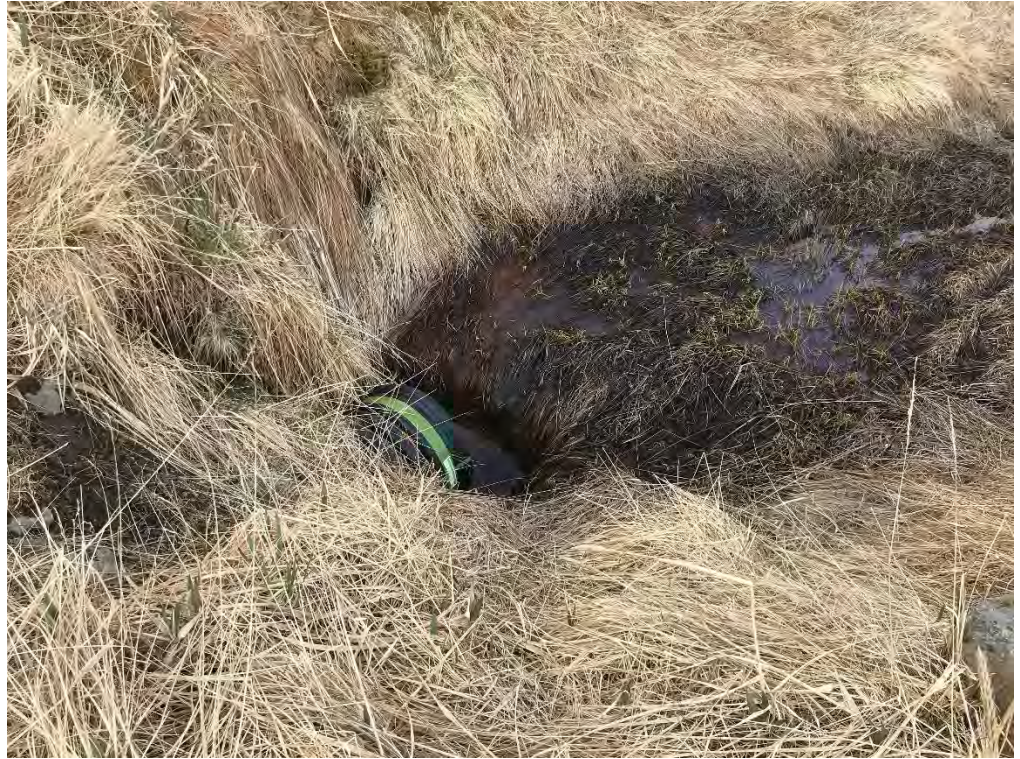
**Description:** Recently  
constructed culvert on the  
north side of access road  
functioning properly.

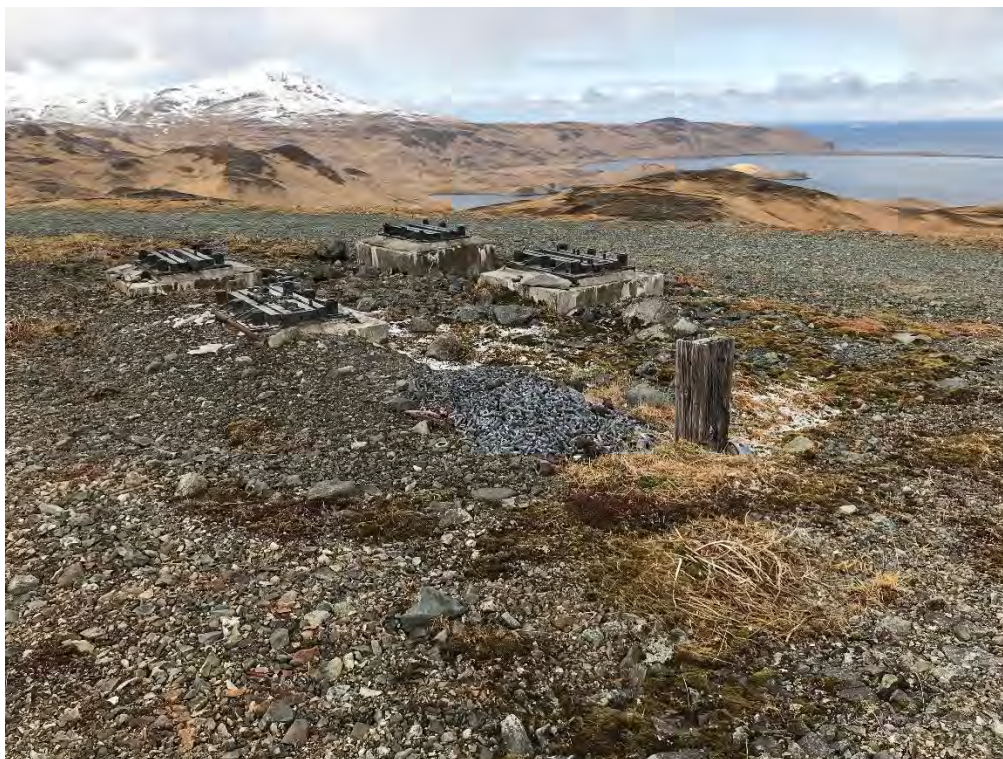
**Description:** Support  
pillars and metallic debris  
(abundant screws, bolts,  
and tools) on southwest  
side of site.

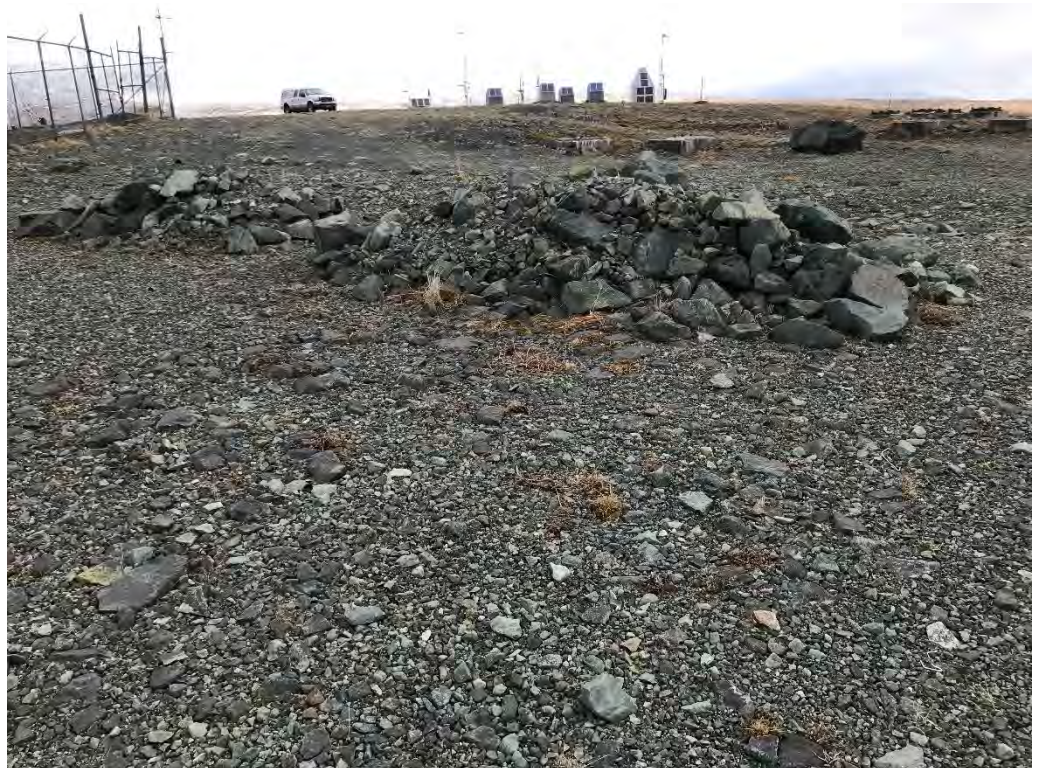
**Description:** Gravel  
debris pile near radio  
transmitting equipment.

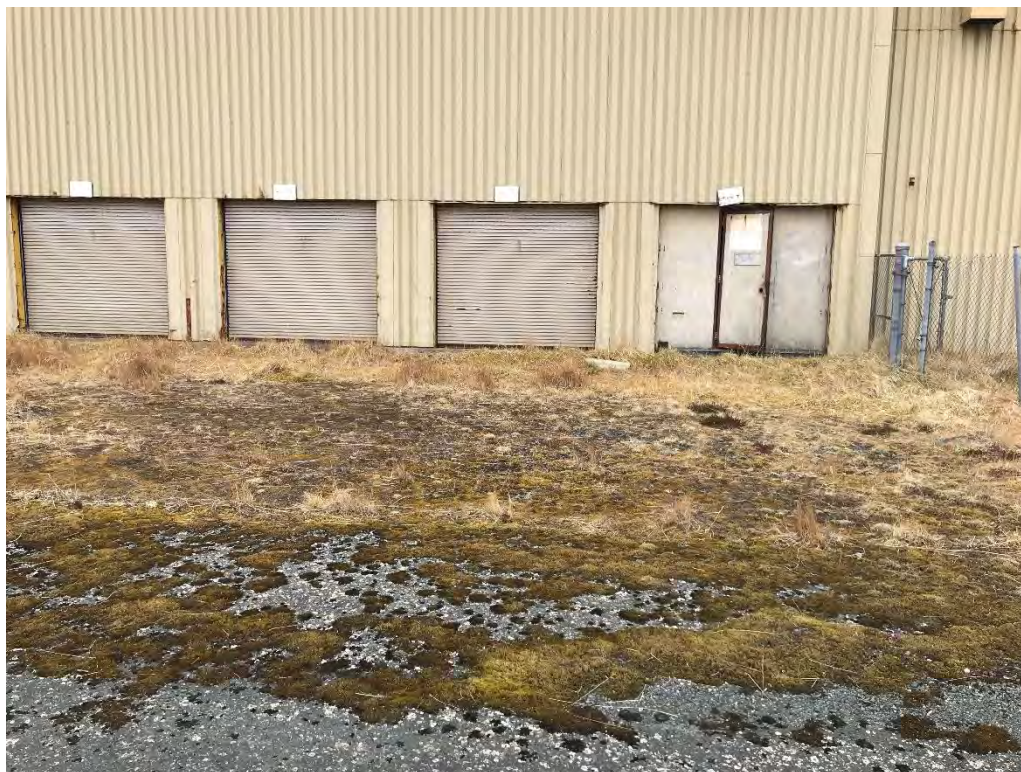
**Description:** Former UST  
excavation location on  
northwest corner of  
hanger. Fill material and  
asphalt cutout observed  
on surface.

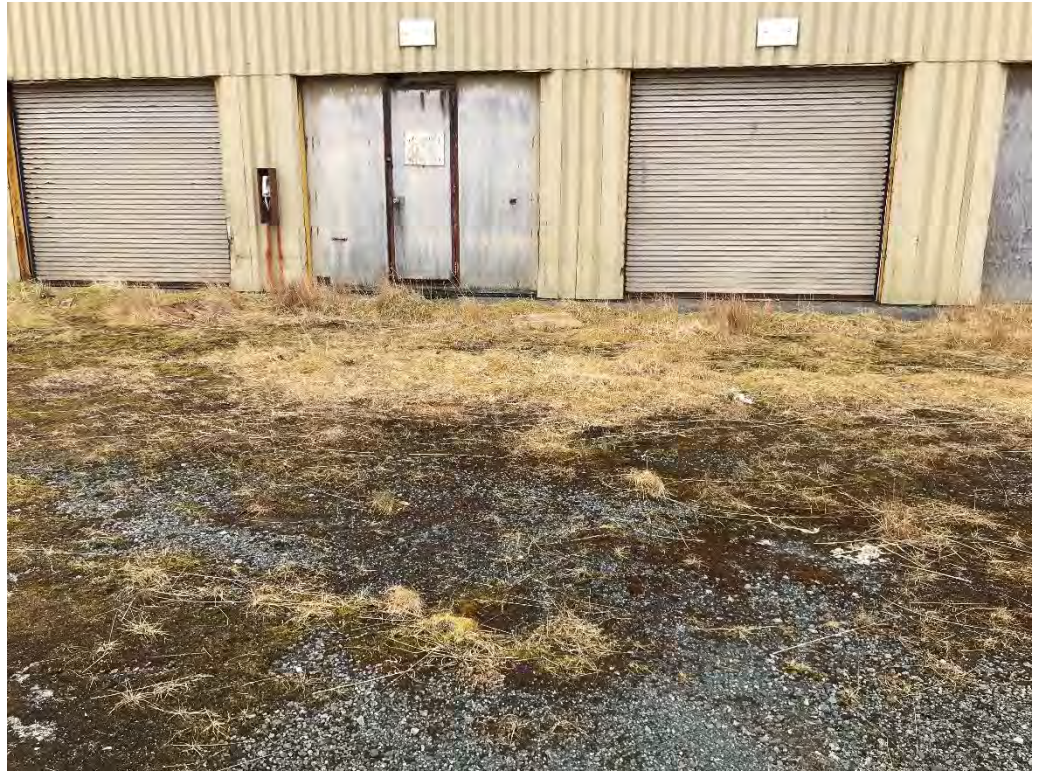
**Description:** Former UST  
excavation location on the  
southwest side of the  
hanger. Fill material and  
asphalt cutout observed  
on surface.

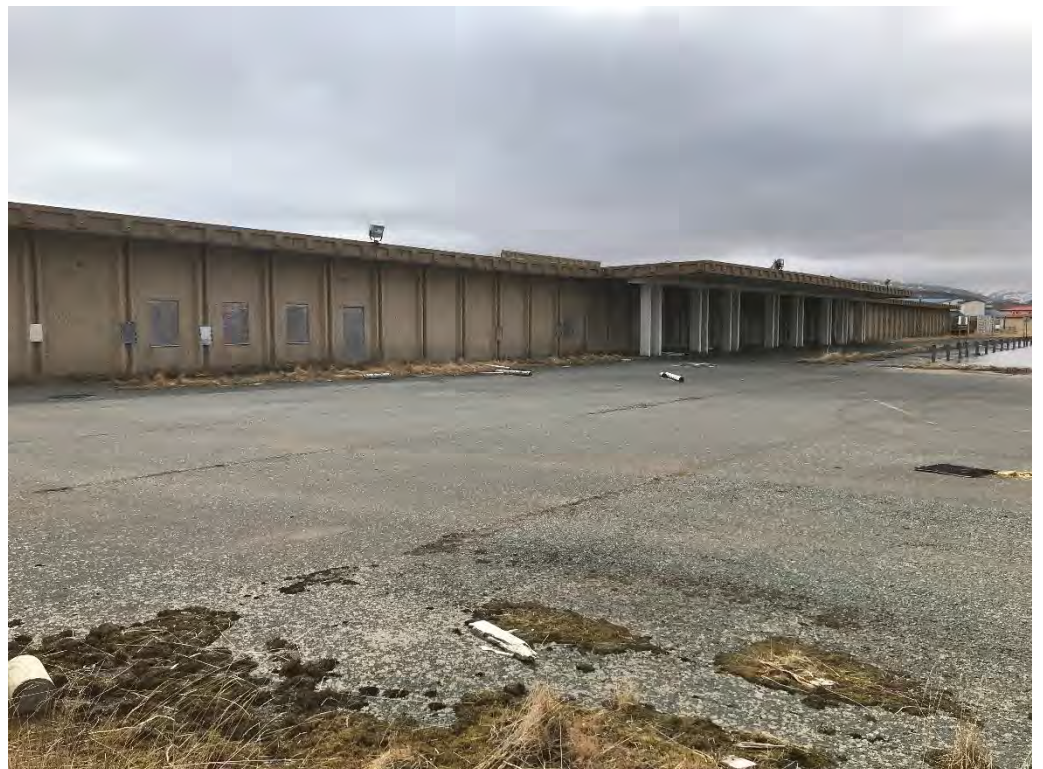
**Description:** Northwest  
corner of Navy Exchange  
Building with visible  
ponding located  
southwest area of the site.

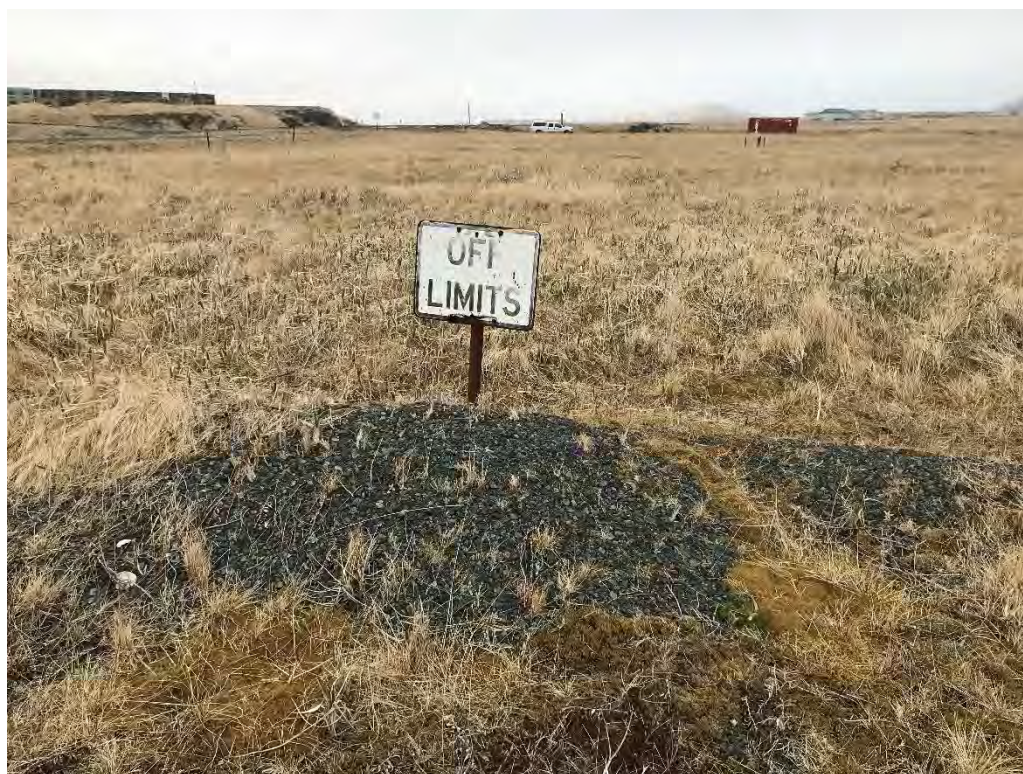
<b>AECOM</b>		<b>PHOTOGRAPHIC LOG</b>	
Department of the Navy Naval Facilities Engineering Command Northwest	5-Year Review Site Inspection Photos		AECOM Project No.: 60636935 Date: 4/21/2021
<b>Site Name :</b> SA 79, Main Road Pipeline South End	 		
<b>Direction Photo Taken:</b> East			
<b>Description:</b> Overview of SA 79, Main Road Pipeline South End. West side of the site facing east. Shipping container visible in the background.

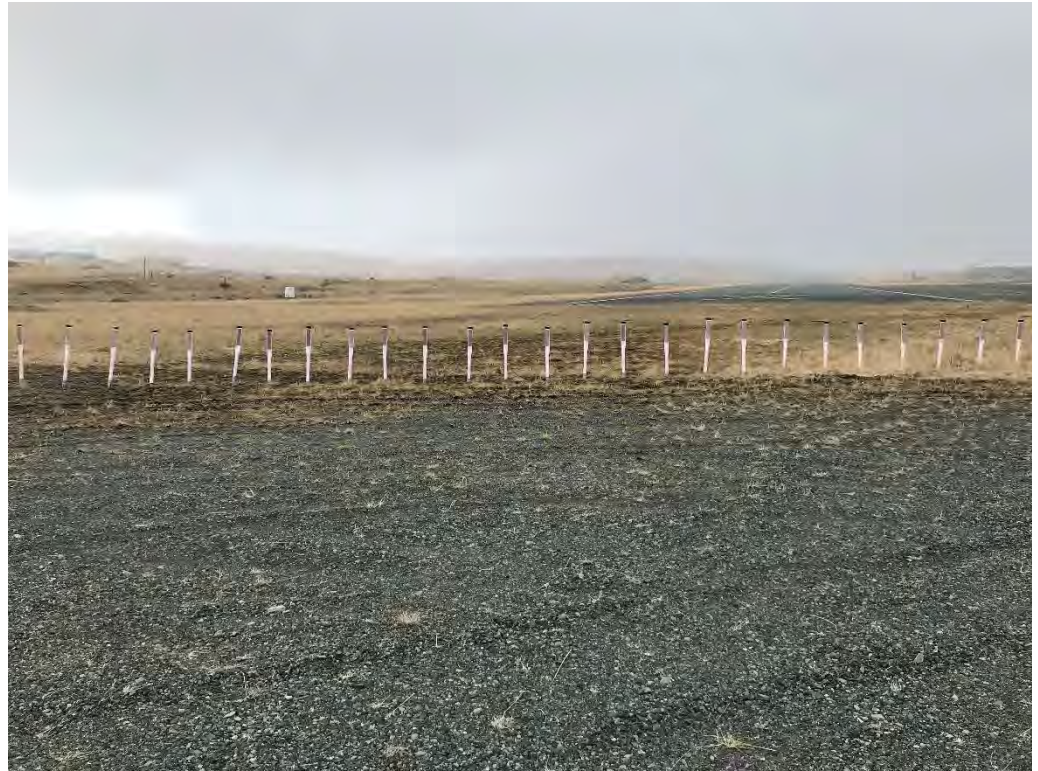
**Description:** Overview of  
South of Runway 18-36  
area adjacent to the south  
end of active runway.

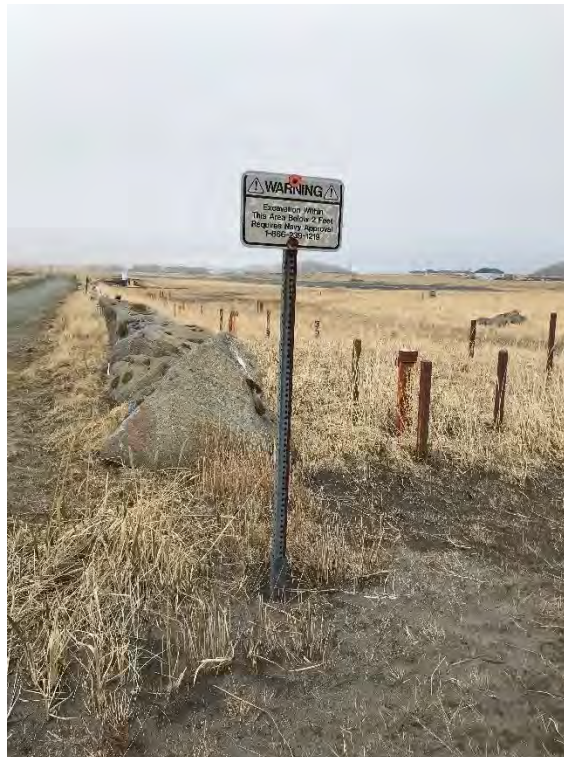
**Site Name:** South of  
Runway 18-36 Area

**Description:** Institutional  
control signage located at  
South of Runway 18-36  
Area adjacent to access  
road along East Canal.

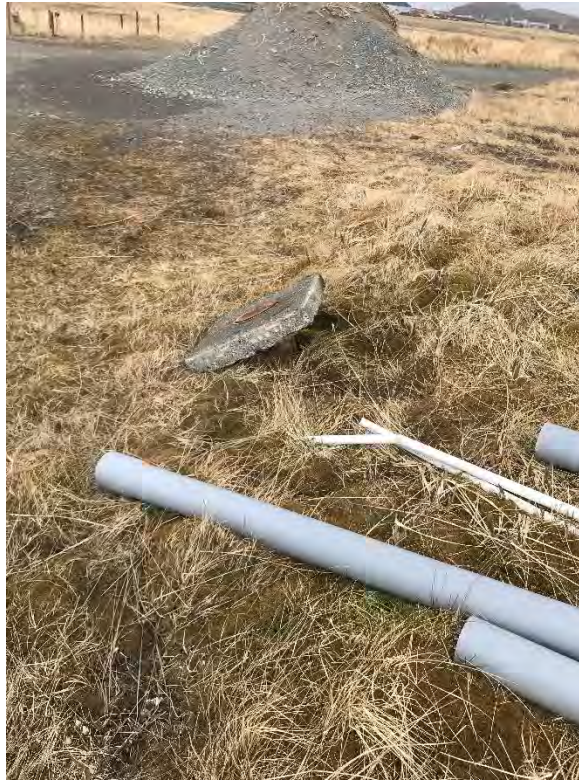
3.	<b>Current Overall Site Conditions</b> Remarks <u>Similar to 2019 IC site inspections and last 4<sup>th</sup> FYR, no changes. MW-AS-1 well monument is destroyed and needs to be repaired.</u>

**Description:** Damaged  
MW AS-1 located at  
entrance of access road  
adjacent to East Canal.

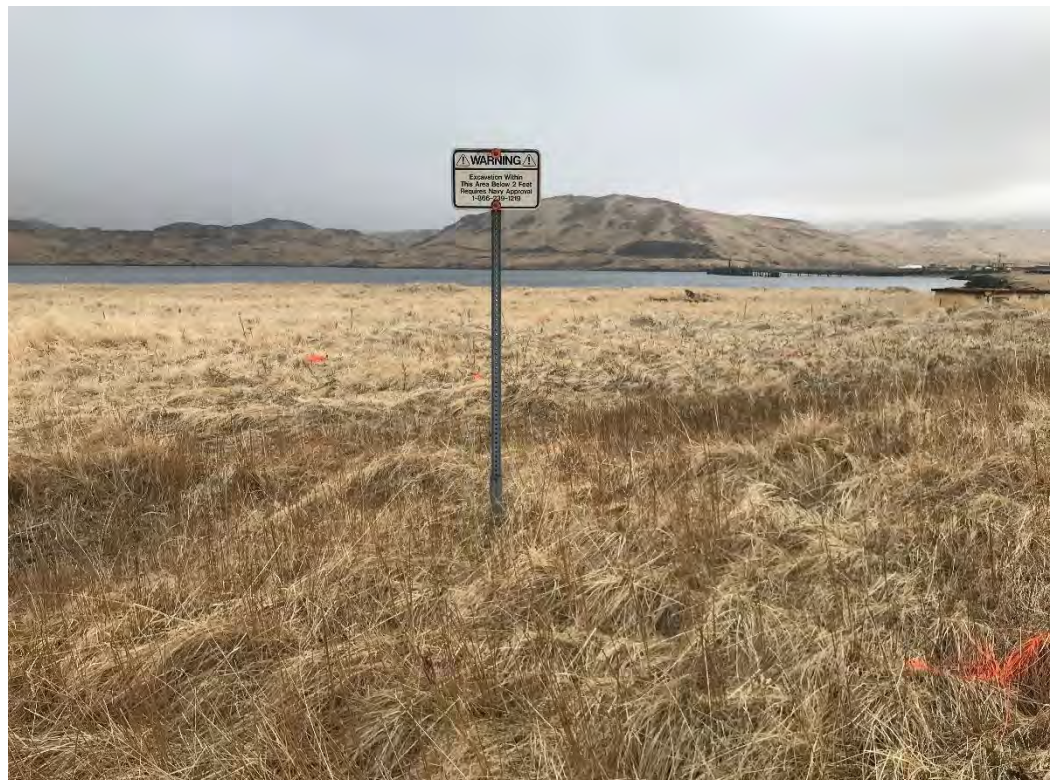
**Site Name :** South of  
Runway 18-36 Area

**Description:** Overview of  
South of Runway 18-36  
facing the bay.

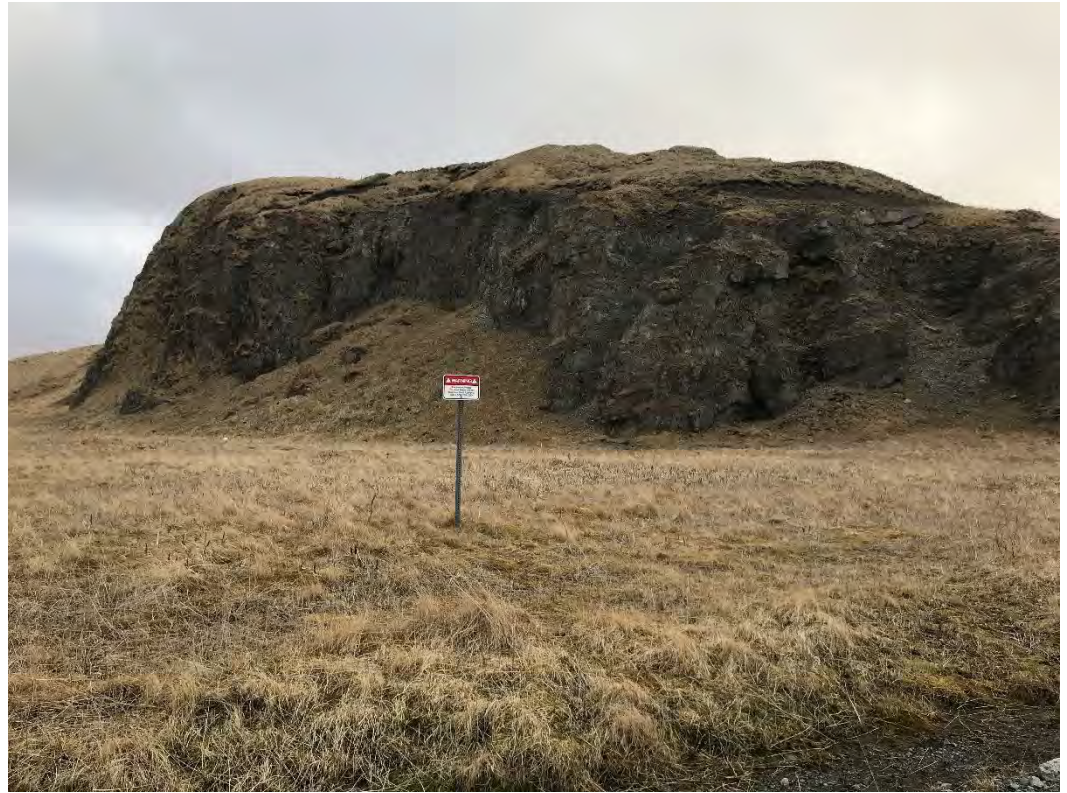
**Description:** Overview of  
NORPAC Hill Seep Area.  
Institutional control  
signage installed just west of  
roadway.

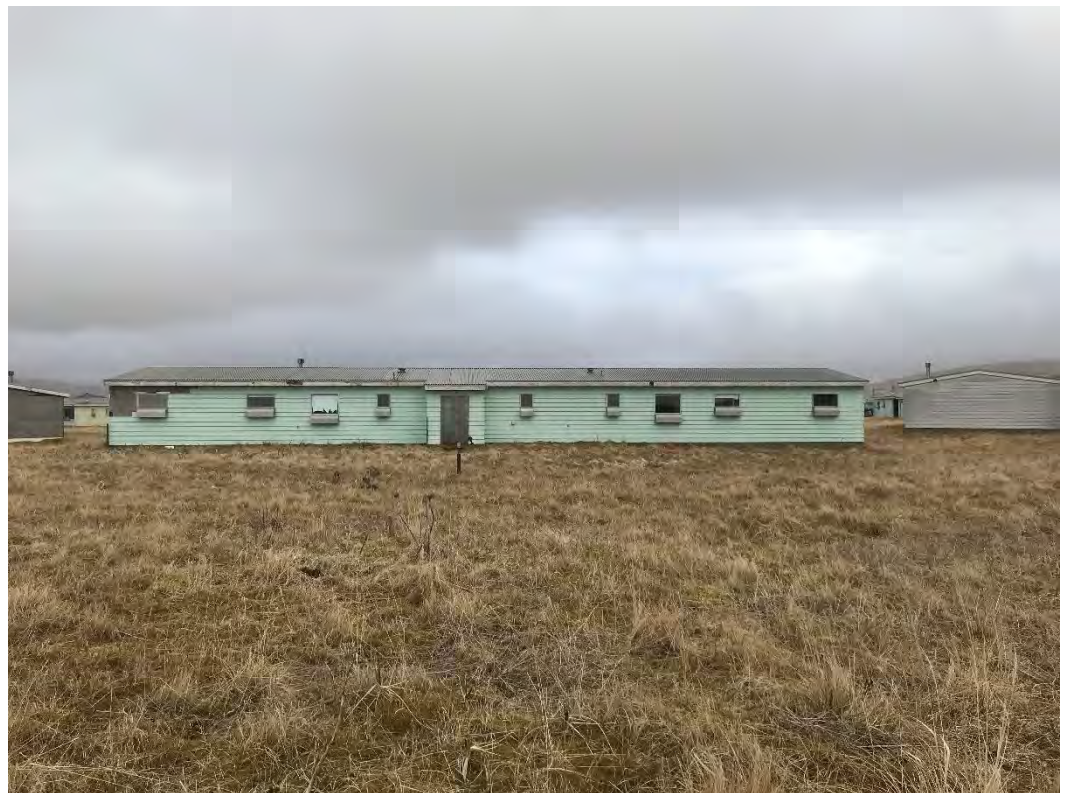
**Site Name :** NORPAC Hill  
Seep Area

**Description:** Building  
located adjacent to  
NORPAC Hill Seep Area.  
Building is not in use.

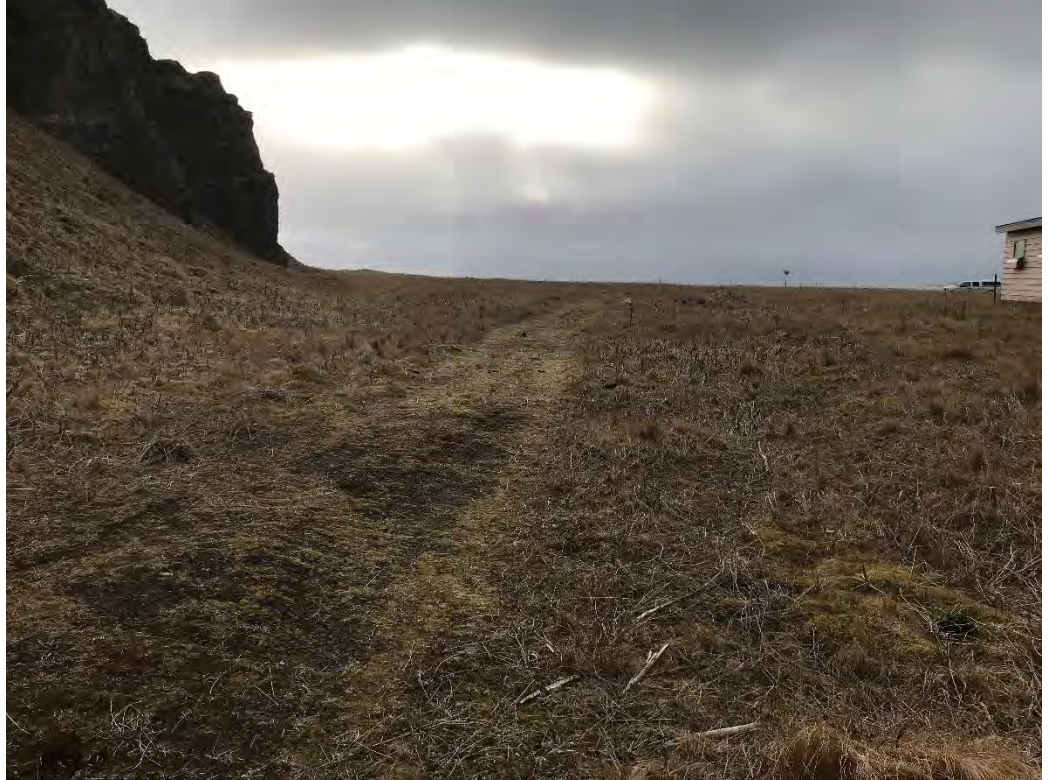
**Description:** Overview of  
NORPAC Hill Seep Area,  
on west edge of site.  
Vehicle tracks visible on  
the ground surface.

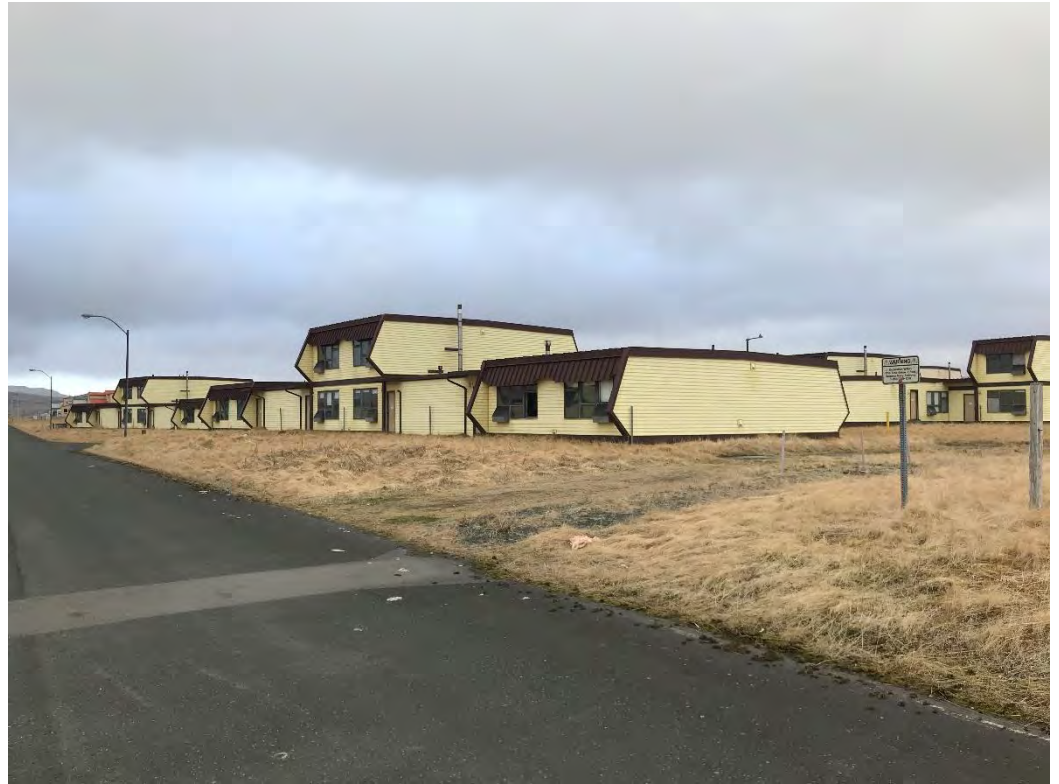
3. <b>Current Overall Site Conditions</b> Remarks <u>Abandoned homes, some homes falling apart. Each home has a sign indicating authorized entry only. Similar to 2019 IC site inspection and previous 4<sup>th</sup> FYR.</u>

**Description:** Typical  
housing unit located within  
the Housing Area, Arctic  
Acres site.

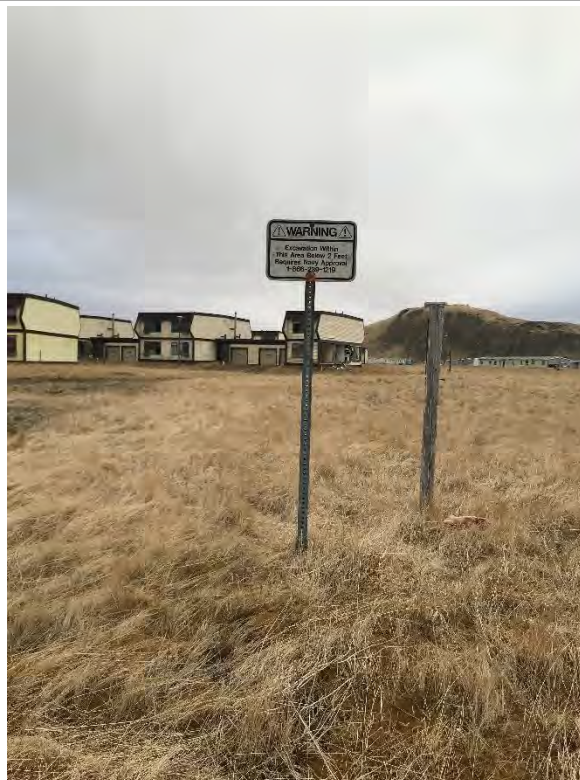
**Site Name :** Housing Area,  
Arctic Acres

**Description:** Excavation  
restriction sign located at  
Housing Area, Arctic  
Acres.

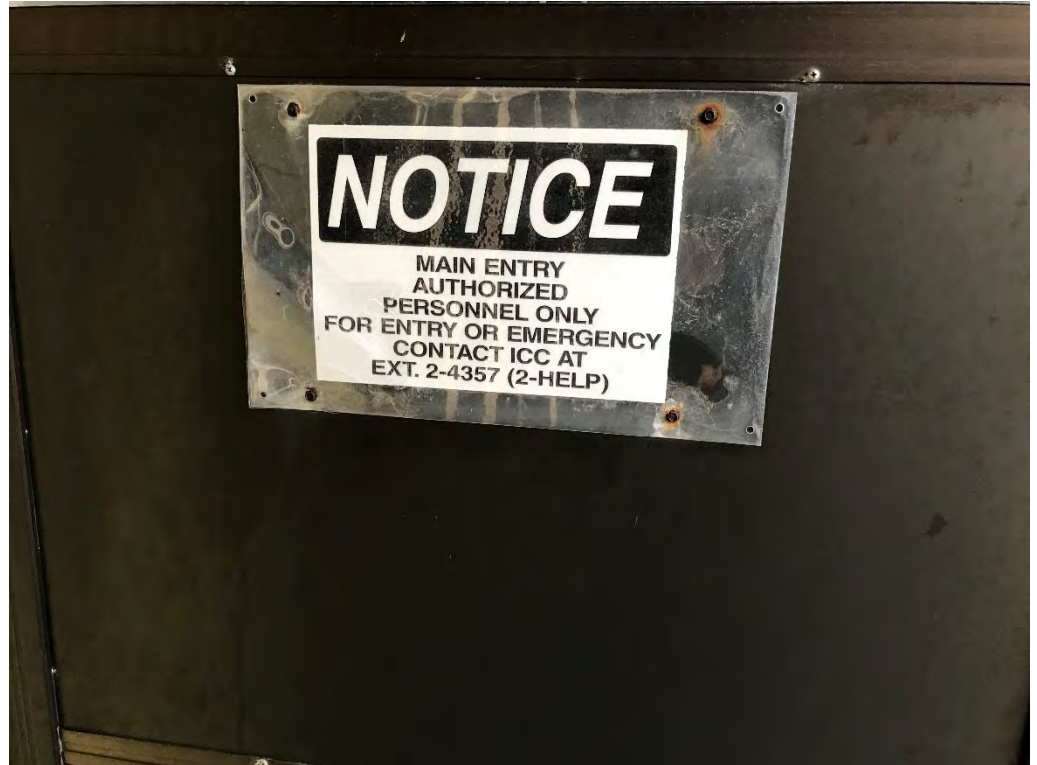
**Description:** Notice  
authorized personnel entry  
sign located at each  
housing unit in Housing  
Area, Arctic Acres.

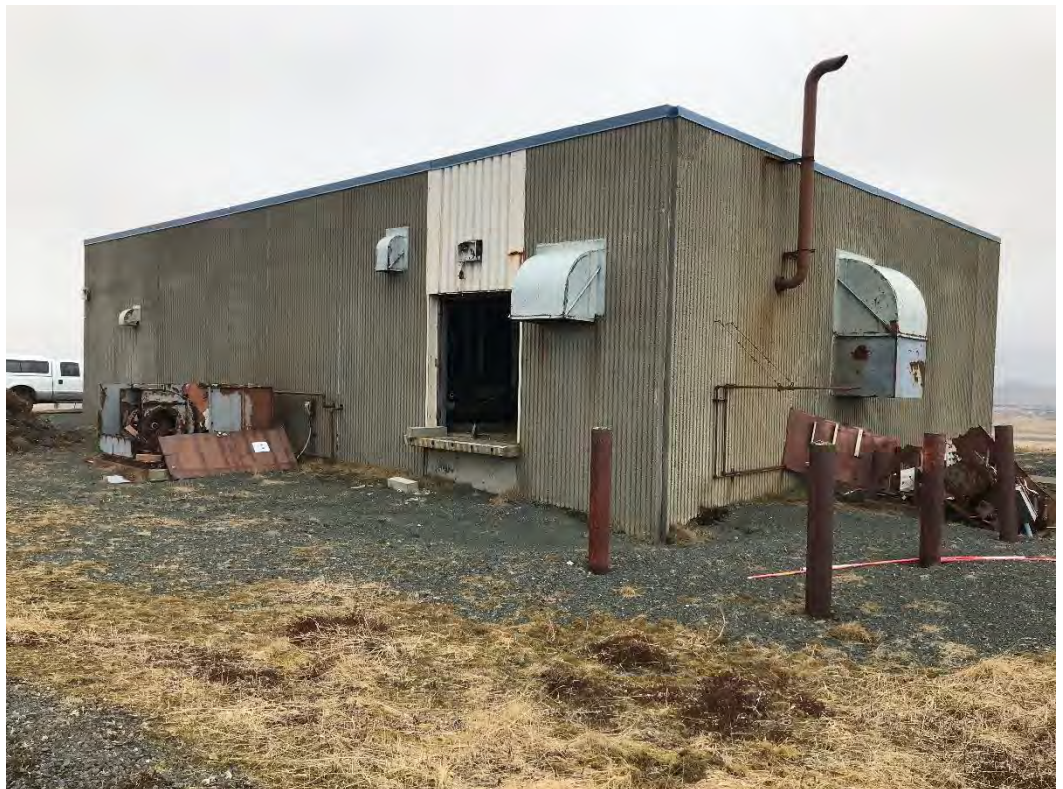
**Site Name :** ASR-8 Facility  
(UST 42007-B)

**Description:** Overview of  
ASR-8 Facility. Photo  
taken on southwest corner  
of site. Debris visible  
along sides of building.

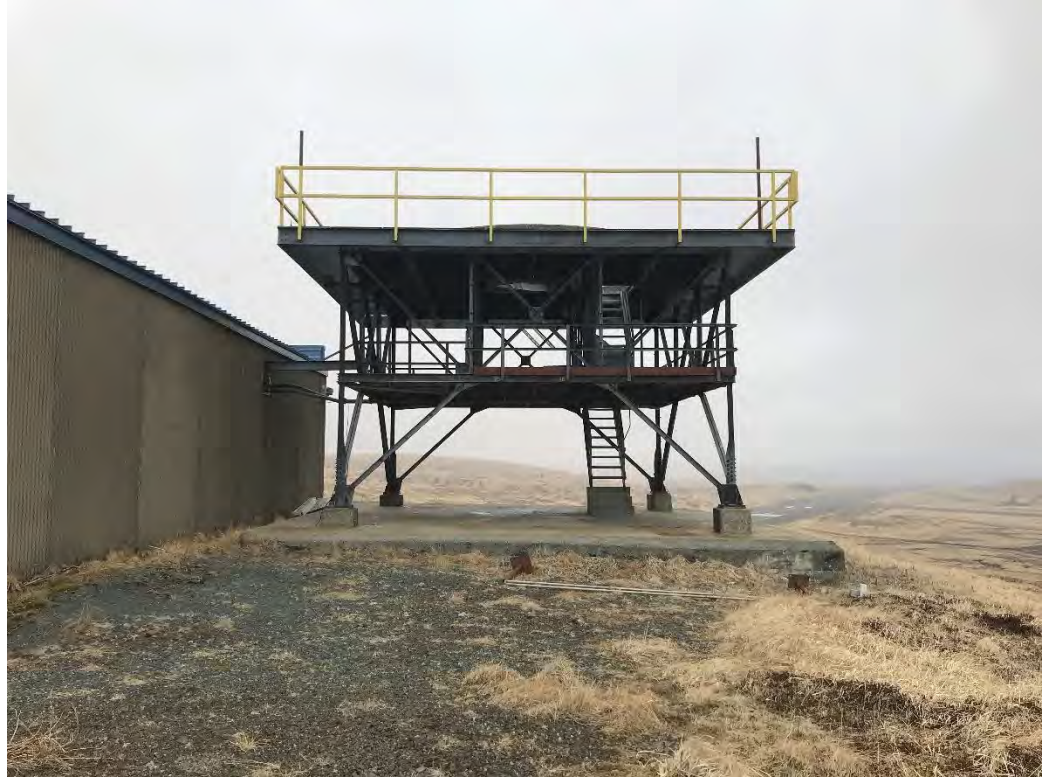
**Description:** Overview of  
ASR-8 Facility. Photo  
taken on south end of site.  
Platform on Southwestern  
side of building.

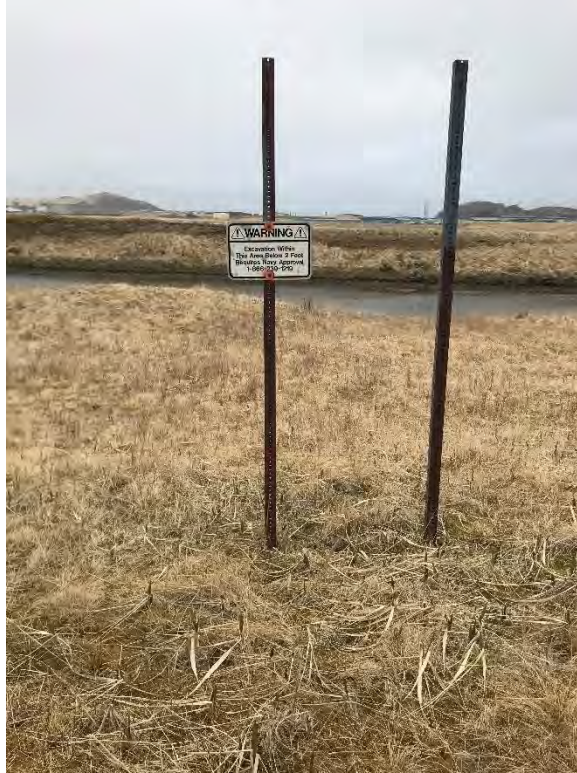
**Description:** Institutional  
controls sign on east end  
of Amulet Housing, Well  
AMW-706 Area.  
Downslope of this sign  
there is a petroleum seep  
present (see next image).

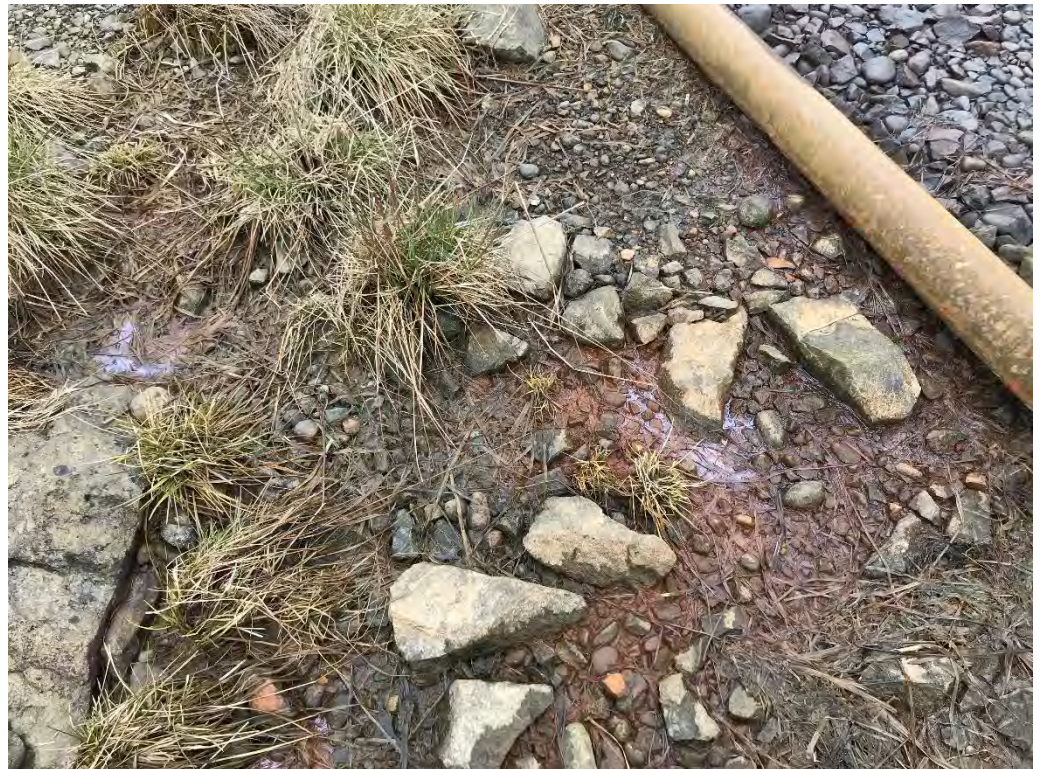
**Site Name:** Amulet  
Housing, Well AMW-706  
Area

**Description:** Petroleum  
seep downslope from  
Institutional control sign at  
Amulet Housing Well  
AMW-706 Area.

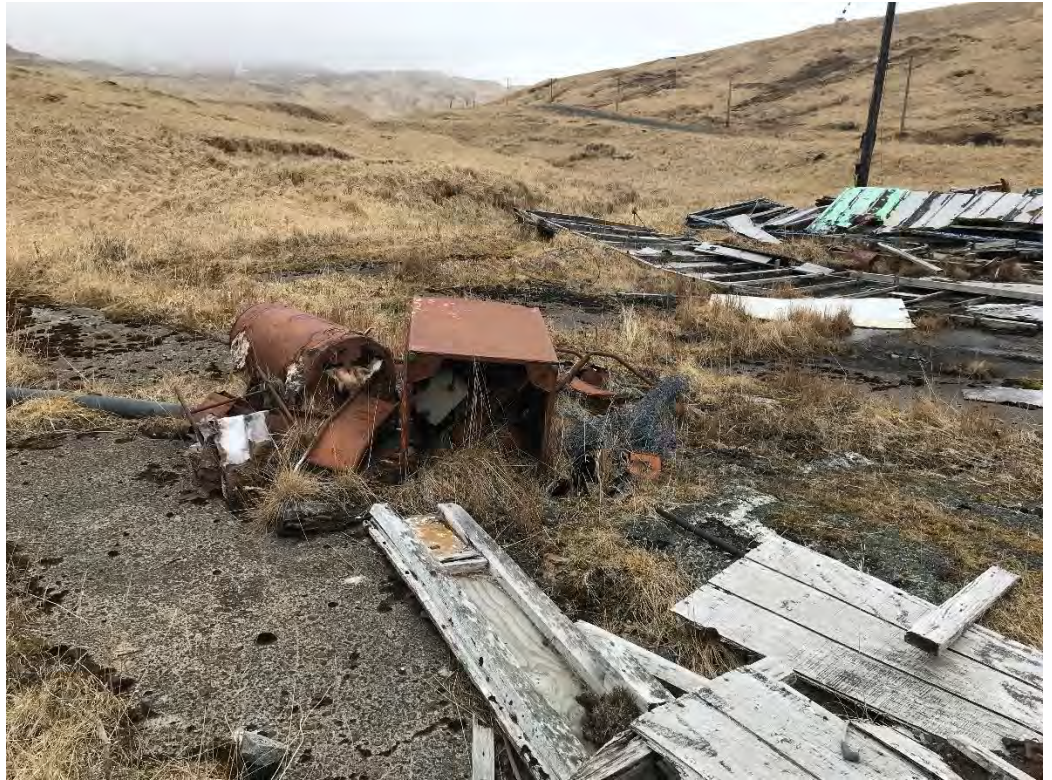
**Description:** Drum and  
scattered debris within the  
SA 86, Old Happy Valley  
Child Care Center Area.

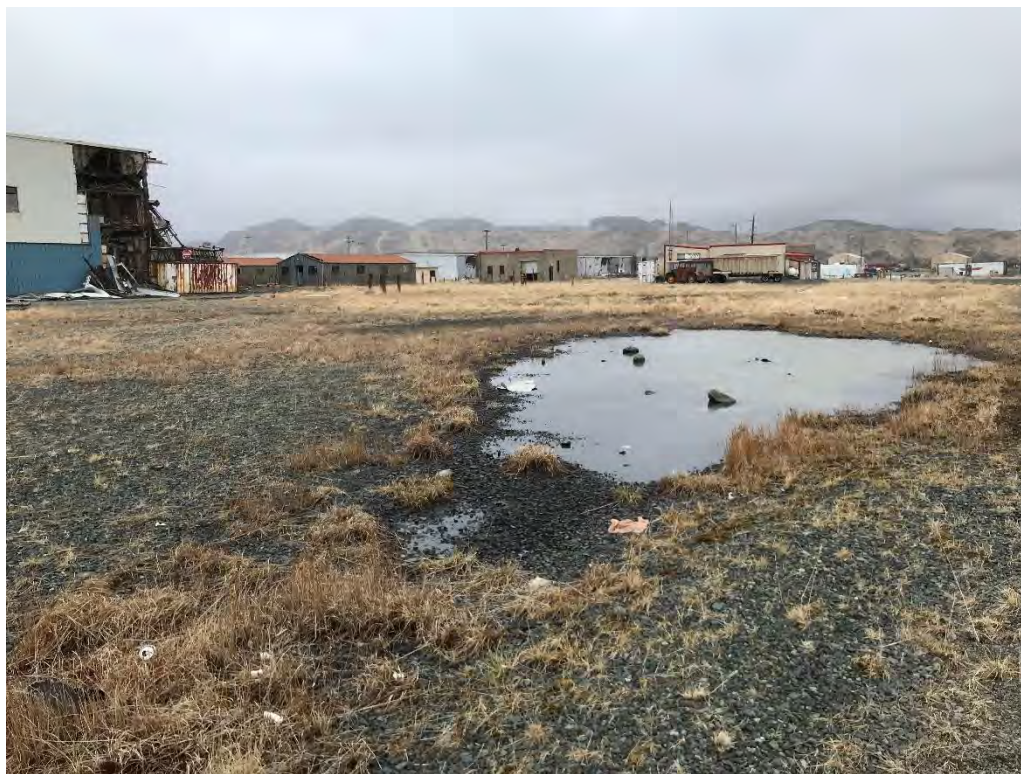
**Description:** Overview of  
SWMU 14, Old Pesticides  
Area. Photo taken on  
northwest end of site.  
Ponding within site is  
visible.

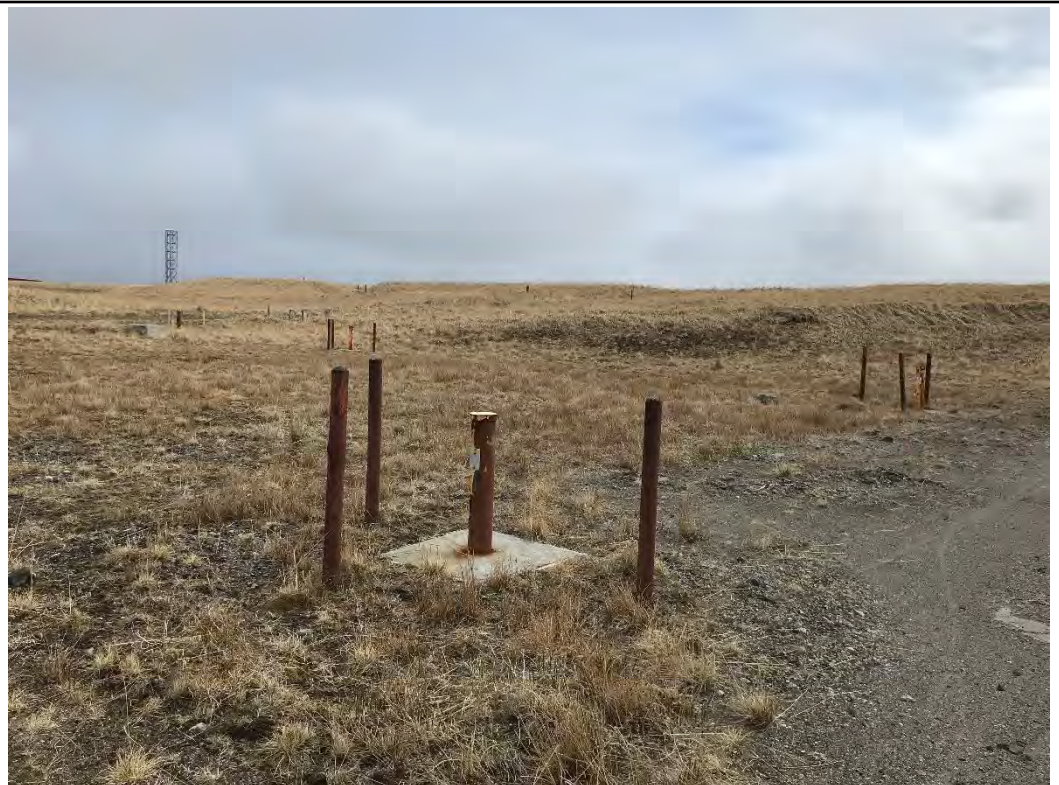
**Site Name :** SWMU 62,  
Housing Fuel Leak Area

**Description:** Well field at  
SWMU 62, Housing Fuel  
Leak Area just east of east  
canal.

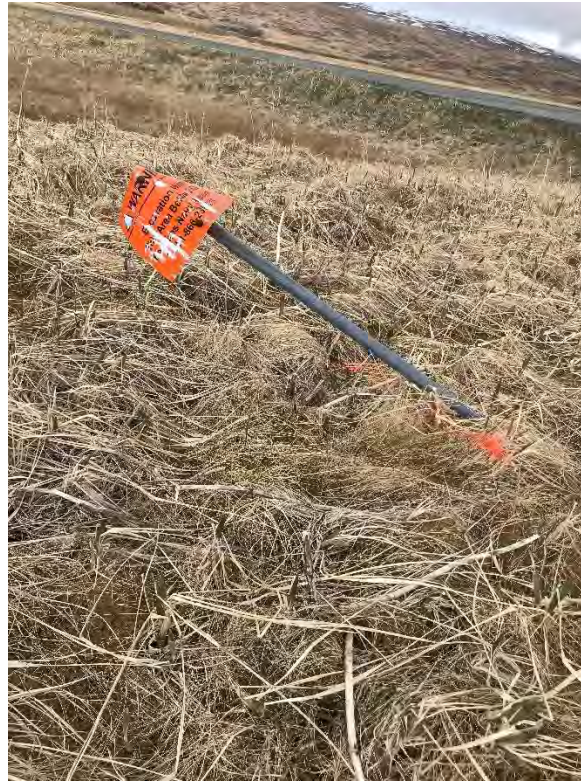
**Description:** Damaged  
sign within GCI  
Compound. Facing east  
canal.

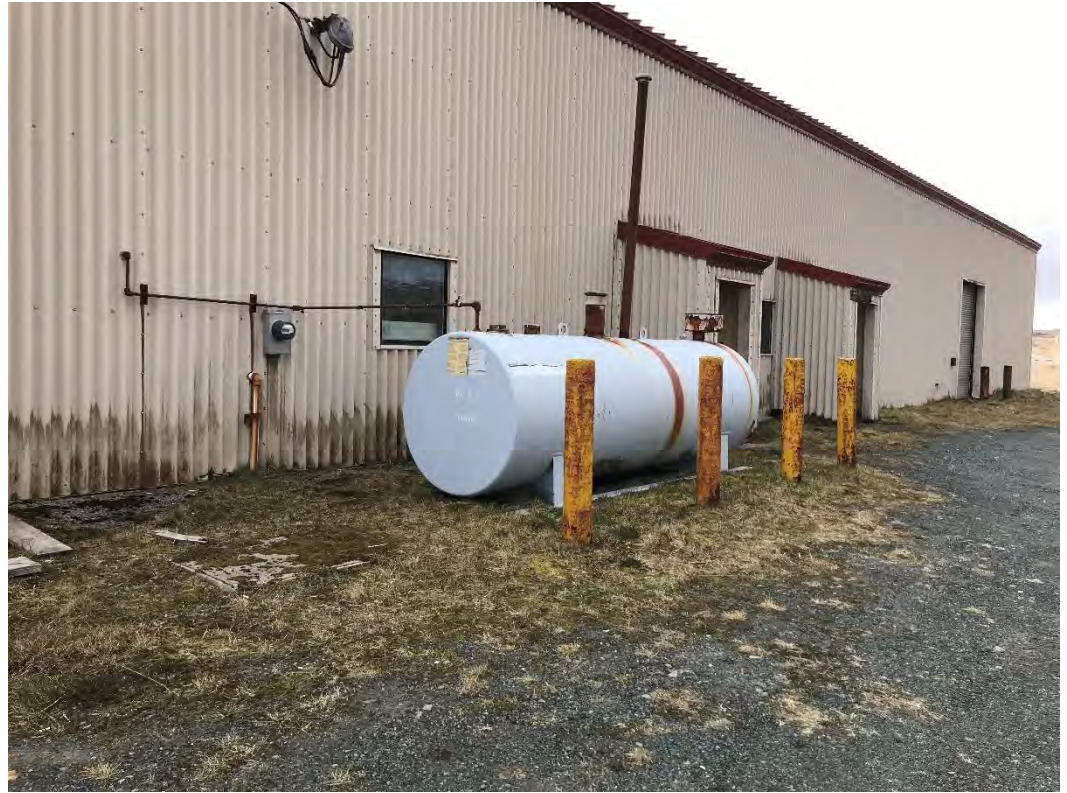
**Description:** UST located  
on north side of building T-  
2776 within GCI  
compound/Area 303 site.
